# INITIAL FIRE SAFETY INSPECTION REPORT

**Ahsan Apparels Ltd.**

**Factory ID: 24079**

**Date: 25 January 2021**

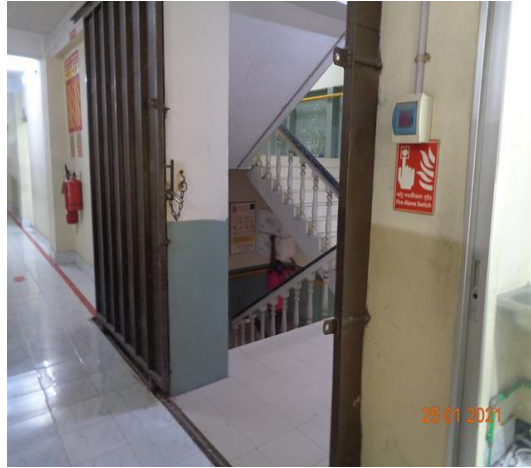
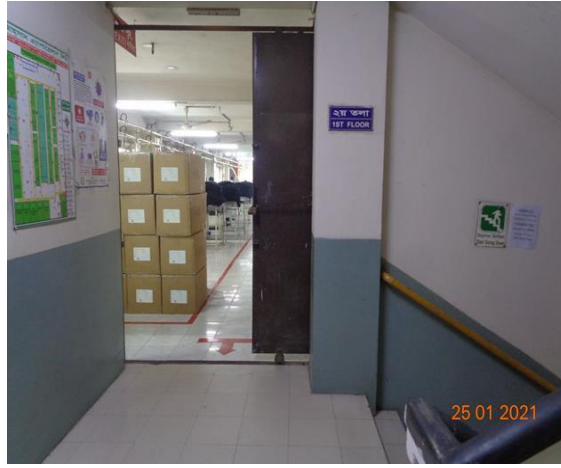
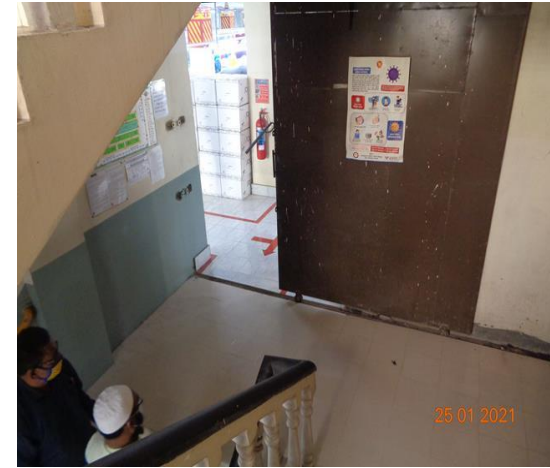
| SI No. | Category | Findings | Required Action | Remediation Time Frame |
|---|---|---|---|---|
| 1 | Fire-Rated Construction | The exit stairs are not separated from [work areas, other spaces] on each floor by fire-rated construction. | <p>Stair shall be enclosed with a minimum 2-hr fire-rated construction. Seal all unprotected openings and provide minimum 1.5 -hr. fire rated doors to separate the exit stairs from work areas and other building spaces on all floor levels. Ensure that the fire doors are self-closing, positive latching and that they are provided with fire exit (panic) hardware where serving production floors.</p> <p>If fire doors are required to be held open for functional reasons, provide automatic-closing devices tied to the fire alarm system.</p> | Within 3 months |

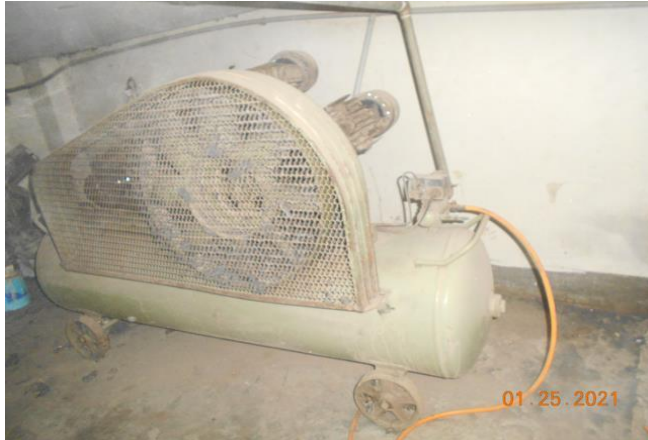
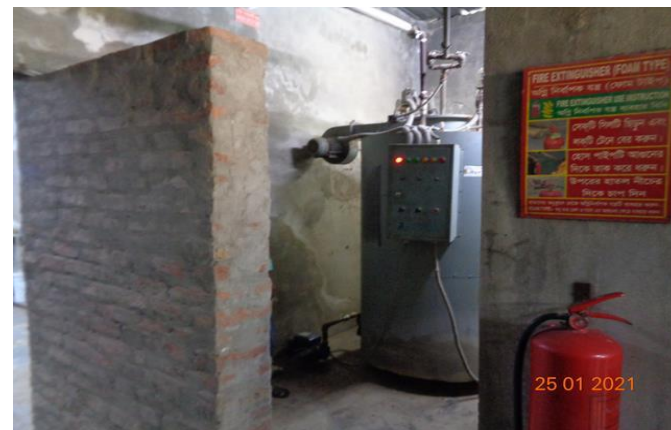
| 2 | Fire-Rated Construction | <p>The Boiler and Compressor room are not separated by fire-rated construction ((openings, non-rated doors, penetrations).</p> <p><b>Location:</b> Boiler at shed-1, compressor under the stair-2.</p> | <p>Separate the boiler room by a minimum 2-hr fire rated construction (for high rise building)/ 1-hr fire rated construction (for low rise building). Seal and/or protected all openings to maintain fire separations.</p> <p>Separate the air compressor room by a minimum 2-hr fire rated construction. Seal and/or protected all openings to maintain fire separations.</p> | Within 3 months |

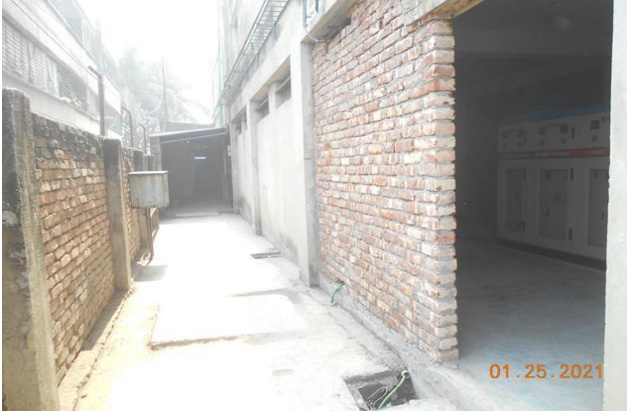
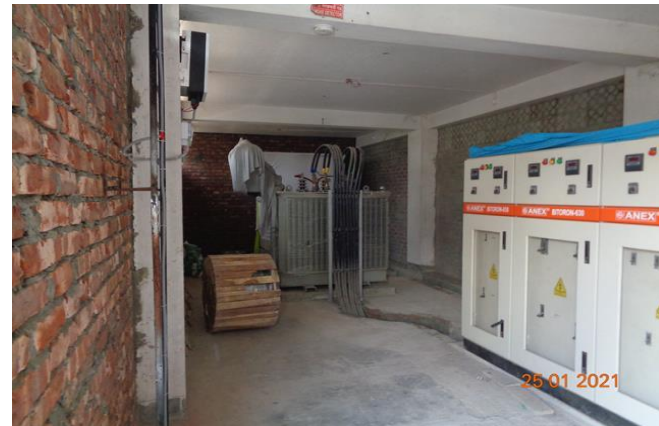
| 3 | Fire Rated Construction | Transformer & LT Panel (sub-station) are not properly separated by fire rated construction (openings, non-rated doors, penetrations).<br><b>Location:</b> Ground floor production building | Separate the transformer & LT panel room by a minimum 2-hr fire rated constructions. Seal and/or protect all opening to maintain the required fire separation. Provide proper ventilation system with consult a qualified engineer. | Within 3 months |

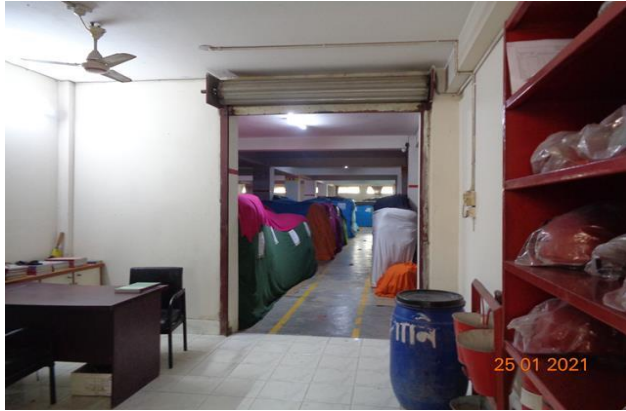
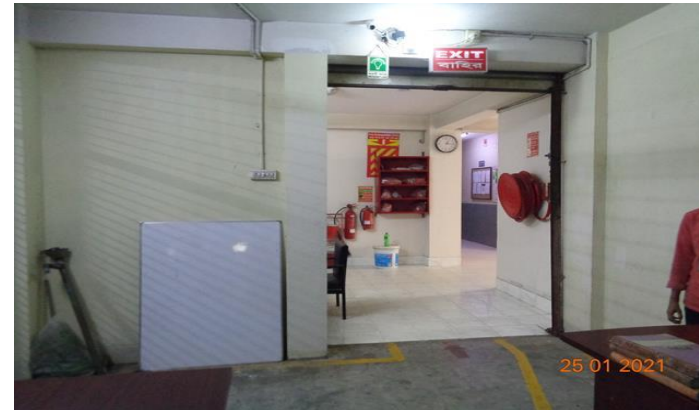
| 4 | Fire Rated Construction | <p>Areas used for combustible storage are not separated by fire rated construction.</p> <p><b>Location:</b> Ground floor fabric ware house and accessories storage room.</p> | <p>Provide dedicated storage rooms separated by minimum 1-hr fire-rated construction. Where separate storage rooms are not feasible, provide defined storage areas and limit the storage arrangement as follows: - Maximum height of 2.4m and maximum area of 23 m<sup>2</sup> - If sprinkler protected: maximum height of 3.66m and maximum area of 93 m<sup>2</sup> Separate areas of unenclosed combustible storage by a minimum clear distance of 3m.</p> | Within 3 months |

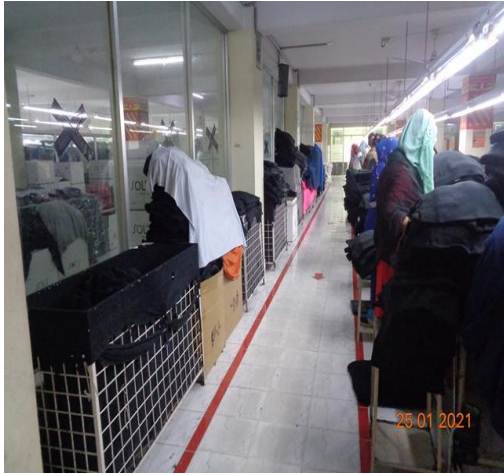
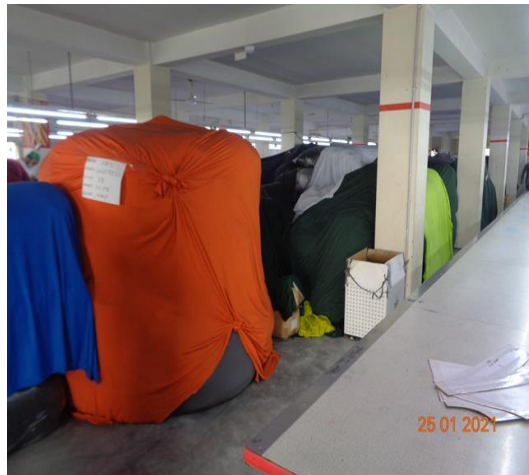
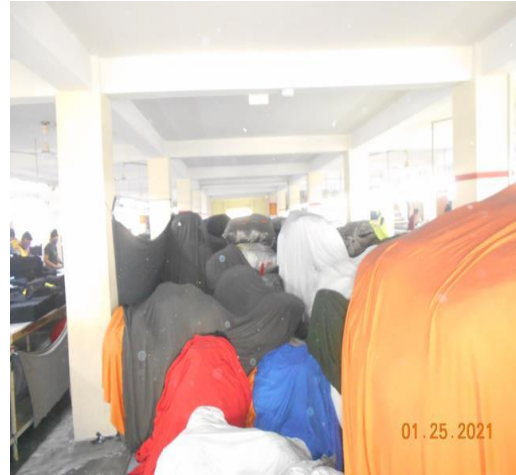
| 5 | Fire-Rated Construction | <p>Areas used (<b>in-process storage</b>) for combustible materials are open to the surrounding occupancy.</p> <p><b>Location:</b> First &amp; fourth floors at production building.</p> | <p>Provide defined storage areas and limit the storage arrangement as follows:-</p> <ol style="list-style-type: none"> <li>1. General Condition: Maximum height of 2.4m and maximum area of 23m<sup>2</sup>. Separate areas of unenclosed combustible storage by a minimum clear distance of 3m.</li> <li>2. If sprinkler protected: maximum height of 3.66m and maximum area of 93m<sup>2</sup>. Separate areas of unenclosed combustible storage by a minimum clear distance of 3m.</li> </ol> <p>or</p> <ol style="list-style-type: none"> <li>3. Enclose the storage area from the surrounding occupancy with a minimum 1 hour construction.</li> </ol> | Within 3 months |

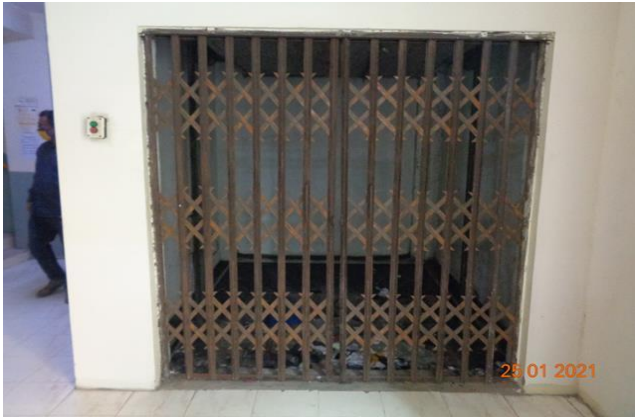
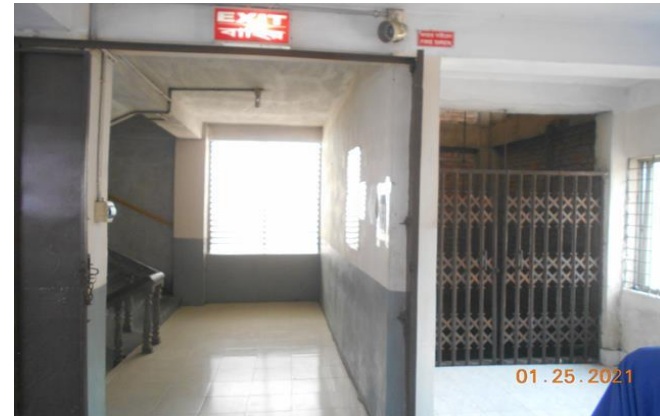
| 6 | Fire Rated Construction | <p>Elevator shaft is located inside the production floor and is not separated by proper fire rated construction (openings, non-rated doors, penetrations)</p> <p><b>Location:</b> North west stair at production building.</p> | <p>Provide a minimum 2-hr fire rated elevator shaft to separate it from each floor. Seal and/or protect all openings to maintain fire separations</p> | Within 3 months |

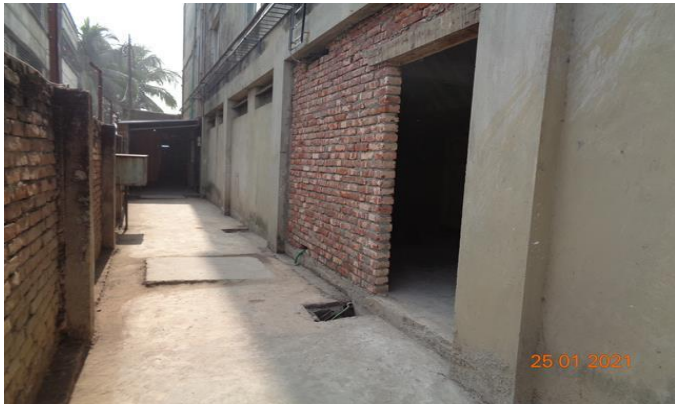
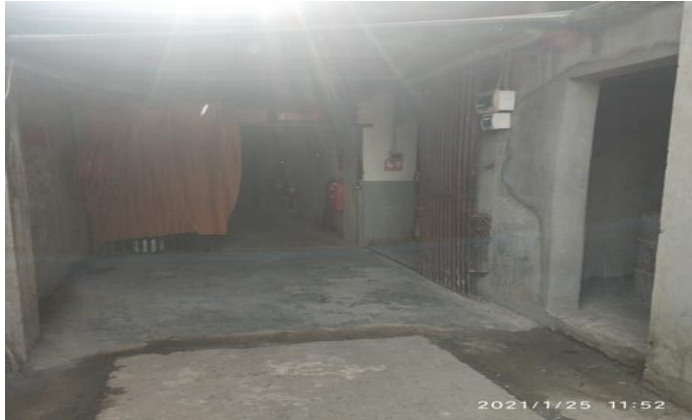
| 7 | Fire-Rated Construction | The South East exit discharge path is less than 10ft. wide and is not separated from the building interior. | Seal all penetrations and openings to the interior of the building along the discharge path, up to a height of 10 ft, to provide a minimum 1-hr fire separation. Alternatively, provide a second remote discharge path to the public way (only include this if feasible). | Within 6 months |

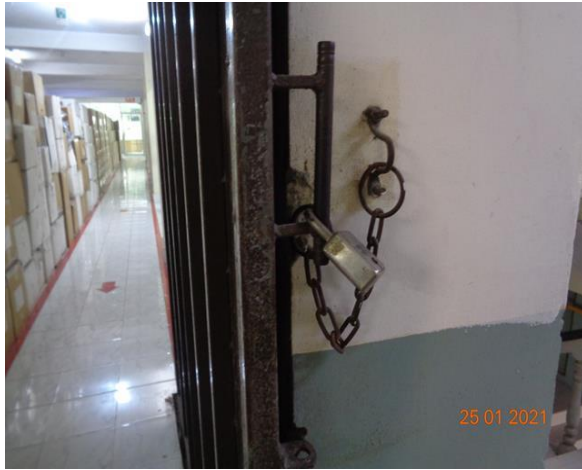
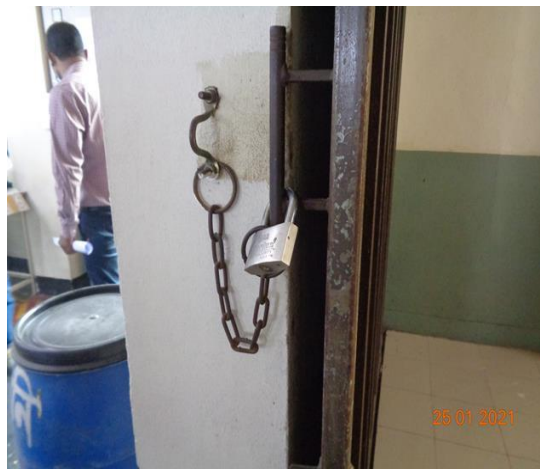
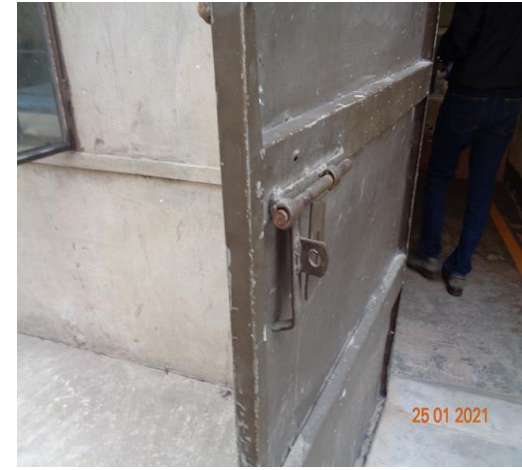
| 8 | Mean of Egress | Mean of Egress doors with locking features are provided along egress routes. Egress gates with locking features are provided at building exits and exit discharge. | Remove locking features from all egress doors and gates. If locks are required for security reasons, utilize special door locking features complying with NFPA 101. | Immediately |

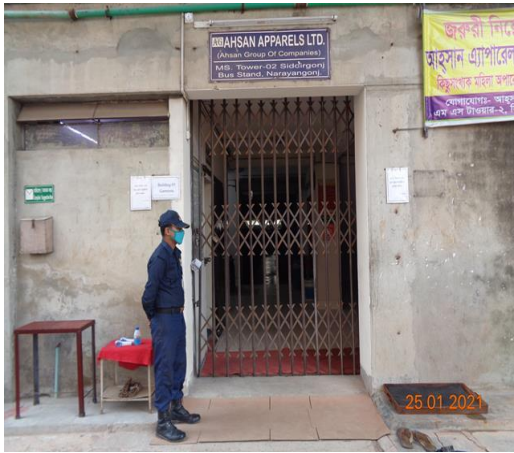
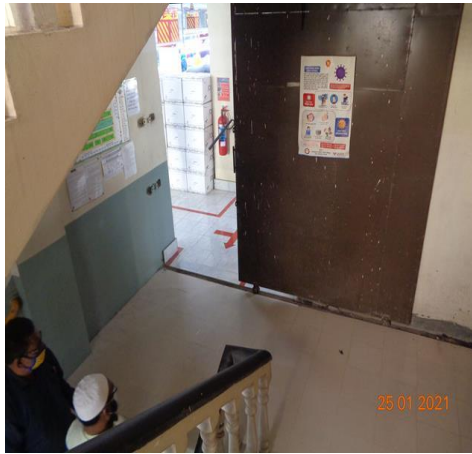
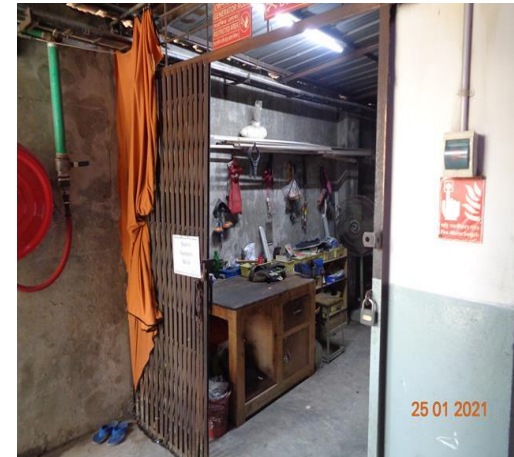
| 9 | Mean of Egress | Collapsible and sliding doors are provided at building exits, exit stair and along egress routes. | Replace all collapsible and sliding doors along the means of egress with side-hinged, swinging egress doors. If locks are required for security reasons, utilize special door locking features complying with NFPA 101. | Within 1 month |

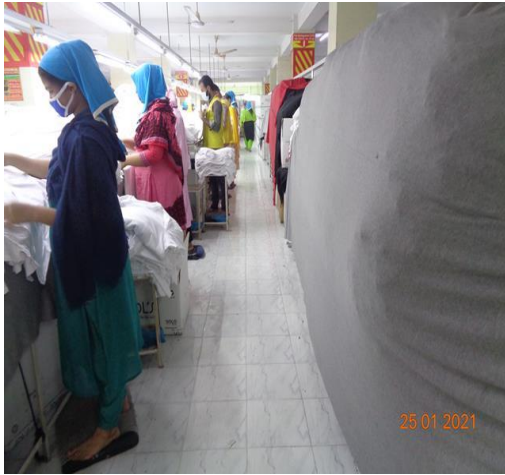
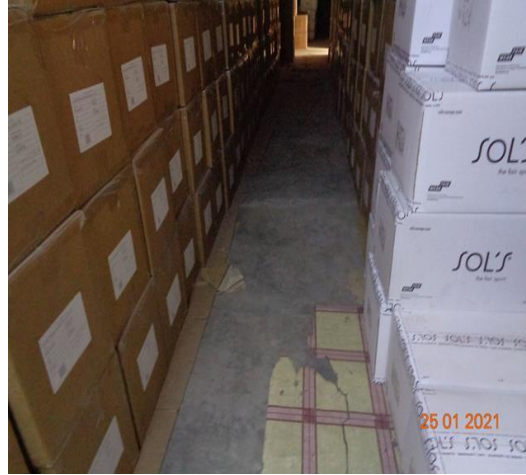
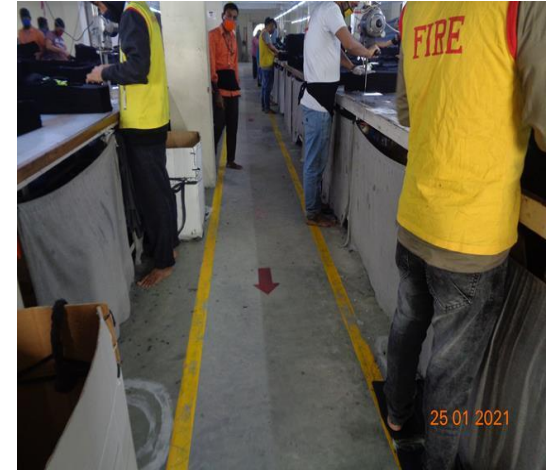
| 10 | Mean of Egress | <p>Width of aisles is less than 0.9m (36-in.) and aisles mark is not properly provided at 2nd floor and shed-2.</p> <p><b>Location:</b> 1st &amp; 4th floors of main building and Shed-2.</p> | <p>Aisles shall be provided with a minimum unobstructed clear-width of 0.9 m (36 in.).</p> | <p>Within 3 months</p> |

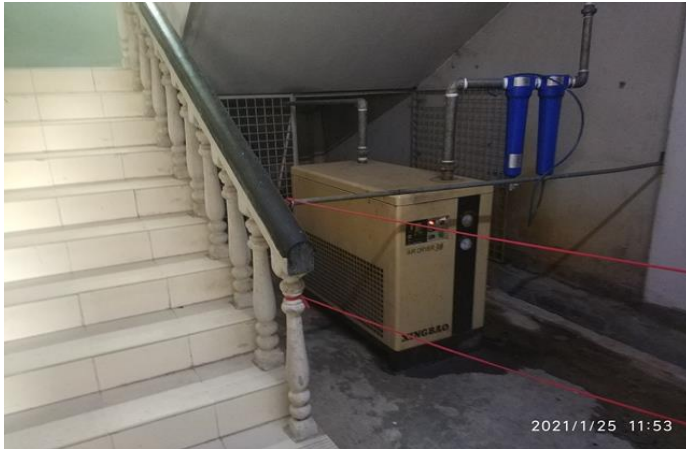
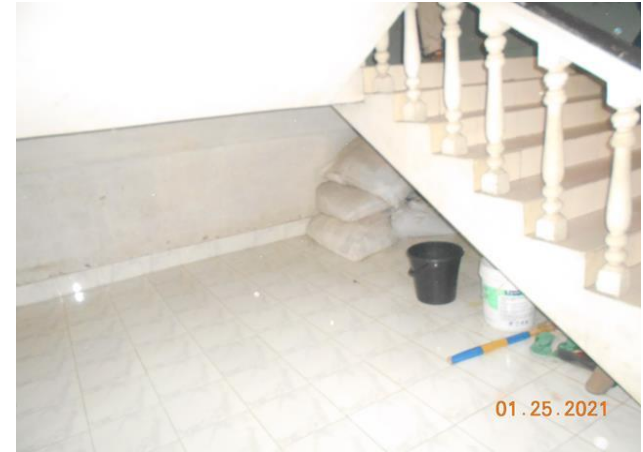
| 12 | Mean of Egress | Storage was located in exit stair.<br><b>Location:</b> Below staircase-1&2 on ground floor. | Remove all storage from exit stair enclosures. | Immediately |

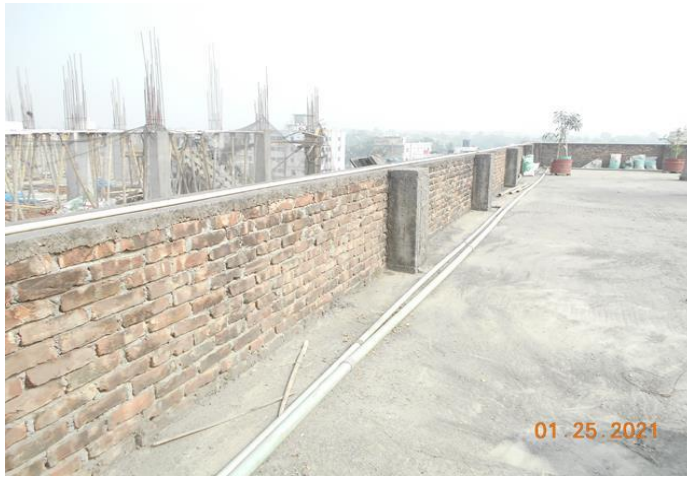
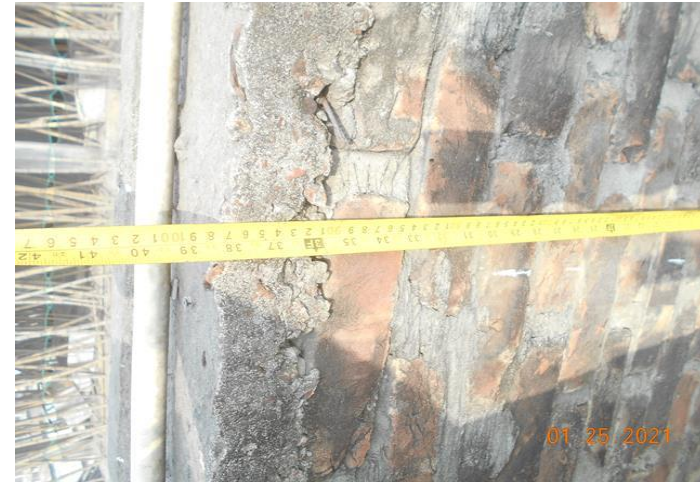
| 13 | Mean of Egress | Parapets or guards are provided in roof which is less than 1067mm (42 inch.). | All occupiable roofs shall be provided with parapets or guards with a minimum height of 1067 mm (42 in.) | Within 3 months |

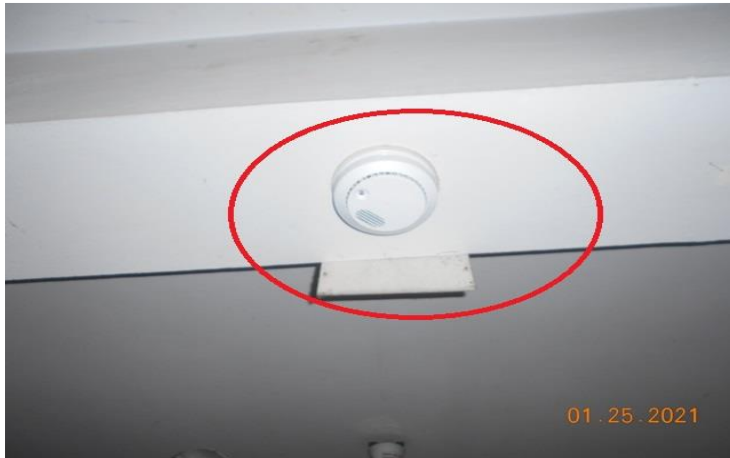
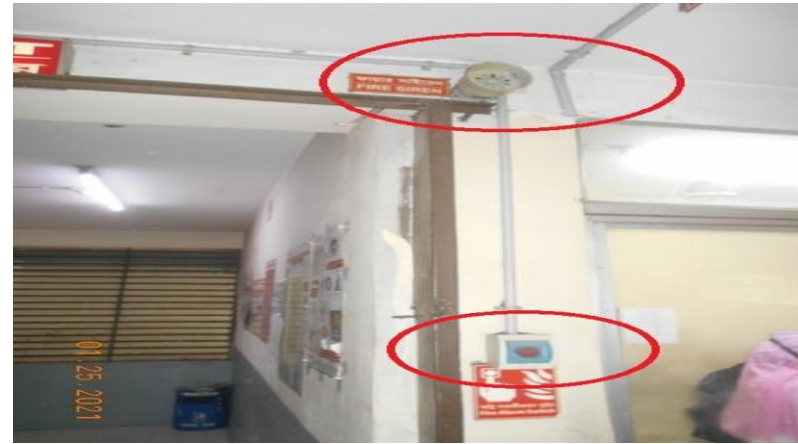
| 14 | Fire Detection & Alarm System | The fire detection system is antiquated, not a listed system, and does not provide alarm and notification features consistent with acceptable standards. | Replace the fire detection system with a new, listed addressable fire detection system in accordance with NFPA 72. | Design within 3 months and installation with 6 months |

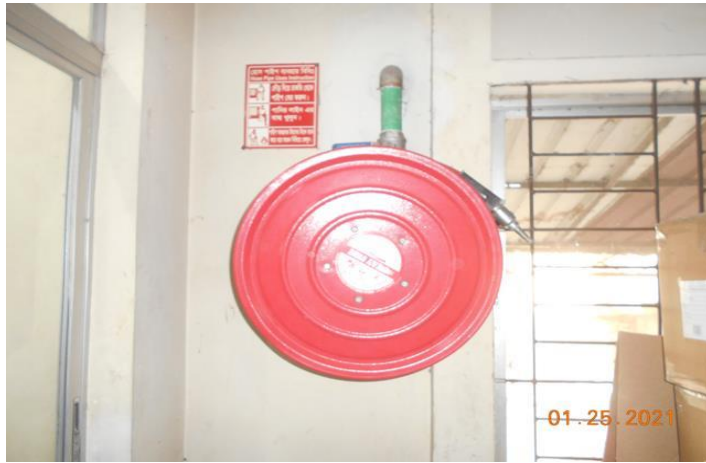
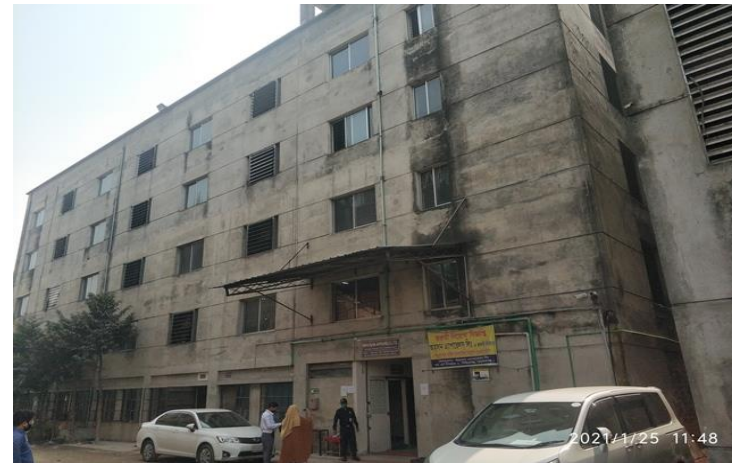
| 16 | Fire Protection | The existing building has an occupied floor greater than 10 meter (33 feet) and is not provided with standpipe system. | Provide Class-III or Class-1 & II standpipe system & fire department connection throughout the building in accordance with NFPA 14, 20,22 and 24. | Design within 4 months and installation with 9 months |

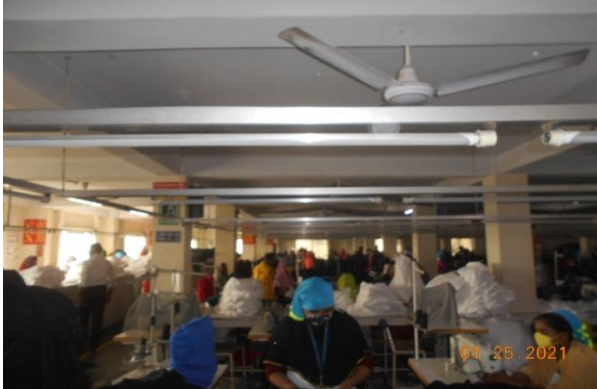
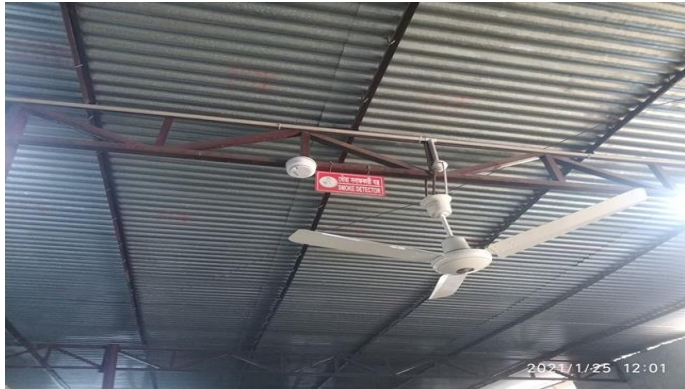
| 20 | Egress Lighting | Based on the number and location of emergency lights observed, adequate illumination levels are not anticipated along egress routes.<br><b>Location:</b> Main building & Shed-2. | Test the emergency lighting system on each floor and provide additional emergency fixtures to supply adequate illumination along the means of egress. Provide a minimum illumination of 10 lux at the floor level within exit stairs and along exit discharge paths and a minimum 2.5 lux along exit access aisles. | Within 3 months |

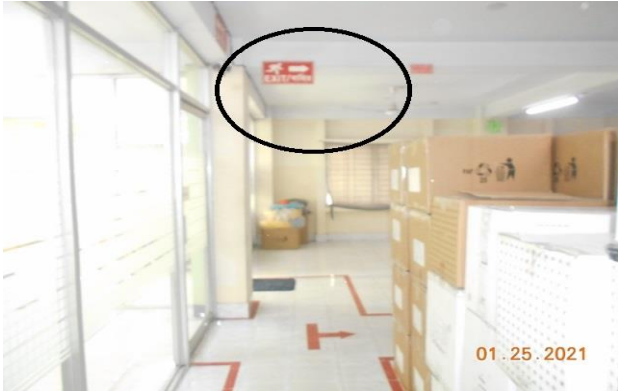
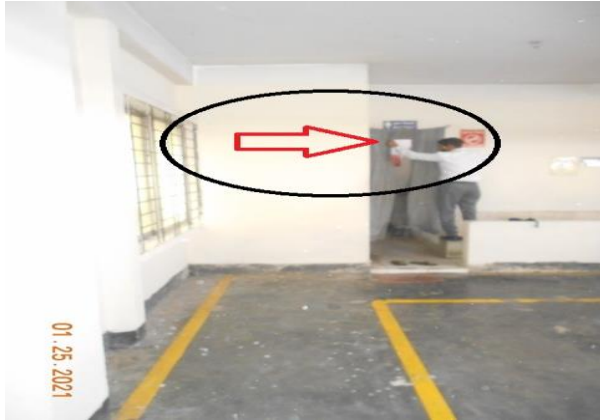
| 21 | Egress Lighting | <p>Illuminated directional signs are not provided where direction of the path of travel to an exit has changed.</p> <p><b>Location:</b> All floor of production building and shed-2.</p> | <p>Illuminated directional signs shall be provided where there is a change in the direction for the path of travel and the direction to an exit is not obvious.</p> | Within 1 month |
