# Ahsan Apparels Ltd.

M S Tower-2, Siddhirgonj, Narayanganj.

25<sup>th</sup> January 2021

# Building Information

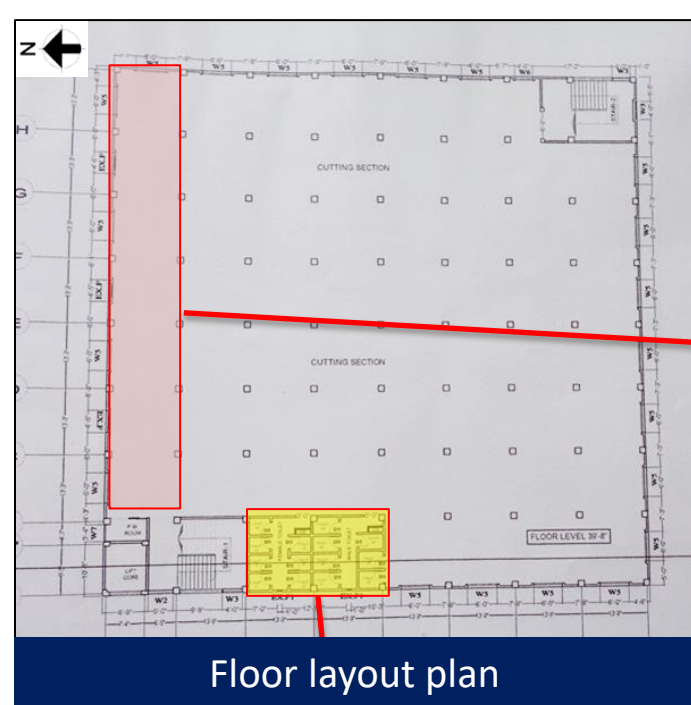
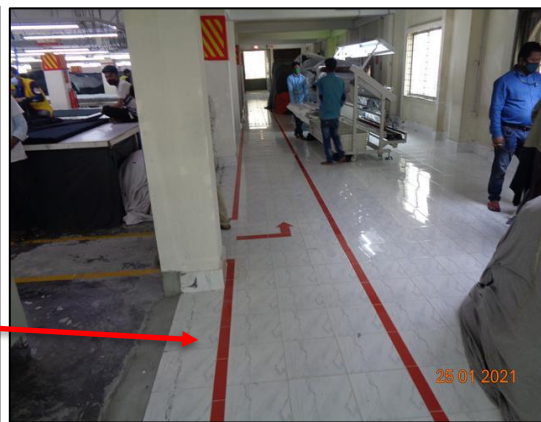
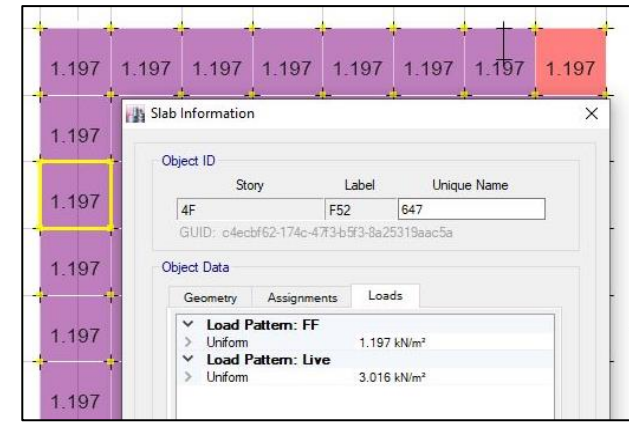
At 4<sup>th</sup> floor additional 50mm floor finishes was found applied on floor slab along the last grid of north side which increases the dead load. In as-built architectural drawing, the information has not been shown. Additionally, the build-up loading has not been incorporated in FEA model.

Building engineer is required to check the slab adequacy for this additionally imposed dead loads.

| Item No. | Observation | Recommended Action Plan | Recommended Timeline |
|---|---|---|---|
| 01 | Additional super imposed dead load on floors (Building -1). | Building Engineer to survey the structure and update the as-built (architectural and structural) drawings. | 6-weeks |
| 02 | Additional super imposed dead load on floors (Building -1). | Building engineer is required to check the slab adequacy for this additionally imposed dead loads. | 6-weeks |

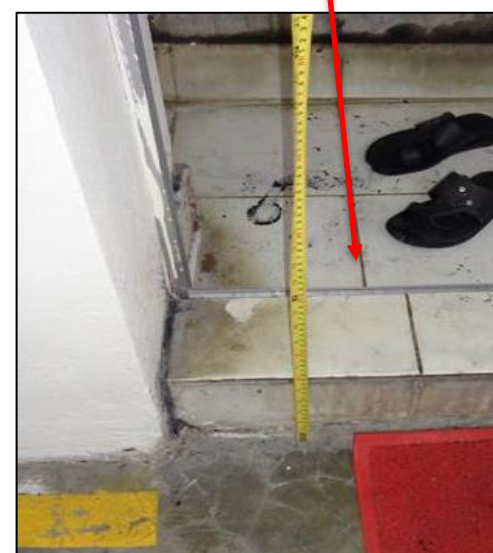
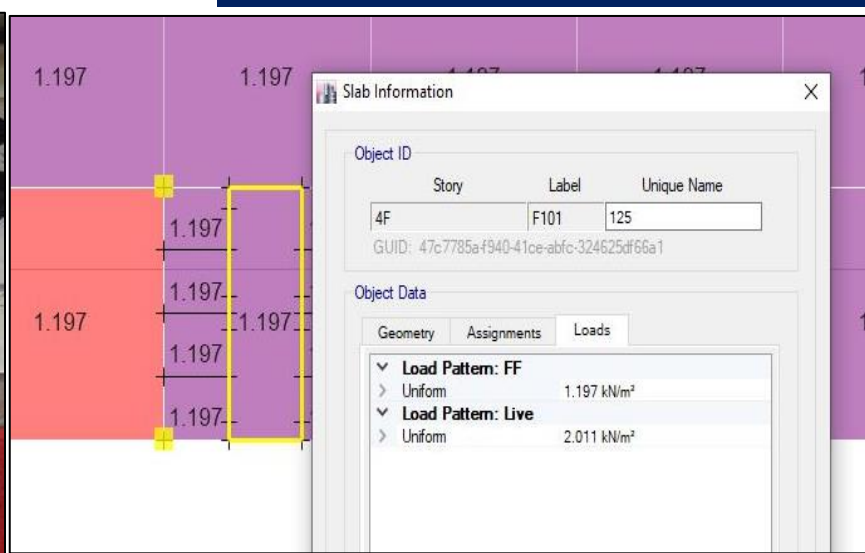
Undocumented 100 mm build up was found at toilet zone area. The build-up information has not been shown in as-built drawing. Also the loading from the build-up has not been incorporated in FEA model.

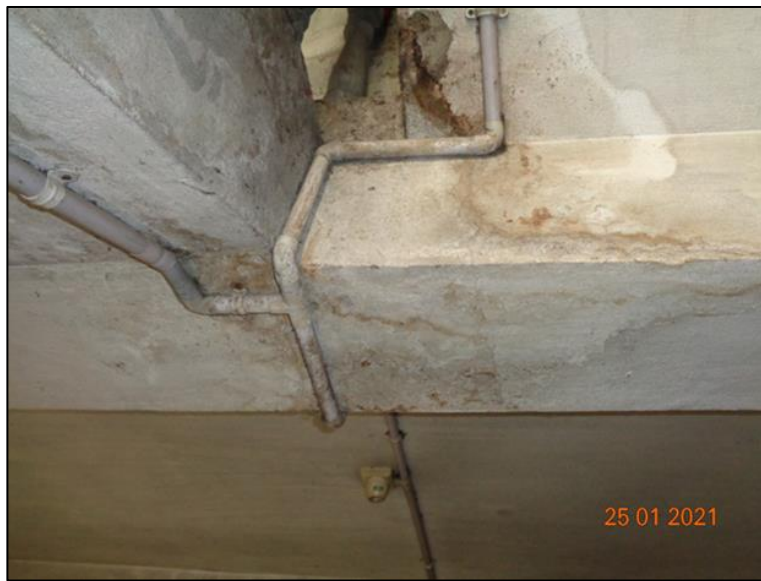
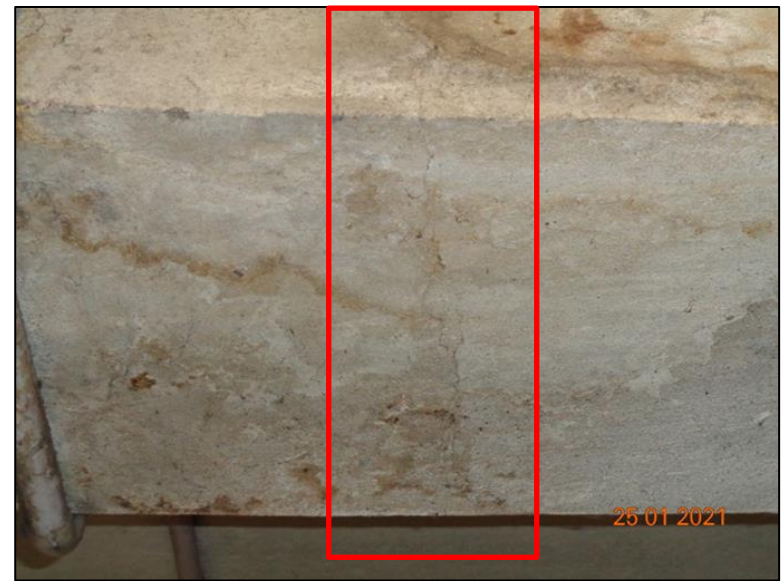
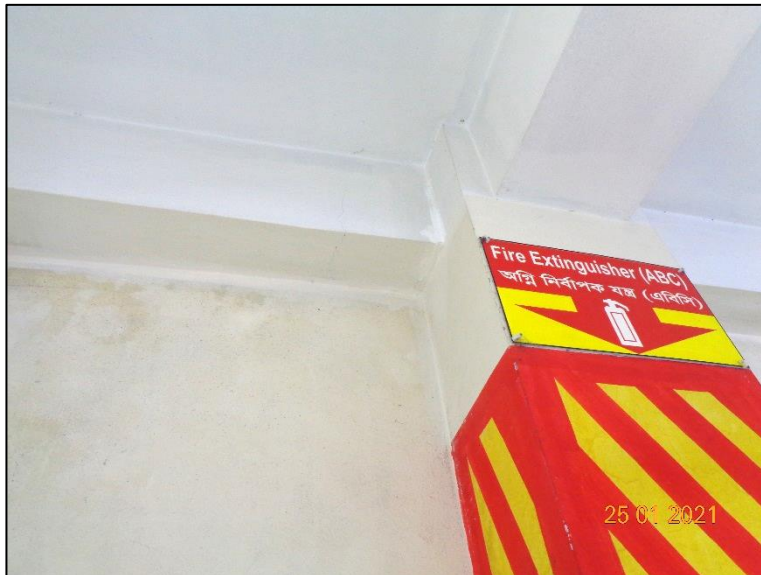
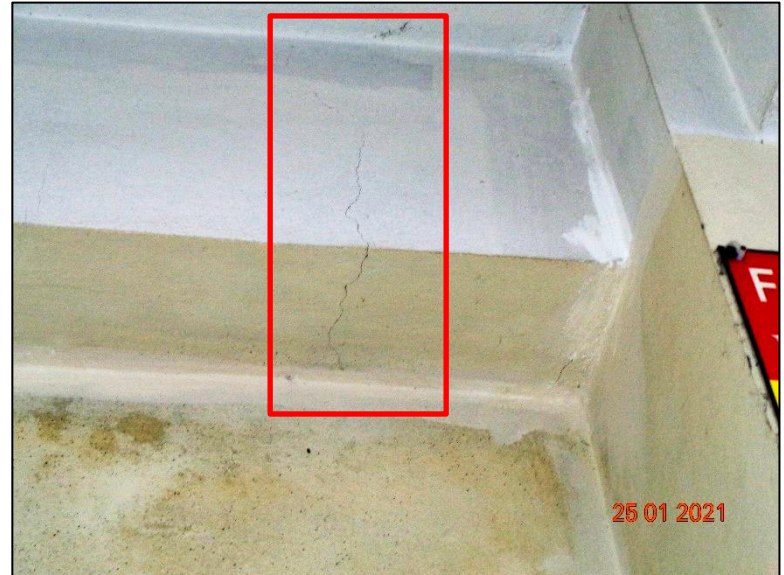
Hairline crack was found in the several beams. Building engineer is required to investigate the crack and carry out suitable repair works.

| Item No. | Observation | Recommended Action Plan | Recommended Timeline |
|---|---|---|---|
| 03 | Hairline cracks in beams (Building-1) | Factory engineer is required to investigate the cause of crack and repair the crack as per recommendation from investigation report. | 6-weeks |

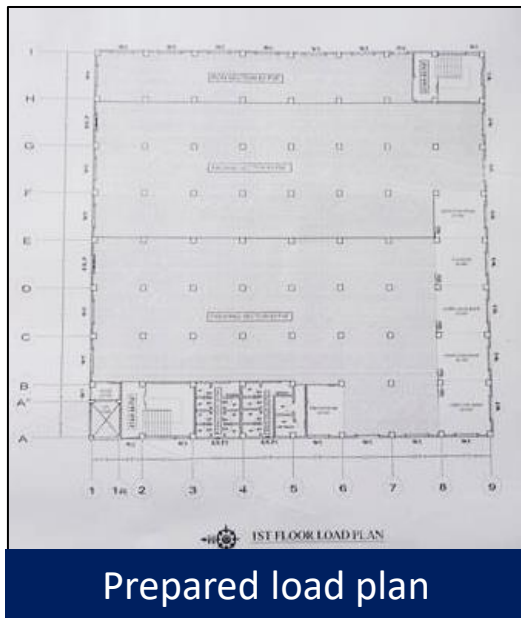
Prepared load plan

Factory prepared the floor live load plan. But load plan was not found posted in floors. Factory is required to post load plan in each of floor and load management program is required to implement effectively.

| Item No. | Observation | Recommended Action Plan | Recommended Timeline |
|---|---|---|---|
| 04 | Load plan not posted in floor (Building -1). | Post the floor live load plan in each of the floors and Implement the load management programs effectively. | 6-weeks |

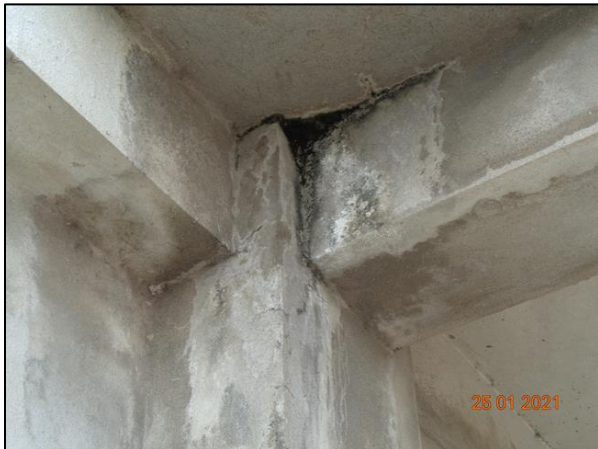
Dampness in Beam & Column

Due to leakage in the water supply line, water ponding found at rooftop and dampness was found at beam, column and roof top slab. Building engineer is required to take necessary measures to prevent the leakage in the water supply line. Also investigate the damp beam & column to verify if any damaged occurred due to the presence of the moisture in structural members.

| Item No. | Observation | Recommended Action Plan | Recommended Timeline |
|---|---|---|---|
| 05 | Water dampness due to leakage in water supply line (Building-1). | Factory management is required to take necessary measures to proof the leakage in water supply line. | 6-weeks |
| 07 | Water dampness due to leakage in water supply line (Building-1). | Factory engineer is required to investigate the damp beam & column to verify if any damaged occurred due to the presence of the moisture. | 6-weeks |

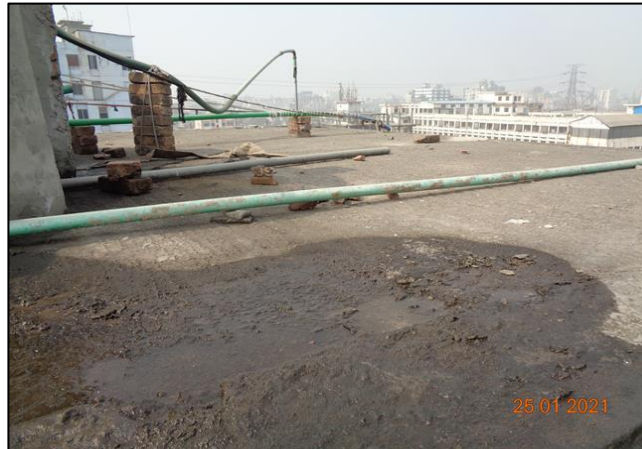
Dampness in roof top slab

| Item No. | Observation | Recommended Action Plan | Recommended Timeline |
|---|---|---|---|
| 06 | Water dampness due to leakage in water supply line (Building-1). | Improve the roof drainage system. | 6-weeks |

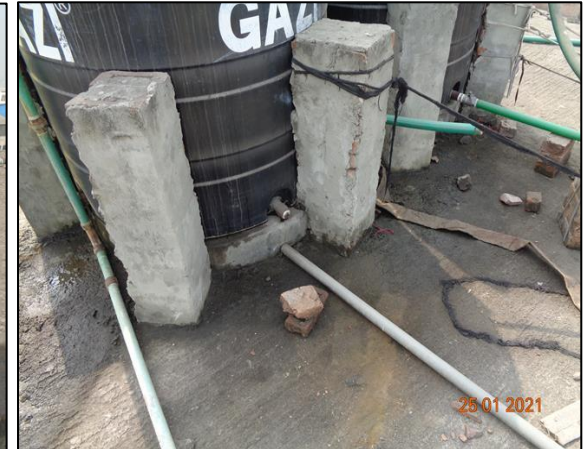
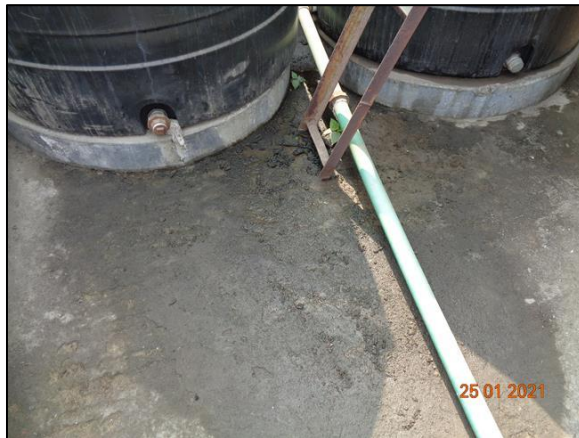
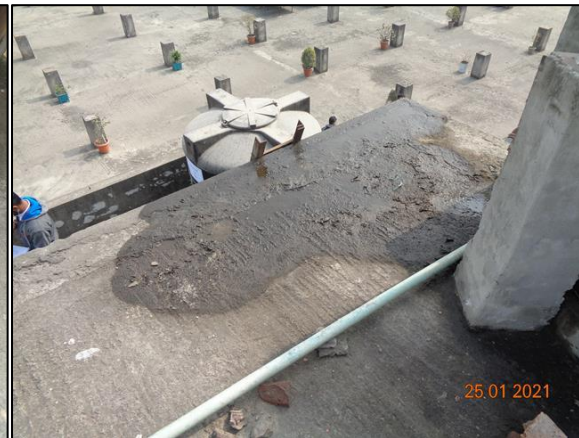
Dampness in roof top slab

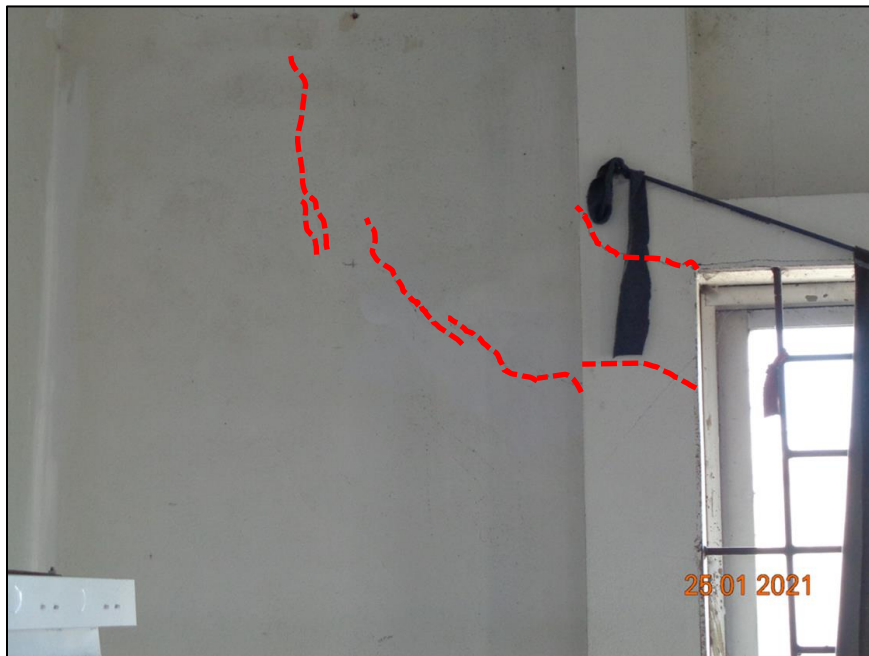
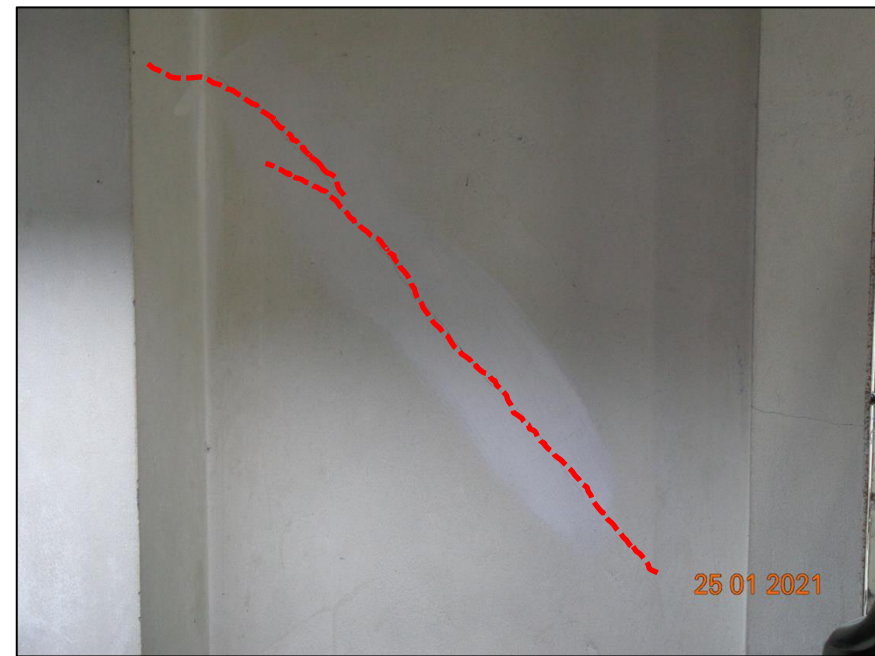
Crack in brick wall

Crack was found in several locations of brick wall. Factory engineer is required to investigate the cause of crack and repair the crack as per recommendation from investigation report.

| Item No. | Observation | Recommended Action Plan | Recommended Timeline |
|---|---|---|---|
| 08 | Cracks in Brick wall (Building-1) | Factory engineer is required to investigate the cause of crack and repair the crack as per recommendation from investigation report. | 6-weeks |

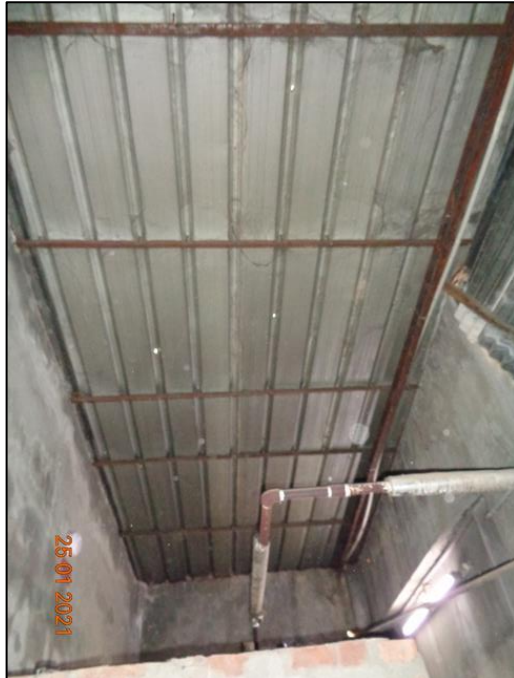
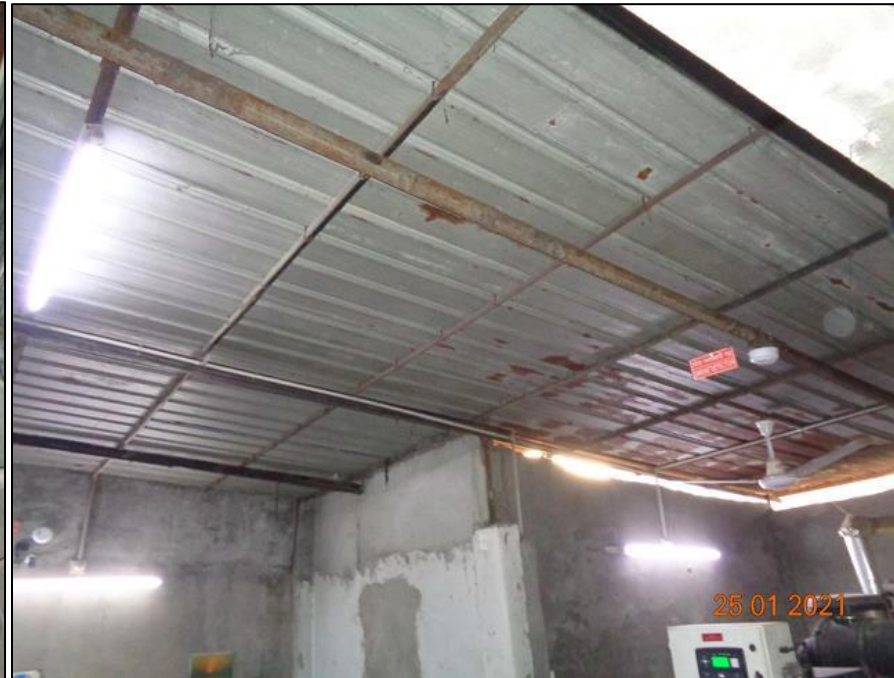
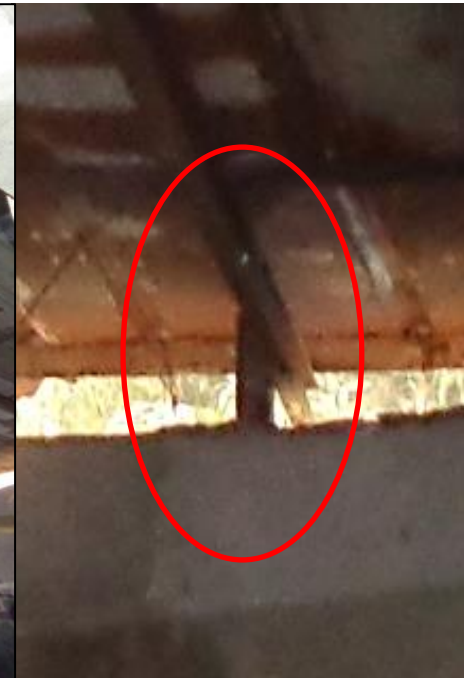
The steel roof made of C channel & angle section is supported by brick wall. Inadequate structural member, poor connection details observed. Apparently non-engineered shed.

| Item No. | Observation | Recommended Action Plan | Recommended Timeline |
|---|---|---|---|
| 09 | Apparently non-engineered shed. (Shed-1) | Building engineer is required to check the adequacy of the rooftop sheds for gravity and lateral forces. or Replace with the engineered sheds. | 6-weeks |
| 10 | Apparently non-engineered shed. (Shed-1) | Carry out remedial works where required. | 6-months |

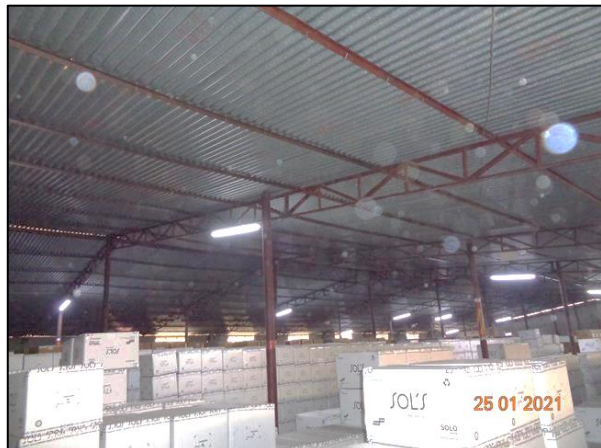
Truss roof System

The steel roof truss is supported by steel pipe column. There is no apparent load path to transfer the lateral loading along the long direction. The vertical & roof bracing was found missing. Poor connection details observed in the joints. Building Engineer is required to check the lateral stability of the steel shed.

| Item No. | Observation | Recommended Action Plan | Recommended Timeline |
|---|---|---|---|
| 11 | Lack of lateral stability (Shed-2) | Building Engineer is required to check the lateral stability of the steel shed. | 6-weeks |
| 12 | Lack of lateral stability (Shed-2) | Building engineer to prepare the Engineering Assessment (EA) including a design report, and a set of structural drawings in compliance with section 1.9.1.1 and section 1.9.1.2 as per BNBC. | 6-weeks |

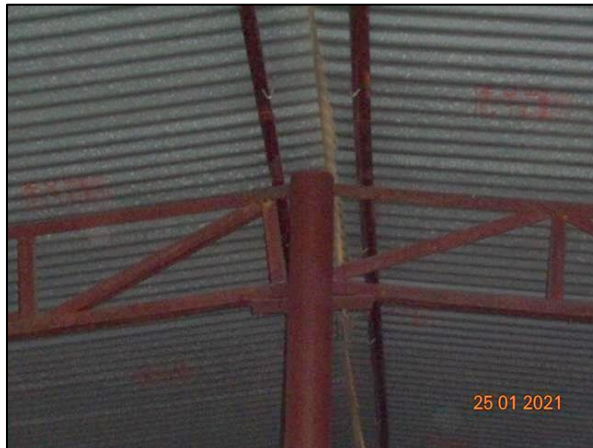
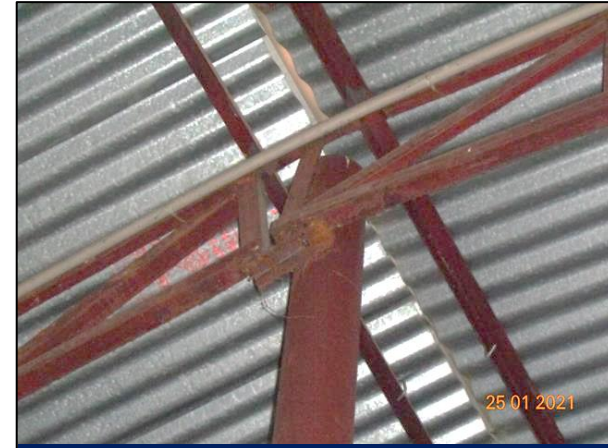
Poor connection details

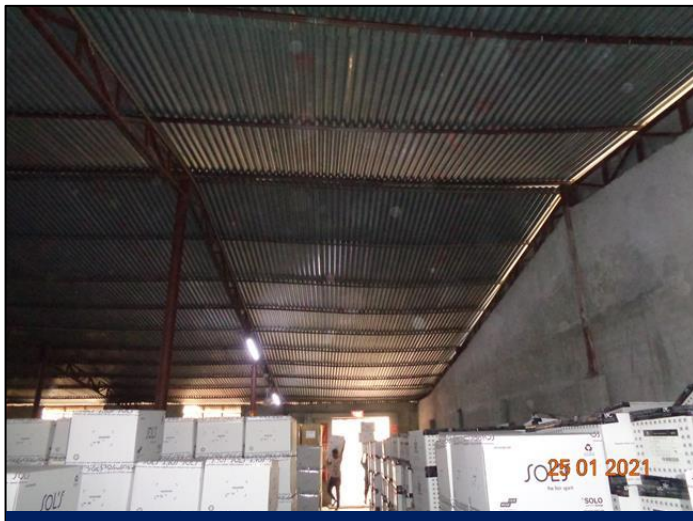
Purlin was found sagging

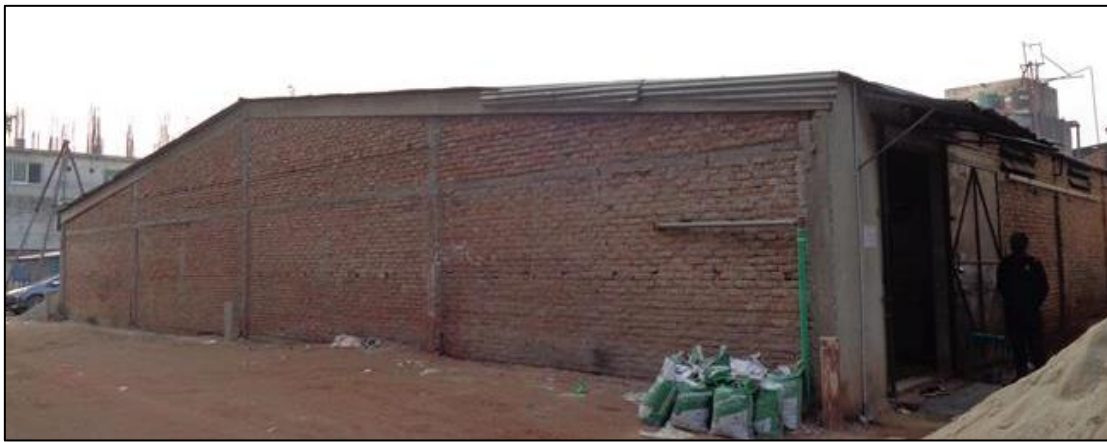
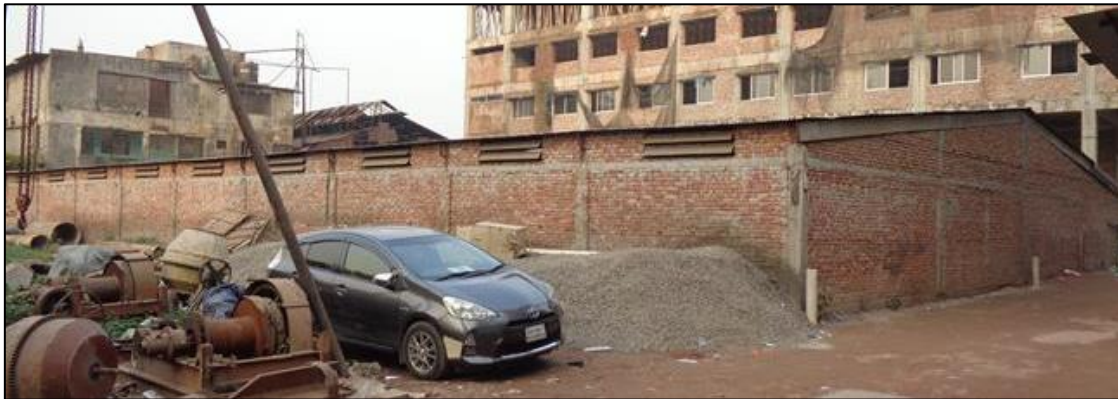
There were no credible as-built drawings and documents to review for the steel shed.

Factory engineer is required to survey the structures and prepare as-built drawings that are in compliance with section 1.9.1.2 as per BNBC.

| Item No. | Observation | Recommended Action Plan | Recommended Timeline |
|---|---|---|---|
| 13 | Lack of as-built drawings (Shed-2) | Building Engineer to survey the structure and prepare accurate as-built (both architectural & structural) drawings in compliance with section 1.9.1.2 as per BNBC. | 6-weeks |

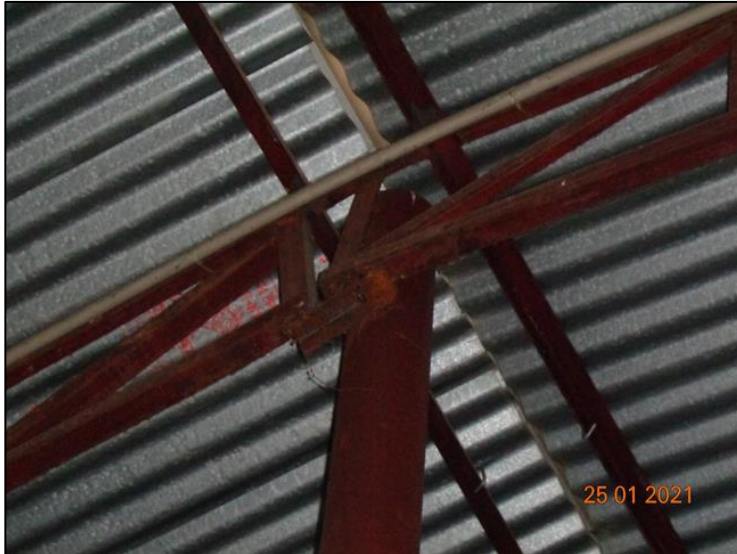
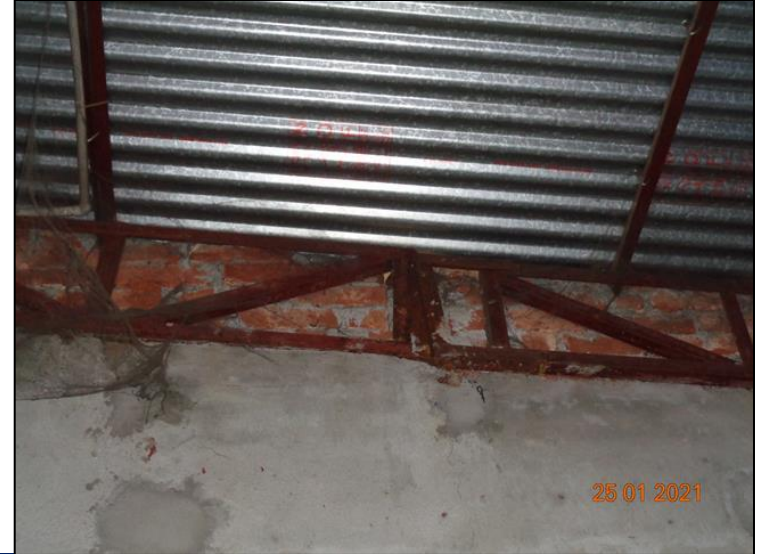
Corrosion in steel column

Corrosion was found in the steel truss members. Factory is required to apply rust proofing on the corroded areas to protect the steel members from corrosion.

| Item No. | Observation | Recommended Action Plan | Recommended Timeline |
|---|---|---|---|
| 14 | Corrosion in steel column (Shed-2) | Factory is required to take necessary actions to protect the steel members from corrosion. | 6-weeks |
