Unisense Apparels Ltd (Extension)

Beraider Chala, Sreepur, Gazipur
(24.20003, 90.42065)

26th January 2021

Observations

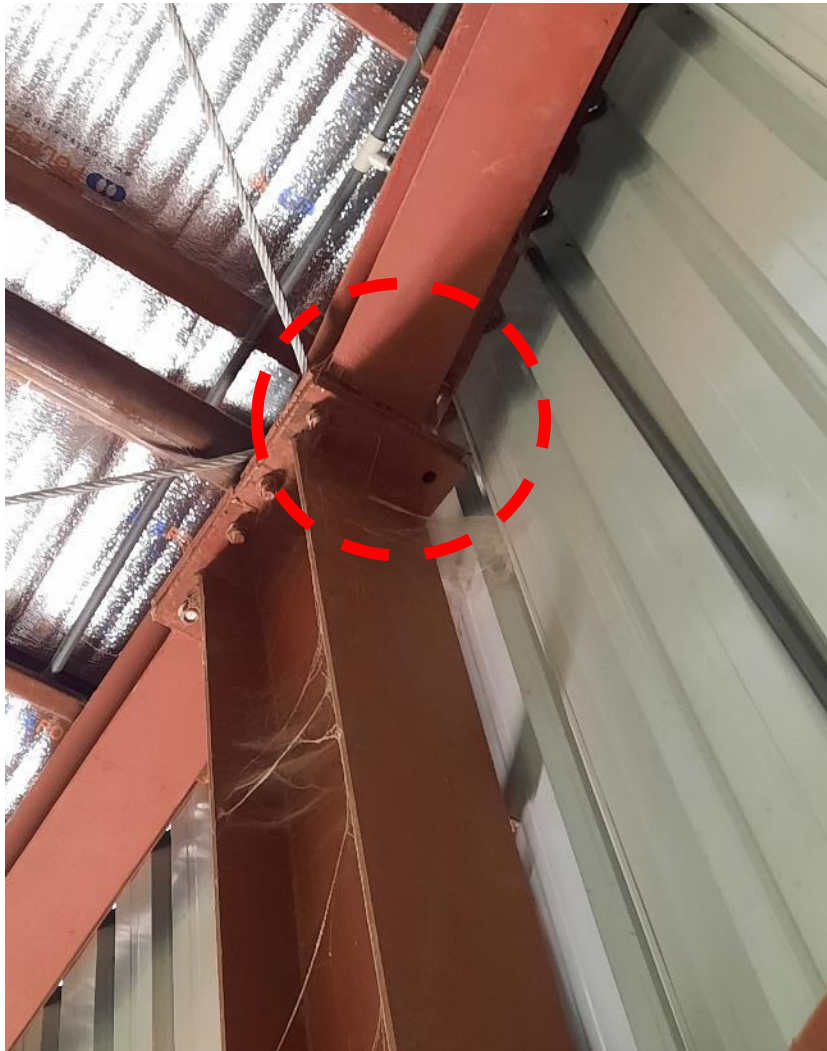
Bolts missing & faulty connection

Missing bolts in the connection

Item No.	Observation	Recommended Action Plan	Recommended Timeline
05	Bolts missing & faulty connection. (Knitting Section)	Building engineer is required to check the adequacy of the column and rafter joints at that location.	6-weeks
06	Bolts missing & faulty connection. (Knitting Section)	Carry out remedial works where necessary.	6-months
07	Corrosion on external steel stair. (Knitting Section)	Apply rust proof paint to the corroded members.	6-weeks
08	As-built drawings not available onsite. (Boiler & Compressor Room)	Building engineer to survey the structure and prepare accurate as-built structural drawings.	6-weeks
09	Exposed rebar at roof top. (Boiler and Compressor Room)	Apply rust proof paint or material to the rebar of column, beam & slab.	6-weeks

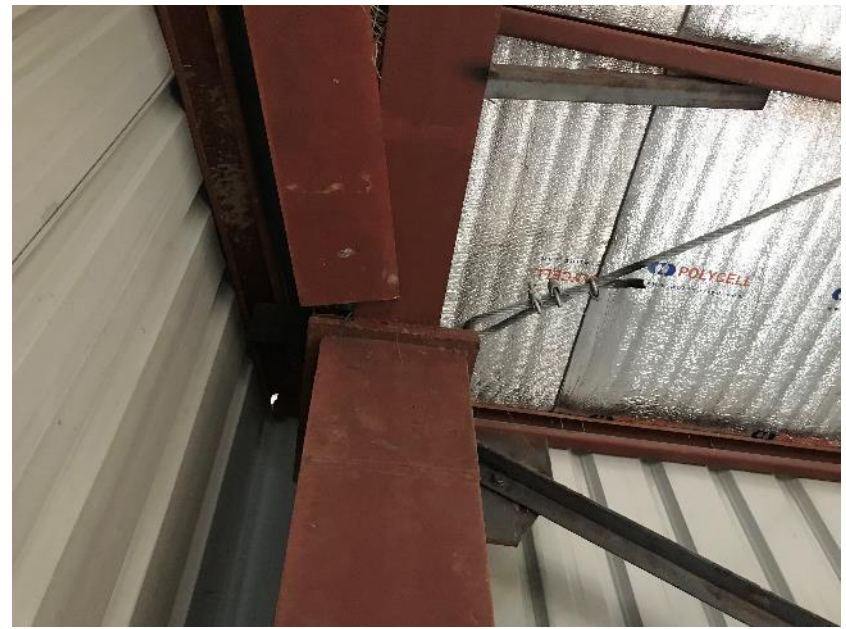
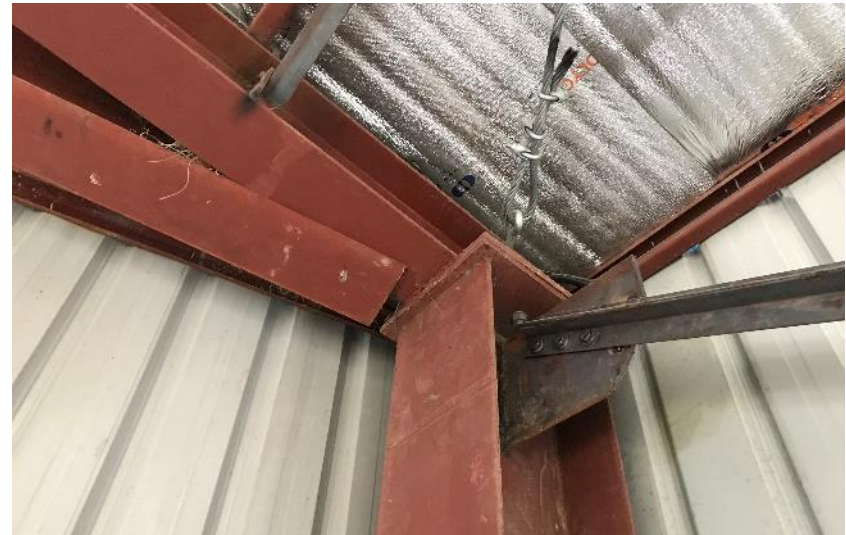
Improper connection observed at rafter and column joint.

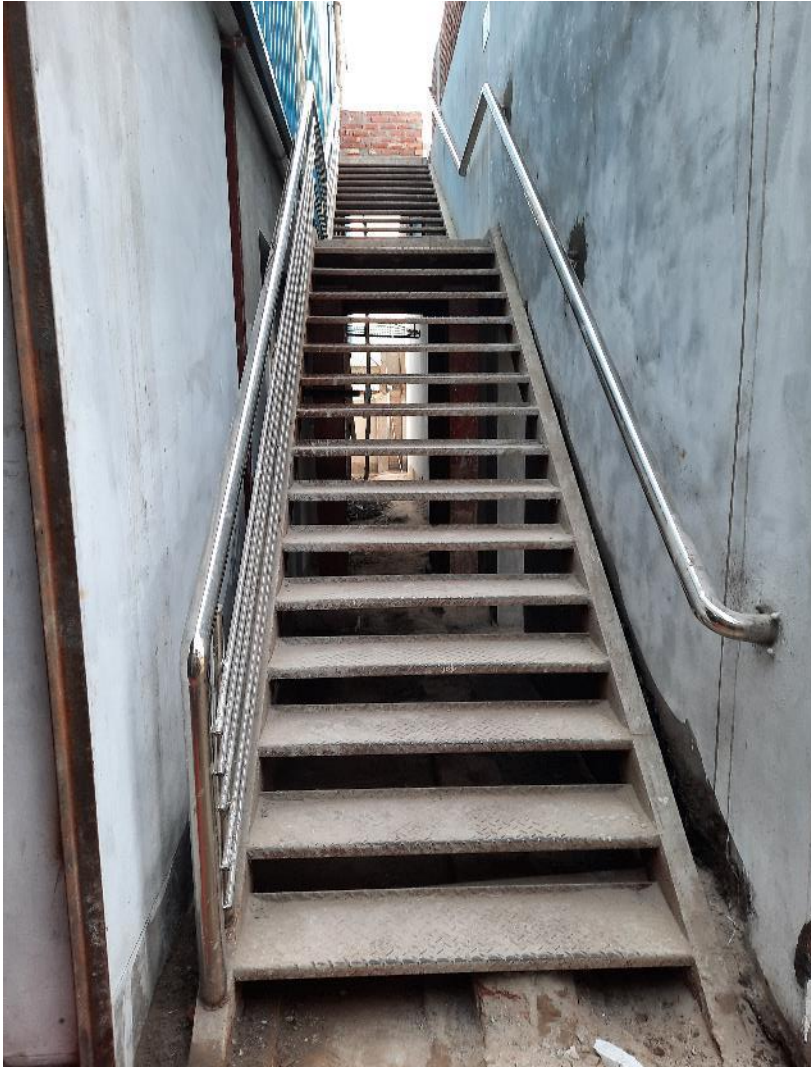
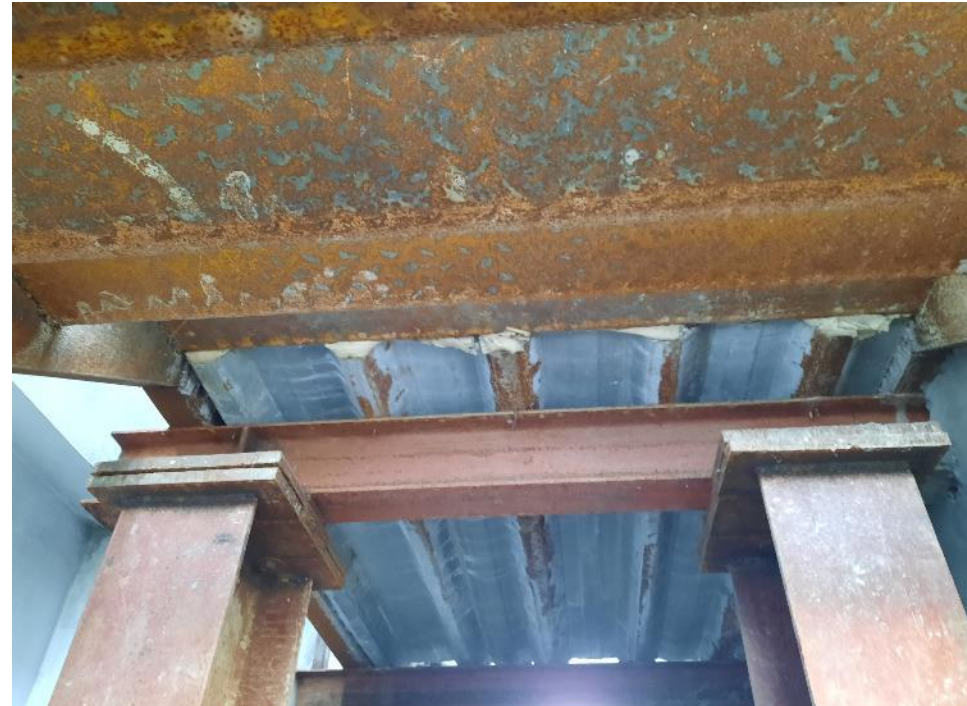
Corrosion on external steel stair

Corrosion observed on the external steel stair. Building engineer is required to provide rust proofing to the steel member.

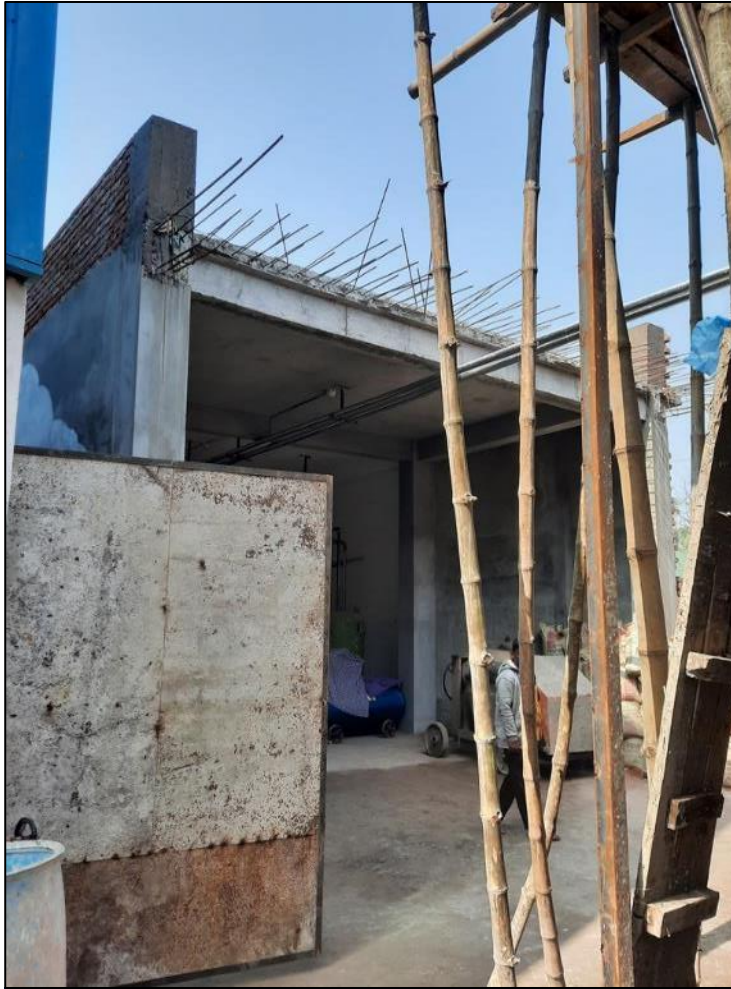
Exposed rebar at roof top

Exposed rebar of beam and slab

Exposed rebar observed at roof top of boiler and compressor room. Building engineer is required to provide rust proofing to these exposed rebar.

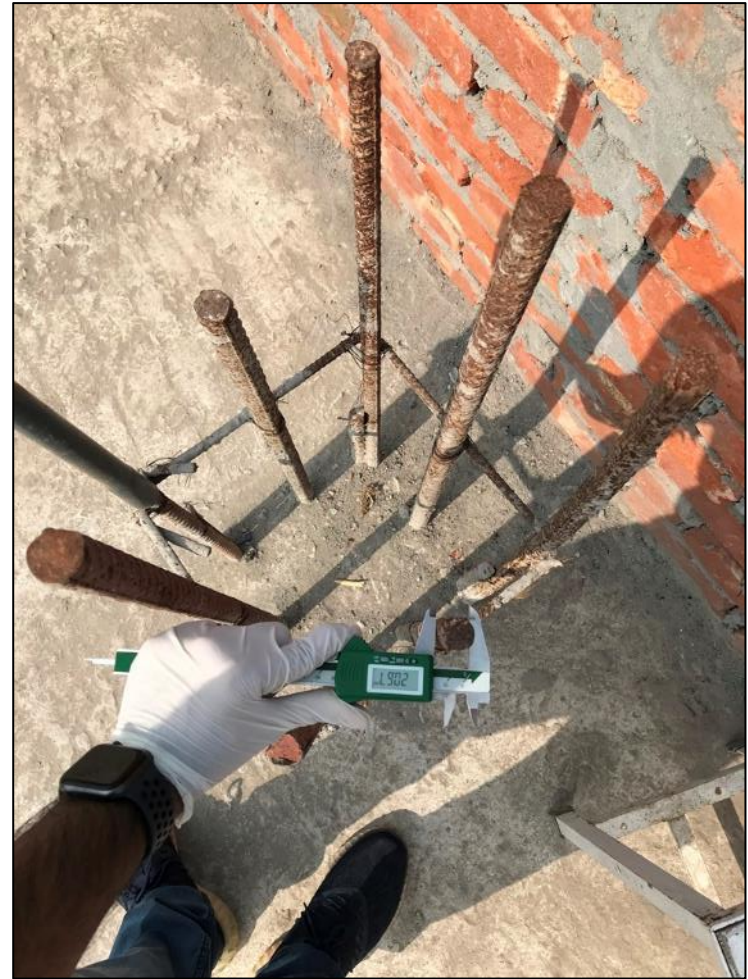
Exposed rebar of column at roof
