# Debonair Limited (extension)

Gorat, Ashulia, Savar, Dhaka.

29th December 2020

# Building Information

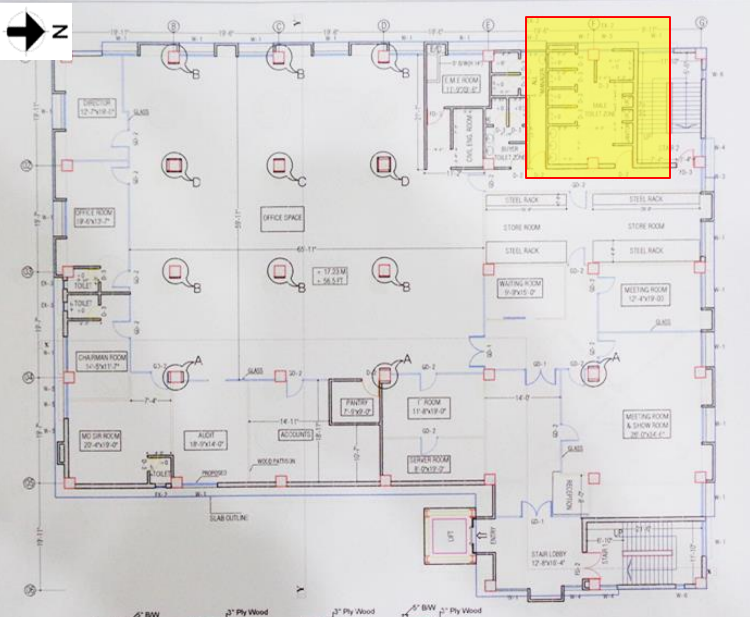
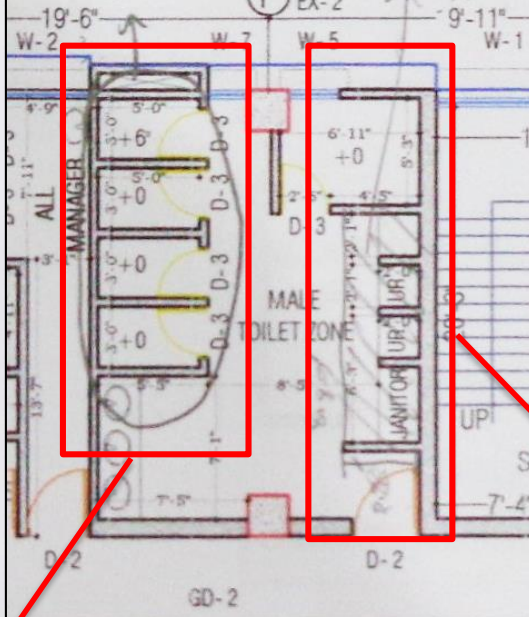
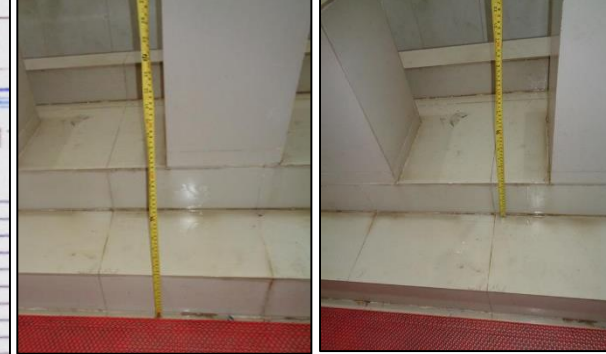
Maximum build up found 300 mm at 4<sup>th</sup> floor ablation zone.

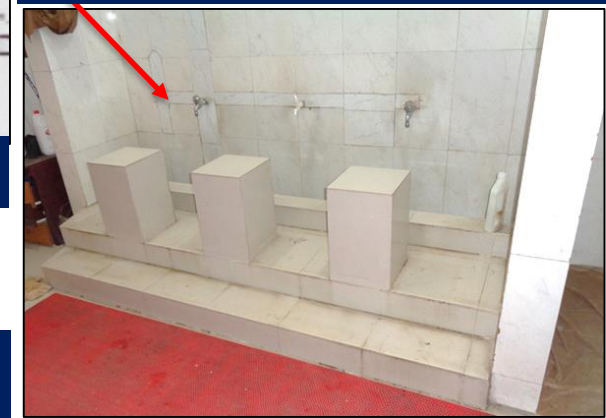
In as-built floor layout, urinal has been shown. But during inspection, ablation zone was found at that location with 300 mm buildup.

Factory engineer is required to survey the whole structure and update the as-built drawing.

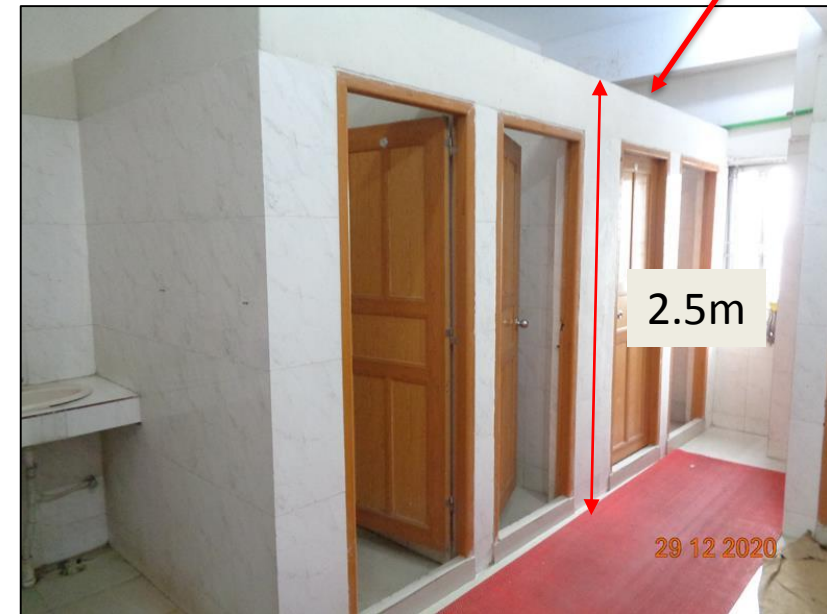
In as-built architectural drawing, the height of the toilet partition wall has not been provided. During inspection, the height of the partition wall was found 2.5 m.

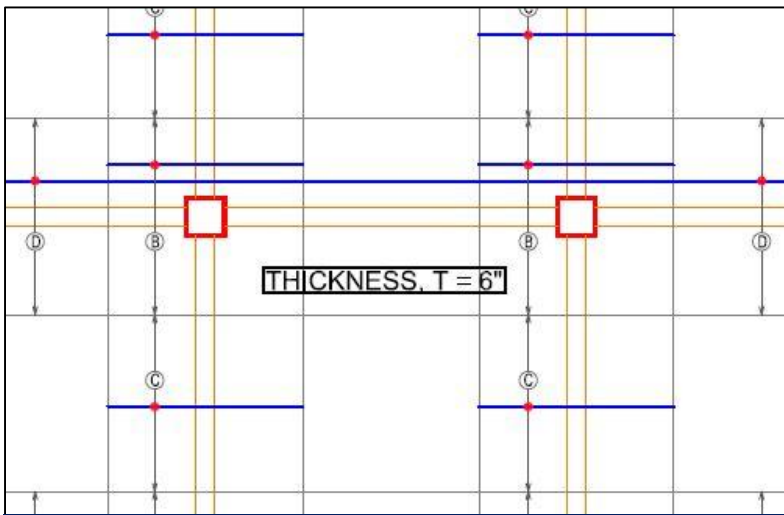
In as-built structural drawing slab thickness has been shown 150mm.

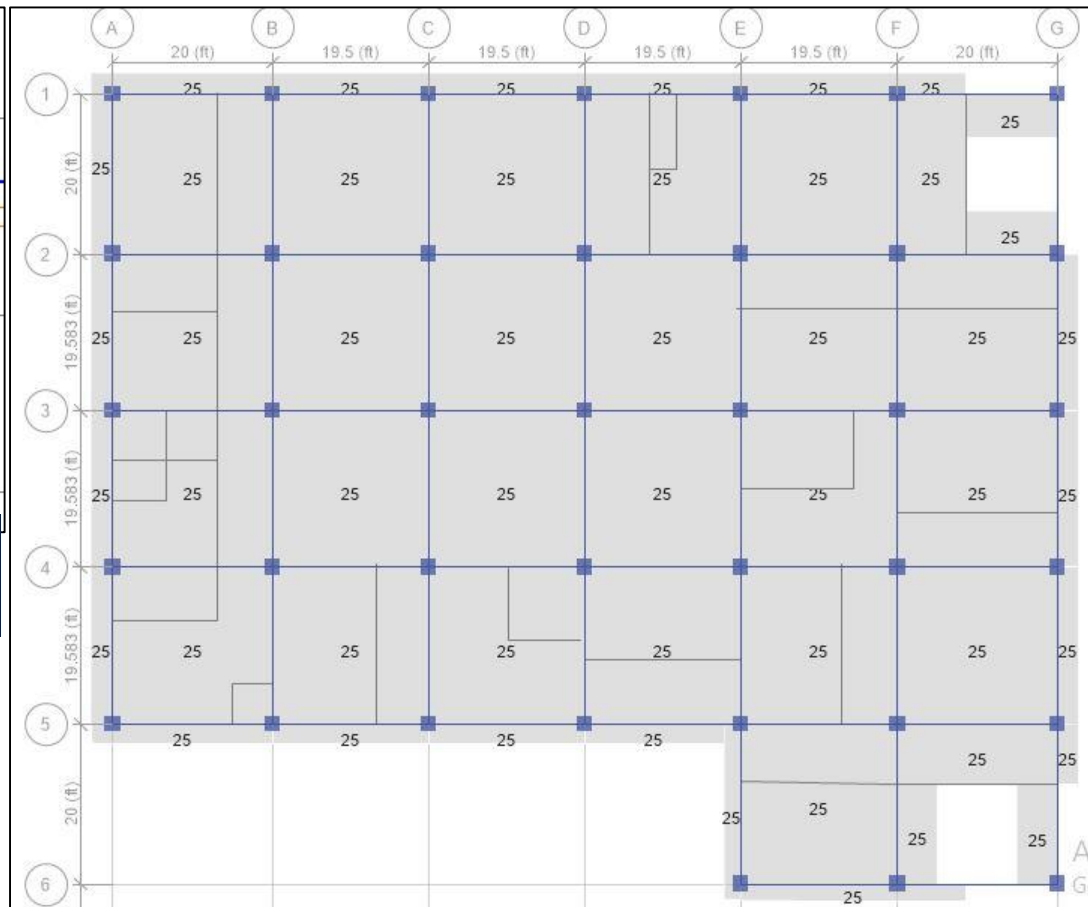
Super imposed Dead Load for Floor Finish is found 25 psf (1.2 kPa).

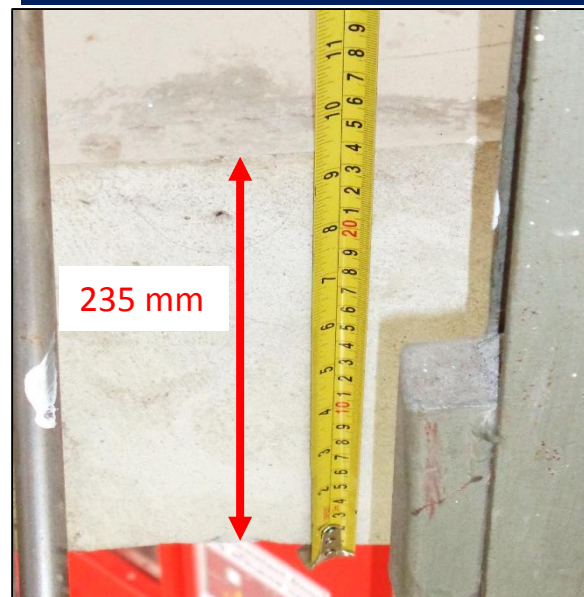
Floor thickness including finishes

Thickness of the floor was found 235 mm including finishes. So, thickness of the floor finishes is 85 mm. In the software analysis, 25 psf (1.2 kPa) has been considered as super imposed dead load which is equivalent to 50 mm floor finishes. Factory engineer is required to review the design considering the additional super imposed dead load.

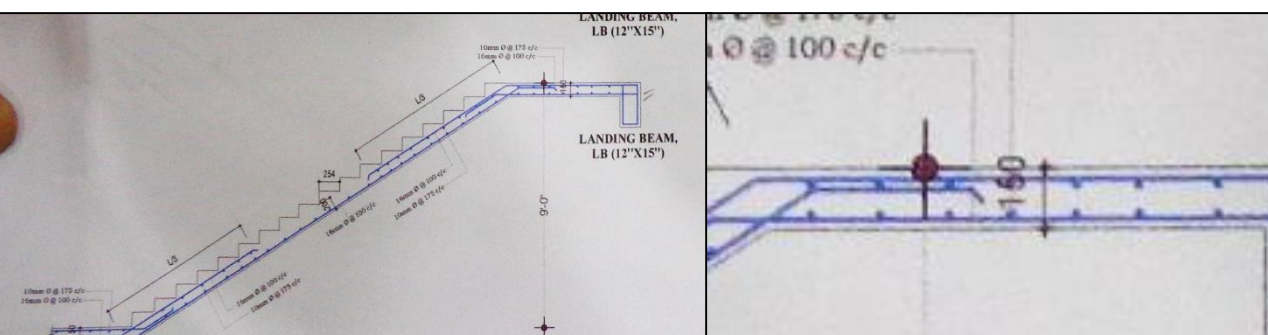
In as-built structural drawing landing slab thickness has been shown as 150 mm.

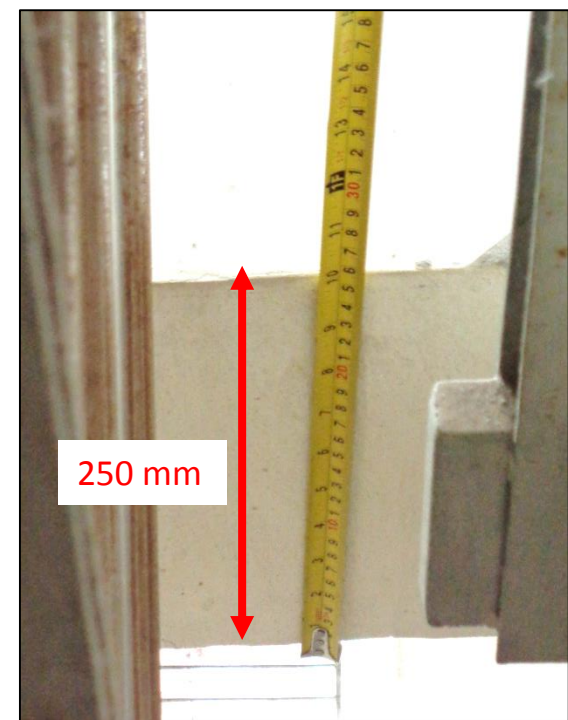
Floor thickness including finishes

Thickness of the landing was found 250 mm including finishes. So, thickness of the floor finishes in landing is 100 mm.

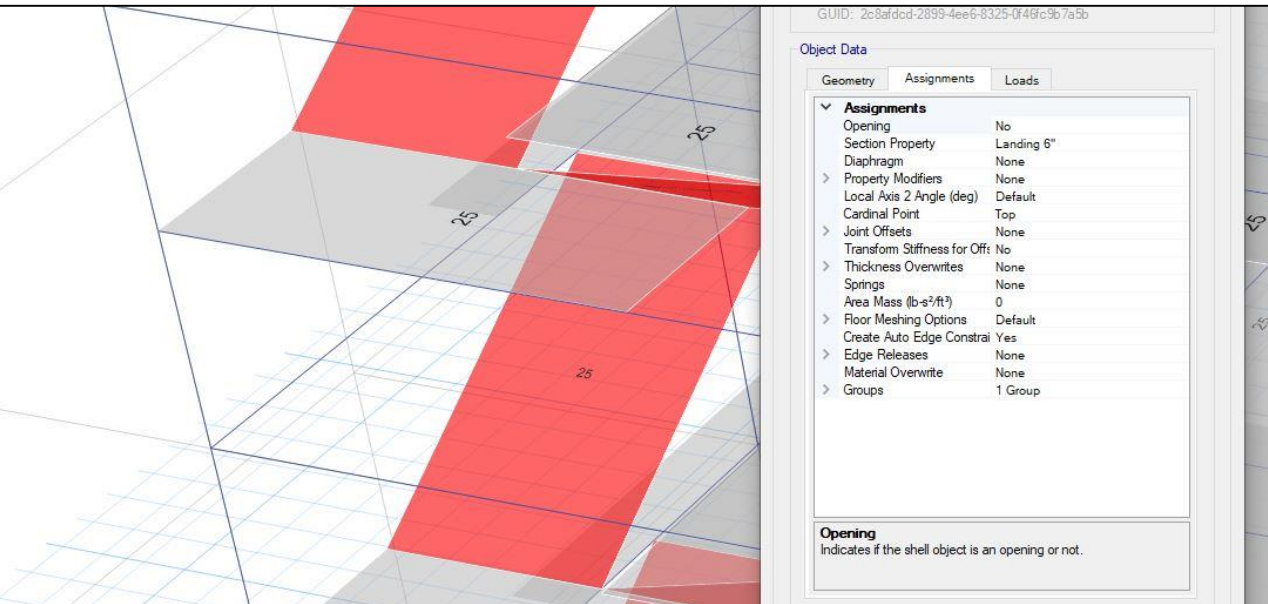
Super imposed Dead Load for Floor Finish is found 25 psf (1.2 kPa).

In the software analysis, 25 psf (1.2 kPa) has been considered as super imposed dead load for floor finishes which is equivalent to 50 mm floor finishes. Factory engineer is required to review the design considering the additional super imposed dead load.

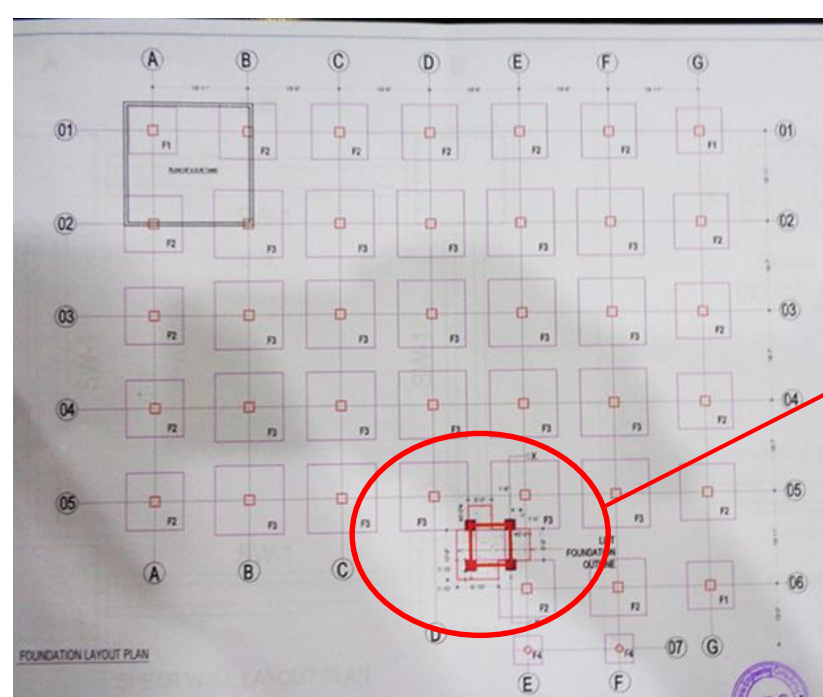
Foundation Layout plan.

As per BNBC every building or structure designed shall have its design documents prepared in accordance with the provision of Section 1.9.1. The design document shall include a design report, and a set of structural drawings, which shall be prepared in compliance with section 1.9.1.1 and section 1.9.1.2 as per BNBC. Factory engineer is required to revise the design documents considering the present condition of the structure.

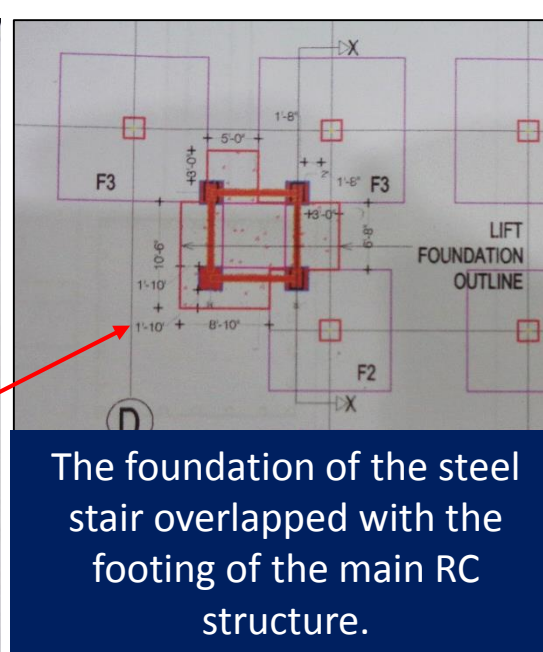
The foundation of the steel stair overlapped with the footing of the main RC structure.

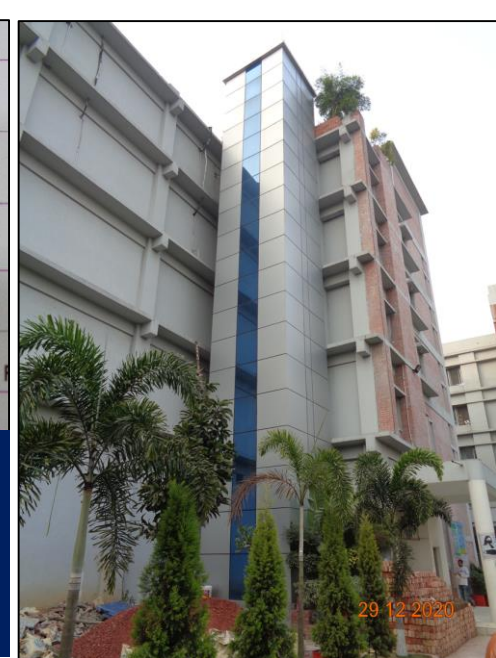
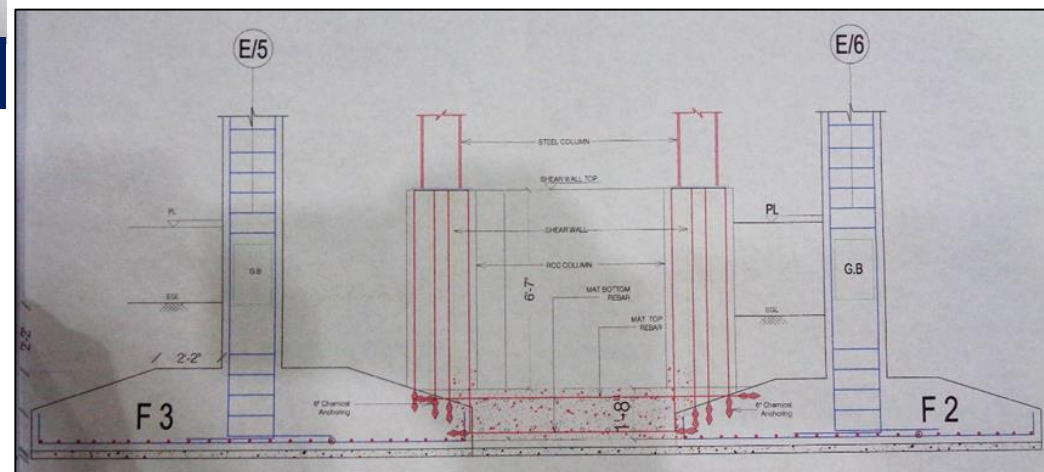
As per drawing, foundation of the steel stair has been connected with the footing of the main RC structure. This issue has not been covered in design report illustrating the capacity of the new foundation system

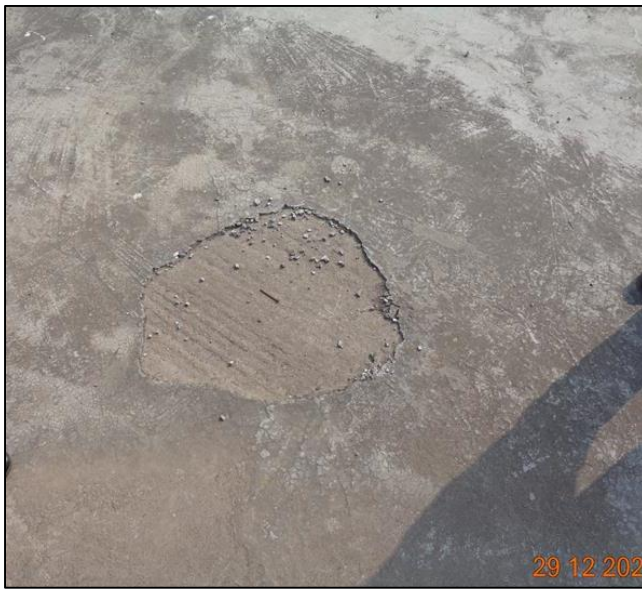
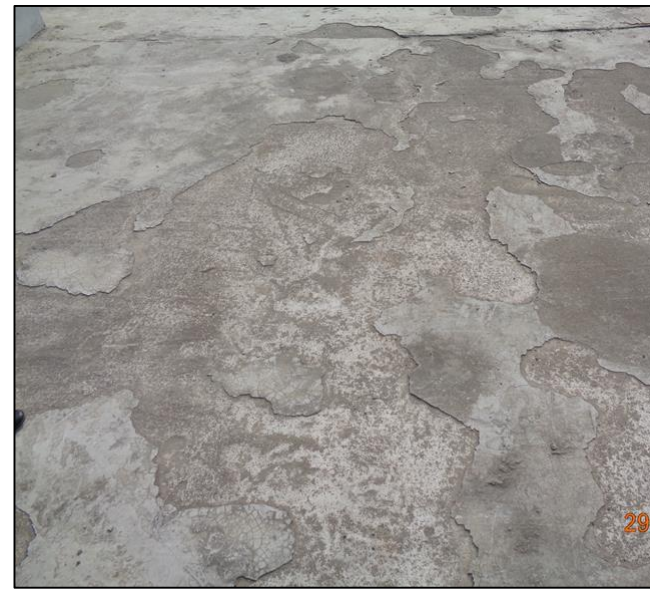
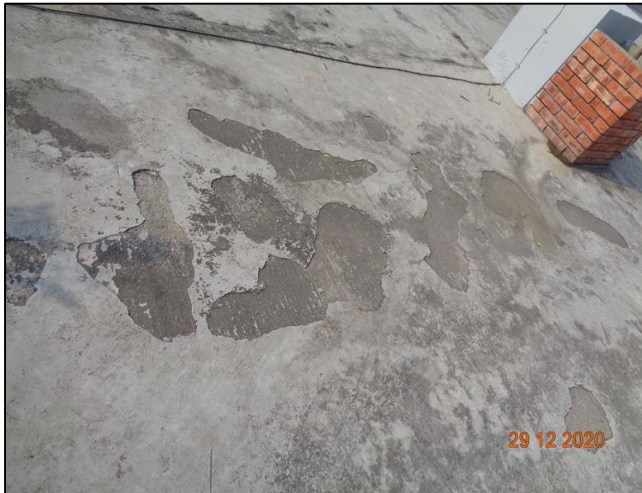
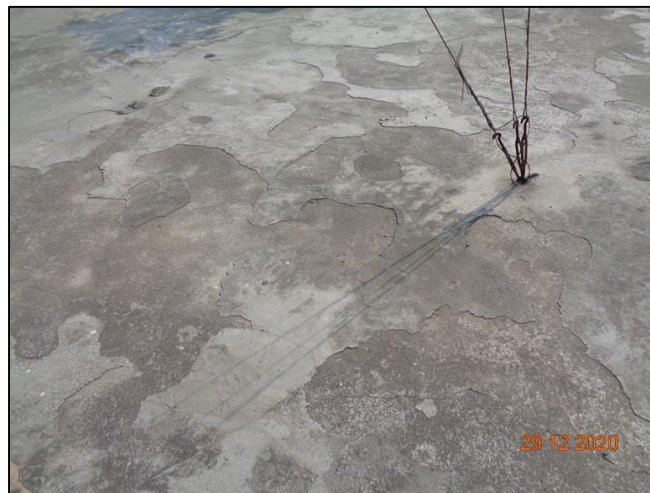
Cement-based finishes of waterproofing was found damaged in certain areas. Consequently, any cracks or damage in the surface finishes on the roof will allow water to pond and seep into the concrete slab beneath the finishes and cause long-term soaking of the slab.

| Item No. | Observation | Recommended Action Plan | Recommended Timeline |
|---|---|---|---|
| 4 | Damage in waterproofing (Office Building) | The factory engineer to repair the damaged area of the finish to prevent water ponding and long-term soaking of the slab. | 6-months |

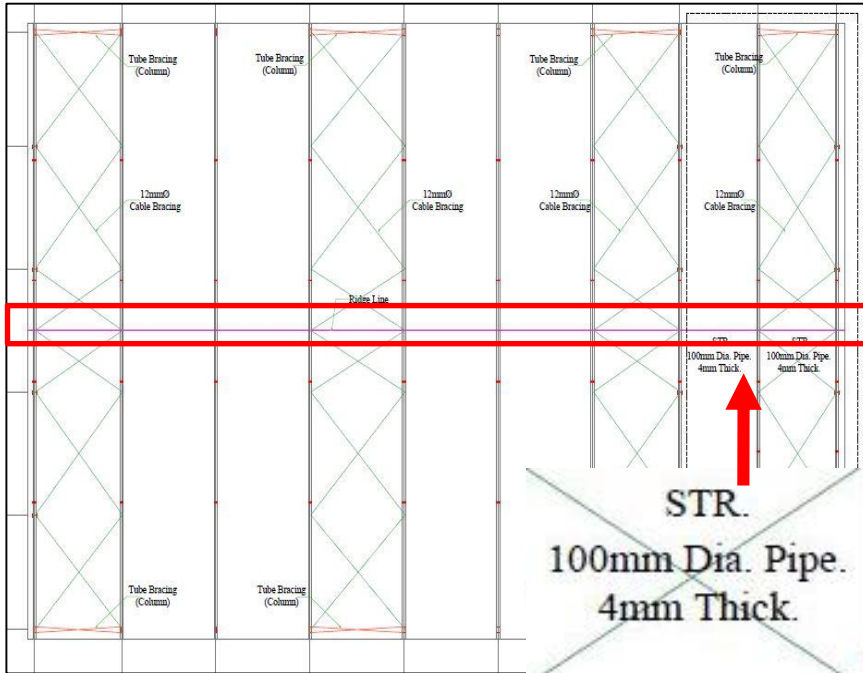
100 mm diameter pipe shown along ridge as a compression strut

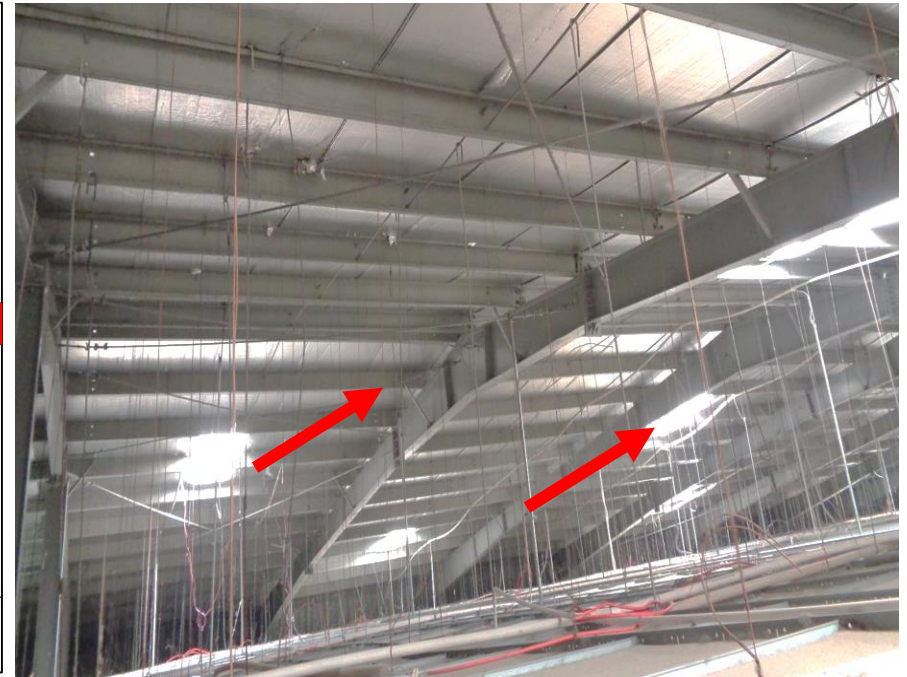
No compression strut was found along ridge.

Factory engineer is required to check the lateral stability in the long direction and requirement of stability member/compression strut in that direction.  
All serviceability and stability checks are required to prepare in compliance with section 1.9.1 as per BNBC.

| Item No. | Observation | Recommended Action Plan | Recommended Timeline |
|---|---|---|---|
| 5 | Missing lateral stability element in long direction.<br>(Template Sewing Shed) | Factory engineer is required to check the lateral stability in the long direction and requirement of stability member/compression strut in that direction. | 6-weeks |
| 6 | Missing lateral stability element in long direction.<br>(Template Sewing Shed) | All serviceability and stability checks are required to prepare in compliance with section 1.9.1 as per BNBC. | 6-weeks |

| Item No. | Observation | Recommended Action Plan | Recommended Timeline |
|---|---|---|---|
| 7 | Missing lateral stability element in long direction.<br>(Template Sewing Shed) | Implement any remediation work where necessary. | 6-months |

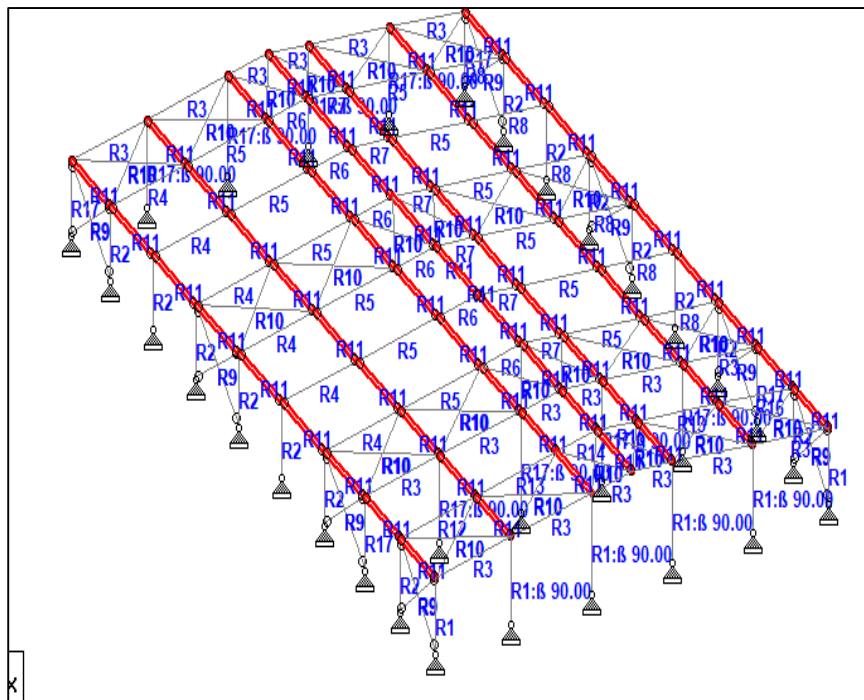
Purlins are assigned in FEA model along rafter to rafter as compression strut

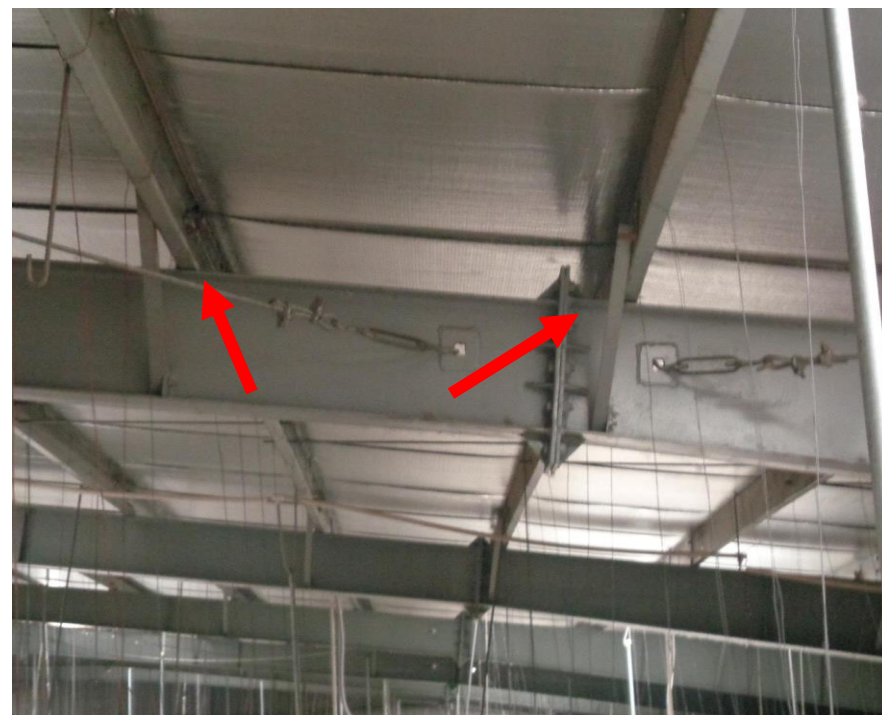
Connection of purlin to rafter

Purlins are assigned as compression strut in FEA model along rafter to rafter. Factory engineer is required to verify the Design Report considering the connection of rafter to purlin and prepare full set of drawings in compliance with section 1.9.1 as per BNBC.

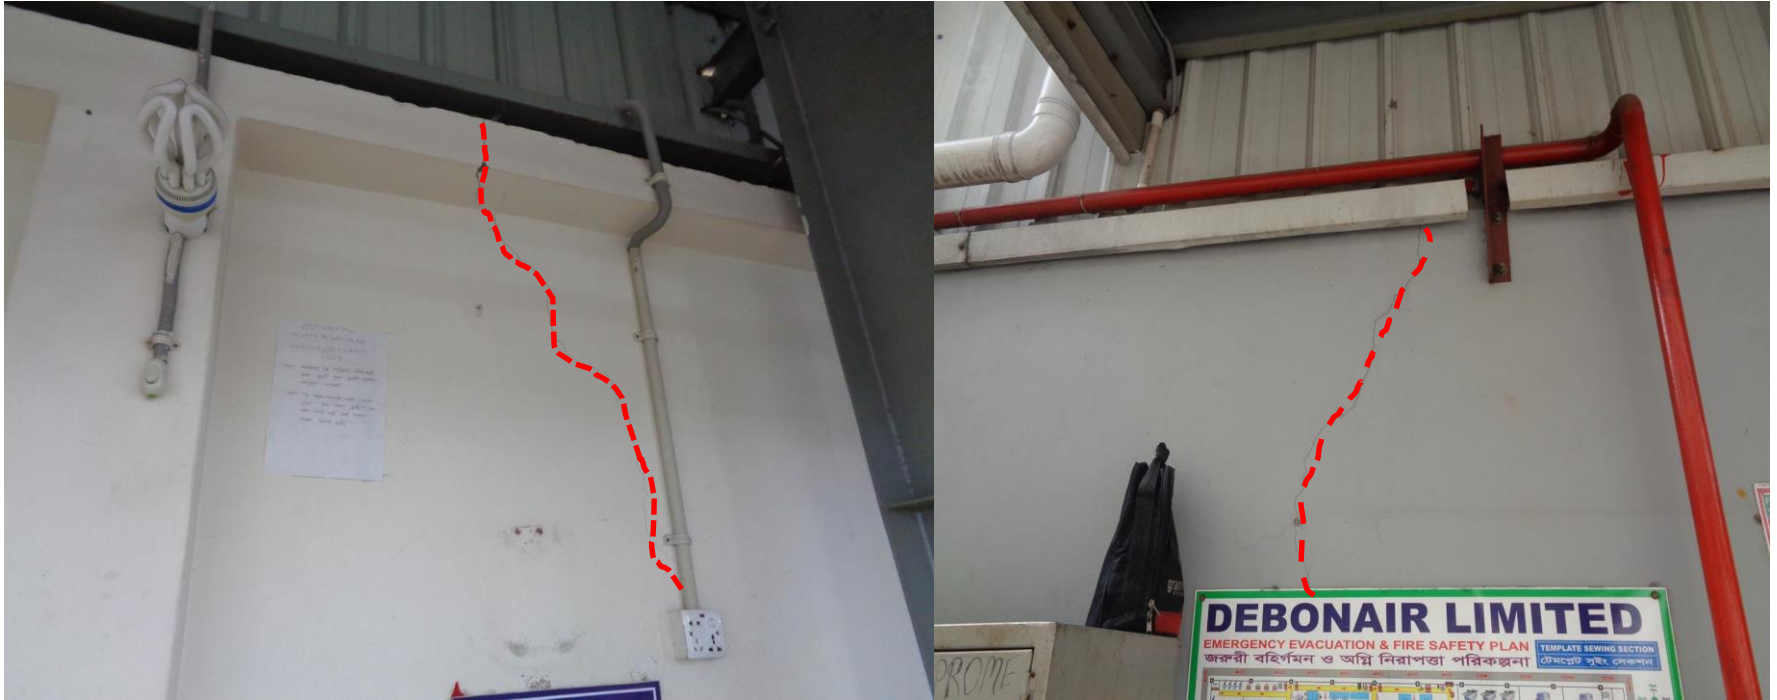
Crack in brick wall

During inspection crack was found in several locations of brick wall. Factory engineer is required to investigate the cause of crack and repair the crack as per recommendation from investigation report.

| Item No. | Observation | Recommended Action Plan | Recommended Timeline |
|---|---|---|---|
| 8 | Crack in Brick wall<br>(Template Sewing Shed) | Factory engineer is required to investigate the cause of crack and repair the crack as per recommendation from investigation report. | 6-weeks |

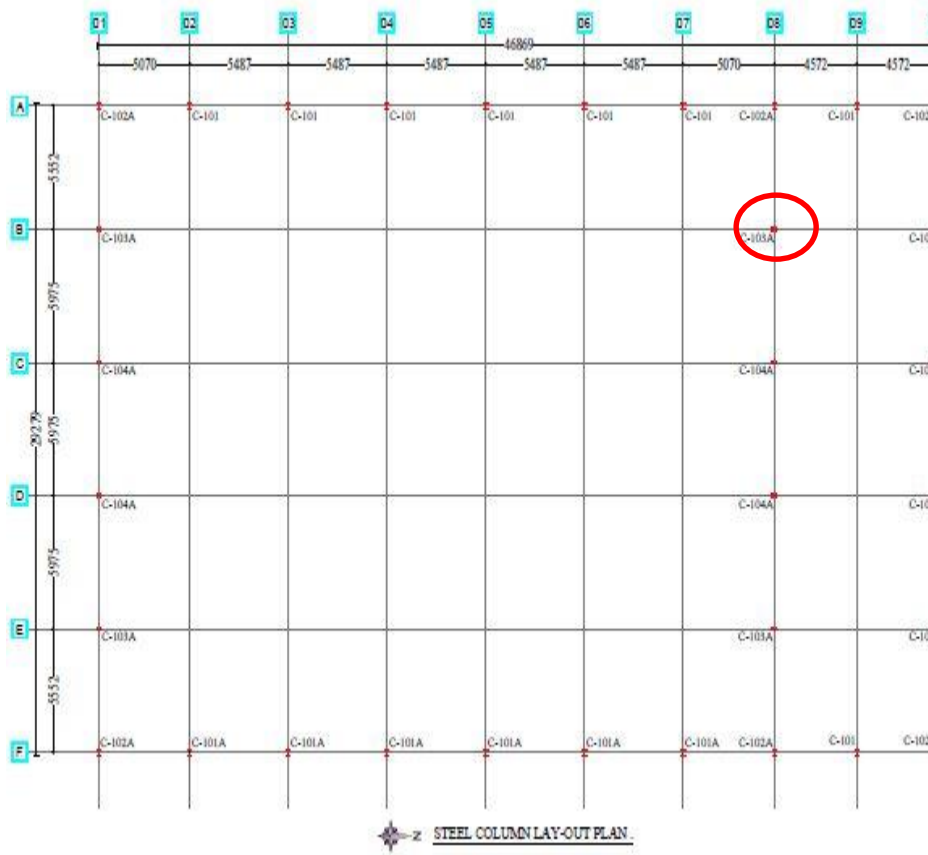
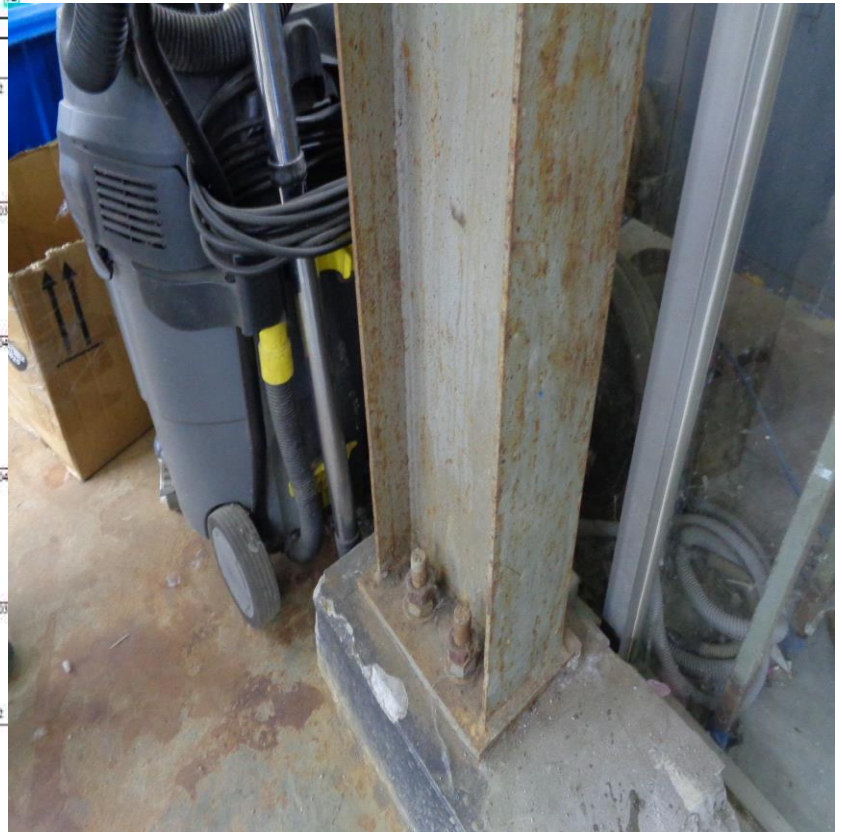
Corrosion in steel column

During inspection corrosion was found in the steel column at Template Sewing Shed. Factory is required to provide rust proof paint on the corroded areas to protect the steel members from corrosion.

| Item No. | Observation | Recommended Action Plan | Recommended Timeline |
|---|---|---|---|
| 9 | Corrosion in steel column (Template Sewing Shed) | Factory is required to provide rust proof paint on the corroded areas to protect the steel members from corrosion. | 6-weeks |

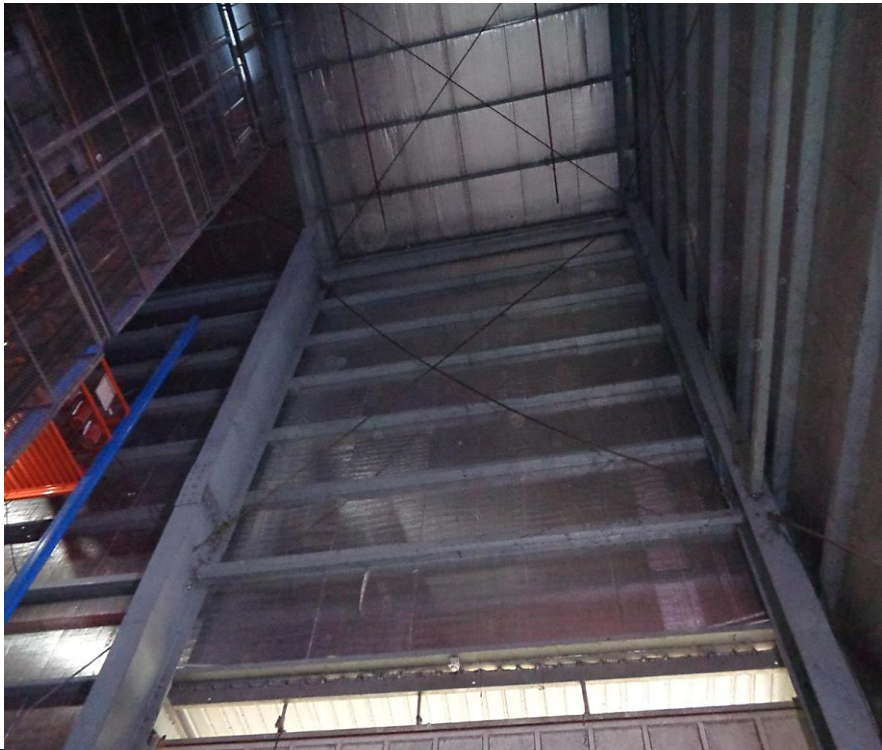
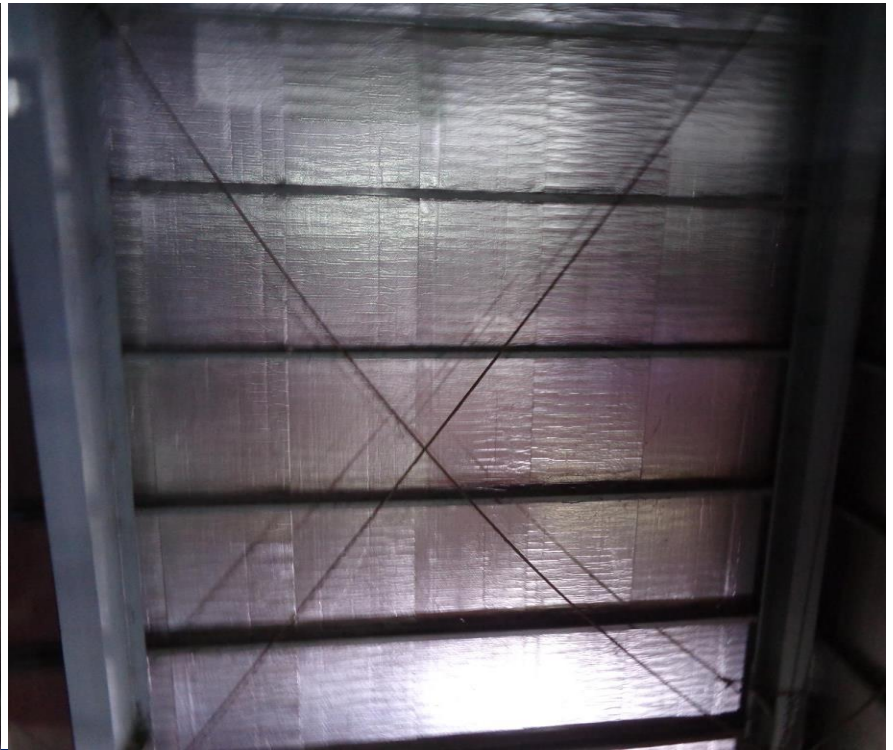
Loose cable bracing

Loose cable bracing was found in several locations. Factory engineers is required to tighten all loose bracing.

| Item No. | Observation | Recommended Action Plan | Recommended Timeline |
|---|---|---|---|
| 10 | Loose cable bracing<br>(Finished Goods Warehouse Shed) | Factory is required to tighten all loose bracing as per guidance by the factory engineer. | 6-weeks |

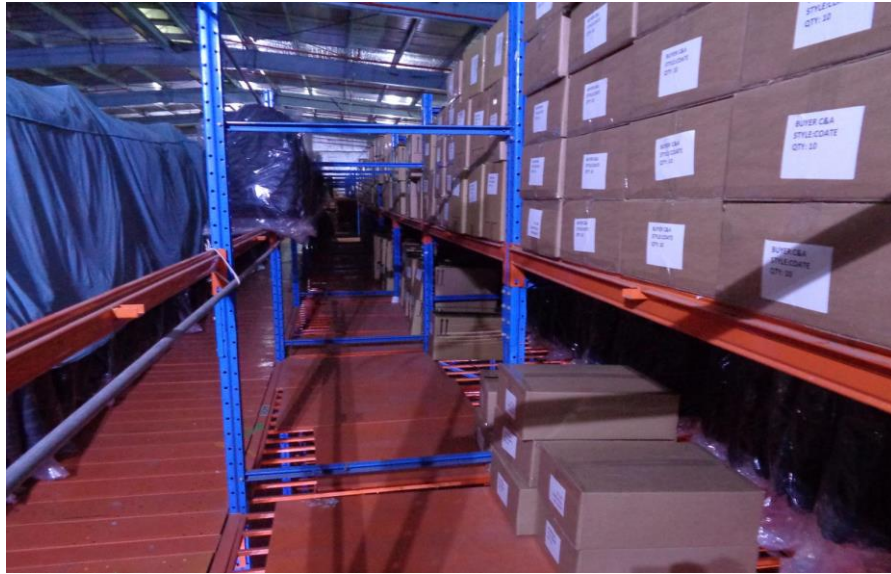
Storage load resting on multi storied steel rack

Storage was found resting on multi storied steel racks inside the Finished Goods Warehouse Shed. Storage was found maximum 2 kPa on the rack's floors. No design documents and allowable load plan were available. Factory engineer is required to produce load plan according to the capacity of steel rack.

| Item No. | Observation | Recommended Action Plan | Recommended Timeline |
|---|---|---|---|
| 11 | Capacity of steel rack to be verified<br>(Finished Goods Warehouse Shed) | Factory engineer is required to carryout the capacity of the rack considering the storage loading. | 6-weeks |
| 12 | Capacity of steel rack to be verified<br>(Finished Goods Warehouse Shed) | Produce and actively manage load plan according to the structural capacity of the steel rack. | 6-weeks |

| Item No. | Observation | Recommended Action Plan | Recommended Timeline |
|---|---|---|---|
| 13 | Capacity of steel rack to be verified (Finished Goods Warehouse Shed) | Implement load management plan. | 6-months |

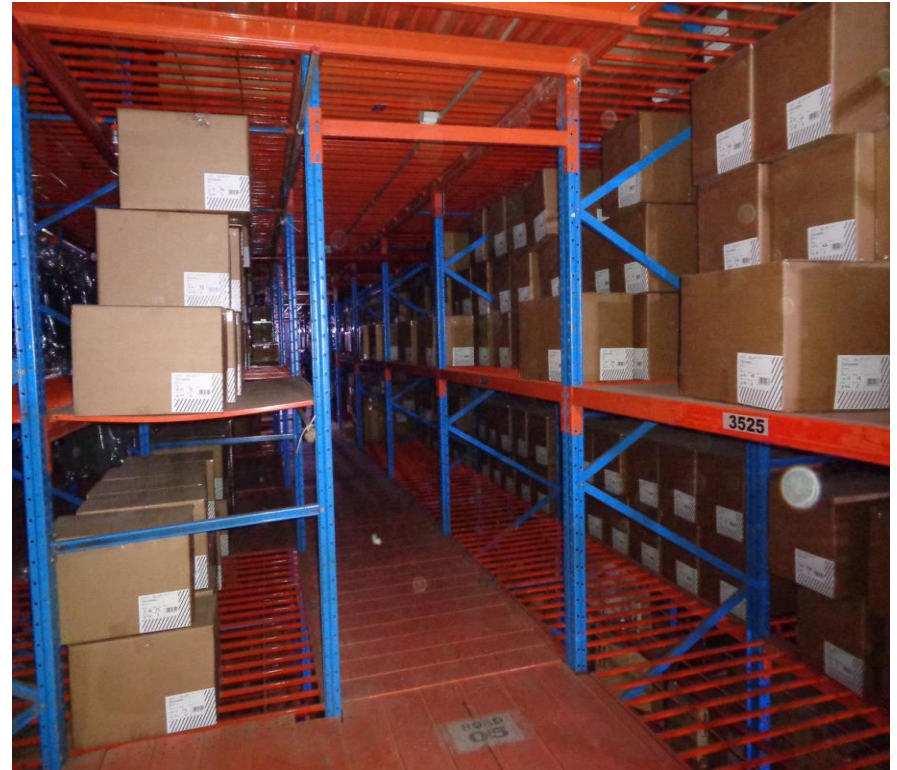
Storage load resting on multi storied steel rack

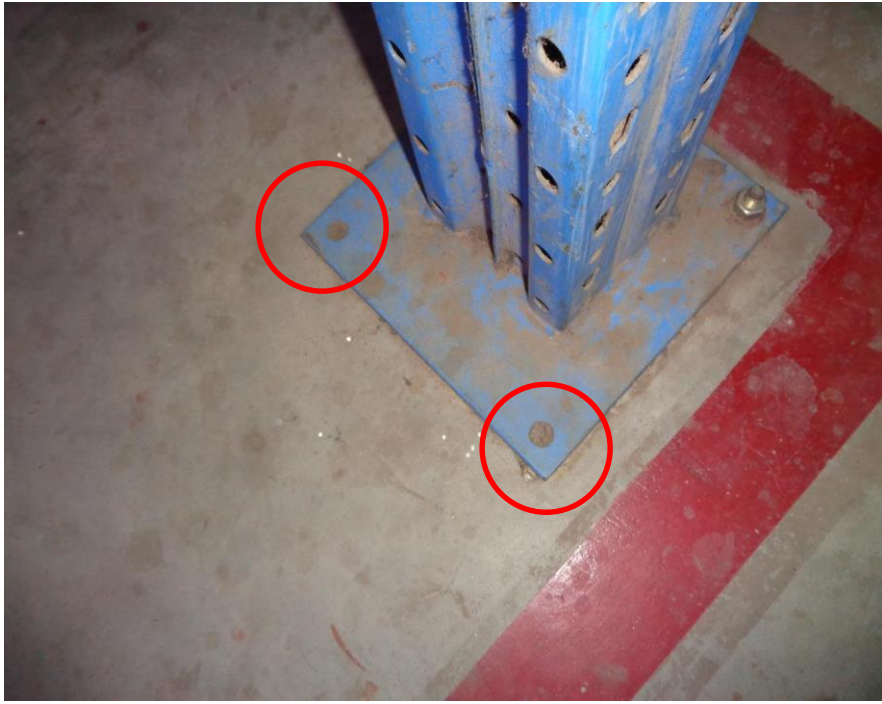
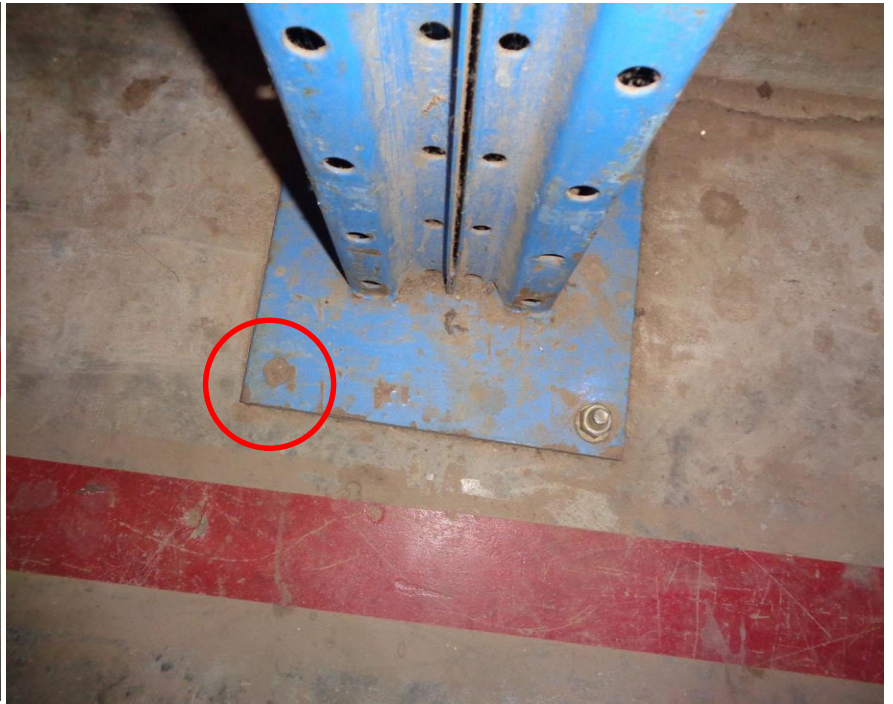
Missing bolts at support

During inspection bolts were missing in support at several locations of steel rack. Factory is required to install all missing bolts as per guidance by the factory engineer.

| Item No. | Observation | Recommended Action Plan | Recommended Timeline |
|---|---|---|---|
| 14 | Missing bolts at support of steel rack (Finished Goods Warehouse Shed) | Install all the missing bolts. | 6-weeks |

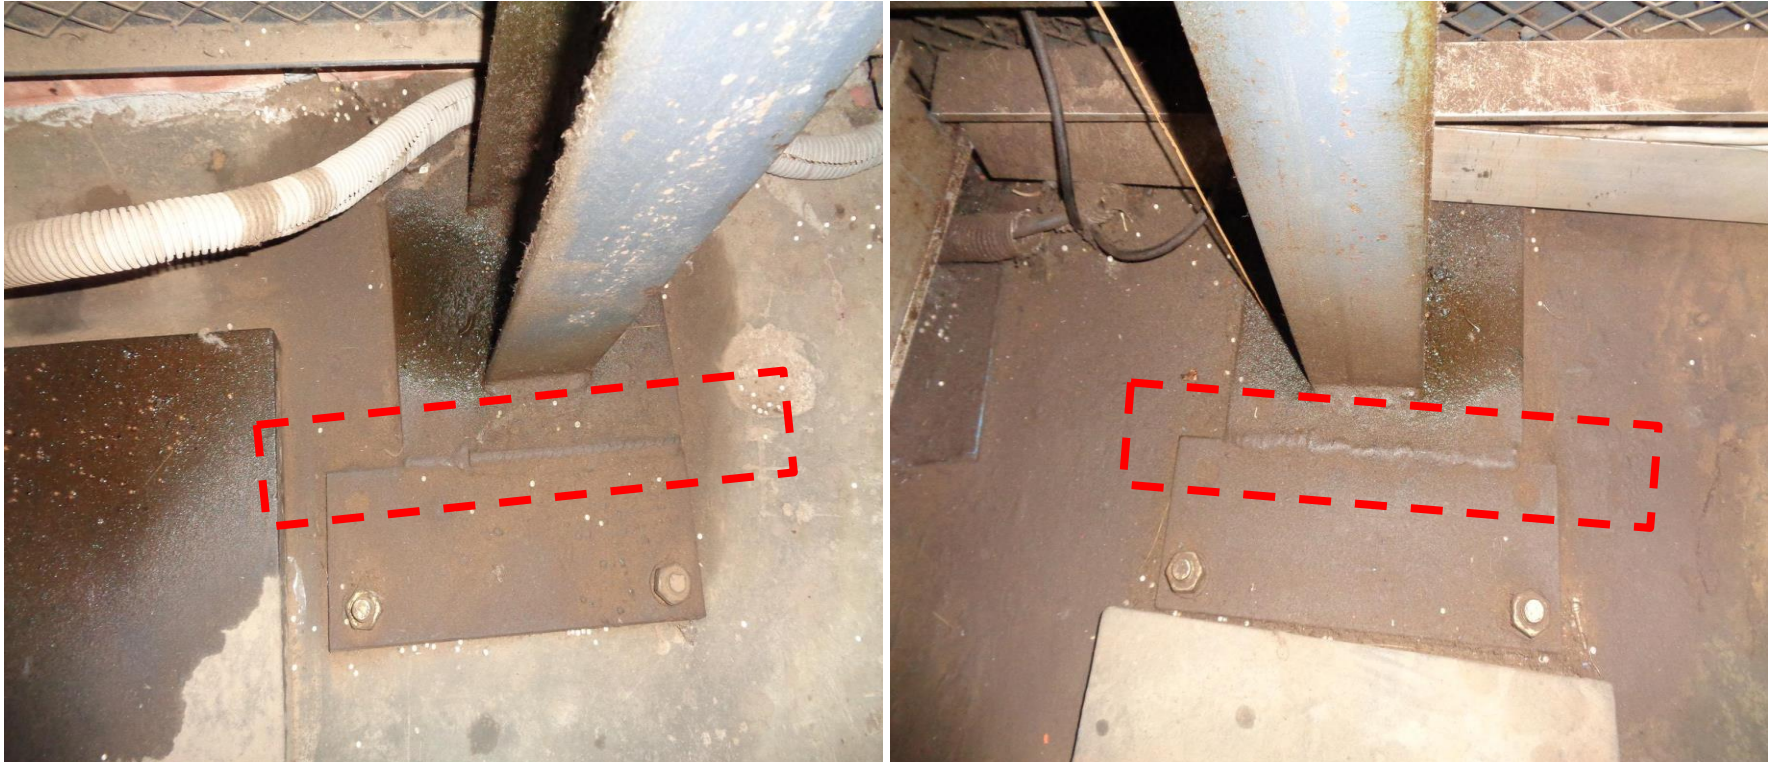
Support system of column is appeared to be unstable

Baseplate of steel column of lift was found welded horizontally with another plate which is appeared to be inadequate. Factory is required to check the adequacy of the support system and implement remediation if required.

| Item No. | Observation | Recommended Action Plan | Recommended Timeline |
|---|---|---|---|
| 15 | Apparently inadequate support system of lift column (Finished Goods Warehouse Shed) | Factory is required to check the adequacy of the support system. | 6-weeks |

| Item No. | Observation | Recommended Action Plan | Recommended Timeline |
|---|---|---|---|
| 16 | Apparently inadequate support system of lift column (Finished Goods Warehouse Shed) | Implement any remediation work if required. | 6-months |
