# Tamanna Tex Ltd. (25242)

Plot No A 34, BSCIC Kanchpur, Sonargon, Narayanganj  
(23.698774, 90.527735)  
2nd February 2021

# Buildings Information

1. Main Production Shed (single storied)
2. Extension Building (G) (single storied)

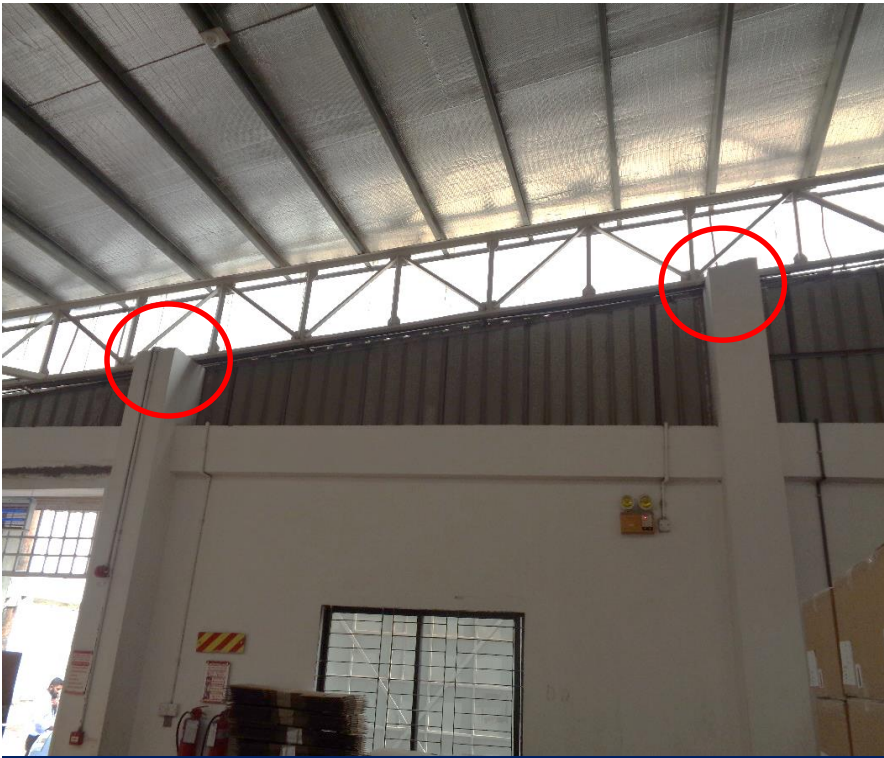
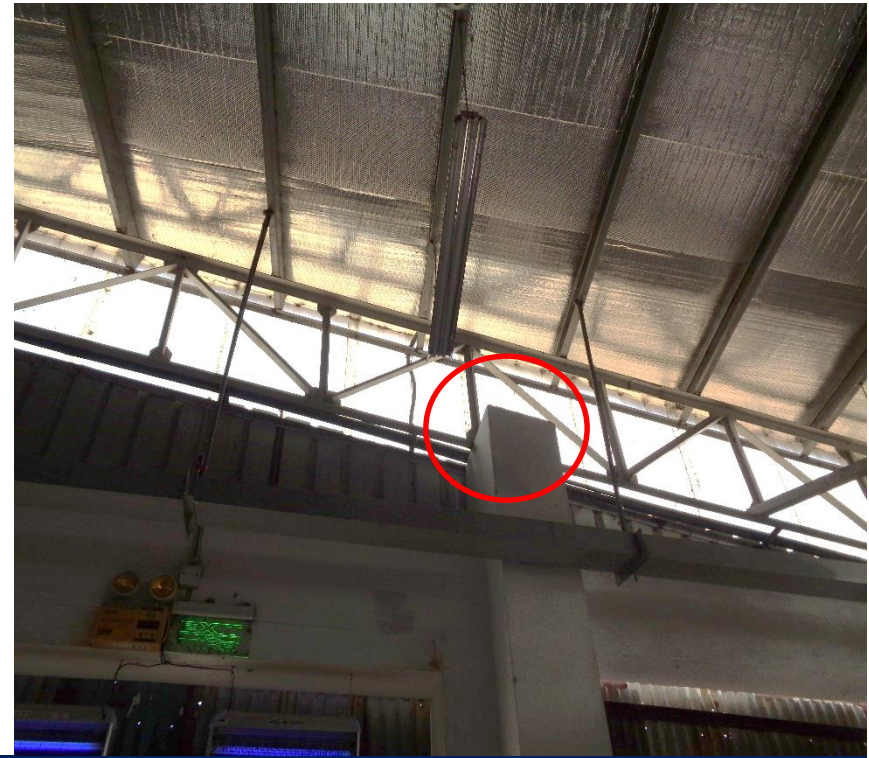
Support is not placed at node point in some locations

Support is not placed at node point in some locations which indicates the irregularity in load transfer system from truss to column. Factory engineer is required to check the adequacy of the load transfer system as a part of Engineering Assessment (EA) and implement any remediation if required.

| Item No. | Observation | Recommended Action Plan | Recommended Timeline |
|---|---|---|---|
| 01 | Irregularity in load transfer system (Main Production Shed) | Factory engineer is required to check the load transfer and support system of existing truss. | 6-weeks |
| 02 | Irregularity in load transfer system (Main Production Shed) | Engineering Assessment (EA) to be prepared for reviewing design, loads and capacity of structural members. | 6-weeks |
| 03 | Irregularity in load transfer system (Main Production Shed) | Complete implementation of any remedial works deemed necessary by the Engineering Assessment (EA). | 6-months |

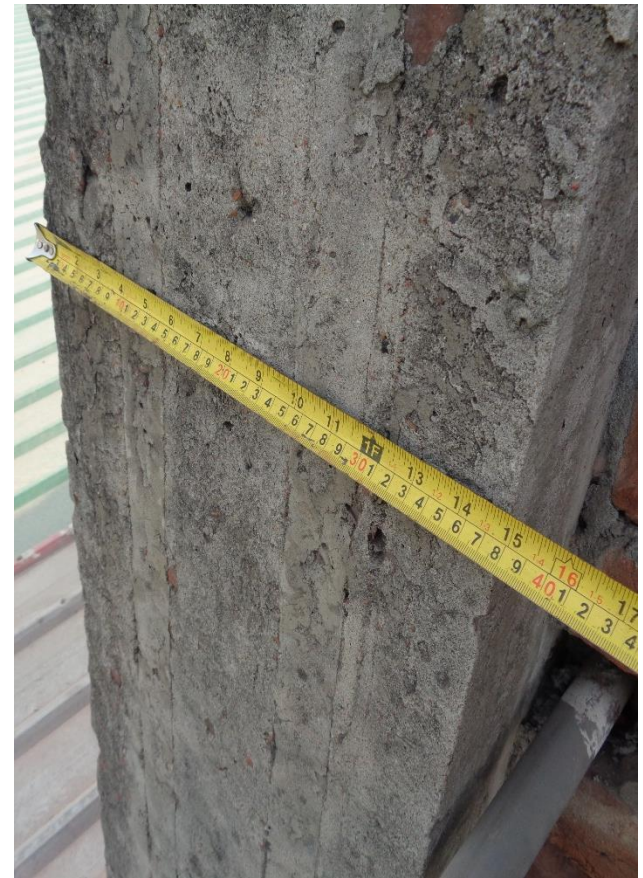
Column dimension measured  
250mmX375mm

Dimension of column C-1 at grid E-2 was found 250mmX375mm instead of 250mmX450mm. Factory engineer is required to update the as-built drawing as per onsite condition.

| Item No. | Observation | Recommended Action Plan | Recommended Timeline |
|---|---|---|---|
| 04 | Discrepancy in as-built drawing with on site condition (Extension Building) | Prepare “as constructed” drawings which reflect the actual site dimensions and complete structural information. | 6-weeks |

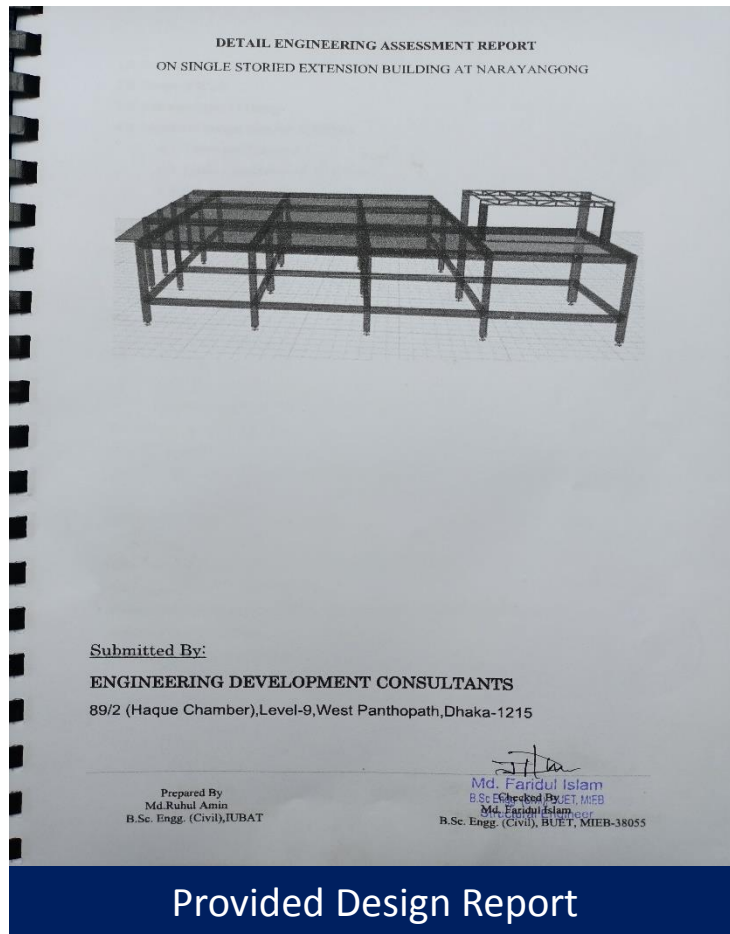
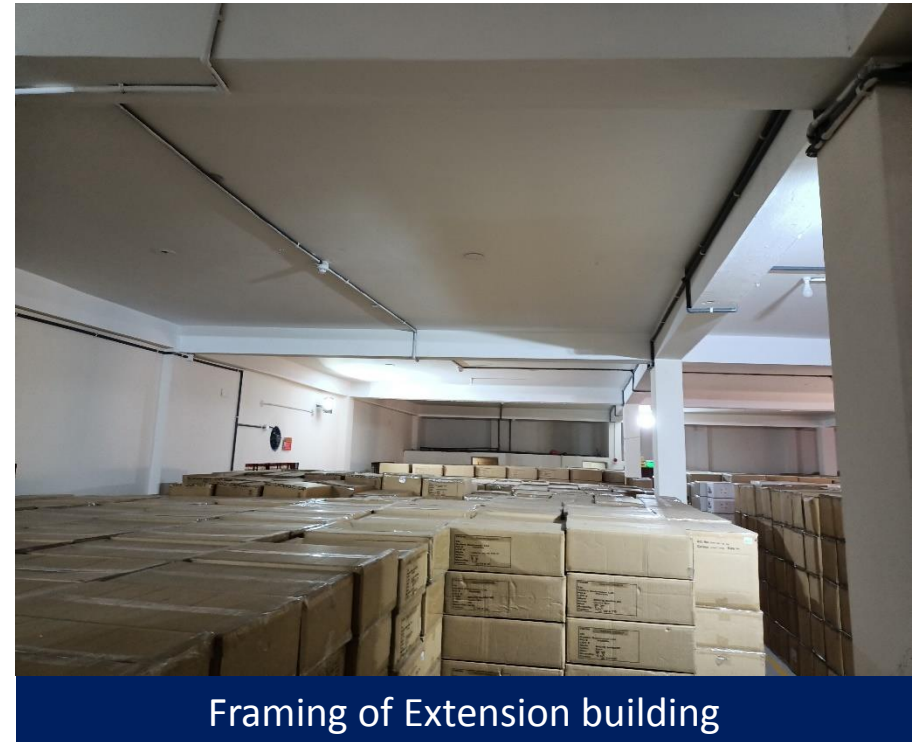
A Design Report was provided for the Extension Building at the time of inspection which is prepared based on software analysis. However, no software analysis (FEA) model was provided to review the Design report. Factory is required to submit the full set of Design Report with software-based analysis model for review.

| Item No. | Observation | Recommended Action Plan | Recommended Timeline |
|---|---|---|---|
| 05 | Incomplete Design Report (Extension Building) | Factory is required to submit the Design Report with analysis model for review. | 6-weeks |

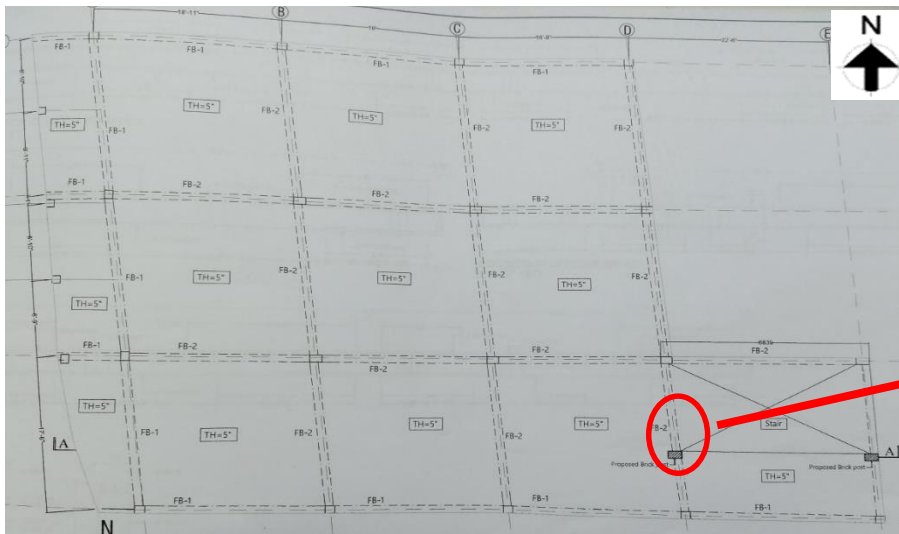
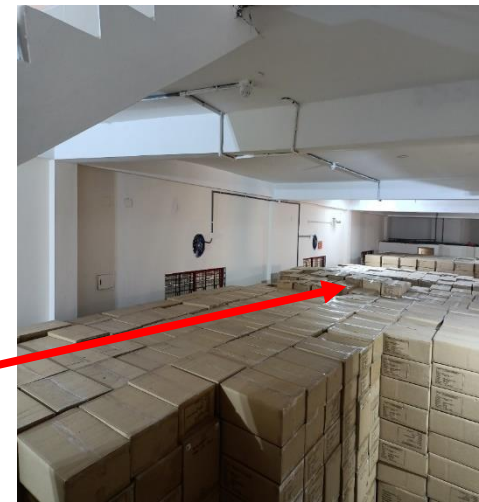
Brick post was missing at this location

A brick post was proposed in provided drawing which was not installed. Also, the roof truss of stair core was not replaced as per proposed drawings. Factory engineer is required to check the proposed scheme and implement if required.

| Item No. | Observation | Recommended Action Plan | Recommended Timeline |
|---|---|---|---|
| 07 | Recommendation in proposed drawing not implemented (Extension Building) | Factory engineer is required to review the proposed scheme. | 6-weeks |

| Item No. | Observation | Recommended Action Plan | Recommended Timeline |
|---|---|---|---|
| 08 | Recommendation in proposed drawing not implemented (Extension Building) | Implement the proposed remediation work if required. | 6-months |

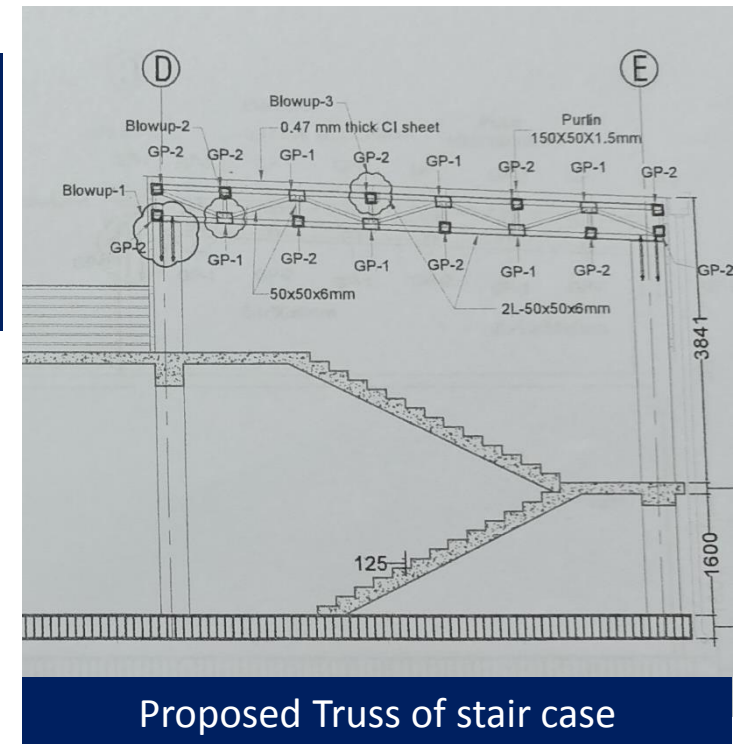
Proposed Truss of stair case

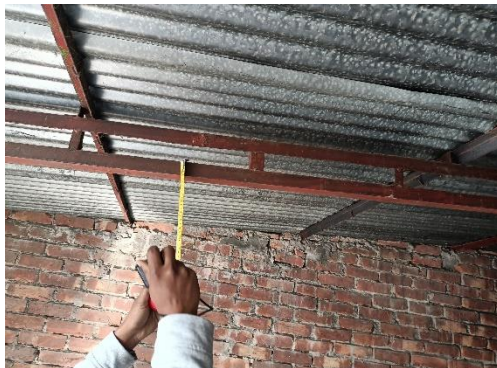
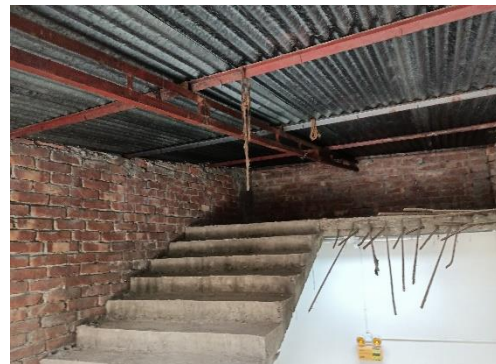
Existing truss at stair case

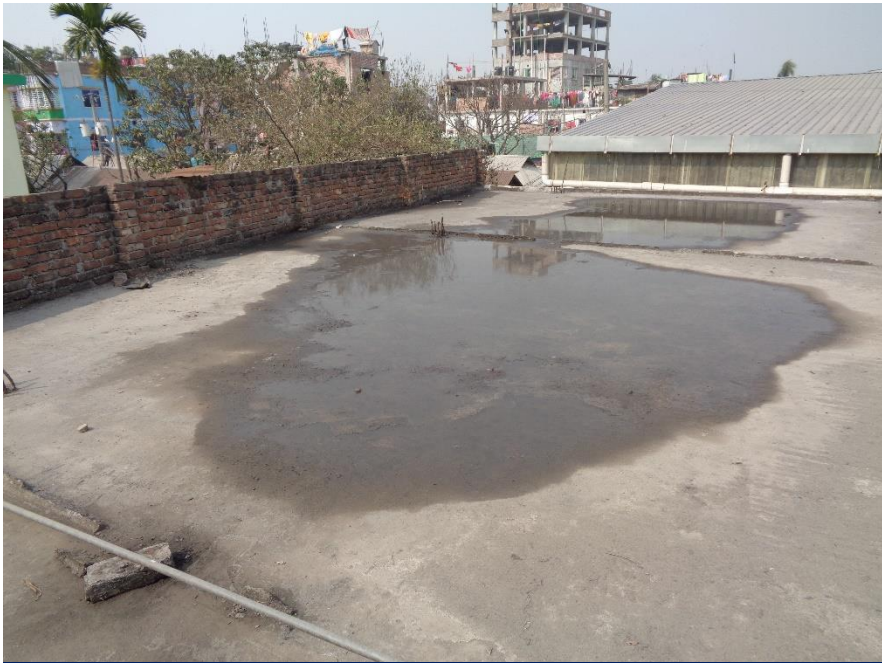
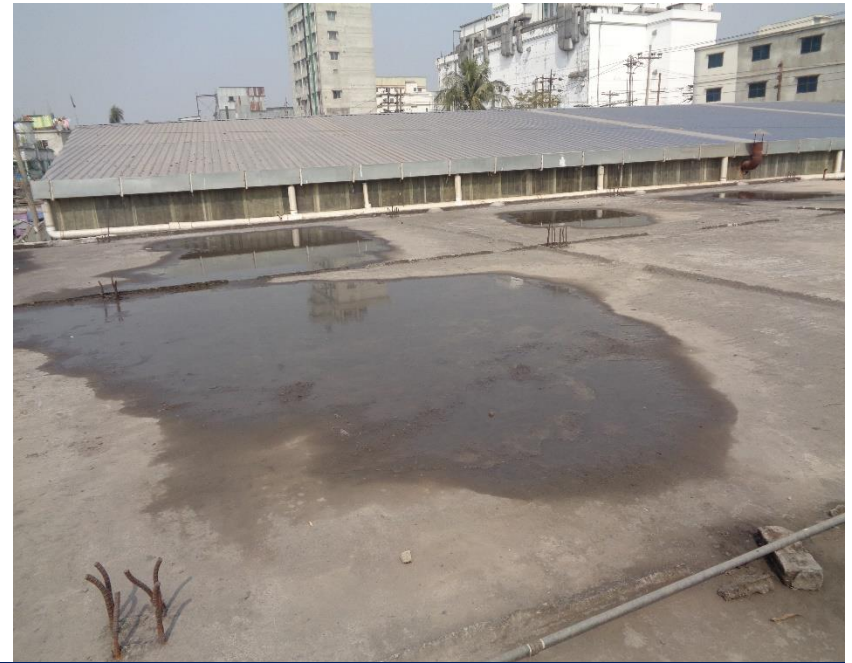
Water ponding on roof slab

Water ponding was found on roof slab. Any cracks or damage on the roof surface will allow water to seep into the concrete slab beneath the finishes and cause long term soaking of the slab and corrosion of the rebar. Factory is required to provide necessary slope and improve drainage system to prevent water ponding.

| Item No. | Observation | Recommended Action Plan | Recommended Timeline |
|---|---|---|---|
| 09 | Water ponding on roof slab (Extension Building) | Factory is required to provide necessary slope and improve drainage system to prevent water ponding. | 6-weeks |

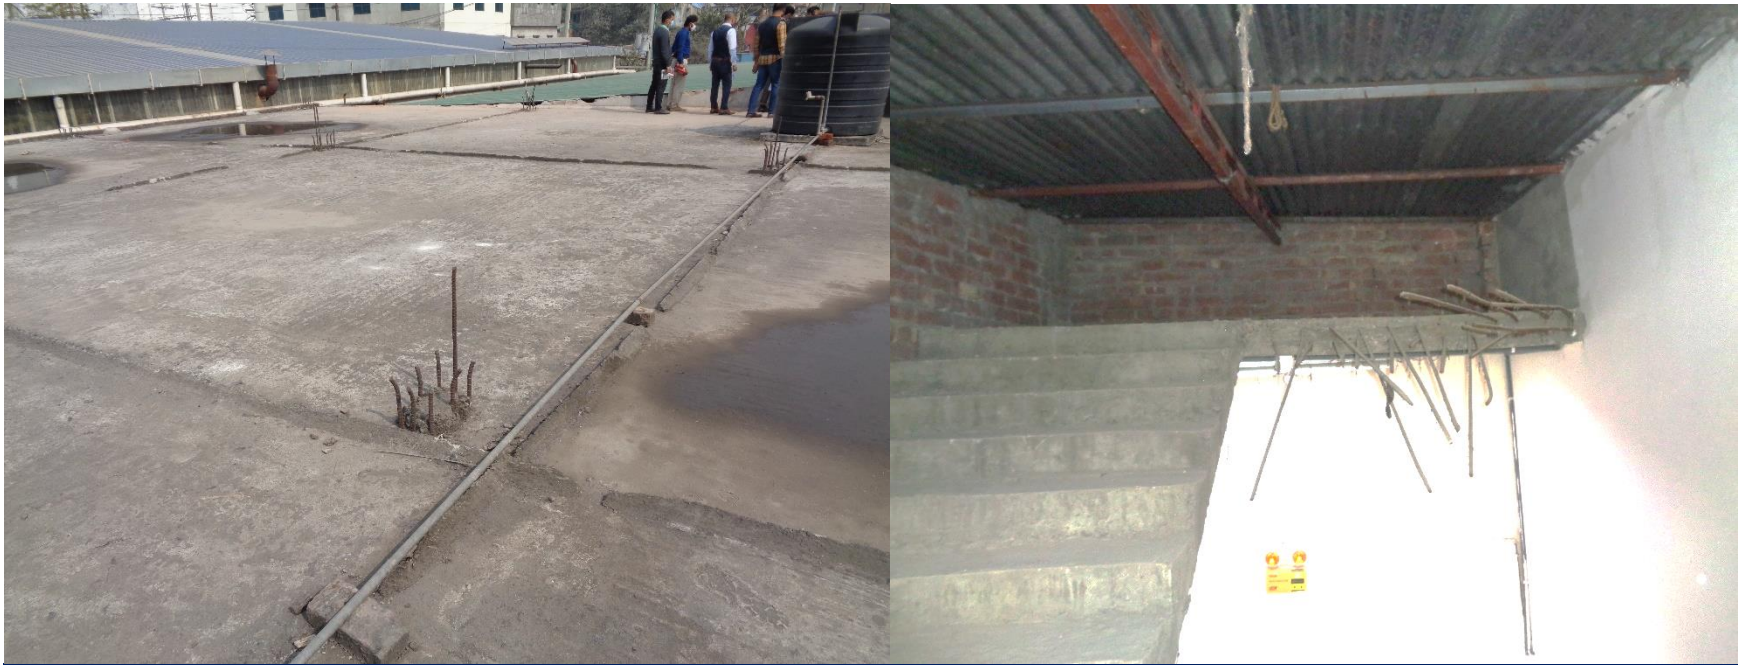
Exposed reinforcement left at roof level & staircase.

Exposed reinforcement is left at roof level & staircase. Factory is required to provide rust proof paint on exposed reinforcement to protect from corrosion.

| Item No. | Observation | Recommended Action Plan | Recommended Timeline |
|---|---|---|---|
| 10 | Corroded and exposed rebar at roof (Extension Building) | Apply rust proof paint to protect from corrosion | 6-weeks |

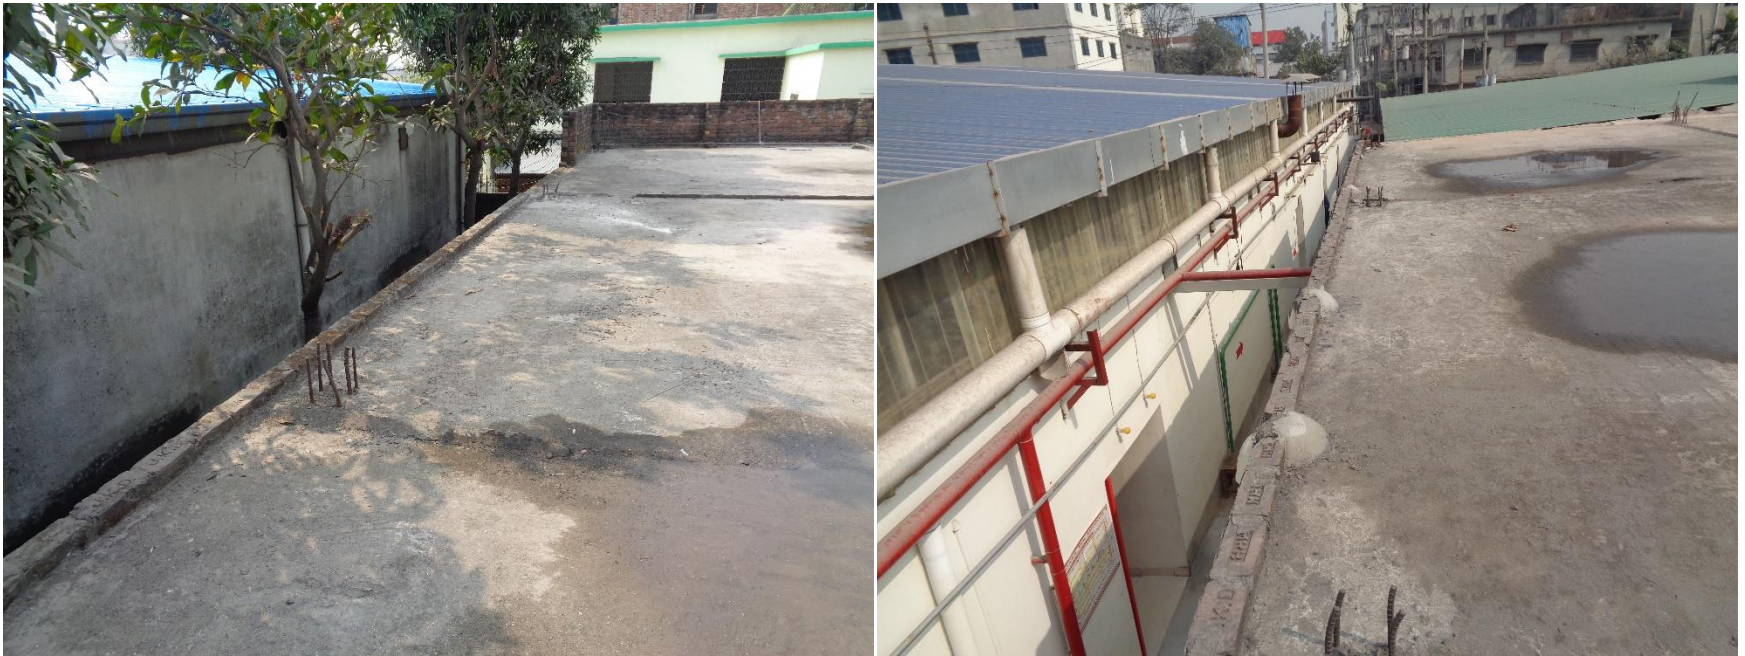
No parapet/railing was found at roof level

No parapet/railing was found at roof level. Factory is required to provide parapet/railing at roof level to avoid possible falling hazard.

| Item No. | Observation | Recommended Action Plan | Recommended Timeline |
|---|---|---|---|
| 11 | Falling hazard at roof level (Extension Building) | Provide parapet/railing at roof level to avoid possible falling hazard. | Immediate-Now |

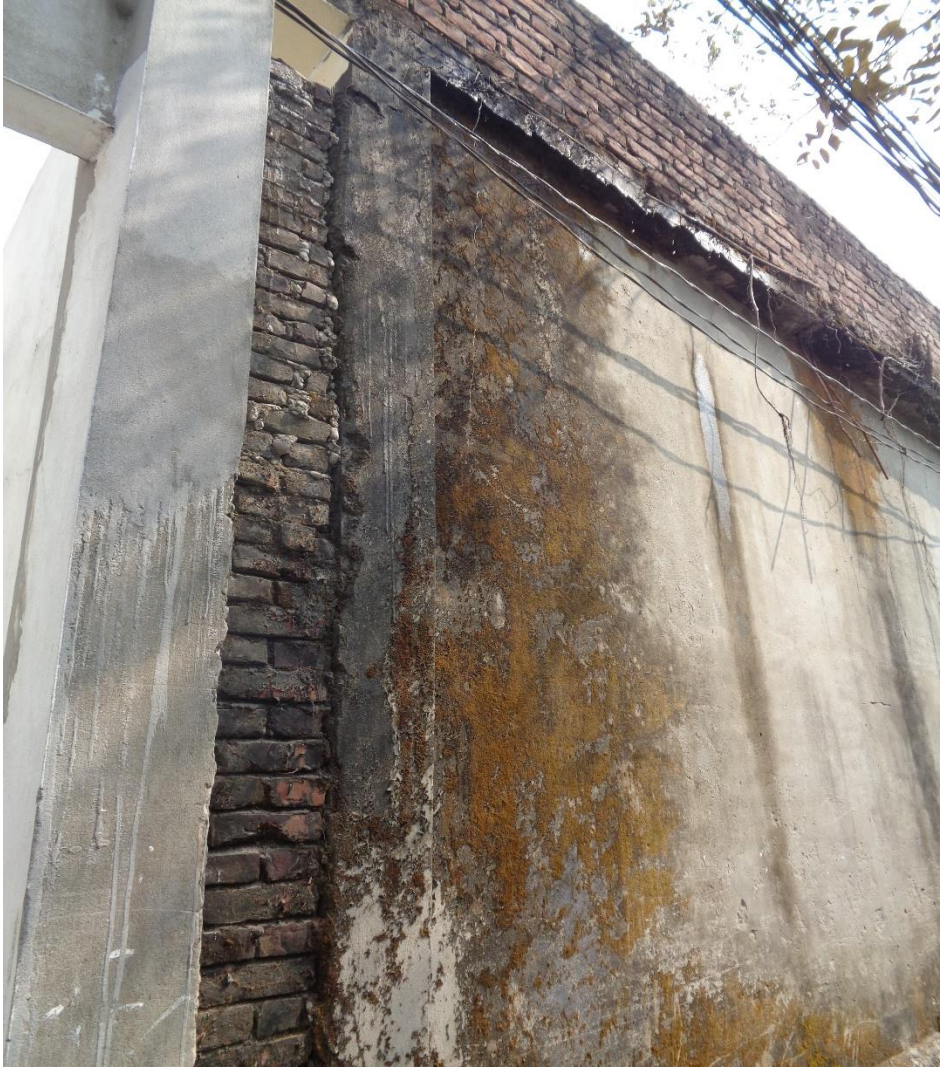
Severed dampness was found in façade at west side

Severed dampness was found at façade at west side due to lack of proper drainage system.

Factory is required to provide proper drainage system on roof slab and repair the damp areas.

| Item No. | Observation | Recommended Action Plan | Recommended Timeline |
|---|---|---|---|
| 12 | Severe dampness at façade (Extension Building) | Factory is required to provide proper drainage system on roof slab and repair the damp areas. | 6-weeks |
