# INITIAL FIRE SAFETY INSPECTION REPORT

**Tamanna Tex Ltd (25242)**

**RSC ID: 24095**

**Plot No A-2 & 3, BSCIC Kanchpur, Sonargaon, Narayanganj**

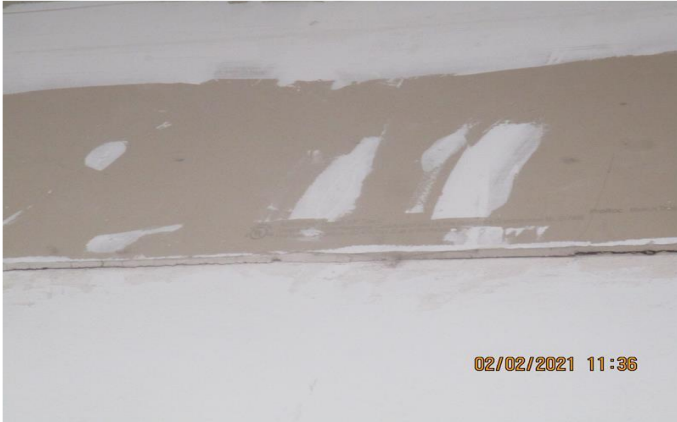
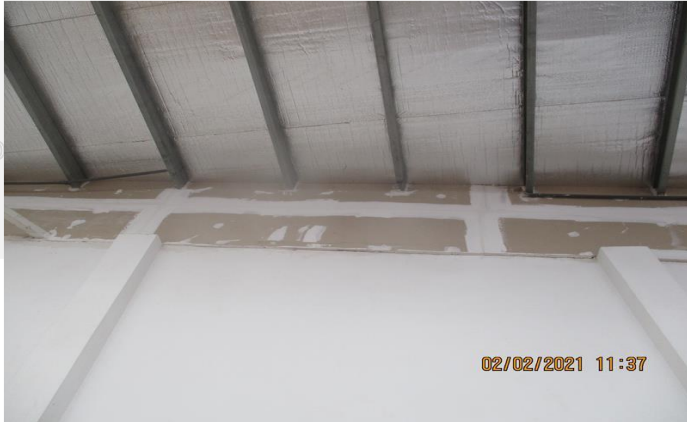
| F-2 | Fire Rated Construction | Store room inside of main production shed was not properly fire separated as non-rated openings were visible in the separating wall constructed by gypsum board moreover credible documents for the gypsum board was not available during inspection. | Maintenance the gypsum board ensuring minimum 1 hr fire rating and submit credible documents which ensures that the installed boards are listed/certified. | Within 3 Months |

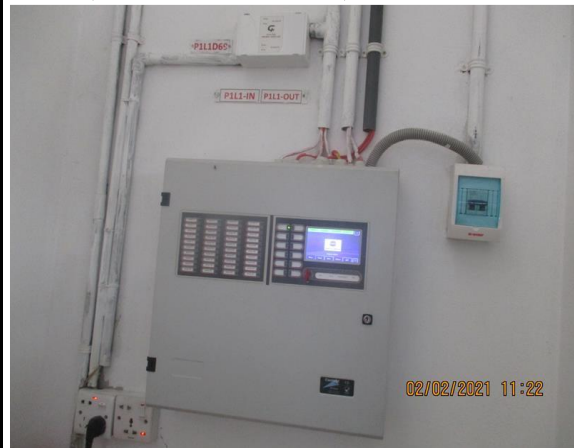
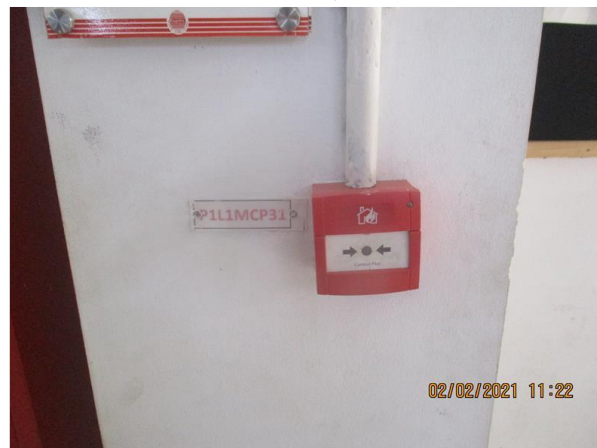
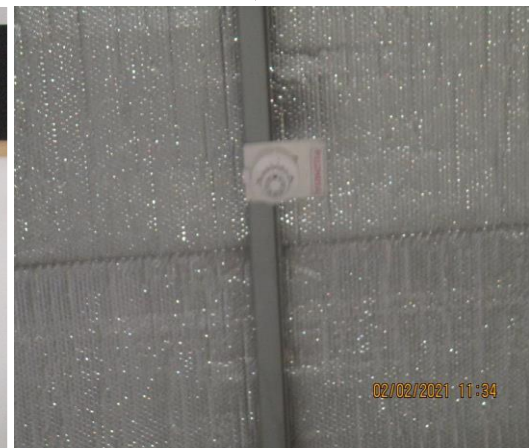
| F-3 | Fire Detection & Alarm System | Fire detection system installation requires detailed review to confirm compliance with NFPA 72 and ACCORD standards | Submit as-built drawings, testing records, equipment certification and other relevant documentation to the RSC for review and approval | Design within 1 month and installation modification within 3 months if required. |

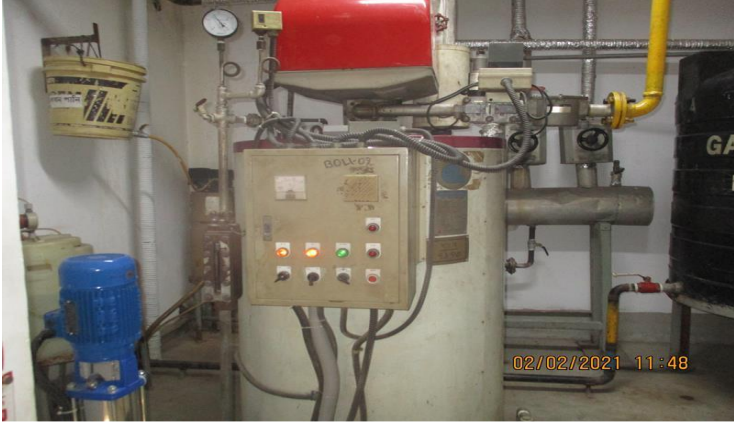
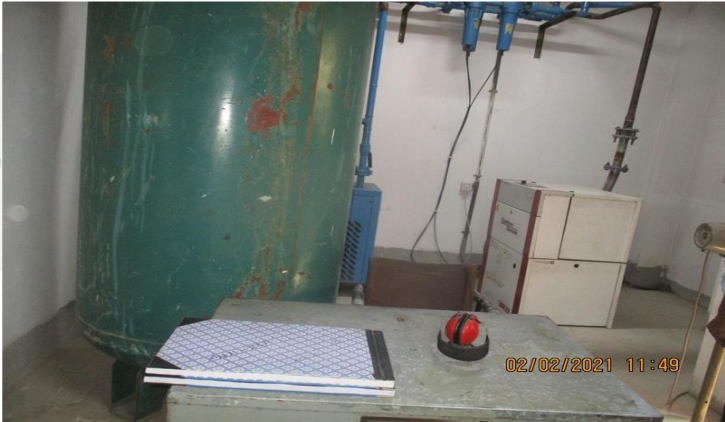
| F-5 | Fire Rated Construction | In the south side of the shed, there was no separation in between boiler and compressor. | Separate the boiler and compressor by a minimum 1-hr fire rated construction. Seal and/or protected all openings to maintain fire separations | Within 3 months |

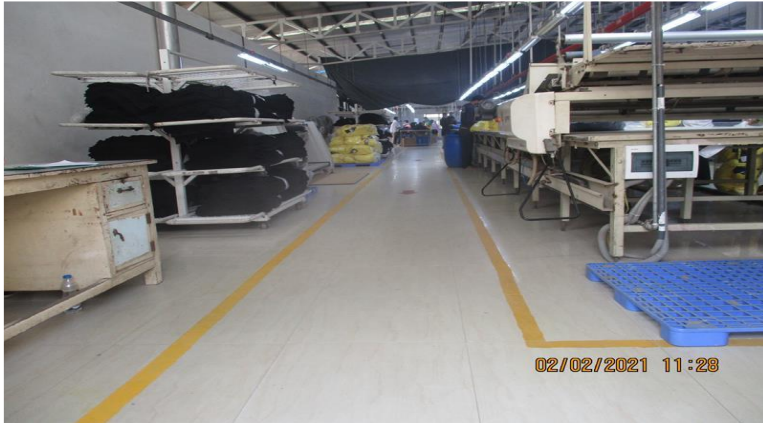
| F-6 | Egress Lighting | Directional signs are not provided where direction of the path of travel to an exit has changed | Illuminated directional signs shall be provided where there is a change in the direction for the path of travel and the direction to an exit is not obvious | within 3 months |
