# AB APPARELS LTD (extension)

225, SINGAIR ROAD, HEMAYETPUR, SAVAR  
(23.790530, 90.265082)

12<sup>th</sup> September 2021

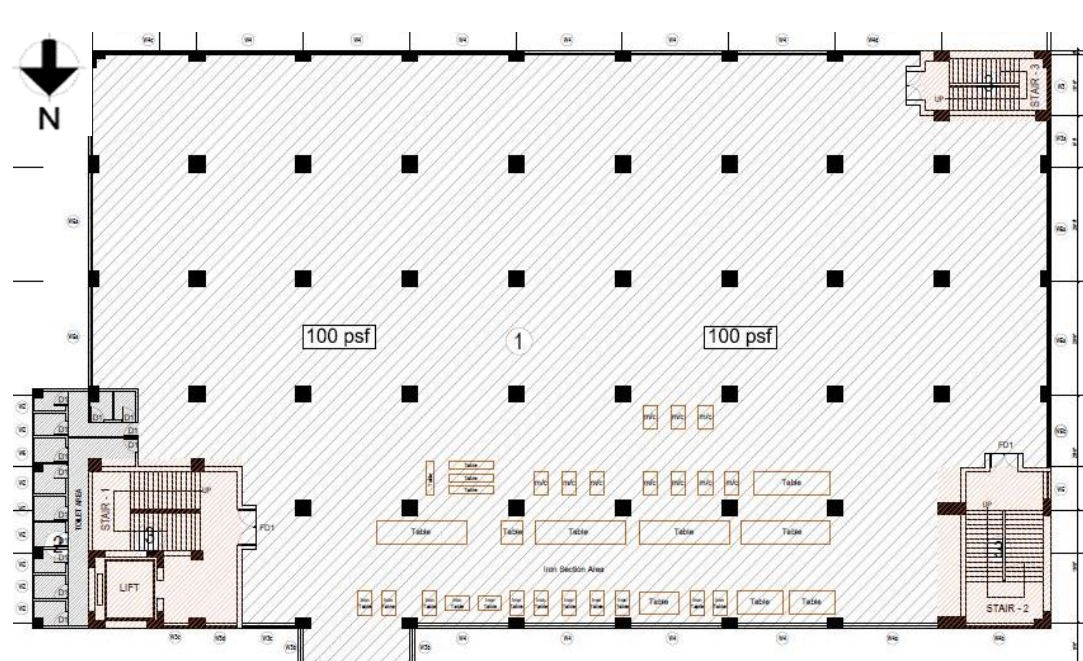
Live load plan- 2<sup>nd</sup> floor 4.7 kPa (100 psf)

Live load on typical floor is considered as 4.7 kPa in prepared load plan. As per BNBC- Part 6, live load for light storage areas is required to be considered minimum 6 kPa. However, the factory engineer is required to revise the load plan as per BNBC requirement and check the design accordingly.

| Item No. | Observation | Recommended Action Plan | Recommended Timeline |
|---|---|---|---|
| 01 | Prepared load plan to be revised (Building-1 (Wash Building)) | Produce and actively manage a set of floor live load plan following BNBC minimum live load requirement and considering foundation & column capacity of the building. | 6-weeks |
| 02 | Prepared load plan to be revised (Building-1 (Wash Building)) | Implement floor load plan. | 6-months |

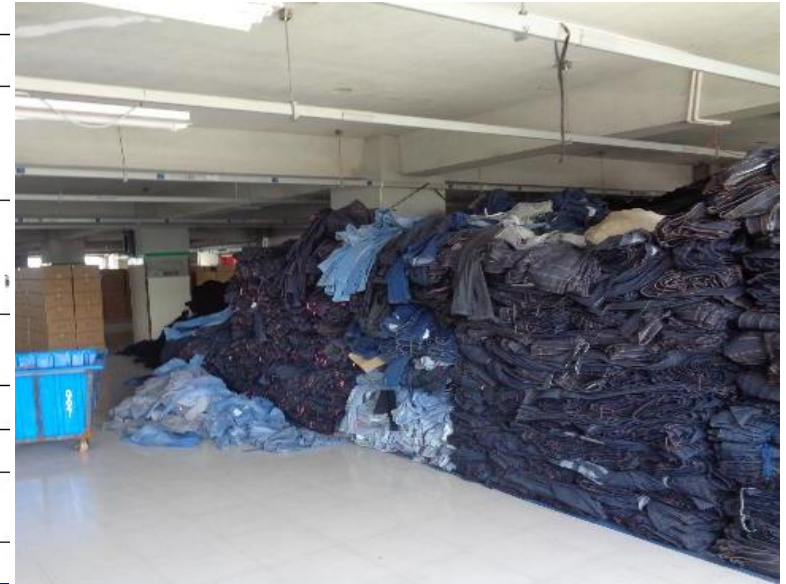
Storage on 2<sup>nd</sup> floor

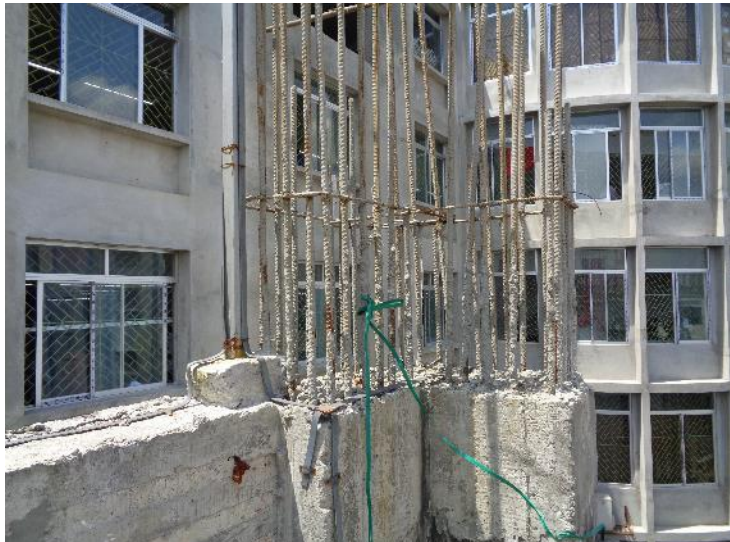
36-rebar at grid L-2

40-rebar are shown in schedule for column LC-1 at 3<sup>rd</sup> floor (current roof), but 36, 39, 38 rebar found in different locations. Factory engineer is required to update the as-built structural drawing.

| Item No. | Observation | Recommended Action Plan | Recommended Timeline |
|---|---|---|---|
| 03 | Inconsistency in the as-built drawing (Building-1 (Wash Building)) | The factory engineer is required to survey the structure and update the as-built structural drawing. | 6-weeks |

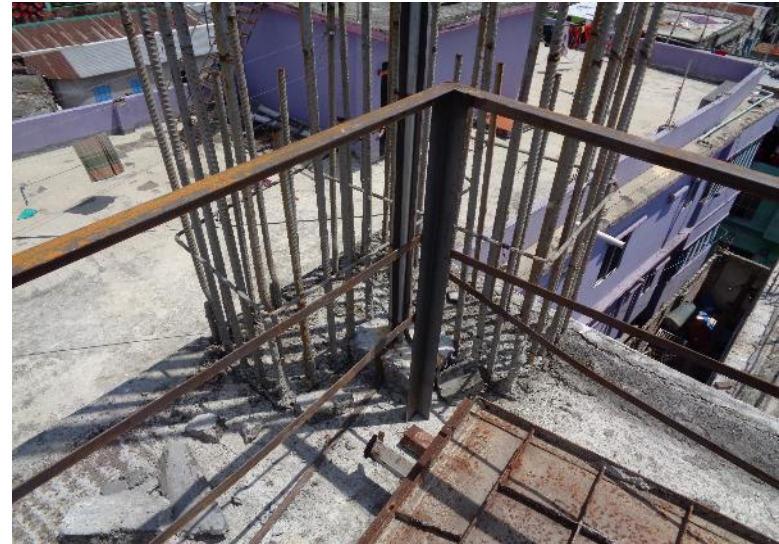
38-rebar at grid B1-9A

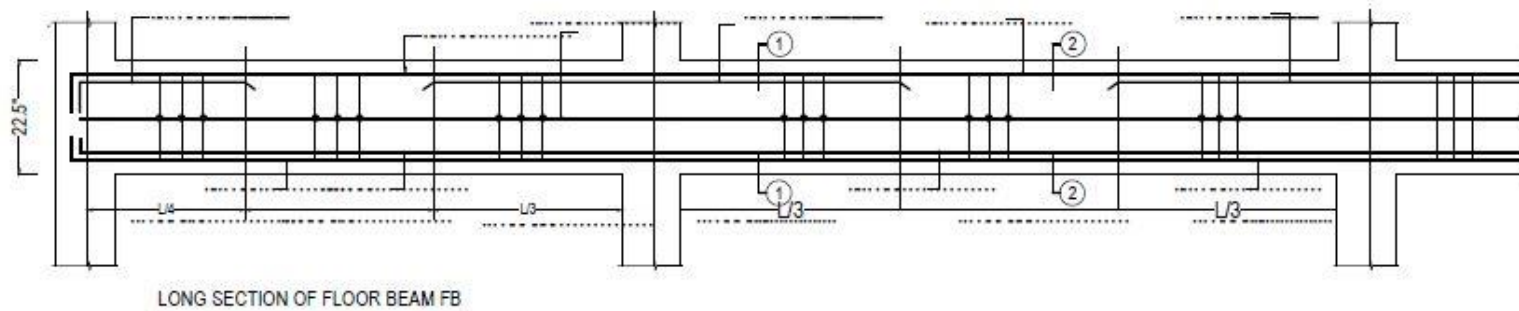
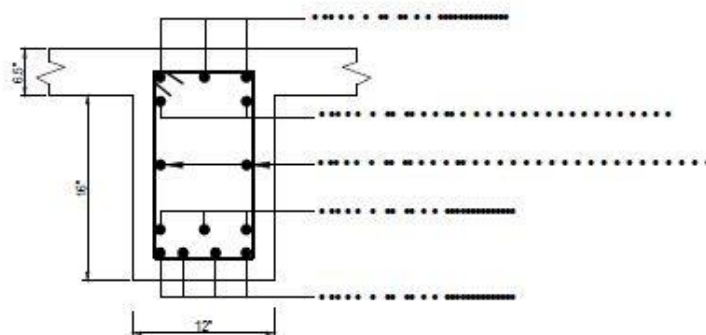
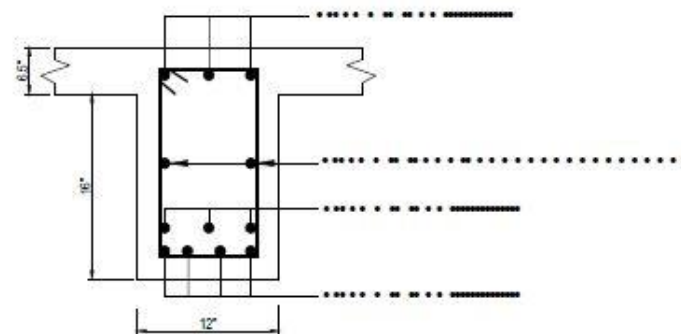
1ST FLOOR BEAM SECTION

Reinforcement diameter is not shown in beam section.

Reinforcement diameter is not shown in beam section. Factory engineer is required to update the as-built structural drawing.

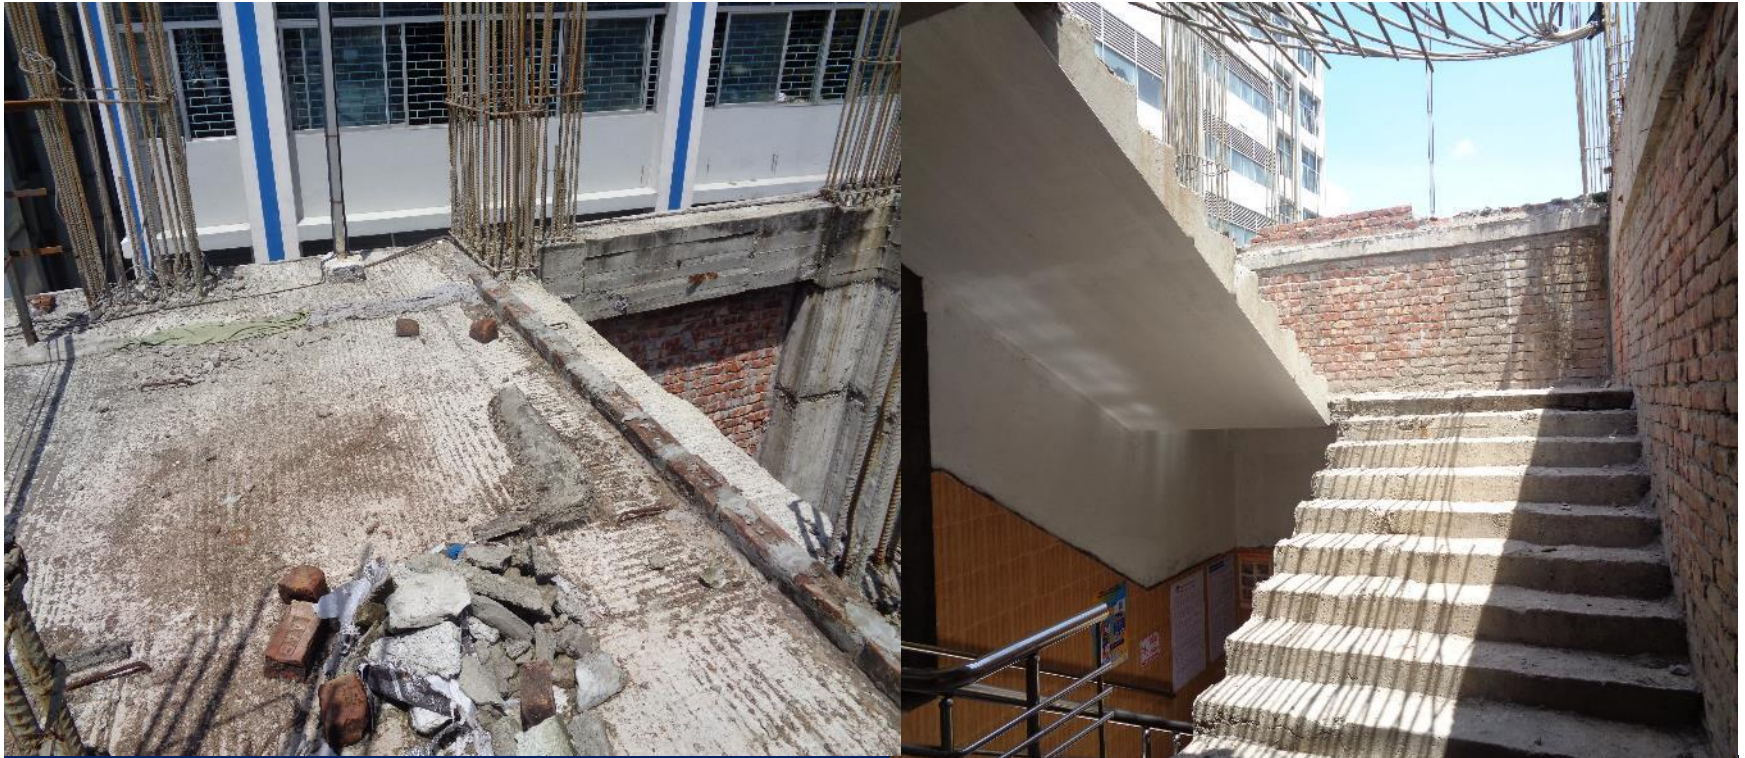
Parapet/railing was missing at several location on roof and staircase

Factory is required to provide parapet/railing at all locations of roof and staircase to avoid possible falling hazard.

| Item No. | Observation | Recommended Action Plan | Recommended Timeline |
|---|---|---|---|
| 04 | Falling hazard (Building-1 (Wash Building)) | Factory is required to provide parapet/railing at all locations of roof and staircase to avoid possible falling hazard. | 6-weeks |

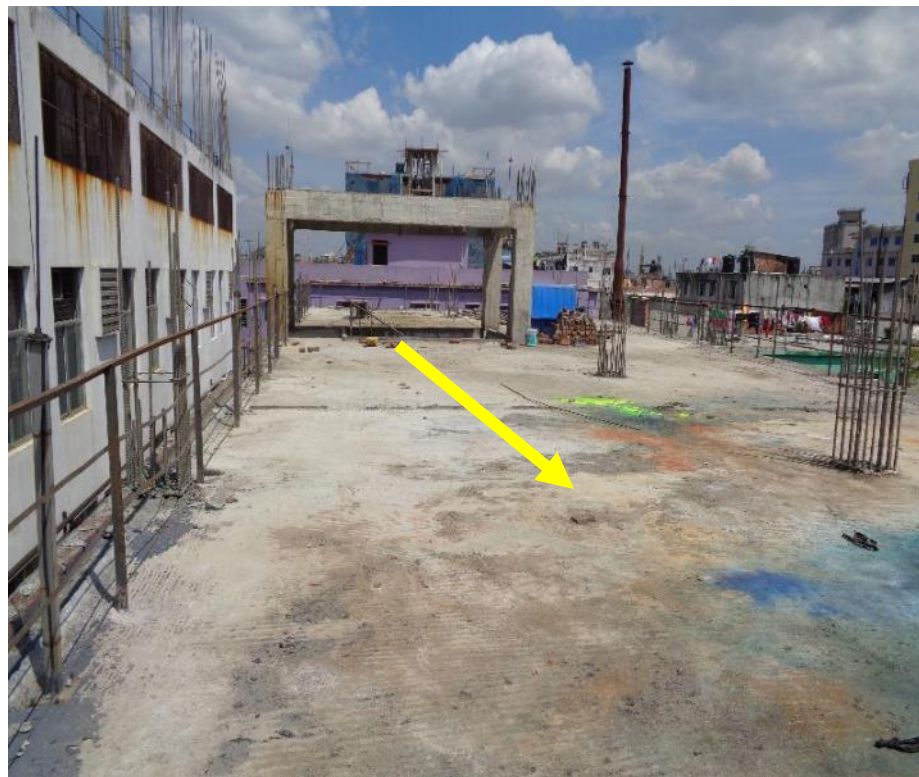
Roof

As per BNBC, every building or structure designed shall have its design documents prepared in accordance with the provision of Section 1.9.1. The design document shall include a design report, and a set of structural drawings, which shall be prepared in compliance with section 1.9.1.1 and section 1.9.1.2 as per BNBC. At the time of inspection, no design report was available which is required to be prepared in compliance with section 1.9.1.1 (part-6, BNBC).

| Item No. | Observation | Recommended Action Plan | Recommended Timeline |
|---|---|---|---|
| 05 | Design Report needs to be prepared (Building-2 (Chemical & Boiler Building)) | Factory engineer is required to prepare a Design Report in compliance with section 1.9.1.1 (part-6, BNBC). | 6-weeks |

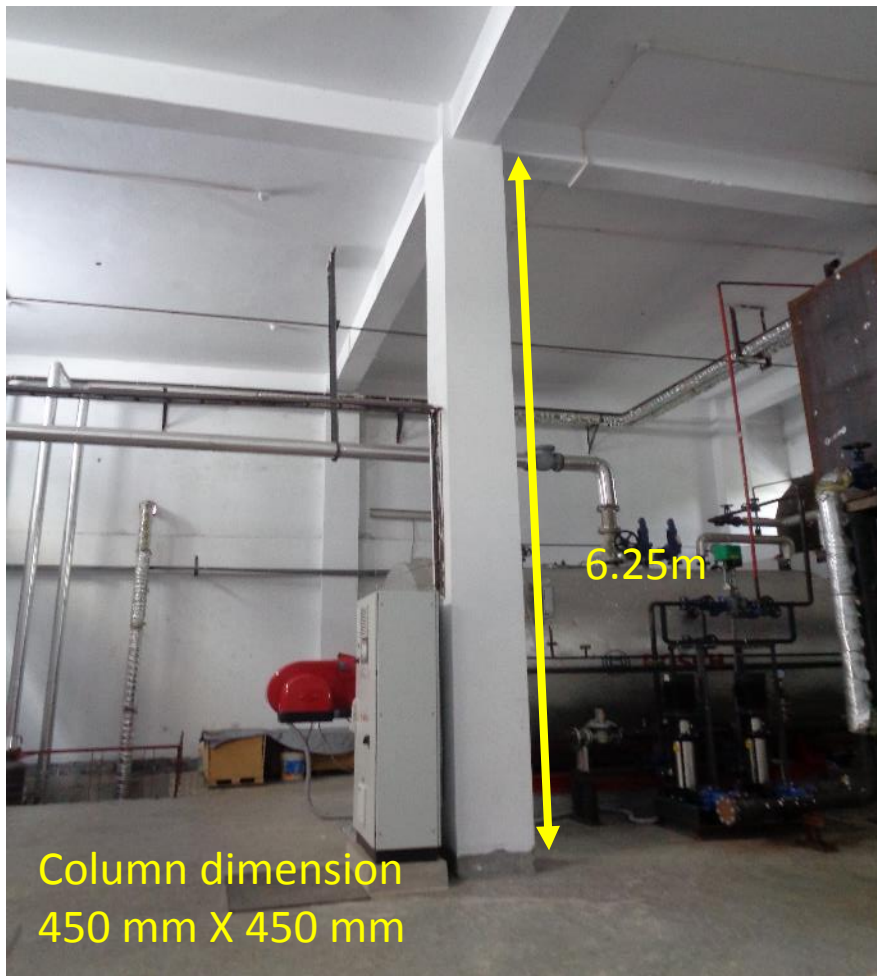
Column dimension  
450 mm X 450 mm

Column appeared to be slender with long  
unsupported length

Cursory calculation shows that slenderness in highlighted columns exceeds normal design limit due to long unsupported length. Factory engineer is required to carryout adequacy check of the highlighted column considering slenderness effect.

| Item No. | Observation | Recommended Action Plan | Recommended Timeline |
|---|---|---|---|
| 07 | Column appears to be slender (Building-2 (Chemical & Boiler Building)) | Factory engineer is required to carryout adequacy check of the highlighted column considering slenderness effect. | 6-weeks |
| 08 | Column appears to be slender (Building-2 (Chemical & Boiler Building)) | Implement any remediation work if required. | 6-months |

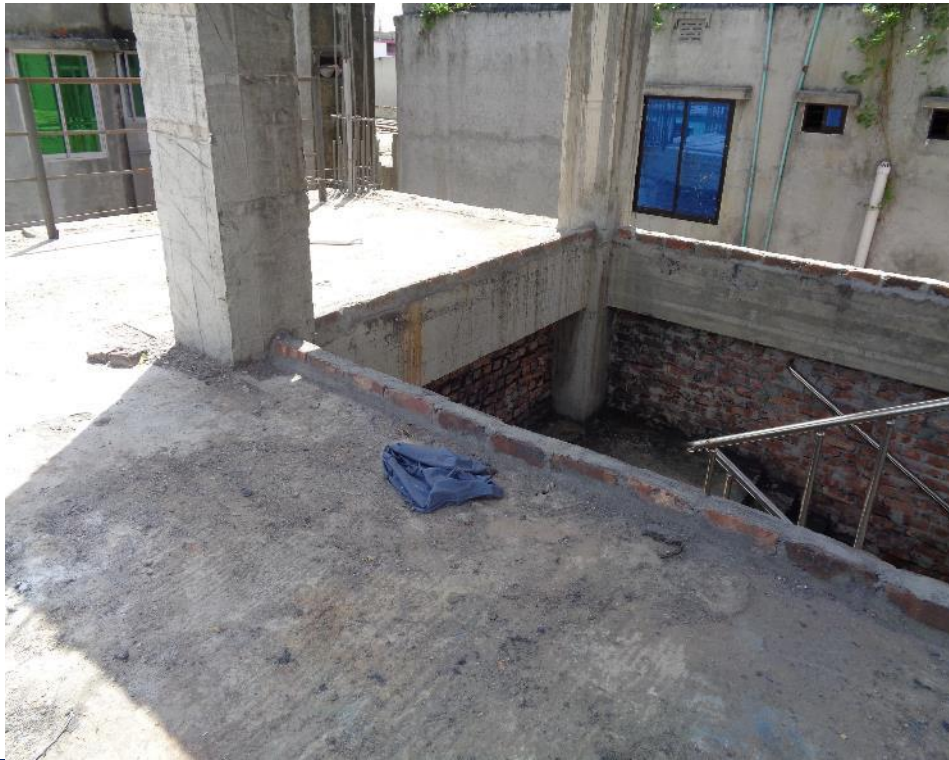
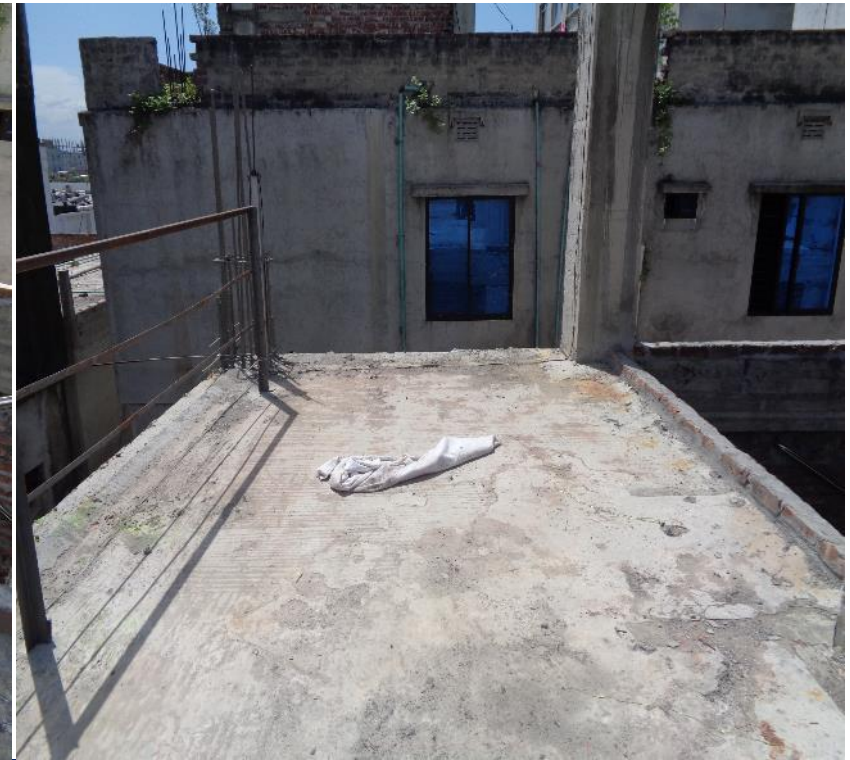
Parapet/railing was missing at several location of roof and staircase

Factory is required to provide parapet/railing at all locations of roof and staircase to avoid possible falling hazard.

| Item No. | Observation | Recommended Action Plan | Recommended Timeline |
|---|---|---|---|
| 09 | Falling hazard (Building-2 (Chemical & Boiler Building)) | Factory is required to provide parapet/railing at all locations of roof and staircase to avoid possible falling hazard. | 6-weeks |

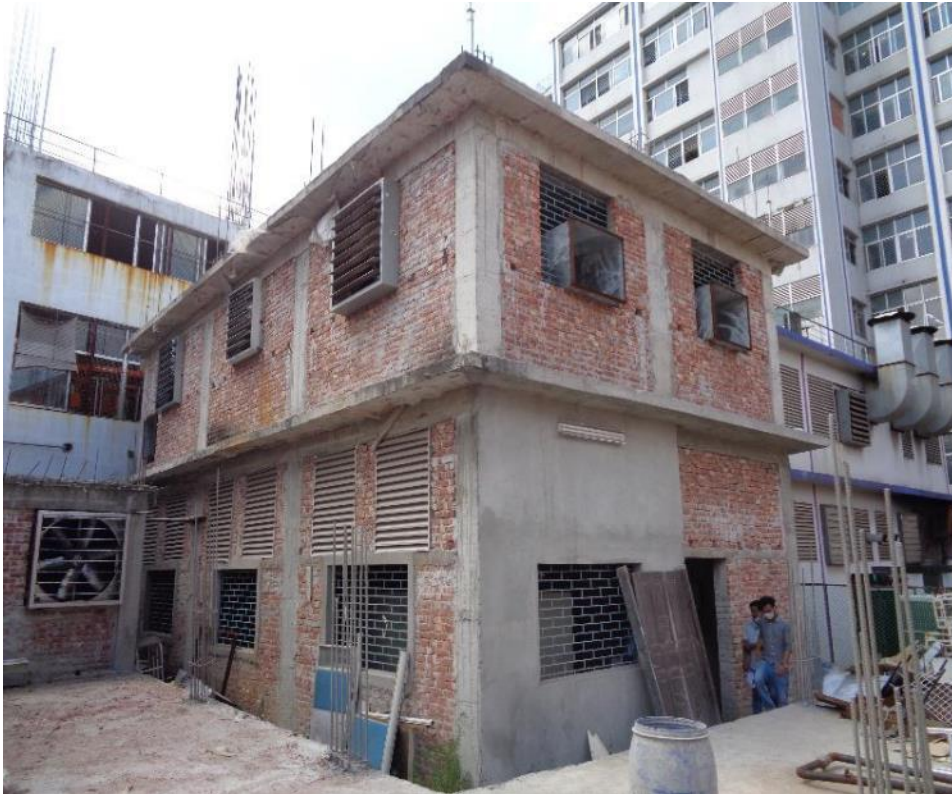
Front view

As per BNBC, every building or structure designed shall have its design documents prepared in accordance with the provision of Section 1.9.1. The design document shall include a design report, and a set of structural drawings, which shall be prepared in compliance with section 1.9.1.1 and section 1.9.1.2 as per BNBC. At the time of inspection, no design report was available which is required to be prepared in compliance with section 1.9.1.1 (part-6, BNBC).

| Item No. | Observation | Recommended Action Plan | Recommended Timeline |
|---|---|---|---|
| 10 | Design Report needs to be prepared (Building-3 (Compressor & Substation Building)) | Factory engineer is required to prepare a Design Report in compliance with section 1.9.1.1 (part-6, BNBC). | 6-weeks |

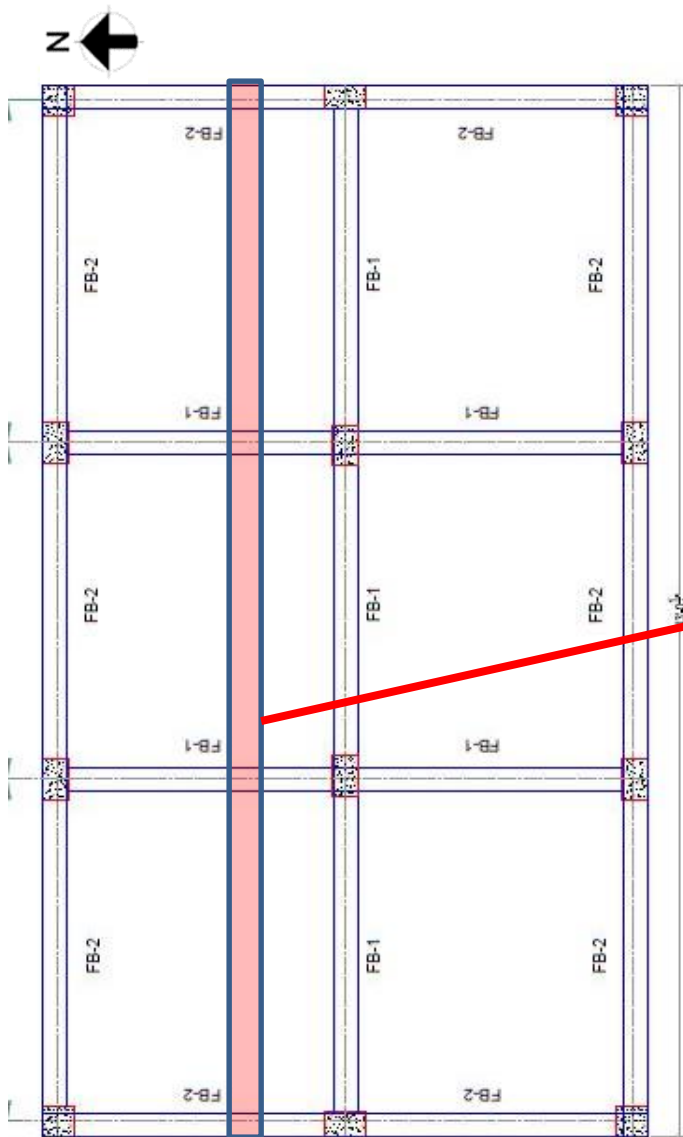
Extra beam found on roof level but not shown in beam layout

Extra beam found on roof level but not shown in beam layout. Factory engineer is required to update the as-built structural drawing.

| Item No. | Observation | Recommended Action Plan | Recommended Timeline |
|---|---|---|---|
| 12 | Discrepancy in as-built drawing (Building-3 (Compressor & Substation Building)) | The factory engineer is required to survey the structure and update the as-built structural drawing. | 6-weeks |

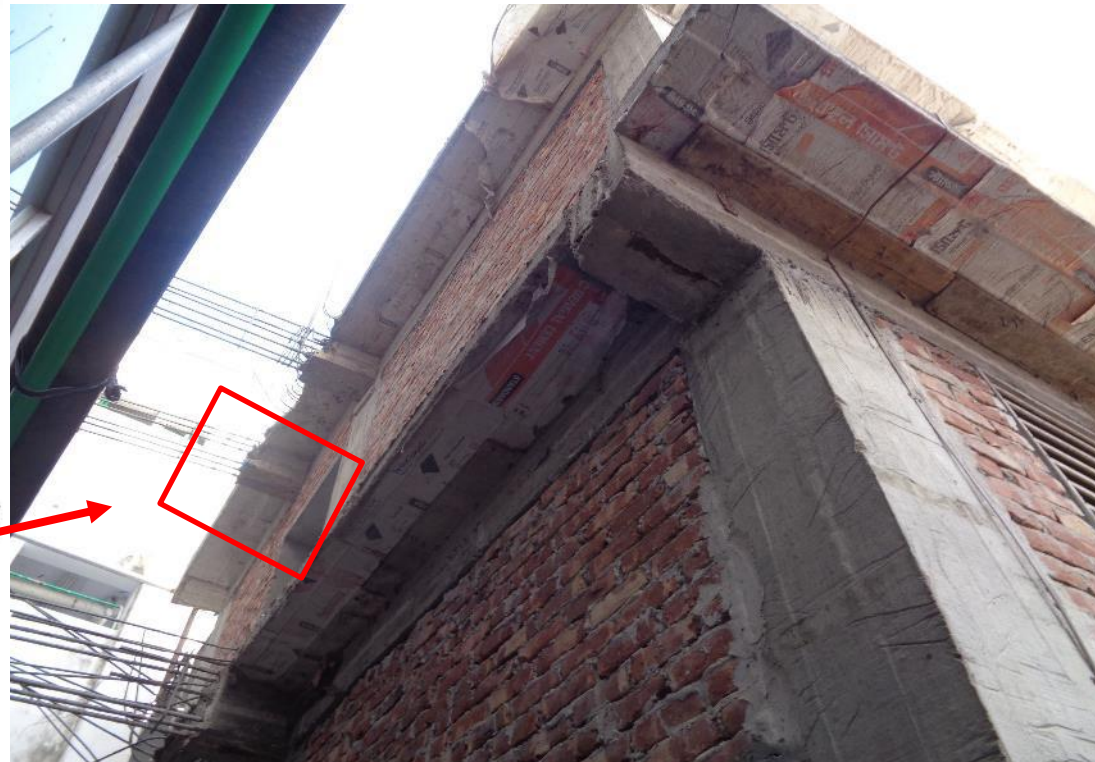
Extra beam at roof level
