# **INITIAL FIRE SAFETY INSPECTION REPORT**

## **AB APPARELS LTD (extension)**

**RSC ID: 24906**

**Date: 12 Sep-2021**

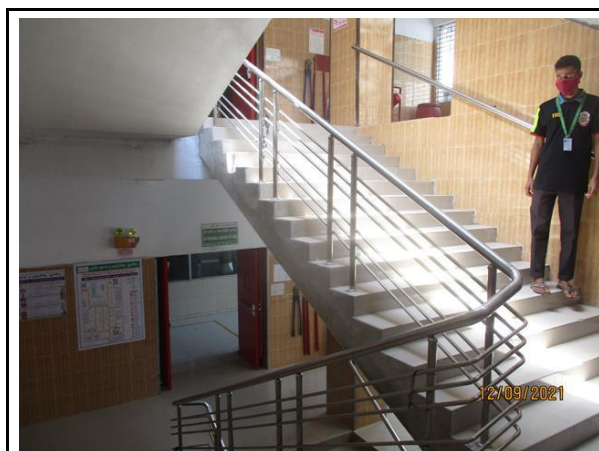
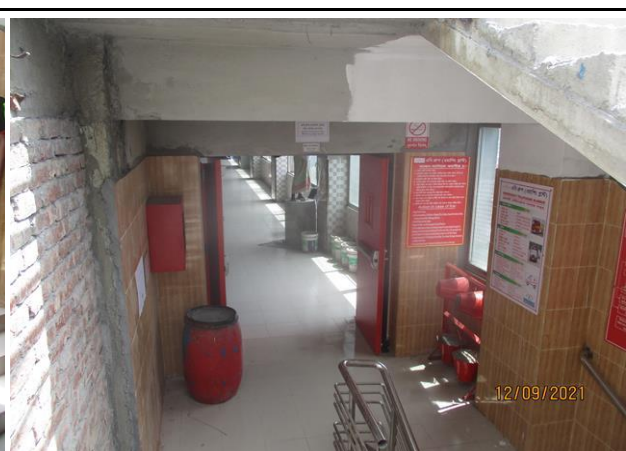
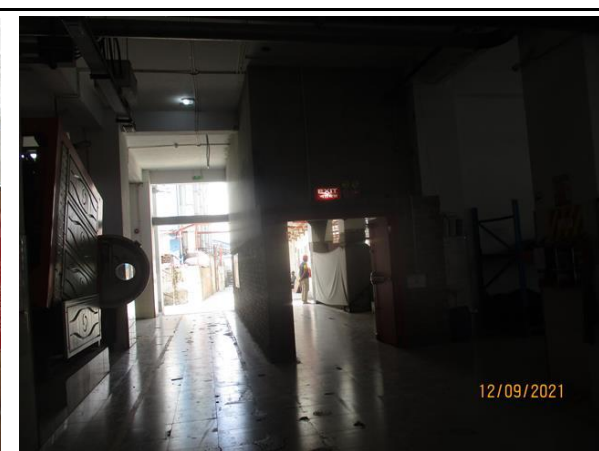
| SI No. | Category | Findings | Required Action | Remediation Time Frame |
|---|---|---|---|---|
| F-1 | Fire Rated Construction | <p>Exit Enclosures are not properly fire separated from other occupancy on each floor by fire rated construction due to non-functionality of installed fire rated doors.</p> <p>Location: Building 1.</p> | <p>Provide minimum 2-hr fire rated separation in exit enclosures with minimum 1.5-hr fire rated doors and seal all unprotected openings and penetration to separate the exit stairs from work areas and other building spaces on all floor levels with similar rating of fire door.</p> <p>Ensure that the fire doors are self-closing and positive latching and that they are provided with fire exit (panic) hardware where serving production floors. If fire doors are required to be held open for functional reasons, provide automatic closing devices tied to the fire alarm system.</p> | Within 3 months |

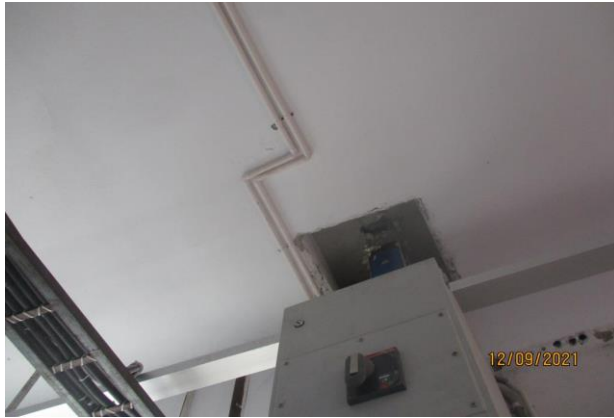
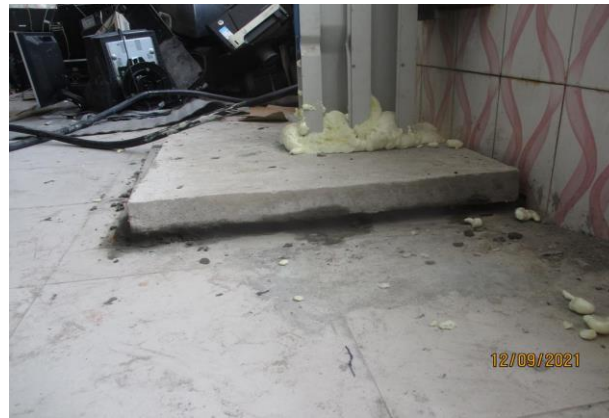
| F-2 | Fire Rated Construction | Unsealed electrical busbar penetration was found in fire rated floor/ceiling assemblies.<br>Location: Building-1 | Provide a minimum 2-hr fire rated shaft to separate the utility risers from each floor level or Seal all penetrations and openings in floors/ceiling assemblies to maintain the fire separation by at least 3-hr (Considering proposed-7 storied). | Within 3 months |

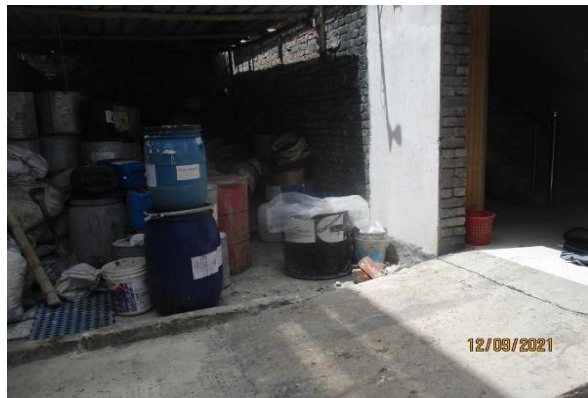
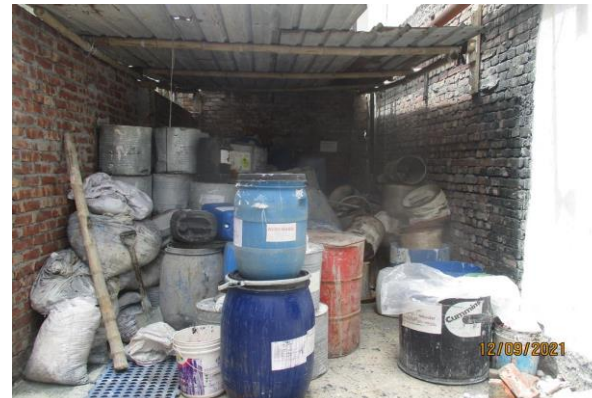
| F-3 | Fire Rated Construction | Wastage chemical storage was found near the exit discharge path.<br>Location: Stair-2, Ground Floor, Building-1. | Remove the wastage chemical storage from the exit discharge path or separate the storage area from the exit discharge path with minimum 4-hr fire rated construction. | Within 3 months |

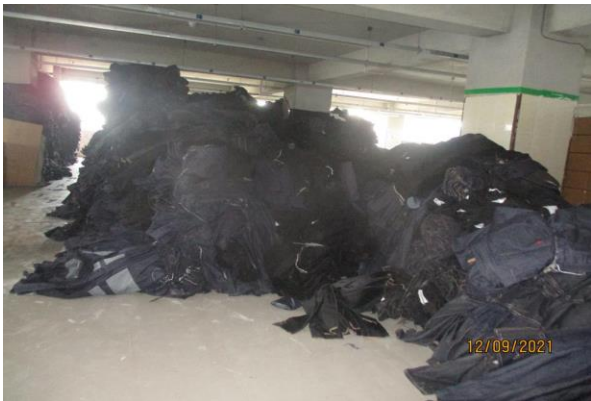
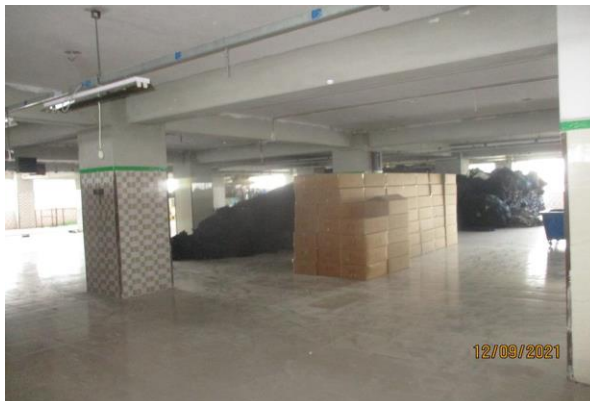
| F-4 | Fire Rated Construction | <p>Areas used for combustible storage are not separated by fire-rated construction .<br/>Location: 2nd Floor of Building-1</p> | <p>Provide dedicated storage rooms separated by minimum 1-hr fire-rated construction.</p> <p>Where separate storage rooms are not feasible, provide defined storage areas and limit the storage arrangement as follows:</p> <ul style="list-style-type: none"> <li>- Maximum height of 2.4m and maximum area of 23m2</li> <li>- If sprinkler protected: maximum height of 3.66m and maximum area of 93m2</li> </ul> <p>Separate areas of unenclosed combustible storage by a minimum clear distance of 3m</p> | Within 3 months |

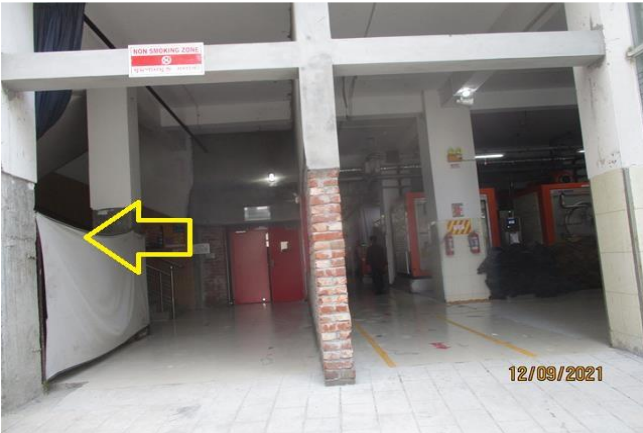
| F-5 | Fire Rated Construction | The elevator discharges inside the stair enclosure.<br>Location: Stair-1 of Building -1 | For new construction, elevators shall not open into an exit enclosure as per ACCORD Standard-6.14.3. So, ensure separate enclosures for the elevator shafts with minimum 2 hr. fire rating. If elevator is not being installed then the door opening can be sealed by minimum 2-hr fire rated construction. | Within 3 months |

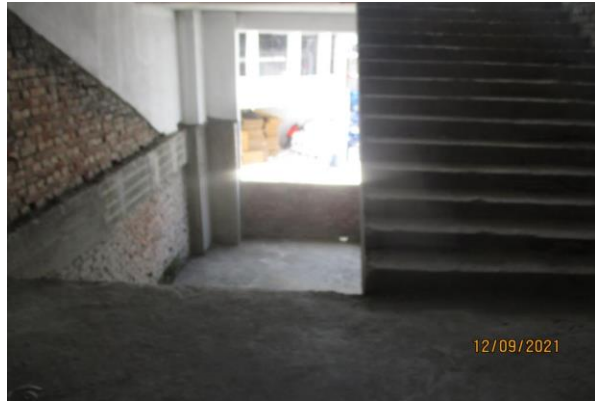
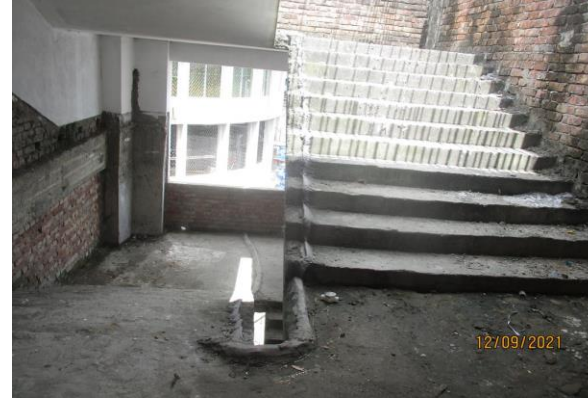
| F-6 | Means of Egress | Handrails are not provided at exit stair.<br>Location: stair-3 of Building-1 | Provide handrails on both sides of the exit stair. New handrails shall have a minimum height of 865 mm (34 in.) and a maximum height of 965 mm (38 in.) as measured from the leading edge of the tread. Intermediate handrails shall be provided when the stair width exceeds 2.2 m (87 in.). | Within 1 month |

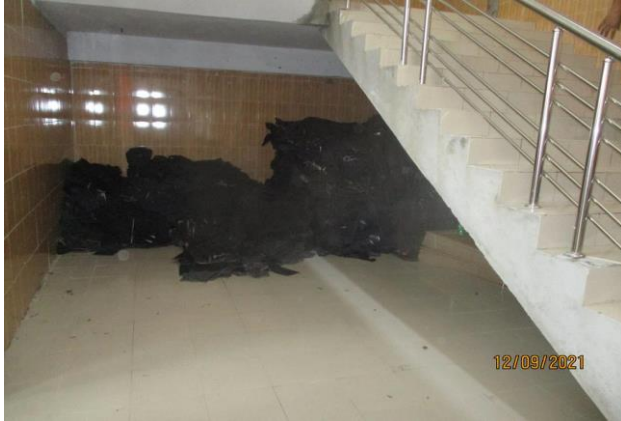
| F-7 | Means of Egress | Storage was located in exit stair.<br>Location: Ground floor of Stair-1 of Building-1 | Remove storage from the exit stairs and egress path | Immediate |

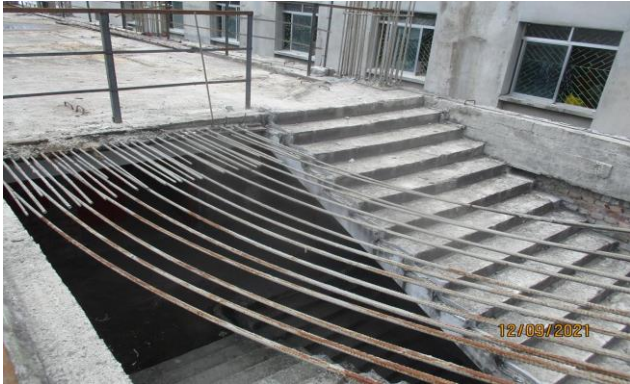
| F-8 | Means of Egress | The stair tops at the roof is open, because of this rain water may enter the stairs and cause slipping hazard. | Cover the stair tops with appropriate construction so that rain water can not enter the stairs. | Within 1 Month |

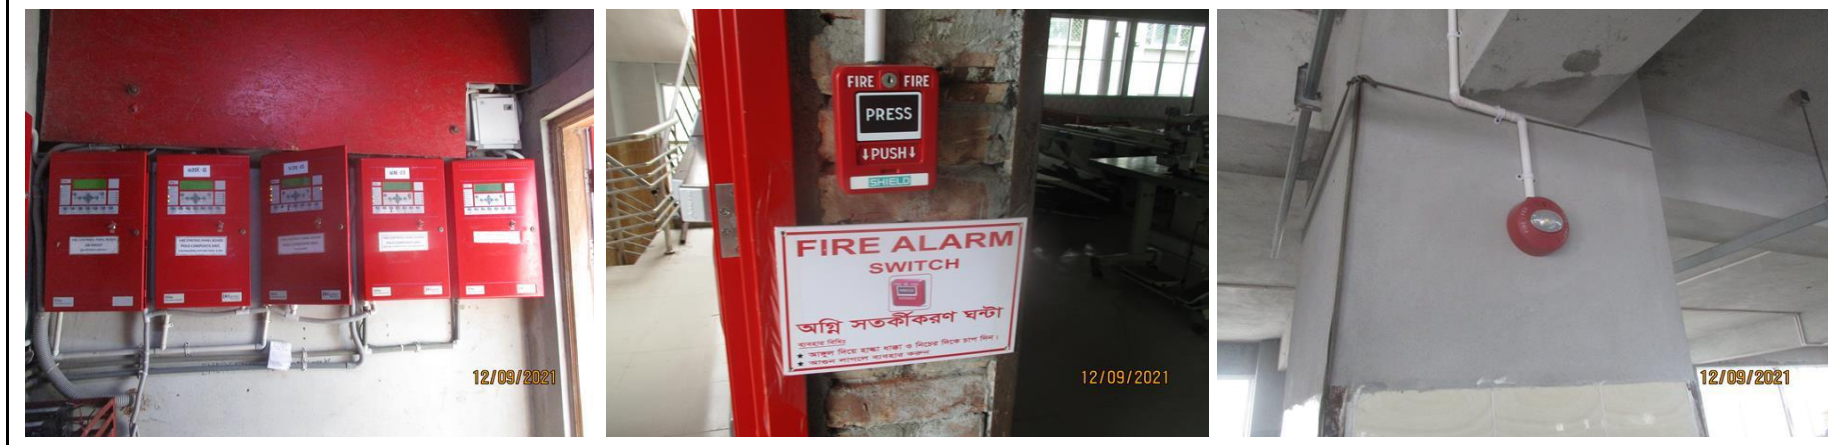
| F-11 | Fire Alarm & Detection System (FADS) | The factory has installed an addressable fire alarm & detection system which is required to be reviewed and verified. | Submit as-built drawings, testing records, equipment certification and other relevant documentation to the RSC for review and approval. Modification (if required) shall have to be done as per the reviewed design and NFPA-72. Upon review & modification (if required) the owner shall verify the system by RSC for final acceptance. | Design within 2 months, Install within 4 months. |
