Sultana Sweaters Limited

Ahakhalia, Hazir Bazar, Mollik Bari, Bhaluka, Mymensingh, Bangladesh.

02 & 16 February 2021

Observations

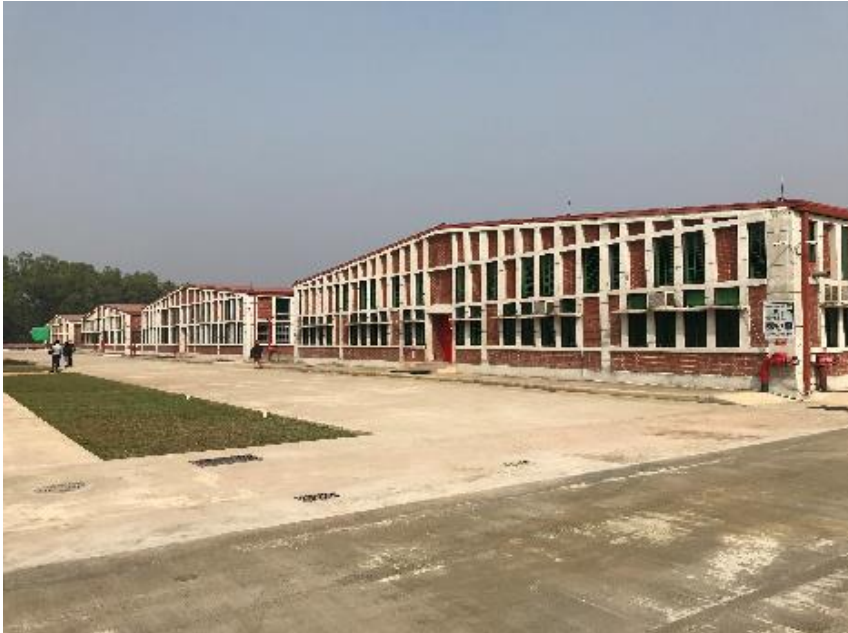
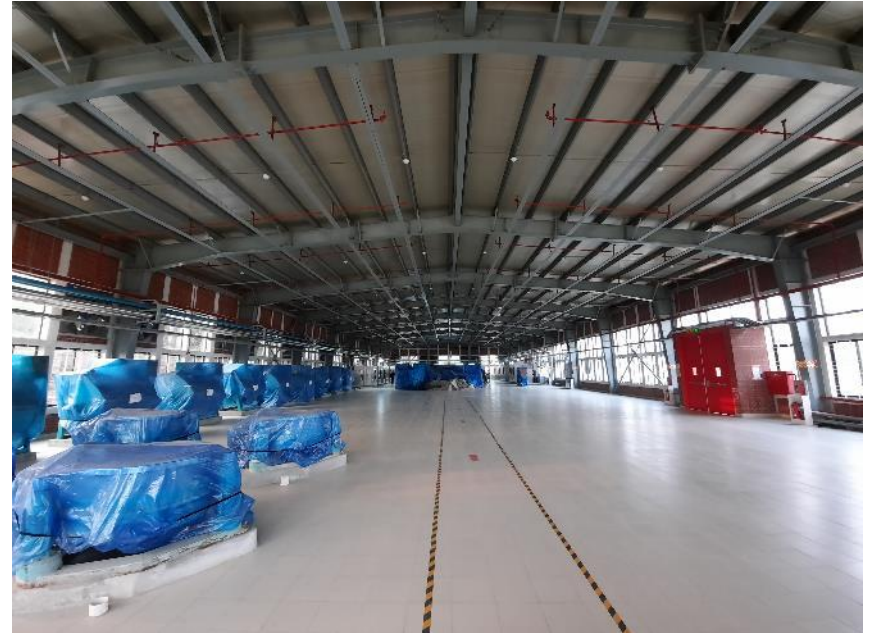
Unavailable of structural design report

As per BNBC every building or structure designed shall have its design documents prepared in accordance with the provision of Section 1.9.1. The design document shall include a design report, and a set of structural drawings, which shall be prepared in compliance with section 1.9.1.1 and section 1.9.1.2 as per BNBC.

Design report of all structures were not found which is required to be prepared in compliance with section 1.9.1.1 (part-6, BNBC).

| Item No. | Observation | Recommended Action Plan | Recommended Timeline |
|---|--|---|---|
| 01 | Structural design reports not available. (All Structures) | Building engineer to prepare the design document including a design report, and a set of structural drawings in compliance with section 1.9.1.1 and section 1.9.1.2 as per BNBC.. | 6-weeks |

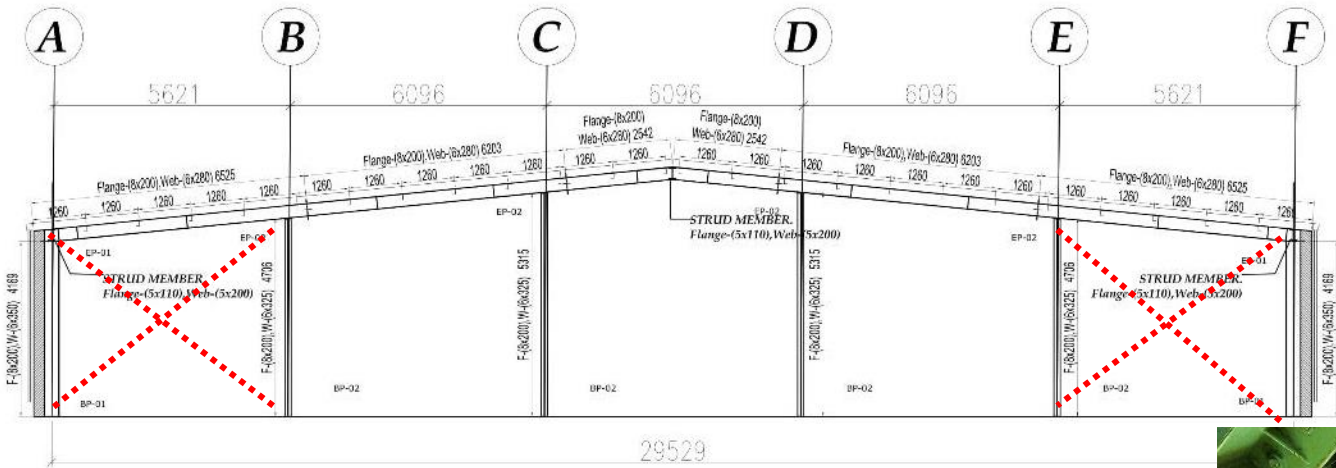
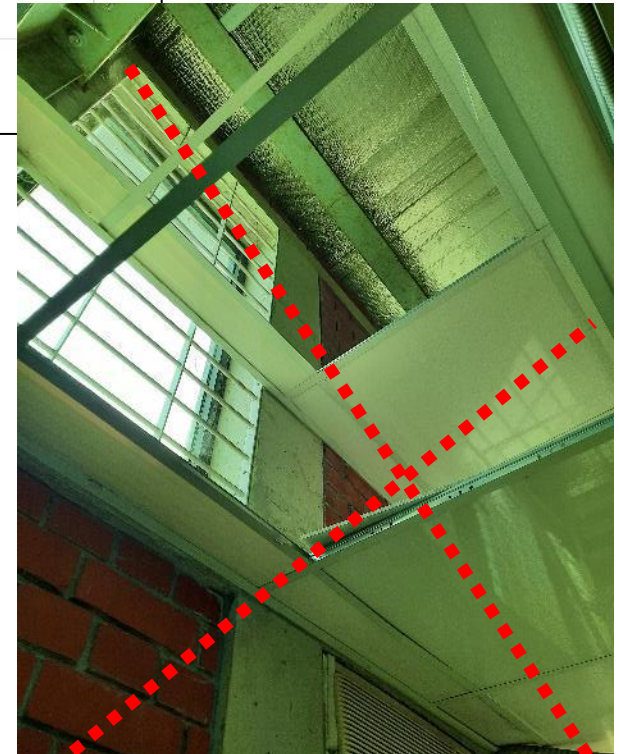
Gable frame section of Shed 1

Missing bracing at Several Location

Missing Bracing

| Item No. | Observation | Recommended Action Plan | Recommended Timeline |
|---|--|---|---|
| 05 | Missing bracing at several locations. (Shed 1,3,4, Substation 1 & 2) | Building engineer is required to re-install all the missing bracing as per the design specifications. | 6-weeks |

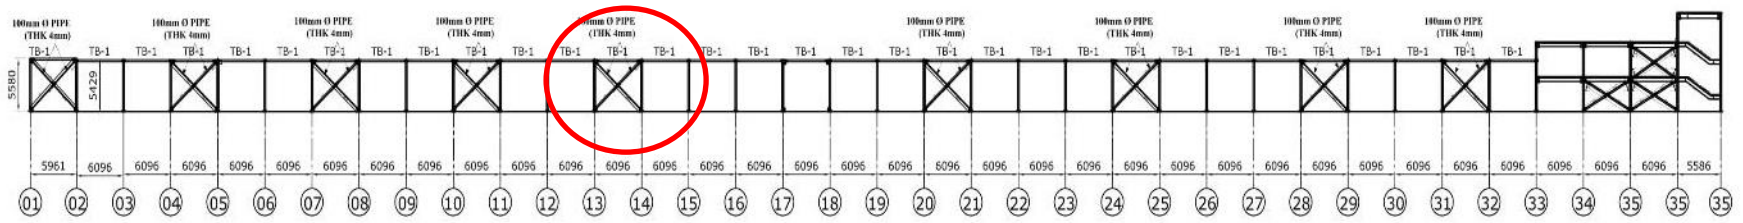
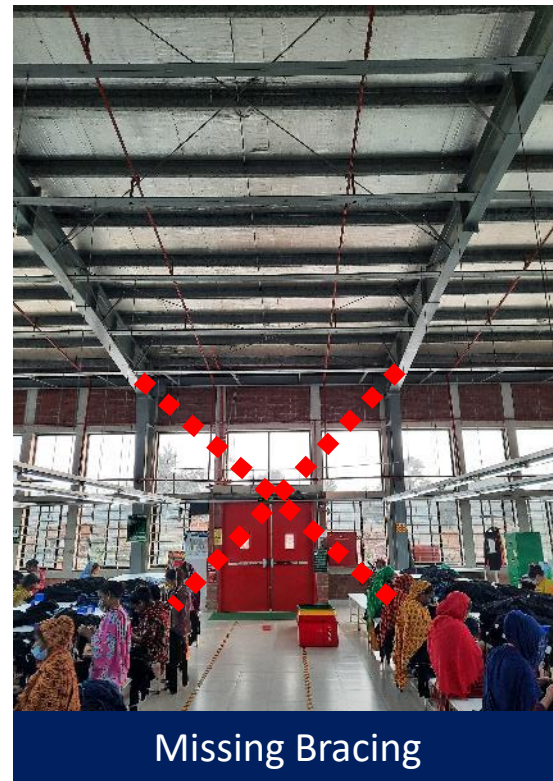
Section details of grid-A

8 **Observations: Shed 3**

Missing Bracing

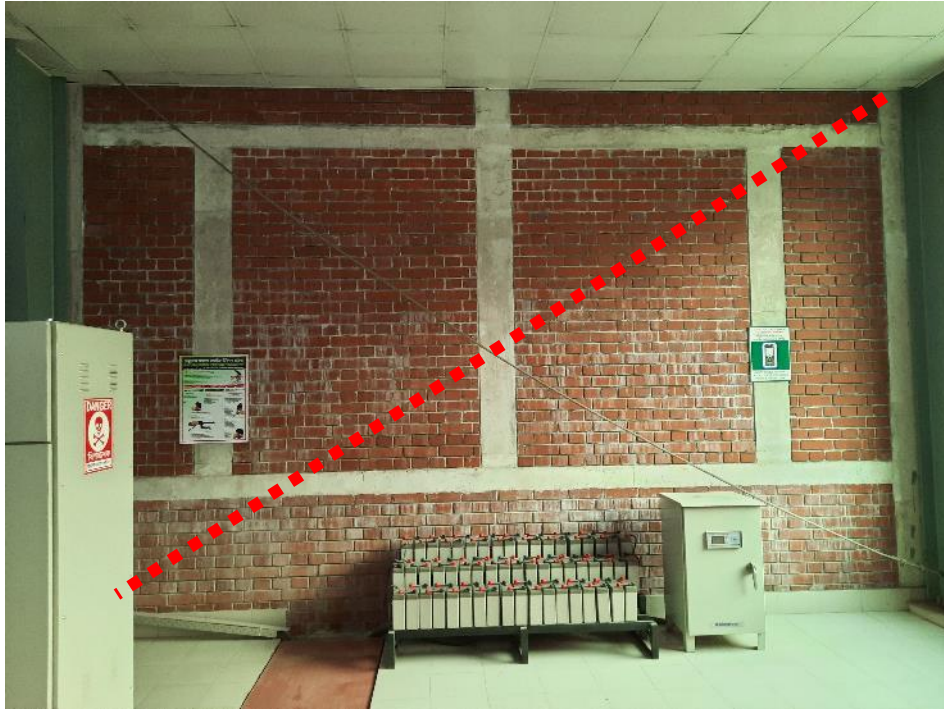
Missing wall bracing

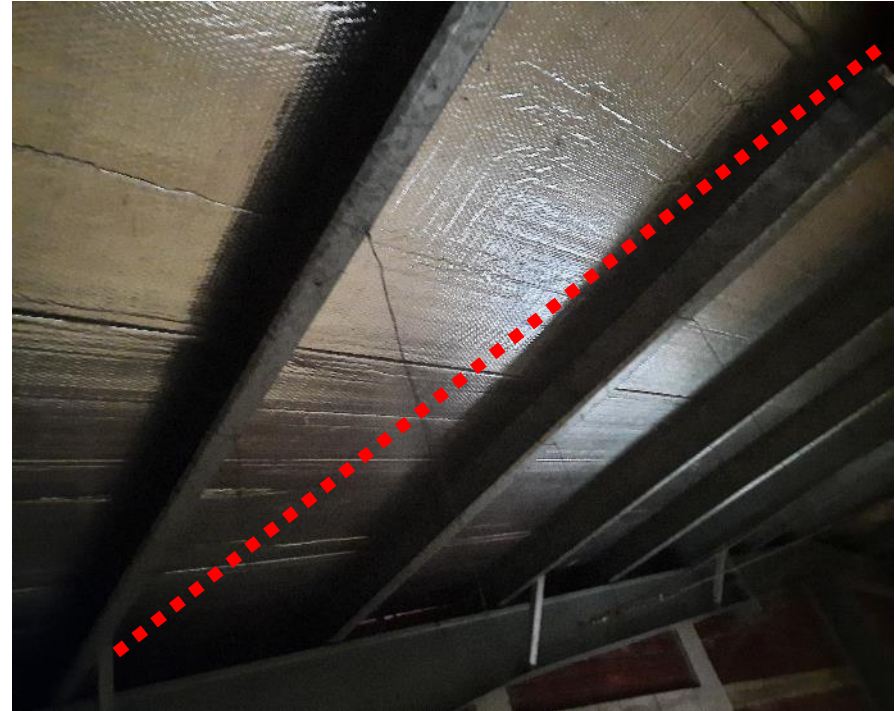
Missing roof bracing

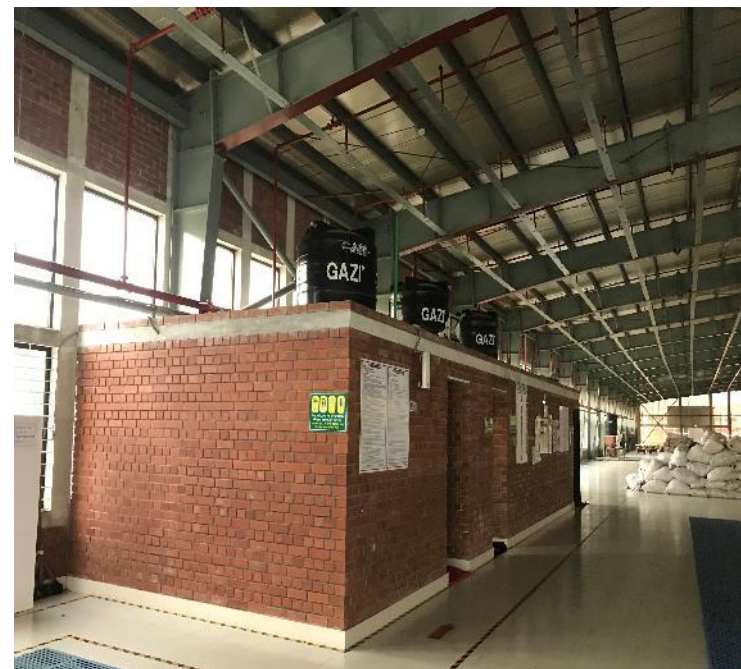
Bracing interrupted in some locations

Bracings are interrupted in toilet zone (Shed 4,5,6,7)

| Item No. | Observation | Recommended Action Plan | Recommended Timeline |
|---|---|---|---|
| 08 | Bracing interrupted in some locations. (Shed 4, 5, 6, 7) | Building engineer is required to check the existing bracing system and the load path of the bracings. | 6-weeks |

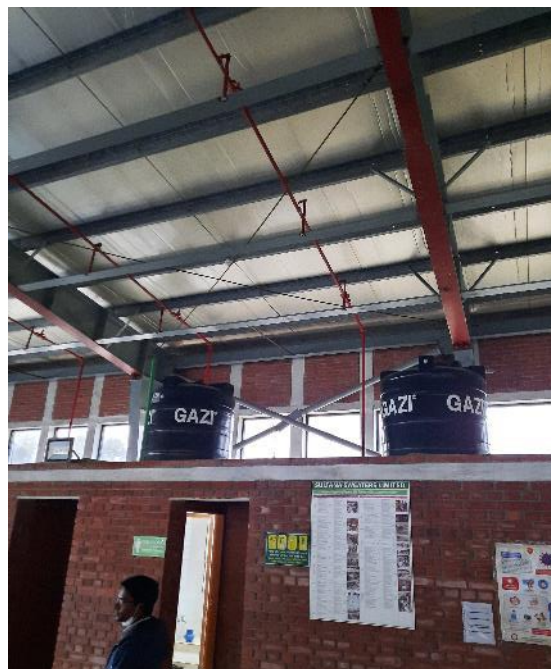
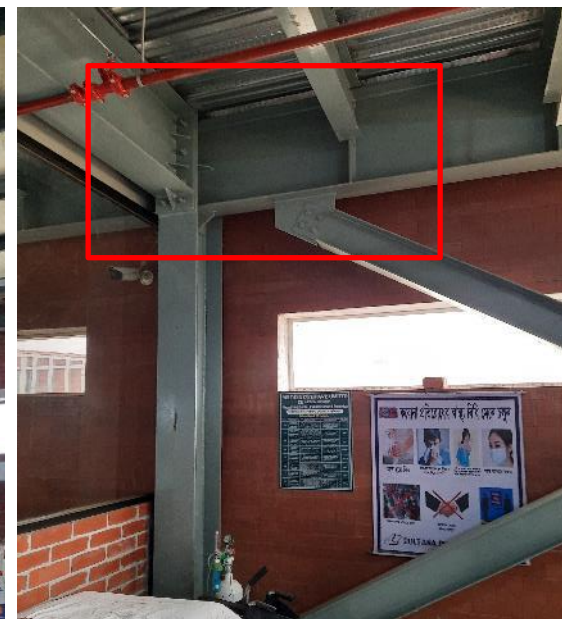
Bracings are offset from the node point- Shed 5

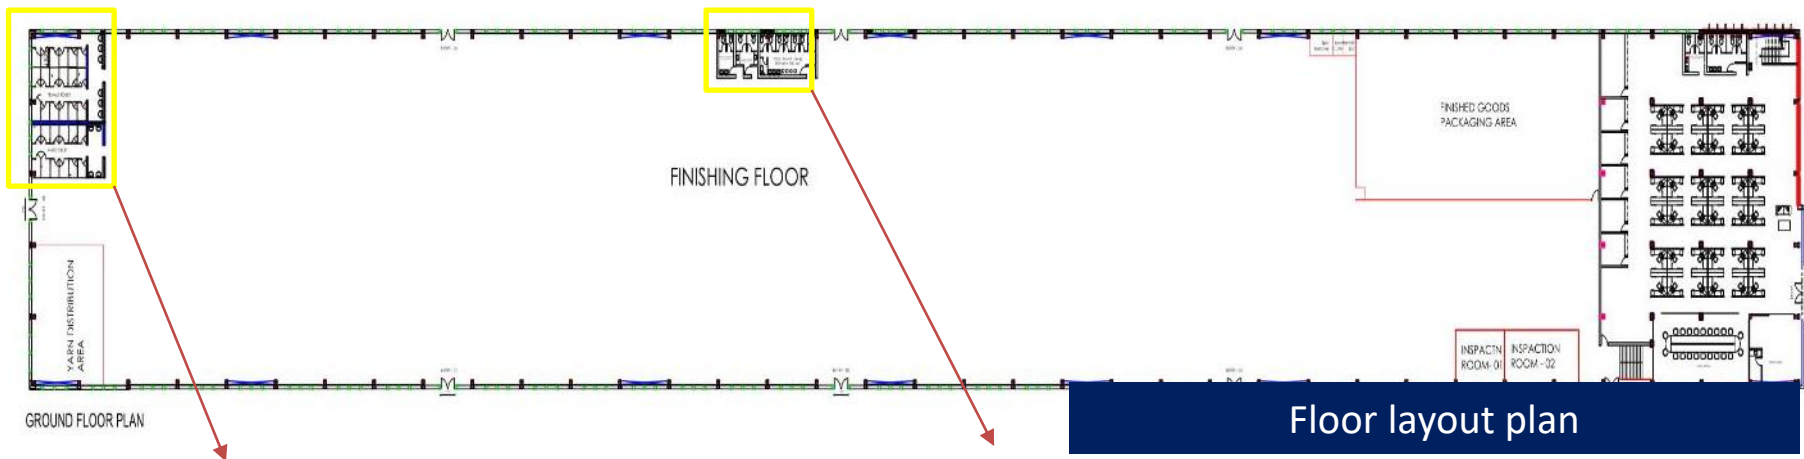
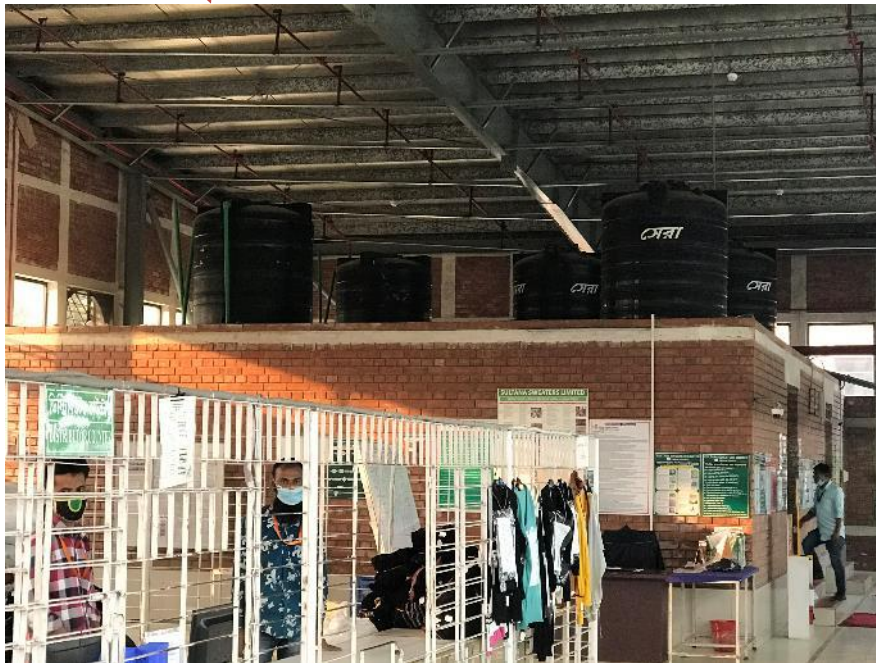
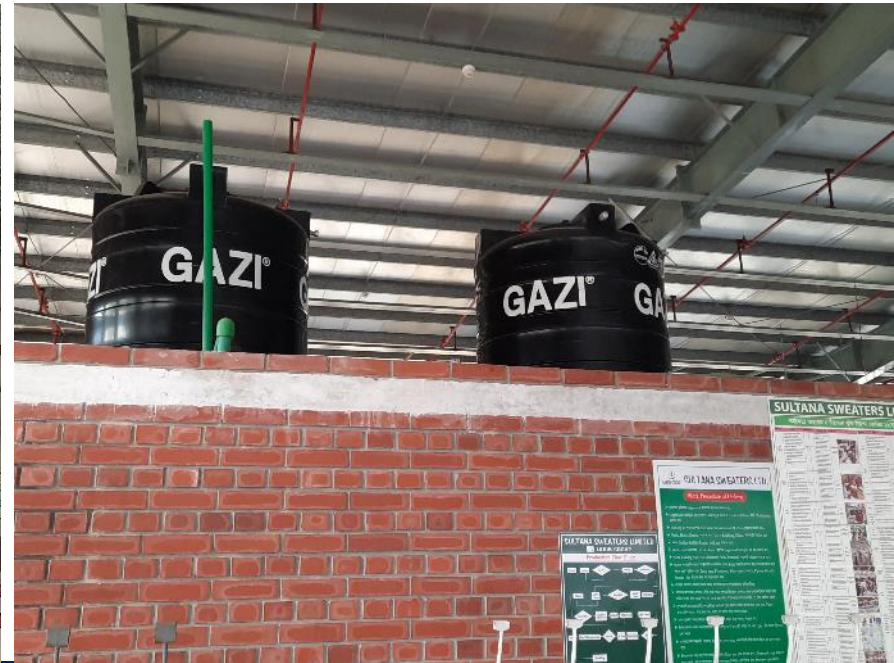
Water tank supported on the toilet zone partition wall

Water tanks are supported on the 125 mm and 250 mm brick walls. Building engineer is required to check the load carrying capacity of the walls.

| Item No. | Observation | Recommended Action Plan | Recommended Timeline |
|---|---|---|---|
| 10 | Water tank supported on the toilet zone partition wall. (Shed 4, 5, 6, 7) | Building engineer is required to check the load carrying capacity of the walls. | 6-weeks |

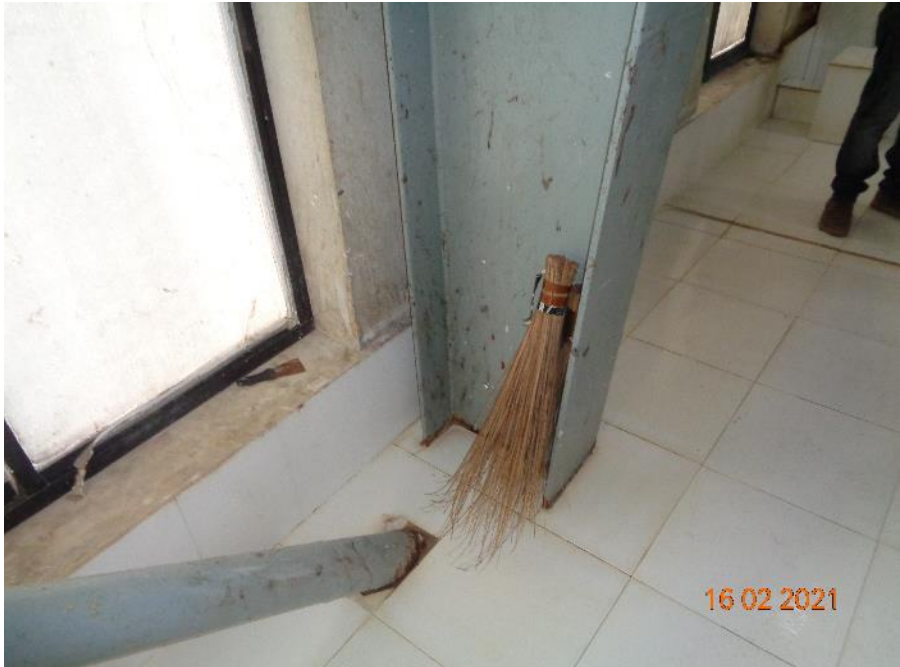
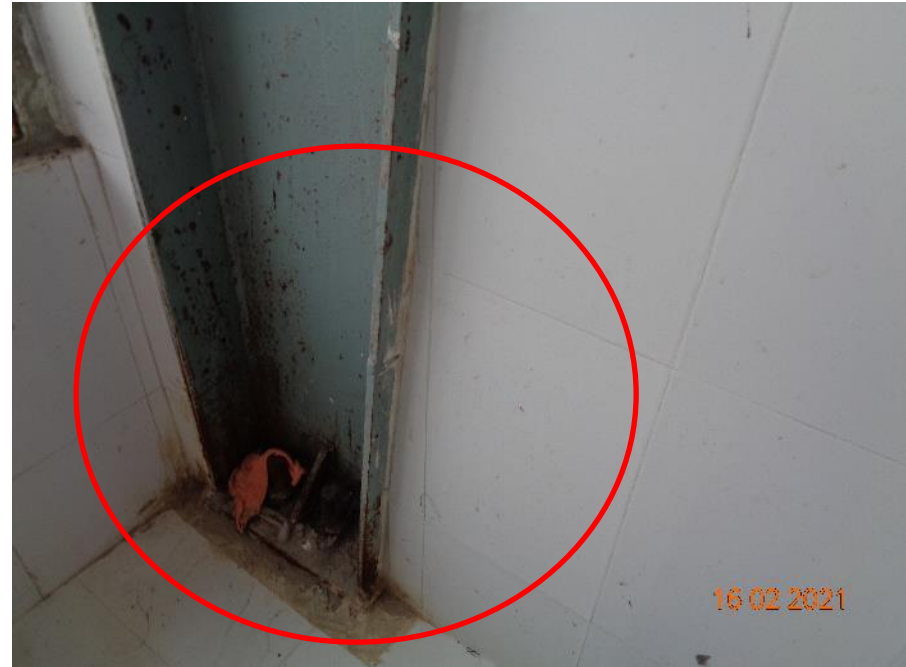
Corrosion on toilet zone steel column

Corrosion was observed on the toilet zone steel columns of shed 4 & 5. Building engineer is required to remove rust and apply anti corrosive paints.

| Item No. | Observation | Recommended Action Plan | Recommended Timeline |
|---|---|--|---|
| 12 | Corrosion on toilet zone steel column. (Shed 4 & 5) | The building engineer to investigate the reason & extent of corrosion and suggest proper remedial measure accordingly. | 6-weeks |
| 13 | Corrosion on toilet zone steel column. (Shed 4 & 5) | Take necessary measures to prevent further corrosion and repair the corroded steel members as per engineer's suggestion. | 6-months |

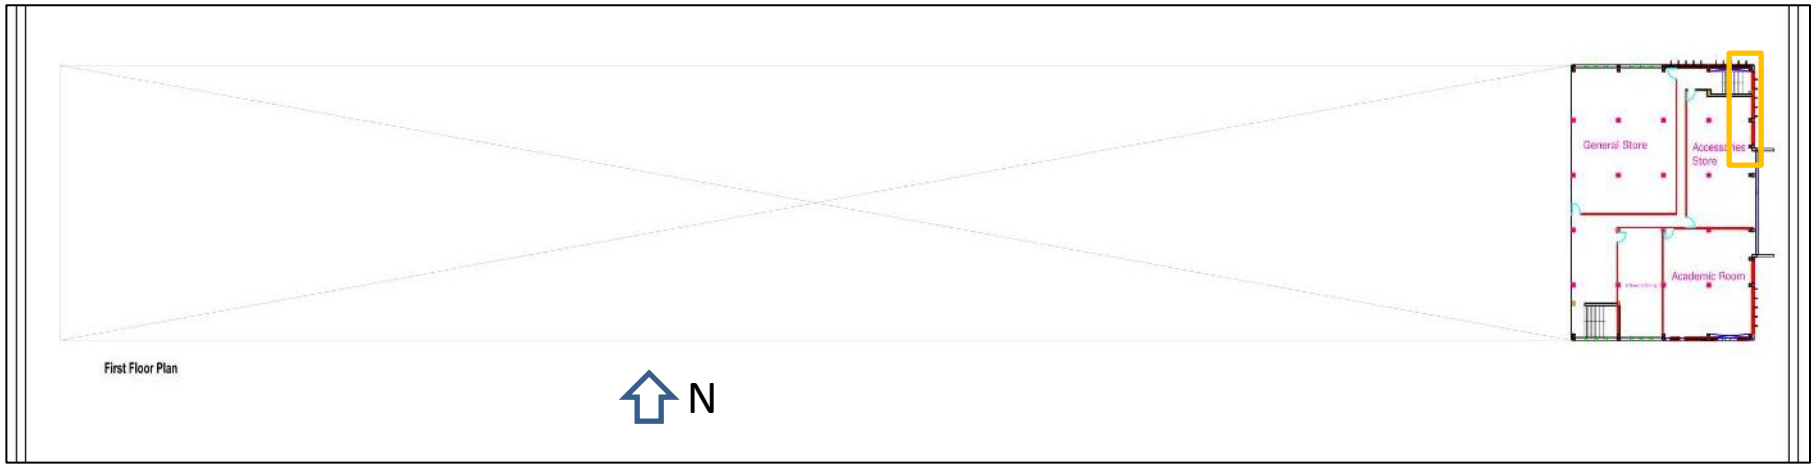
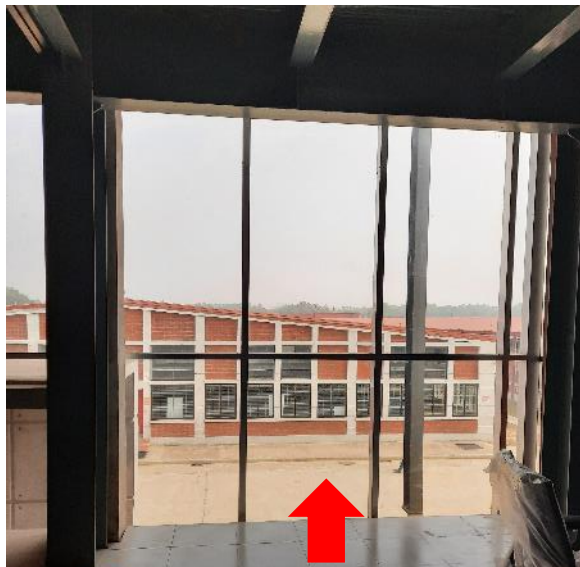
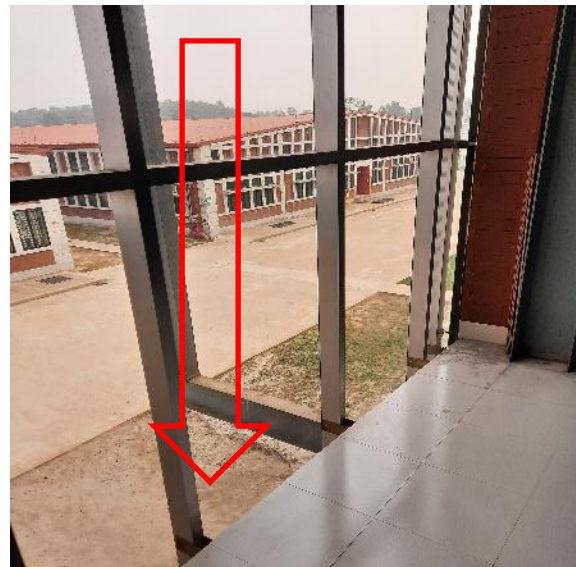
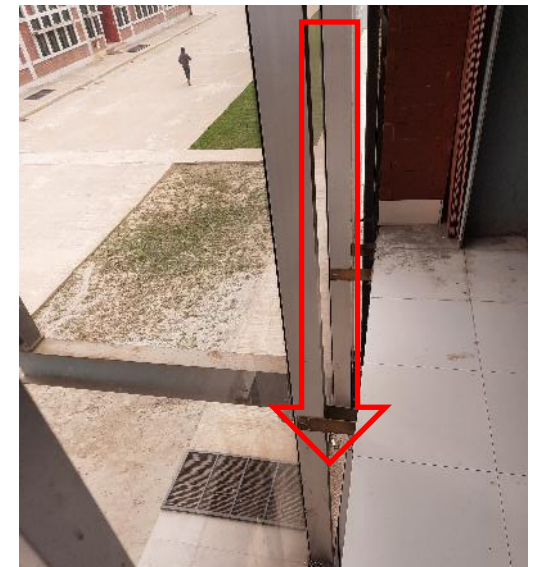
First floor layout plan of Shed 5

Falling hazard at East zone-Grid 39

No edge protection provided on this gable grid. Falling hazard may occurred anytime. Building engineer is required to provide edge protection on this area.

| Item No. | Observation | Recommended Action Plan | Recommended Timeline |
|---|---|--|---|
| 14 | Falling hazard at East zone-Grid 39. (Shed-5) | Building engineer is required to provide edge protection on this area. | 6-weeks |

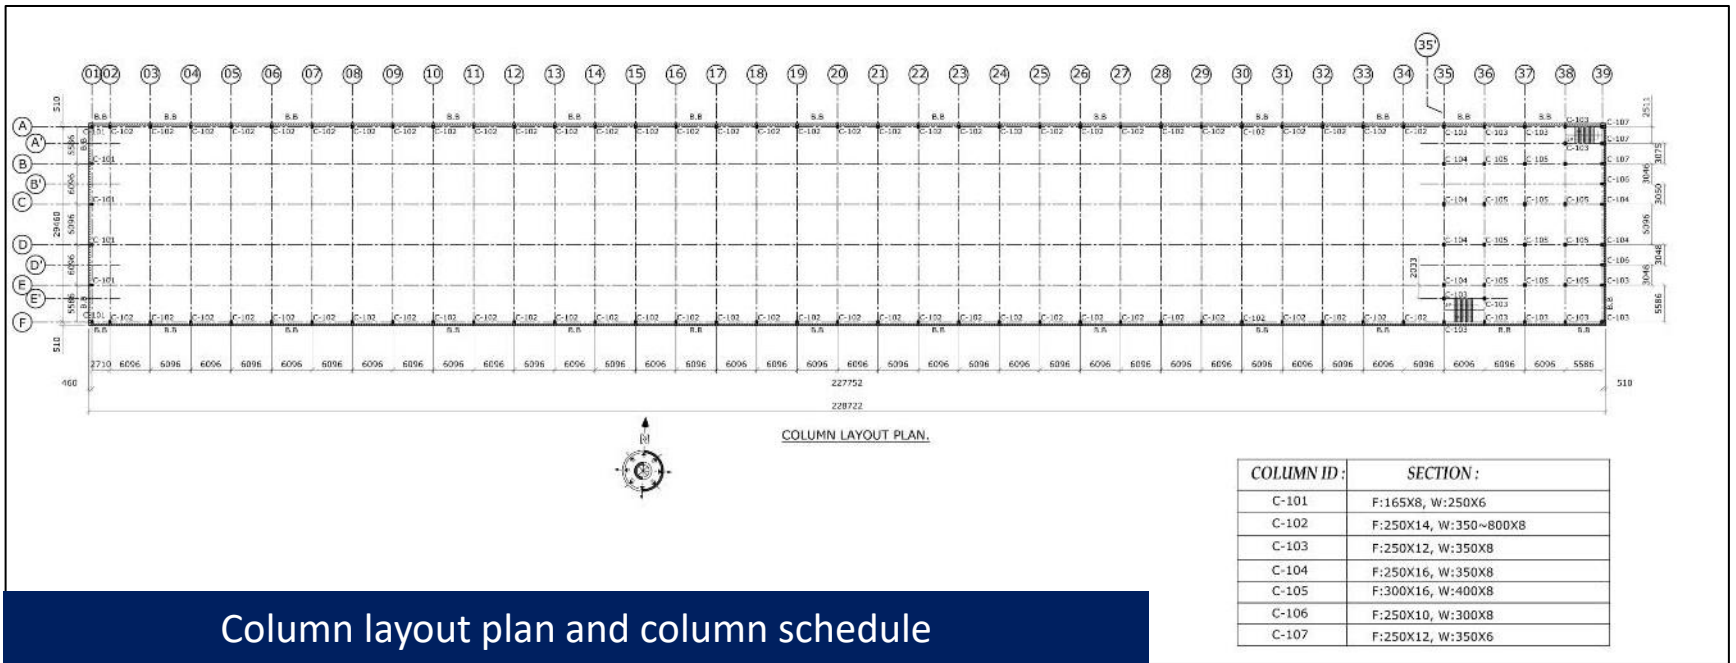
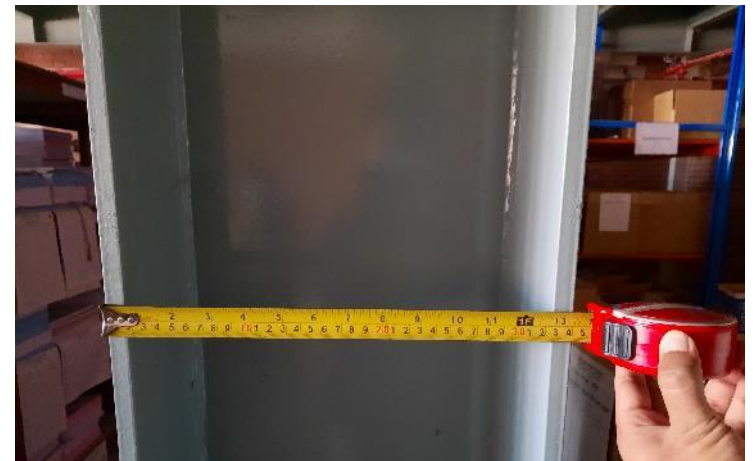
Column layout plan and column schedule

Inconsistency in as-built drawing

C-105 column was measured F 300X16, W 345X8 instead of F 300X16, W 400X8. Building engineer is required check the column capacity considering reduced size also update the as-built drawings.

| Item No. | Observation | Recommended Action Plan | Recommended Timeline |
|---|---|--|---|
| 15 | Inconsistency in as-built drawing. (Shed 5 & Boiler Room 1) | Building Engineer to survey the structure and prepare accurate as-built structural drawings. | 6-weeks |

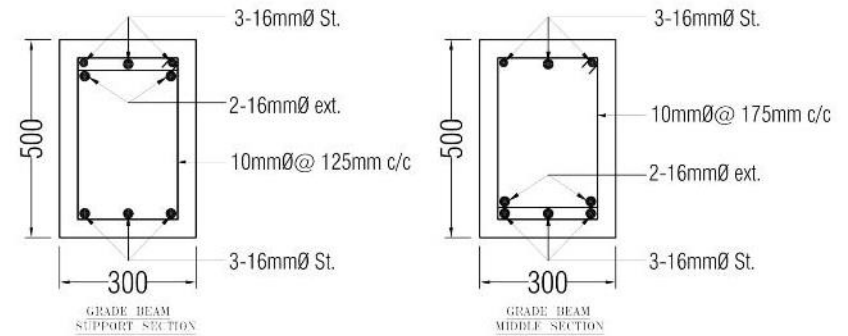
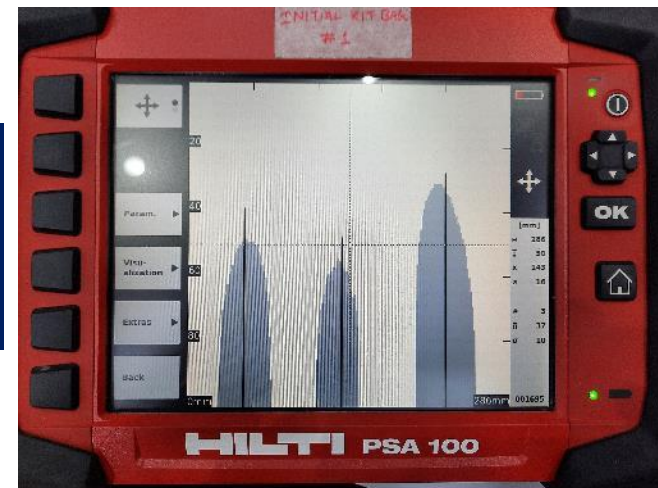
Column schedule

Total number of rebar counted 10-16 mm diameter by ferro scanner instead of 12-16 mm diameter. Building engineer is required to check the column adequacy and revise the as-built drawings.

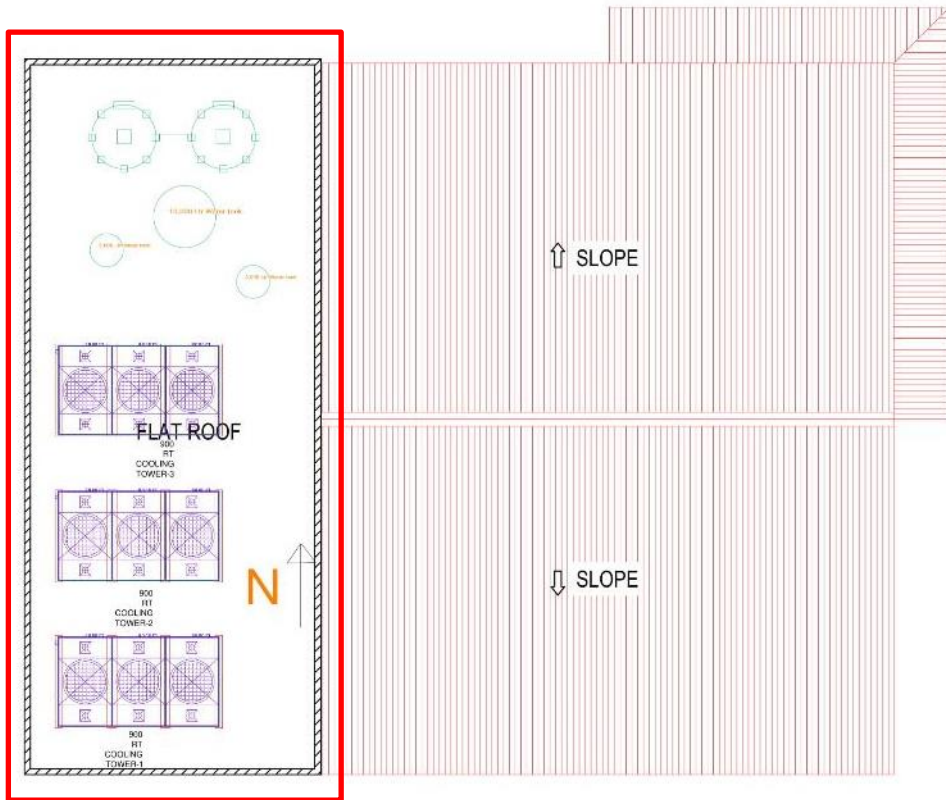
Live Load plan of the roof

Heavy loading on roof slab

Heavy loading was observed on the roof of substation roof. Building engineer is required to check the flexure capacity of the slab.

| Item No. | Observation | Recommended Action Plan | Recommended Timeline |
|---|--|--|---|
| 16 | Heavy loading on roof slab. (Utility & Sub-Station Building 2) | Building Engineer is required to check the flexural capacity of the slab to carry the imposed loading. | 6-weeks |

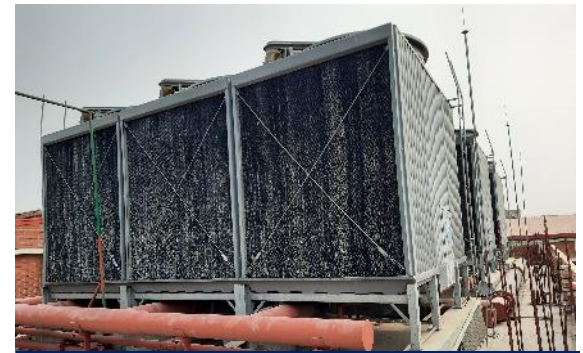
Cooling tower

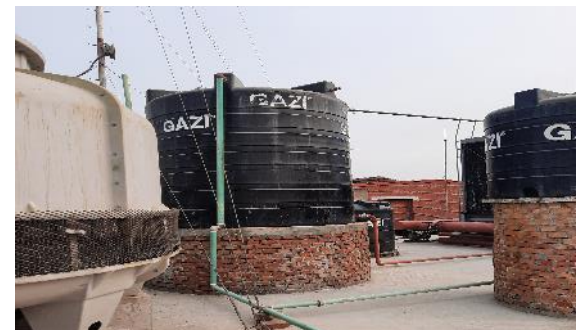
Water tank with build-up

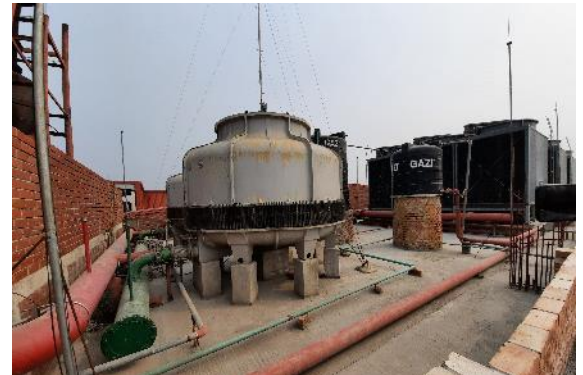
Chiller loading

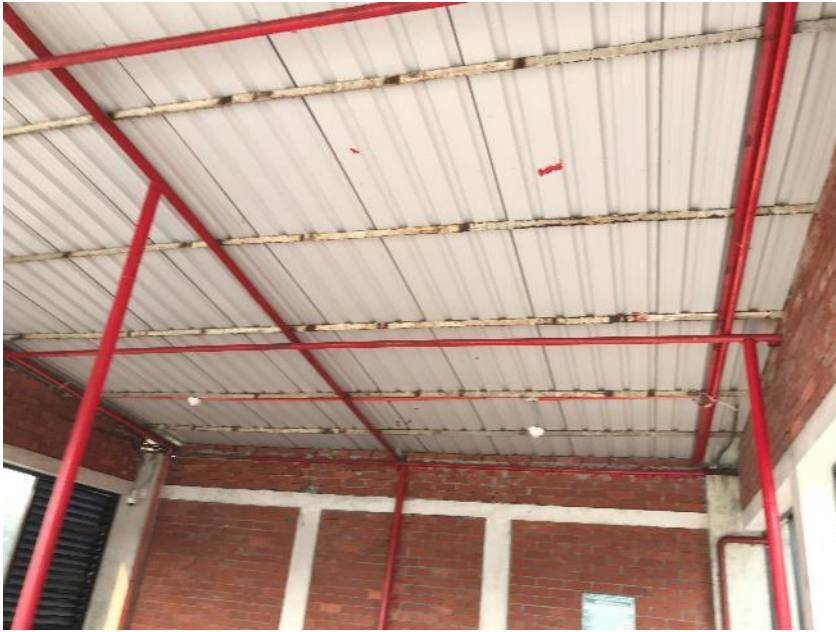
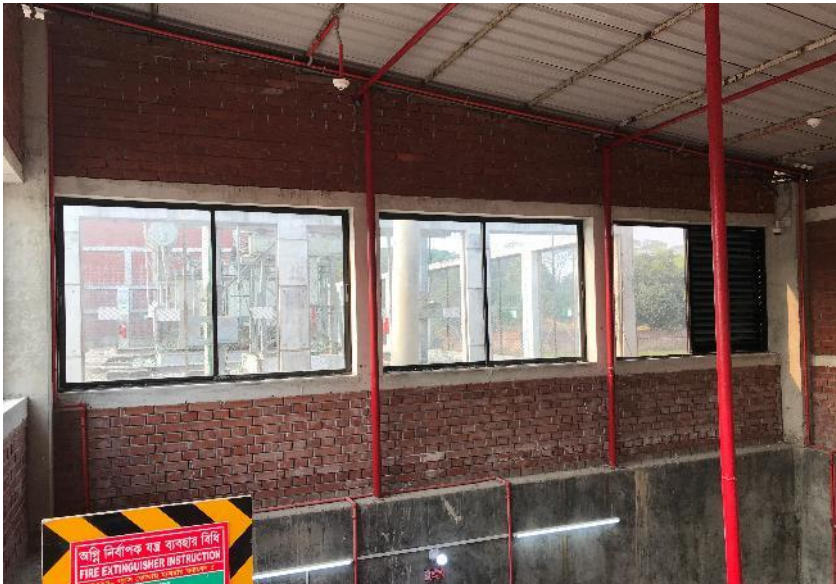
Non-Engineered roof shed

Inadequate structural members

Poor connection details, Inadequate structural members. Apparently non-engineered shed.

| Item No. | Observation | Recommended Action Plan | Recommended Timeline |
|---|--|--|---|
| 18 | Non-Engineered roof shed. (Fire Pump Room) | Building engineer is required to check the adequacy of the roof shed for gravity and lateral forces. or Replace with the engineered sheds. | 6-weeks |

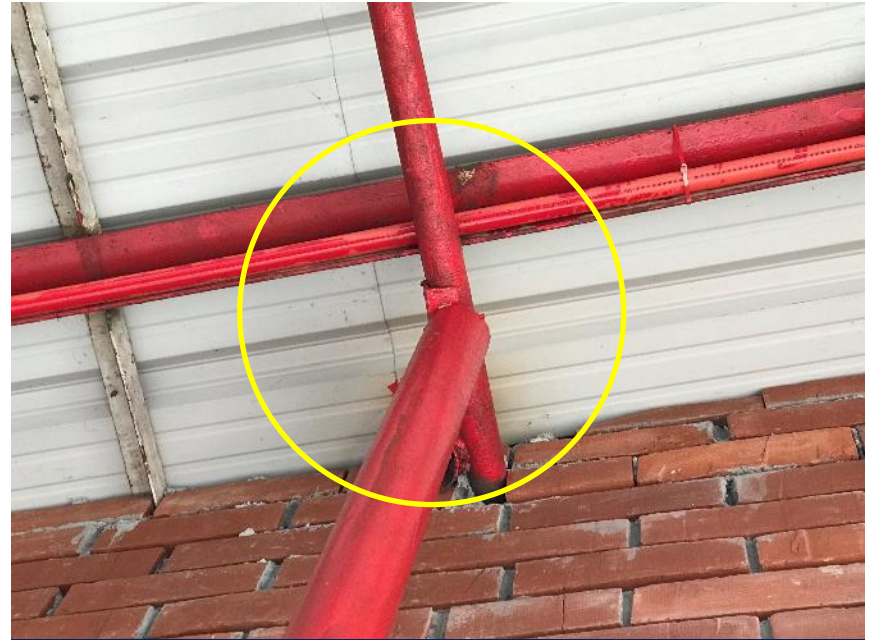
Poor connection details
