AMC Knit Composite Ltd.

Baniar Chala, Member Bari, Gazipur.

24th February 2021 & 25th May 2021

Structural Safety Inspection Report

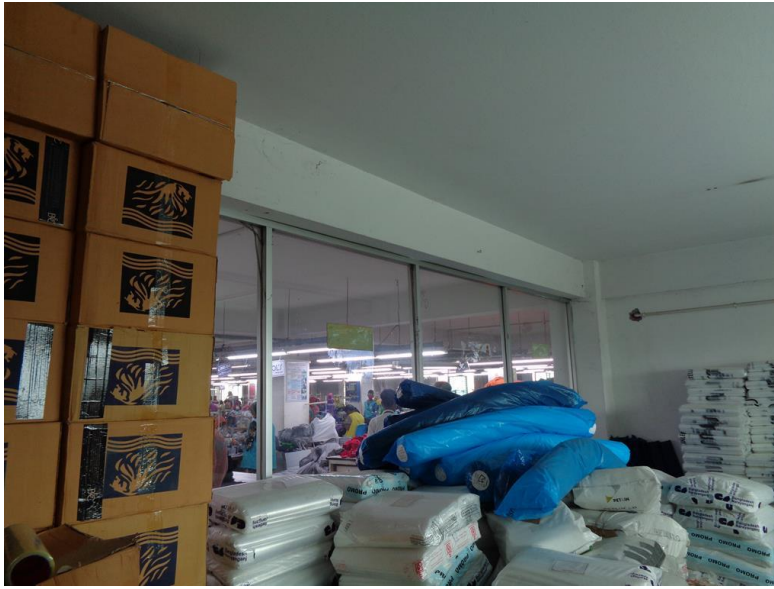
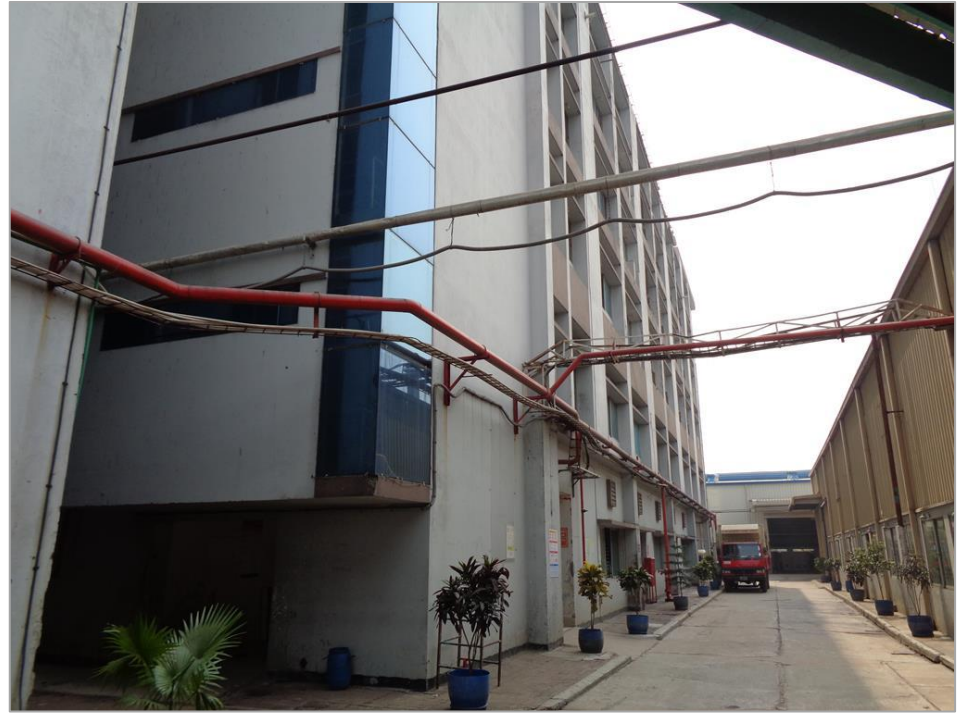
No design report was available

Interior of the building

As per BNBC every building or structure designed shall have its design documents prepared in accordance with the provision of Section 1.9.1. The design document shall include a design report, and a set of structural drawings, which shall be prepared in compliance with section 1.9.1.1 and section 1.9.1.2 as per BNBC. During the inspection, design report was not available which is required to be prepared in compliance with section 1.9.1 (part-6, BNBC).

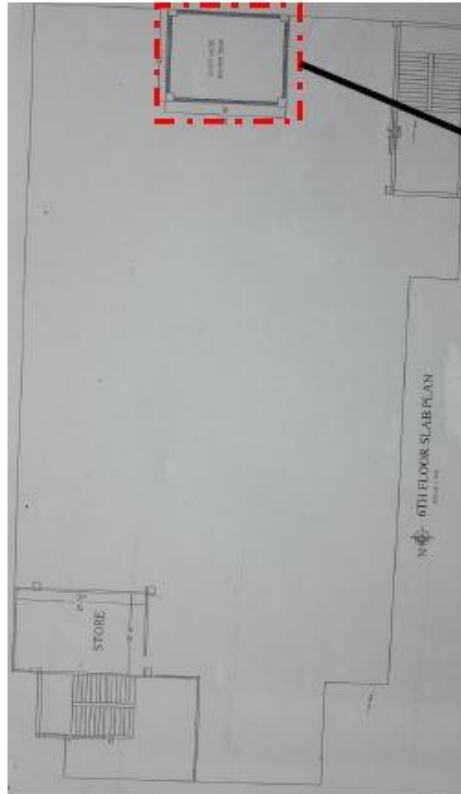
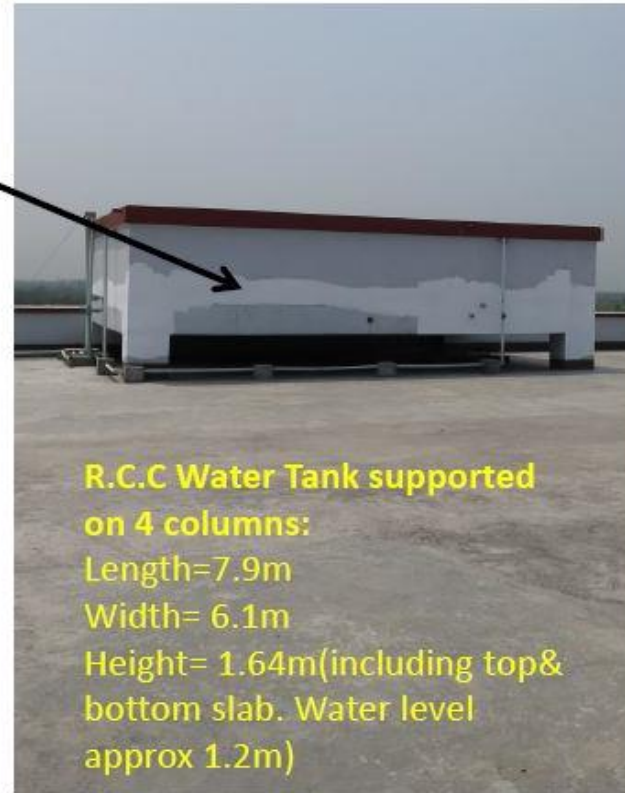
Loading on Roof

Item 1: Excessive storage loading on floors

R.C.C Water Tank supported on 4 columns:
Length=7.9m
Width= 6.1m
Height= 1.64m(including top & bottom slab. Water level approx 1.2m)

Factory engineer has carried out Detailed Engineering Assessment (DEA) based on the observation of ARUP report. Overstressed columns and footings observed in output of analysis file. Factory engineer suggested retrofitting to the over stressed members which is still under review.

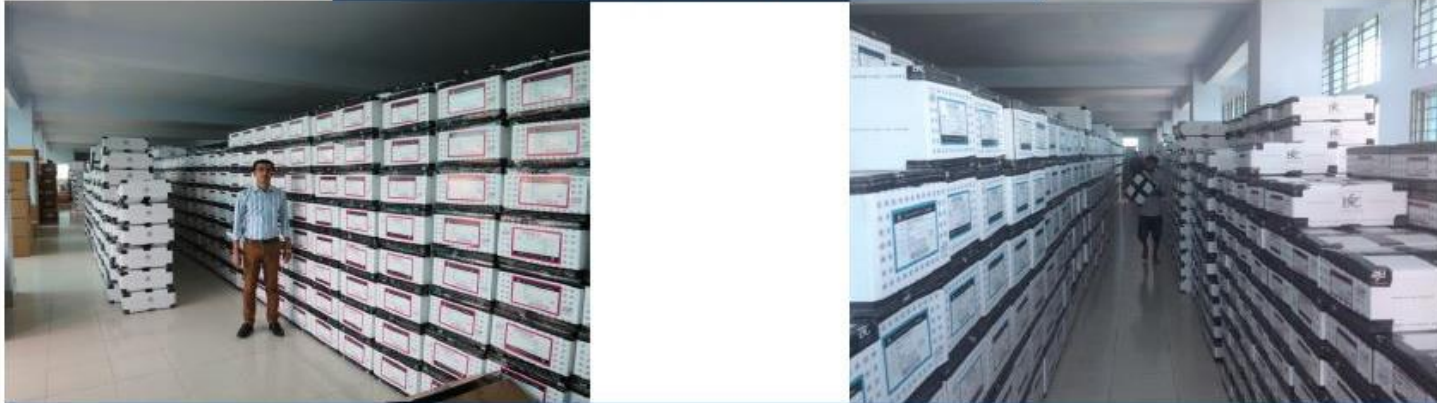
Loading on 6th Floor

Finished Goods stored throughout floor area. Average the loading on that floor was 2.5Kpa

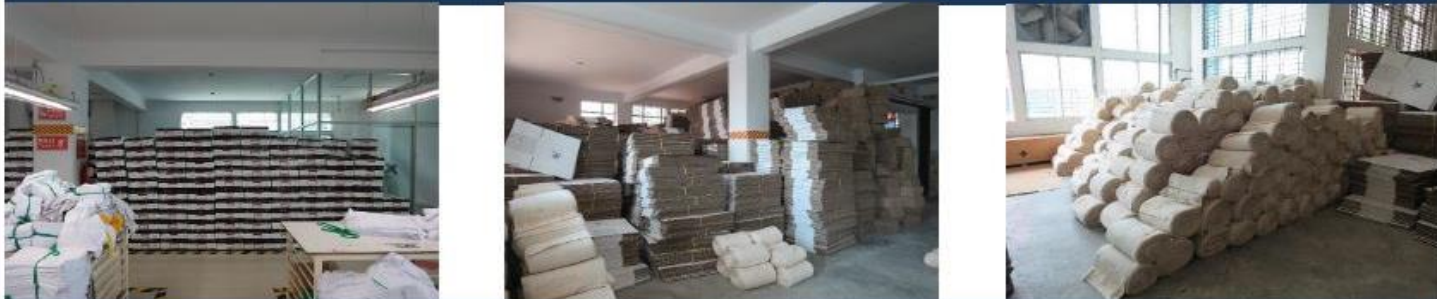
Random storage on other suspended floors

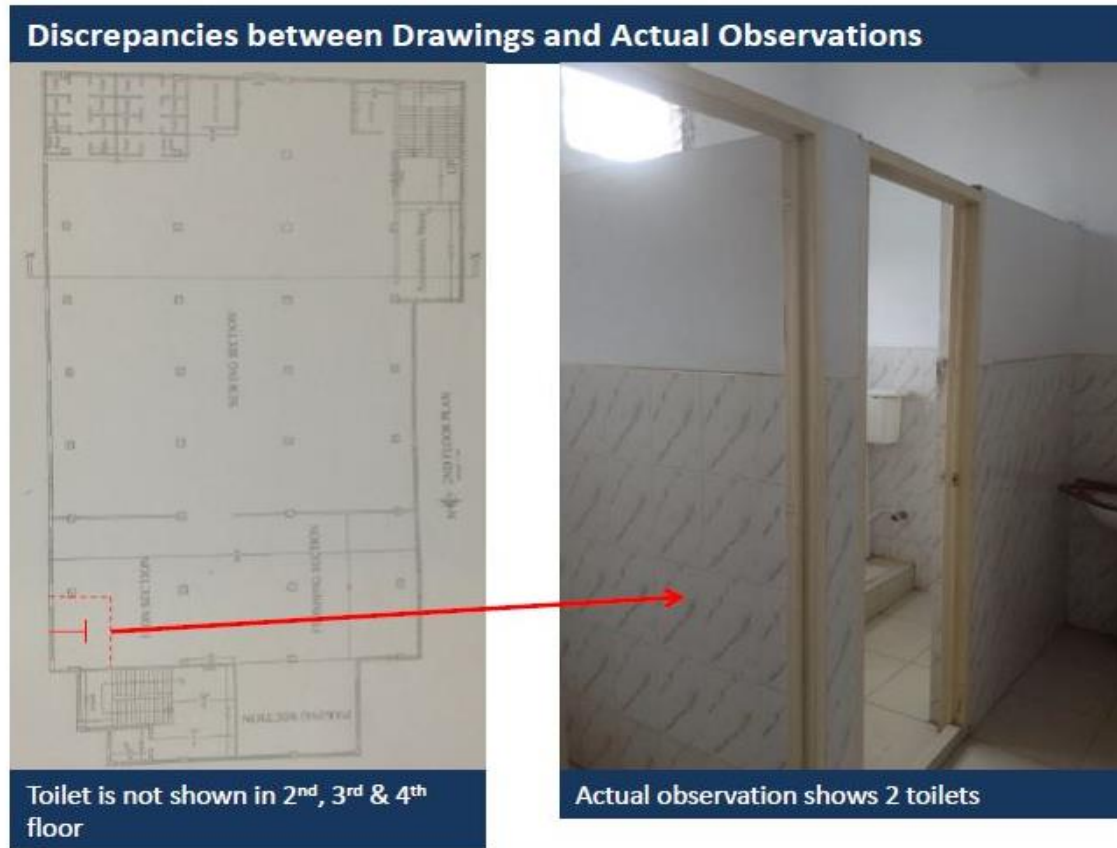
Item 2: Discrepancies between Drawings and Actual Observations on 2nd, 3rd & 4th floors

Factory engineer has carried out Detailed Engineering Assessment (DEA) based on the observation of ARUP report. Overstressed columns and footings observed in output of analysis file. Factory engineer suggested retrofitting to the over stressed members which is still under review.

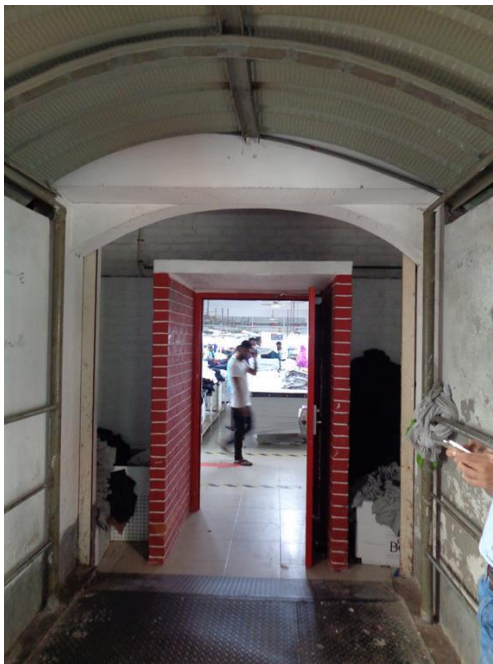
Connection with Building

Connecting bridges were found between Old & New Buildings at 2nd, 3rd & 4th floor levels. No drawings were found for this bridge. There is no clear load path for the bridge. Building is required to verify the connection between the bridge and structures and prepare engineering assessment accordingly. Moreover, factory engineer is required to check the lateral stability of the structure and prepare as-built drawings.

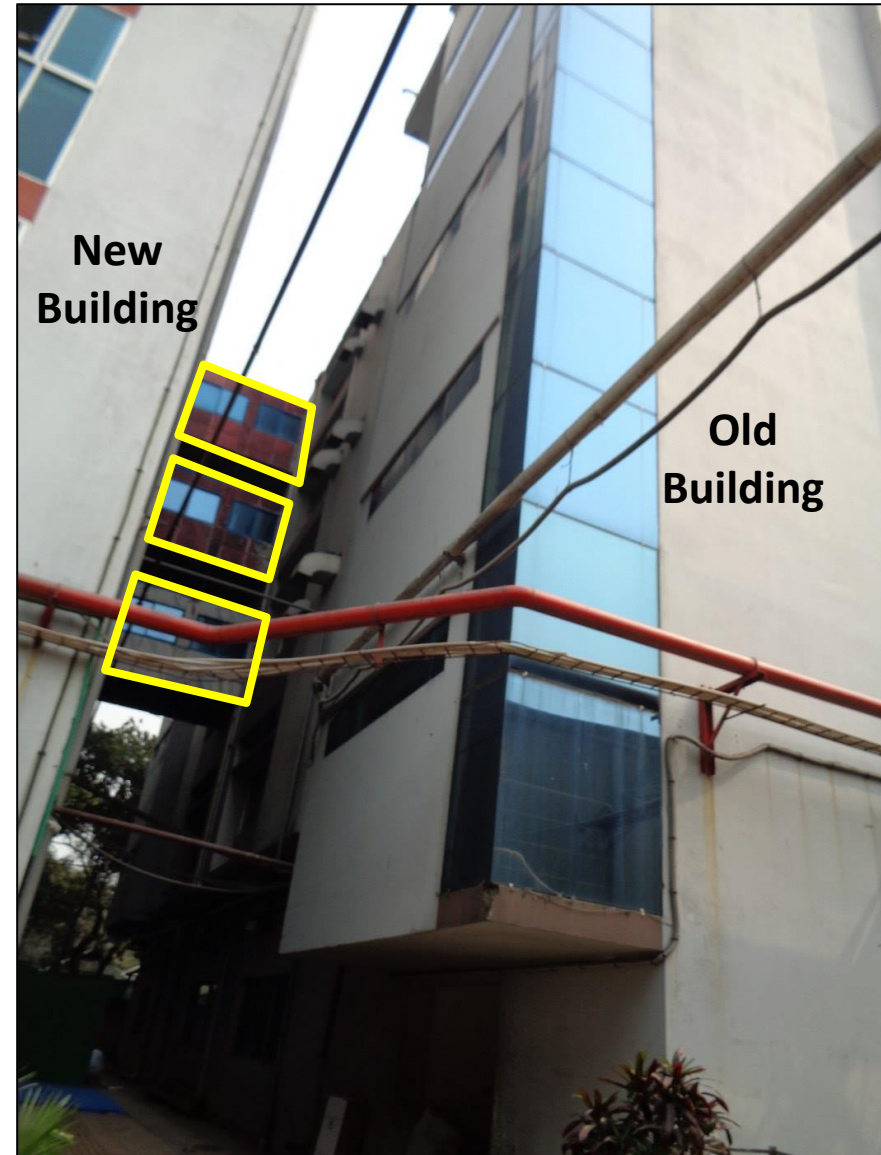
Connecting bridges at 2nd, 3rd & 4th floor levels

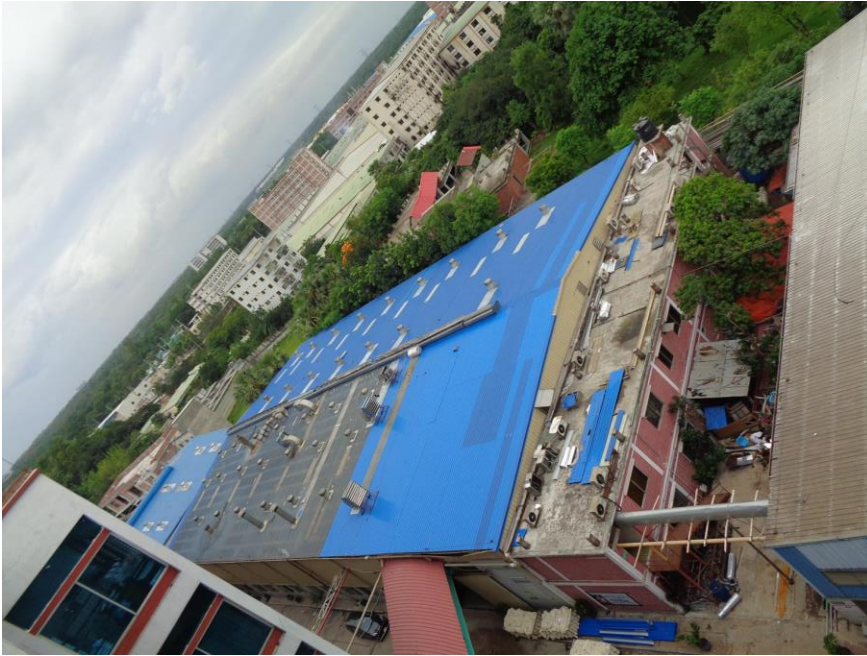
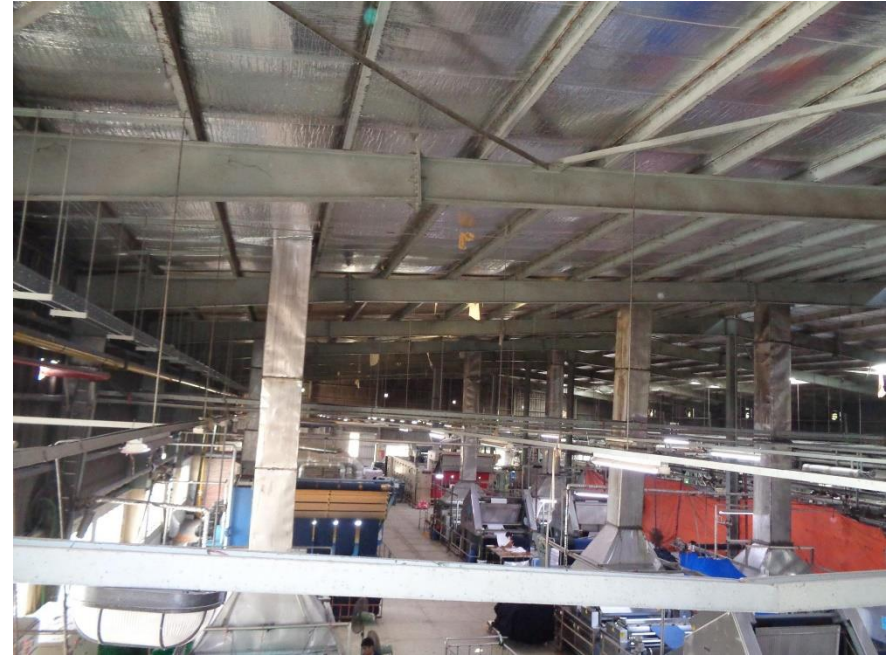
No design reports were available

During inspection, load plan for the mezzanine floor and design reports were not available for the shed. As per BNBC every building or structure designed shall have its design documents prepared in accordance with the provision of Section 1.9.1. The design document shall include a design report, and a set of structural drawings, which shall be prepared in compliance with section 1.9.1.1 and section 1.9.1.2 as per BNBC.

Factory Engineer is required to prepare Engineering Assessment report in compliance with section 1.9.1 (part-6, BNBC). Also include the load plan of the mezzanine portion.

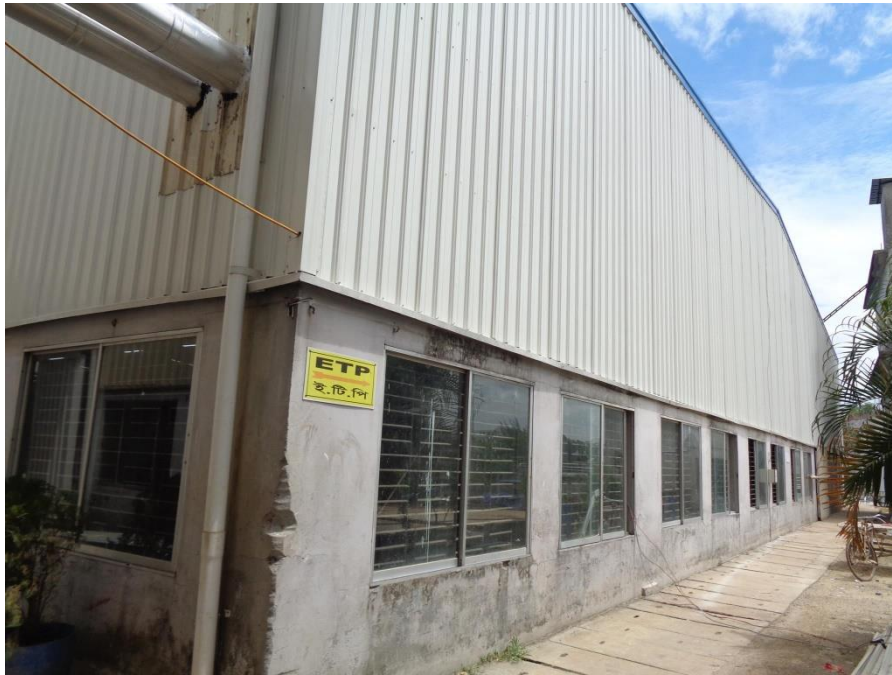
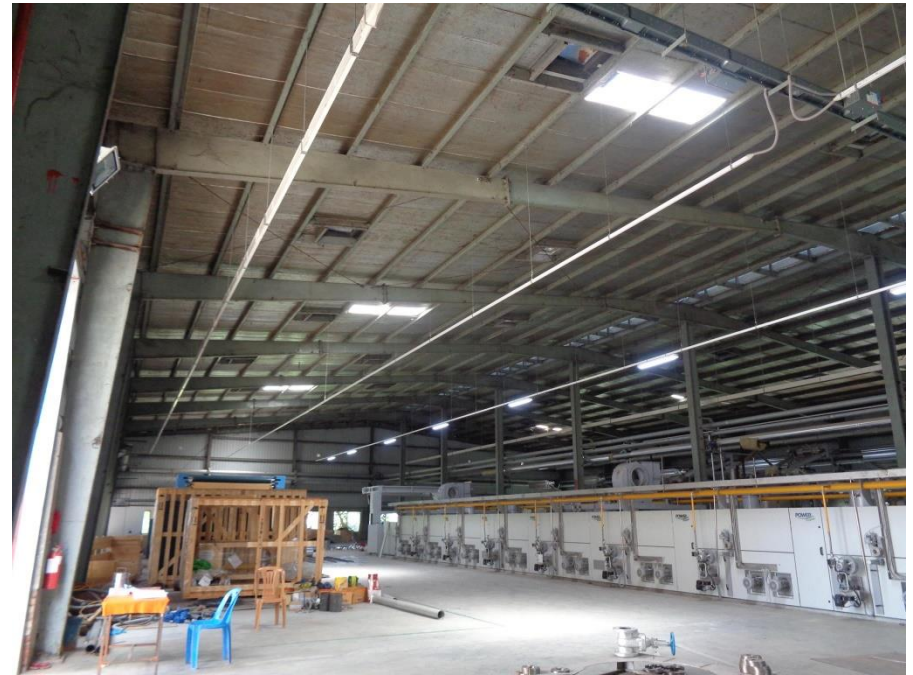
No design reports were available

During inspection, as-built drawings and design report were not available. As per BNBC every building or structure designed shall have its design documents prepared in accordance with the provision of Section 1.9.1. The design document shall include a design report, and a set of structural drawings, which shall be prepared in compliance with section 1.9.1.1 and section 1.9.1.2 as per BNBC. Factory Engineer is required to prepare as-built drawings and design report in compliance with section 1.9.1 (part-6, BNBC).

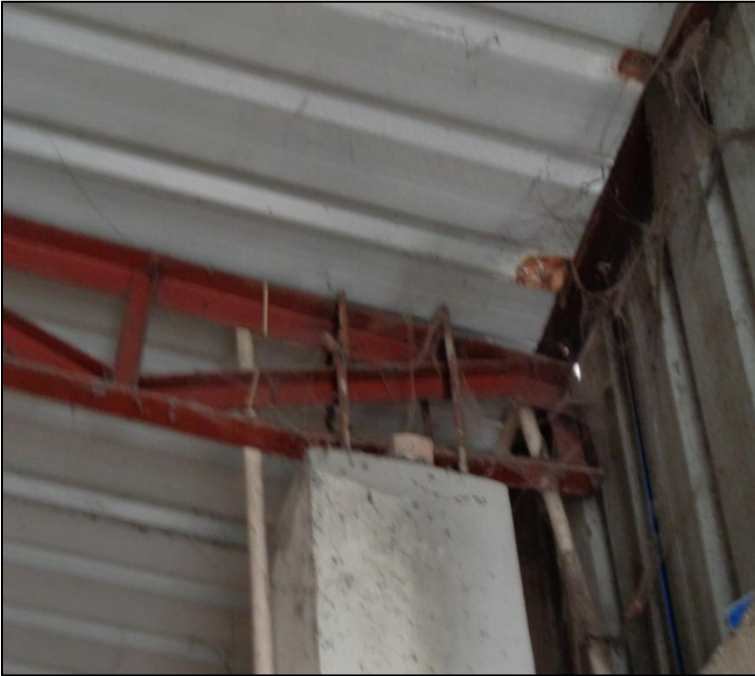
Poor connection details

The steel roof shed made of angle truss which is supported over RC column. Poor connections were found. Building engineer is required to survey the whole structure and prepare accurate as-built drawings. Also check the adequacy of the members and lateral stability of the shed and prepare design document in compliance with section 1.9.1 (part-6, BNBC 2006).

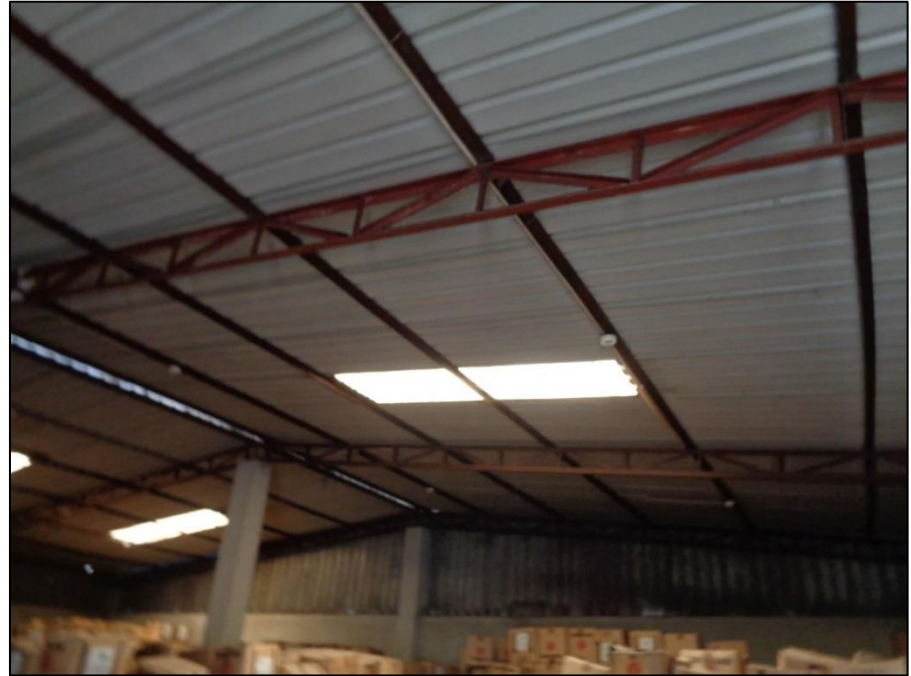
Lack of lateral bracing

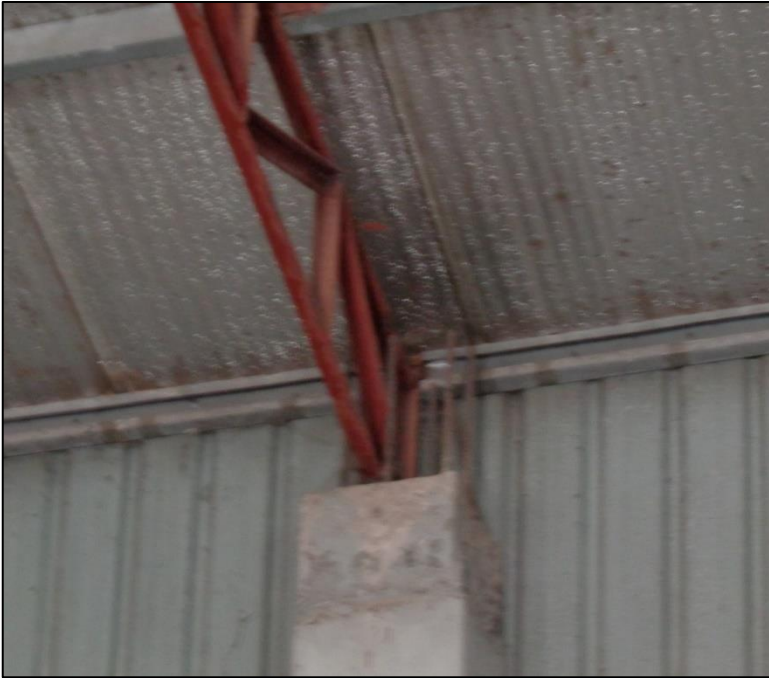
Poor connection details

The steel roof shed made of angle truss which is supported over RC column. Poor connections were found. Building engineer is required to survey the whole structure and prepare accurate as-built drawings. Also check the adequacy of the members and lateral stability of the shed and prepare design document in compliance with section 1.9.1 (part-6, BNBC 2006).

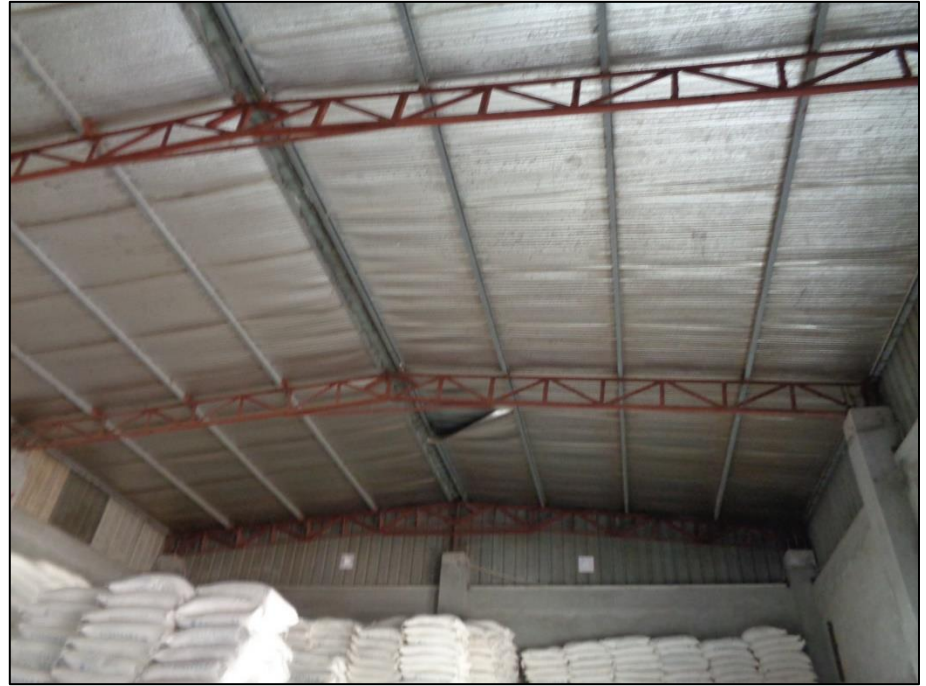
Lack of lateral bracing

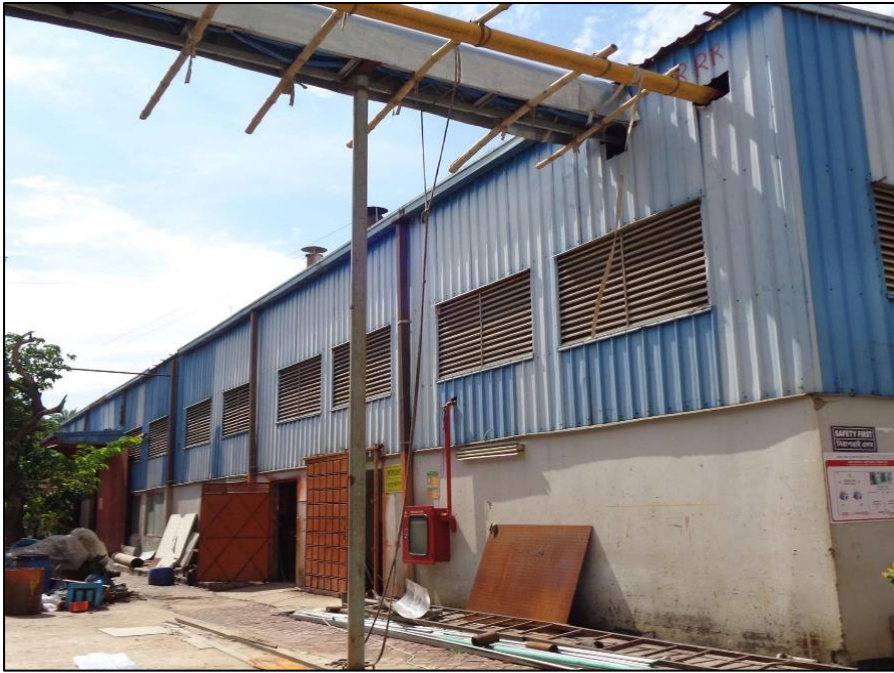
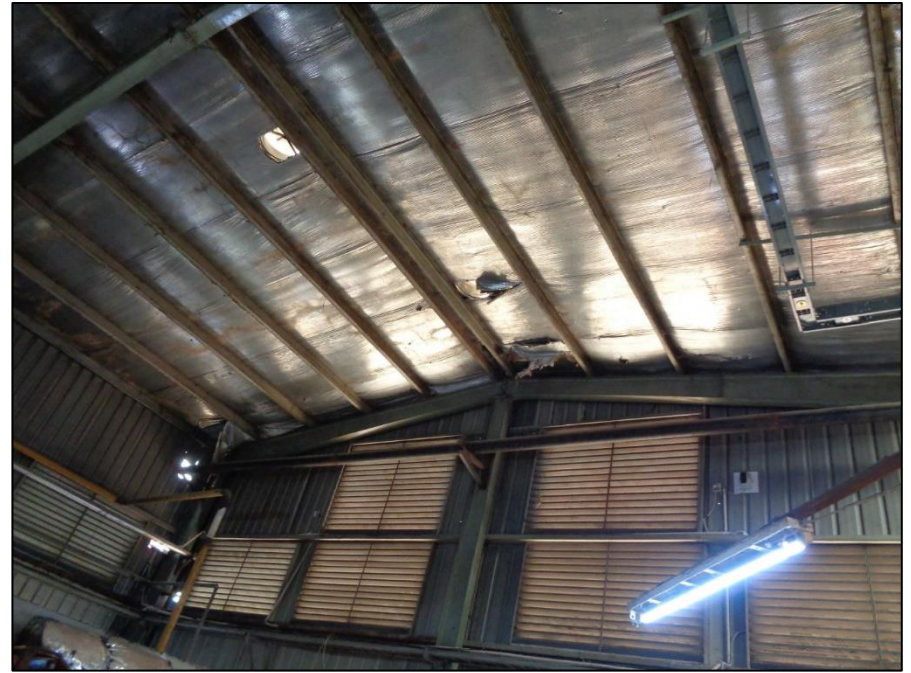
No design reports were available

During inspection, as-built drawings and design report were not available. As per BNBC every building or structure designed shall have its design documents prepared in accordance with the provision of Section 1.9.1. The design document shall include a design report, and a set of structural drawings, which shall be prepared in compliance with section 1.9.1.1 and section 1.9.1.2 as per BNBC. Factory Engineer is required to prepare as-built drawings and design report in compliance with section 1.9.1 (part-6, BNBC).

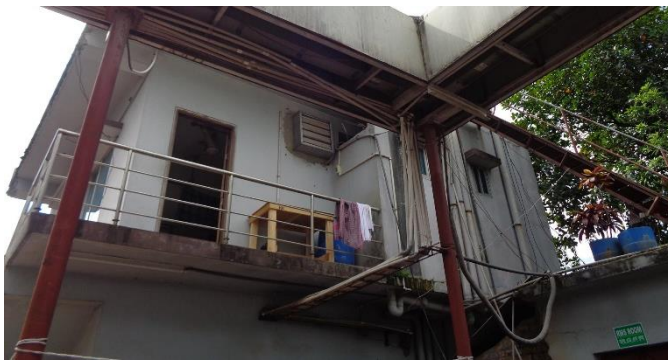
Toilet on the cantilever area

During inspection, design report was not available and there was a toilet zone on the 1st floor. As per BNBC every building or structure designed shall have its design documents prepared in accordance with the provision of Section 1.9.1. The design document shall include a design report, and a set of structural drawings, which shall be prepared in compliance with section 1.9.1.1 and section 1.9.1.2 as per BNBC. Factory Engineer is required to prepare design report in compliance with section 1.9.1 (part-6, BNBC). Also check the adequacy of the cantilever area.

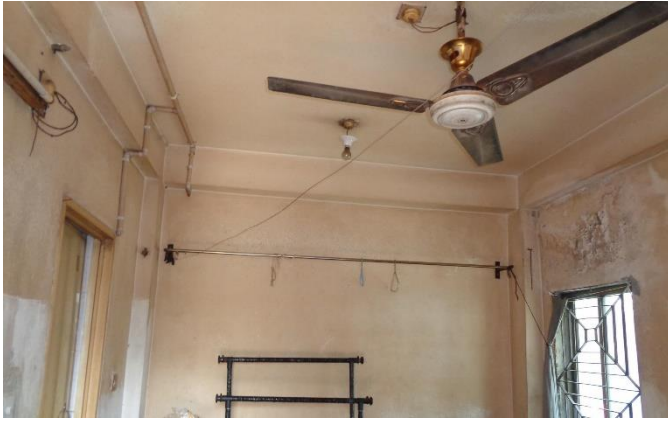
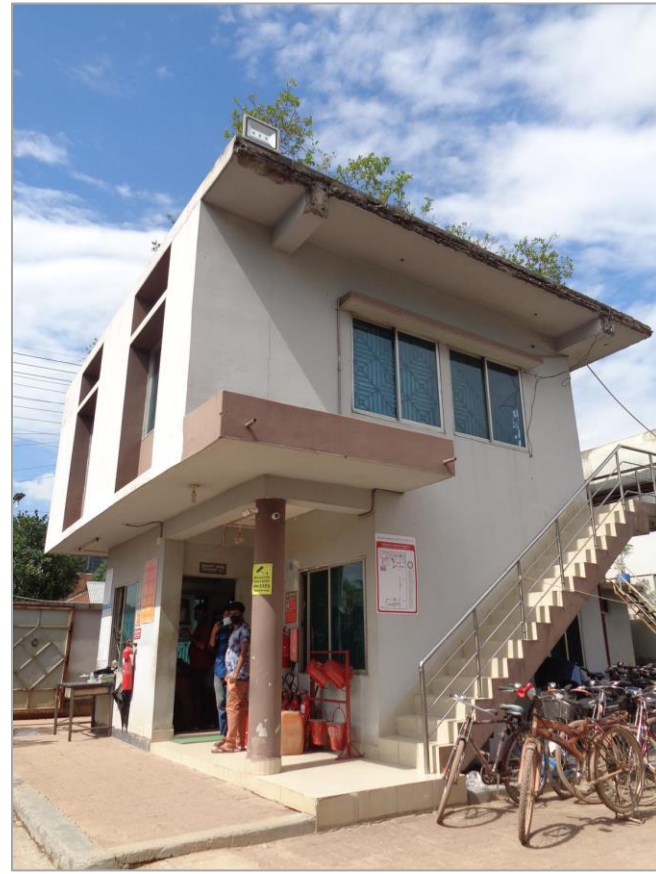
No design reports were available

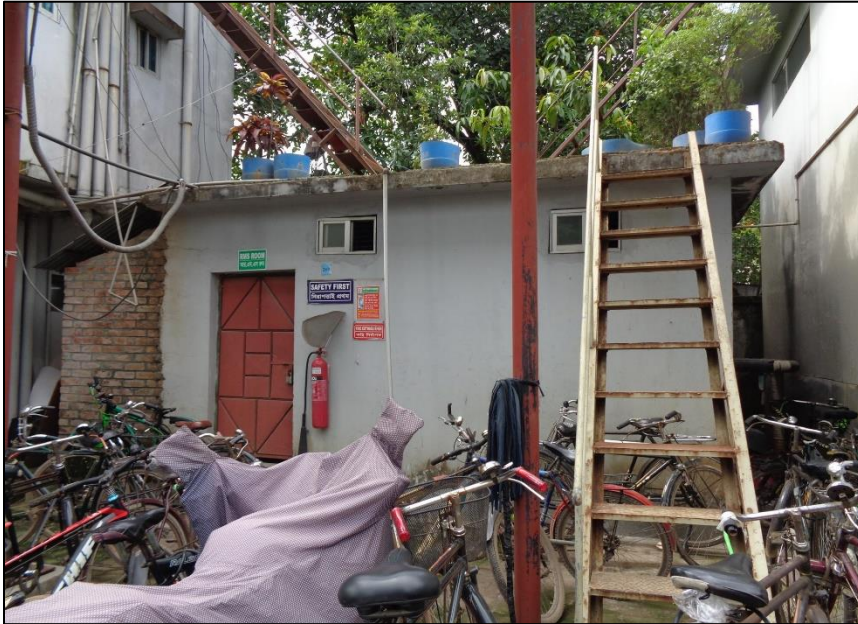
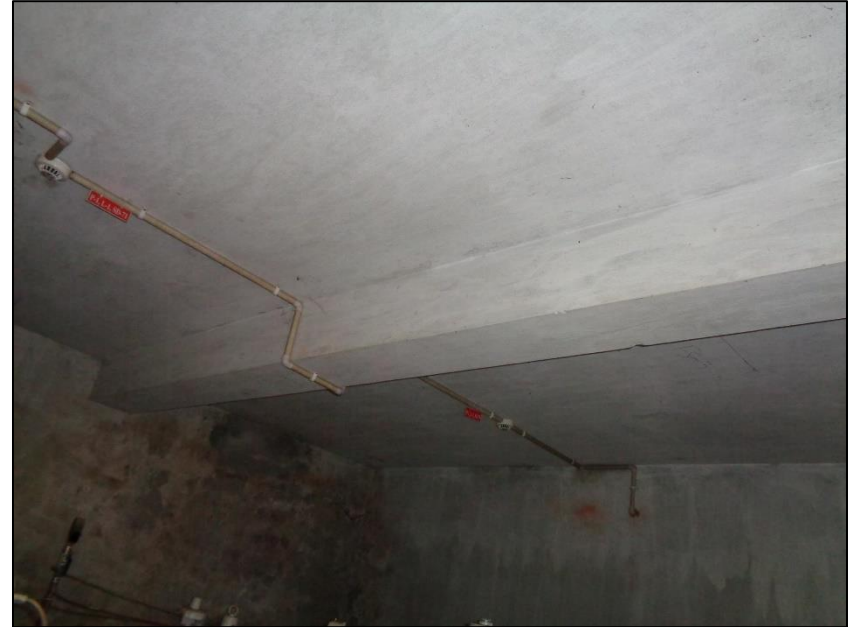
No design report available

As-built drawings and design report were not available. As per BNBC every building or structure designed shall have its design documents prepared in accordance with the provision of Section 1.9.1. The design document shall include a design report, and a set of structural drawings, which shall be prepared in compliance with section 1.9.1.1 and section 1.9.1.2 as per BNBC. Factory Engineer is required to prepare as-built drawings and Engineering Assessment report in compliance with section 1.9.1 (part-6, BNBC). And check the adequacy of the connection.

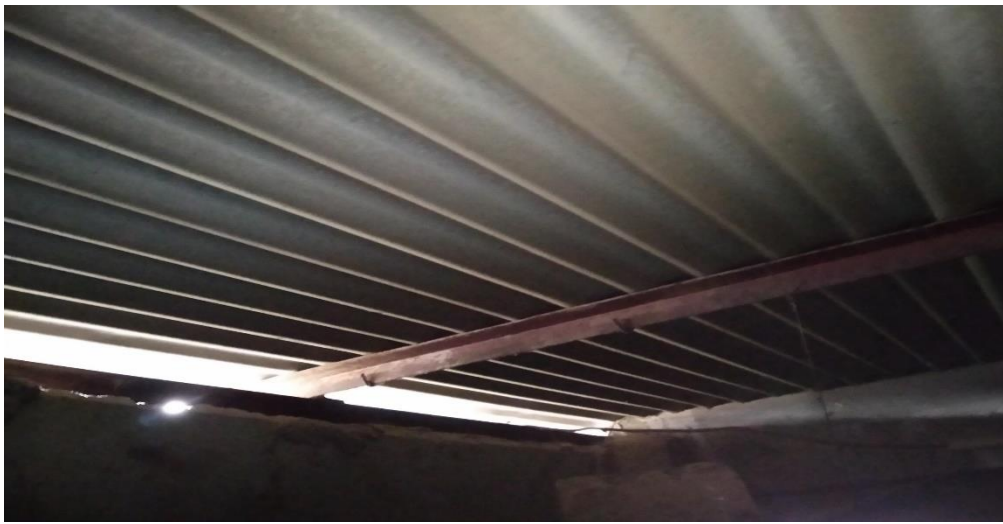
Apparently non-engineered connection at roof shed

Poor connections were observed at roof. Moreover, as-built drawings and design report were not available. As per BNBC every building or structure designed shall have its design documents prepared in accordance with the provision of Section 1.9.1. The design document shall include a design report, and a set of structural drawings, which shall be prepared in compliance with section 1.9.1.1 and section 1.9.1.2 as per BNBC.

Factory Engineer is required to prepare as-built drawings and Engineering Assessment report in compliance with section 1.9.1 (part-6, BNBC). And check the adequacy of the connections.

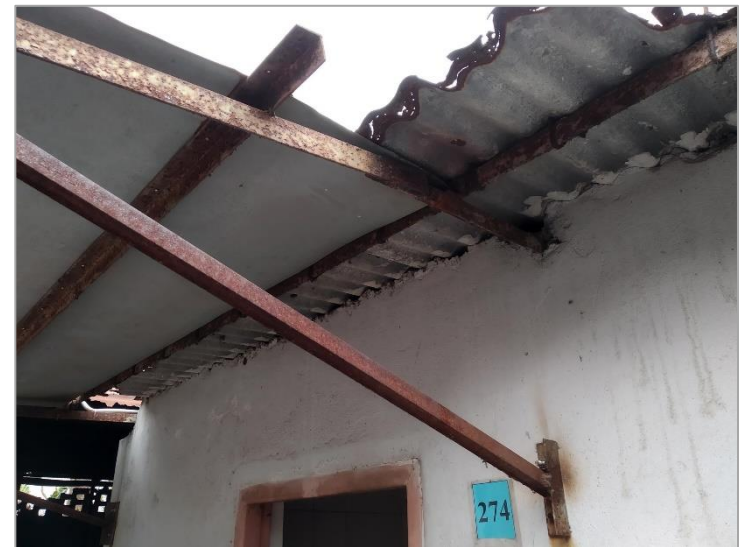
Non engineered connection

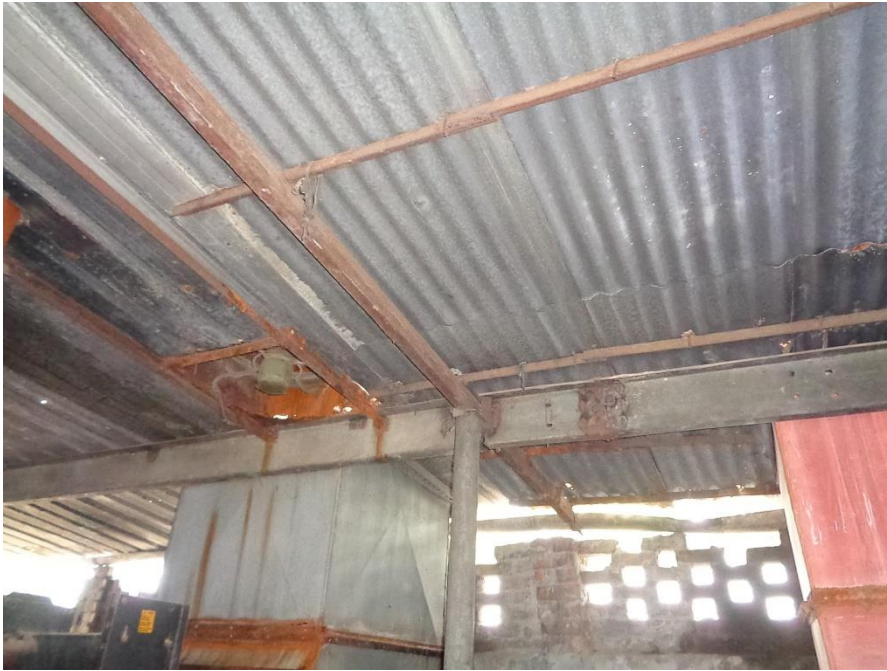
Apparently non-engineered connection at roof shed

Poor connections were observed at roof. Moreover, design report was not available. As per BNBC every building or structure designed shall have its design documents prepared in accordance with the provision of Section 1.9.1. The design document shall include a design report, and a set of structural drawings, which shall be prepared in compliance with section 1.9.1.1 and section 1.9.1.2 as per BNBC. Factory Engineer is required to prepare Engineering Assessment report in compliance with section 1.9.1 (part-6, BNBC). And check the adequacy of the connection.

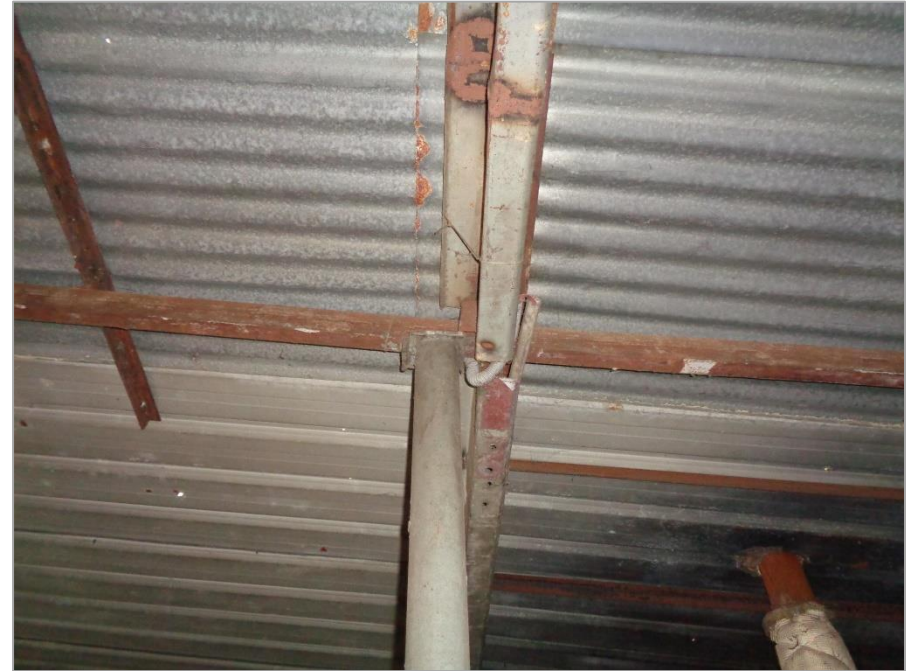
Non engineered connection

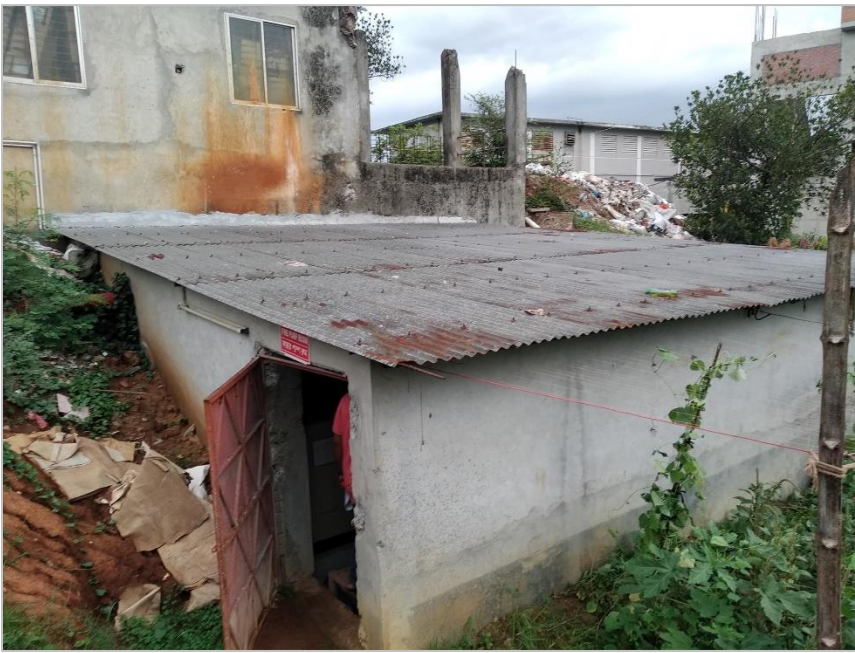
Apparently non-engineered connection at roof shed

Poor connections were observed at roof. Moreover, as-built drawings and design report were not available. As per BNBC every building or structure designed shall have its design documents prepared in accordance with provision of Section 1.9.1. The design document shall include a design report, and a set of structural drawings, which shall be prepared in compliance with section 1.9.1.1 & section 1.9.1.2 as per BNBC. Factory Engineer is required to prepare as-built drawings and Engineering Assessment report in compliance with section 1.9.1 (part-6, BNBC). And check the adequacy of the connection.

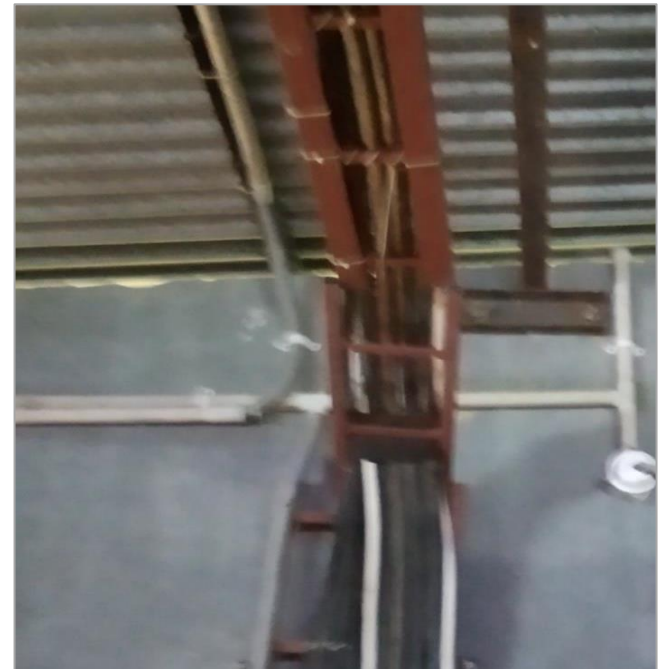
Non engineered connection
