Hamid Tex Fashion Ltd.

203, Habirbari, Seed Store Bazar, Bhaluka, Mymensingh-2240, Bangladesh
(24.339661, 90.375837)

17th June 2021

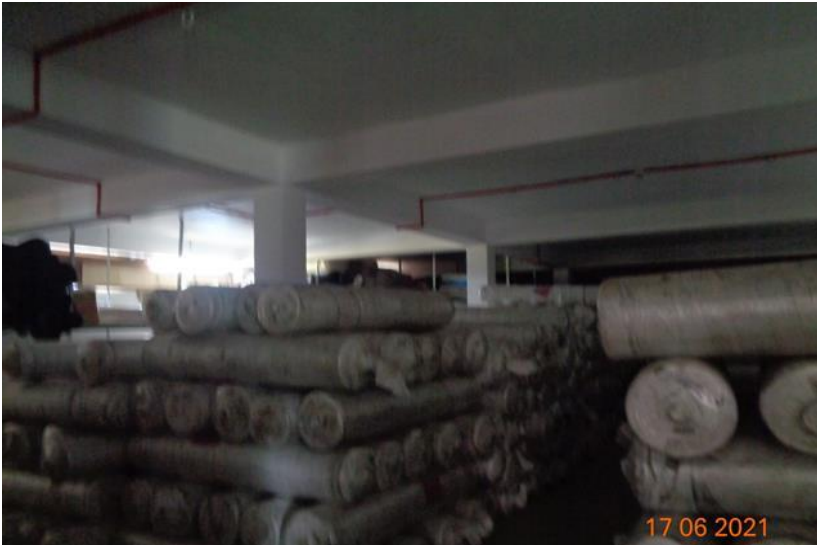
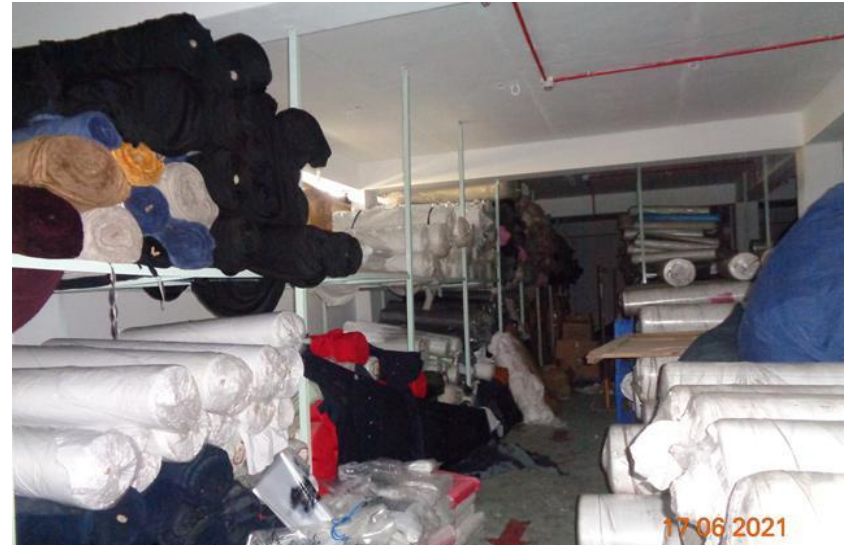
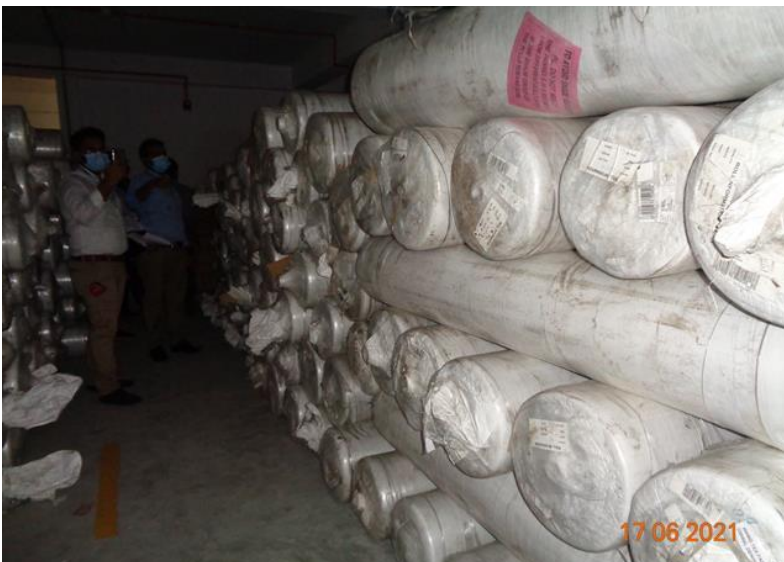
Heavy loading on 1st floor

5 to 6 kPa loading was found in storage

5 to 6 kPa loading was found in storage area(1st floor). Load plan of the building was not produced. Also, load management program was not implemented. Reduce the load to 2kpa immediately. Produce and actively manage a loading plan for all floor plates within the factory considering the floor capacity and column capacity.

Item No.	Observation	Recommended Action Plan	Recommended Timeline
01	Heavy loading on 1st floor. (Main Building)	Reduce & maintain the floor live load below 2 kPa.	Immediate
02	Heavy loading on 1st floor. (Main Building)	Building engineer is required to review design loads & column stress considering floor & column capacity.	6-weeks
03	Heavy loading on 1st floor. (Main Building)	Building engineer is required to produce floor loading plan for each floor by design review.	6-weeks
04	Heavy loading on 1st floor. (Main Building)	Implement floor load management program.	6-weeks
05	Hairline crack on 1st floor flat plate. (Main Building)	Building engineer is required to check the extent of crack and suggest remedial action.	6-weeks
06	Hairline crack on 1st floor flat plate. (Main Building)	Building engineer is required to check the slab capacity.	6-weeks
07	Hairline crack on 1st floor flat plate. (Main Building)	Carry out remedial works where required.	6-months

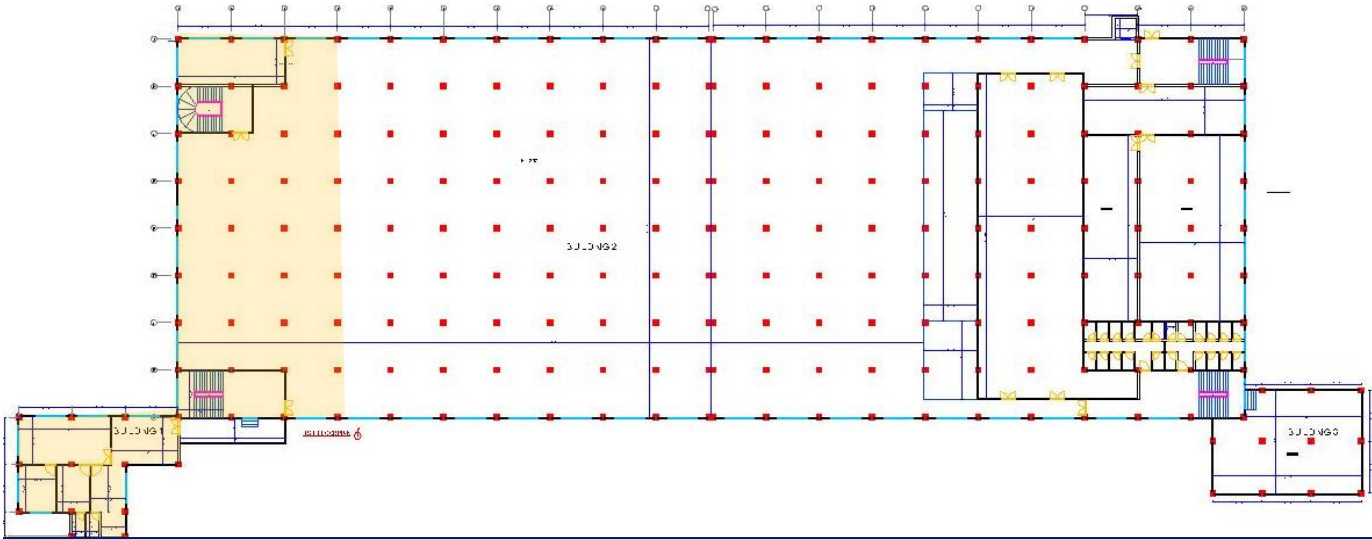
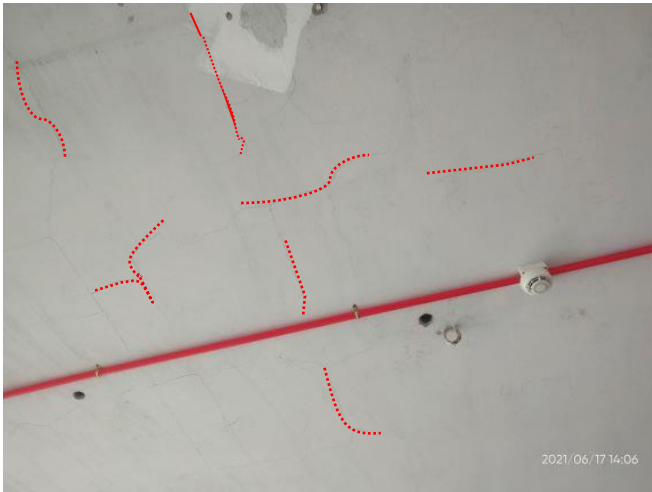
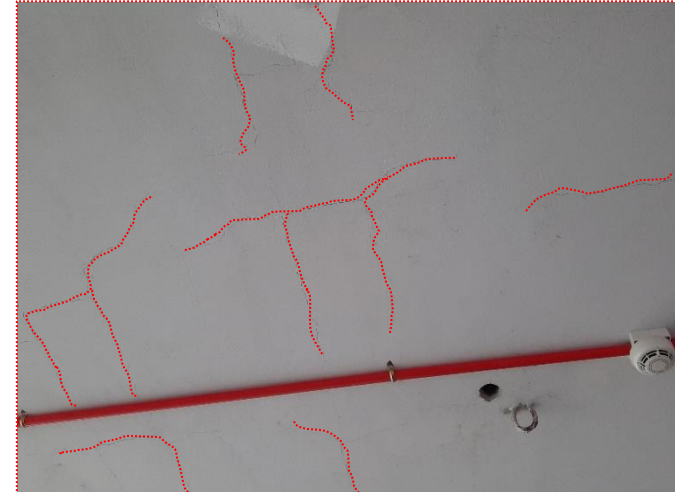
1st Floor Roof Slab Layout Plan

Hairline crack on 1st floor flat plate

Hairline cracks observed in 1st floor roof flat plate slab soffit. Building engineer is required to check the extent of crack and suggest remedial action.

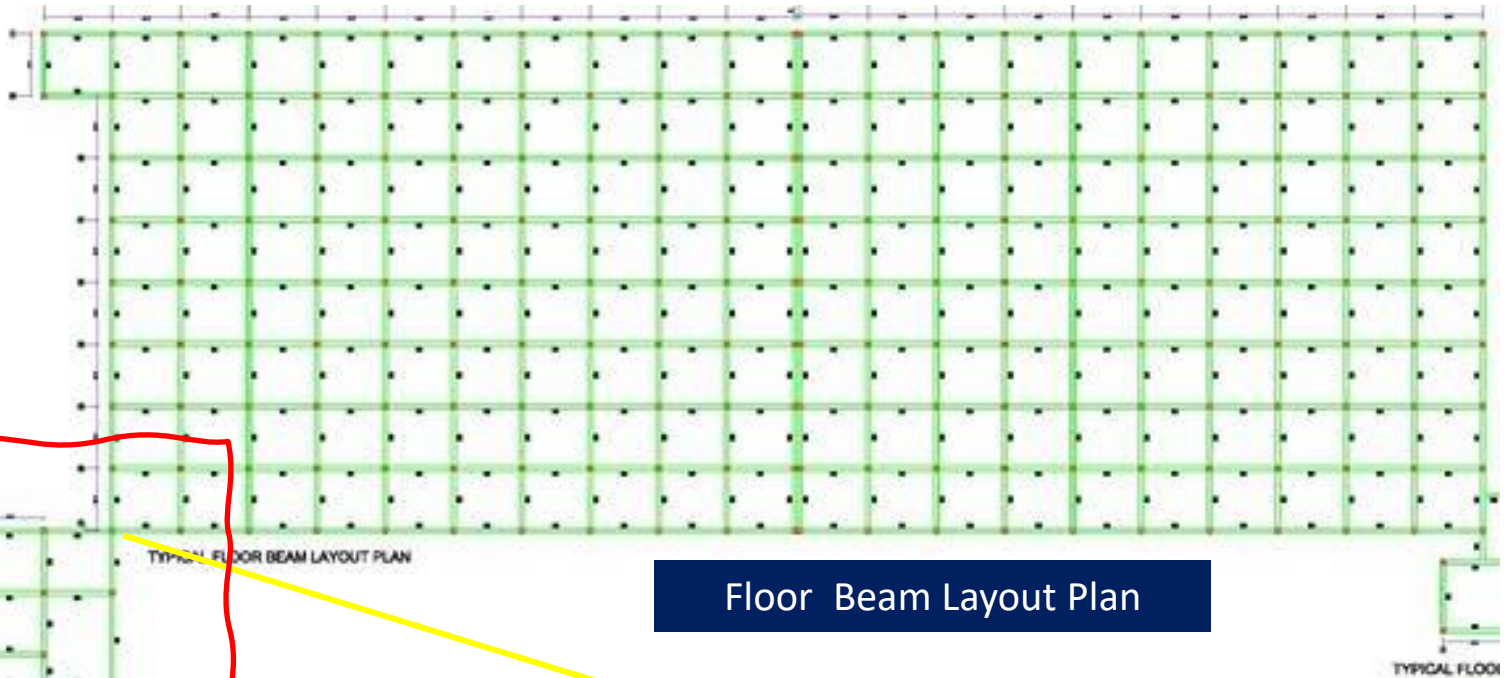
Floor Beam Layout Plan

Torsional effect on the building

The building is geometrically irregular shaped. Due to lateral forces the building might be affected for torsional irregularity. Building engineer is required to check the torsional effect of the building due to lateral forces.

08	Torsional effect on the building. (Main Building)	Building engineer is required to check the torsional effect of the building due to lateral forces.	6-weeks
09	Torsional effect on the building. (Main Building)	Carry out any remedial works if required.	6-months
10	Discrepancies in as-built drawing. (Main Building)	Building engineer is required to survey the structure and prepare accurate as-built (architectural and structural) drawings in compliance with section 1.9.1 of BNBC.	6-weeks

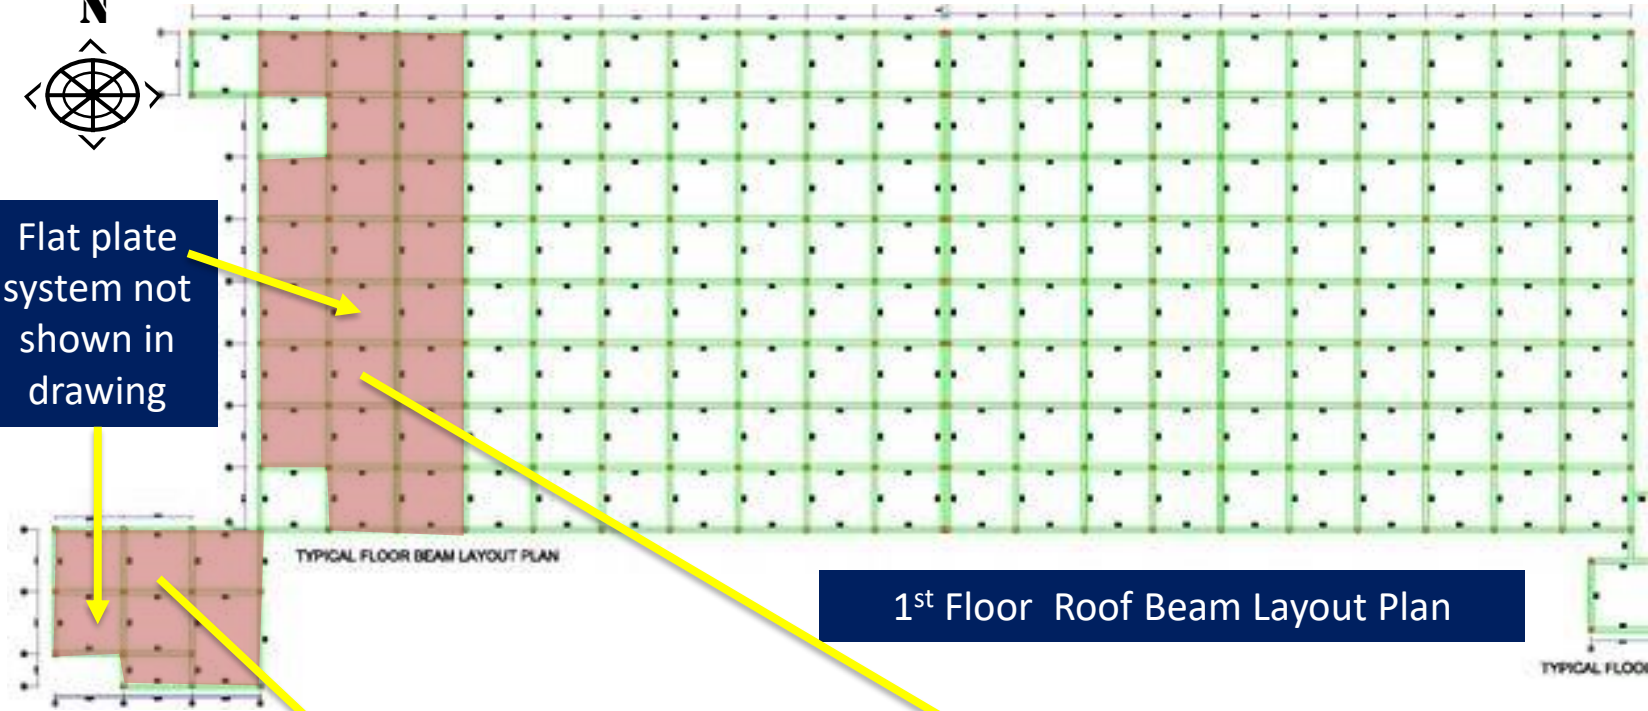
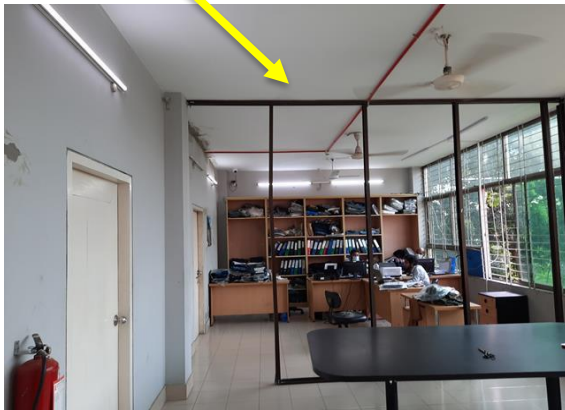
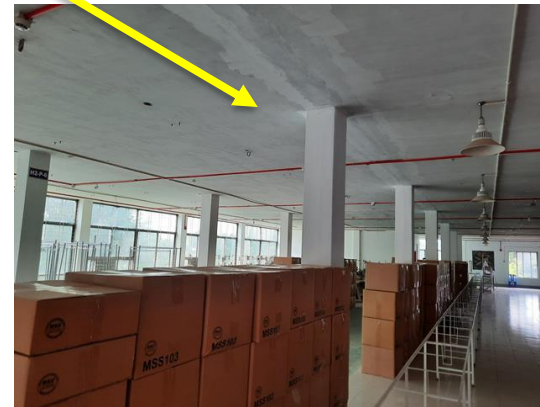
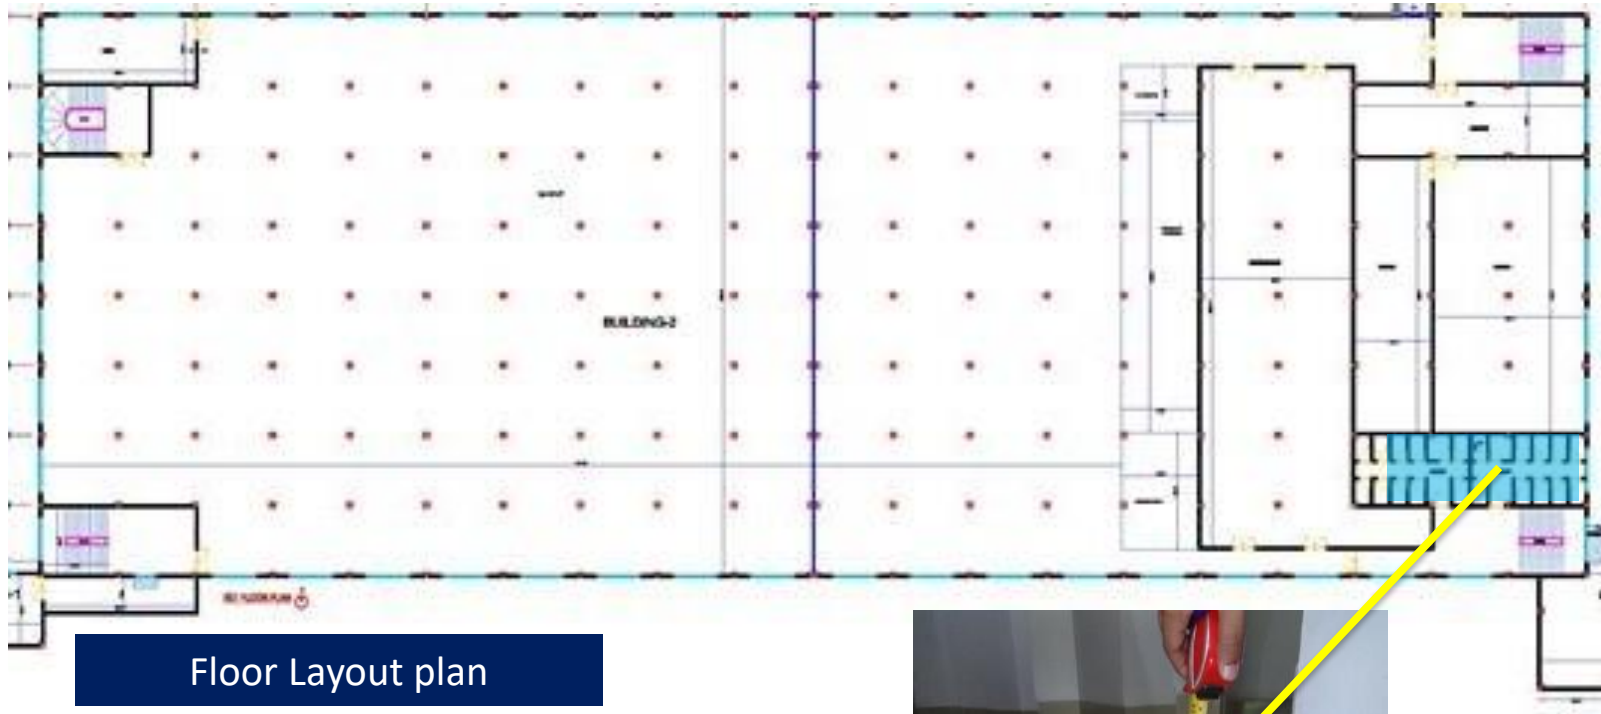
Floor Layout plan

Discrepancies in as-built drawing

Flat plate system not shown in drawing

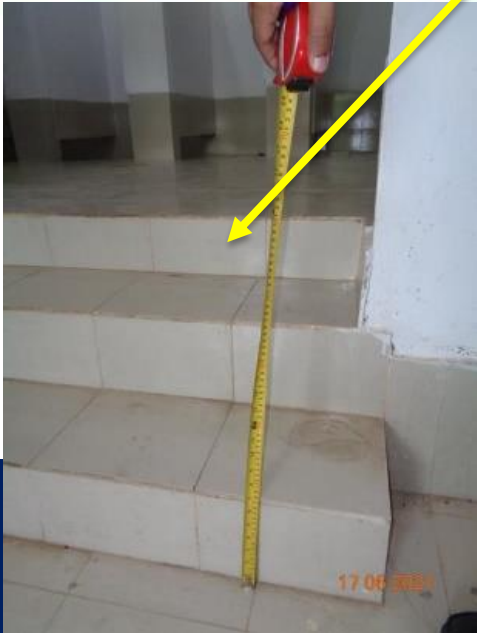
500 mm Buildup at 1st Floor Toilet Block.

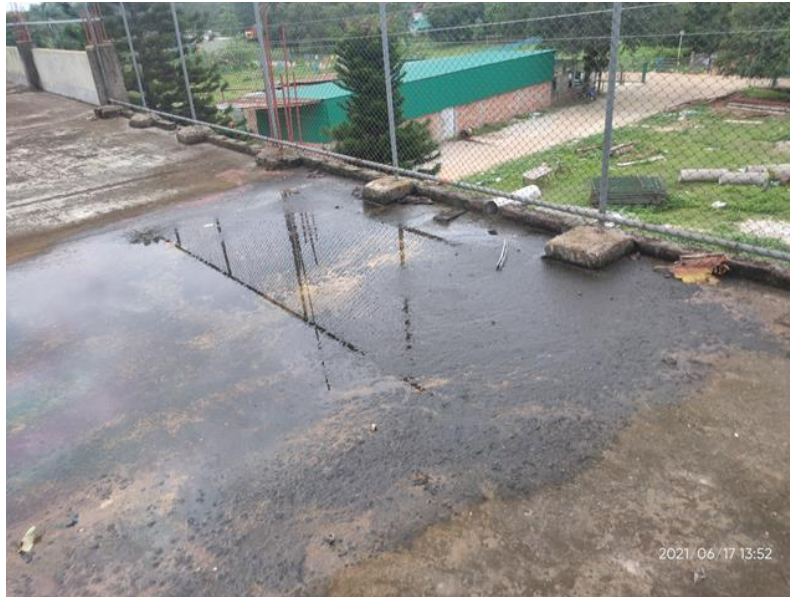
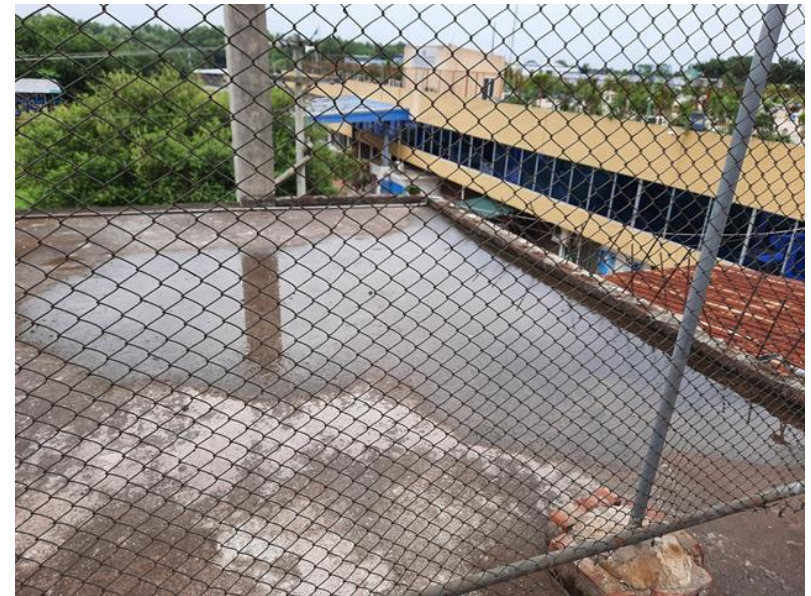
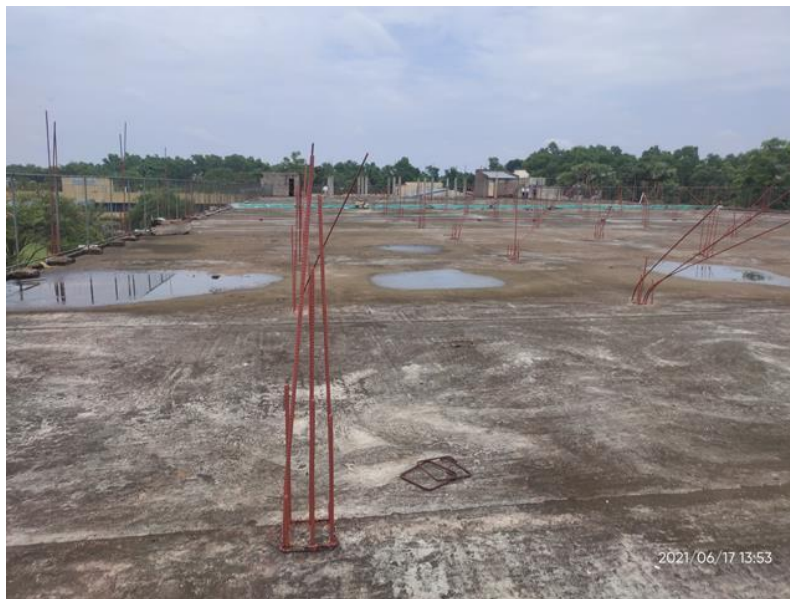
Water Ponding on Roof

Water ponding observed on the roof. Building engineer is required to develop proper drainage system on roof with adequate slope and apply water proofing compound on roof slab to resist water ingress.

Item No.	Observation	Recommended Action Plan	Recommended Timeline
11	Water ponding on roof. (Main Building)	Building engineer is required to apply water proofing & develop proper drainage system on roof with adequate slope to resist water ingress.	6-weeks
12	Exposed rebar at roof. (Main Building)	All exposed reinforcement is to be protected from corrosion which may cause degradation of the concrete.	6-weeks
13	Columns susceptible to be overstressed due to slenderness effect. (Generator Building)	Building engineer is required to check the column capacity for slenderness effect.	6-weeks
14	Columns susceptible to be overstressed due to slenderness effect. (Generator Building)	Carry out any remedial works if required.	6-months
15	Discrepancies in as-built drawing. (Generator Building)	Building Engineer is required to survey the structure and prepare accurate as-built (architectural and structural) drawings in compliance with section 1.9.1 of BNBC.	6-weeks

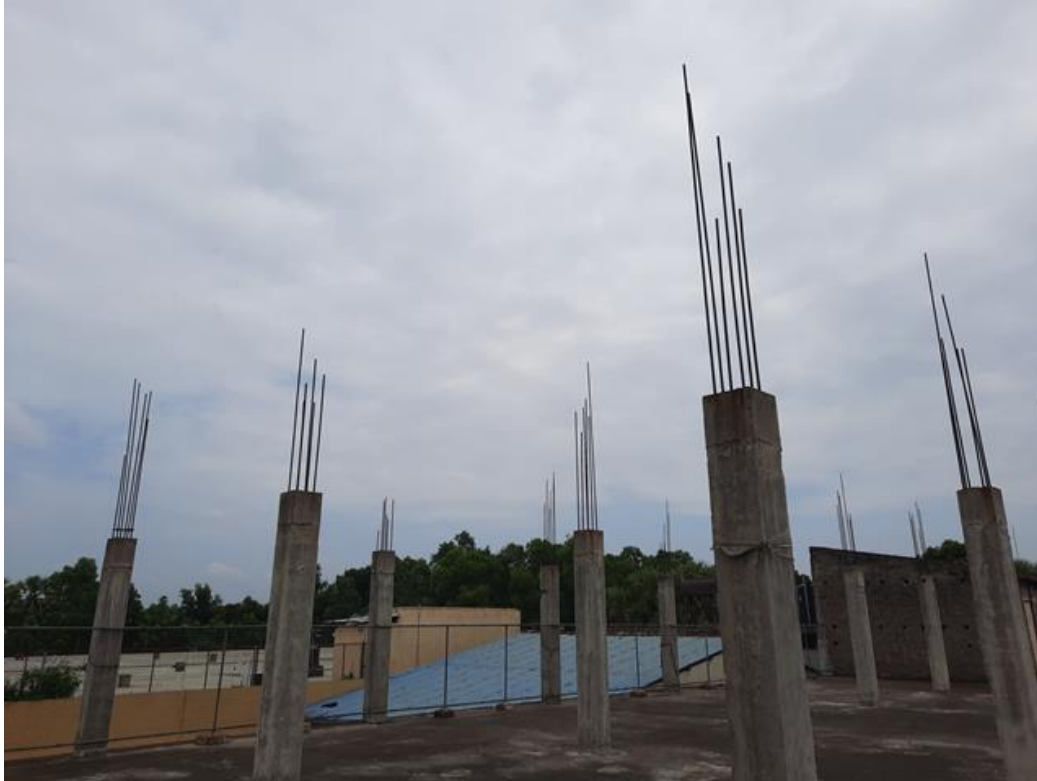
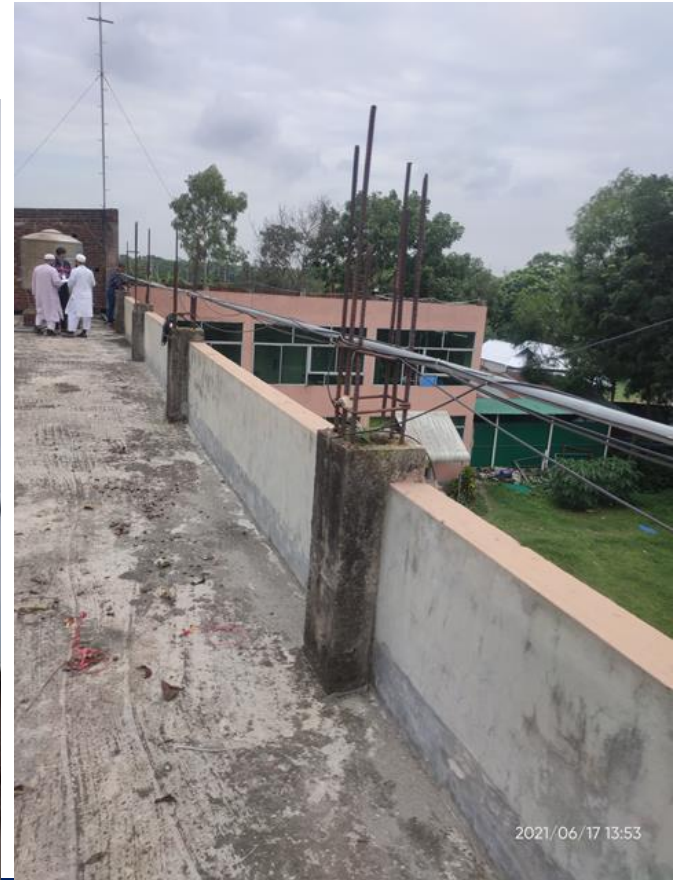
Exposed Rebar at Roof

Exposed rebar observed in the roof. Remove the exposed rebar or provide rust proof paint on rebar.

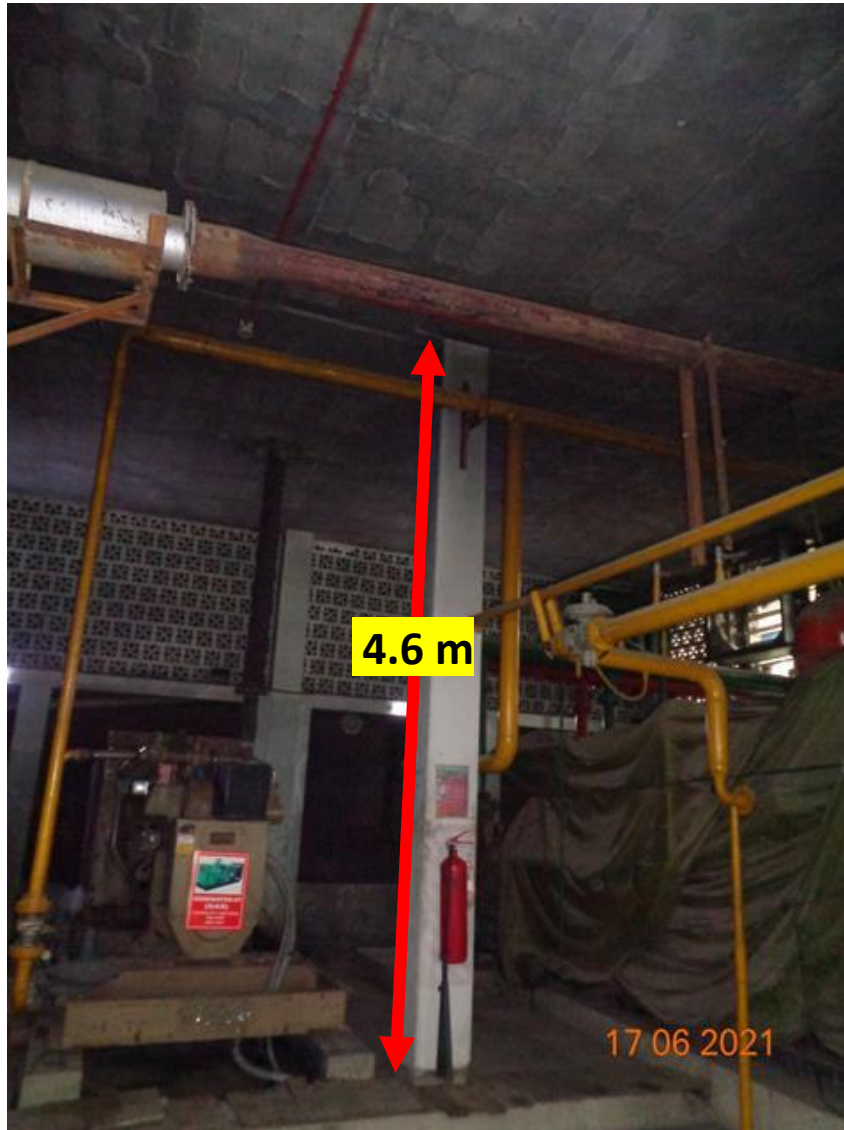
Column Schedule

Columns Susceptible to be overstressed due to slenderness effect

Ground floor column 4.6 m in length and 300X300 mm in size. The KL/r ratio= 50.27 indicate that the columns are critical for slenderness effect. So, the Building engineer is required to check the column capacity considering slenderness effect.

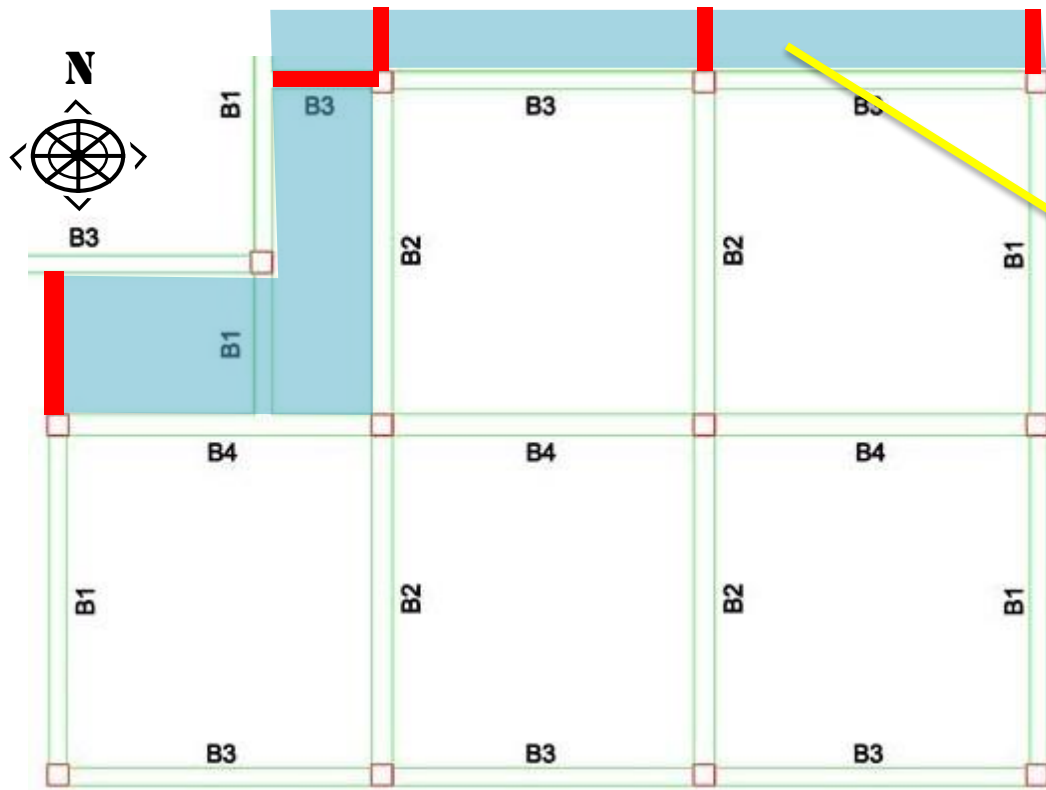
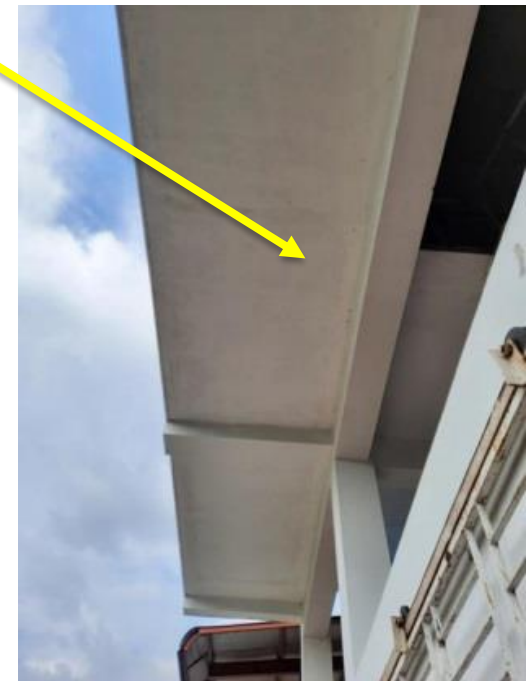
1st Floor Roof Beam Layout Plan

Discrepancies in as-built drawing

Cantilever Portion-Not Shown in Drawing

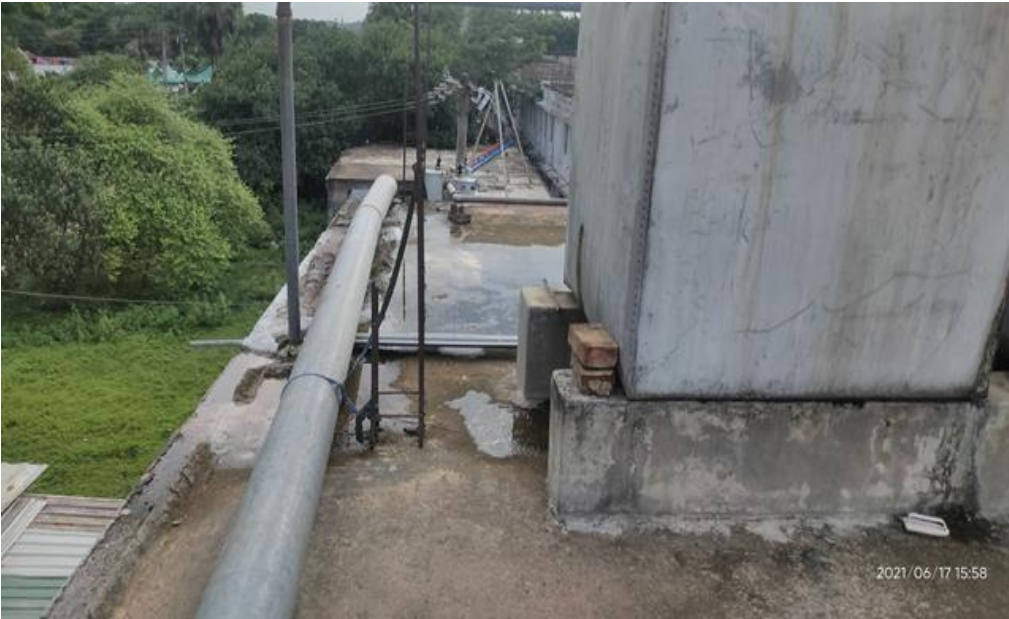
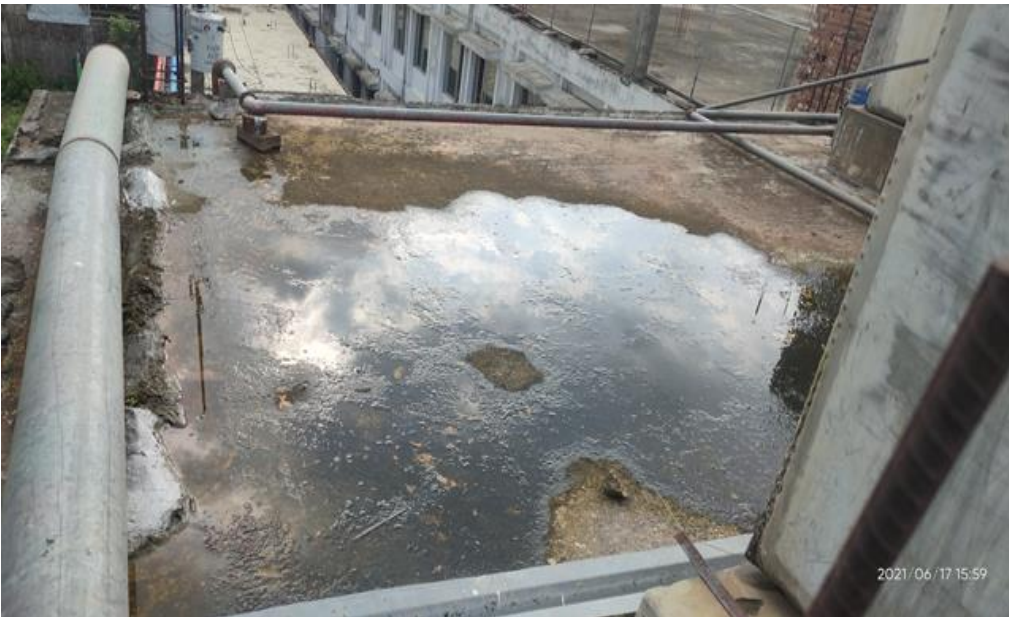
Water Ponding on Roof

Water ponding observed on the roof. Building engineer is required to develop proper drainage system on roof with adequate slope and apply water proofing compound on roof slab to resist water ingress.

16	Water ponding on roof. (Generator Building)	Building engineer is required to apply water proofing & develop proper drainage system on roof with adequate slope to resist water ingress.	6-weeks
17	Exposed rebar at roof. (Generator Building)	All exposed reinforcement is to be protected from corrosion which may cause degradation of the concrete.	6-weeks

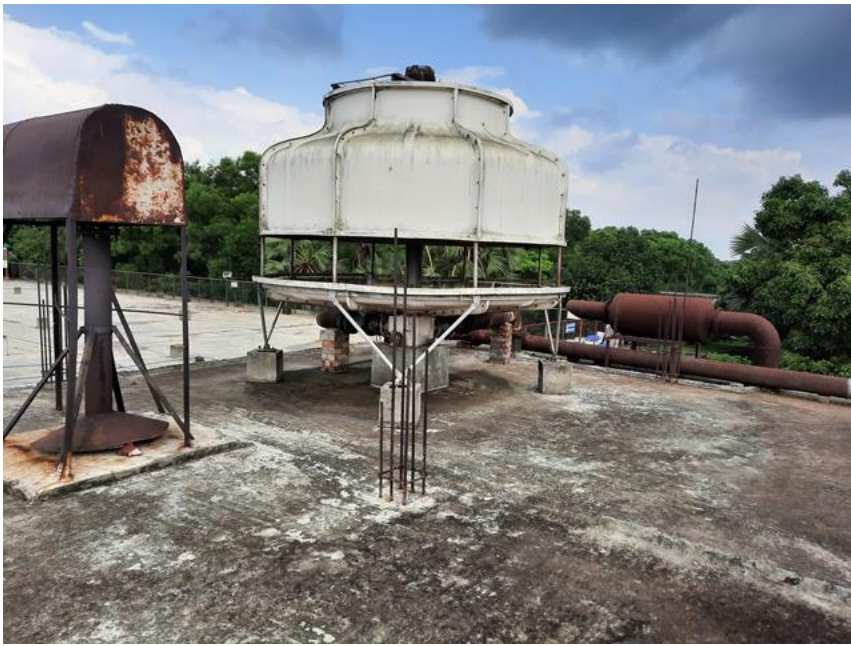
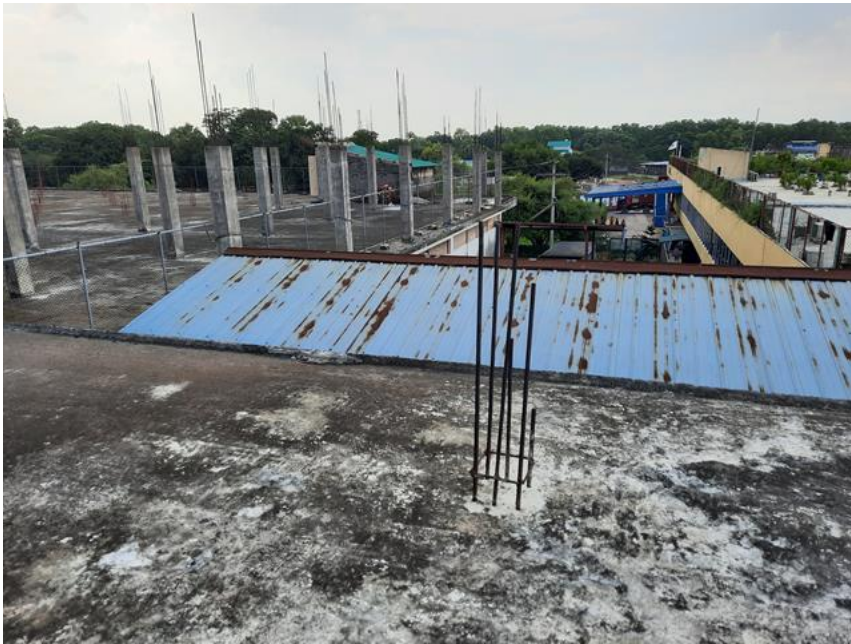
Exposed Rebar at Roof

Exposed rebar
observed in the roof.
Remove the exposed
rebar or provide rust
proof paint on rebar.

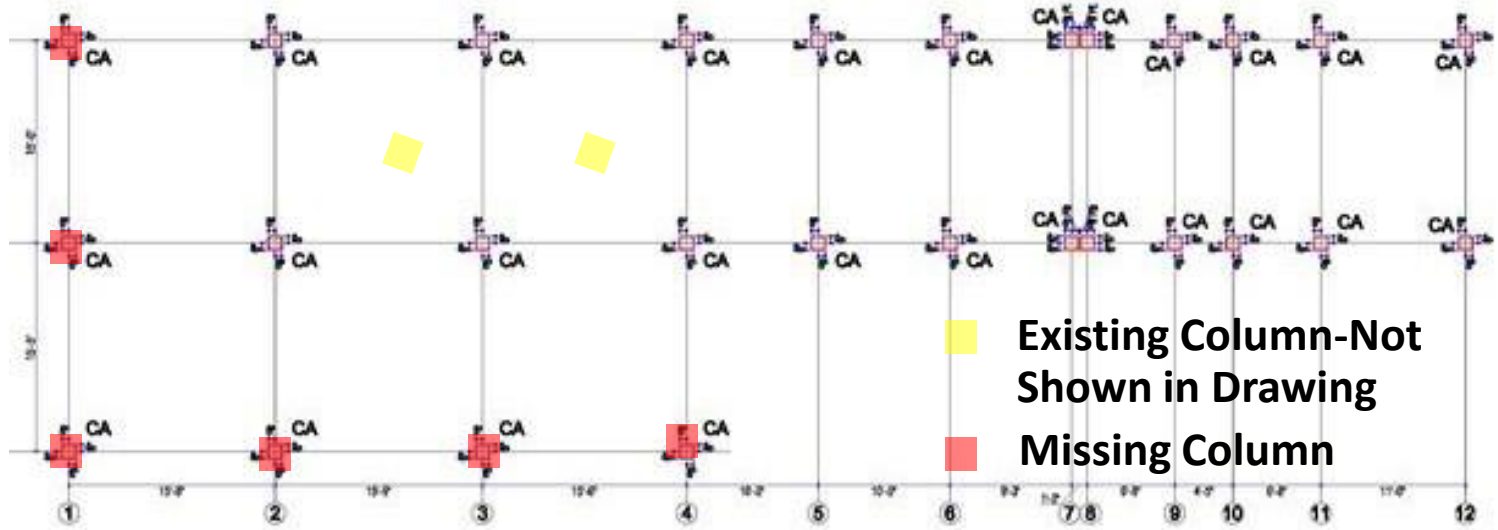
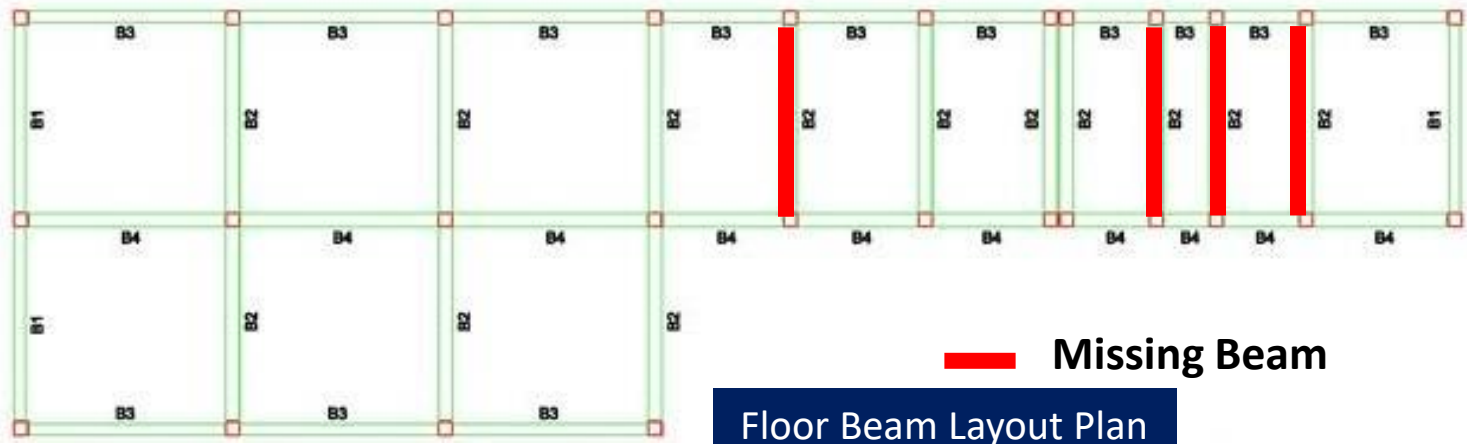
Discrepancies in as-built drawing

As-built drawings not matched with the site condition. Building engineer is required to survey the structure and prepare accurate as-built drawing.

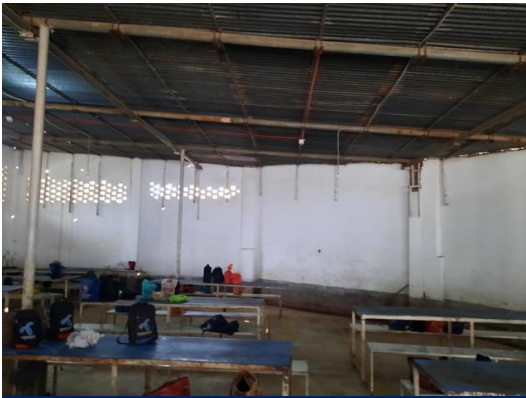
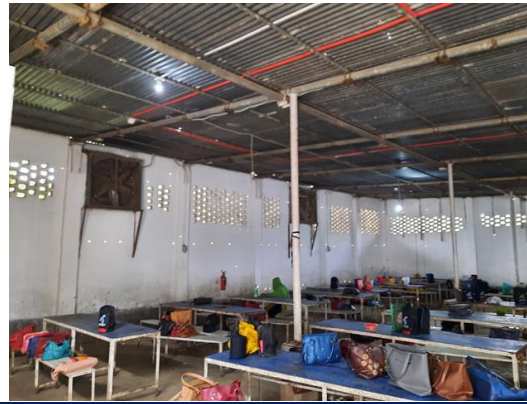
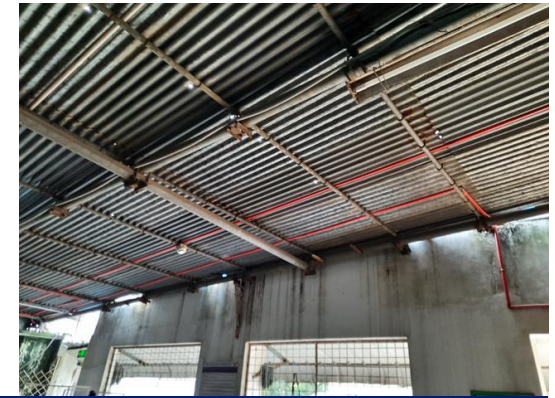
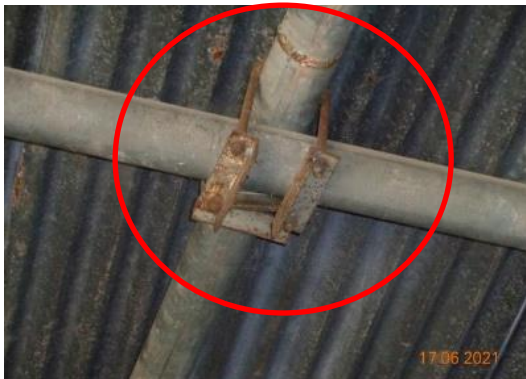
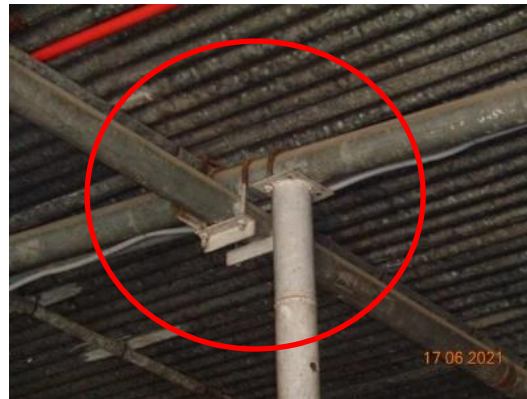
Non Engineered Dining Shed

Non-Engineered Shed

Poor Connection

Apparently inadequate steel member, No clear/defined load path, Poor connection details observed. Apparently non-engineered shed. Building engineer is required to check the stability of the shed or replace by an engineered structure.

Item No.	Observation	Recommended Action Plan	Recommended Timeline
18	Discrepancies in as-built drawing. (Sample Building)	Building Engineer is required to survey the structure and prepare accurate as-built (architectural and structural) drawings in compliance with section 1.9.1 of BNBC.	6-weeks
19	Non-engineered dining shed. (Dining Shed)	Building engineer is required to check the stability of the shed or replace by an engineered structure.	6-weeks
20	Non-engineered dining shed. (Dining Shed)	Carry out remedial works where necessary.	6-months
