# INITIAL FIRE SAFETY INSPECTION REPORT

**Four Design (Pvt.) Ltd**

**RSC ID: 24109**

**Date: 08-Feb-2021**

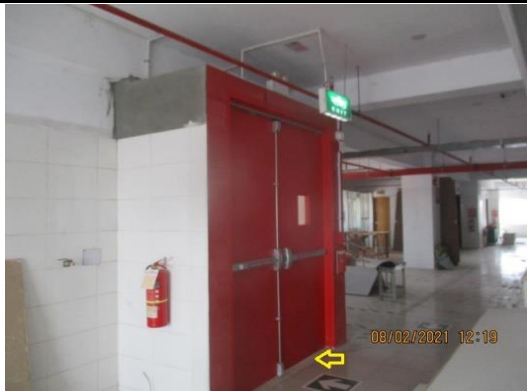
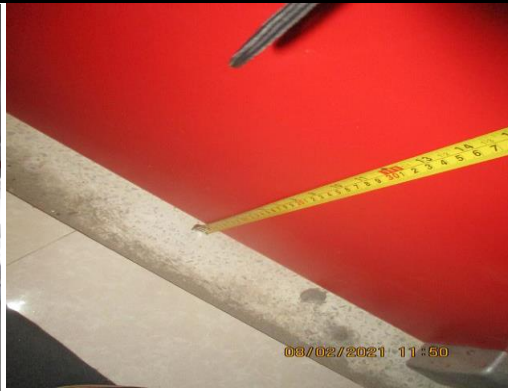
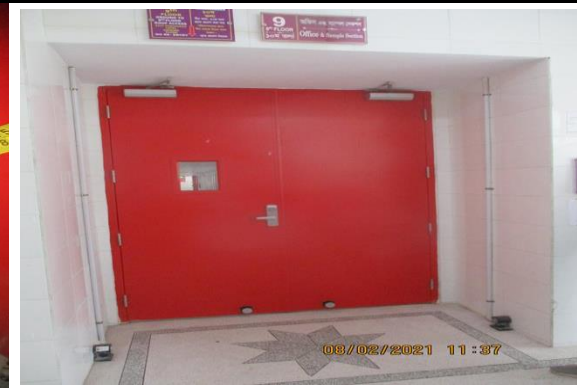
SI No.	Category	Findings	Required Action	Remediation Time Frame
F-1	Fire Rated Construction	Exit Enclosures are not properly fire separated from other occupancy on each floor by fire rated construction due to installation error of the fire rated doors. The gap in-between door and floor was more than 19 mm.	<p>Provide minimum 2-hr fire rated separation exit enclosure. Provide minimum 1.5-hr fire rated doors and seal all unprotected openings and penetration to separate the exit stairs from work areas and other building spaces on all floor levels. The clearance under the bottom of a fire door shall be a maximum of 19mm.</p> <p>Ensure that the fire doors are self-closing and positive latching and that they are provided with fire exit (panic) hardware where serving production floors. If fire doors are required to be held open for functional reasons, provide automatic closing devices tied to the fire alarm system.</p> <p>Once fire doors are installed, every door in a stair enclosure serving more than 5 stories shall be provided with re-entry unless it meets ACCORD standard 6.8.3.1.</p>	Within 3 months

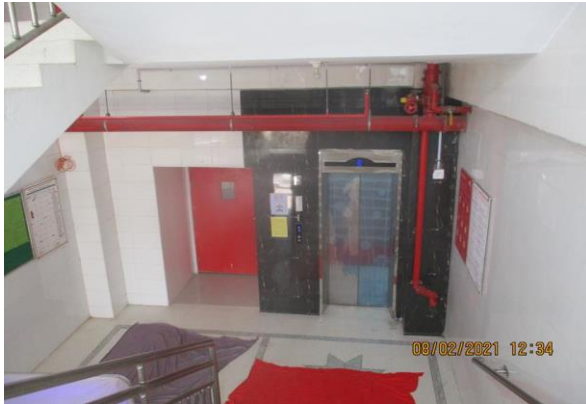
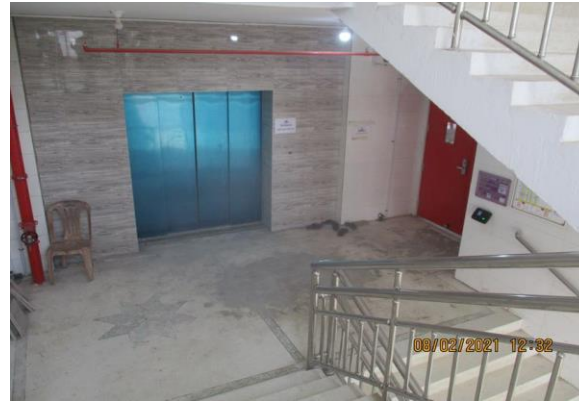
F-2	Fire Rated Construction	Elevator shafts are directly open into the inside of stair-1 & Stair-2.	For new construction, elevators shall not open into an exit enclosure as per ACCORD-6.14.3. So, separate the stair enclosure from elevator shaft although the building.	Within 3 months
-----	-------------------------	---	---	-----------------

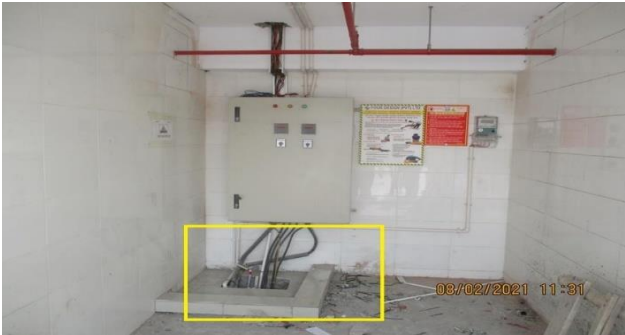
F-3	Fire Rated Construction	Penetrations in floor/ceiling assemblies are found unsealed on each level of all floors. Location: North side (Stair-3) Electrical riser on all floors of Production building-1	Seal all penetrations and openings in floor/ceiling (full thickness of the floor/ceiling) assemblies by minimum 3-hr fire-rated materials to maintain the required fire-resistance rating.  Provide a minimum 2-hr fire-rated shaft to separate the utility risers from each floor if required.	Within 3 months

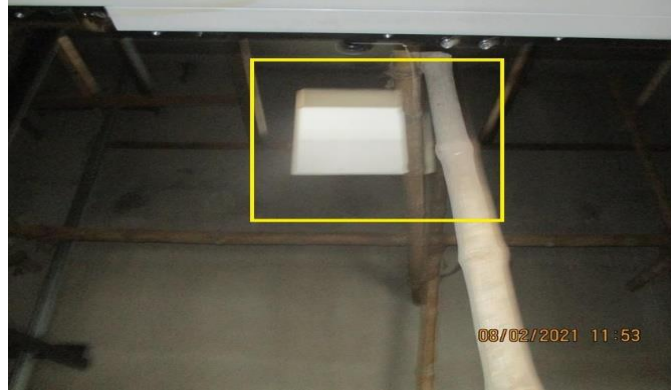
F-4	Fire Rated Construction	Lift shaft was not properly fire separated due to unprotected opening with production floor. Location: Stair-2 of production building -1	Seal all penetrations and openings in the wall (full thickness of the wall) assemblies by minimum 2-hr fire-rated materials to maintain the required fire-resistance rating.	Within 3 months

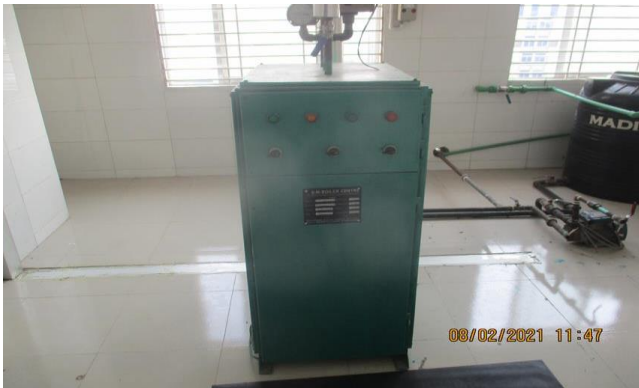
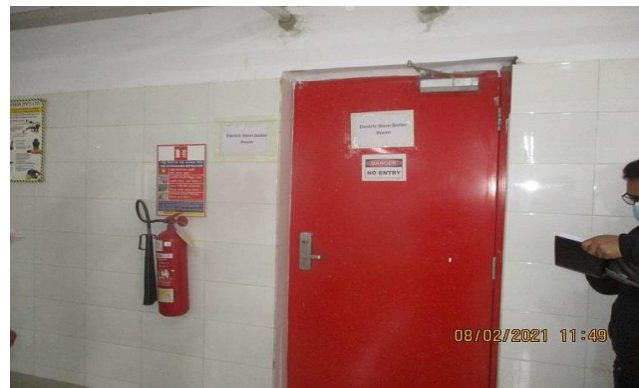
F-5	Fire Rated Construction	Boiler room are not properly fire separated by fire rated construction due to non functionality of fire door. Location : 9th floor of production building -1	Ensure that the fire doors are self-closing and positive latching and that they are provided with fire exit (panic) hardware where serving production floors. Keep the fire rated doors close all time, if for functional reason require to keep open then interfacing facility with functional FACP Shall be ensured.	Within 3 months
-----	-------------------------	--	---	-----------------

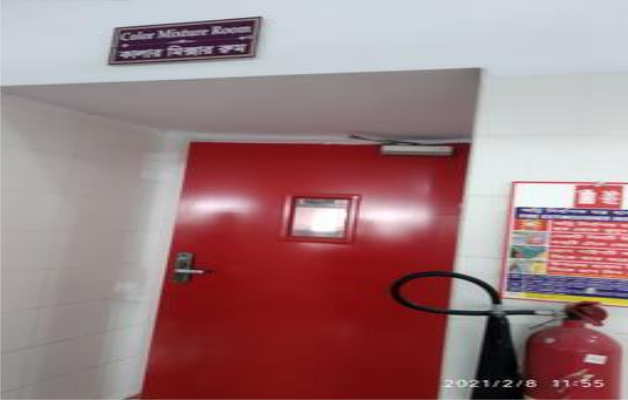
F-6	Fire Rated Construction	Room used for combustible storage on the 7th floor are not properly fire separated by fire rated construction due to non functionality of fire door. Location 7th floor of production building-1	Provide dedicated storage rooms separated by minimum 1 hr. fire rated construction. Ensure that the fire doors are self-closing and positive latching and that they are provided with fire exit (panic) hardware where serving production floors.	Within 3 months

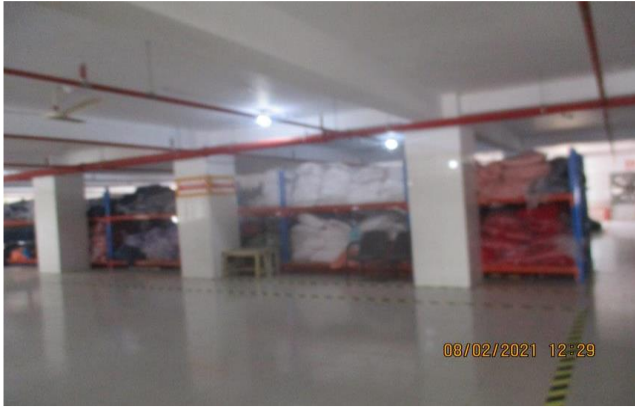
F-7	Fire Rated Construction	Areas used for in-process storage of combustible materials are open to the surrounding occupancy which are not separated by fire rated construction at 3th floor of production building 01	<p>Provide dedicated storage rooms separated by minimum 1-hr fire-rated construction.</p> <p>Or,</p> <p>Where separate storage rooms are not feasible, Provide defined storage areas and limit the storage arrangement as follows:-</p> <ol style="list-style-type: none"> <li>1. General Condition: Maximum height of 2.4m and maximum area of 23m<sup>2</sup>. Separate areas of unenclosed combustible storage by a minimum clear distance of 3m.</li> <li>2. If sprinkler protected: maximum height of 3.66m and maximum area of 93m<sup>2</sup>. Separate areas of unenclosed combustible storage by a minimum clear distance of 3m.</li> </ol>	Within 3 months

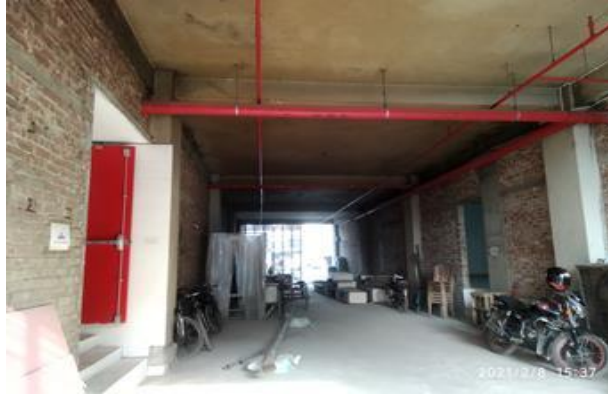
F-8	Fire Rated Construction	Exit discharge path(passageway) are not properly fire separated by fire rated construction due to unprotected opening & penetration. Location: production building 01	Separate the exit passageway (ceiling, floor, wall etc.) by 2- hr. fire-resistance rated construction and shall terminate at an exit discharge.	Within 3 months

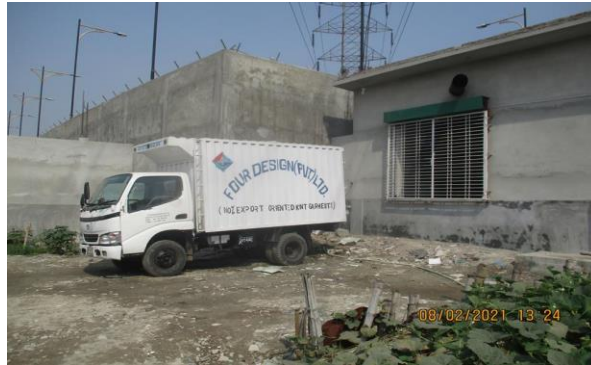
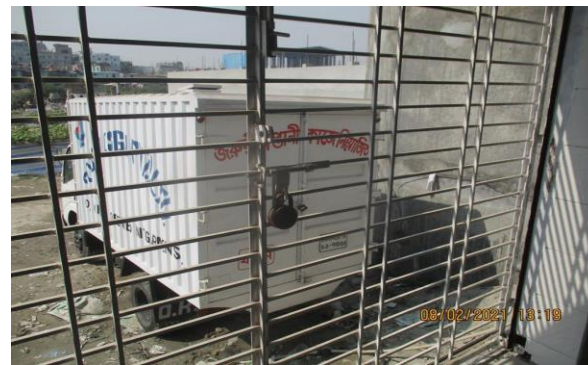
F-9	Fire Rated Construction	Liquefied or compressed gas cylinders were located within the factory near utility building-02.	The storage or use of liquefied or compressed flammable gas cylinders shall be prohibited within the factory building as per ACCORD -3.4.2.1.11 standard. So remove LPG/CNG from the Factory.	Within 1 Month
-----	-------------------------	---	---	----------------

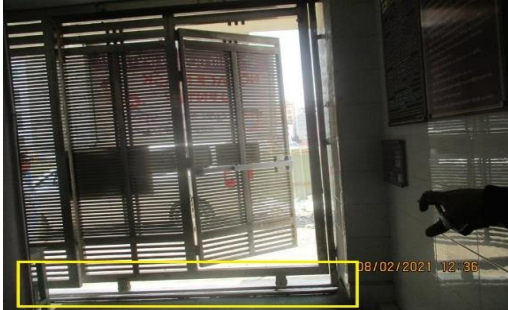
F-10	Means of Egress	The egress path along means of egress has interrupted by obstruction. Location: Bottom of pocket gate of stair -1 & Stair-2 ground floor of production building-1	Means of egress shall be maintained continuously free and clear of all obstructions.	Within 1 month

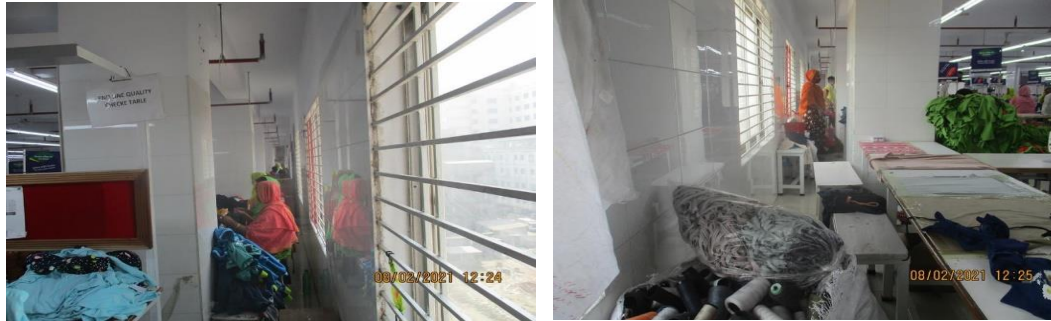
F-11	Means of Egress	Stair designation is not posted at the exit stair at all level. Location : production building-1	Stair designation shall be posted at the entrance to exit stair at all level.	Within 1 month
F-12	Means of Egress	The egress path along the means of egress has been interrupted by obstruction/storage. Location: west side of 4th floor production building 01.	Means of egress shall be maintained continuously free and clear of all obstructions/storage. Or Aisles shall be provided with a minimum unobstructed clear- with of 0.9m (36 in).	Immediately
