# Four Design (Pvt.) Ltd.

Plot#S-7,S-8, BSCIC, Hosiery I/E, Shashongaon, Fatullah, Narayanganj, Bangladesh.

8<sup>th</sup> February 2021

# Buildings Information

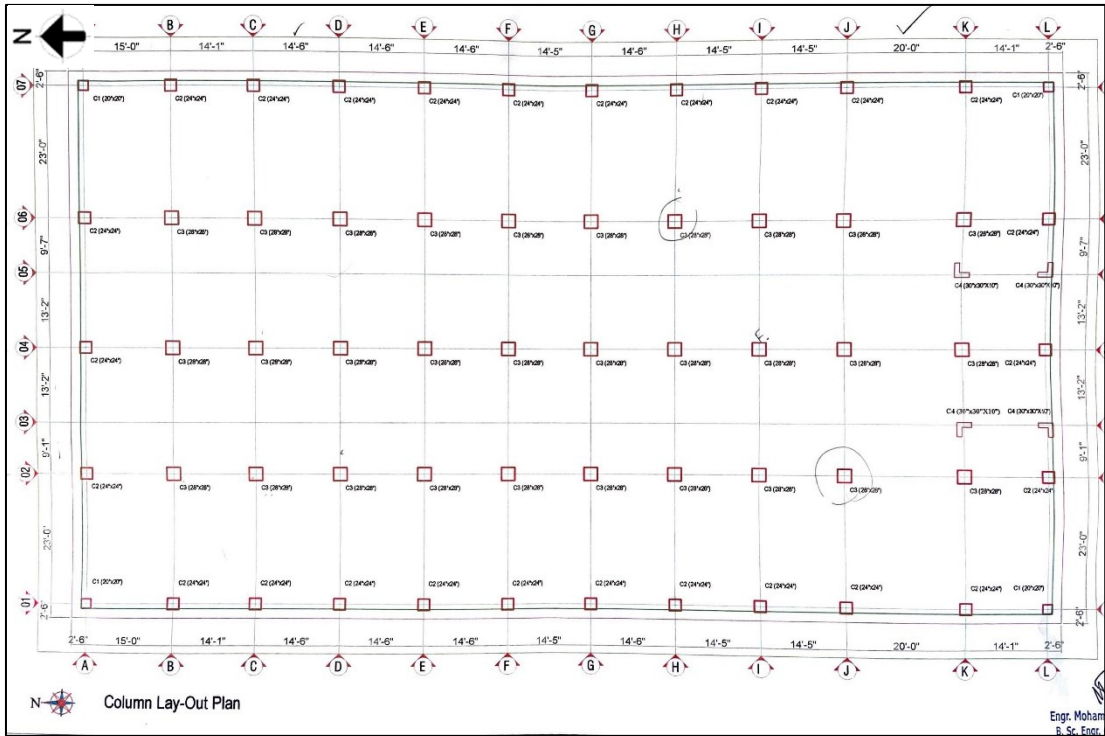
Column Layout Plan

**Column to be stressed exceeds normal design limit**

Cursory calculation indicates that columns are stressed above normal design limit considering prepared live load plan and minimum concrete strength based on aggregate type. Factory engineer is required to review design, load & column stress.

Item No.	Observation	Recommended Action Plan	Recommended Timeline
01	Column to be stressed exceeds normal design limit. (Garments Building)	Factory Engineer to review design, loads and columns stresses.	6-weeks
02	Column to be stressed exceeds normal design limit. (Garments Building)	Verify in situ concrete stresses either by 100mm dia. cores or existing cylinder strength data or [100mm dia. cores from 4 columns].	6-weeks
03	Column to be stressed exceeds normal design limit. (Garments Building)	Factory Engineer to prepare design report as per BNBC (part 6; Article 1.9.1) by reviewing design, loads and capacity of structural members	6-weeks
04	Column to be stressed exceeds normal design limit. (Garments Building)	Produce and actively manage a loading plan for all floor plates within the factory giving consideration to floor capacity and column capacity.	6-weeks
05	Column to be stressed exceeds normal design limit. (Garments Building)	Carry out remedial works where necessary.	6-months

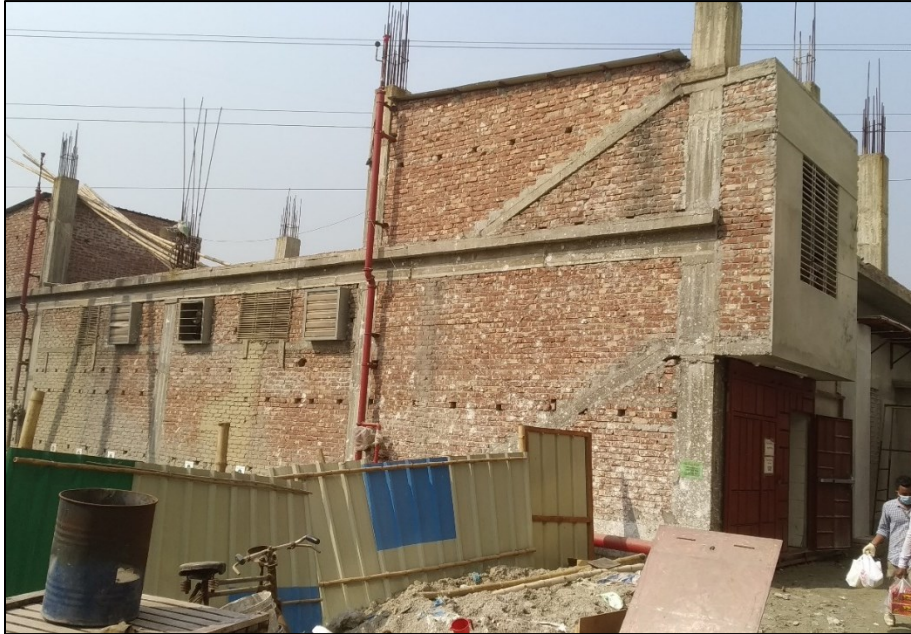
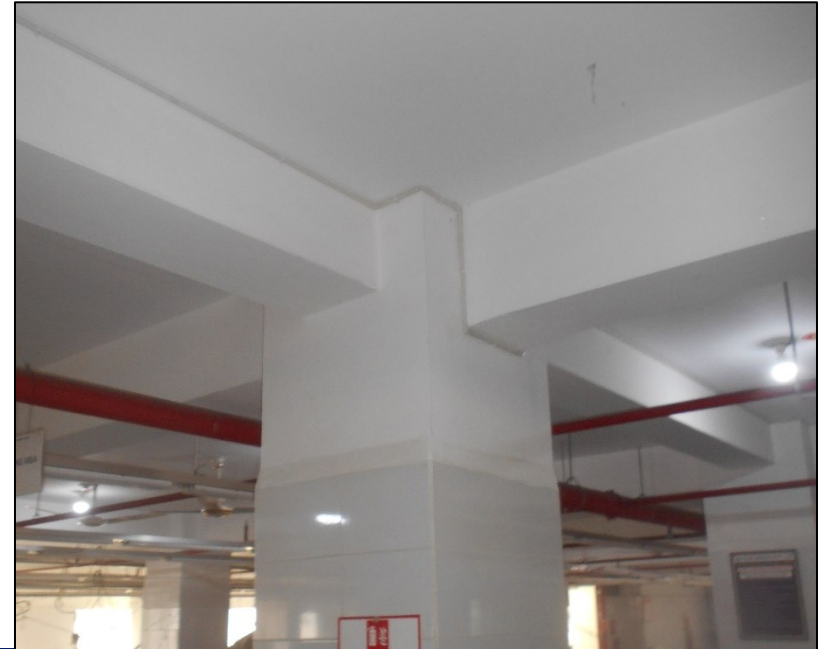
# Lack of information in as-built drawing

There was a partial construction drawing to review. Factory engineer is required to survey the structures and prepare as-built drawings, in compliance with section 1.9.1.2 as per BNBC 2006.

Item No.	Observation	Recommended Action Plan	Recommended Timeline
06	Lack of as-built drawings. (Utility Building)	Building Engineer to survey the whole structure and prepare accurate as-built drawings in compliance with section 1.9.1.2 as per BNBC.	6-weeks
07	Exposed rebar at roof. (Utility Building)	Remove rust from exposed rebar and apply anti-corrosive paint.	6-weeks

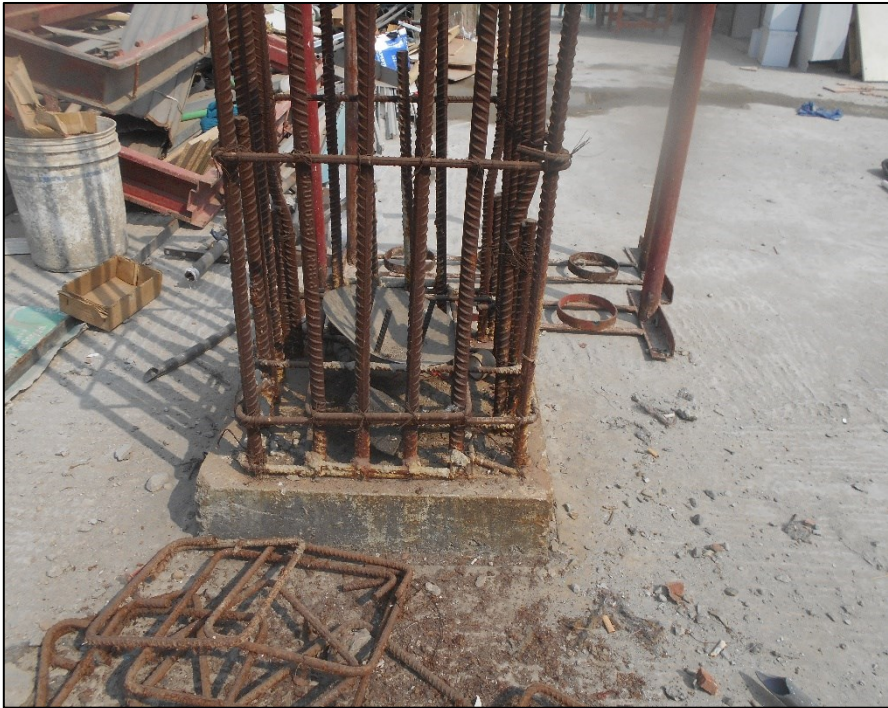
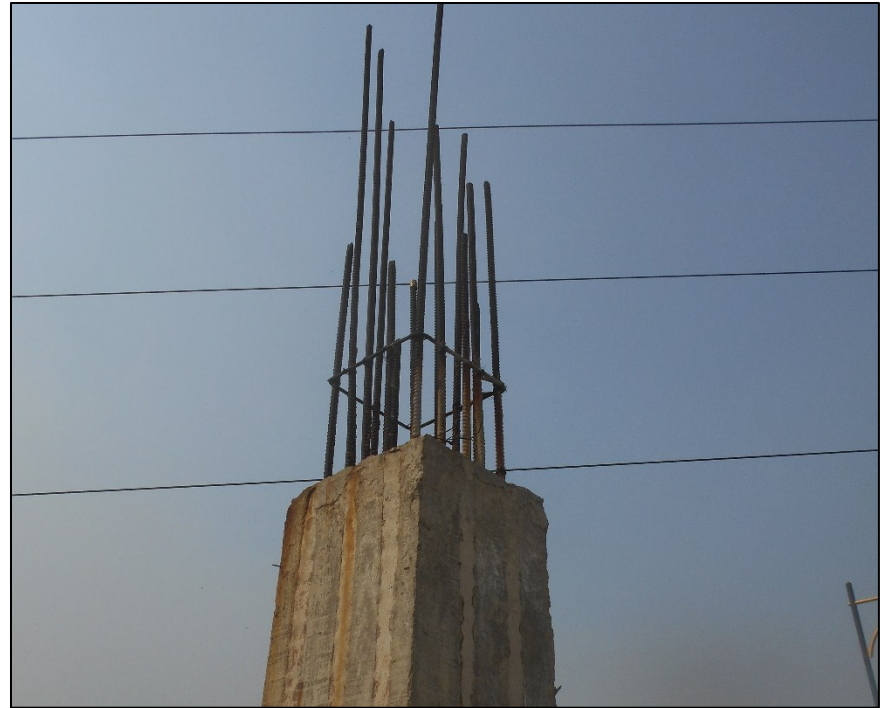
## Exposed rebar at roof

Corrosion was observed on exposed reinforcements at roof top columns. All exposed reinforcements are to be protected from corrosion which may cause degradation of the concrete.
