Hamza Clothing Ltd.

Bangabandhu Road, Tongabari, Ashulia

26th August & 7th September 2021

Observations

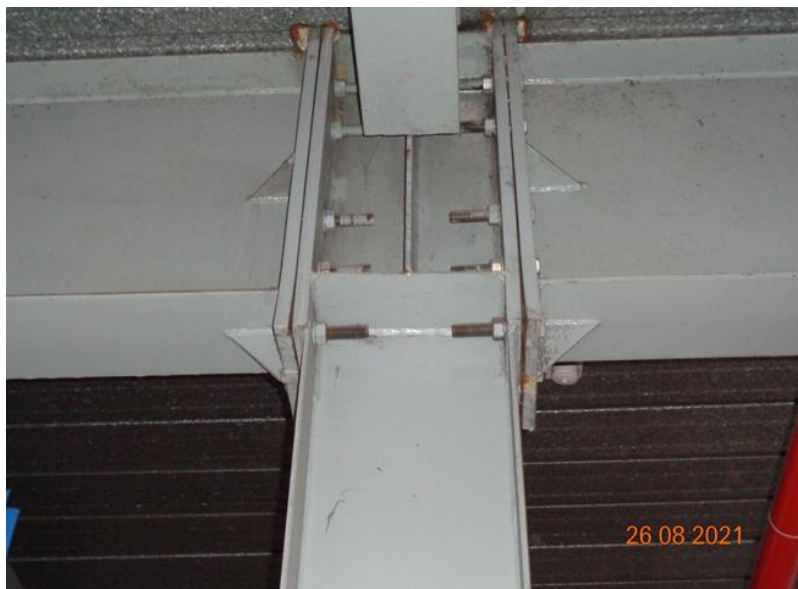
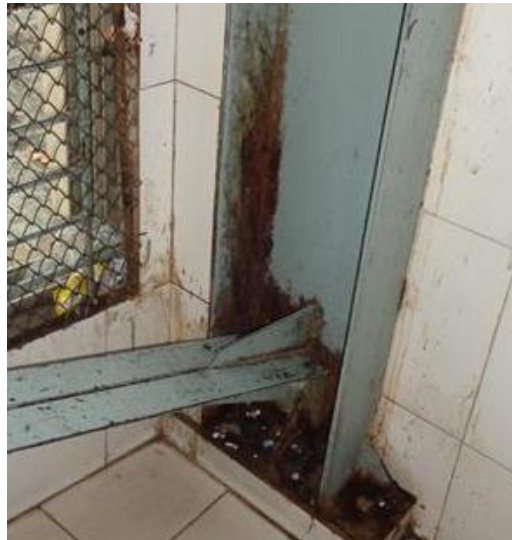
Beam-Column Connection

Bracing-Column Connection

Connection of sub-beam with Main Beam

Factory performed DEA and as per recommendation of DEA, factory completed the retrofitting works. In DEA report connection adequacy has not been provided for any type of connection. Factory engineer is required to provide the connection adequacy check for all types of connections in DEA report which is required to be reviewed by RSC.

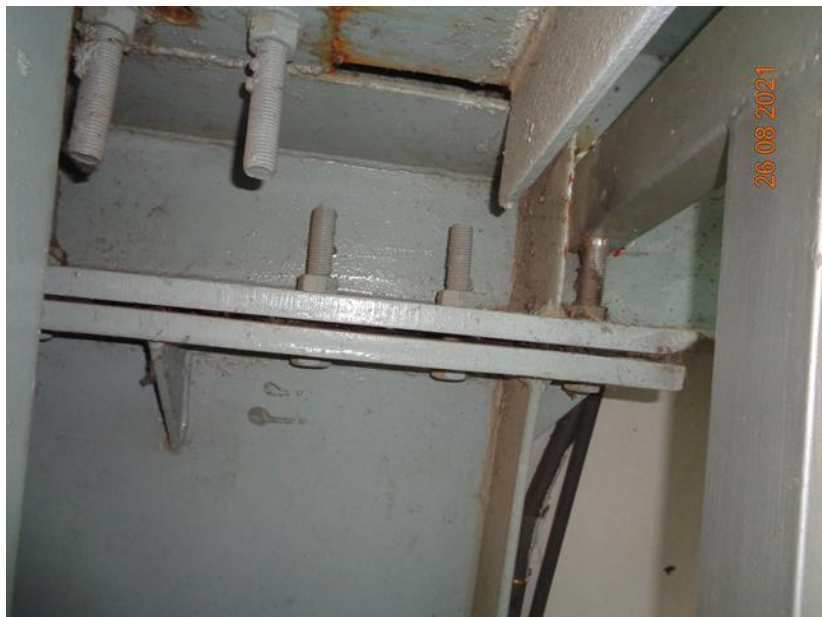
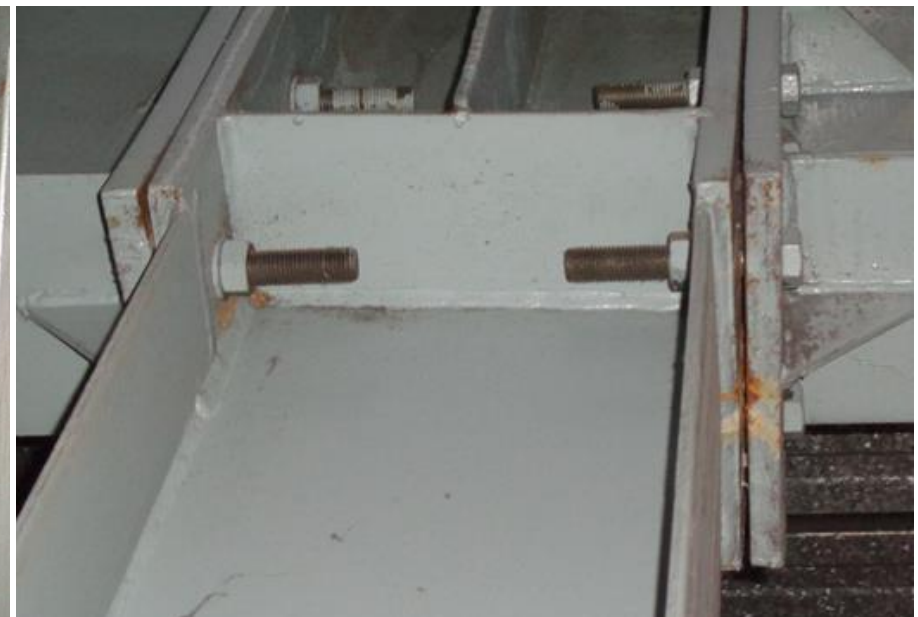
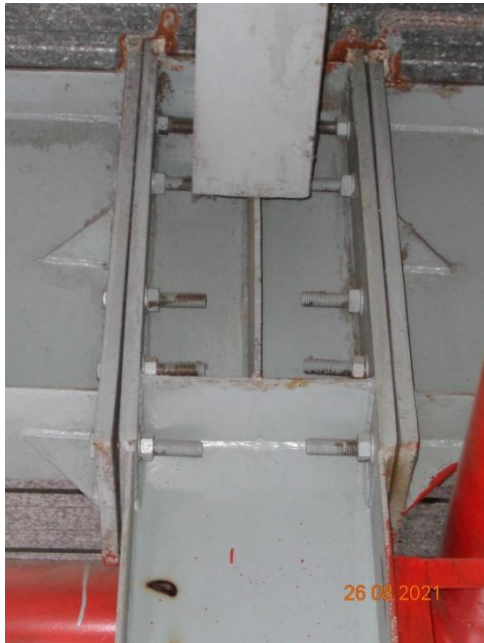
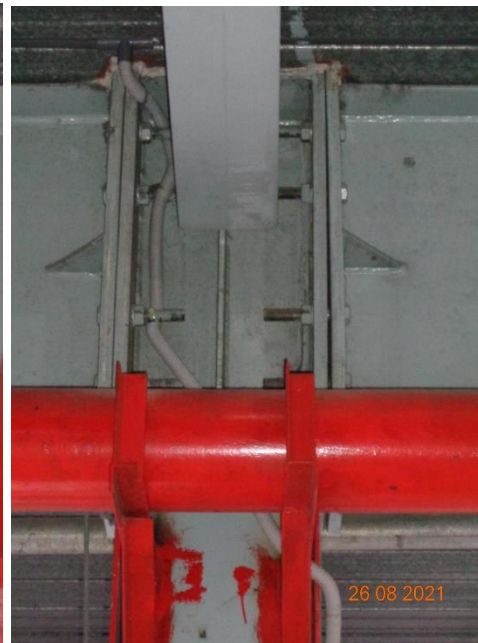
Gap observed in Beam- Column connection

Connection gap at several location.

Connection gaps observed at column-beam joint at several location. Factory engineer is required to carry out suitable remedial works.

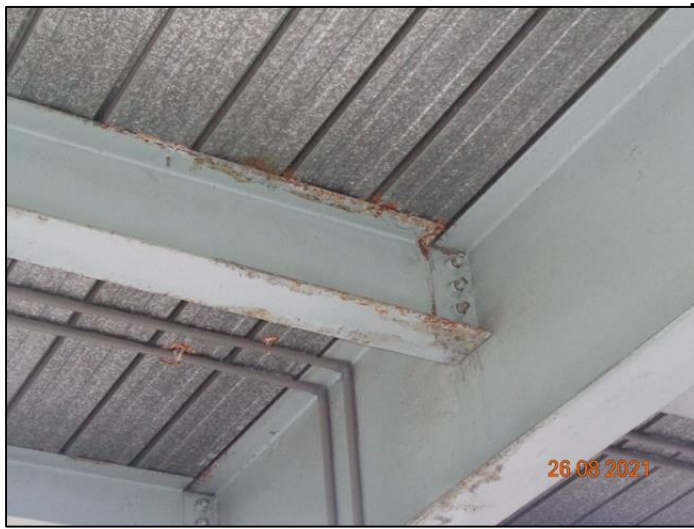
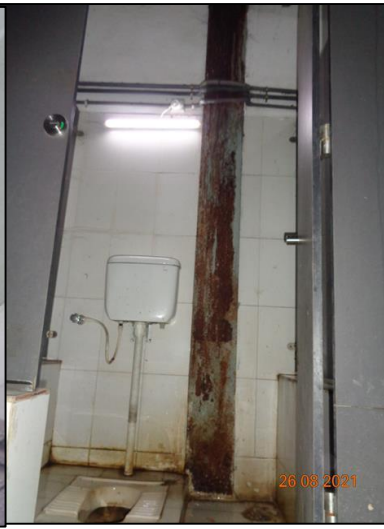
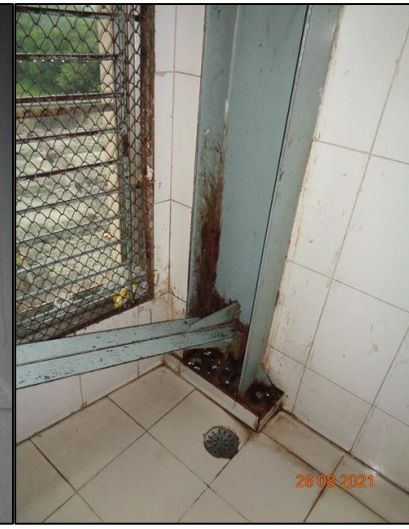
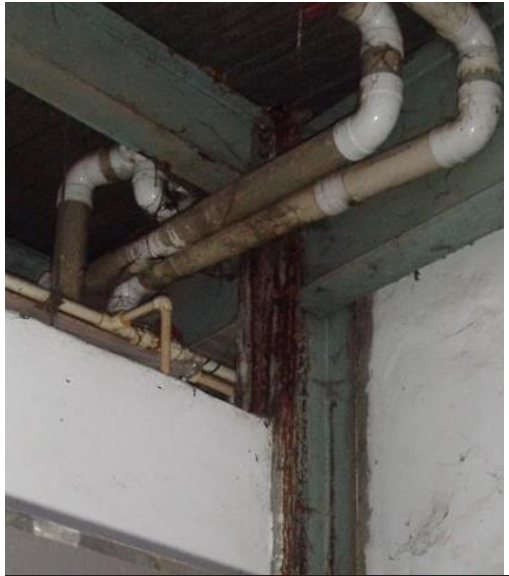
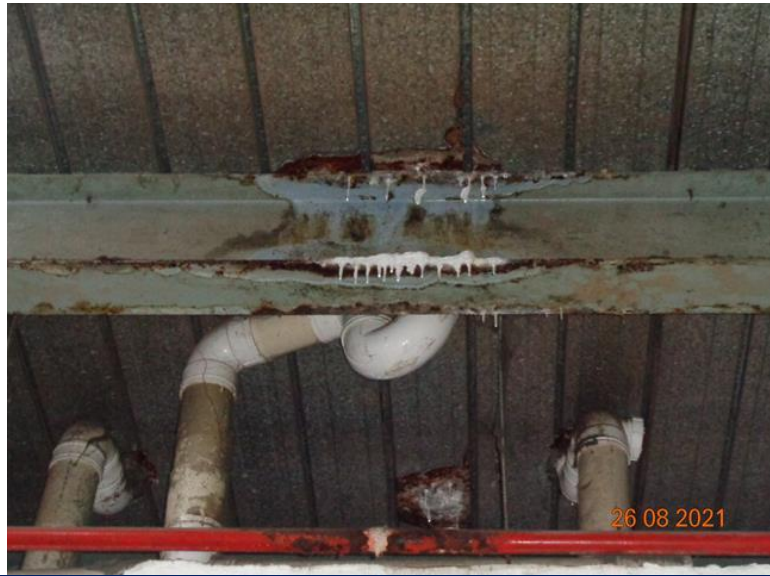
Severe corrosion in steel member

Corrosion in steel beam, column & beam-column connections

Severe Corrosion in steel member was observed in various locations. The building engineer to investigate the reason of corrosion, extend of damage and suggest proper remedial measure accordingly.

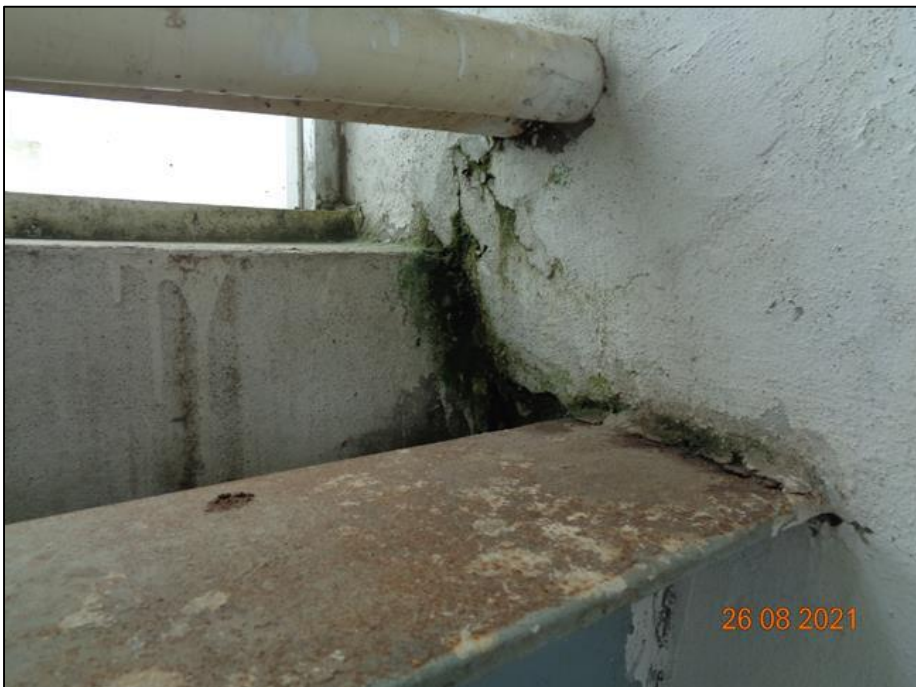
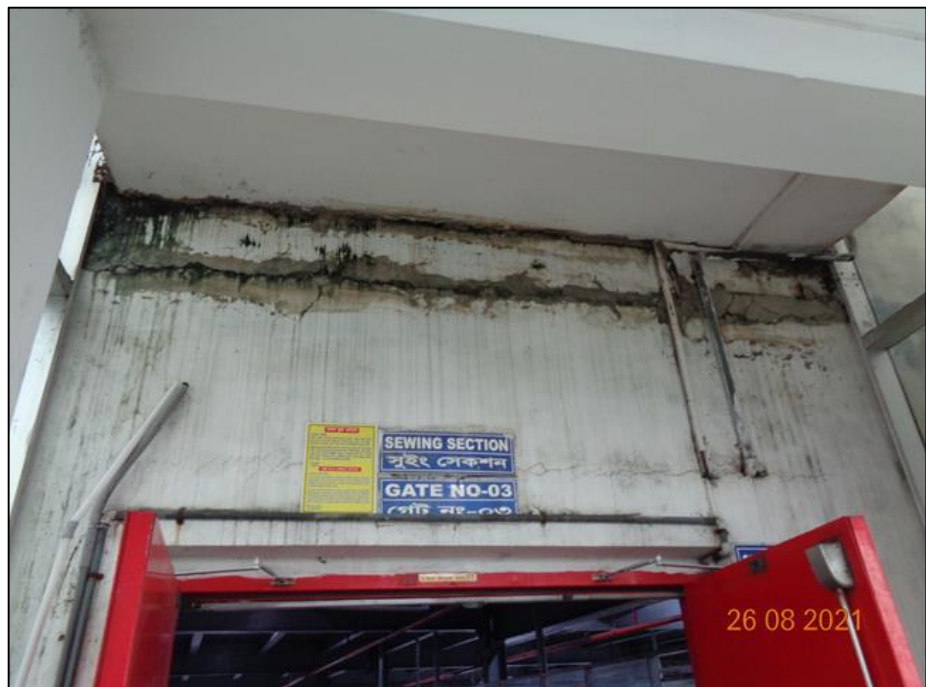
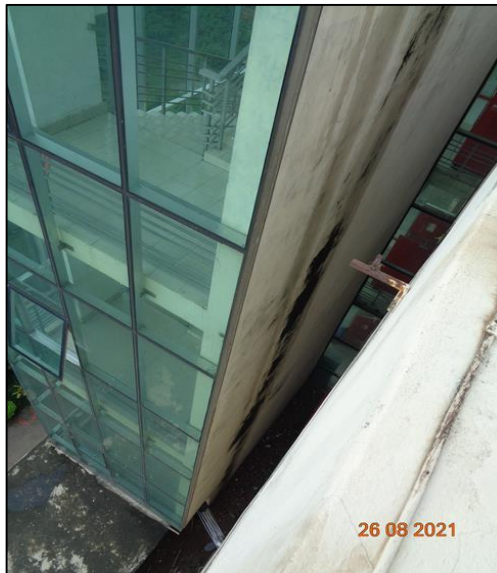
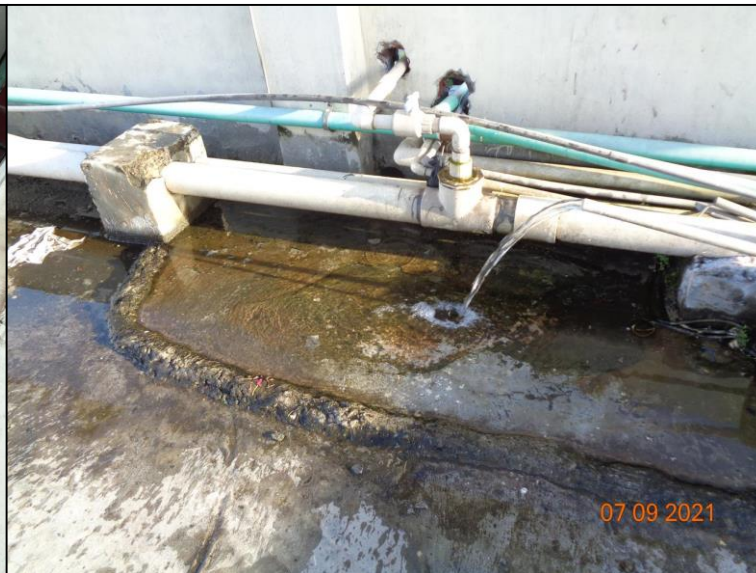
Dampness in brick wall

Dampness found in brick wall.

Dampness found in several locations of the structure. Building engineer is required to take necessary measures to prevent source of dampness and repair the existing damp areas.

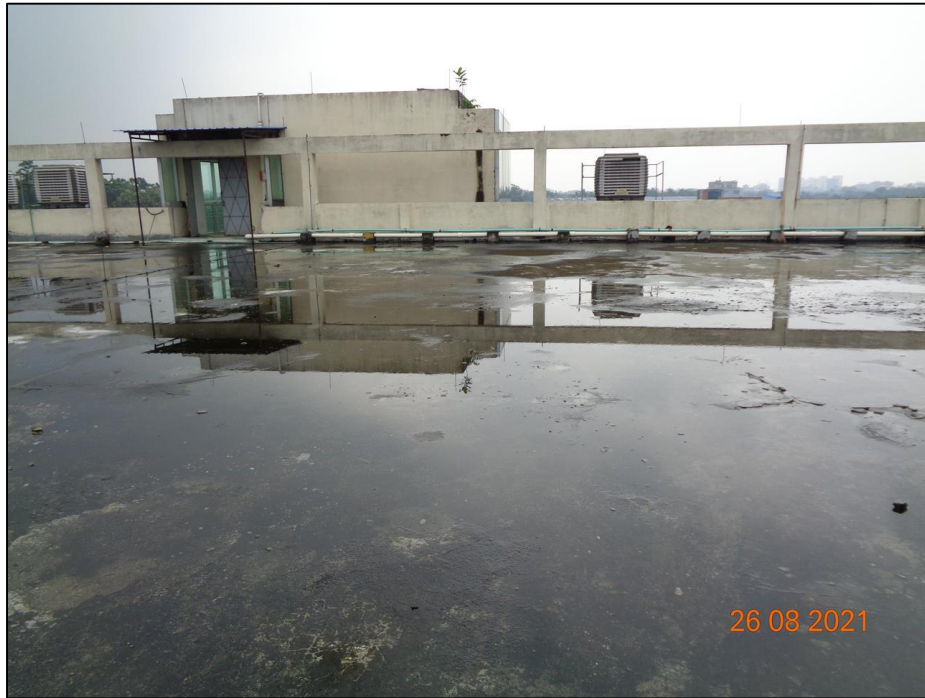
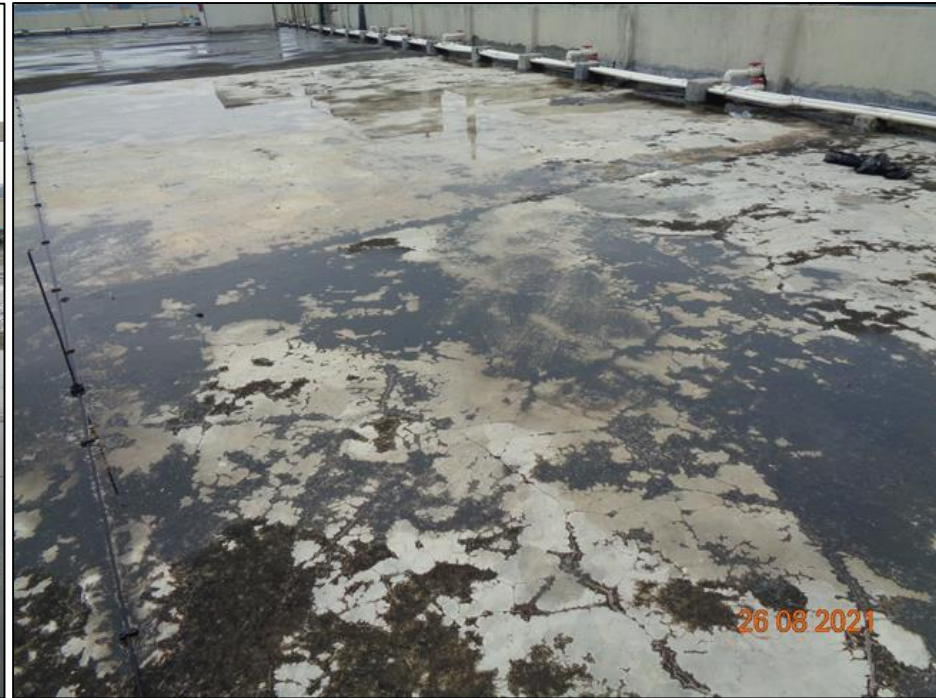
Water ponding at roof

Water ponding was found at roof area. The water drainage system was found but adequate sloping was not found. The factory engineer is required to develop proper drainage system with adequate sloping on the mentioned area.

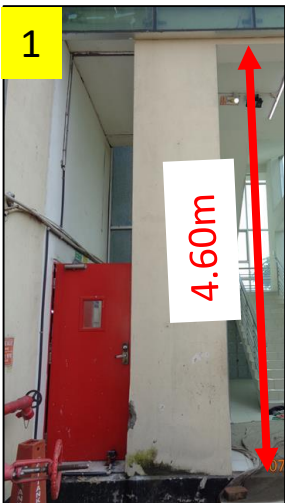
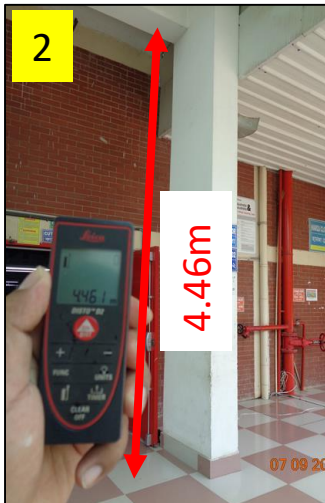
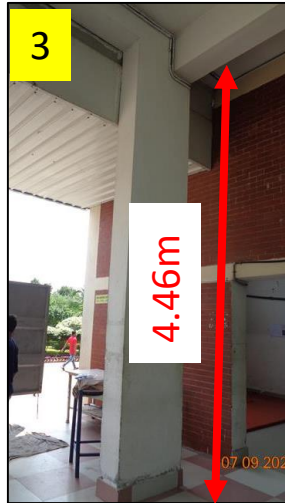
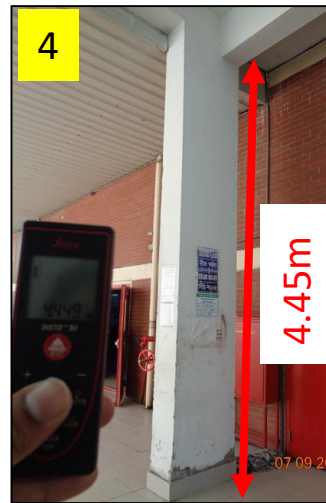
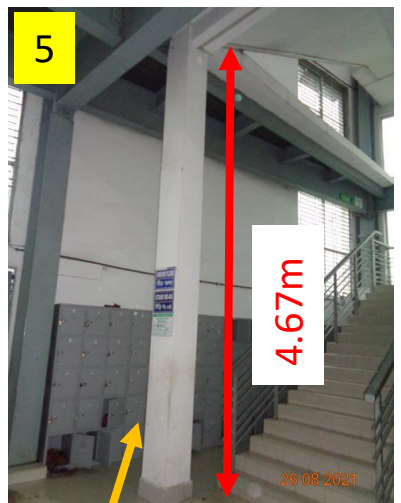
DEA documents need to be revised for Stairs.

Least dimension of the column for stair (1-4) was found 250mm and for the stair-5 was found 300mm

Ground floor column for the stair (1-4) was found 4.45 m (least one) in unsupported length and least dimension 250 mm in size. And the ground floor column for the near stair-5 was found 4.67 (unsupported length) and dimension 300mm. The unsupported length/width=17.52 for stair (1-4) and unsupported length/width=15.67 for the stair-5 indicate that the columns are critical for slenderness effect. So, the factory engineer is required to check and address this issue in the DEA report.

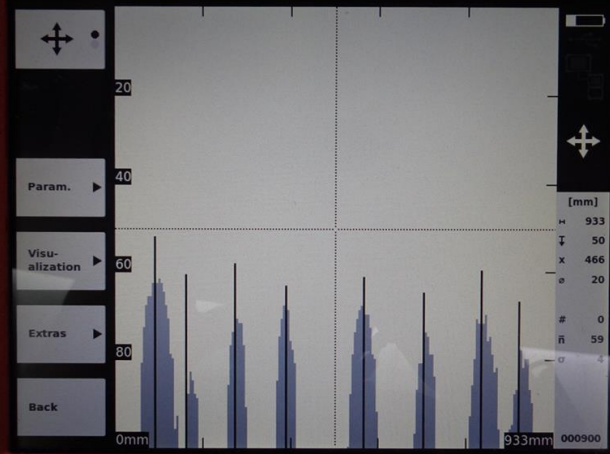
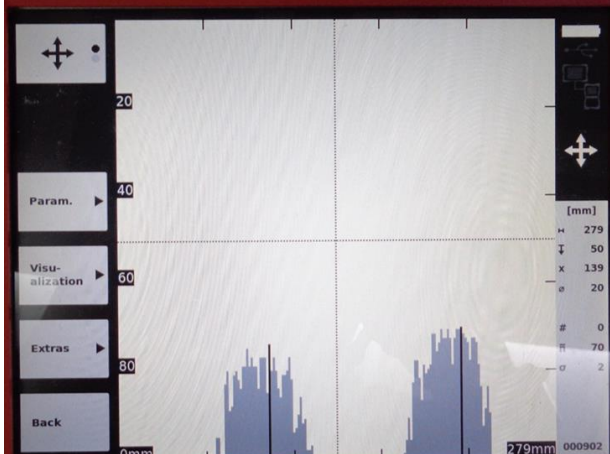
From the ferro-scanning, 8 nos re-bar in long face (left image) and 2 nos re-bar in short face (right image) was found.

Number of re-bar was found mismatch in between as built drawing and actual site condition. Total 20 nos re-bar has been shown in drawing. But from the ferro-scanning, total 16 nos of re-bar was found. Factory engineer is required to survey the who structure and update the as-built drawing as per site condition.

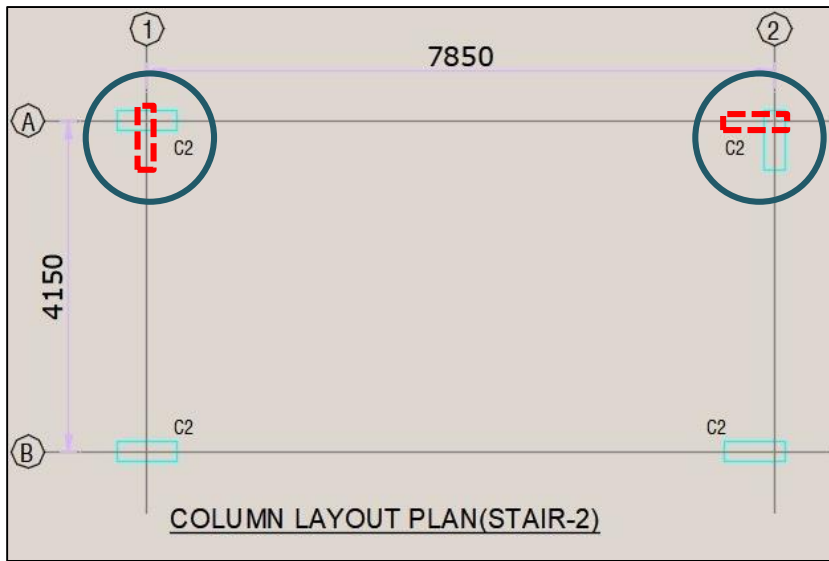
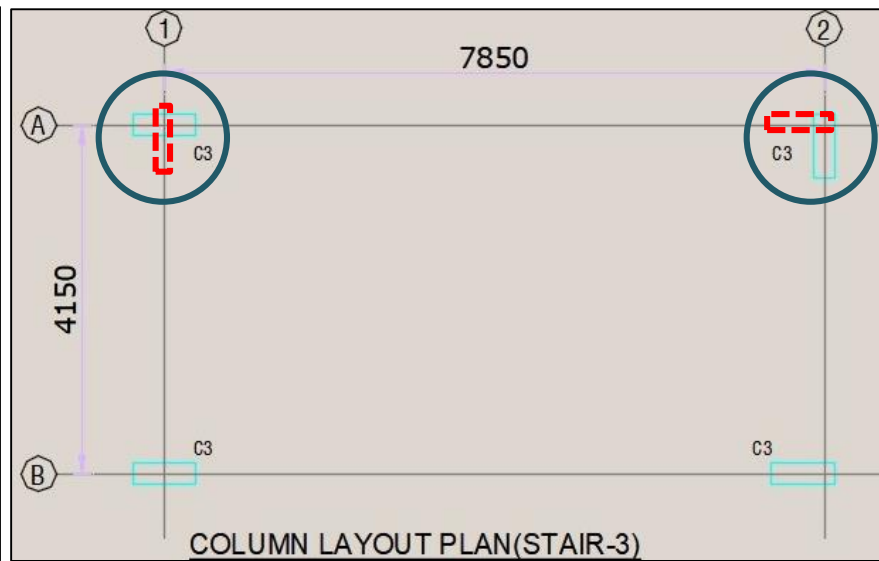
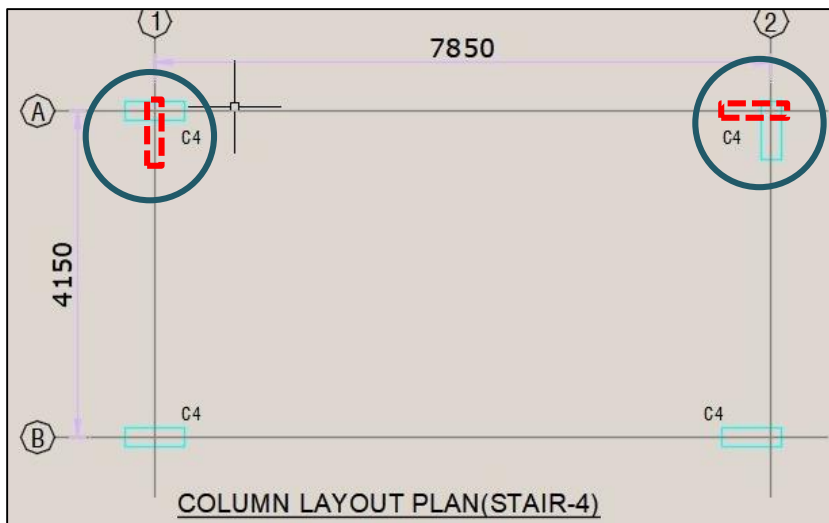
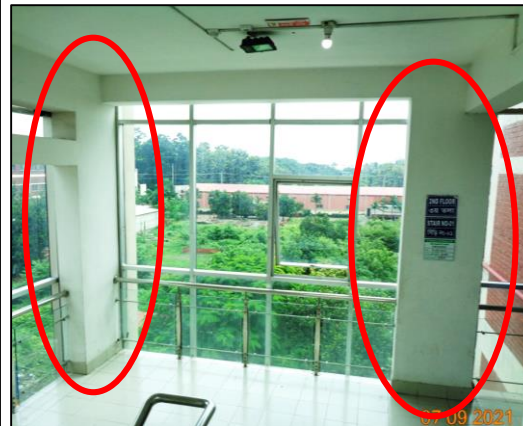
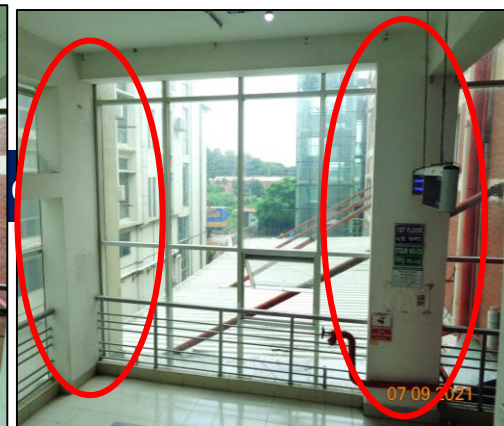
Orientation of marked column found mismatched

Orientation of the column does not match with as built drawing. Column orientation was found as per the dotted red marked.

Mis-match found between the as-built drawing and actual site condition. Column orientation does not match with at marked location. Factory engineer is required to survey the whole structure and update as-built drawing.

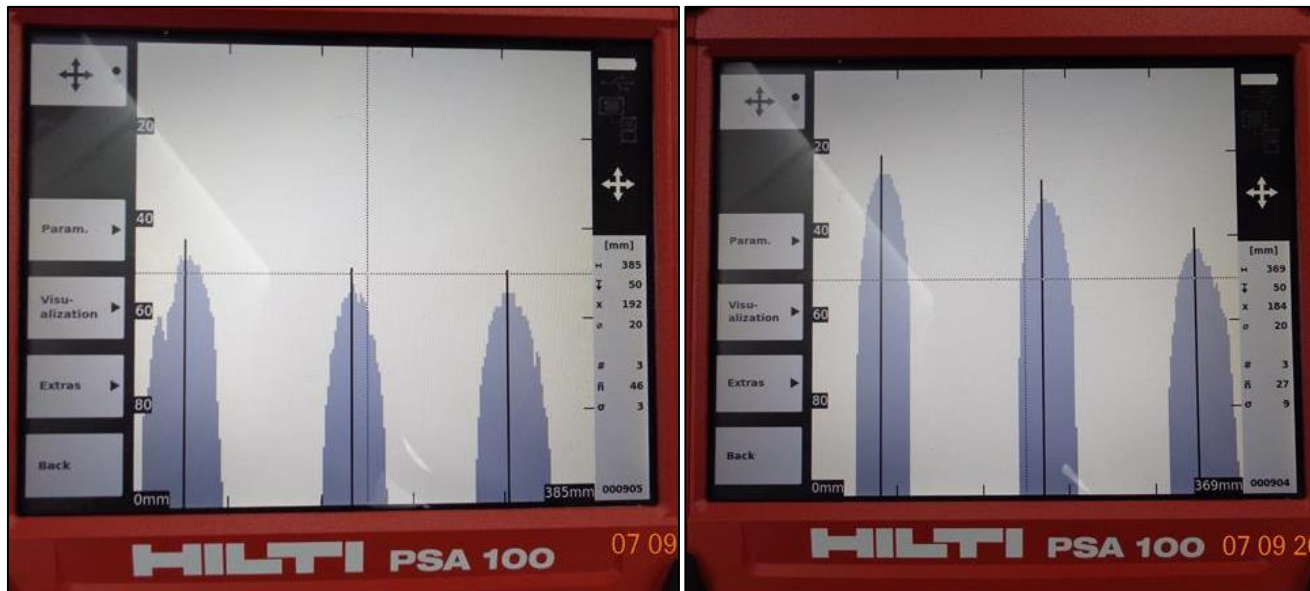
Number of re-bar was found mismatch in between as built drawing and actual site condition. Total 10 nos re-bar has been shown in drawing. But from the ferro-scanning, total 8 nos of re-bar was found. Factory engineer is required to survey the whole structure and update the as-built drawing as per site condition and also check the column capacity.

From the ferro-scanning, 3 nos re-bar was found each face of the column.

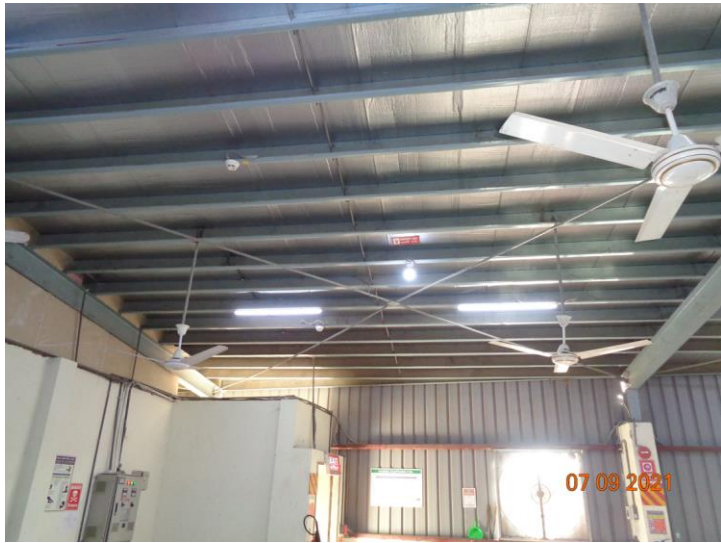
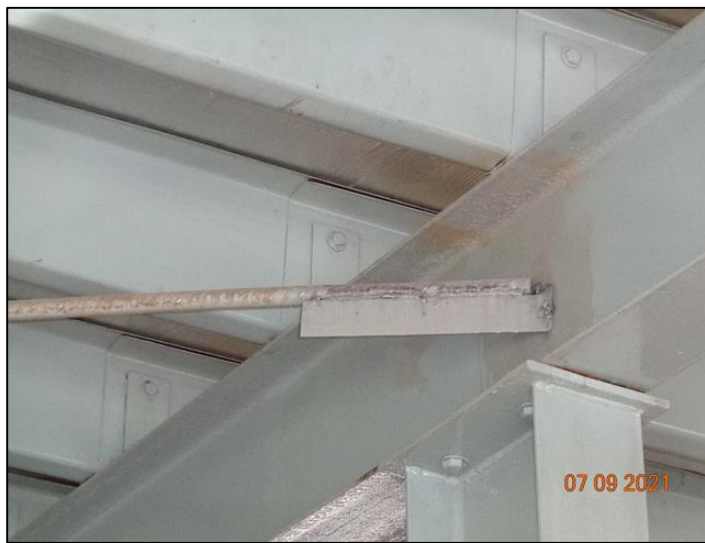
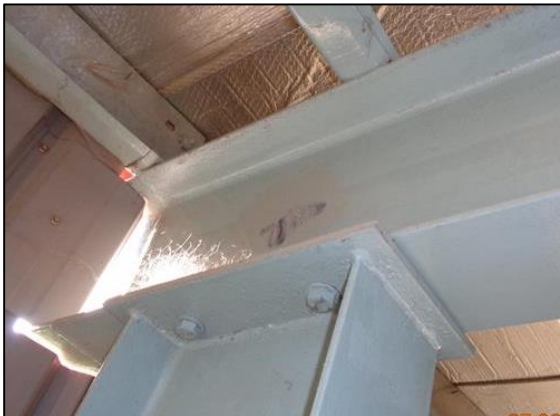
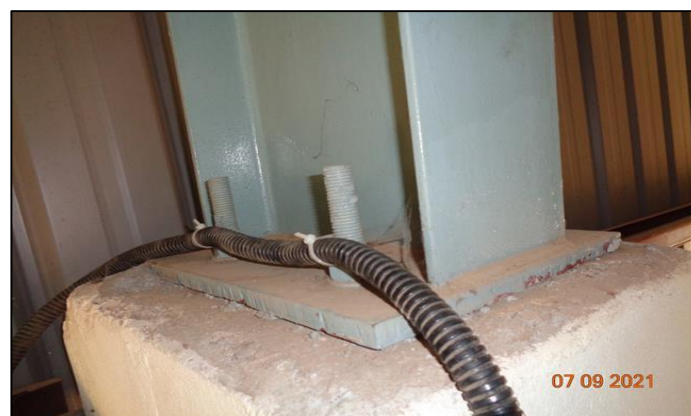
Roof bracing is made of 25mm dia re-bar is connected with rafter by welding. Adequacy check of the connection has not been provided in DEA report

Connection of the roof bracing seems to be inadequate.

Adequacy check of bolted connection has not been provided in DEA report

Factory engineer is required to update the DEA report providing the adequacy check for all types of connections.

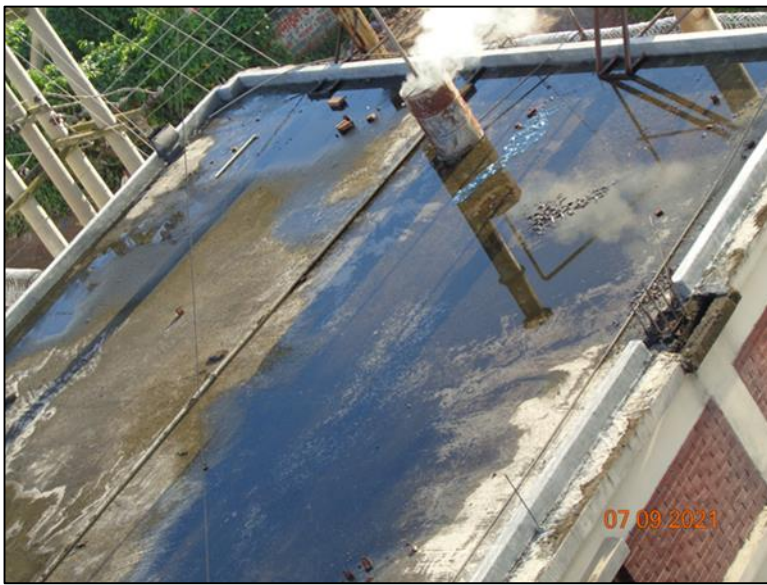
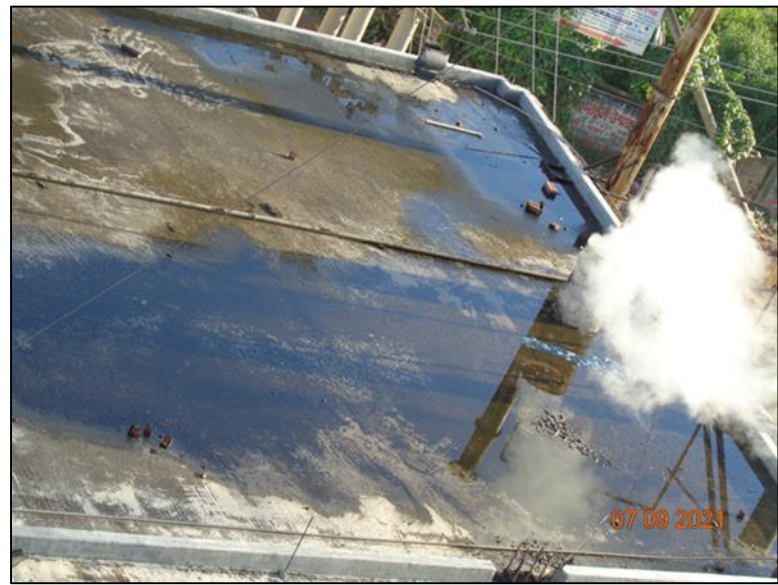
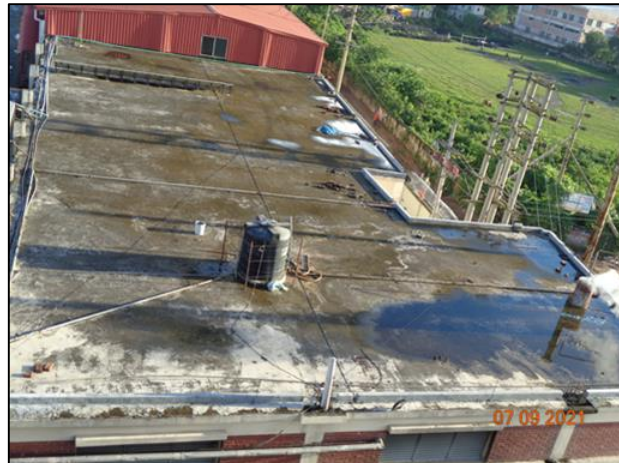
Water ponding at roof

Water ponding was found at roof area. The water drainage system was found but adequate sloping was not found. The factory engineer is required to develop proper drainage system with adequate sloping on the mentioned area.

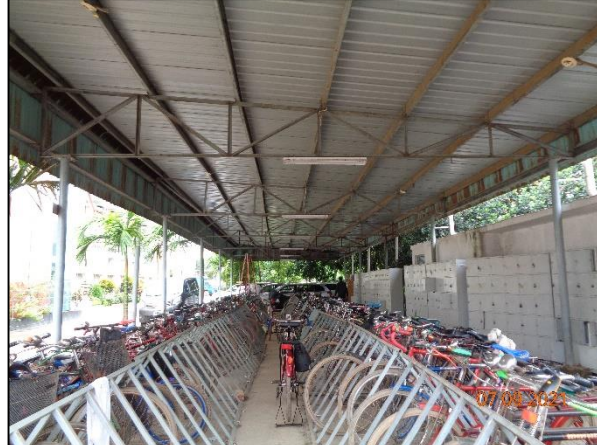
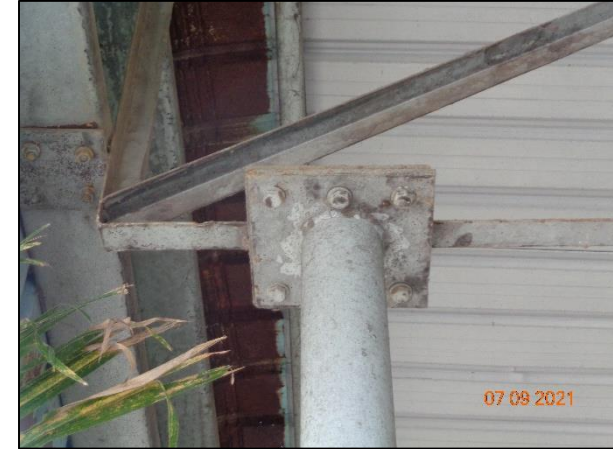
Lack of lateral stability

Poor connection details

The steel roof truss is supported by steel pipe column. No vertical & roof bracing was found. As a result, there is no apparent load path to transfer the lateral loading along the long direction. Building Engineer is required to check the lateral stability of the steel shed and check the adequacy of the connection.

As per BNBC every building or structure designed shall have its design documents prepared in accordance with the provision of Section 1.9.1. The design document shall include a design report, and a set of structural drawings, which shall be prepared in compliance with section 1.9.1.1 and section 1.9.1.2 as per BNBC. During the inspection, design report, soil test report & material test report has not been found. Now, the building engineer is required to prepare Engineering Assessment (EA) for the structure. which compliance with section 1.9.1 (part-6, BNBC).

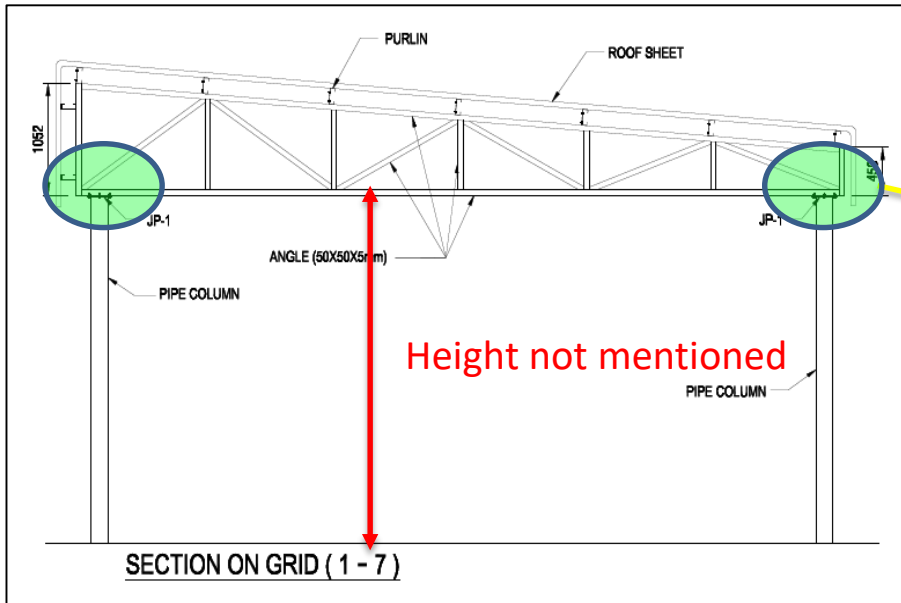
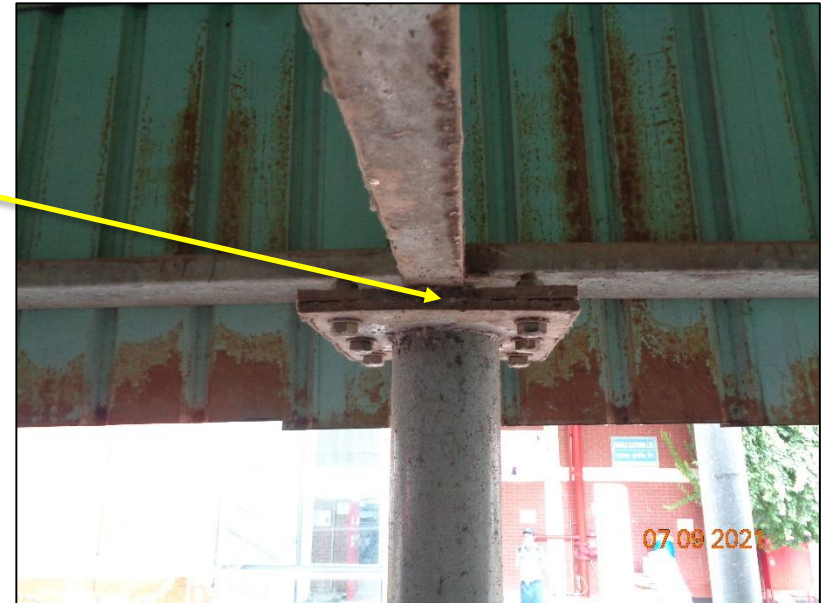
Lack of information in as-built drawing

Truss sectional details

Steel pipe to truss connection

Details of steel pipe column to truss connection (JP-1) was missing in as-built drawing. Also, height of the shed was not mentioned in as-built drawing. Building Engineer is required to survey the whole structure and prepare accurate as-built (both architectural & structural) drawings.

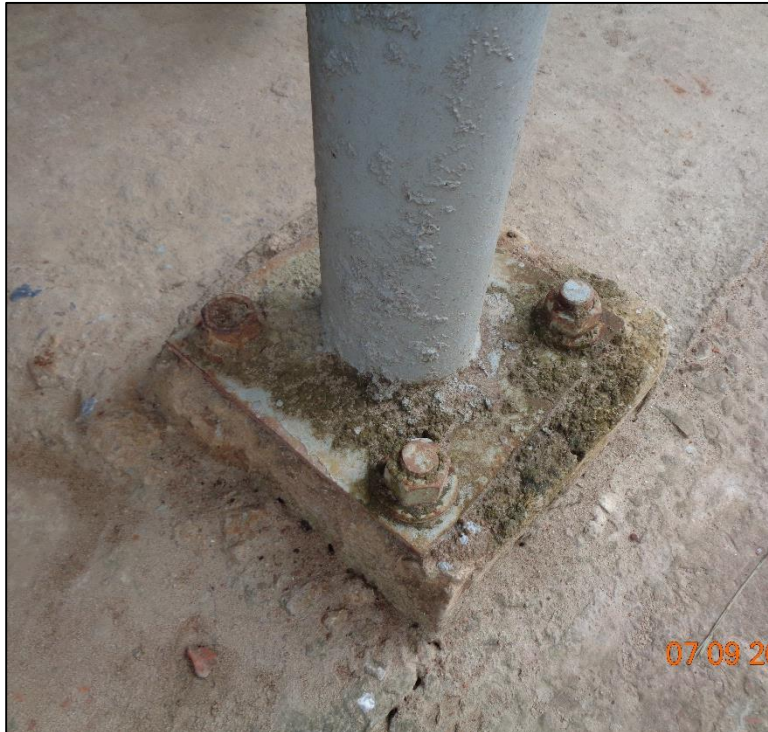
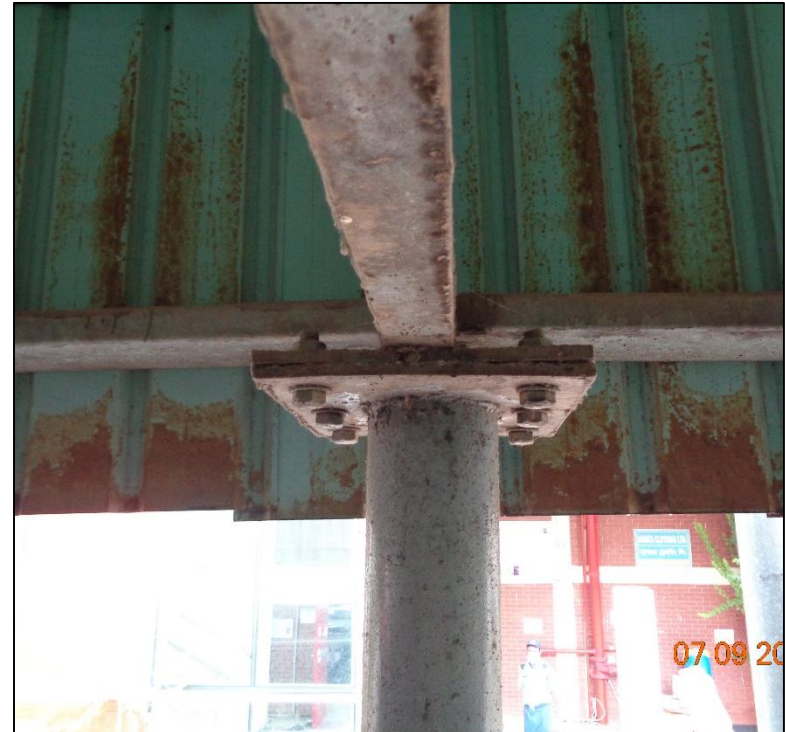
Corrosion in steel member

Corrosion in steel column

Corrosion in steel member was observed in various locations. The building engineer is required to investigate the reason of corrosion and suggest proper remedial measure accordingly.

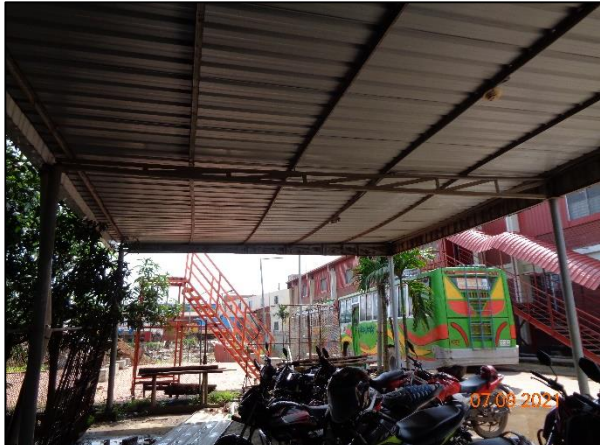
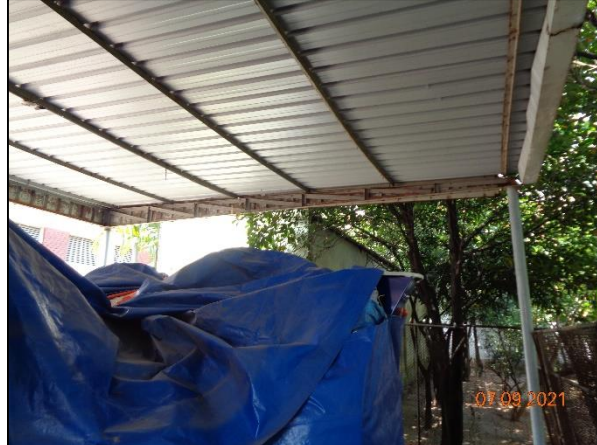
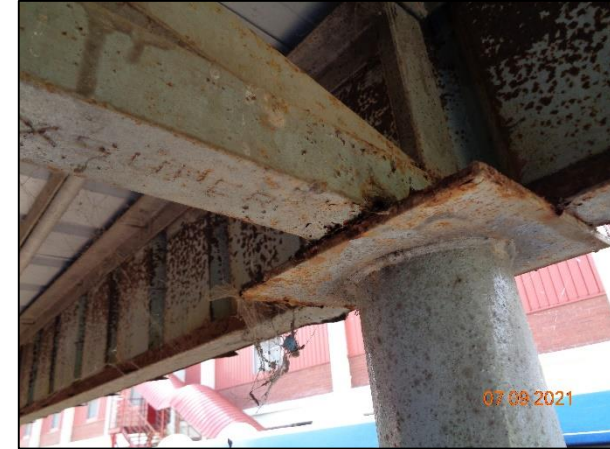
Lack of lateral stability

Truss roof System

Poor connection details

The steel roof truss is supported by steel pipe column. No vertical & roof bracing was found. As a result, there is no apparent load path to transfer the lateral loading along the long direction. Building Engineer is required to check the lateral stability of the steel shed and check the adequacy of the connection.

As per BNBC every building or structure designed shall have its design documents prepared in accordance with the provision of Section 1.9.1. The design document shall include a design report, and a set of structural drawings, which shall be prepared in compliance with section 1.9.1.1 and section 1.9.1.2 as per BNBC. During the inspection, design report, soil test report & material test report has not been found. Now, the building engineer is required to prepare Engineering Assessment (EA) for the structure. which compliance with section 1.9.1 (part-6, BNBC).

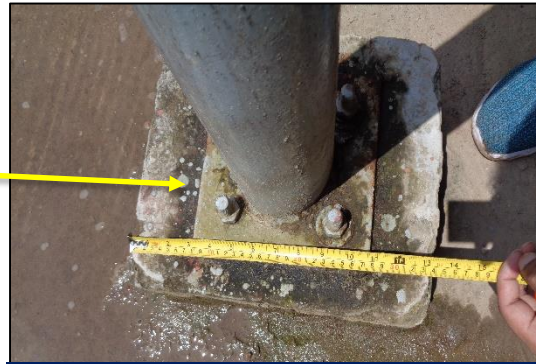
Short column details

Short column measurement

In as-built drawing short column size was mentioned as 300mm X 300mm. But short column dimension was found 350mm X 300mm.

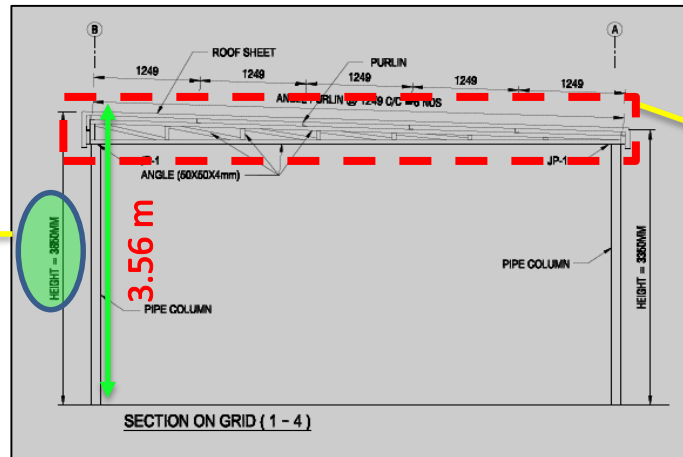
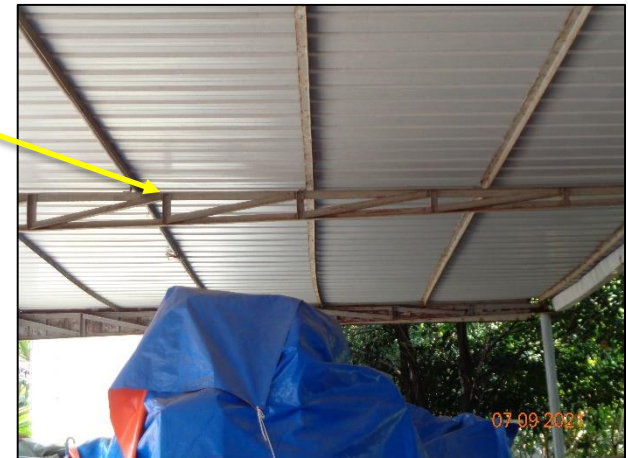
Truss sectional details

Truss orientation on-site

Orientation of truss diagonal members were found different from as-built drawing at grid 2 & 4. Also, shed height at grid B was mentioned 3.85 m. But actually, height was found 3.56 m. Building Engineer is required to survey the whole structure and prepare accurate as-built (both architectural & structural) drawings.

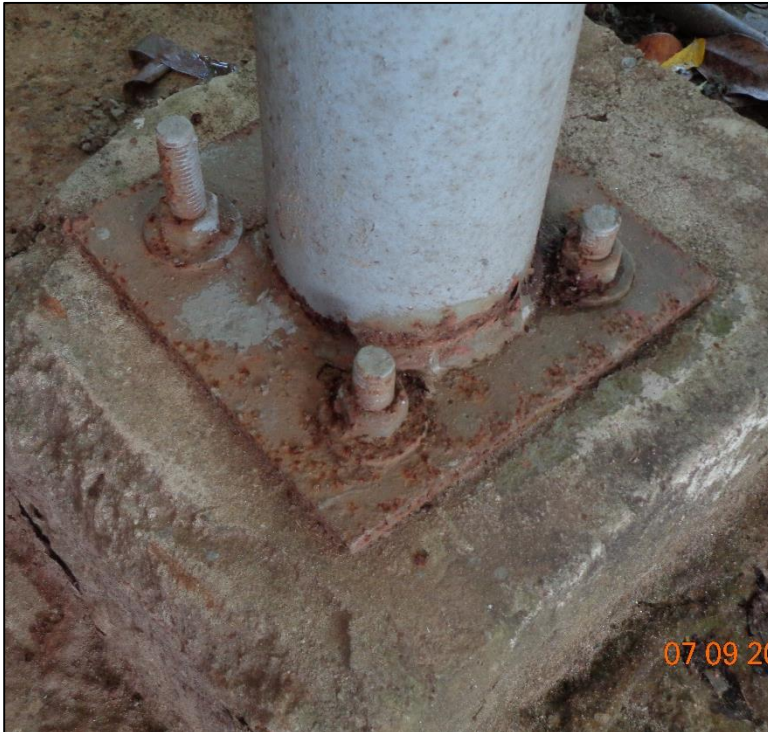
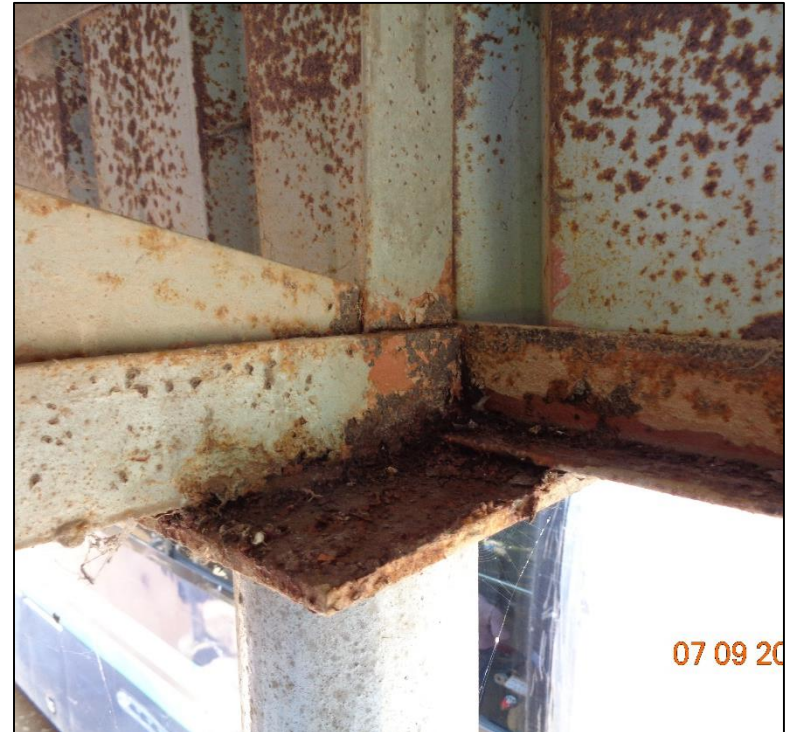
Corrosion in steel member

Corrosion in steel column

Corrosion in steel member was observed in various locations. The building engineer is required to investigate the reason of corrosion and suggest proper remedial measure accordingly.

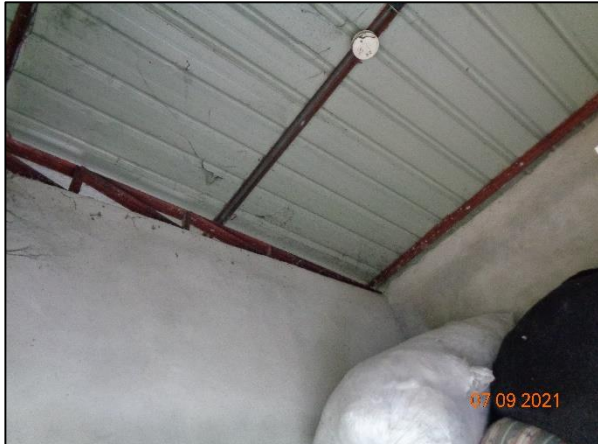
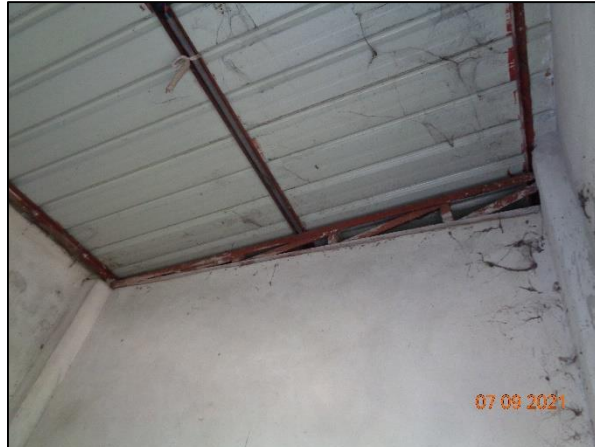
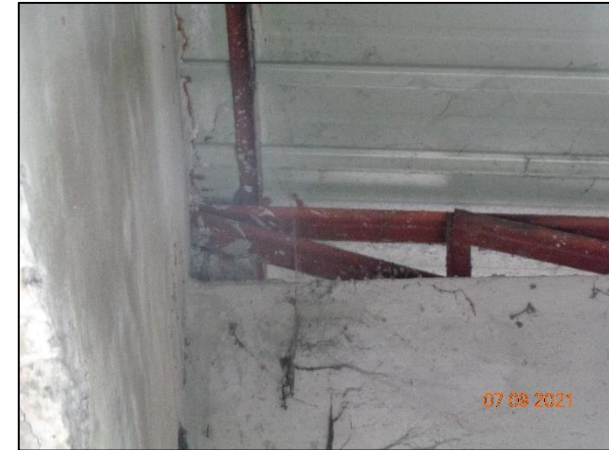
Lack of lateral stability

Truss roof System

Poor connection details

The steel roof truss is supported by brick column. No vertical & roof bracing was found. As a result, there is no apparent load path to transfer the lateral loading along the long direction. Building Engineer is required to check the lateral stability of the steel shed and check the adequacy of the connection.

As per BNBC every building or structure designed shall have its design documents prepared in accordance with the provision of Section 1.9.1. The design document shall include a design report, and a set of structural drawings, which shall be prepared in compliance with section 1.9.1.1 and section 1.9.1.2 as per BNBC. During the inspection, design report, soil test report & material test report has not been found. Now, the building engineer is required to prepare Engineering Assessment (EA) for the structure. which compliance with section 1.9.1 (part-6, BNBC).

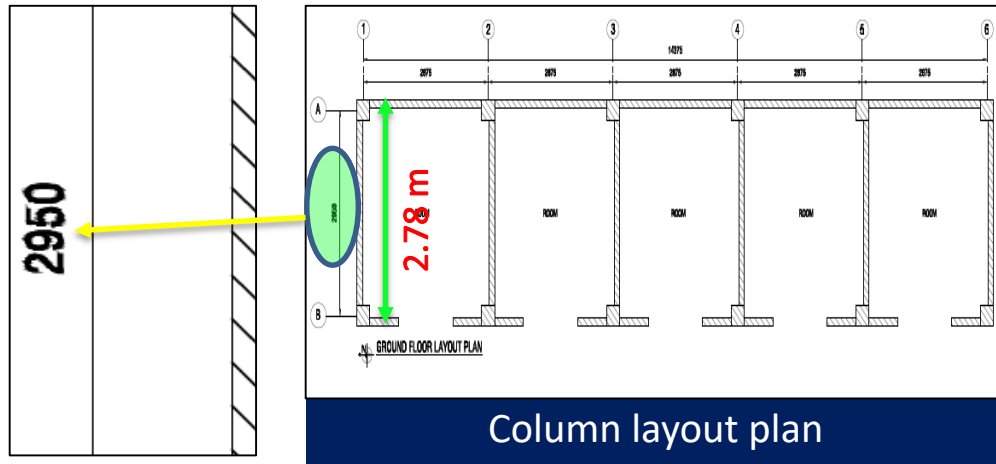
Discrepancies in as-built drawing

In as-built drawing short direction dimension was mentioned as 2.95 m. But dimension was found 2.78 m.
