Hamza Clothing Ltd.

Bangabandhu Road, Tongabari, Ashulia

26th August & 7th September 2021

Observations

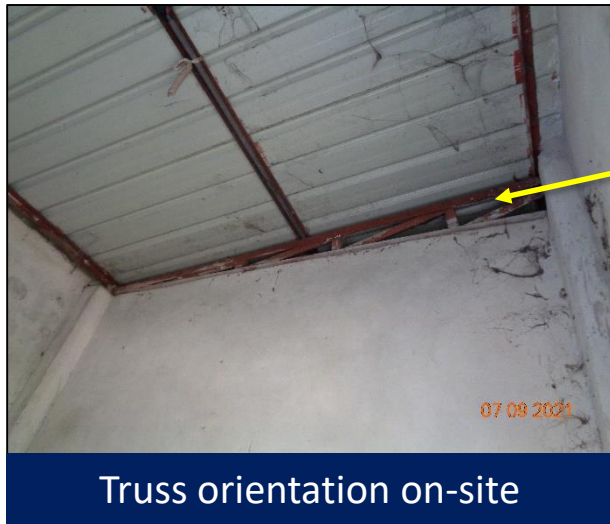
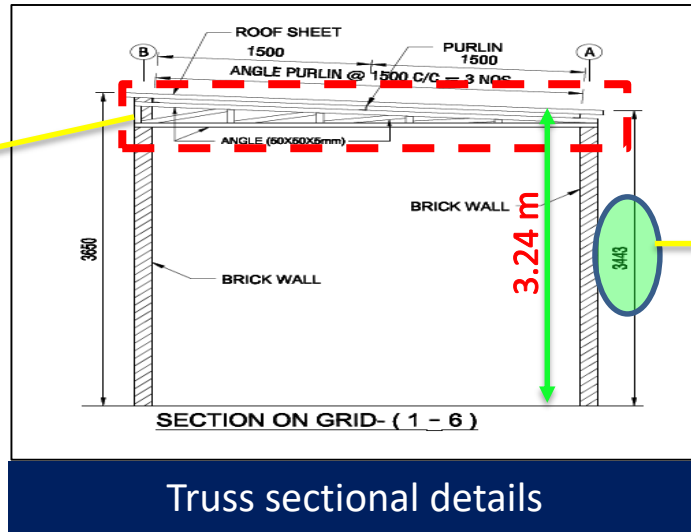
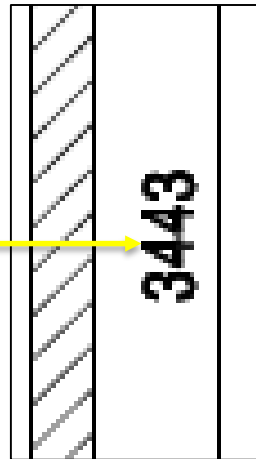
Orientation of truss diagonal members were found different from as-built drawing. Also, shed height at grid A was mentioned 3.44 m. But height was found 3.24 m. Building Engineer is required to survey the whole structure and prepare accurate as-built (both architectural & structural) drawings.

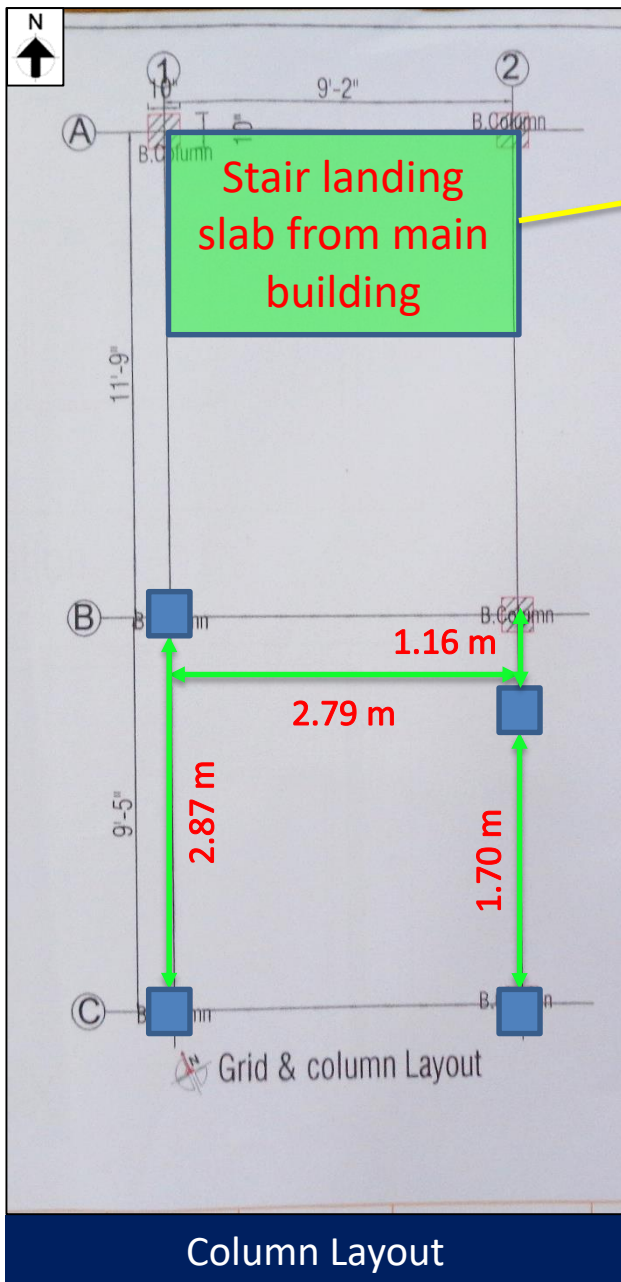
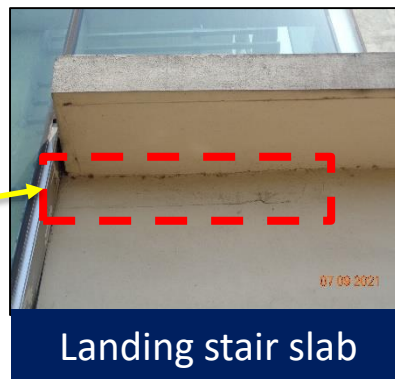
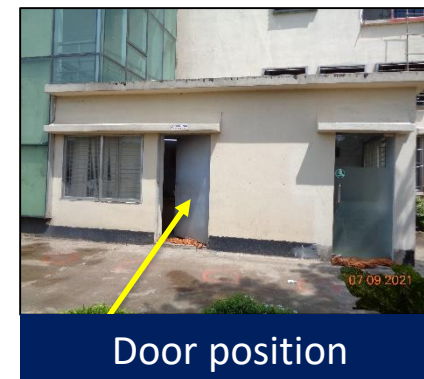
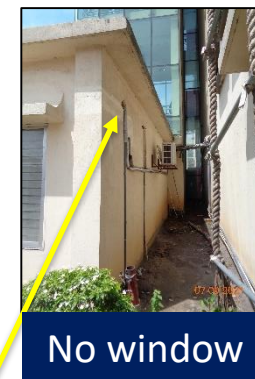
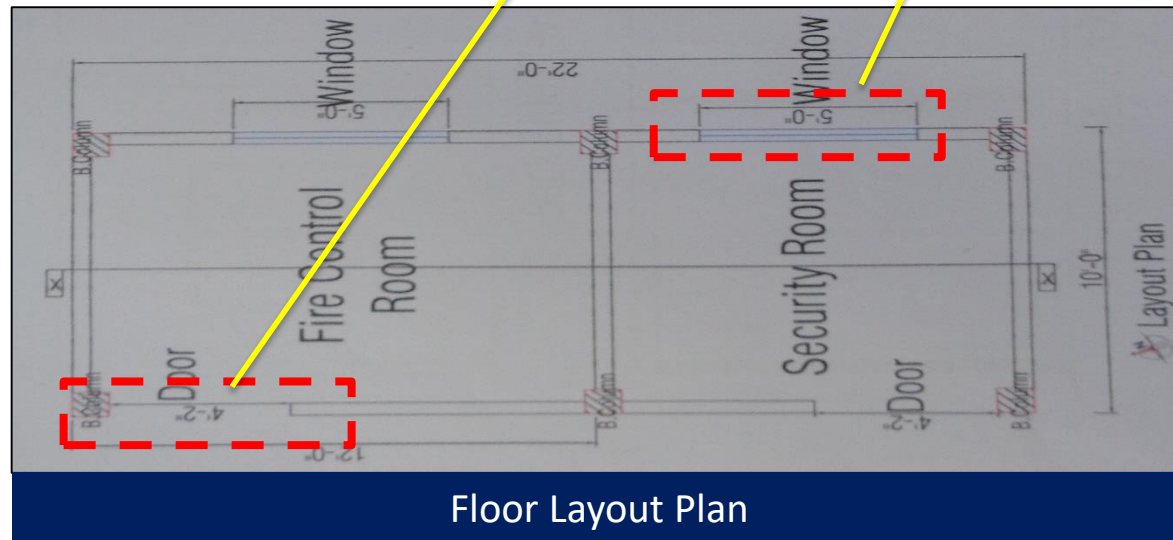
Discrepancies in as-built drawing

Grid dimension, column position, door & window position do not match with as-built drawing. Building Engineer is required to survey the whole structure and prepare accurate as-built (both architectural & structural) drawings.

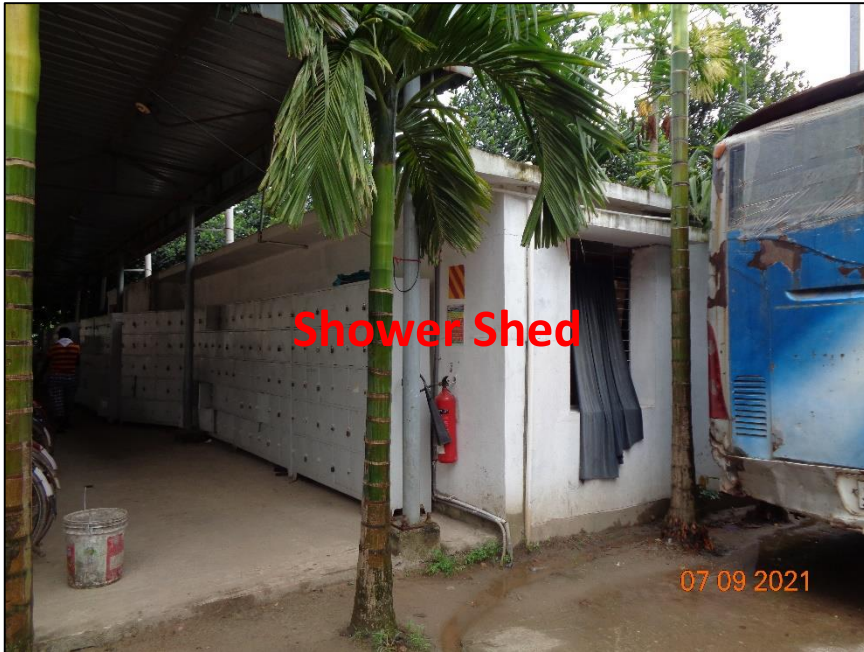
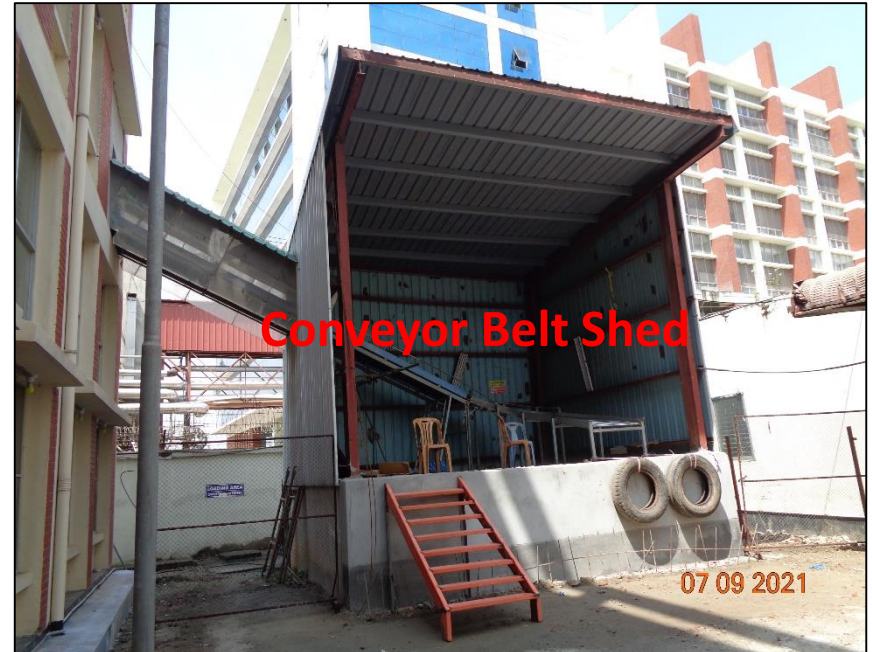
Absence of as-built drawing

No as-built drawing for both shower shed & conveyor shed

During the inspection, the as built drawing was not provided. Building Engineer is required to survey the whole structure and prepare accurate as-built (both architectural & structural) drawings which compliance with section 1.9.1 (part-6, BNBC).
