# Intimate Creations Limited

Plot no: 62-63, Sector-7, South halishahar, CEPZ, Chattogram-4223, Bangladesh

28<sup>th</sup> September 2021

# Observations

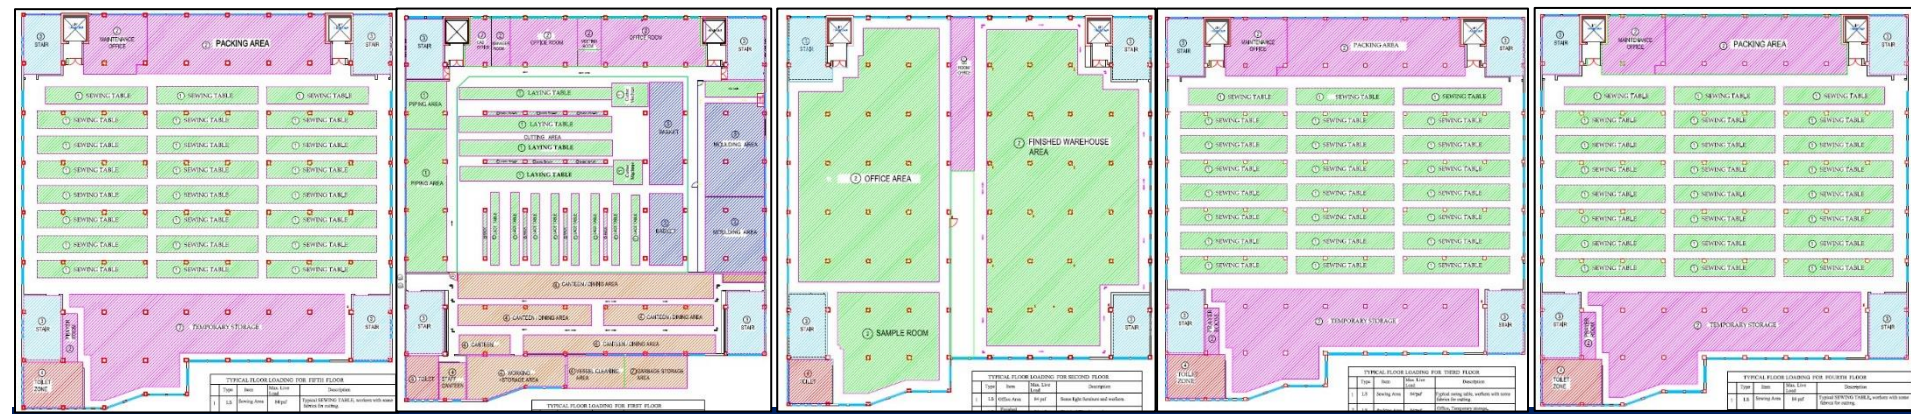
Load plan for 1<sup>st</sup> to 5<sup>th</sup> floor. - Floor loading has been shown (84 psf) 4 kPa.

Floor loading has been shown 4 kPa for 2<sup>nd</sup> floor at Storage area.

In Design report floor loading has been considered (105 psf) 5 kPa which do not match with posted load plan in floor.

As per BNBC, minimum 6 kPa live loading is required to be considered for the light storage facilities. During inspection, load plan was found posted considering (84 psf) 4 kPa at 2<sup>nd</sup> floor.

As per BNBC, every building or structure designed shall have its design documents prepared in accordance with the provision of Section 1.9.1. Now, the factory engineer is required to revise design report the structure as per BNBC 2006.

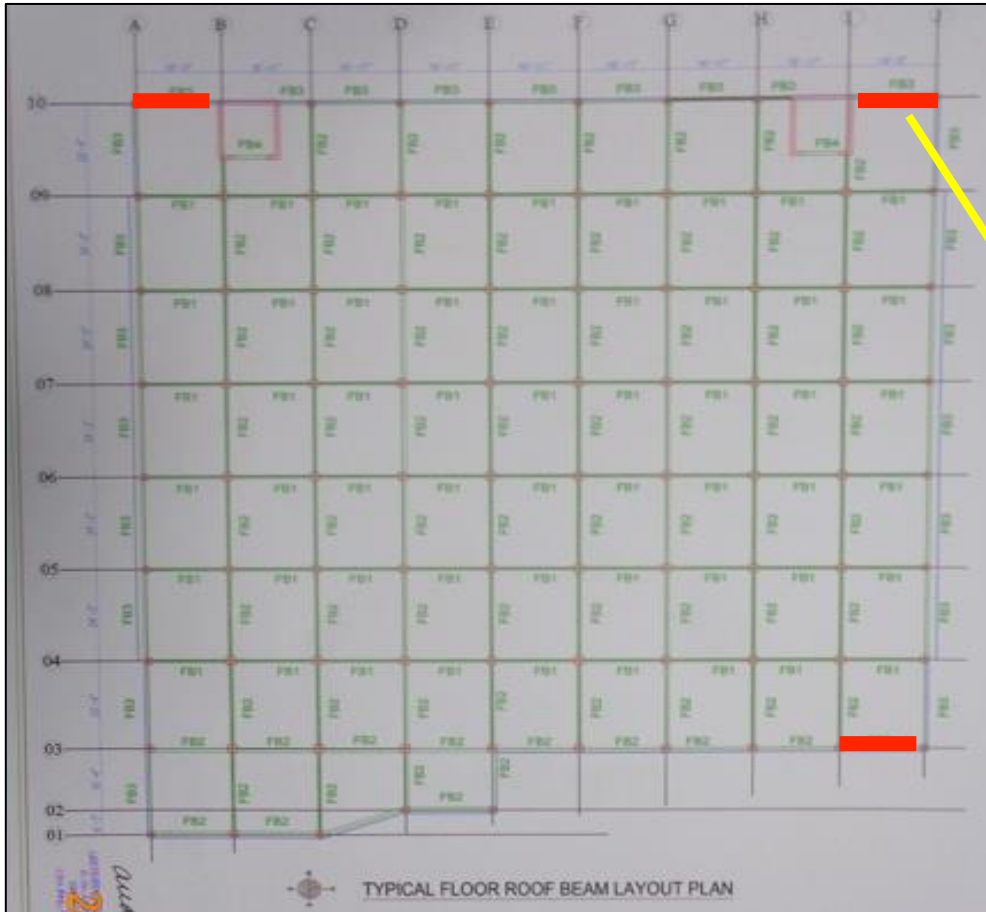
Beam Layout

Floor beam layout did not match with on site condition. Floor beam at staircase (marked as red on drawing) at all floor level was found missing.

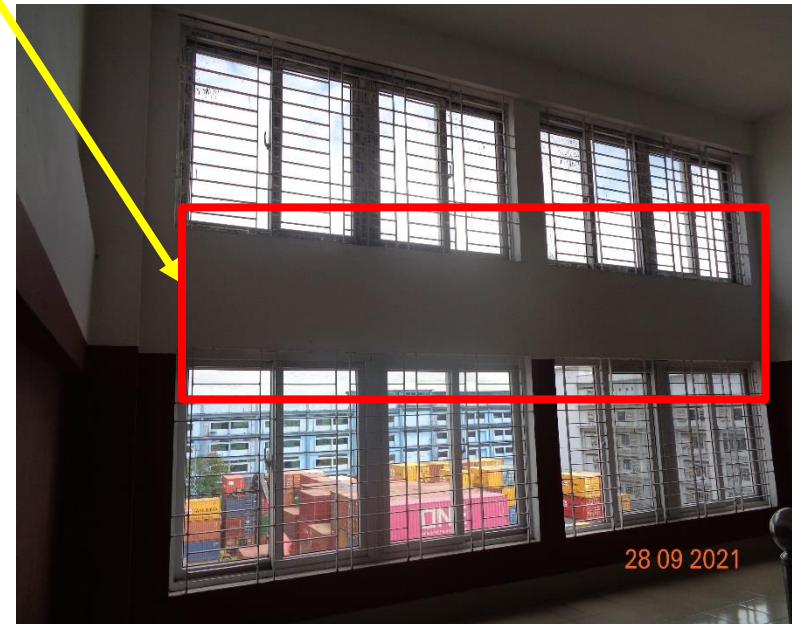
Beam missing

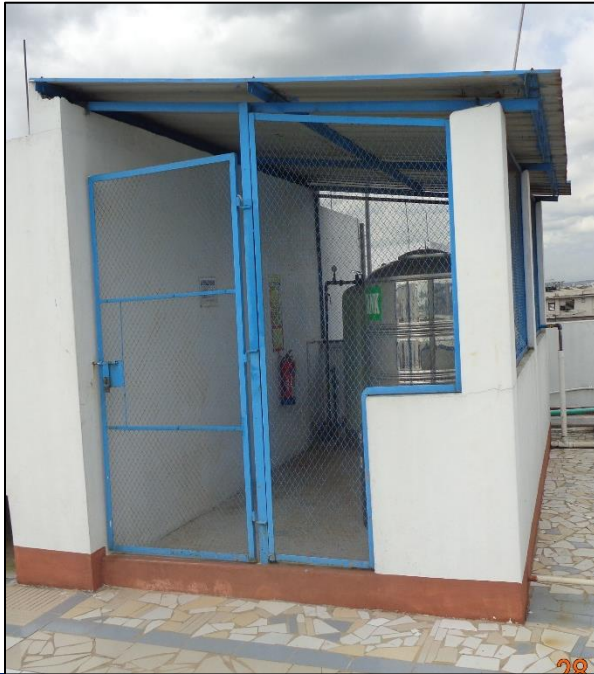
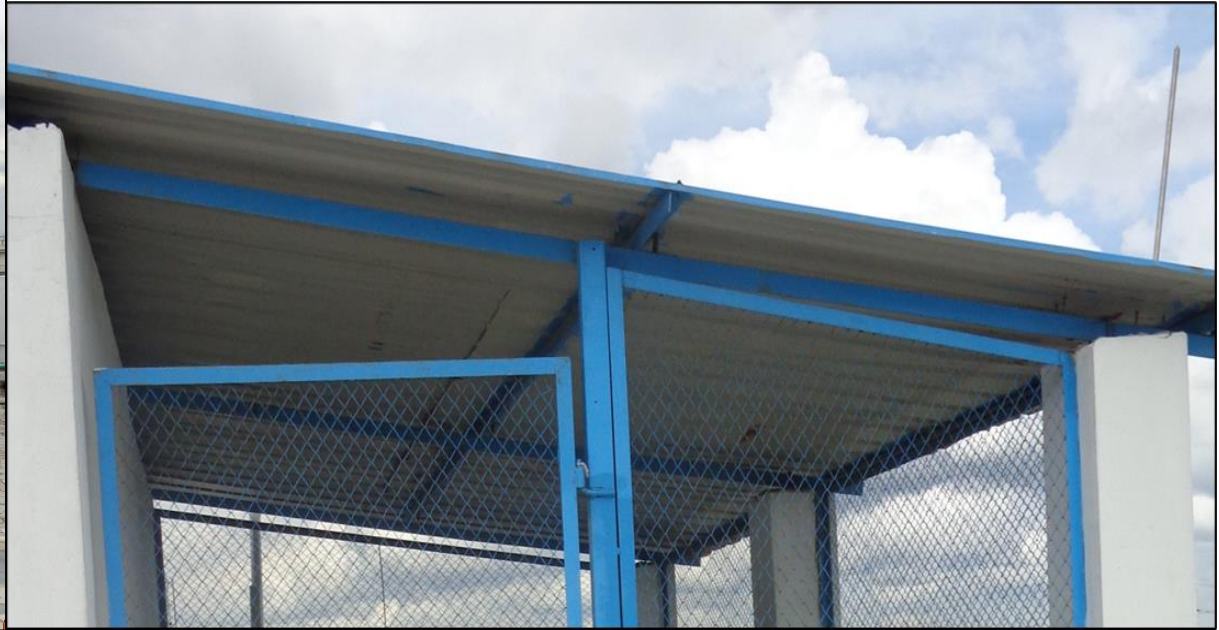
**Non-engineered shed on roof (RO plant)**

Non-engineered shed. The factory engineer is required to replace the non-engineered shed with an engineered one.

06	Non-engineered shed on roof (RO plant) (Main Building)	Carry out remedial/alteration works if necessary.	6-months
07	Undocumented steel mezzanine at ground floor (Main Building)	Building Engineer to check the adequacy of the steel mezzanine for vertical & lateral loading.	6-weeks

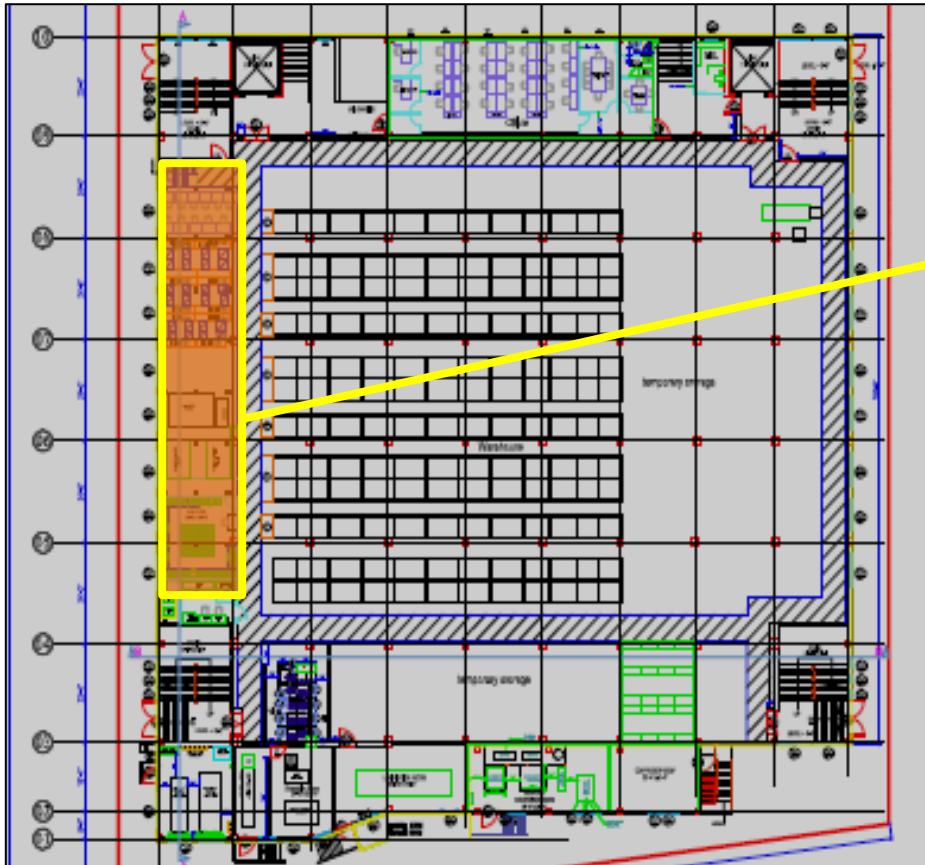
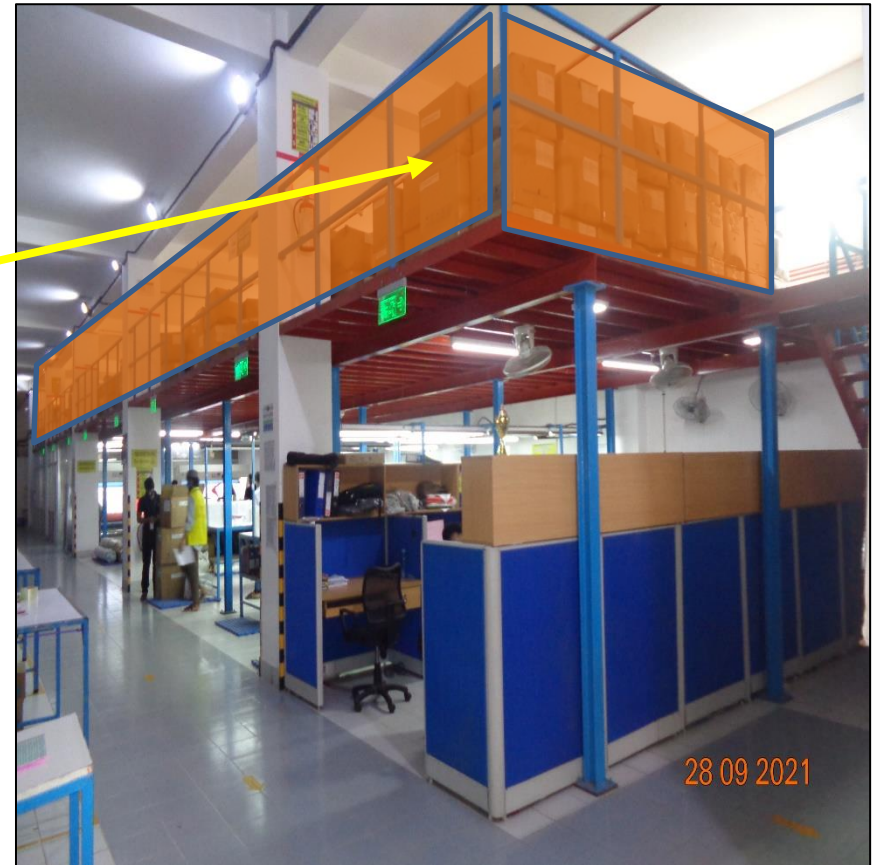
# Undocumented steel mezzanine at ground floor

A self supported steel mezzanine was observed at the ground floor of main building. Building Engineer is required to check the adequacy of the mezzanine for vertical & lateral loadings and prepare a floor live load plan based on floor, column and foundation capacity.

Item No.	Observation	Recommended Action Plan	Recommended Timeline
08	Undocumented steel mezzanine at ground floor (Main Building)	Building Engineer to prepare the allowable load plans.	6-weeks
09	Undocumented steel mezzanine at ground floor (Main Building)	Carry out remedial works if necessary.	6-months
10	Undocumented steel mezzanine at ground floor (Main Building)	Continue to implement load plan.	6-months
11	Lack of information in as-built drawings (Compressor Room)	Building Engineer is to survey the whole structure and update as-built drawings representing accurate site condition.	6-weeks
12	Apparently non-engineered shed (Compressor Room)	Building engineer to check the stability of the lightweight roof structure against lateral loading.	6-weeks
13	Apparently non-engineered shed (Compressor Room)	Carry out the remedial works where necessary.	6-months
14	Absence of design documents (Compressor Room)	Factory engineer is required to prepare the design documents including a design report, and a set of structural drawings in compliance with section 1.9.1.1 and section 1.9.1.2 as per BNBC part 6 and submit to RSC for review.	6-weeks

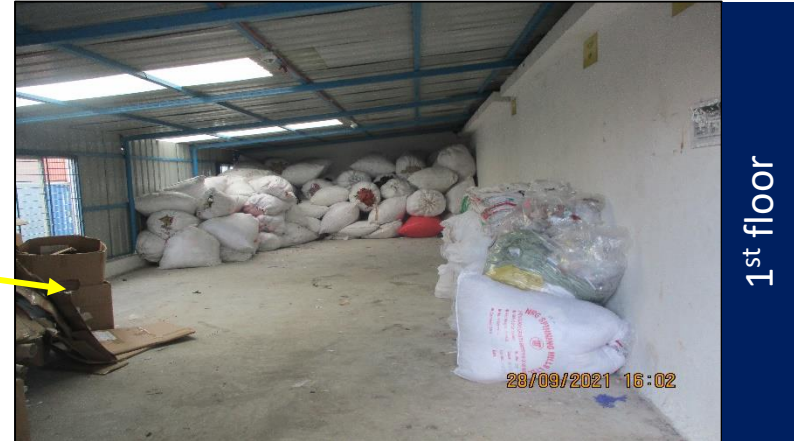
1st floor

As per as built drawing “Compressor Room” is a single storied structure. But, during inspection we found that there is a steel shed on the roof of Compressor Room.

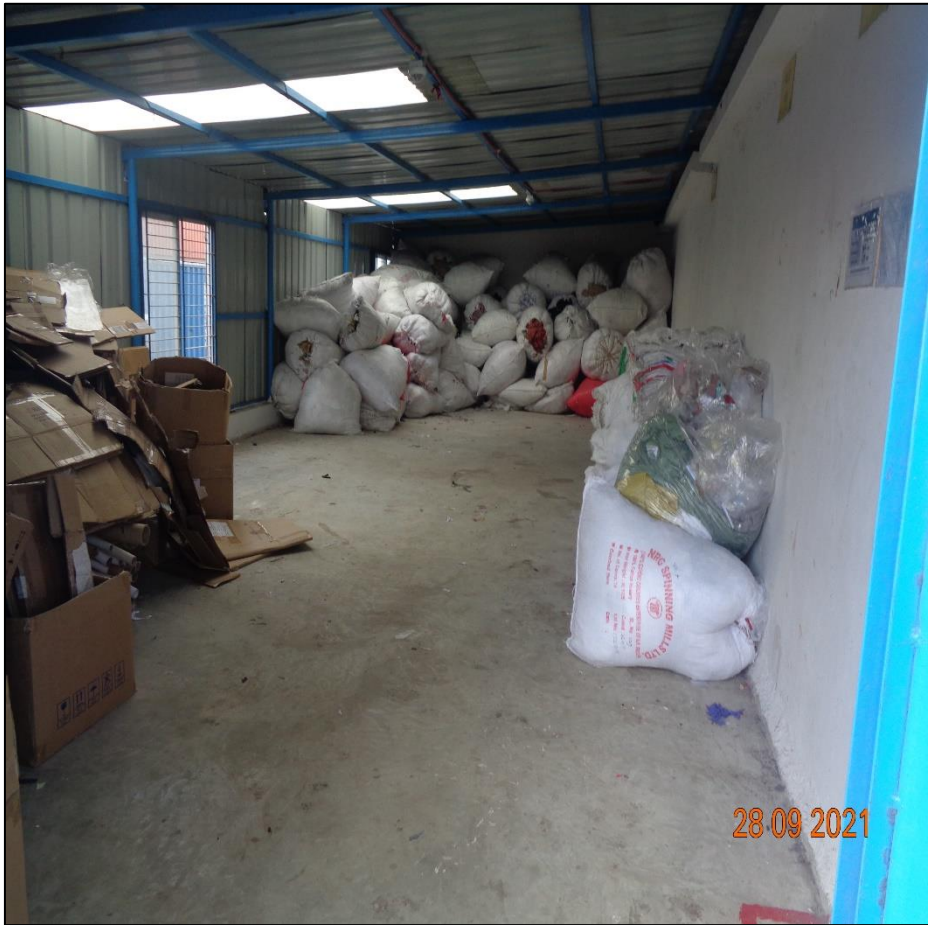
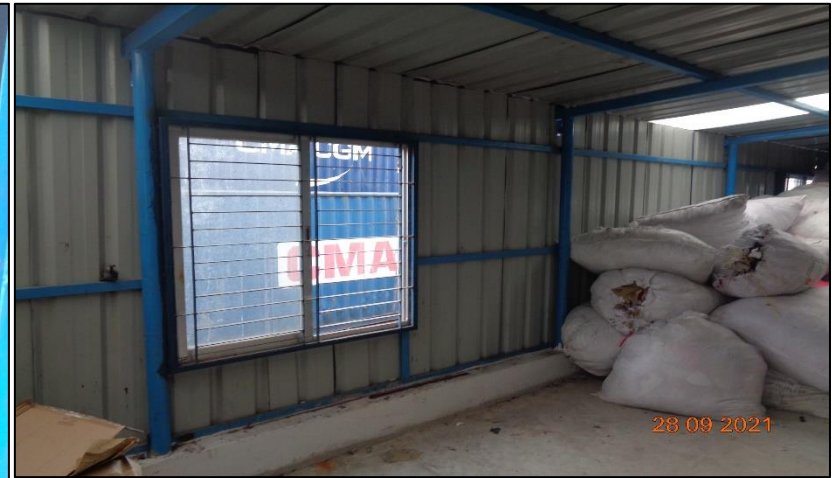
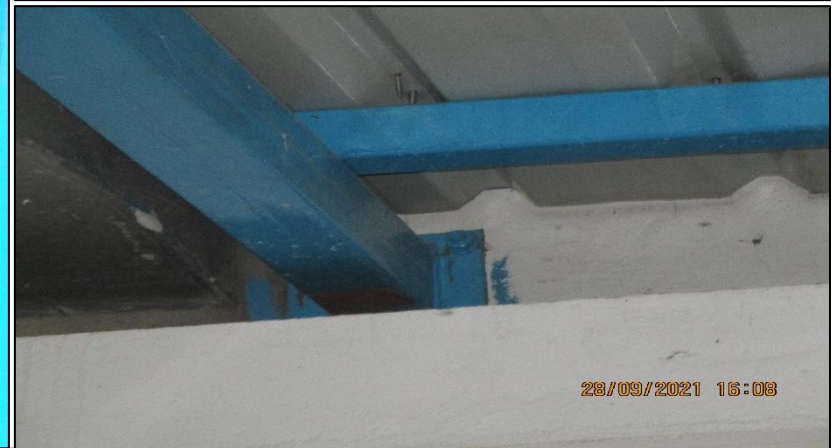
# Apparently non-engineered shed

Garbage reception area above compressor room is apparently non-engineered shed. Box rafter is anchored in brick wall at one end and rest on steel box on other side. Building engineer to check the stability of the lightweight roof structure against lateral loading and if inadequate then replace the structure with an engineered one.

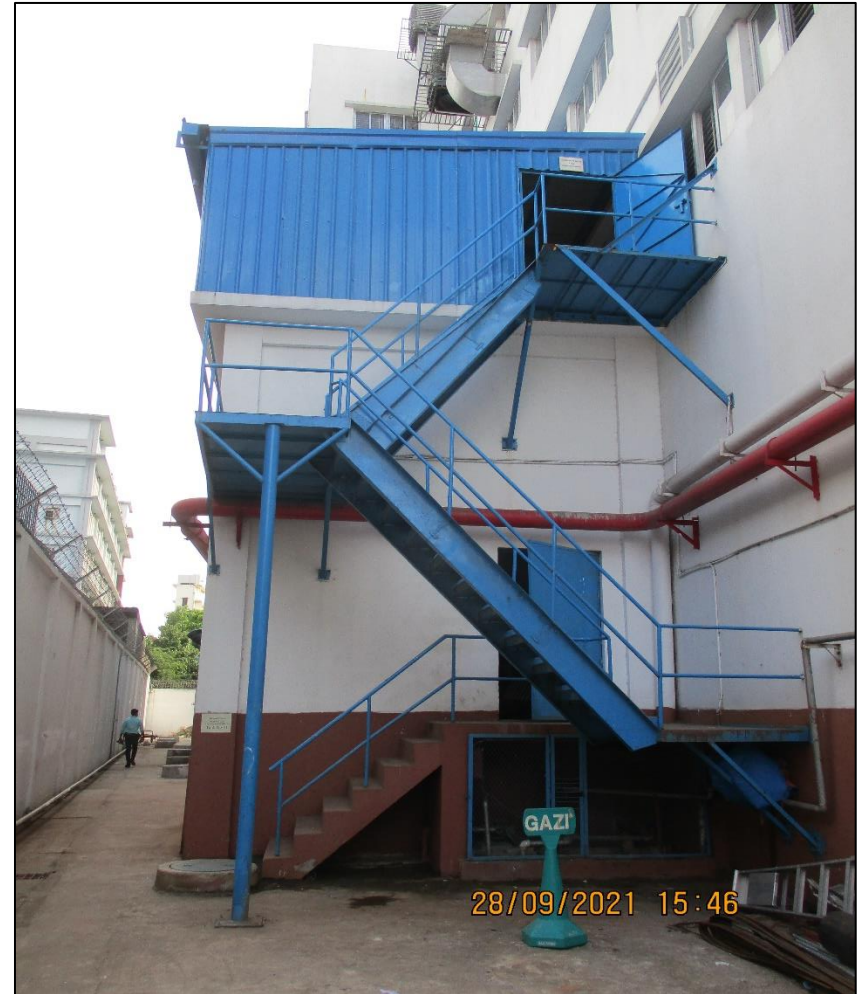
As per BNBC, every building or structure designed shall have its design documents prepared in accordance with the provision of Section 1.9.1. The design document shall include a design report, and a set of structural drawings, which shall be prepared in compliance with section 1.9.1.1 and section 1.9.1.2 as per BNBC. At the time of inspection, design report and load plan was not available which is required to be prepared in compliance with section 1.9.1.1 (part-6, BNBC).

Design report and load plan was not available for Compressor Room

Item No.	Observation	Recommended Action Plan	Recommended Timeline
15	Absence of design documents (Compressor Room)	Carry out remedial works ( if any ) after review by RSC.	6-months
16	Non engineered external steel stair (Compressor Room)	Factory engineer is required to carry out connection adequacy & lateral stability check of the steel stair.	6-weeks
17	Non engineered external steel stair (Compressor Room)	Implement remediation work where necessary	6-months
18	Apparently non-engineered roof (Pump Room)	Building engineer to check the uplift capacity of the lightweight roof structure against lateral loading.	6-weeks
19	Apparently non-engineered roof (Pump Room)	Carry out remedial/alteration works if necessary	6-months
20	Adequacy of cantilever slab (Pump Room)	Building Engineer to survey the structure and prepare accurate as-built (both architectural & structural) drawings.	6-weeks
21	Adequacy of cantilever slab (Pump Room)	Building Engineer to check the adequacy of cantilever slab.	6-weeks

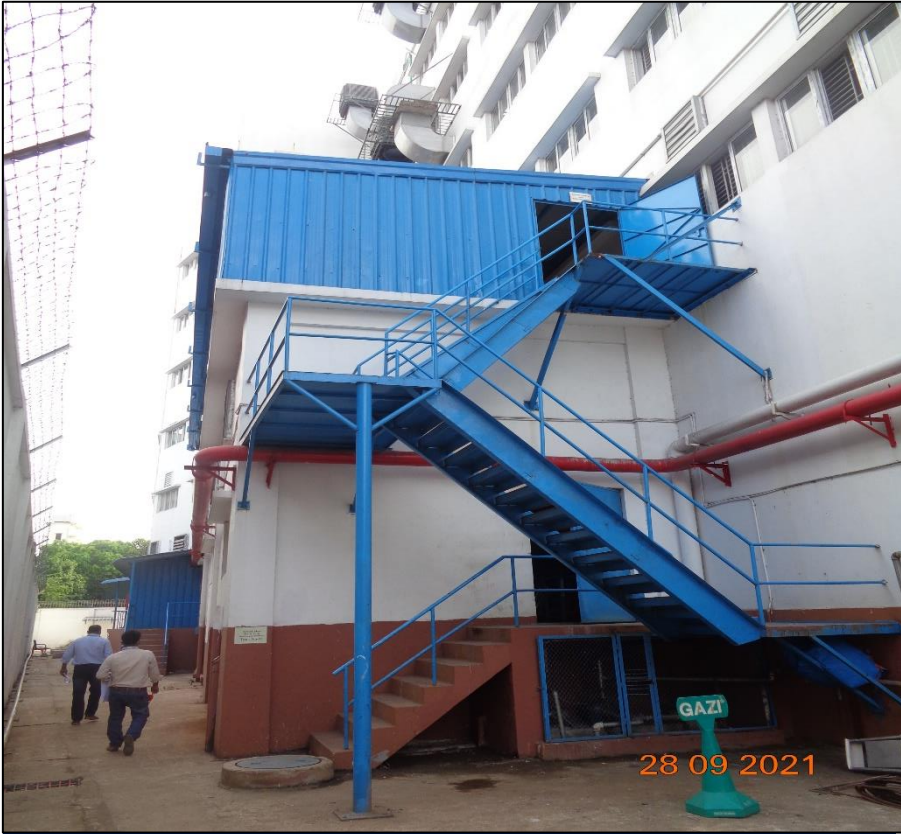
External Steel Stair

Apparently inadequate connection was observed at external steel stair of Compressor Room. Factory engineer is required to carry out connection adequacy & lateral stability check of the steel stair.

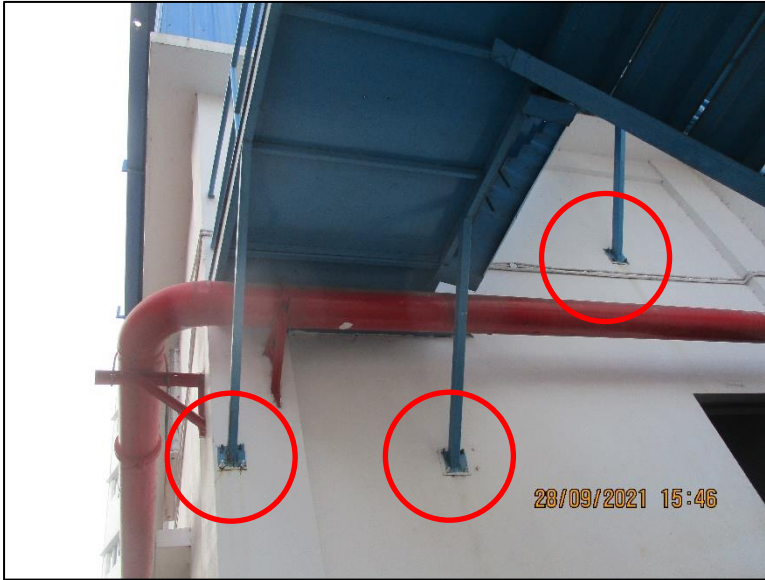
Apparently Inadequate Connection

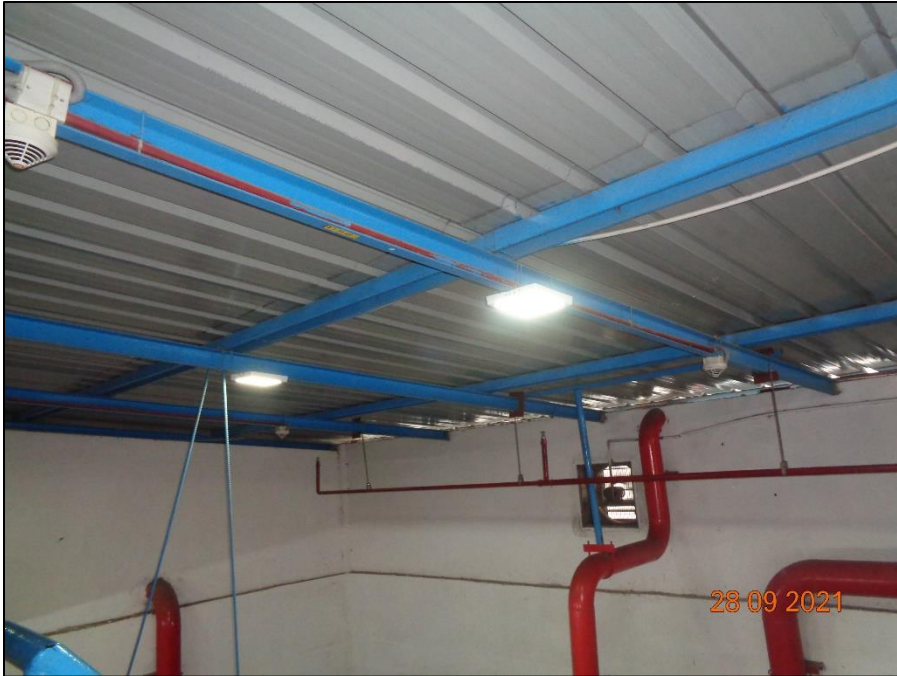
Light weight roof supported on peripheral wall

Roof of pump room is apparently non-engineered. C-channel rafter is embedded in peripheral brick wall. Building engineer to check the stability of the lightweight roof structure against lateral loading and if inadequate then replace the structure with an engineered one.

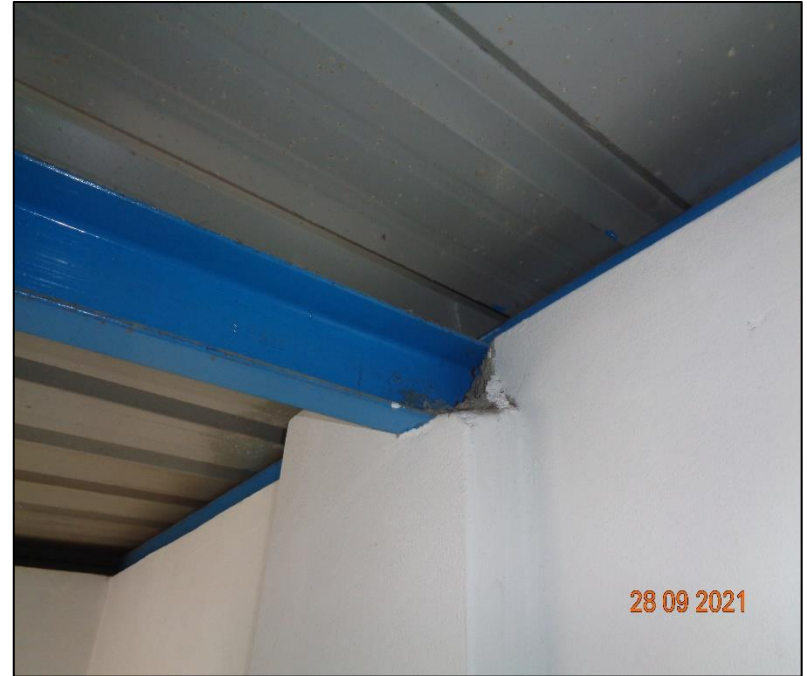
Non-engineered connection

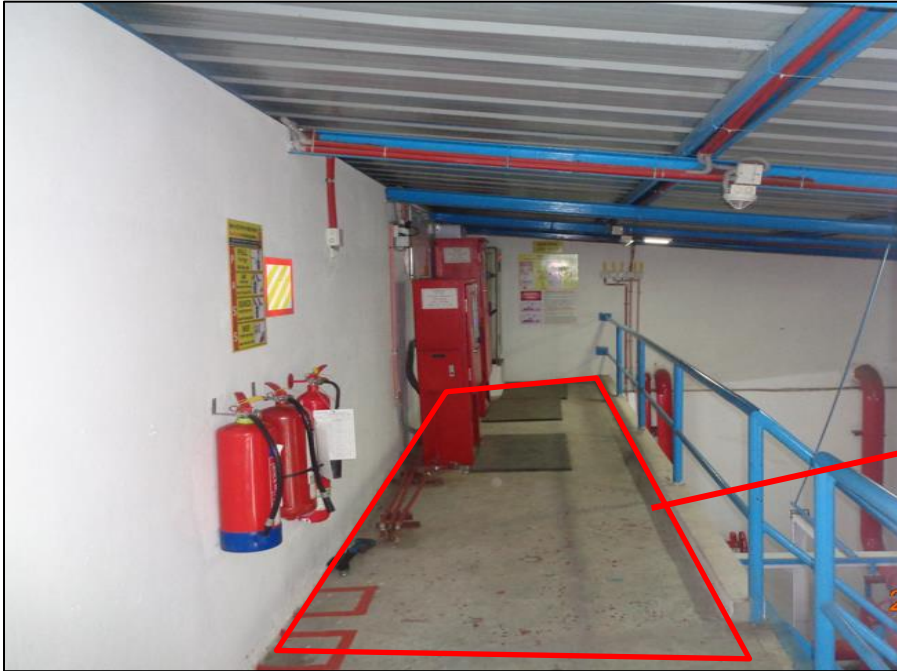
Cantilever slab in pump room

During inspection, 1.2 m (4 ft) wide cantilever slab in the east side of pump room was observed which was not shown in drawings. The cantilever slab to be incorporated in drawing. Also, adequacy of the slab to be checked.

22	Adequacy of cantilever slab (Pump Room)	Carry out remedial/alteration works if necessary	6-months

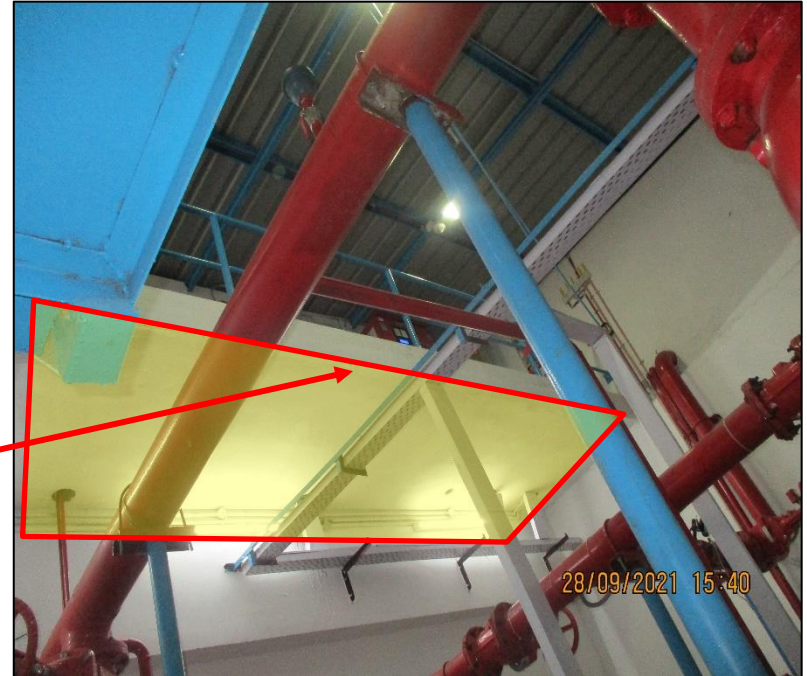
No support system

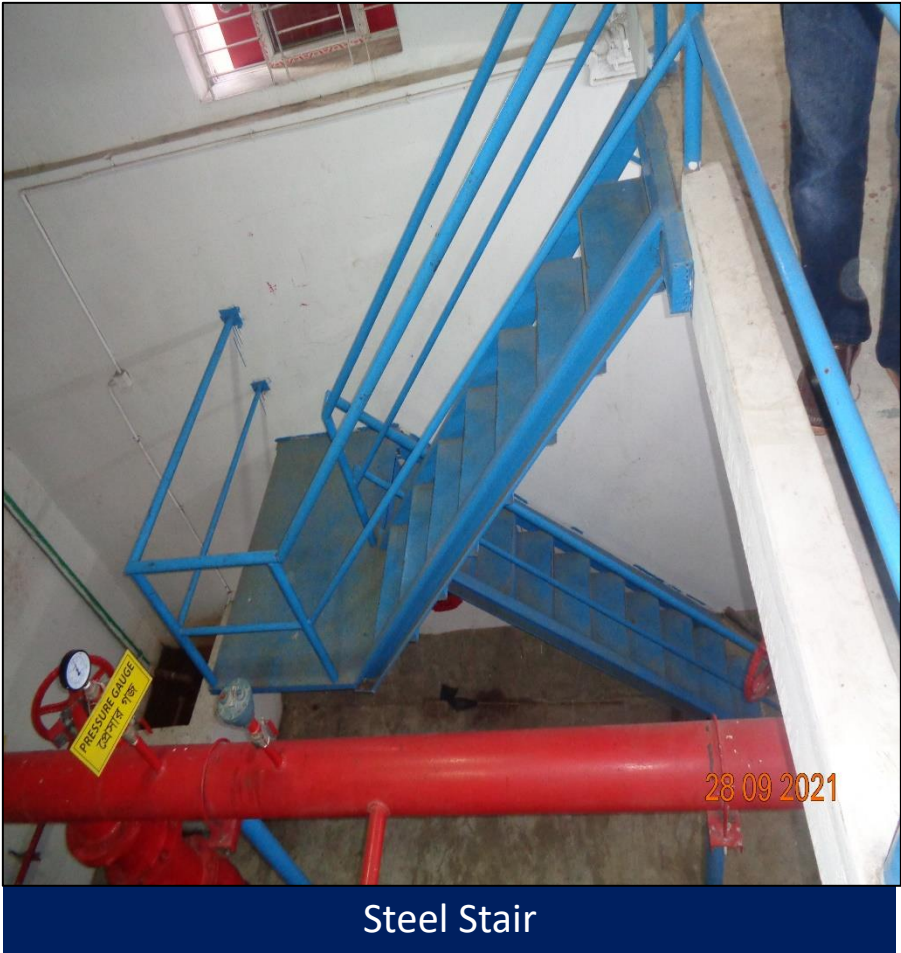
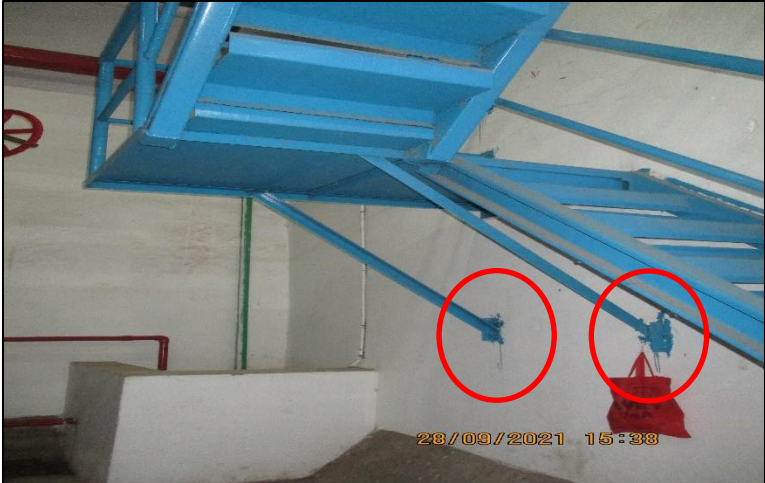
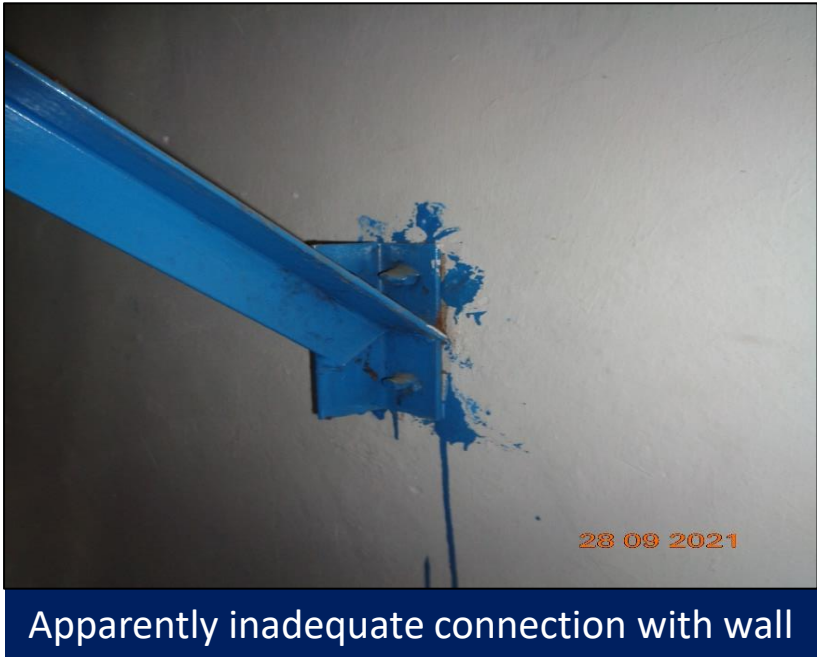
# Non engineered steel stair

Apparently inadequate connection was observed at steel stair of pump Room. Factory engineer is required to carry out connection adequacy check of the steel stair.

Item No.	Observation	Recommended Action Plan	Recommended Timeline
23	Non engineered steel stair (Pump Room)	Factory engineer is required to carry out connection adequacy & lateral stability check of the steel stair.	6-weeks
24	Non engineered steel stair (Pump Room)	Implement remediation work where necessary	6-months
25	Foundation system unknown (Guard Room, Childcare & medical).	The factory engineer is required to verify the foundation system and prepare accurate as built structural drawings. Foundation system must be verified.	6-weeks

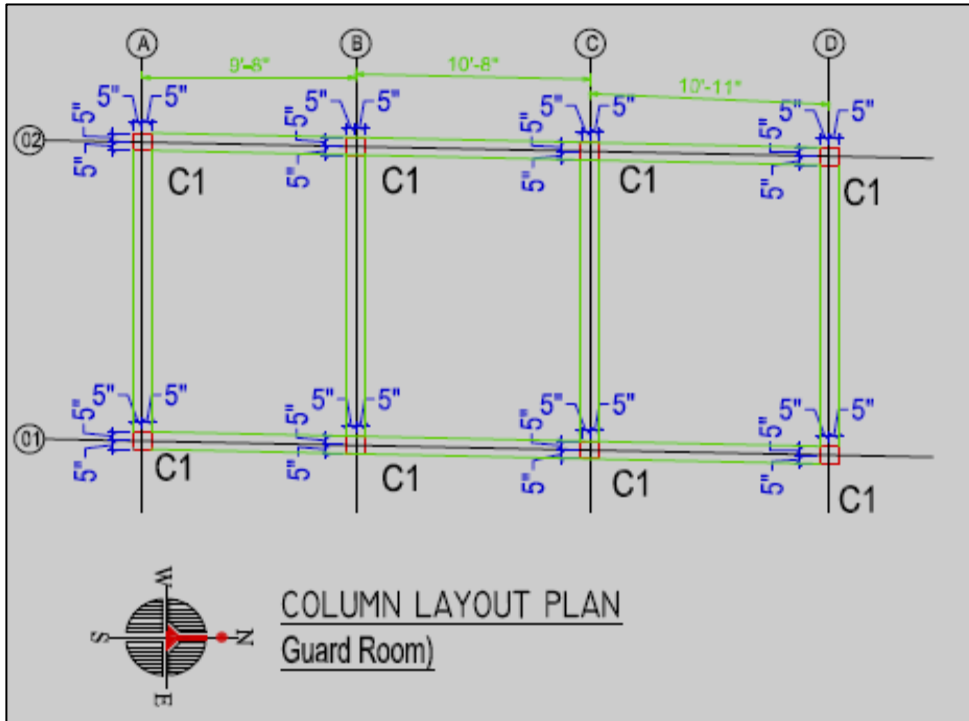
Column layout plan

Guard Room, Childcare, Medical is a single storied RCC building. Foundation layout & details were missing in as built structural drawing. Factory is required to verify the foundation system and prepare accurate as built structural drawings.
