Confidence Texwear Ltd.

Mahona, Bhubanipur, Shirirchala, Gazipur Sadar, Gazipur.

8th February 2021

Buildings Information

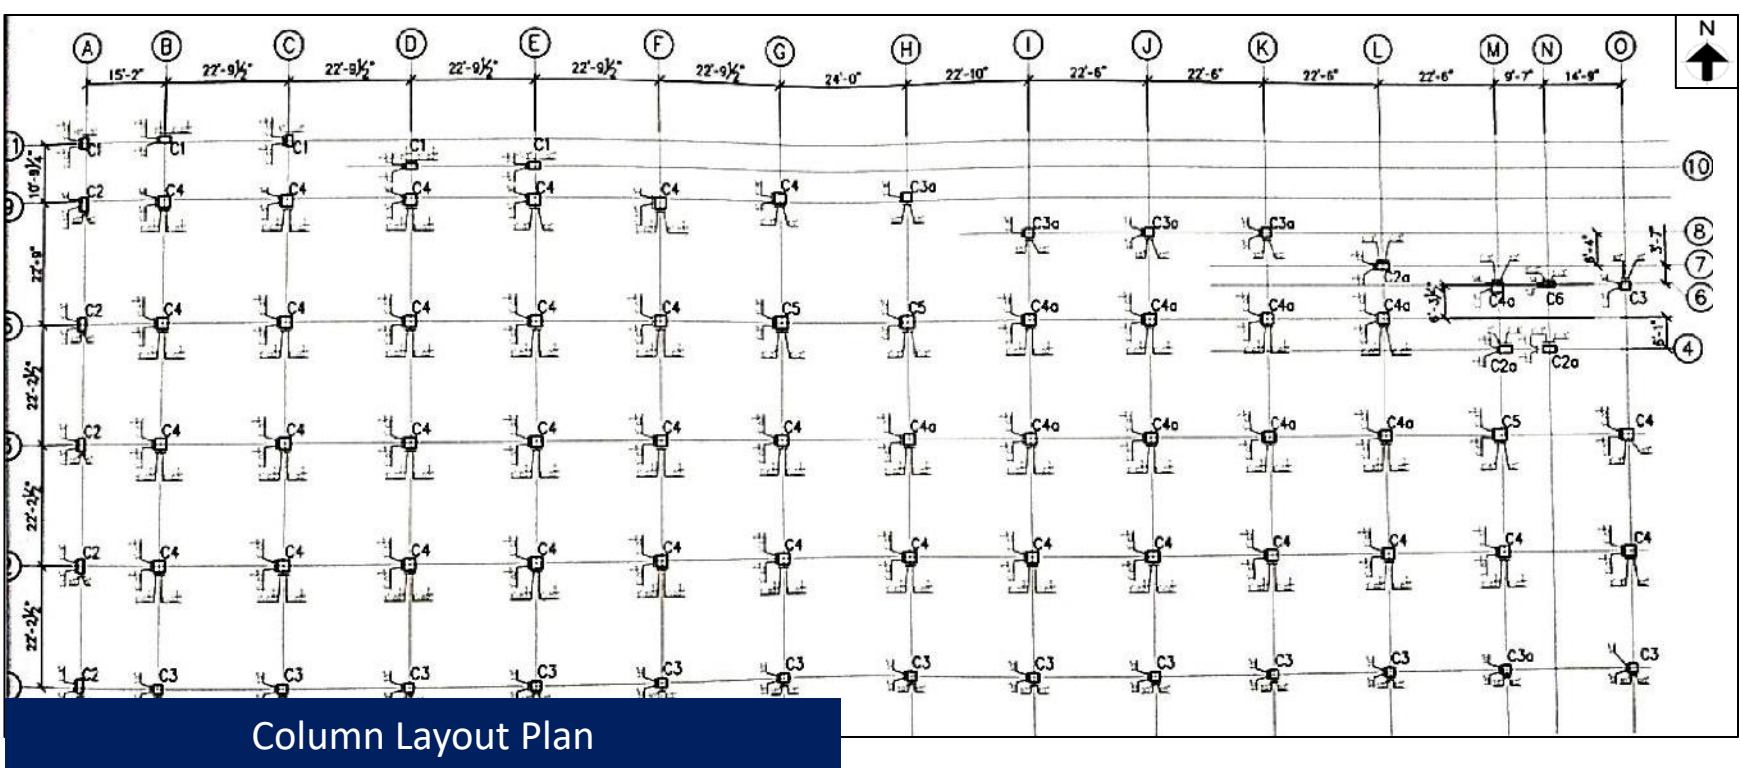
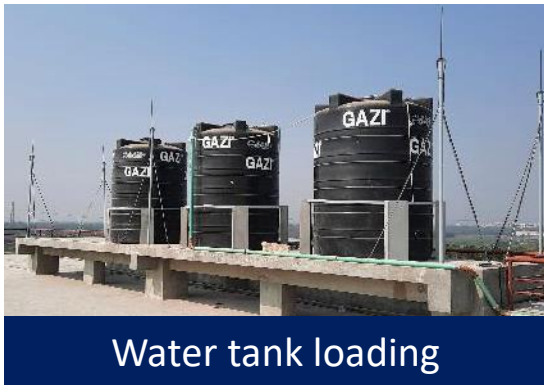
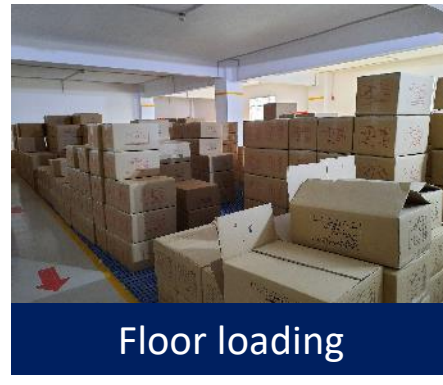
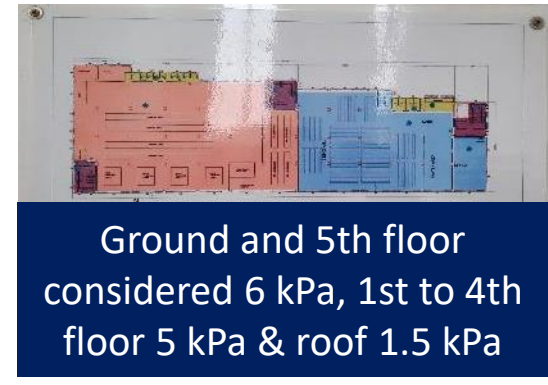
Columns are stressed above normal design limit

Cursory calculation indicates that columns are stressed above normal design limit considering prepared live load plan and minimum concrete strength value from aggregate type. Building engineer is required to review design, load & column stress.

Item No.	Observation	Recommended Action Plan	Recommended Timeline
01	Columns are stressed above normal design limit. (Building 1)	Building engineer to review design, loads and columns stresses.	6-weeks
02	Columns are stressed above normal design limit. (Building 1)	Verify in situ concrete stresses either by 100mm dia. cores or existing cylinder strength data or [100mm dia. cores from 4 columns].	6-weeks
03	Columns are stressed above normal design limit. (Building 1)	Building engineer is required to review the design considering slenderness effect on the columns.	6-Weeks
04	Columns are stressed above normal design limit. (Building 1)	Building Engineer to prepare design report as per BNBC (part 6; Article 1.9.1) by reviewing design, loads and capacity of structural members.	6-weeks
05	Columns are stressed above normal design limit. (Building 1)	Produce and actively manage a loading plan for all floor plates within the factory considering floor capacity and column capacity.	6-weeks

06	Columns are stressed above normal design limit. (Building 1)	Carry out any remedial works where necessary.	6-months

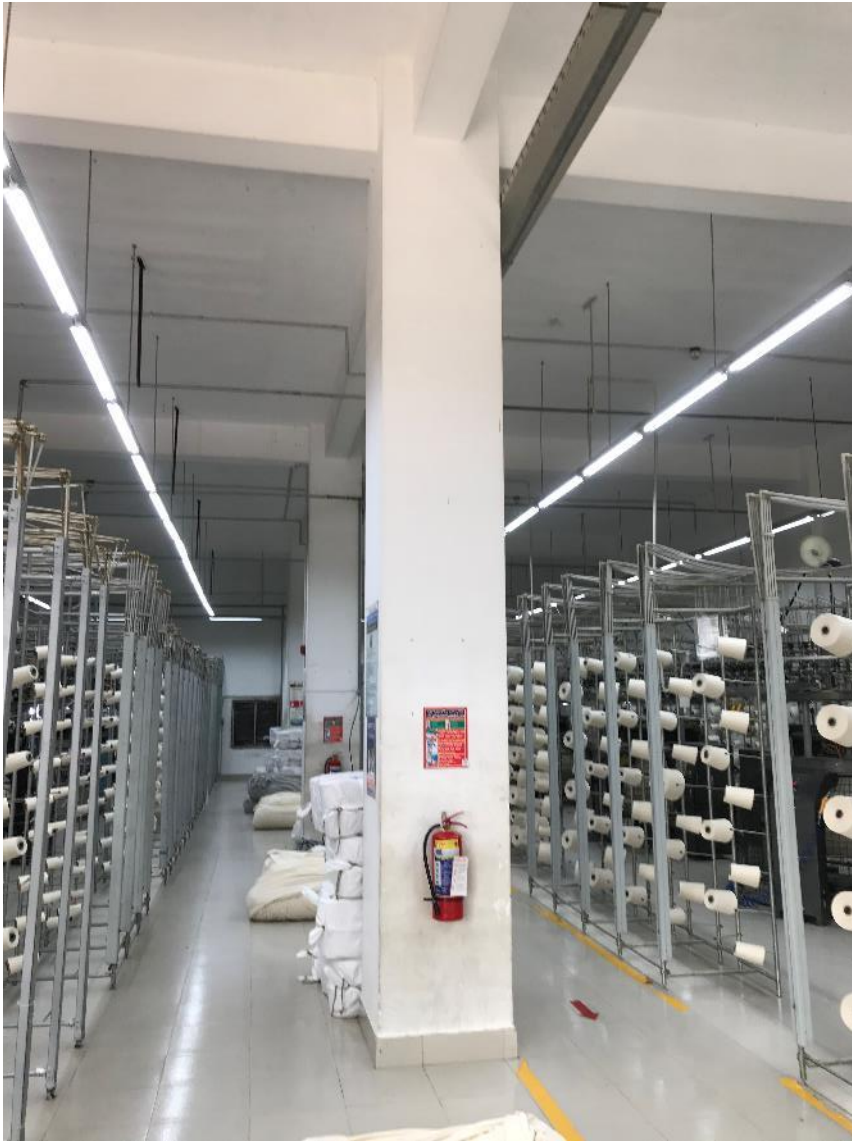
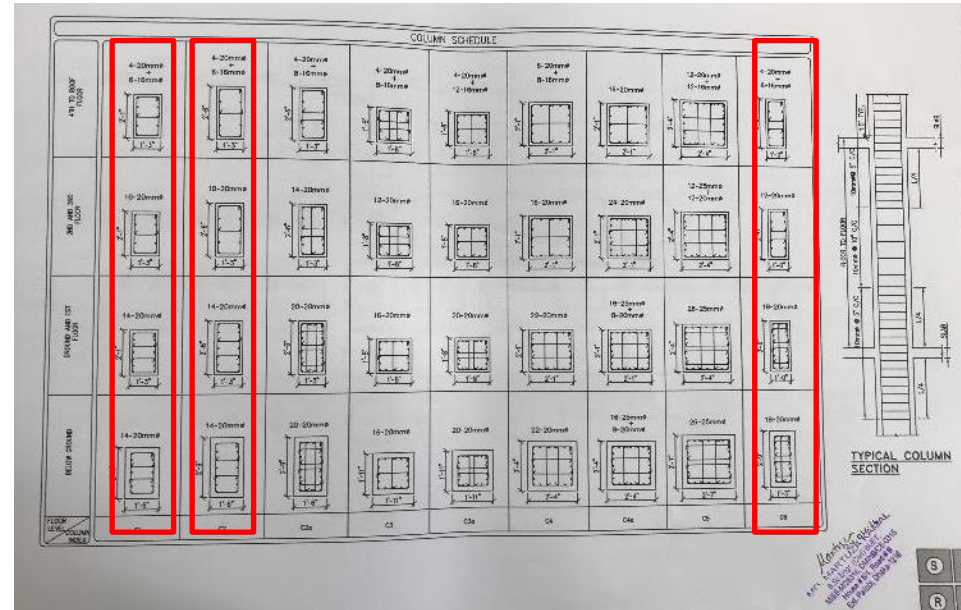
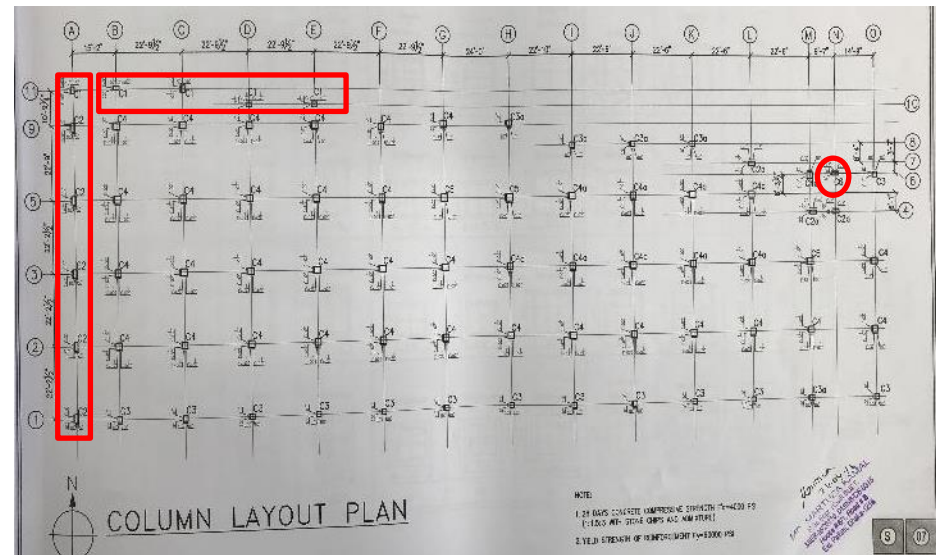
Ground floor height is 5300 mm, least dimension of some columns are 300 mm (C7), 375 mm (C1,C2). Building engineer is required check the slenderness effect of the columns.
