# MOUCHAK KNIT COMPOSITE LTD. (New Building)

Mouchak, Kaliakoir, Gazipur  
(24.0231N, 90.2889E)  
12 April 2022

1. New Building: Six storied RC building with a partial basement.

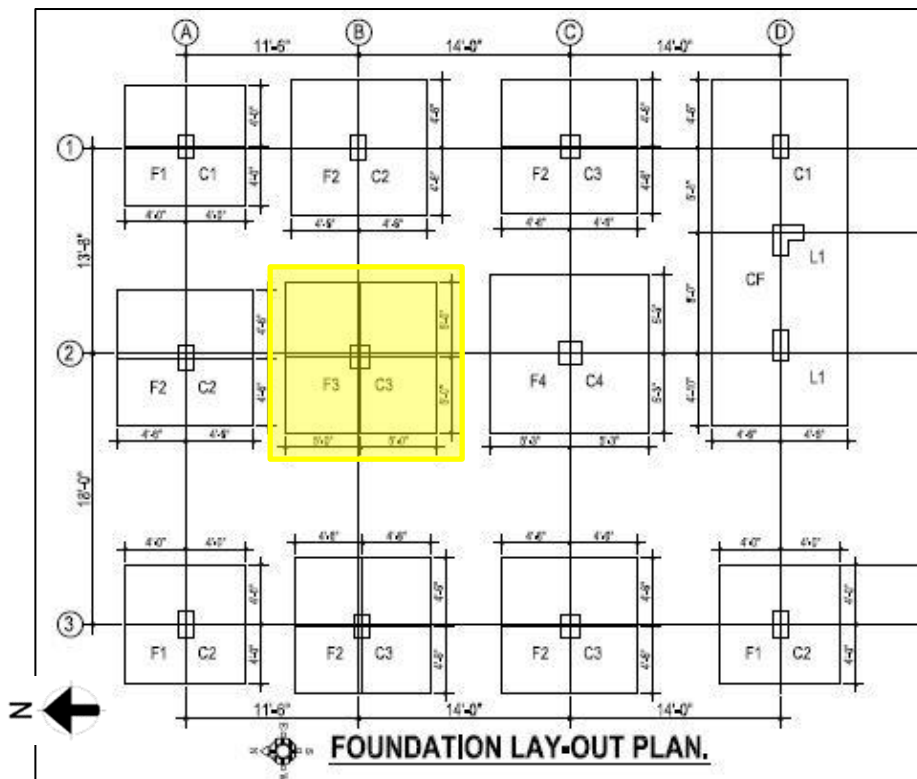
Stressed column/foundation in layout

Cursory calculation indicates that stress in column and foundation exceeds normal design limit at marked locations considering the floor live load as per prepared live load plan (3 kPa for typical floor, 5 kPa for stair and 1.5 kPa for roof), minimum concrete strength based on aggregate type and allowable soil bearing capacity 13.45 Ton/m<sup>2</sup> (132 kPa). Building engineer is required to review the design, loads, column and foundation stresses for the area identified above. Verify in-situ concrete strength by taking 4-100 mm diameter core from column (lower tier of the building).

| Item No. | Observation | Recommended Action Plan | Recommended Timeline |
|---|---|---|---|
| 01 | Stress in column and foundation exceeds normal design limit (New Building) | Building engineer is required to review the design, load, column and foundation stresses of the area identified above. | 6-weeks |

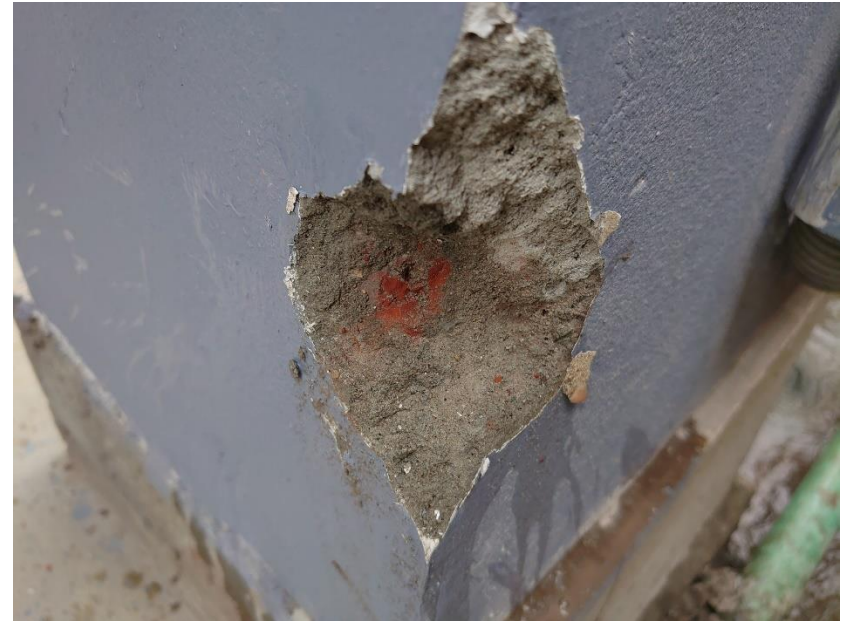
Strength of concrete and rebar considered in Engineering Assessment test report as 24.13 MPa and 500 MPa without any test report. Also, aggregate type mentioned as stone chips in Engineering Assessment but physically found as brick chips in columns.

Brick chips found as aggregate in columns

| Item No. | Observation | Recommended Action Plan | Recommended Timeline |
|---|---|---|---|
| 02 | Stress in column and foundation exceeds normal design limit (New Building) | Verify in-situ concrete strength by taking 4-100 mm diameter core from column (lower tier of the building). | 6-weeks |

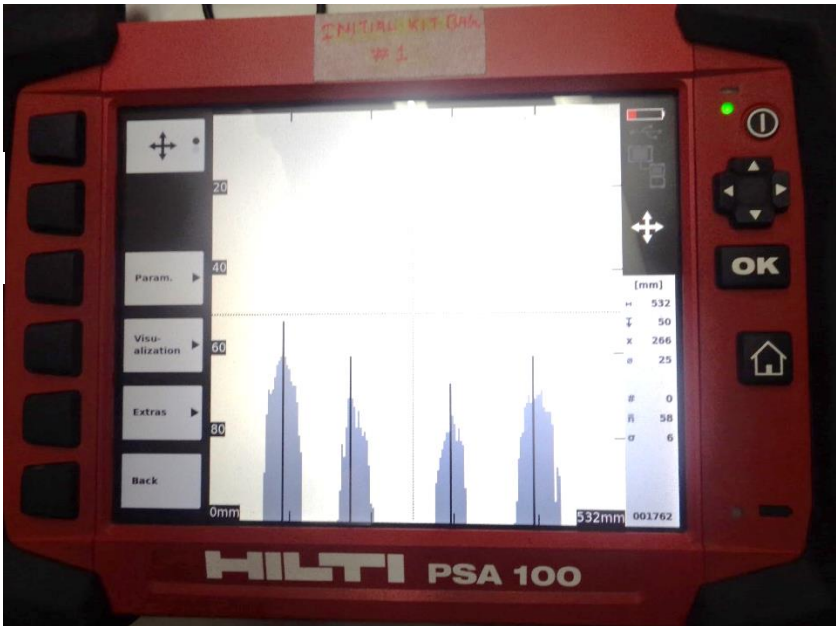
Ferro scan report shows 4 rebar at each side of column C-4 at 3<sup>rd</sup> floor

5 rebar shown for each side above 1<sup>st</sup> floor for column C-4 but Ferro scan shows 4 rebar at each side of column C-4 at 3<sup>rd</sup> floor (12 rebar counted instead of 16). Building engineer is required to resurvey the whole structure and update as-built drawing accordingly.

| Item No. | Observation | Recommended Action Plan | Recommended Timeline |
|---|---|---|---|
| 07 | Discrepancy and missing information in as-built drawing (New Building) | Building engineer is required to update the as-built drawing. | 6-weeks |

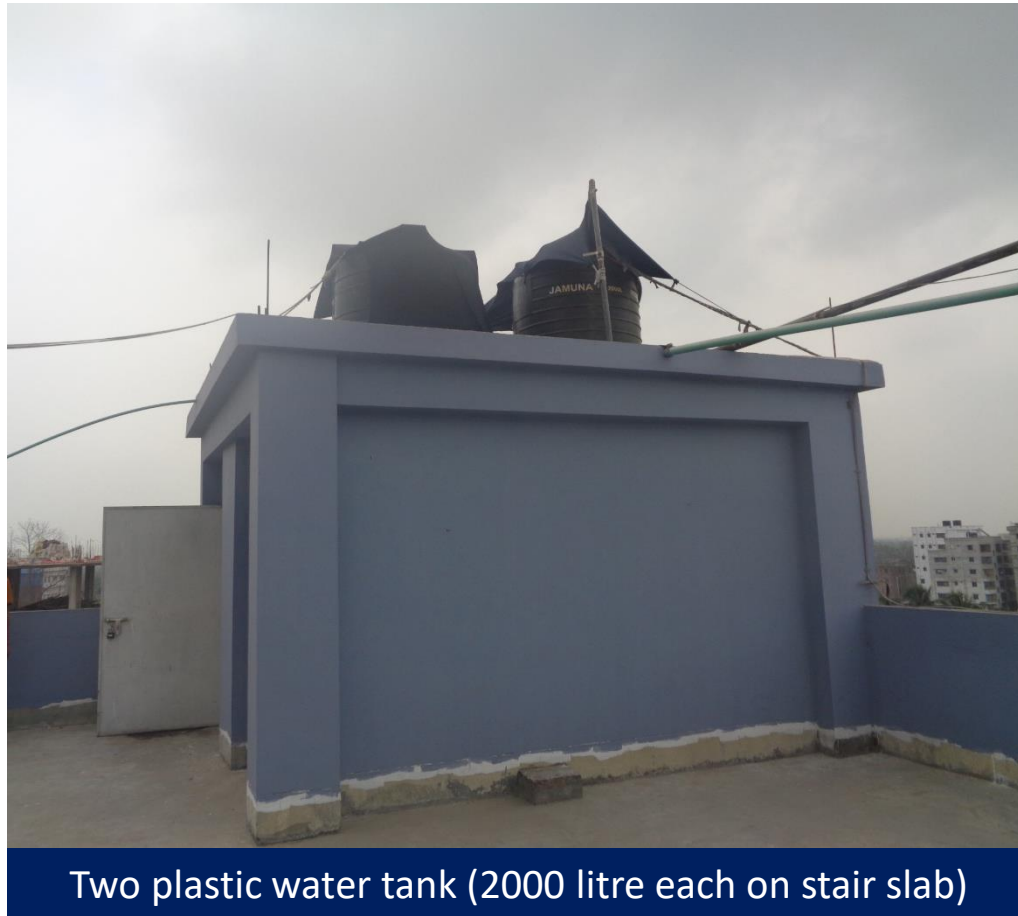
Two plastic water tank (2000 litre each on stair slab)

Plan of stair top level was not shown in drawing. Two plastic water tank (2000 litre each on stair slab). Building engineer is required to survey the whole structure and update as-built drawing accordingly.

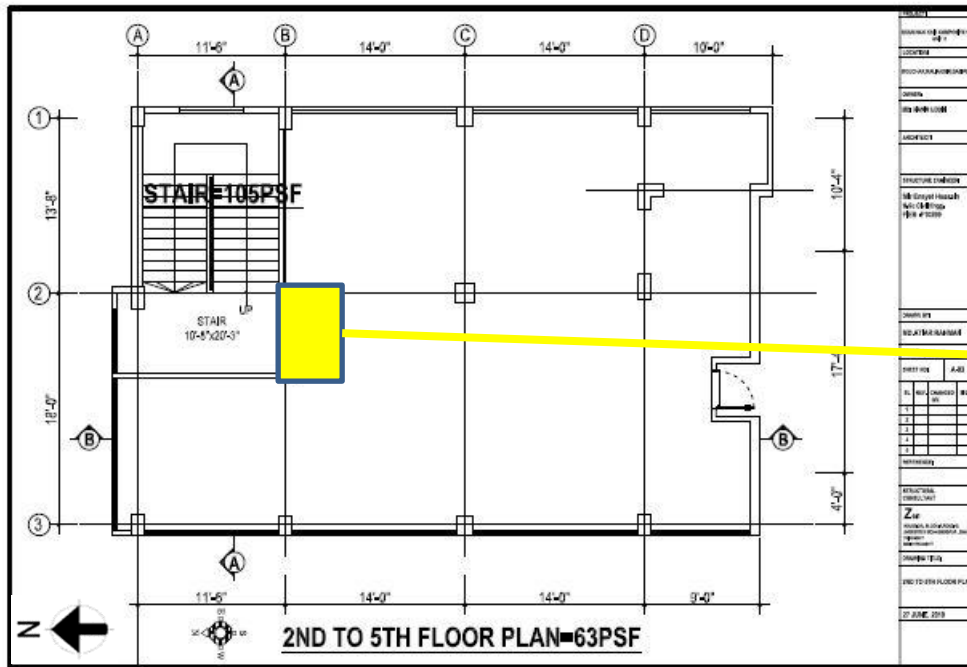
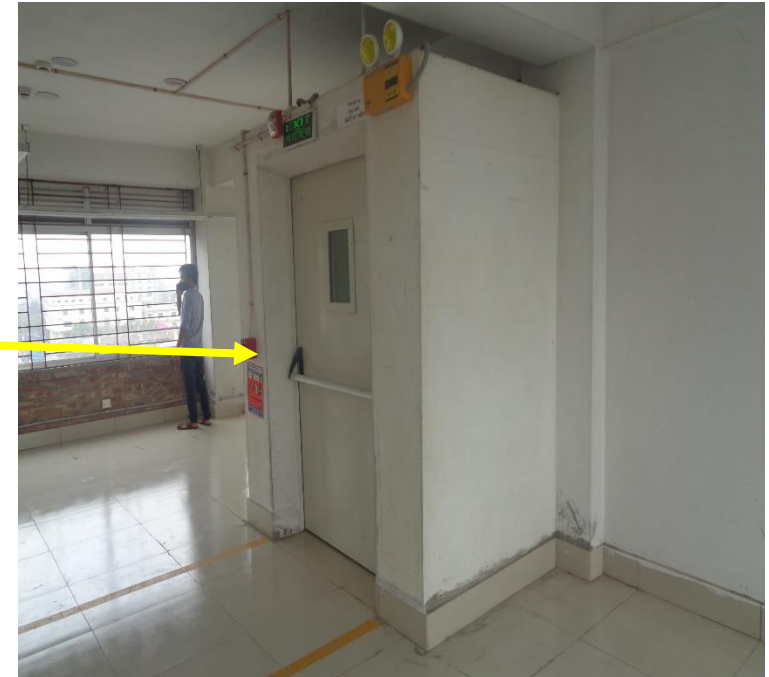
Extra wall with slab for fire door found on each floor but not shown in drawing.

Extra walls with slab for fire door were not shown in drawing. Building engineer is required to survey the whole structure and update as-built drawing accordingly.

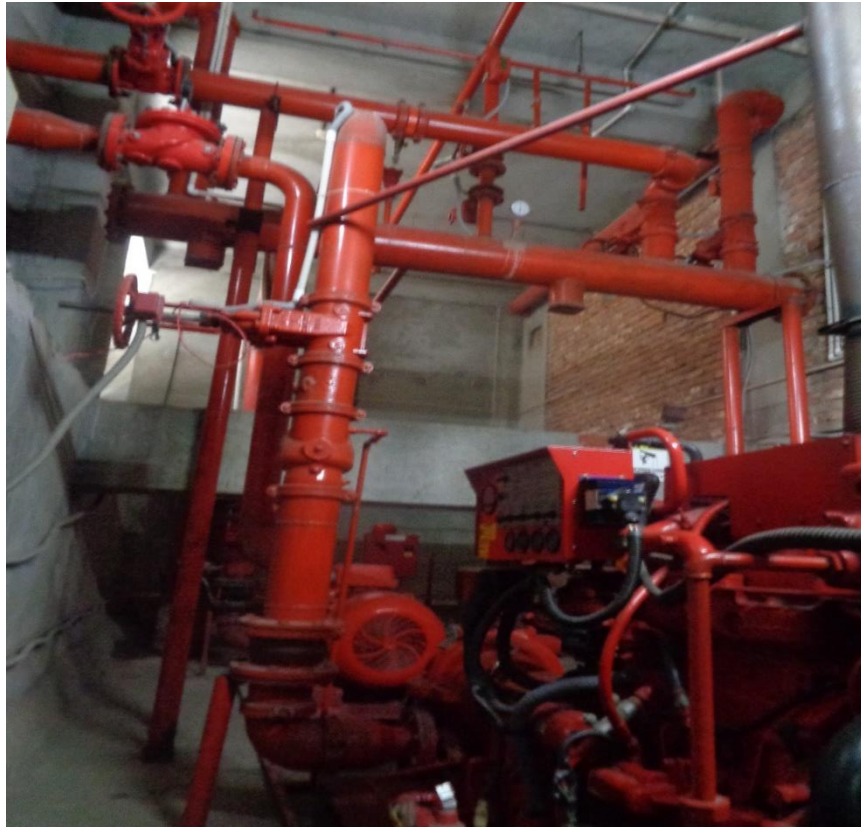
Basement plan not shown in drawing

Plan of basement level was not shown in drawing. Building engineer is required to survey the whole structure and update as-built drawing accordingly.

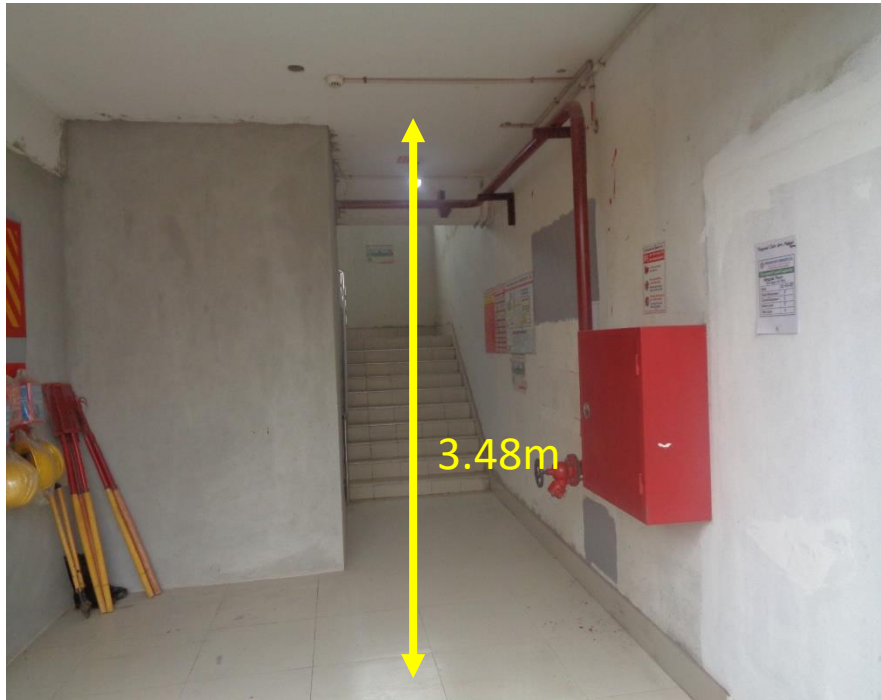
Ground floor height measured 3.48 m

Ground and 1<sup>st</sup> floor height (floor to ceiling) was measured as 3.48m but shown in drawing as 3.04m. Building engineer is required to resurvey the whole structure and update as-built drawing accordingly.

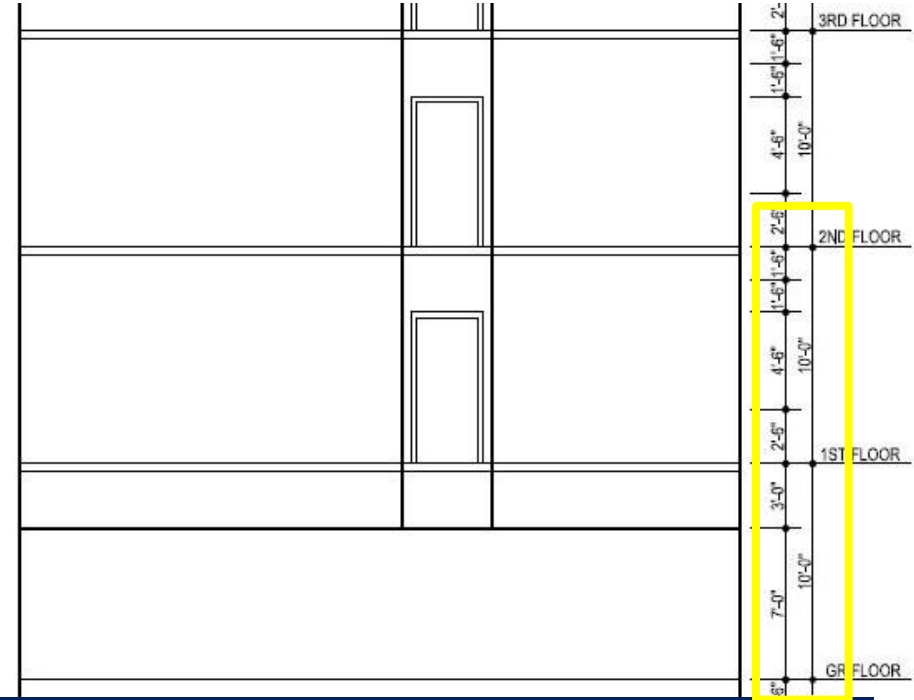
Ground floor height shown as 3.04 m
