# Northern Corporation Ltd.- Sreepur

## Northern Garments Limited

Tepirbari, Sreepur, Gazipur, Bangladesh  
(24.240588, 90.417995)  
5<sup>th</sup> January 2021 & 1<sup>st</sup> February 2021

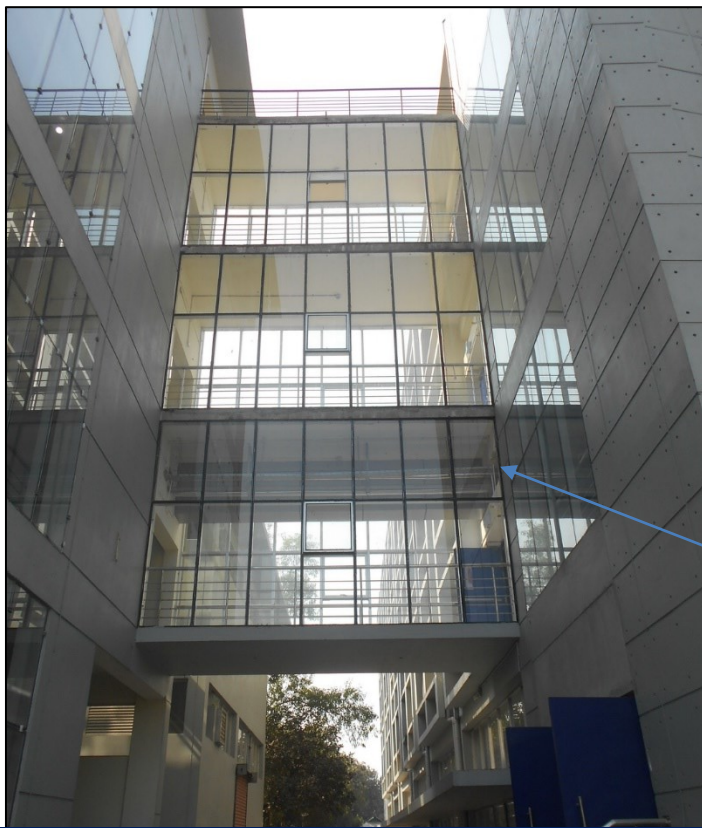
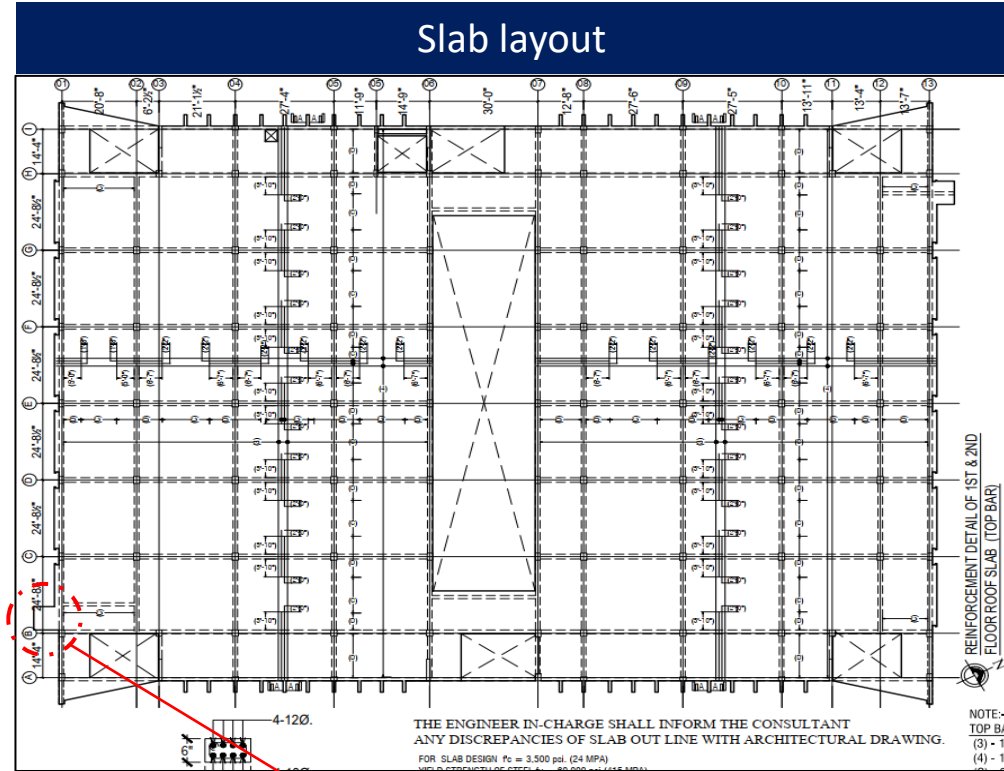
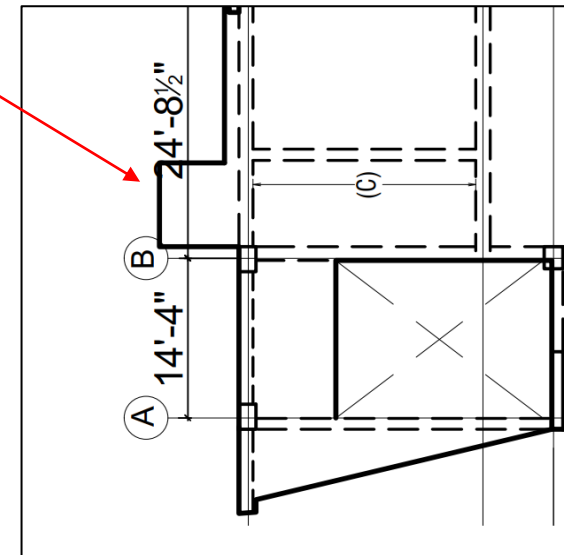
Connecting bridge between production building and store building

According to slab layout drawing of production building, the marked portion is a cantilever slab between production building and store building. But the slab was found structurally connected between both structures. This slab is susceptible to different movement from two different structures. The load transfer mechanism via this slab and capacity is required to be assessed.

| Item No. | Observation | Recommended Action Plan | Recommended Timeline |
|---|---|---|---|
| 01 | Connecting Slab between Production building and Store building (Production Building) | Building Engineer to check the capacity of the slab of cantilever bridge and prepare an assessment report. | 6-weeks |
| 02 | Connecting Slab between Production building and Store building (Production Building) | Produce & actively manage loading plan for this slab panel considering slab capacity. | 6-weeks |
| 03 | Connecting Slab between Production building and Store building (Production Building) | Complete implementation of any remedial works deemed necessary by the assessment report. | 6-months |

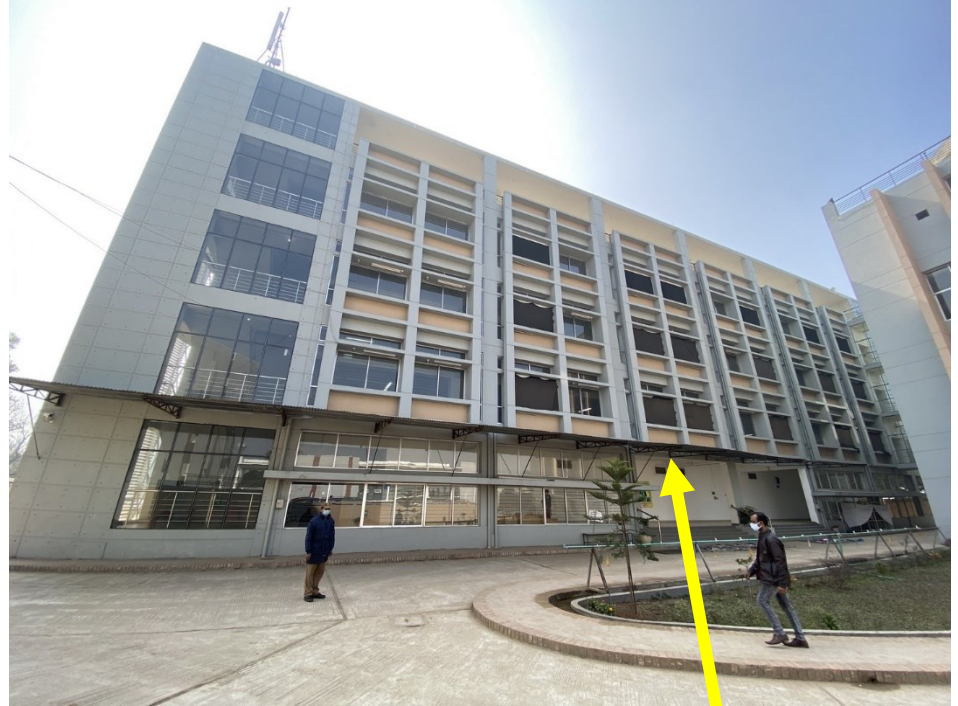
As per BNBC, every building or structure designed shall have its design documents prepared in accordance with the provision of Section 1.9.1. The design document shall include a design report, and a set of structural drawings, which shall be prepared in compliance with section 1.9.1.1 and section 1.9.1.2 as per BNBC. At the time of inspection, only as-built drawing, load plan and geotechnical report were available, but no design report was available which is required to be prepared in compliance with section 1.9.1.1 (part-6, BNBC).

No design report was available for Production Building

| Item No. | Observation | Recommended Action Plan | Recommended Timeline |
|---|---|---|---|
| 04 | Absence of design documents (Production Building) | Factory engineer is required to prepare the design documents including a design report, and a set of structural drawings in compliance with section 1.9.1.1 and section 1.9.1.2 as per BNBC part 6 and submit to RSC for review. | 6-weeks |

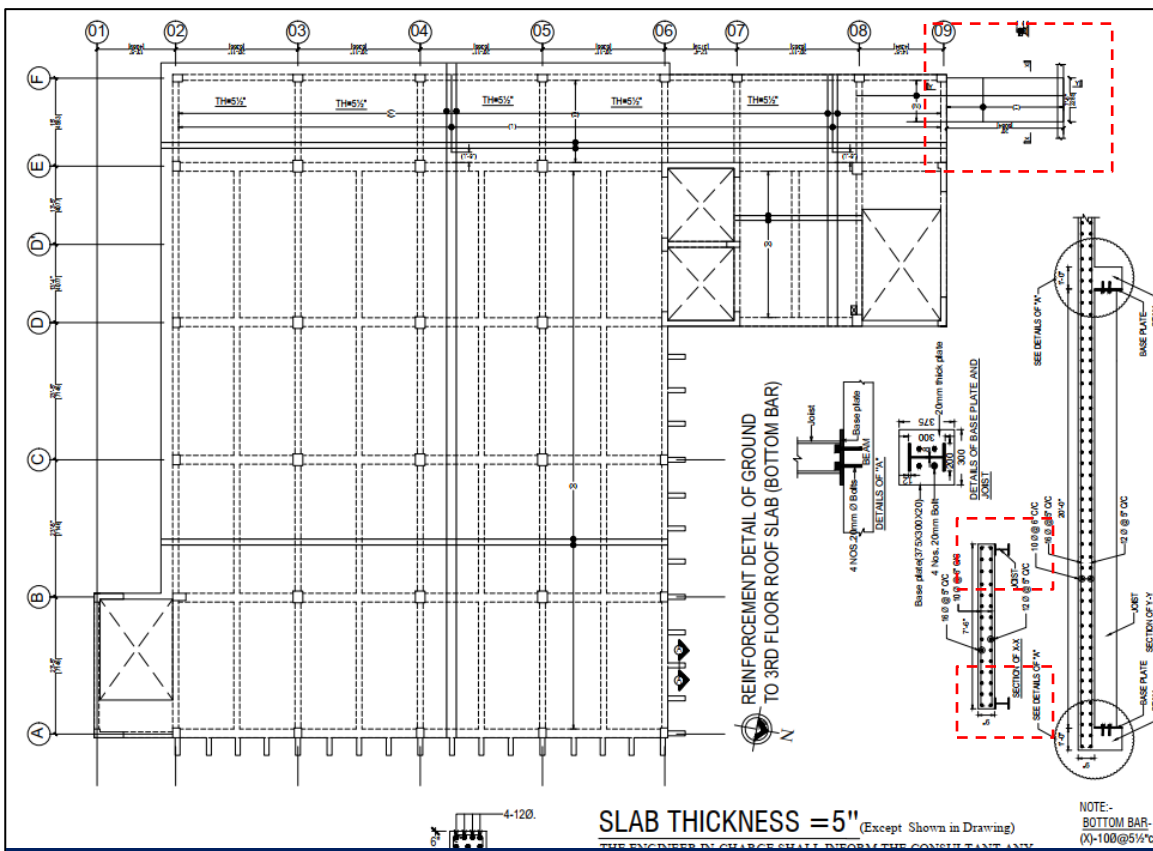
Slab layout of store building

The slab of the connecting bridge connects the production building and store building. According to drawing, there should be two Steel I joist to support this slab. During inspection, this I joist was not found beneath of this slabs.

| Item No. | Observation | Recommended Action Plan | Recommended Timeline |
|---|---|---|---|
| 08 | Discrepancies in as-built drawings of slab and lack of drawing for canopy structure (Store Building) | Building Engineer is to survey the whole structure and update as-built drawings representing accurate site condition. | 6-weeks |
| 09 | Discrepancies in as-built drawings of slab and lack of drawing for canopy structure (Store Building) | Install the missing Steel I joist as per the drawing. | 6-weeks |

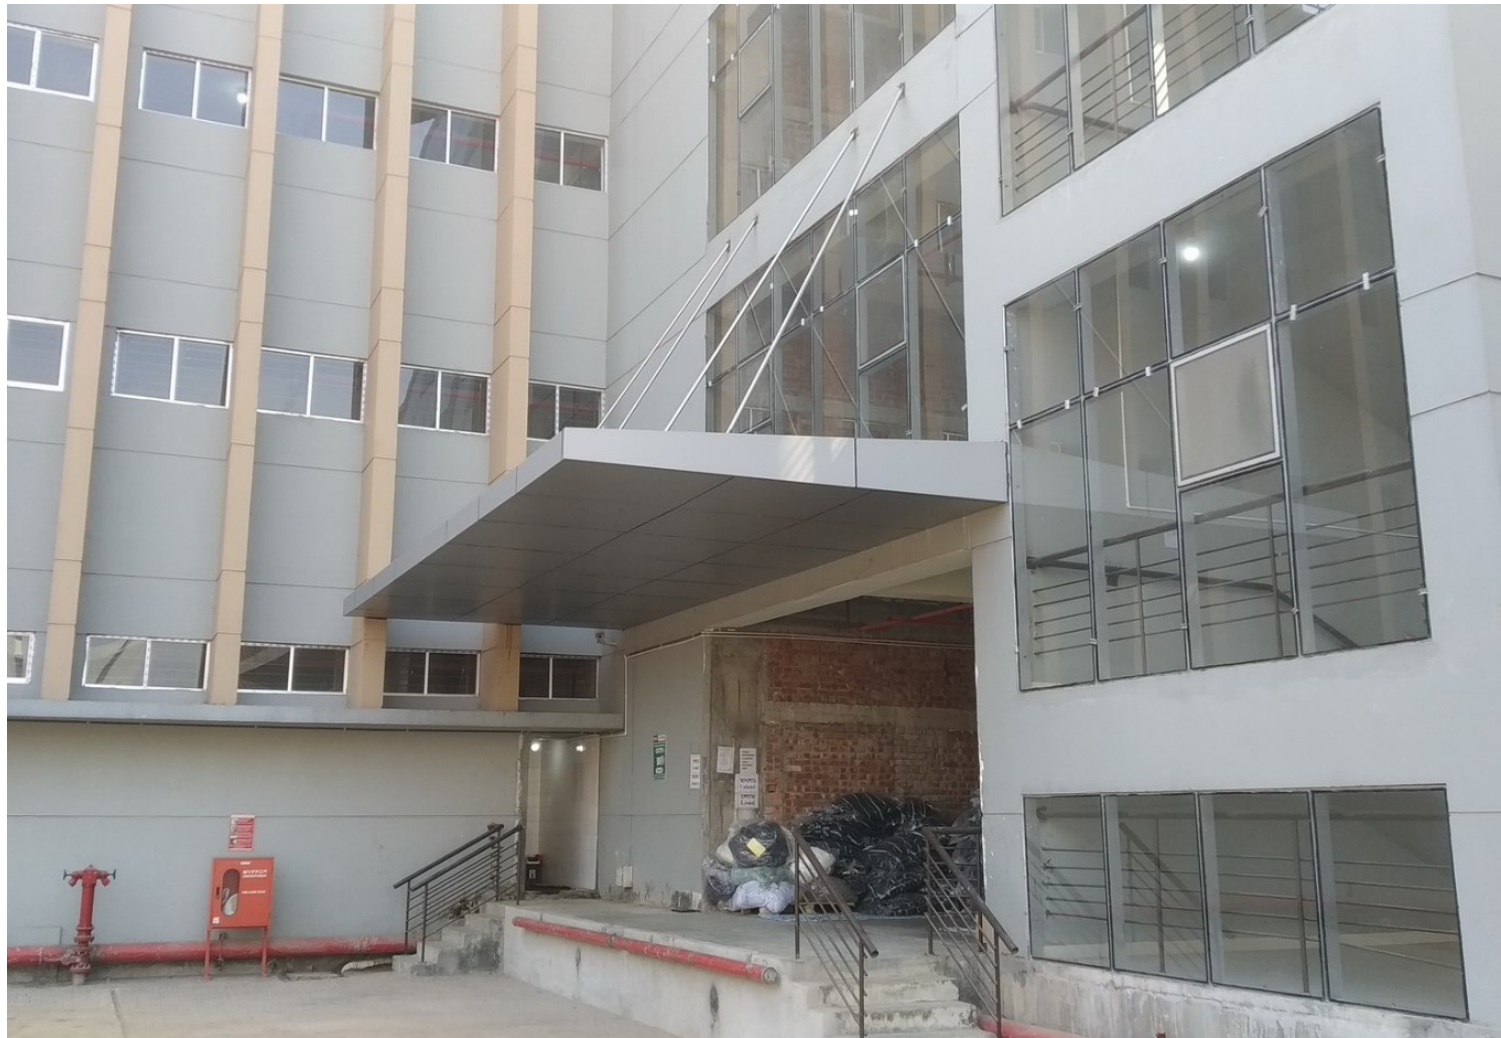
No drawing or detailing was available for this canopy at ground floor roof level of store building.

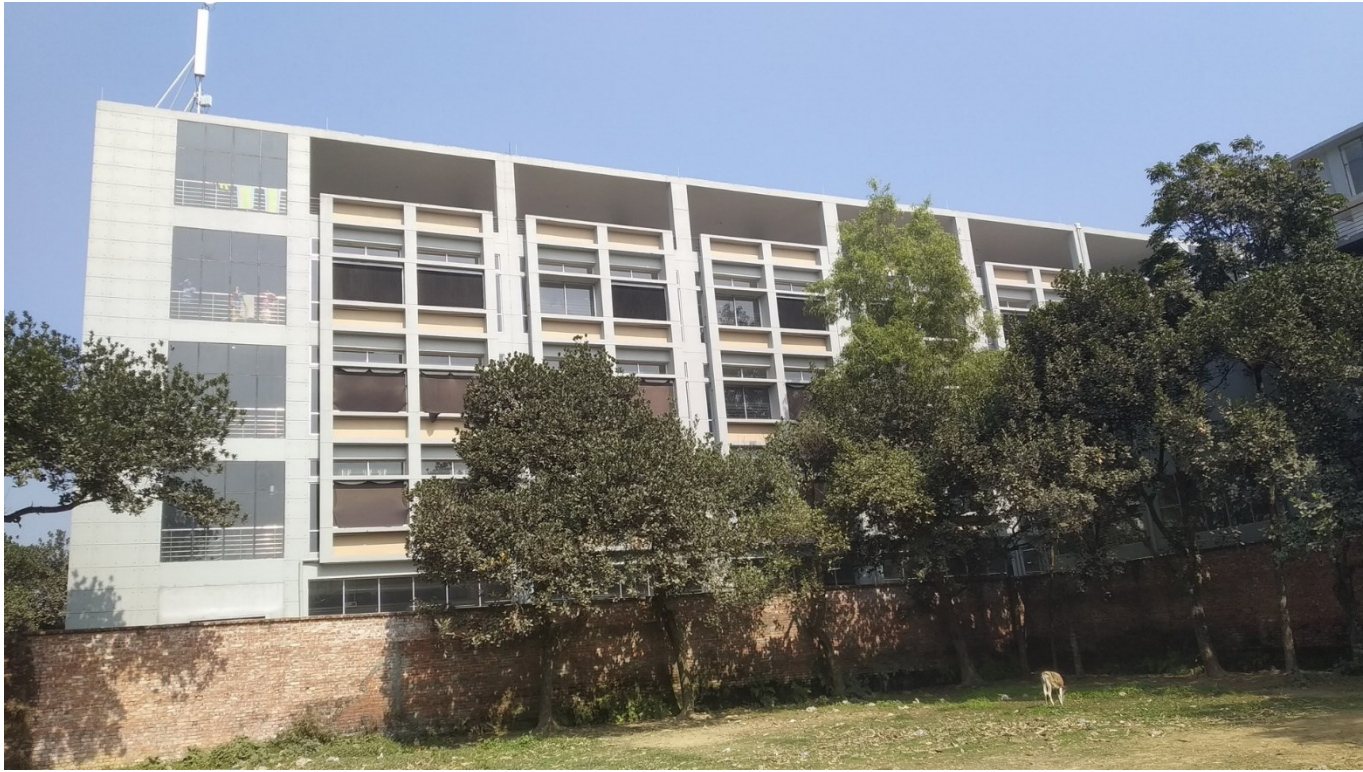
No design report was available for Store Building

As per BNBC, every building or structure designed shall have its design documents prepared in accordance with the provision of Section 1.9.1. The design document shall include a design report, and a set of structural drawings, which shall be prepared in compliance with section 1.9.1.1 and section 1.9.1.2 as per BNBC. At the time of inspection, only as-built drawing, load plan and geotechnical report were available, but no design report was available which is required to be prepared in compliance with section 1.9.1.1 (part-6, BNBC).

| Item No. | Observation | Recommended Action Plan | Recommended Timeline |
|---|---|---|---|
| 10 | Absence of design documents (Store Building) | Factory engineer is required to prepare the design documents including a design report, and a set of structural drawings in compliance with section 1.9.1.1 and section 1.9.1.2 as per BNBC part 6 and submit to RSC for review. | 6-weeks |

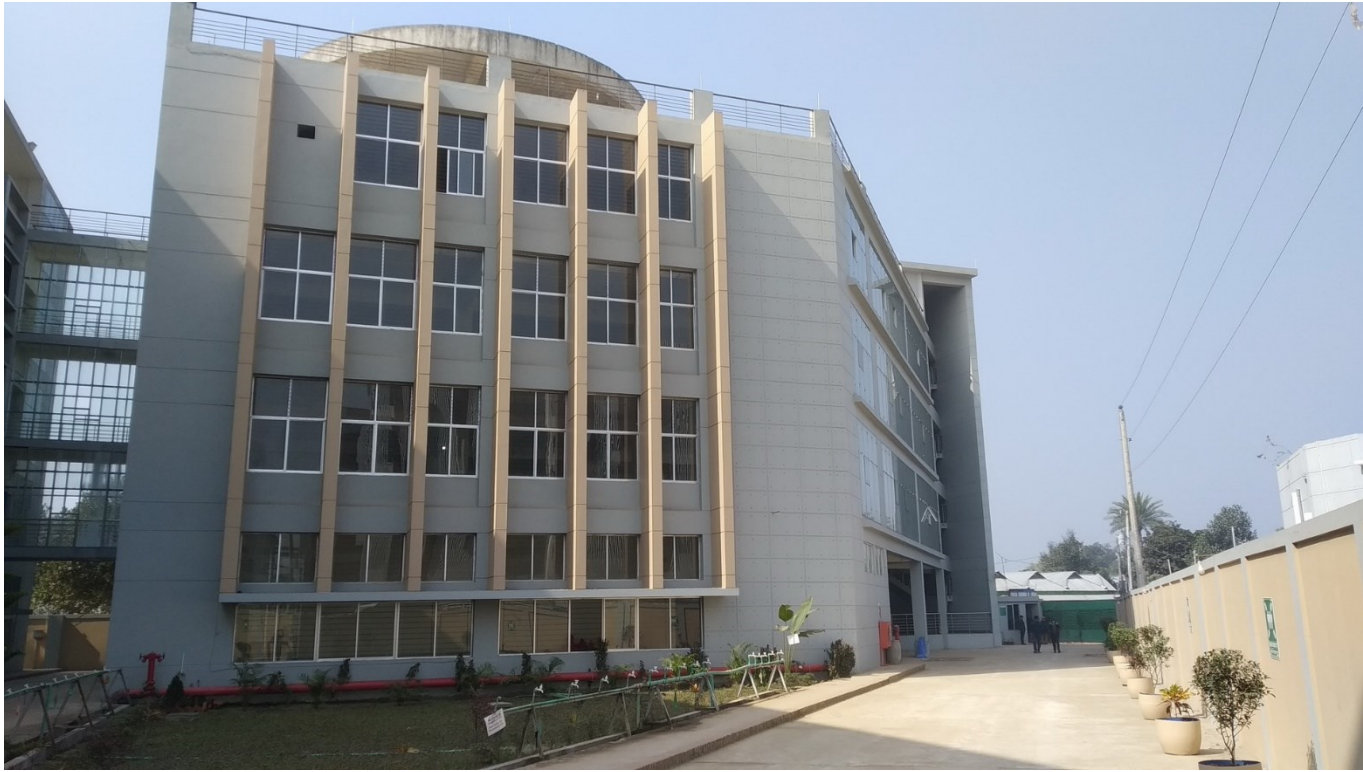
No design report was available for Admin Building

As per BNBC, every building or structure designed shall have its design documents prepared in accordance with the provision of Section 1.9.1. The design document shall include a design report, and a set of structural drawings, which shall be prepared in compliance with section 1.9.1.1 and section 1.9.1.2 as per BNBC. At the time of inspection, only as-built drawing, load plan and geotechnical report were available but no design report was available which is required to be prepared in compliance with section 1.9.1.1 (part-6, BNBC).

| Item No. | Observation | Recommended Action Plan | Recommended Timeline |
|---|---|---|---|
| 14 | Absence of design documents (Admin Building) | Factory engineer is required to prepare the design documents including a design report, and a set of structural drawings in compliance with section 1.9.1.1 and section 1.9.1.2 as per BNBC part 6 and submit to RSC for review. | 6-weeks |

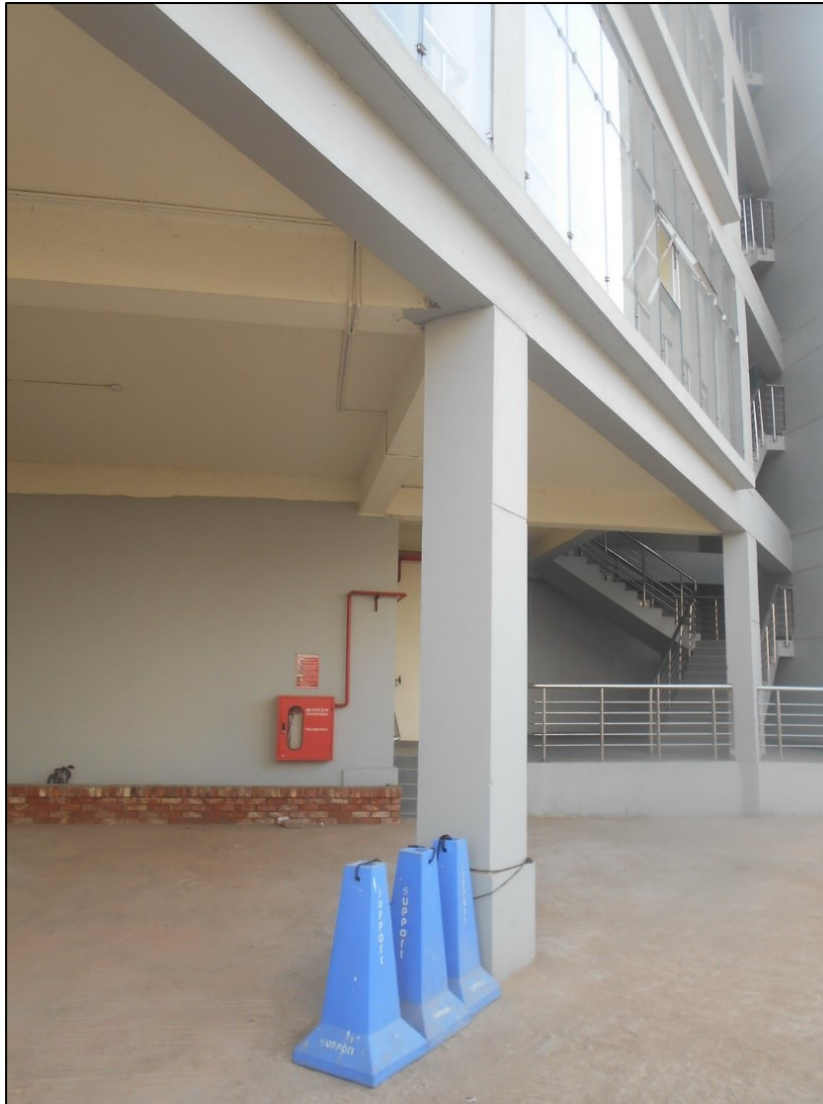
Column of admin building on ground floor

The column of ground floor of admin building is susceptible to impact load from vehicular movement. Factory management is required to provide barrier to protect the column.

| Item No. | Observation | Recommended Action Plan | Recommended Timeline |
|---|---|---|---|
| 18 | Column Susceptible to vehicle impact (Admin Building) | Building engineer is required to take necessary measures to prevent the vehicle impact by providing the barrier around the column. | 6-weeks |

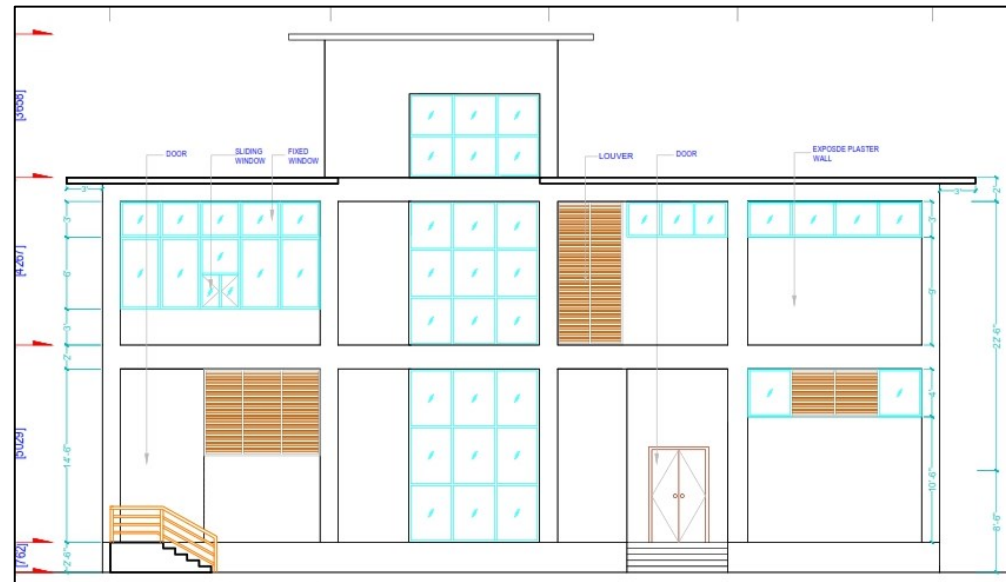
As per BNBC, every building or structure designed shall have its design documents prepared in accordance with the provision of Section 1.9.1. The design document shall include a design report, and a set of structural drawings, which shall be prepared in compliance with section 1.9.1.1 and section 1.9.1.2 as per BNBC. At the time of inspection, only as-built drawing, load plan and geotechnical report were available, but no design report was available which is required to be prepared in compliance with section 1.9.1.1 (part-6, BNBC).

No design report was available for Utility Building

| Item No. | Observation | Recommended Action Plan | Recommended Timeline |
|---|---|---|---|
| 19 | Absence of design documents (Utility Building) | Factory engineer is required to prepare the design documents including a design report, and a set of structural drawings in compliance with section 1.9.1.1 and section 1.9.1.2 as per BNBC part 6 and submit to RSC for review. | 6-weeks |
