# Executive Greentex Limited

Mulaid Telihati Gilarchala, Sreepur, Gazipur.

9<sup>th</sup> and 23<sup>rd</sup> February 2021

# Observations

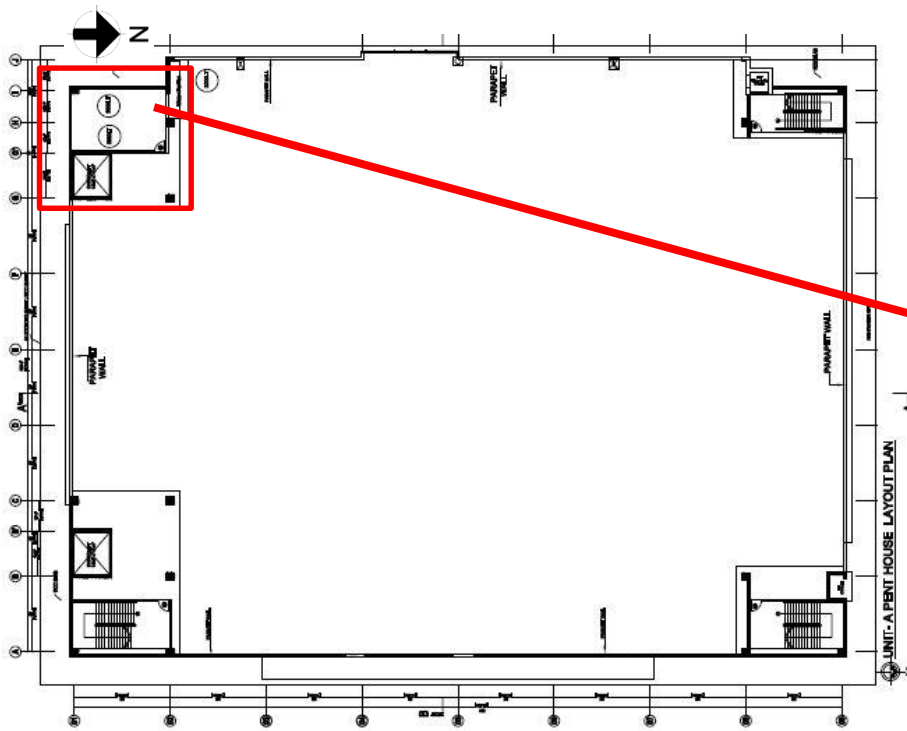
Roof layout

Position of plastic water tank didn't match with roof layout. Two plastic water tank each of 5000 liter were found resting on lift machine room but shown in drawing on staircase. Factory engineer is required to survey the whole structure and update the as-built drawing as per on-site condition in accordance with section 1.9.1.2 (BNBC Part-6) . Also, check the adequacy of the slab of the lift machine room.

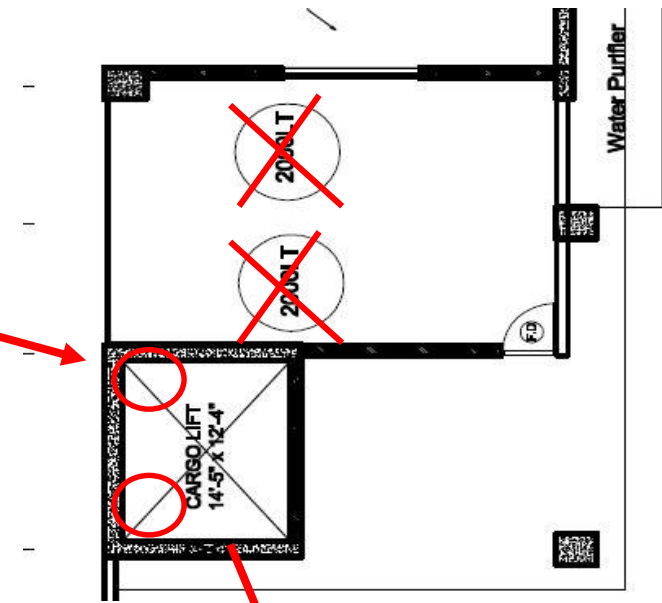
Water tank position didn't match

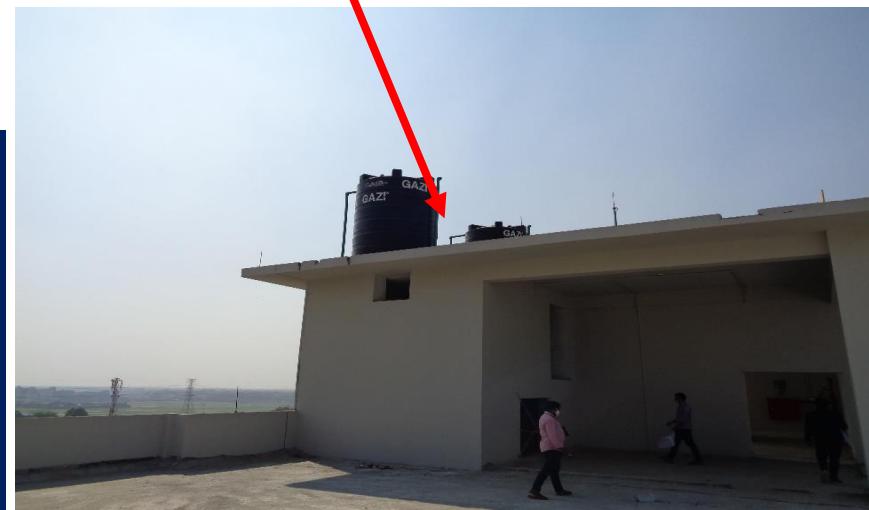
2 Water tanks (capacity-5000 liter) are rested on lift room

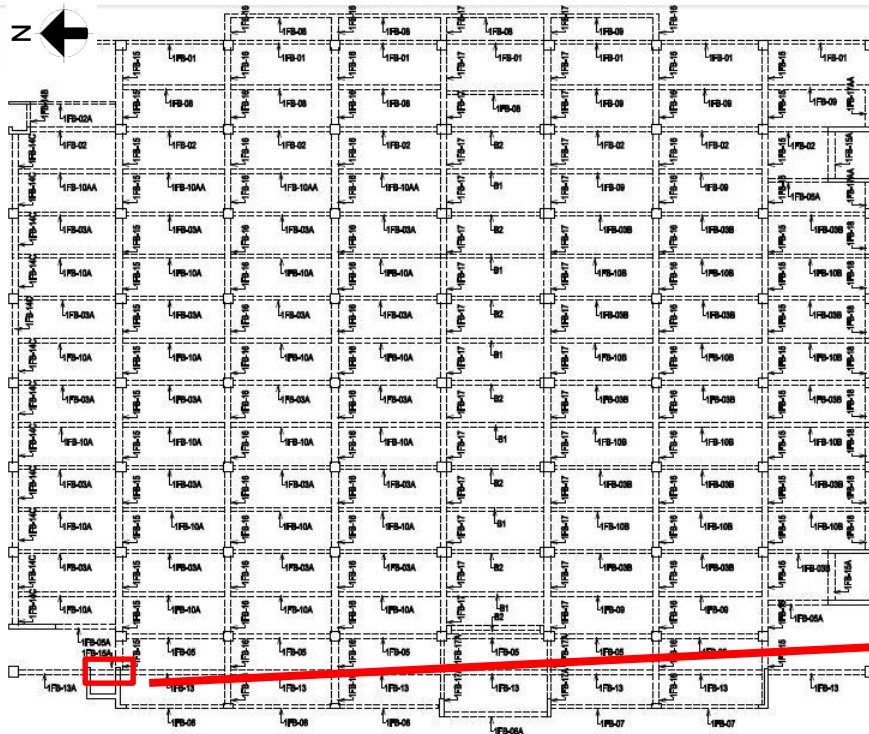
Beam layout

At roof level (north -west stair) shear wall constructed over beam but doesn't continue at lower level. Factory engineer is required to survey the whole structure and update the as-built drawing as per on-site condition in accordance with section 1.9.1.2 (BNBC Part-6).

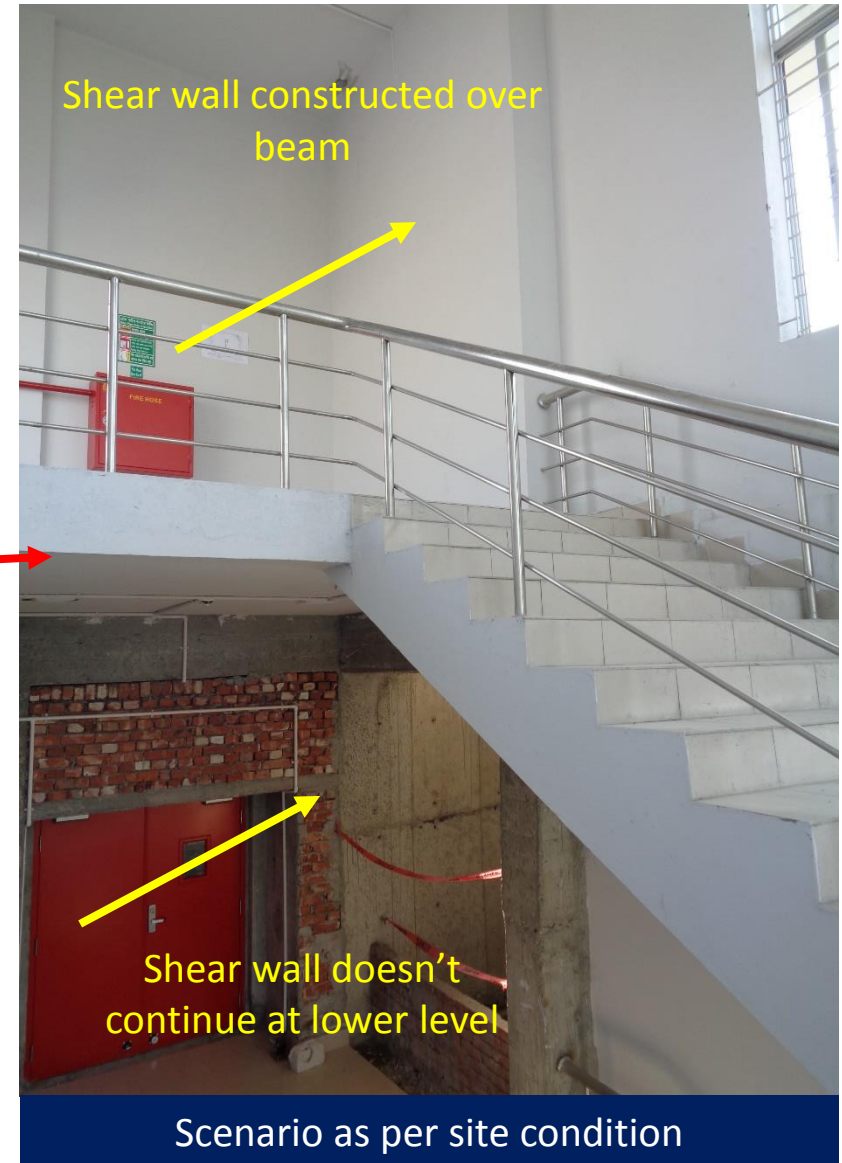
Scenario as per site condition

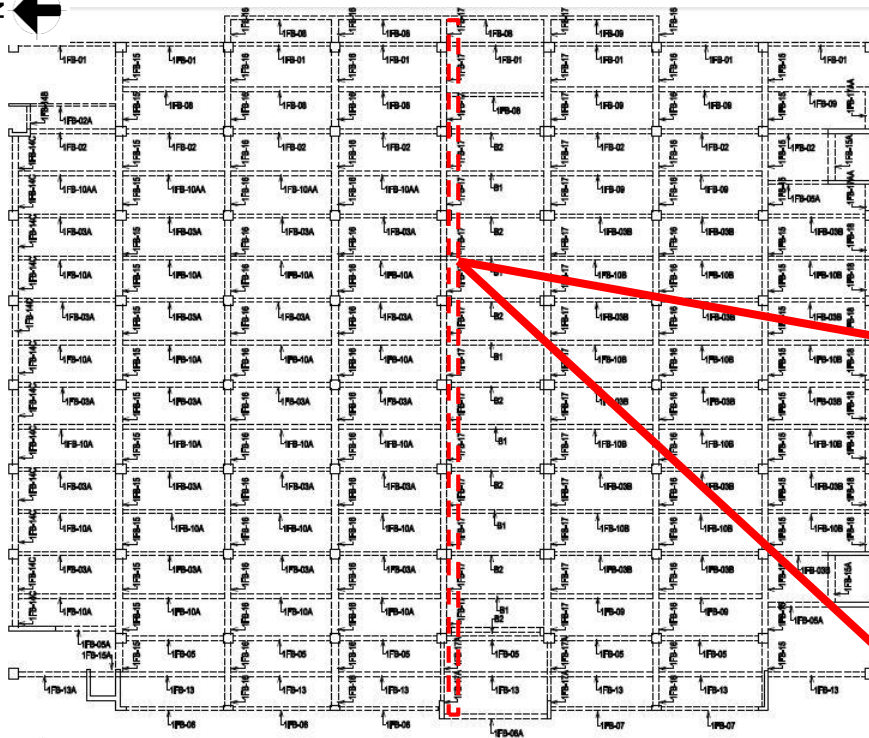
Typical beam layout

At conveyor area extra beam (375mm W X 525mm d/s) was found at First to top floor but not shown in provided drawing. Also, at upper floor the beam layout of that area was found different with as-built condition. Factory engineer is required to survey the whole structure and update the as-built drawing as per on-site condition in accordance with section 1.9.1.2 (BNBC Part-6).

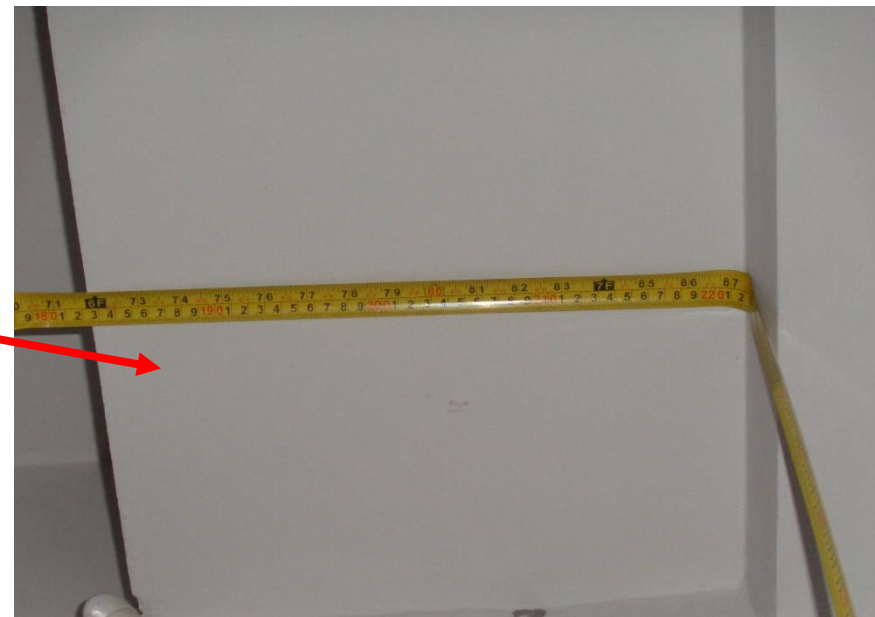
Width of the beam measured 375mm W

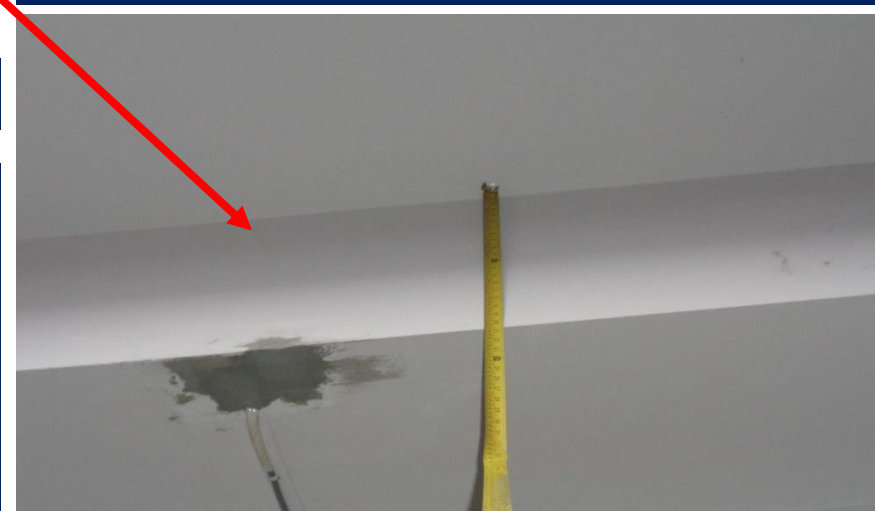
Depth of the beam measured 525mm d/s

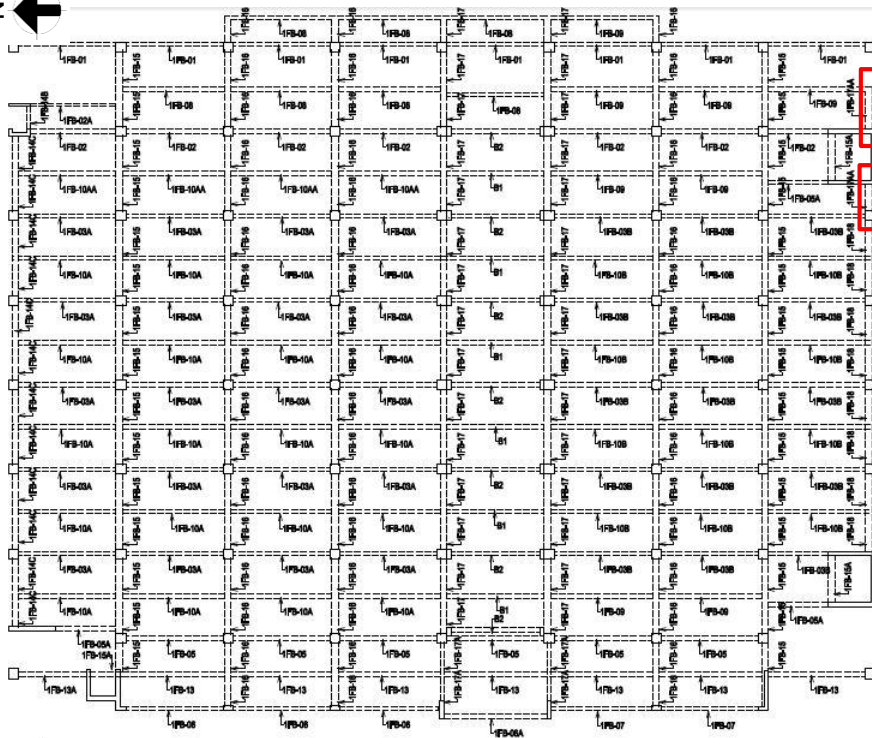
Typical beam layout

Width of the highlighted beam was found 375mm instead of 600 mm. Factory engineer is required to survey the whole structure and update the as-built drawing as per on-site condition in accordance with section 1.9.1.2 (BNBC Part-6).

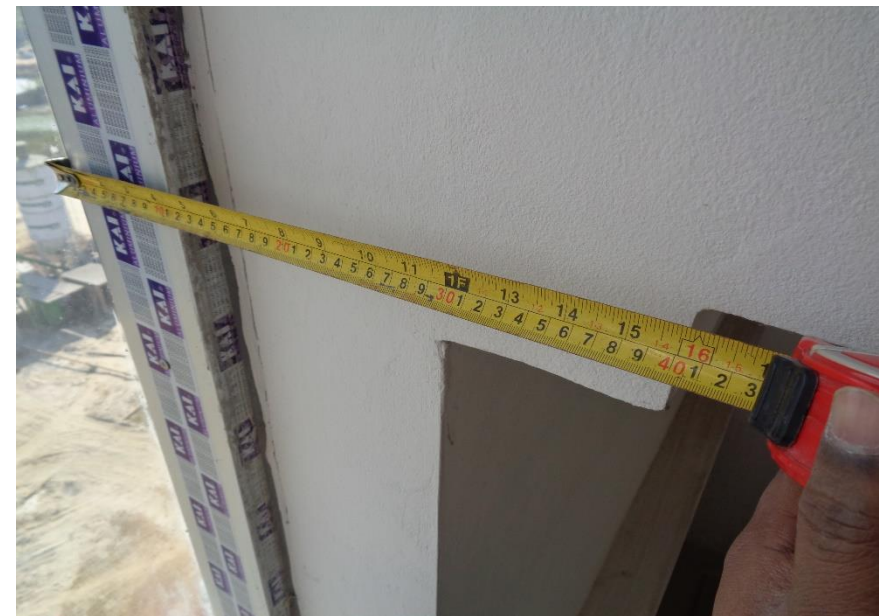
Width of the beam measured 375mm W

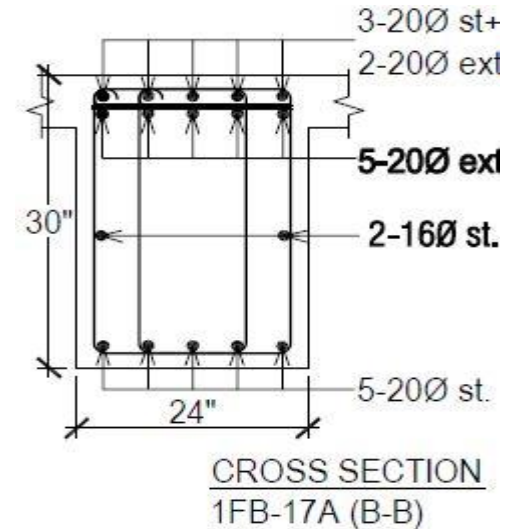
Depth of the beam shown 600 mm

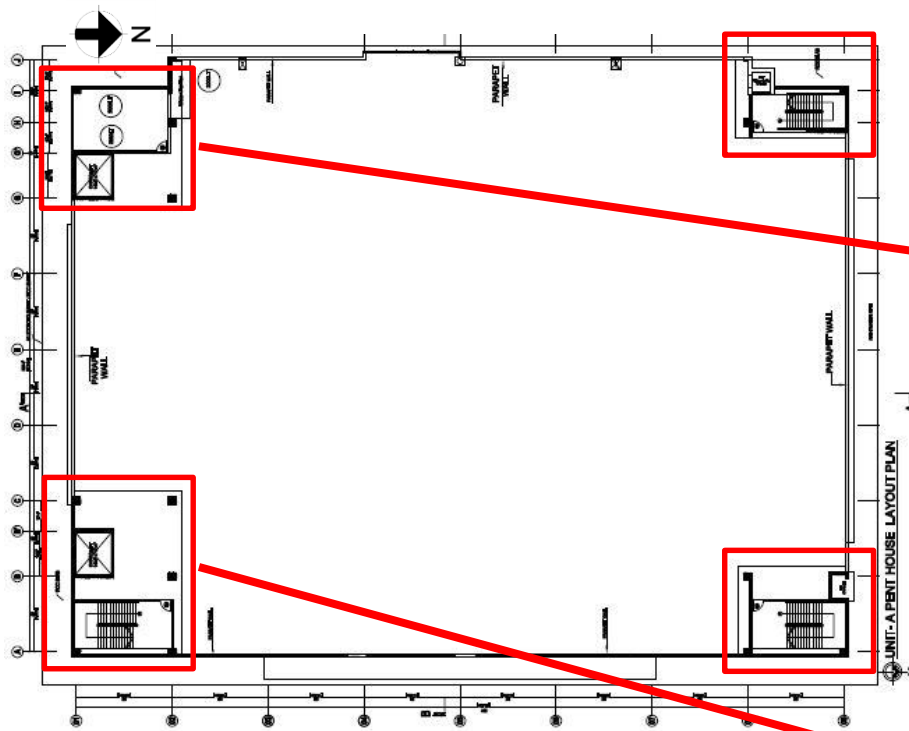
Roof layout

No detail of beam/slab was shown in provided drawing for the staircase and lift machine room at roof level. Factory engineer is required to survey the whole structure and update the as-built drawing as per on-site condition in accordance with section 1.9.1.2 (BNBC Part-6) . Also, update the Design report in accordance with 1.9.1.1 (BNBC Part-6).

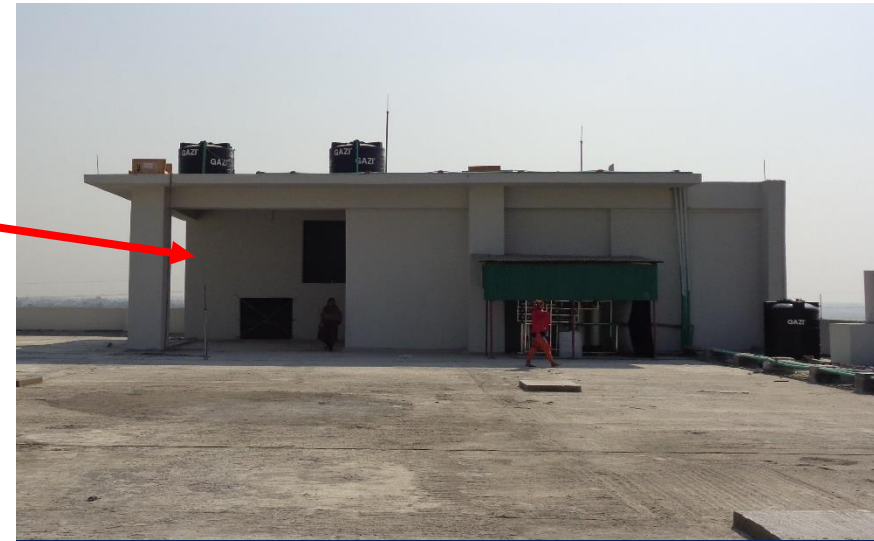
Stair room at south west side

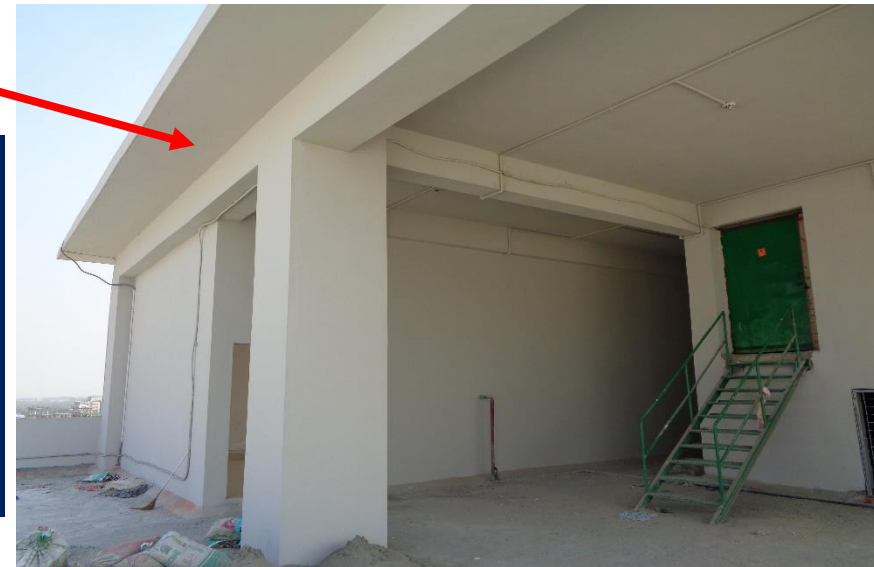
Stair and lift area at south east corner

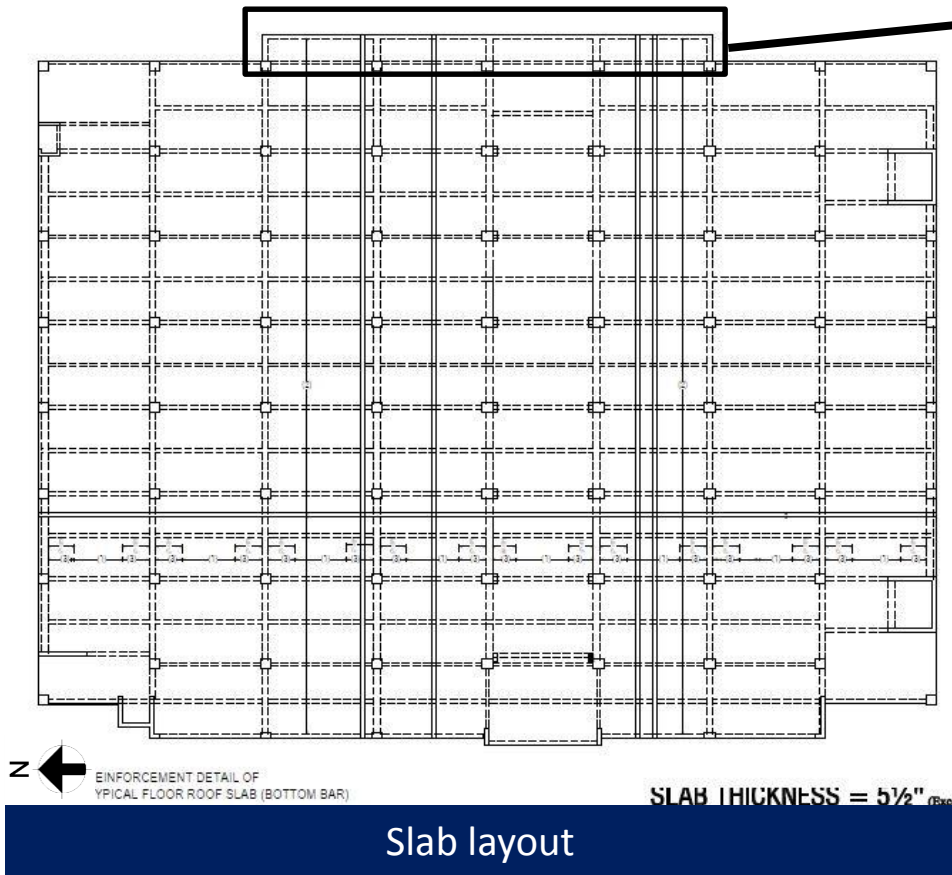
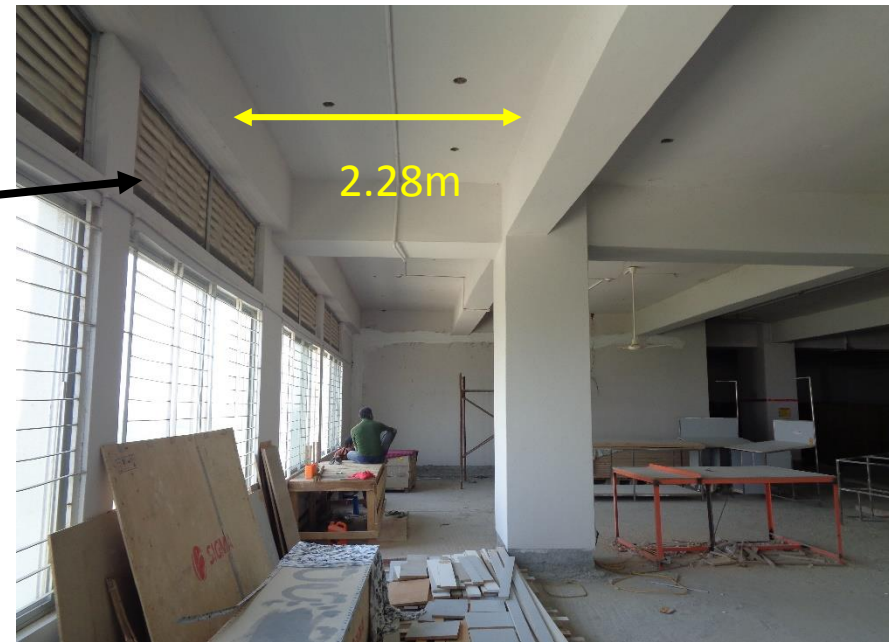
Dimension of cantilever was measured 2.28m

Dimension of cantilever at highlighted locations was not shown in provided drawing. Dimension of cantilever was measured 2.28m. Factory engineer is required to survey the whole structure and update the as-built drawing as per on-site condition in accordance with section 1.9.1.2 (BNBC Part-6). Also, update the Design report in accordance with 1.9.1.1 (BNBC Part-6).

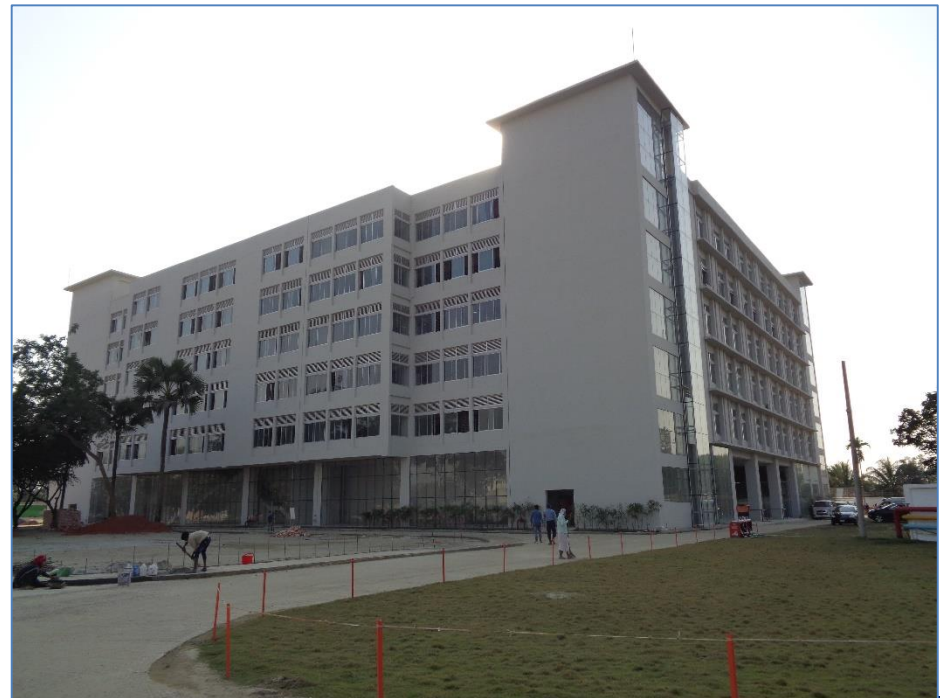
A Design Report was provided for the Main Building at the time of inspection which is prepared based on software analysis. Slab adequacy check was not provided in the design report. Also, wind speed was considered 210 Km/h instead of 215km/h for the specified area. Moreover, response modification coefficient  $R=9$  has been considered in design report. No calculation has been provided regarding IMRF in the design report.

| Item No. | Observation | Recommended Action Plan | Recommended Timeline |
|---|---|---|---|
| 4 | Inconsistencies in the design report (Main Building) | Building engineer is required to check the Design Report as per BNBC and incorporate proper loading assignment. | 6-weeks |
| 5 | Inconsistencies in the design report (Main Building) | Building engineer is required to provide slab adequacy check for 4.7 kPa live load. | 6-weeks |

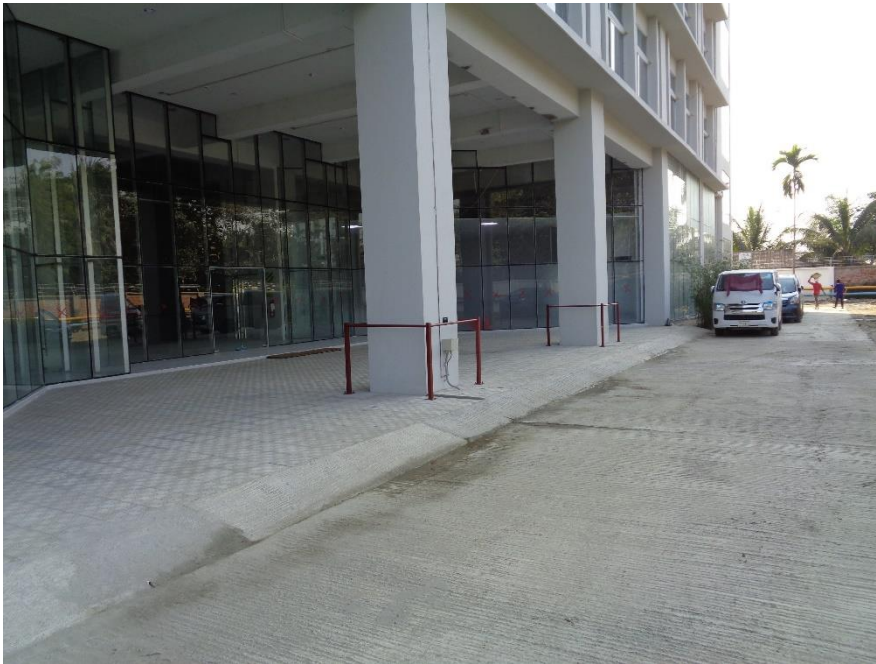
Barrier provided with thin member

Barrier provided for some columns to prevent the vehicle impact, but the members installed as barrier appears to be thin and fragile. Factory is required to provide the barrier to prevent vehicle impact with proper engineering calculation against possible vehicle load.

| Item No. | Observation | Recommended Action Plan | Recommended Timeline |
|---|---|---|---|
| 7 | Protection against vehicle impact appears to be inadequate (Main Building) | Factory is required to provide the barrier to prevent vehicle impact with proper engineering calculation against possible vehicle load. | 6-weeks |

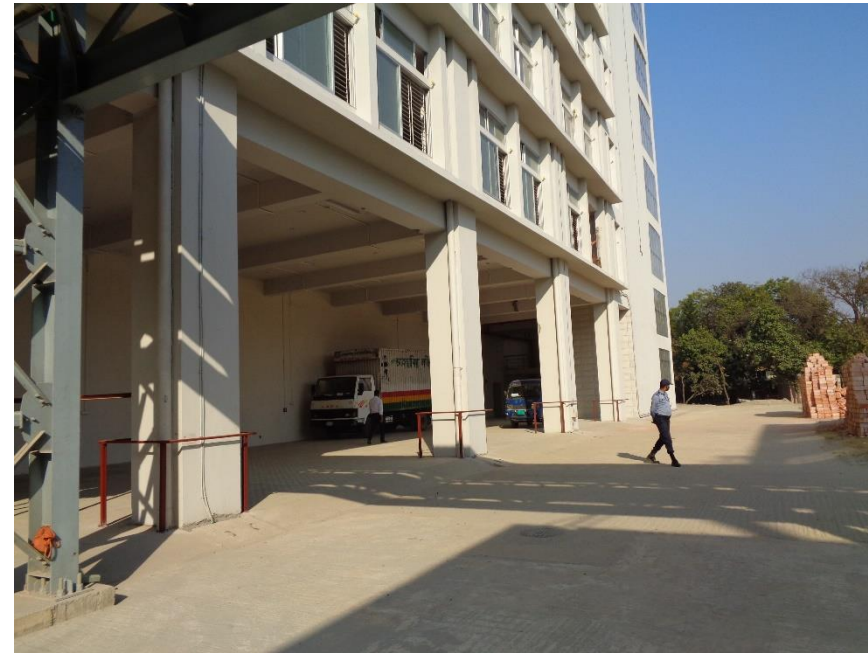
Barrier provided with thin member

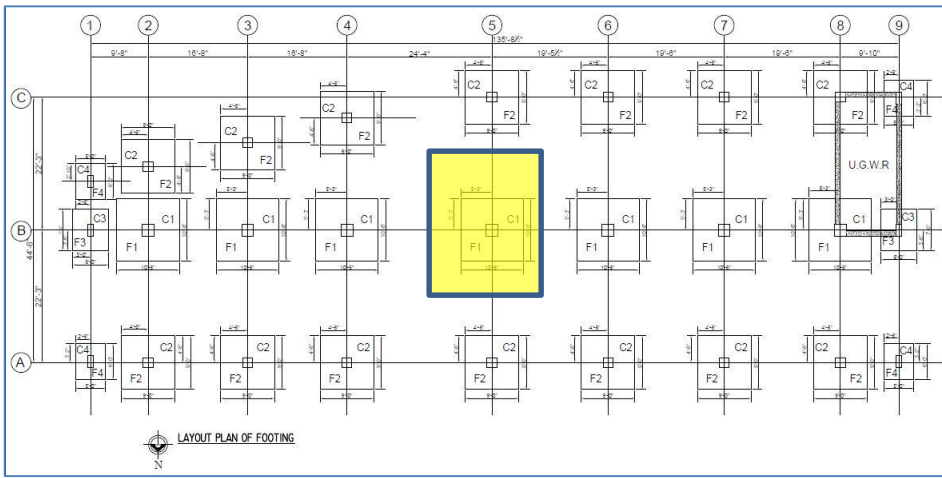
Footing Layout Plan.

Cursory calculation indicates that stress in foundation exceeds normal design limit in the highlighted area considering the prepared live load plan (11.9 KPa for typical floor and roof). Factory engineer is required to review the adequacy of footings and comply with BNBC as a part of Engineering Assessment (EA). Also, maintain live load below 5 KPa at all floor areas including roof until the Engineering Assessment (EA) is finalized.

| Item No. | Observation | Recommended Action Plan | Recommended Timeline |
|---|---|---|---|
| 8 | Stress in foundation exceeds normal design limit as per provided load plan (Utility Building) | Factory engineer is required to review the adequacy of footings and comply with BNBC as a part of Engineering Assessment (EA). | 6-weeks |
| 9 | Stress in foundation exceeds normal design limit as per provided load plan (Utility Building) | Maintain live load below 5 KPa at all floor areas including roof until the Engineering Assessment (EA) is finalized. | 6-weeks |

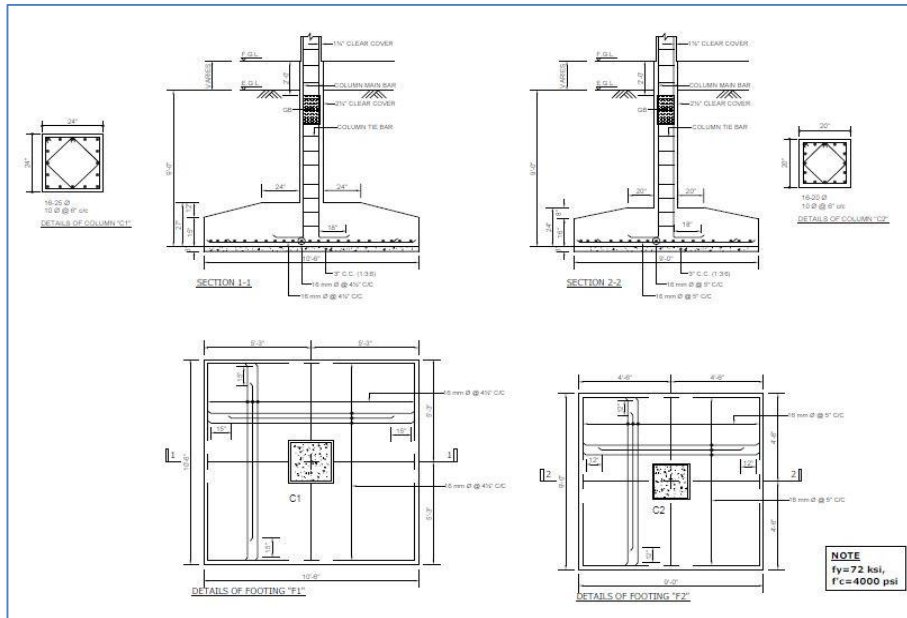
Marked footings are shown as overstress in existing Design Report

In existing Design Report, some footings are demonstrated as overstressed considering live load as 11.9 kPa but no remediation plan is proposed for those overstressed footings. Factory engineer is required to propose remediation plan as a part of the Engineering Assessment (EA) and implement accordingly.

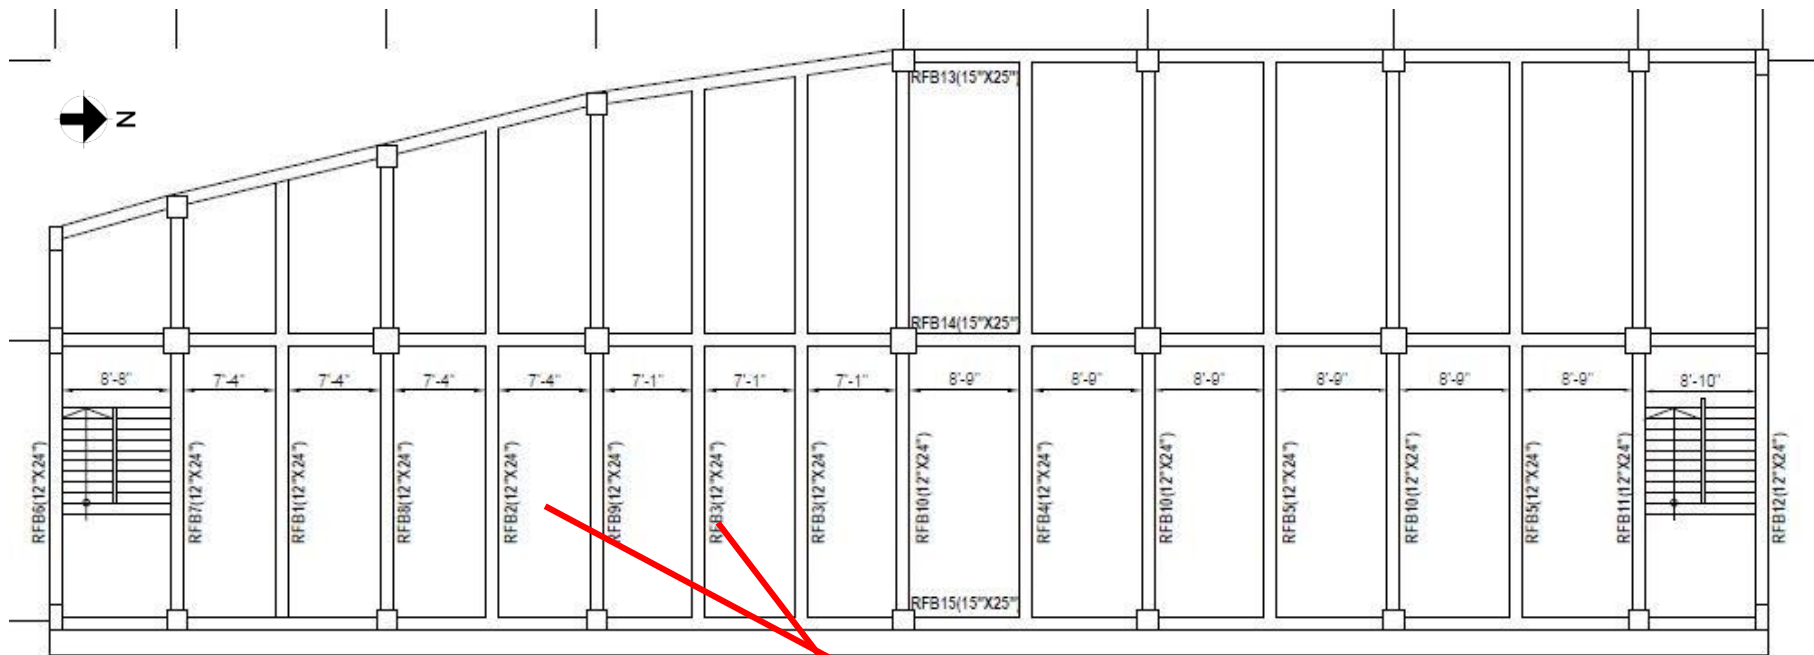
Roof beam layout

Dimension of same beam is shown differently in beam layout and beam section. For example, width of RFB-2 shown in layout but in section dimension shown for the same beam as 350mm. However, dimension of all beams was found as per section of the beam. Factory engineer is required to survey the whole structure and update the as-built drawing as per on-site condition in accordance with section 1.9.1.2 (BNBC Part-6).

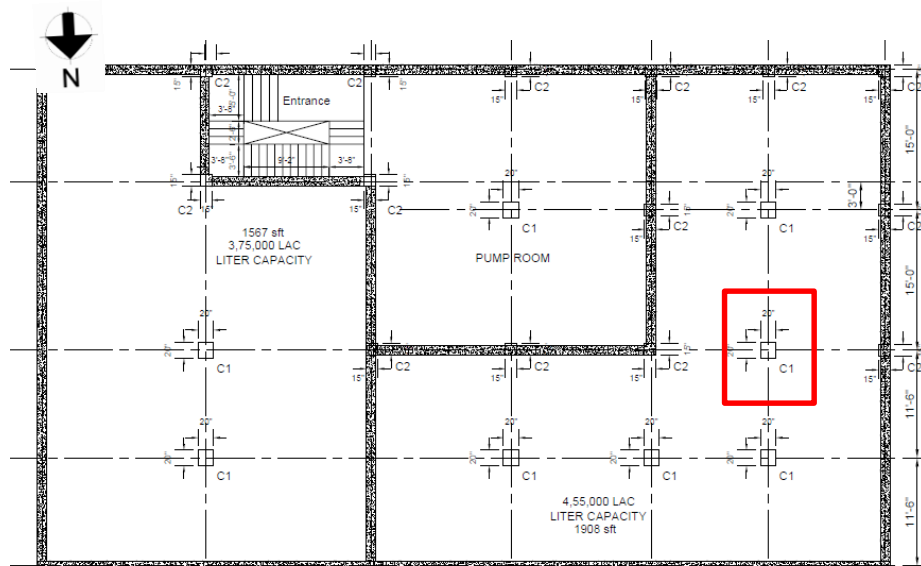
Dimension shown 500mmX500

Column layout is not produced separately for Ground floor. Dimension column C-1 at grid F-3 was found 375mmX375mm instead of 500mmX500mm (shown in provided drawing). Factory engineer is required to survey the whole structure and update the as-built drawing as per on-site condition in accordance with section 1.9.1.2 (BNBC Part-6). Also, review column the stress in accordance with 1.9.1.1 (BNBC Part-6).

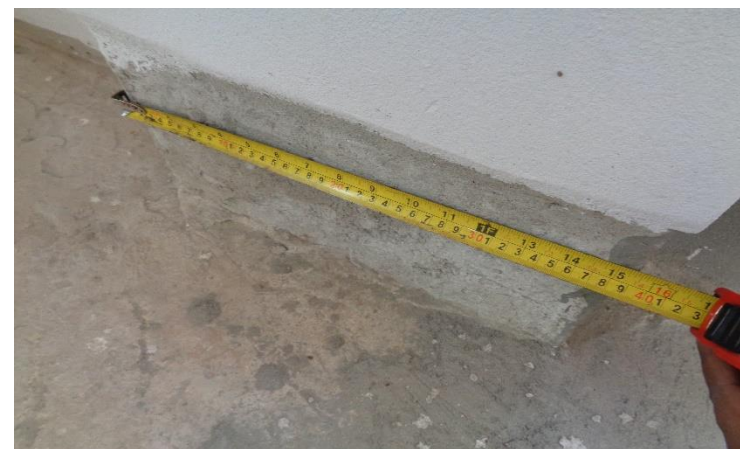
Dimension found 375mmX375mm

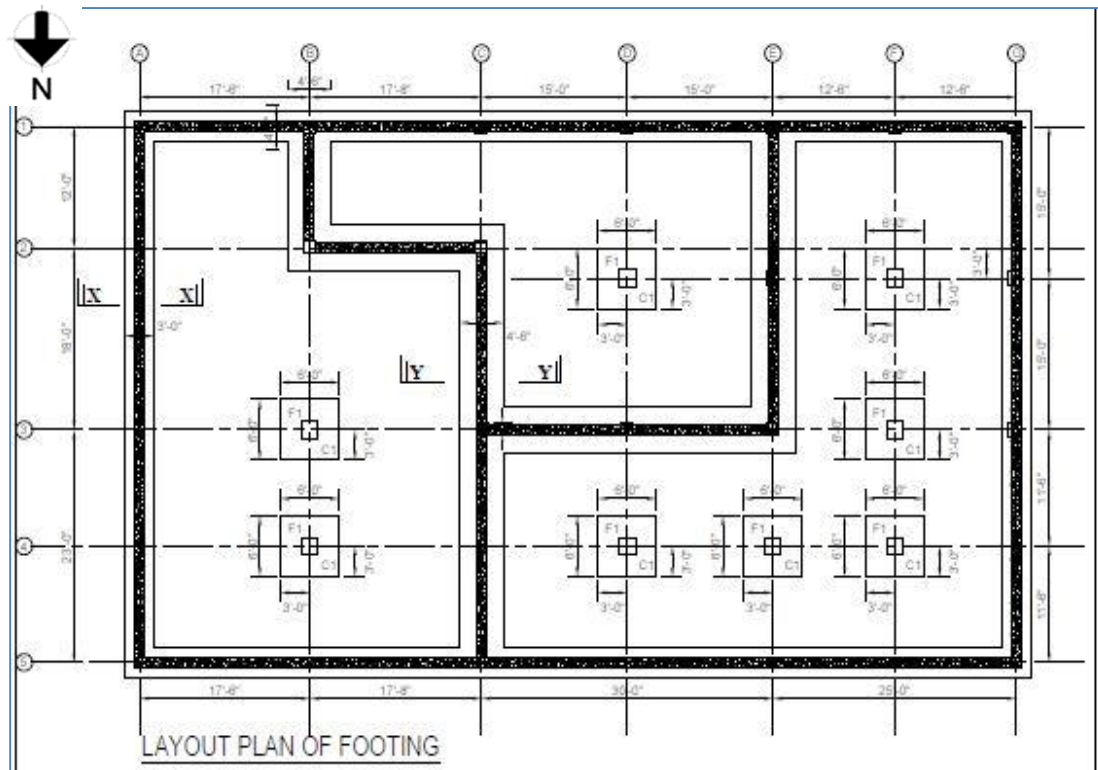
Foundation layout (Isolated footing)

Foundation depth from Existing Ground Level (EGL) not shown in provided drawing. Factory engineer is required to survey the whole structure and update the as-built drawing as per on-site condition in accordance with section 1.9.1.2 (BNBC Part-6).

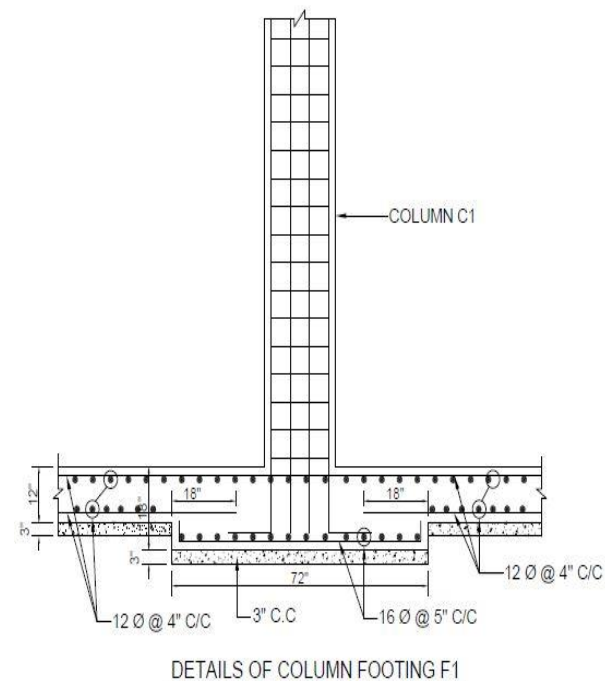
Foundation depth is not mentioned in drawing

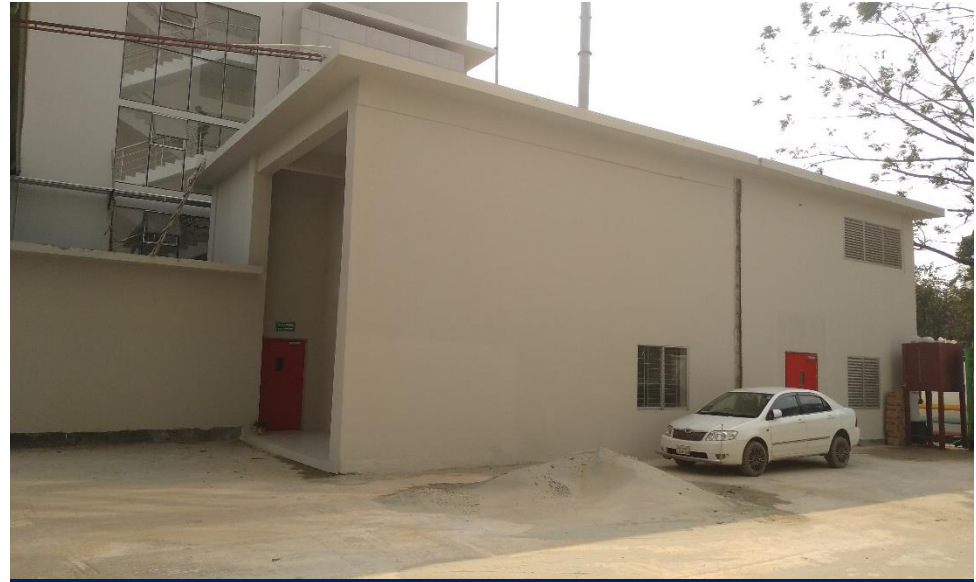
As per BNBC, every building or structure designed shall have its design documents prepared in accordance with the provision of Section 1.9.1. The design document shall include a design report, and a set of structural drawings, which shall be prepared in compliance with section 1.9.1.1 and section 1.9.1.2 as per BNBC. At the time of inspection, only as-built drawing, load plan and geotechnical report were available, but no design report was available which is required to be prepared in compliance with section 1.9.1.1 (part-6, BNBC).

No design report was available for Boiler Building

| Item No. | Observation | Recommended Action Plan | Recommended Timeline |
|---|---|---|---|
| 16 | Absence of design documents (Boiler Building) | Factory engineer is required to prepare the design documents including a design report, and a set of structural drawings in compliance with section 1.9.1.1 and section 1.9.1.2 as per BNBC part 6 and submit to RSC for review. | 6-weeks |
