Mondol Intimates Limited New Building

Shirir chala, Bagar Bazar, Mohona Bhabanipur, Gazipur sadar, Gazipur, Bangladesh
(24.1651181 90.4287471)
10th February 2021

1. Factory Building (Building 2) (G+8)

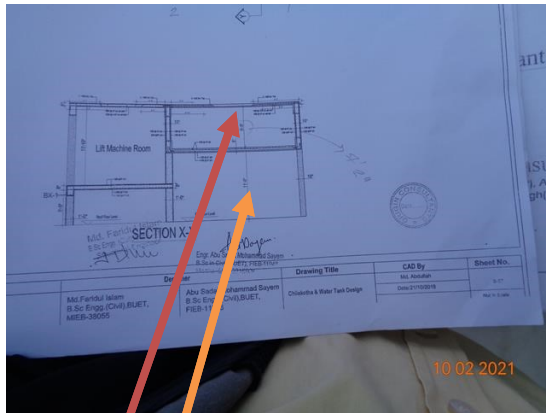
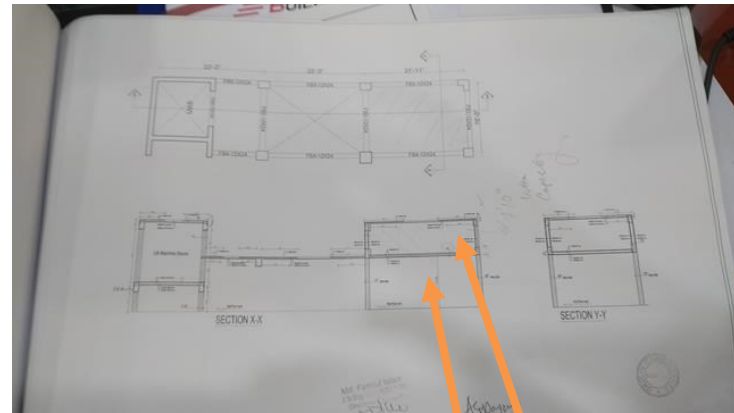
Discrepancies in as-built drawing

| Item No. | Observation | Recommended Action Plan | Recommended Timeline |
|---|---|--|---|
| 01 | Discrepancies in as-built drawing [Building 2]. | Factory Engineer to survey the structure and prepare accurate as-built (architectural and structural) drawings in compliance with section 1.9.1.2 as per BNBC. | 6-weeks |

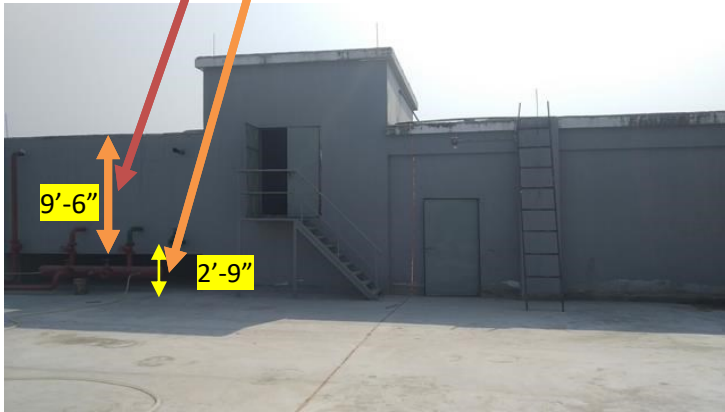
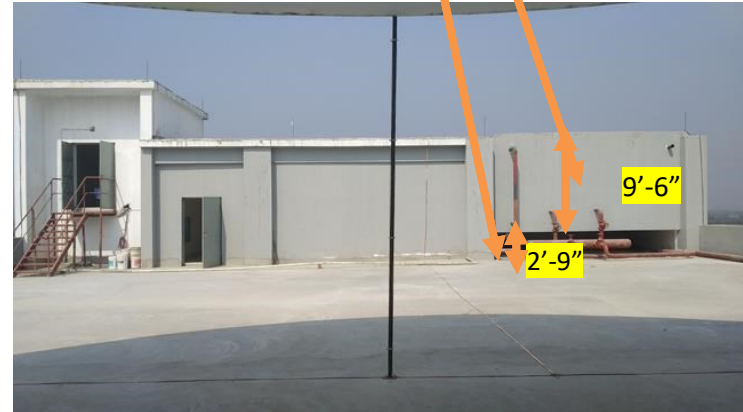
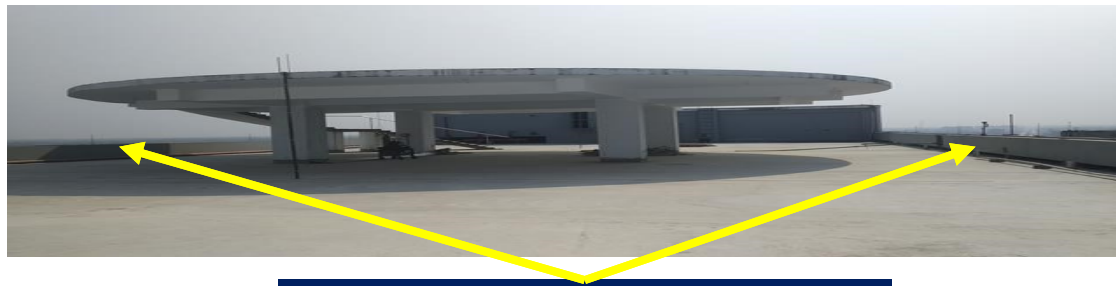
Over Head Water Tank Section

Gardening-Not shown in drawing

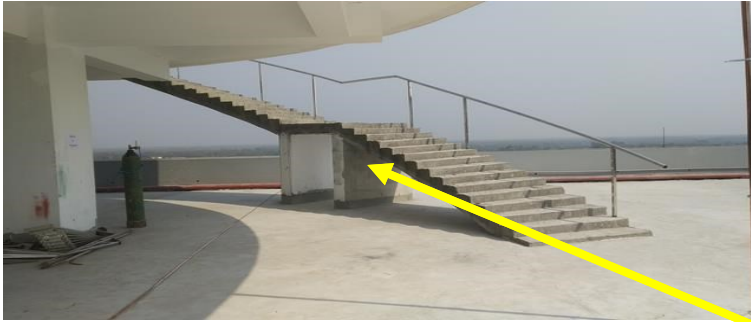
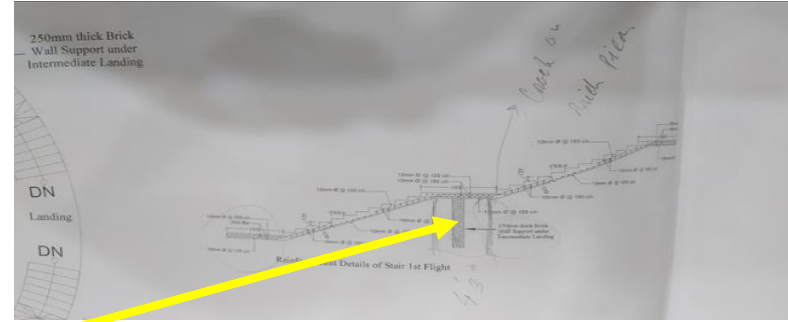
Stair (Roof to Helipad) supported by two brick wall, but one brick wall is shown in drawing

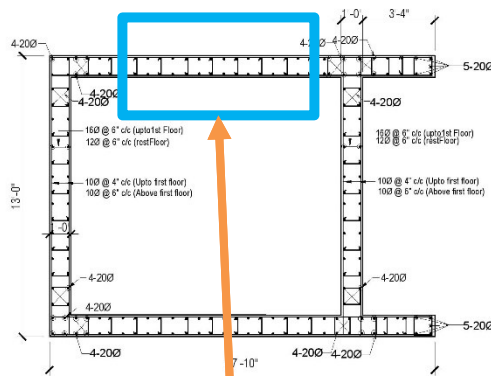
Lift Wall Reinforcement Detail (SW1)
Below EGL AND 1ST TO TOP FLOOR

SW1: Door Opening-
Not Shown in Drawing

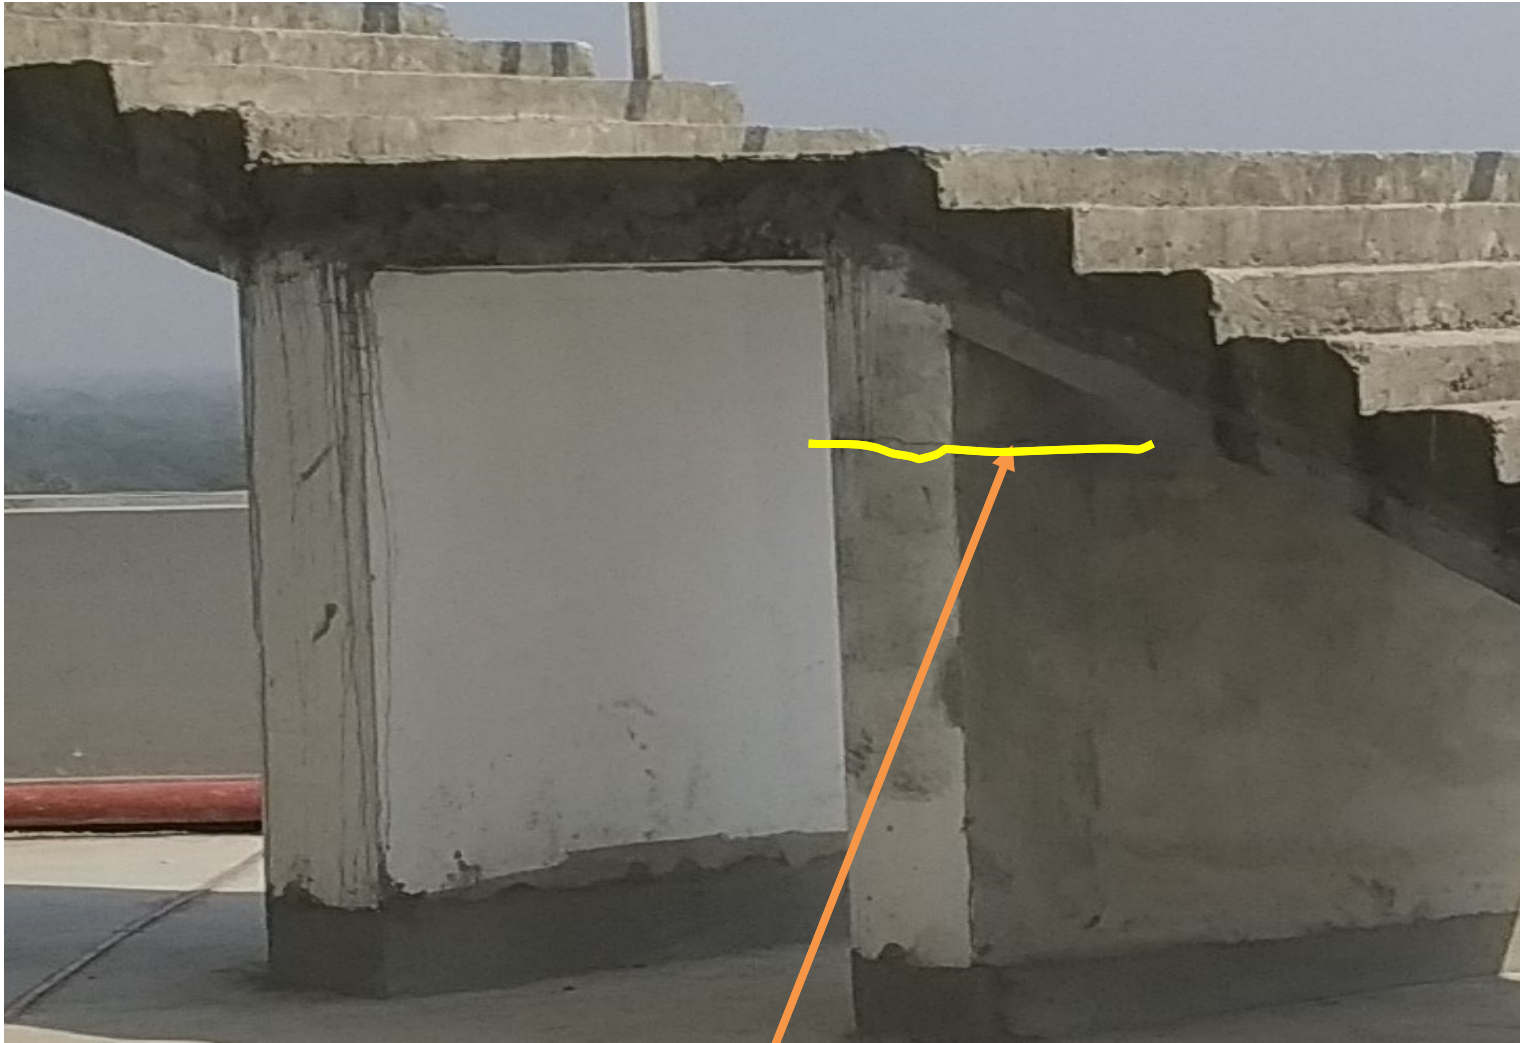
Crack in brick wall

Cracks was found in brick wall supporting stair (roof to helipad). Factory engineer is required to investigate the cause of crack and repair the crack as per recommendation from investigation report.

| Item No. | Observation | Recommended Action Plan | Recommended Timeline |
|---|---|--|---|
| 02 | Crack in brick wall [Building 2]. | Factory engineer is required to investigate the cause of crack and repair the crack as per recommendation from investigation report. | 6-weeks |

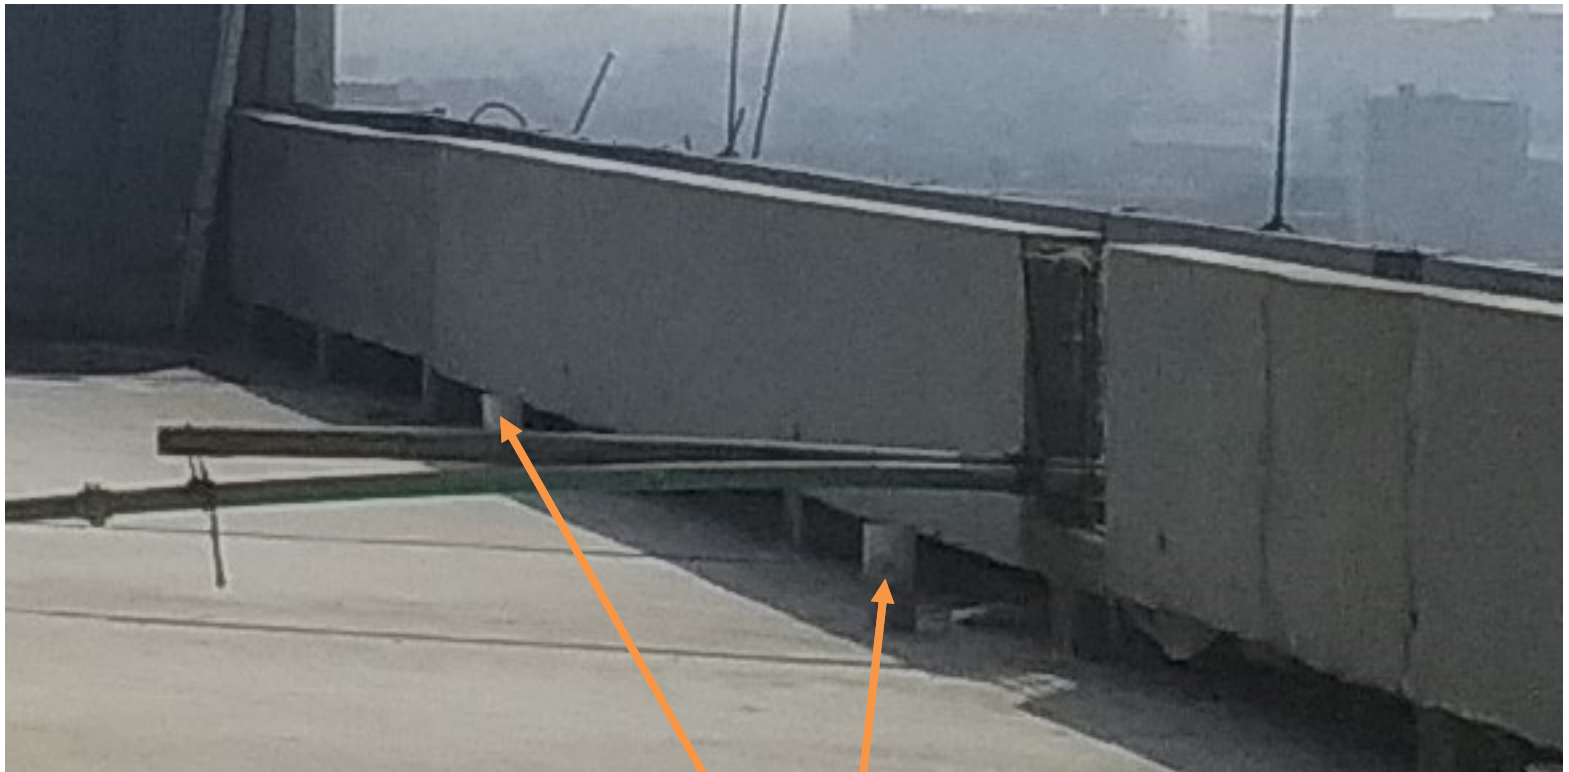
Inactive drainage pipe at roof

Drainage pipe is not active at roof.

| Item No. | Observation | Recommended Action Plan | Recommended Timeline |
|---|---|--|---|
| 03 | Inactive drainage pipe at roof [Building 2]. | Factory engineer is required to remove all obstacles from inlet of roof drainage pipe and improve roof drainage system. | 6-weeks |

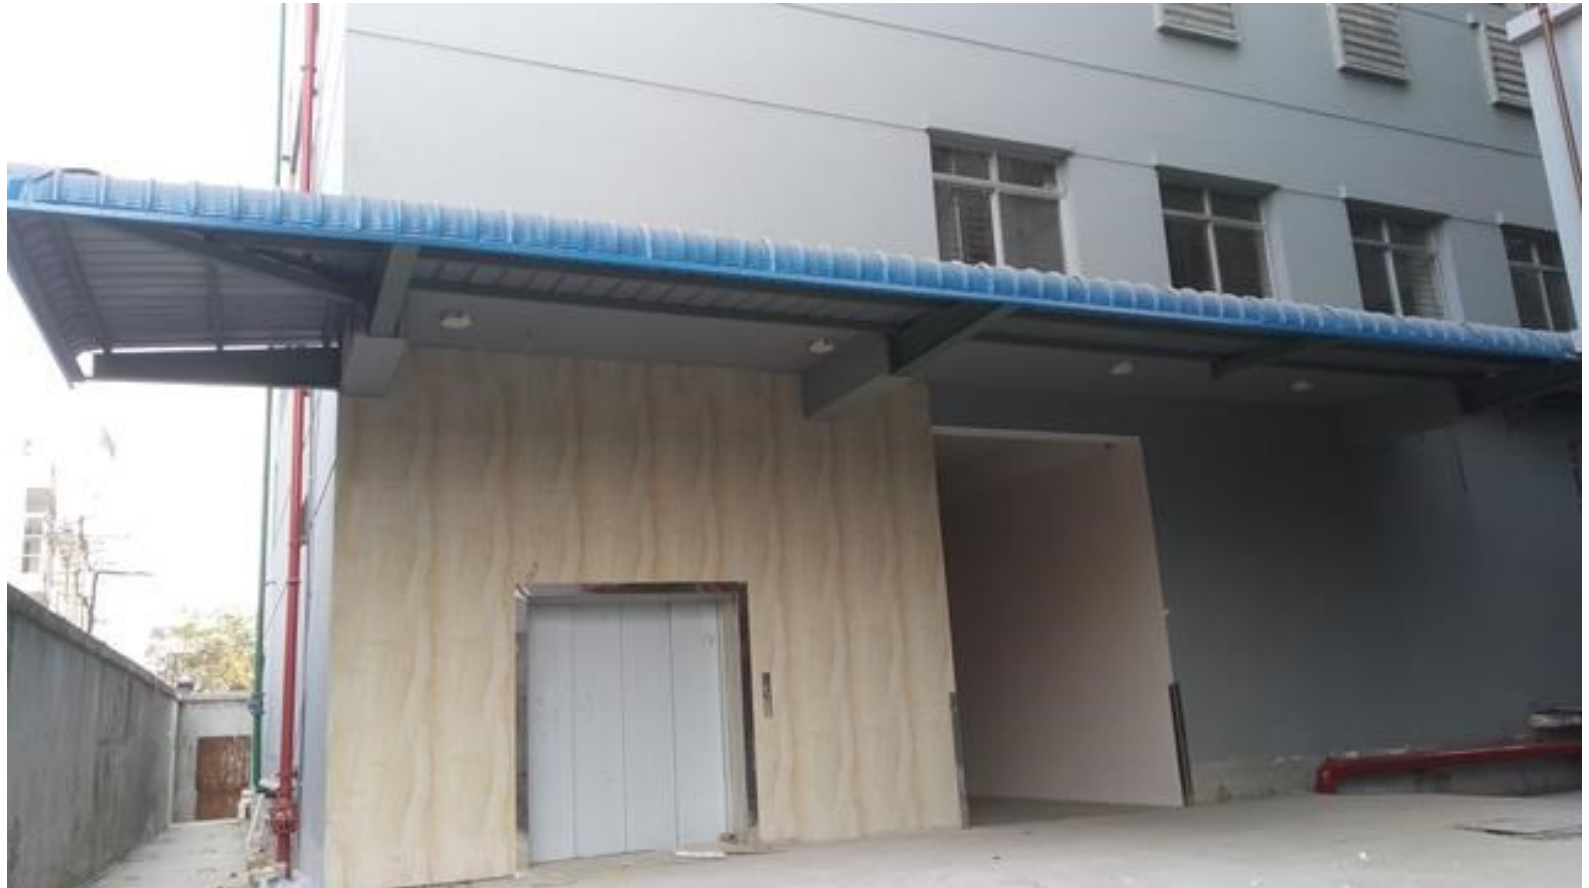
Adequacy Check of Canopy.

No detailing of canopy. Factory is required to produce detailing and check adequacy of canopy.

| Item No. | Observation | Recommended Action Plan | Recommended Timeline |
|---|---|--|---|
| 04 | Adequacy Check of Canopy [Building 2]. | Factory engineer is required to produce as-built drawing in compliance with section 1.9.1.2 as per BNBC. | 6-weeks |
| 05 | Adequacy Check of Canopy [Building 2]. | Check adequacy of member size and connection of canopy. | 6-weeks |

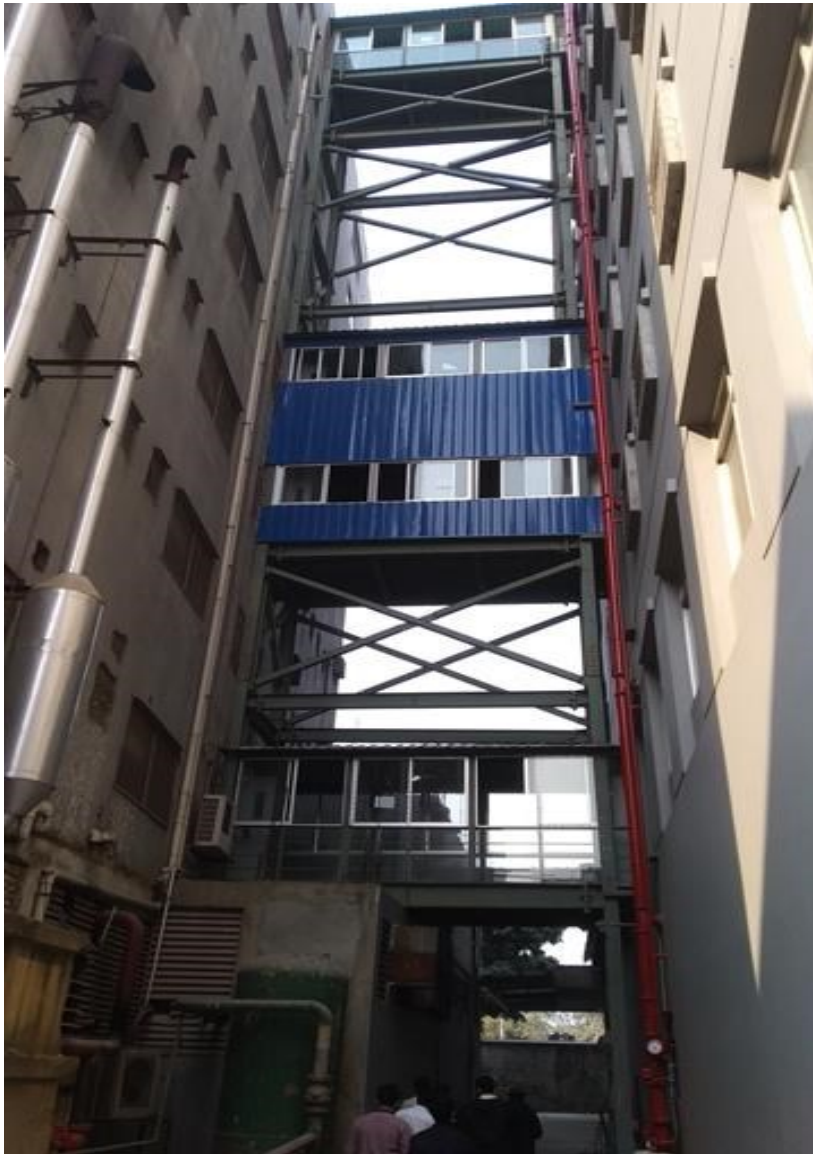
Unavailable structural design report

As per BNBC every structure designed shall have its design documents prepared in accordance with the provision of section 1.9.1. The design document shall include a design report, and a set of structural drawings, which shall be prepared in compliance with section 1.9.1.1 and section 1.9.1.2 as per BNBC.

Design report of connecting bridge was not found which is required to be prepared in compliance with section 1.9.1.1 (part-6, BNBC).

| Item No. | Observation | Recommended Action Plan | Recommended Timeline |
|---|---|---|---|
| 06 | Unavailable structural design report [Connecting Bridge]. | Factory engineer to prepare the design document including a design report, and a set of structural drawings in compliance with section 1.9.1.1 and section 1.9.1.2 as per BNBC. | 6-weeks |
| 07 | Unavailable structural design report [Connecting Bridge]. | Review the design of the structures considering the gravity & lateral loading described in BNBC. | 6-weeks |

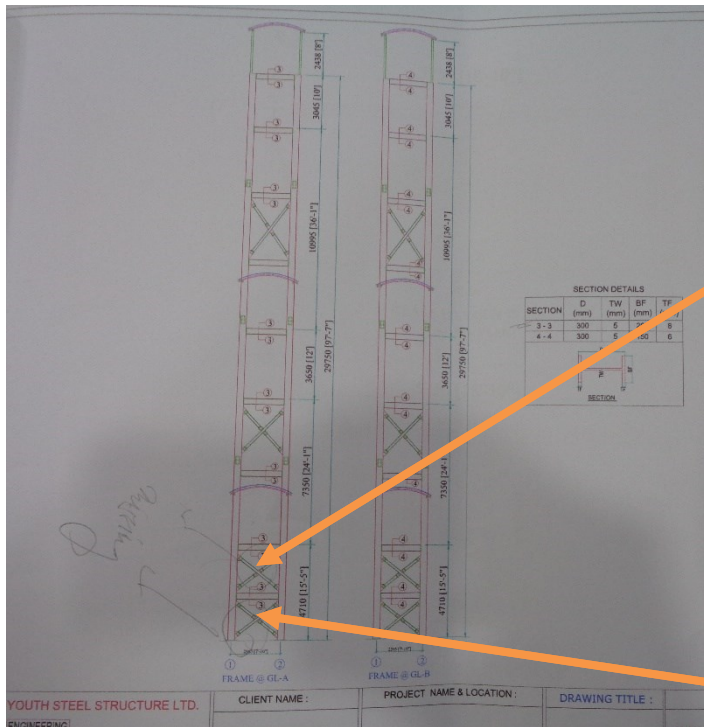
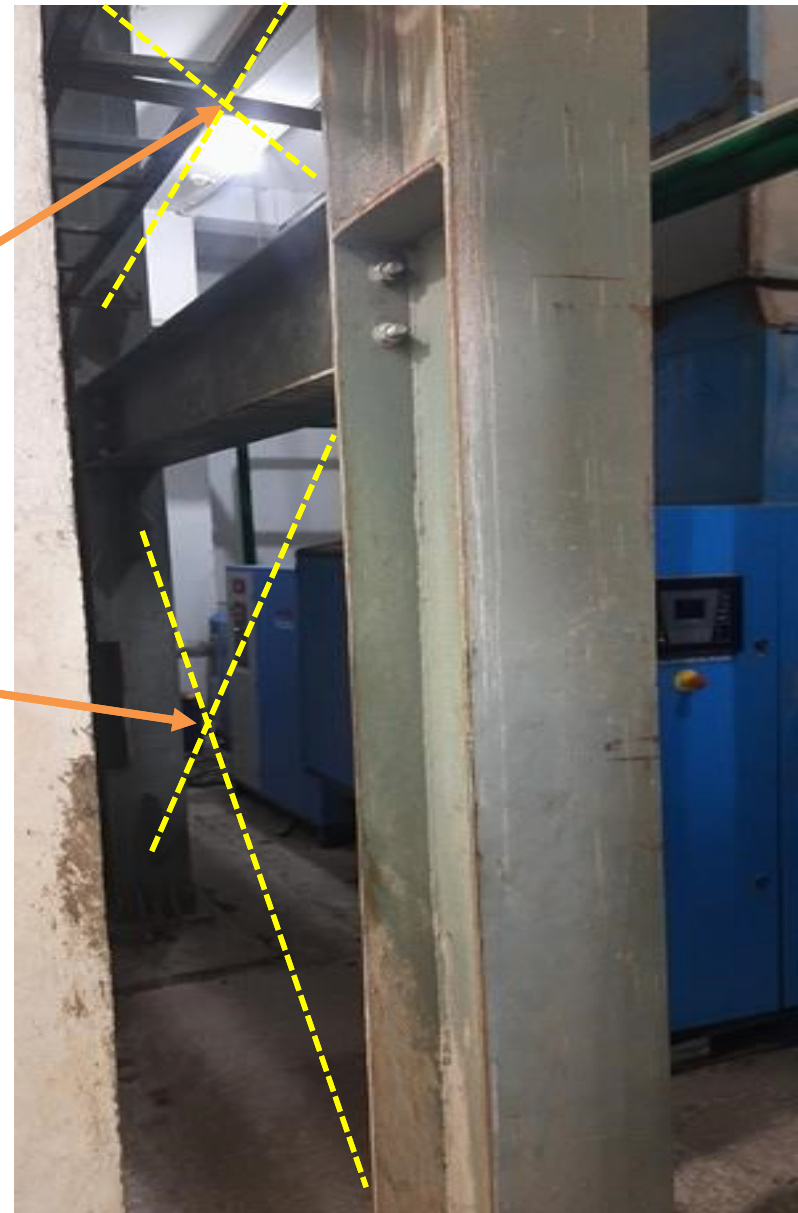
Bracing Missing at several locations

Bracing missing at several Location. Factory engineer is required to install missing bracing or check the stability of the bridge for existing condition.

| Item No. | Observation | Recommended Action Plan | Recommended Timeline |
|---|---|---|---|
| 08 | Bracing missing at several locations [Connecting Bridge]. | Factory engineer is required to install missing bracing or check the stability of the bridge for existing condition. | 6-weeks |

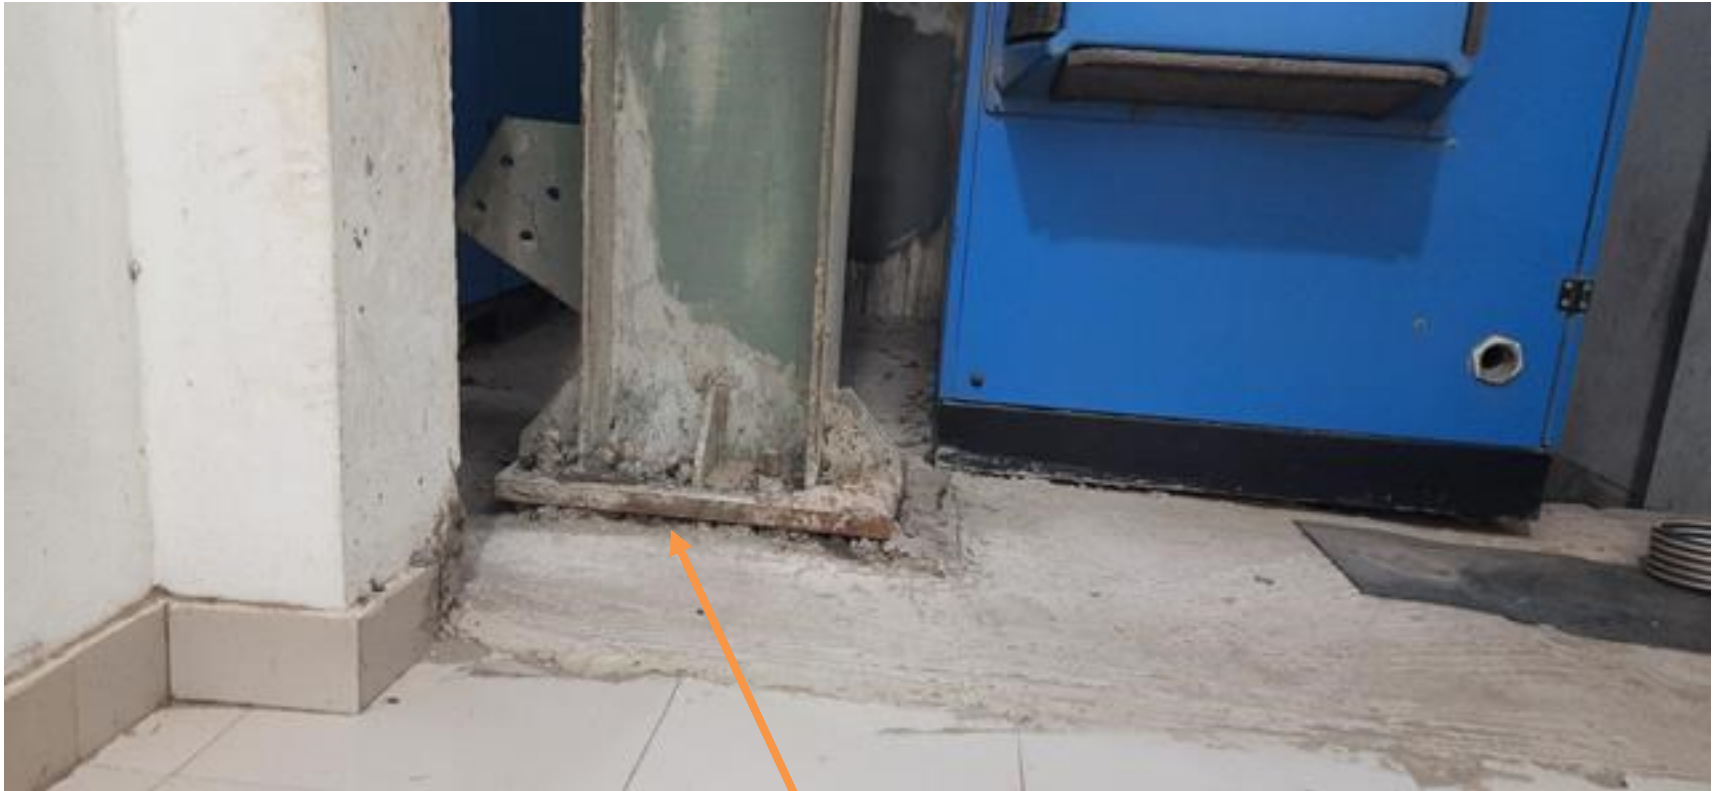
Gap between pedestal column and steel base plate

Gap between pedestal column and steel base plate. Factory is required to fill the gap properly..

| Item No. | Observation | Recommended Action Plan | Recommended Timeline |
|---|---|---|---|
| 09 | Gap between pedestal column and steel base plate [Connecting Bridge]. | Factory engineer is required to fill the gap with suitable materials. | 6-weeks |

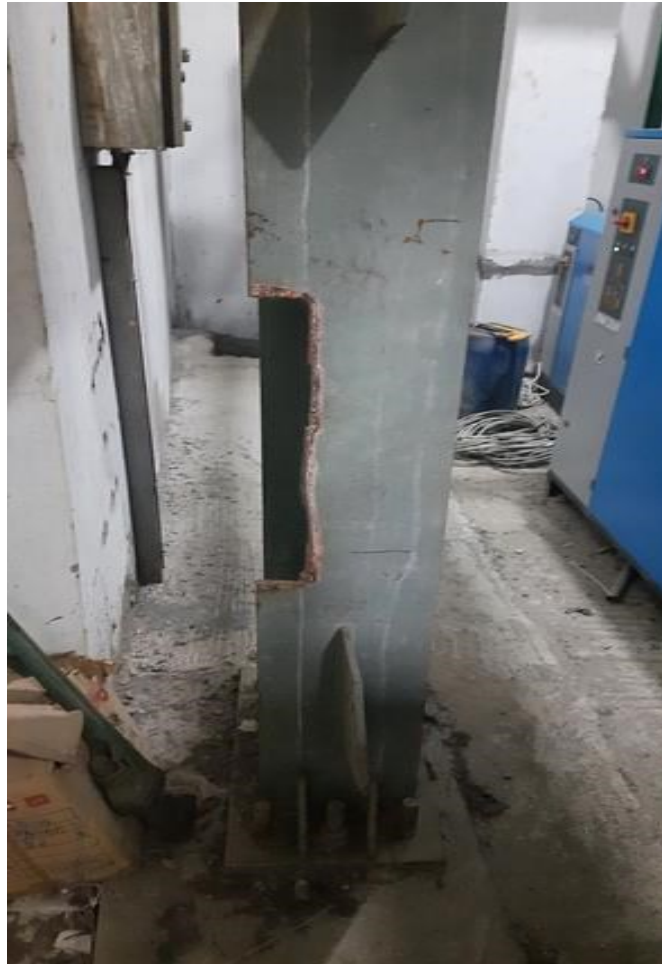
Plate cutting for testing- not filled

A portion is cut from flange of steel column. Factory is required to fill the portion with steel plate of same strength.

| Item No. | Observation | Recommended Action Plan | Recommended Timeline |
|---|---|---|---|
| 10 | Plate cutting for testing- not filled. [Connecting Bridge]. | Factory engineer is required to fill the cut portion with steel plate of same strength. | 6-weeks |
