# Lavender Garment Limited

Mouchak, Kaliakoir, Gazipur

11 December 2022

# Buildings Information

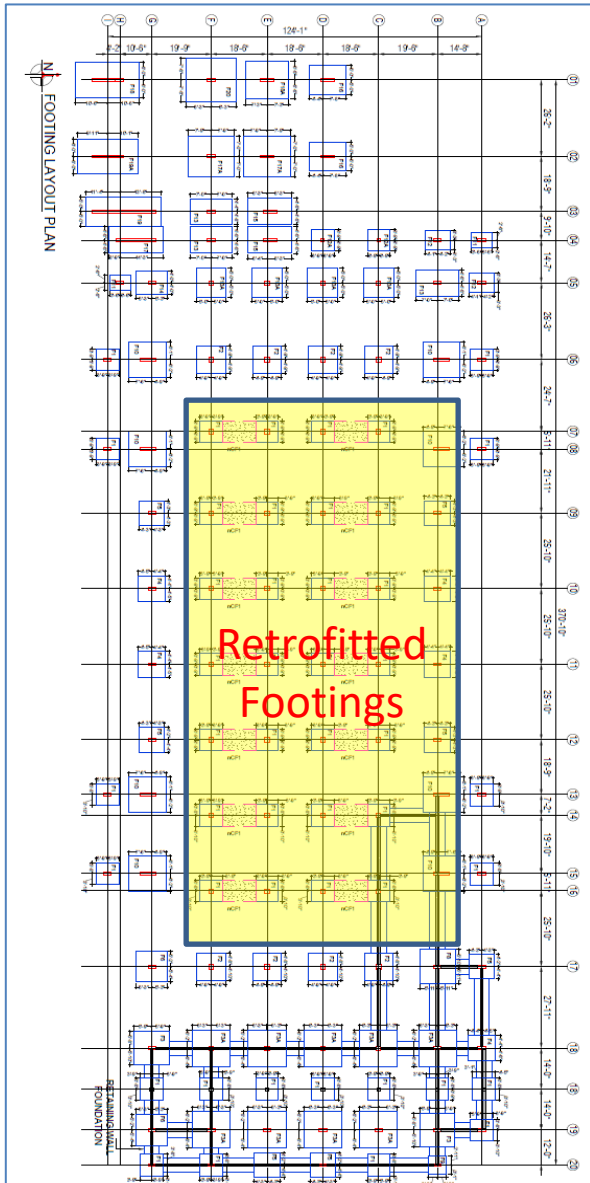
Footing Layout

Reference/construction drawings were not available for the production Building. Also, some footings have been retrofitted at middle. Only a sectional details have been provided for these footings, but no pictorial evidence or material test report was found for the retrofitted footings. The building engineer is required to provide reference drawings with proper evidence of retrofitting works.

| Item No. | Observation | Recommended Action Plan | Recommended Timeline |
|---|---|---|---|
| 04 | Lack of reference drawings and lack of information in as-built drawing (Building-1) | Building engineer to survey the structure and prepare as-built structural drawings with clear connection details. | 6-weeks |
| 05 | Lack of reference drawings and lack of information in as-built drawing (Building-1) | Building engineer is required to provide reference drawings with proper evidence of retrofitting works. | 6-weeks |

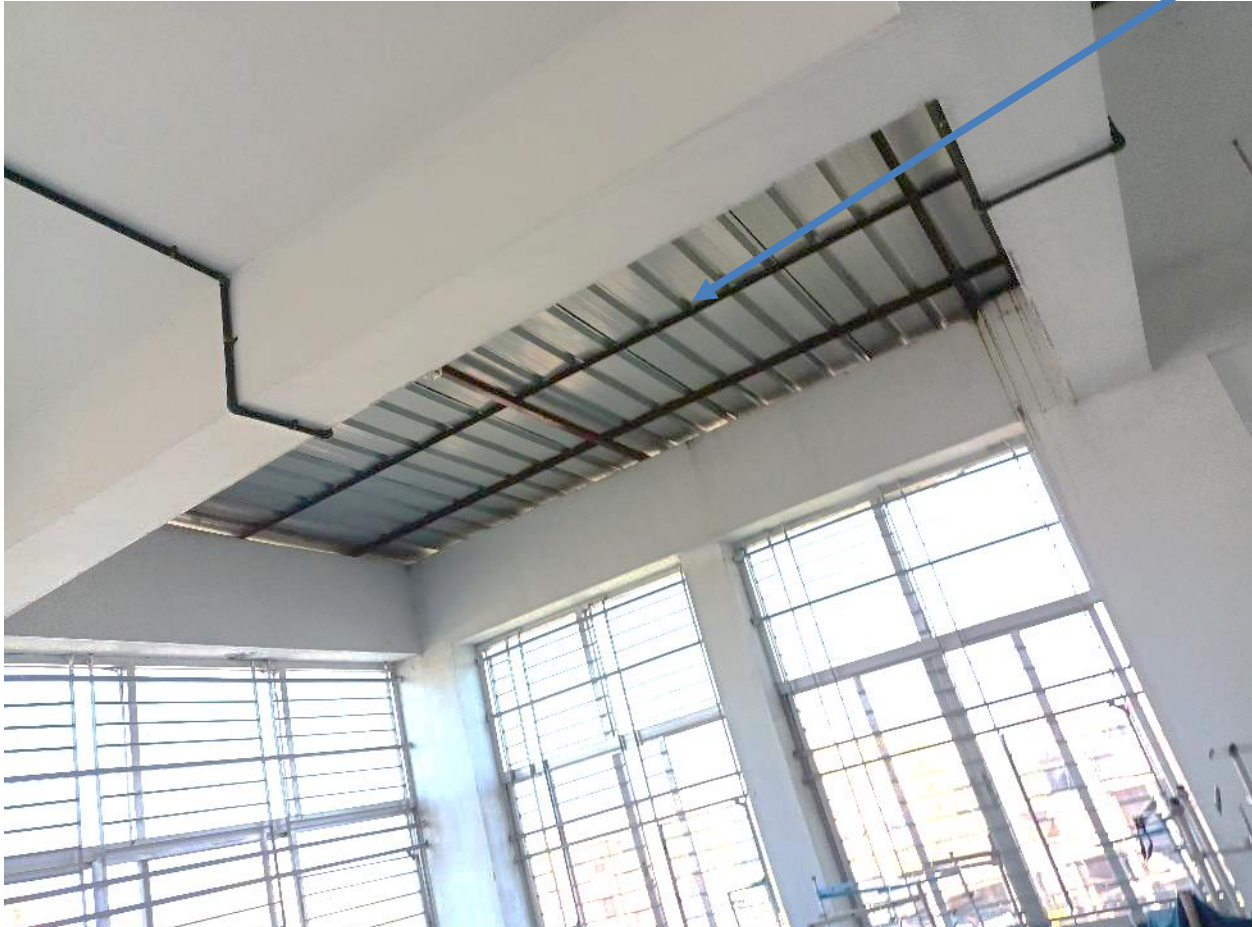
Undocumented Lightweight Roof

A small portion of steel light roof was found on 2<sup>nd</sup> floor of Building-1 at Northeast corner. No structural details was available for the roof. The building engineer to survey the structure and prepare as-built structural drawings with clear connection details.

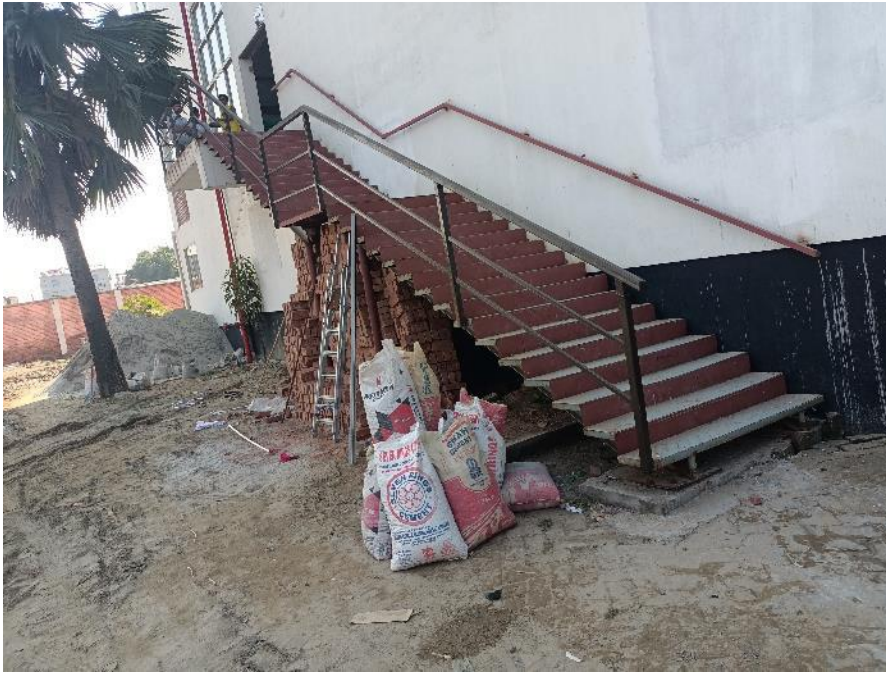
Apparently inadequate member and poor connection was observed on external steel stair at the East of the Production Building. Also, discontinue landing beam was found at mid landing of the stair.

External steel stair at East

Building engineer is required to carry out the member adequacy & stability and implement remediation where required.

| Item No. | Observation | Recommended Action Plan | Recommended Timeline |
|---|---|---|---|
| 06 | Non engineered external steel stair, apparently inadequate member & lack of lateral stability. (Building-1) | Building engineer is required to carry out member adequacy, connection adequacy & lateral stability check of the steel stair. | 6-weeks |
| 07 | Non engineered external steel stair, apparently inadequate member & lack of lateral stability. (Building-1) | Replace the existing stair with a properly designed stair or implement remediation work where necessary. | 6-months |

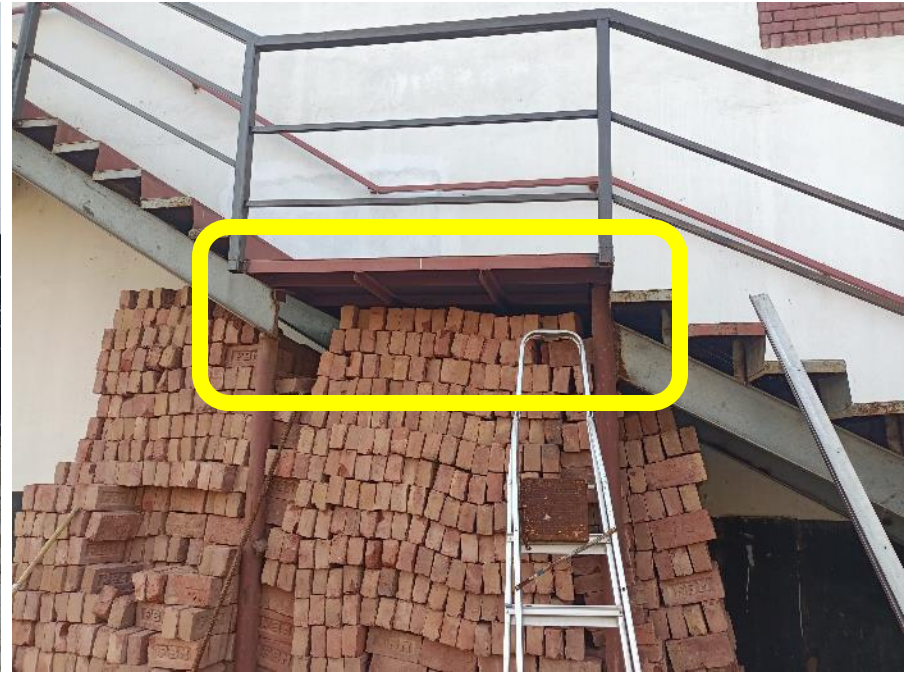
Inadequate support and discontinue beam

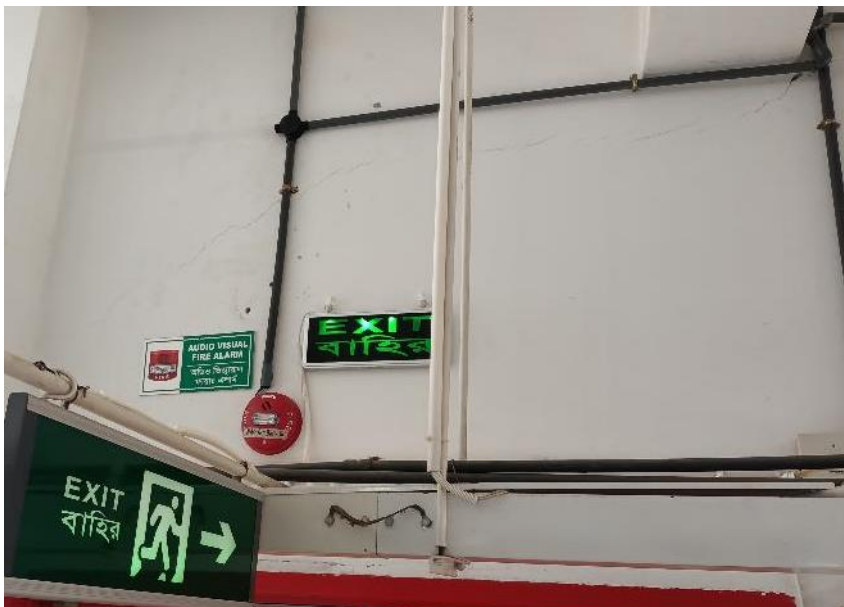
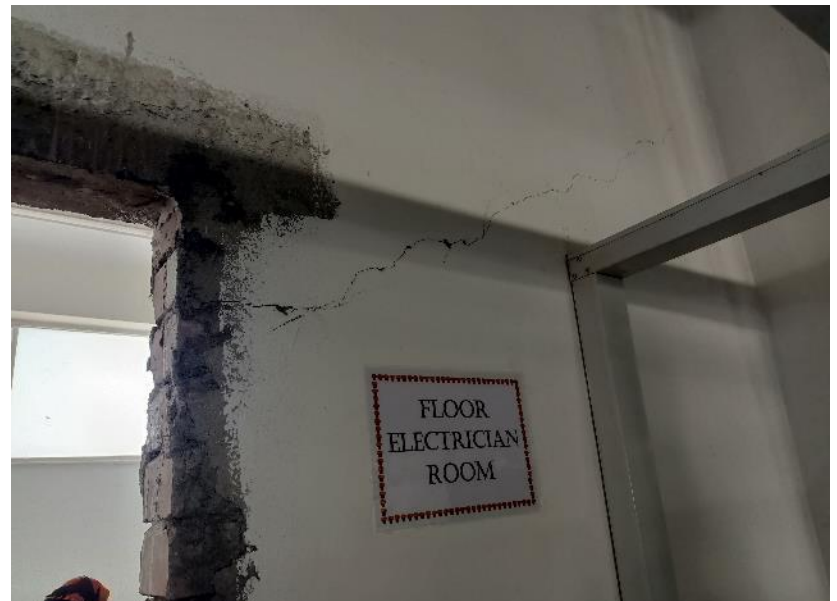
Cracks on brick wall in several location on 2nd floor

Hairline cracks were found on brick wall in several location on 2<sup>nd</sup> floor and ground floor. Factory engineer is required to investigate the cracks, produce investigation report showing extent of cracks and repair methodology. Building engineering is required to repair the cracks as per crack investigation report.

| Item No. | Observation | Recommended Action Plan | Recommended Timeline |
|---|---|---|---|
| 08 | Cracks on brick wall in several location. (Building-1) | Building engineer is required to investigate the cracks, produce investigation report showing extent of cracks and repair methodology. | 6-weeks |
| 09 | Cracks on brick wall in several location. (Building-1) | Building is required to repair the cracks as per crack investigation report. | 6-weeks |

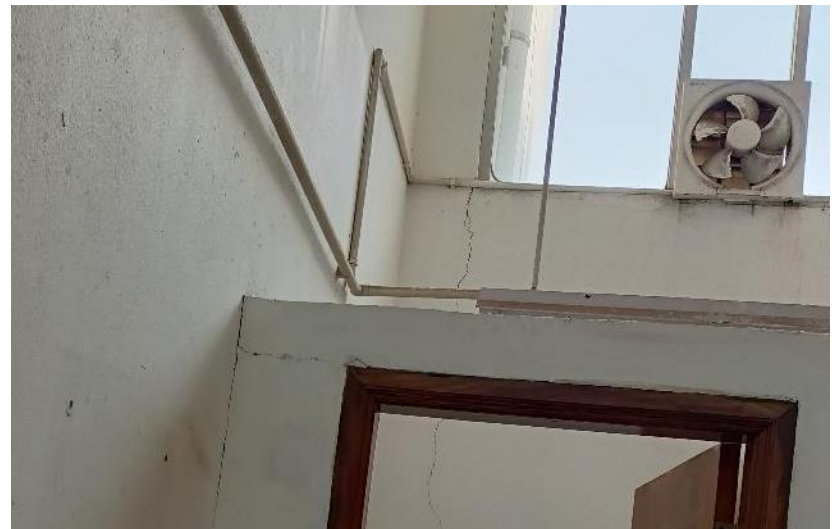
Cracks on brick wall on ground floor

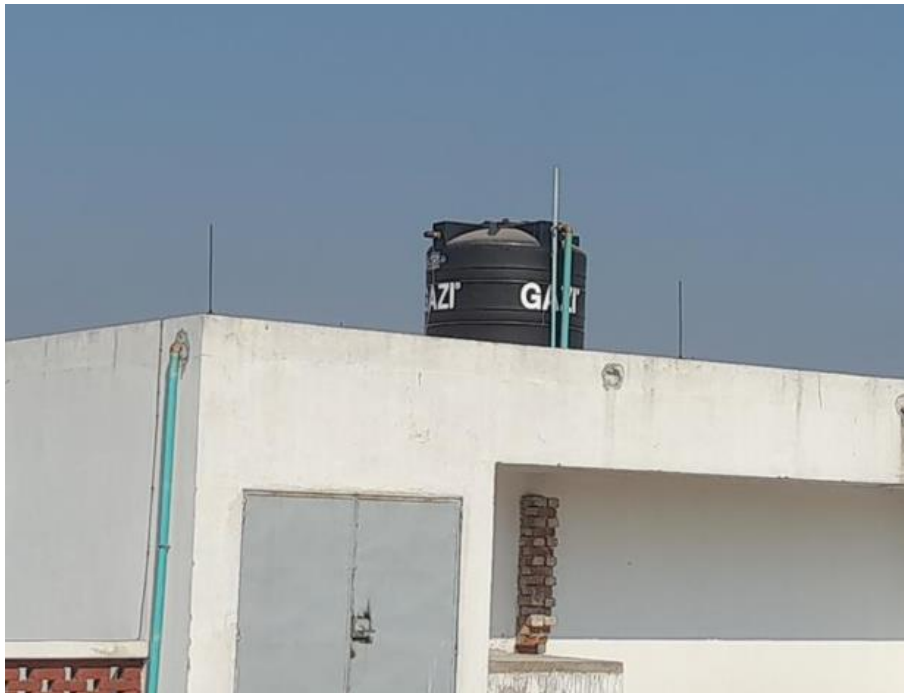
Some plastic tanks resting on the rooftop and racks on different floors are not adequately anchored or braced to resist lateral (earthquake) forces.

Plastic water tank on roof

Adequately anchor and brace all non-structural elements (all buildings) to resist earthquake forces to comply with the BNBC.

| Item No. | Observation | Recommended Action Plan | Recommended Timeline |
|---|---|---|---|
| 10 | Non-structural elements not anchored or braced. (Building-1) | Building is required to anchored or braced properly all kinds of non-structural elements. | 6-weeks |

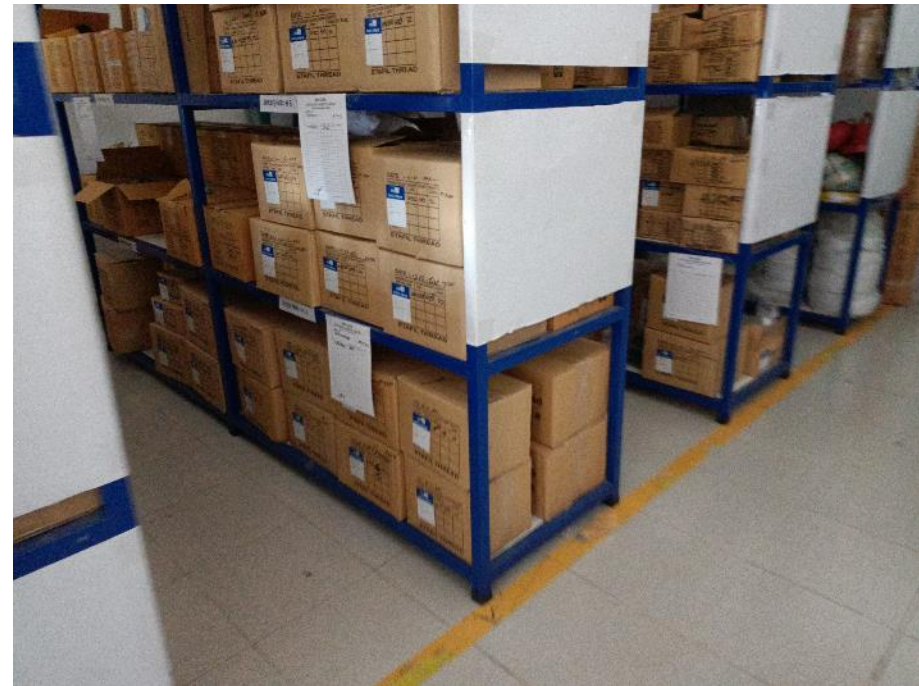
Rack on floor level

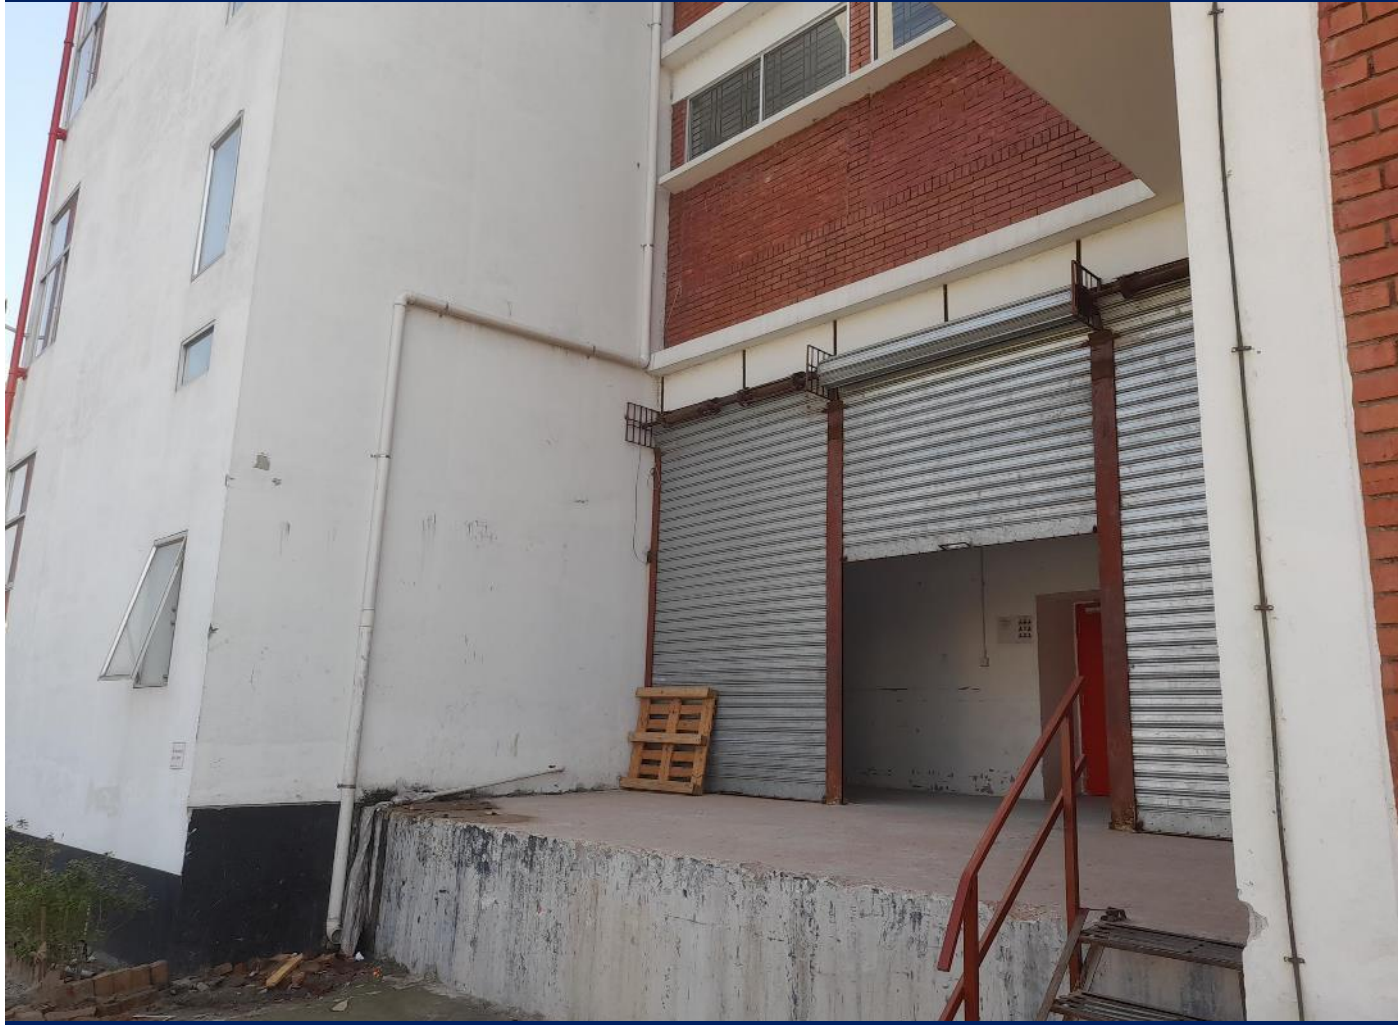
Columns on loading/unloading areas are Susceptible to Vehicle impact. The building engineer is required to take necessary action to prevent the vehicle impact in the columns.

Column at loading/unloading bay

| Item No. | Observation | Recommended Action Plan | Recommended Timeline |
|---|---|---|---|
| 11 | Column Susceptible to Vehicle impact. (Building-1 ) | Building engineer is required to take necessary action to prevent the vehicle impact in the columns. | 6-weeks |

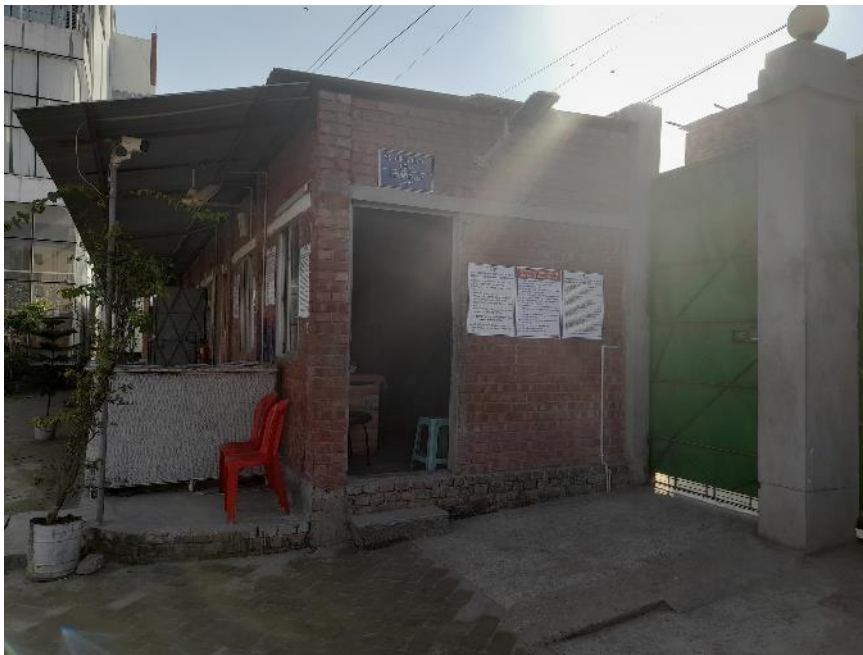
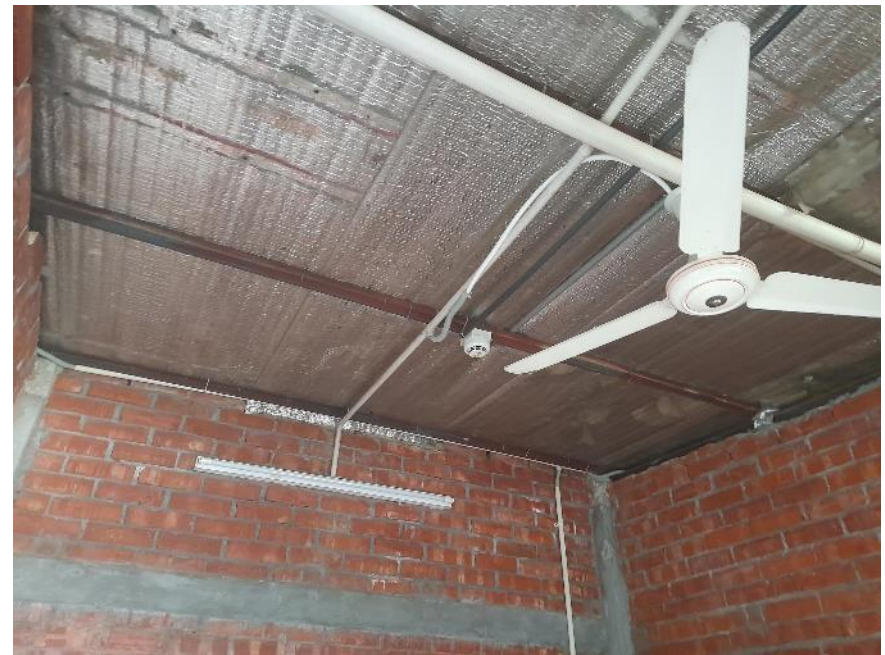
Facilities Shed

As-built drawings were not found for the single storied Facilities Shed. The building engineer to survey the structure and prepare as-built structural drawings with clear connection details.

| Item No. | Observation | Recommended Action Plan | Recommended Timeline |
|---|---|---|---|
| 12 | Lack of drawings-Structural & Architectural. (Shed-1) | Building engineer is required to prepare the full set of as-built drawing in compliance with section 1.9.1.2 (part-6, BNBC). | 6-weeks |

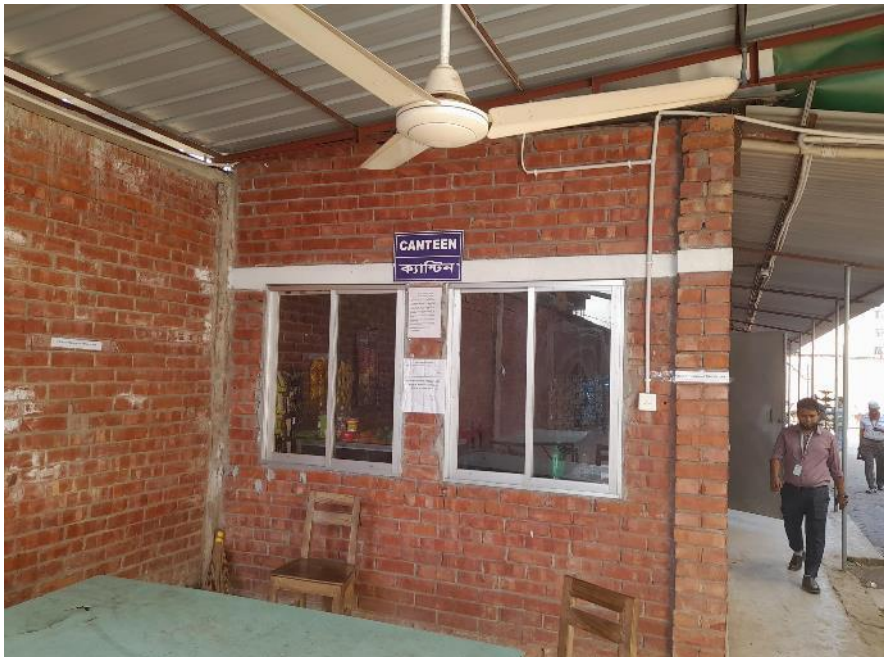
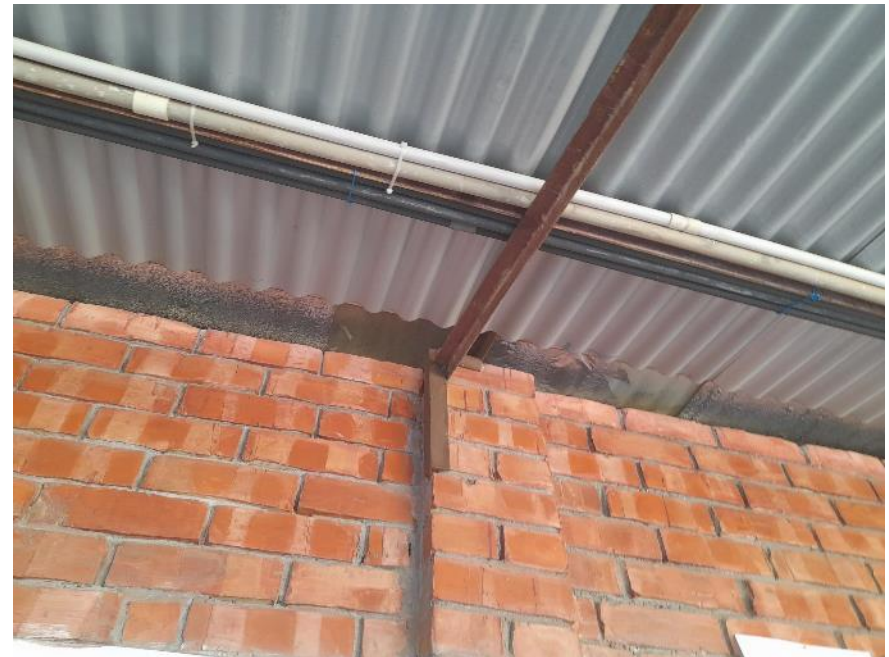
Facilities Shed

Apparently inadequate connection was observed at the lightweight roof of the single storied Facilities Shed. The building engineer to check the connection adequacy of the lightweight roof against the uplift pressure of wind.

| Item No. | Observation | Recommended Action Plan | Recommended Timeline |
|---|---|---|---|
| 13 | Apparently non-engineered connection. (Shed-1) | Building engineer is required to check the connection of the steel shed for the uplift pressure of wind. | 6-weeks |
| 14 | Apparently non-engineered connection. (Shed-1) | Complete implementation of remedial works if required. | 6-months |

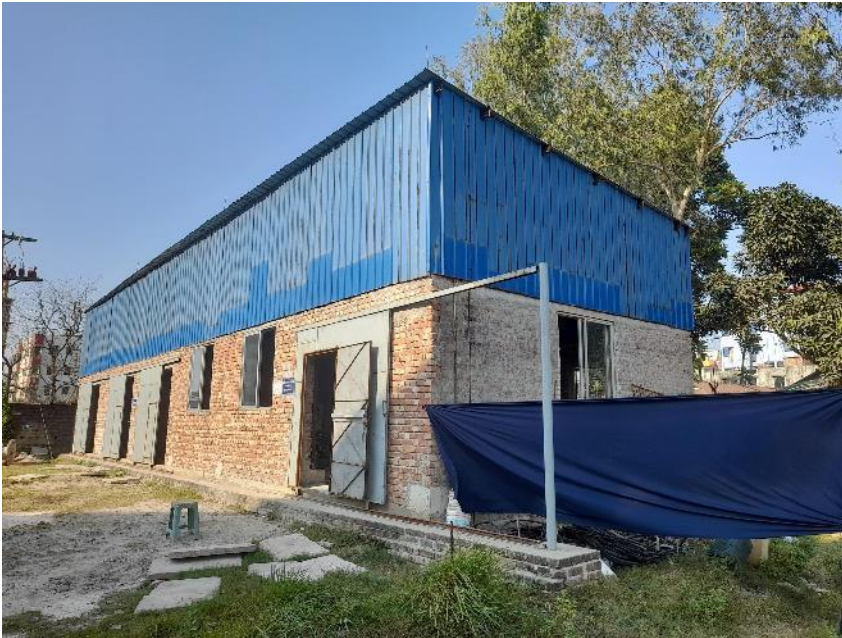
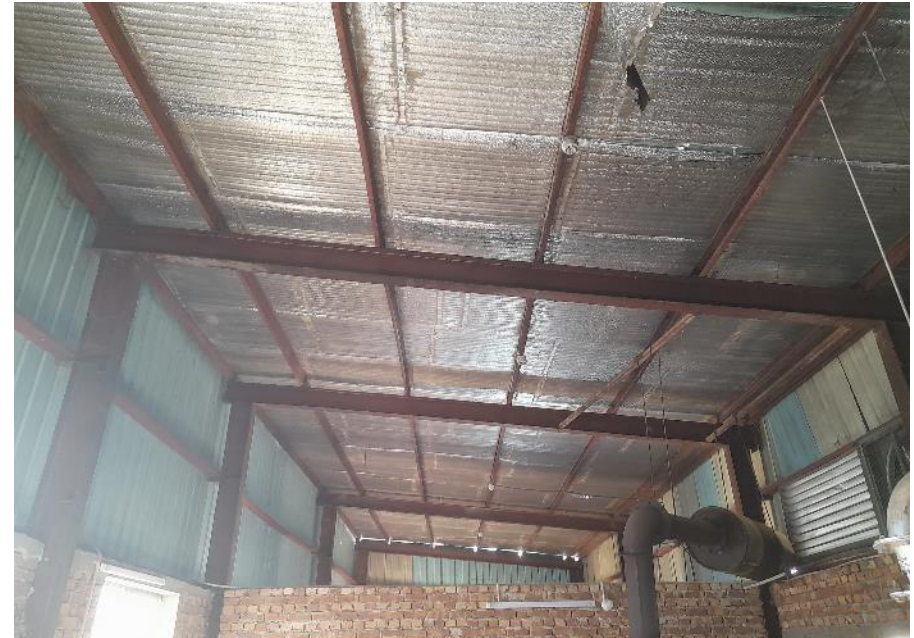
Utility Shed

As-built drawings were not found for the single storied Utility Shed. The building engineer to survey the structure and prepare as-built structural drawings with clear connection details.

| Item No. | Observation | Recommended Action Plan | Recommended Timeline |
|---|---|---|---|
| 15 | Lack of as-built drawing. (Shed-2) | Building engineer is required to prepare the full set of as-built drawing in compliance with section 1.9.1.2 (part-6, BNBC). | 6-weeks |

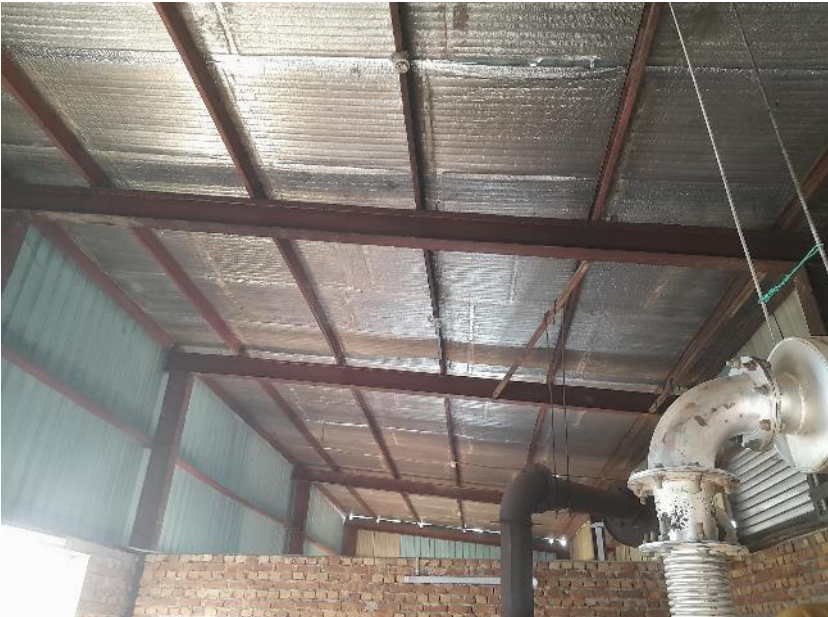
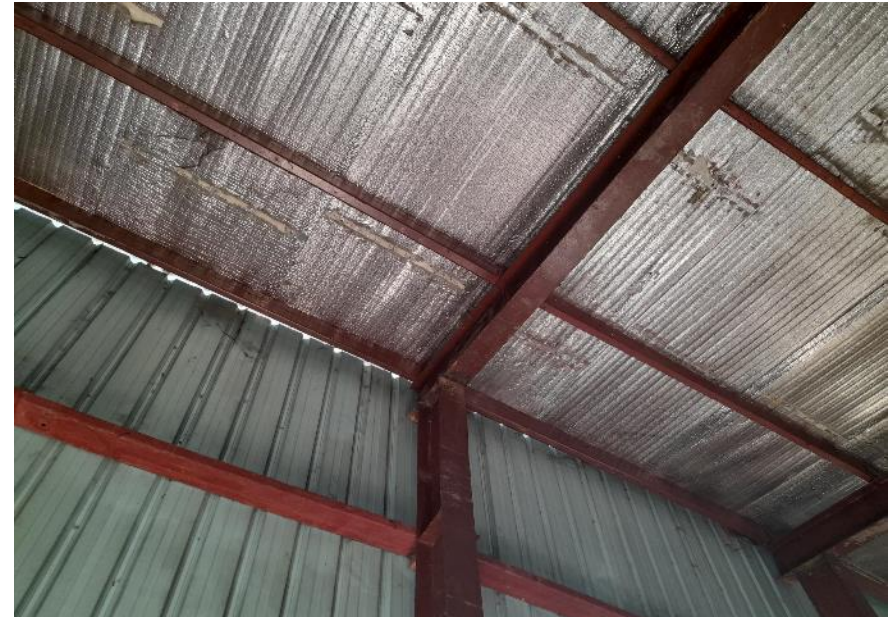
**Lack of lateral stability system**

Lack of compression member along long direction of the shed

The building engineer is required to prepare the as-built drawing and check the lateral stability system of the steel shed.

| Item No. | Observation | Recommended Action Plan | Recommended Timeline |
|---|---|---|---|
| 16 | Lack of lateral stability system. (Shed-2) | Building engineer is required to check the lateral stability system and suggest proper remedial actions accordingly. | 6-weeks |
| 17 | Lack of lateral stability system. (Shed-2) | Carry out suggested remedial works. | 6-months |
