# Bangla Poshak Ltd.

Sikder Complex, Chaidana, National University, Gazipur, Bangladesh  
(23.961573, 90.380068)

29 March 2014

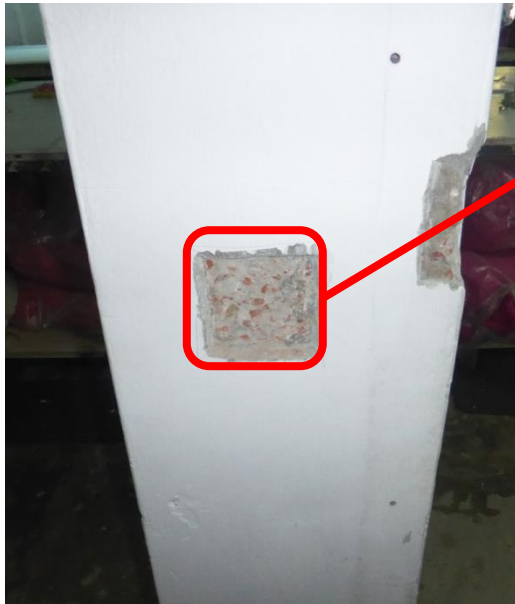
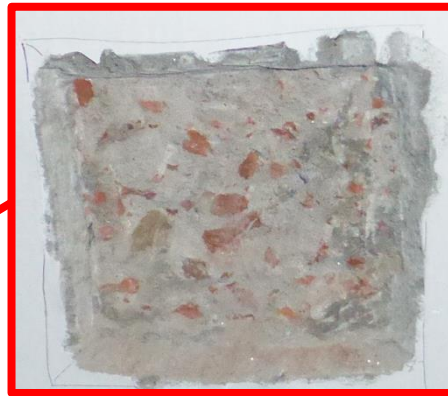
**Tested column at  
ground level- Brick  
aggregate observed.**

**Preliminary calculations indicate that the working  
stresses in some columns are at a high level.**

**Brick aggregate observed.**

**Building Engineer to check that columns have been  
designed to accommodate applied loads including  
edge cantilevers and areas of heavy loading.**

| Item No. | Observation | Recommended Action Plan | Recommended Timeline |
|---|---|---|---|
| 1 | Highly stressed columns | Building Engineer to review design, loads and columns stresses including any additional loading as documented in the observations chapter. | 6-weeks |
| 2 | Highly stressed columns | Verify in situ concrete strength either by 75mm/100mm diameter cores from a minimum 4 columns or existing cylinder strength data. Building Engineer to identify columns where cores can be taken without overstressing the columns. | 6-weeks |
| 3 | Highly stressed columns | Produce and actively manage a loading plan for all floor plates within the factory giving consideration to floor capacity and column capacity. | 6-months |

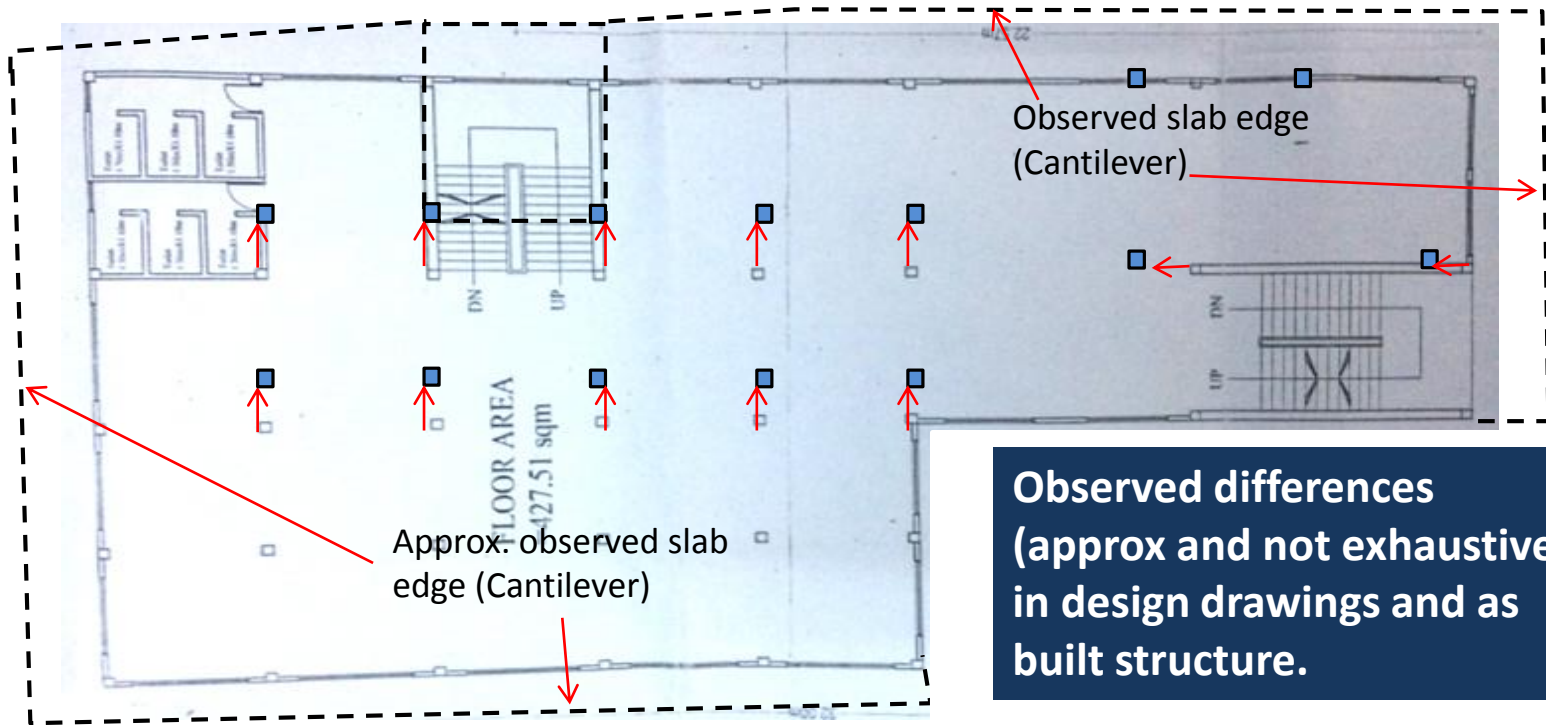
**Design drawings are not consistent with the as-built structure**

**Differences in column locations and sizes, edge cantilevers, core locations and reinforcement arrangement observed.**

**Accurate set of as-built documentation required**

| Item No. | Observation | Recommended Action Plan | Recommended Timeline |
|---|---|---|---|
| 7 | Building documentation does not match as built structure and undocumented cantilever slabs | Building engineer to check, collect information and produce accurate and complete as-built documentation | 6-weeks |
| 8 | Building documentation does not match as built structure and undocumented cantilever slabs | Building engineer to submit calculations and structural perform an engineering assessment on the as built structure and confirm that the structural elements can withstand the applied loading. | 6-weeks |

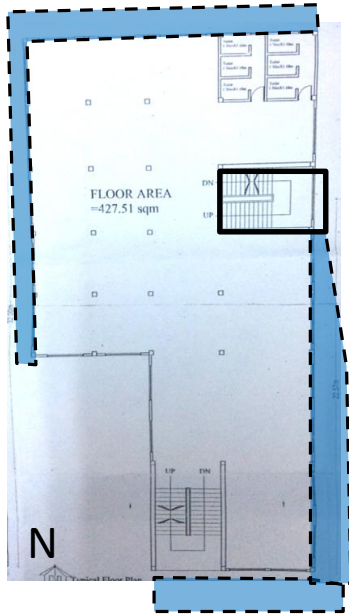
**Cantilever slabs at all levels.**

**Undocumented cantilever slabs and stair observed beyond column lines in a number of locations at all levels of the building.**

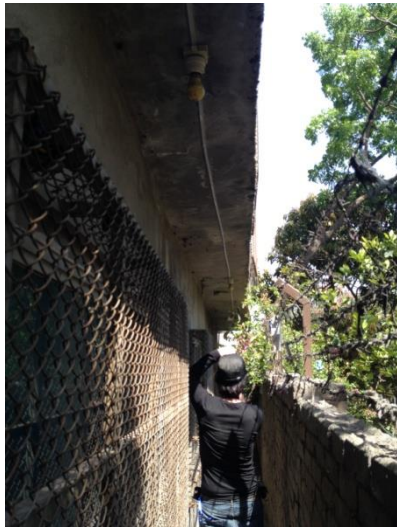
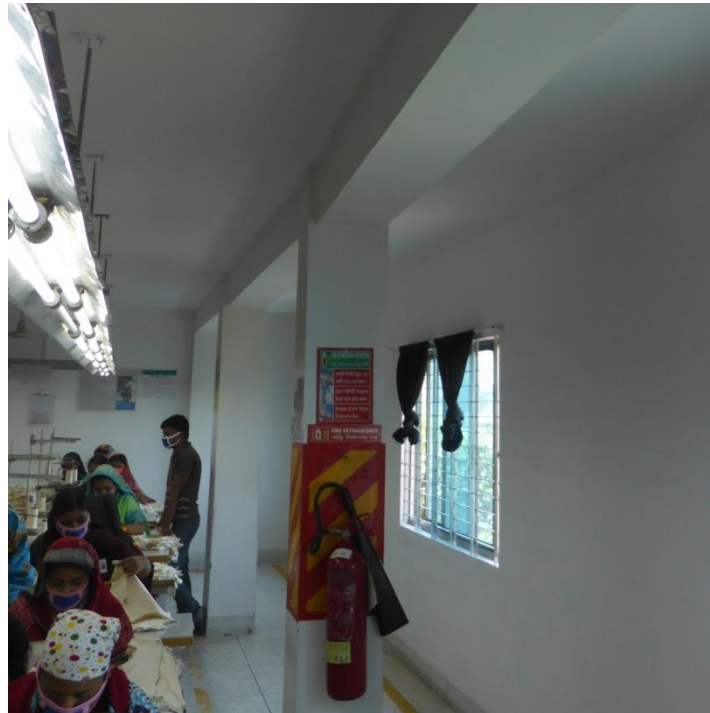
**Typical Edge cantilever supporting brick facade.**

**Cantilever at south facade.**

**Brick masonry facade weight supported at the tip of cantilevers.**

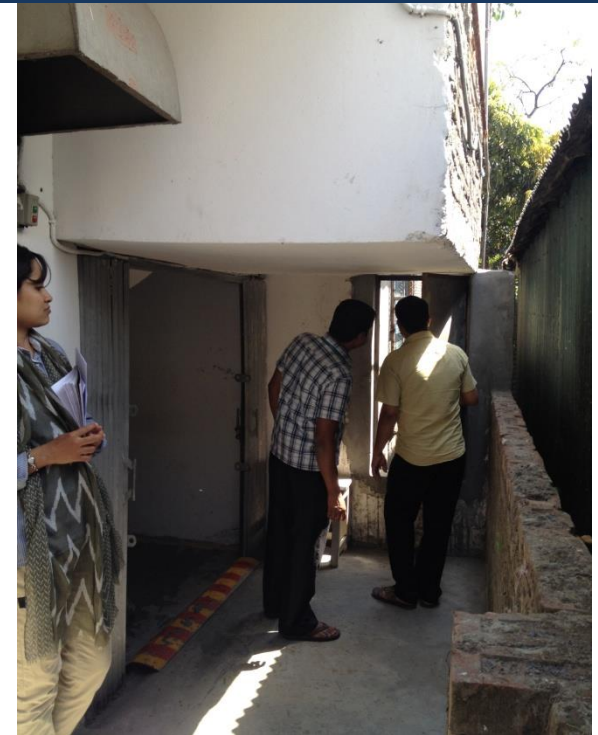
**West stair cantilever.**

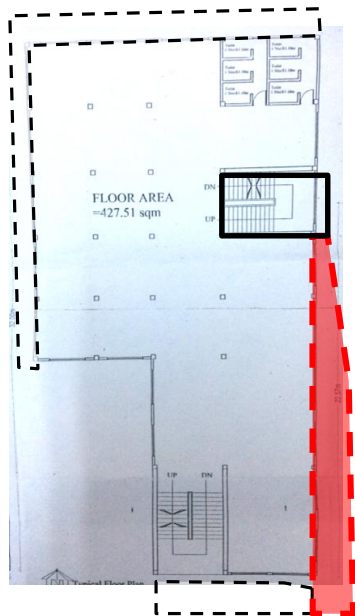
West slab cantilever.

On west facade it is unclear at ground level whether the edge is a cantilever or whether supported off an additional line of columns. Design review required.

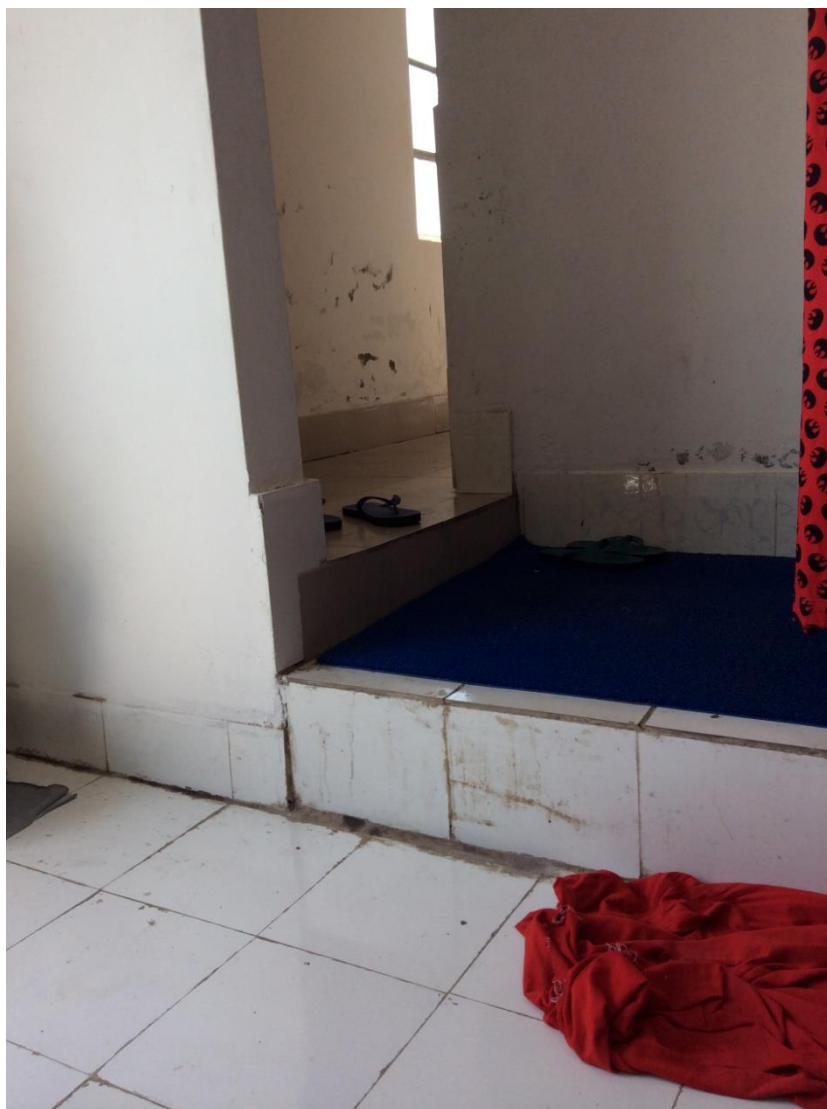
**Increased floor build-up in toilet block areas  
(~300mm general to ~450mm in cubicles).**

**Partition walls around block and between  
additional cubicles**

| Item No. | Observation | Recommended Action Plan | Recommended Timeline |
|---|---|---|---|
| 10 | Localised areas of high loading in all buildings | Extent of build-up loading in toilet and wash areas to be surveyed and weight of water tanks on roof to be assessed. Building Engineer to assess the capacity of floor & roof slabs to provide evidence that the structure is designed to carry these loads | 6-weeks |

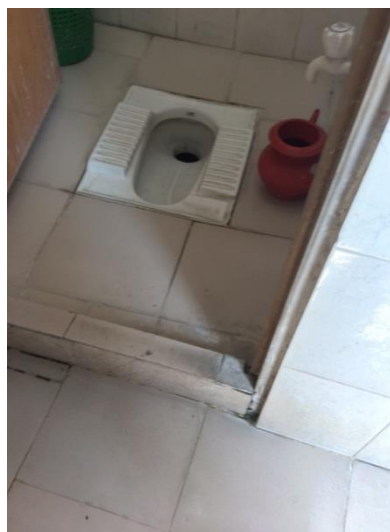
**Typical floor build up in  
toilet areas and  
additional step up in  
cubicle.**

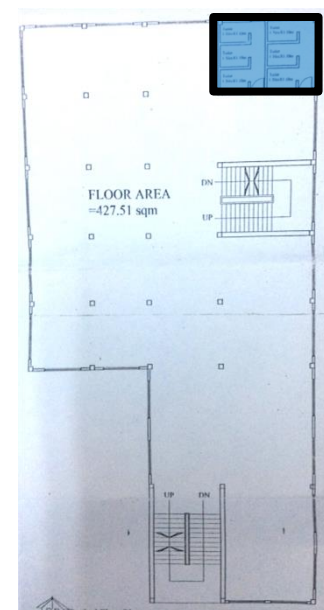
**Typical toilet block location.  
Arrangement not as shown  
on drawings.**

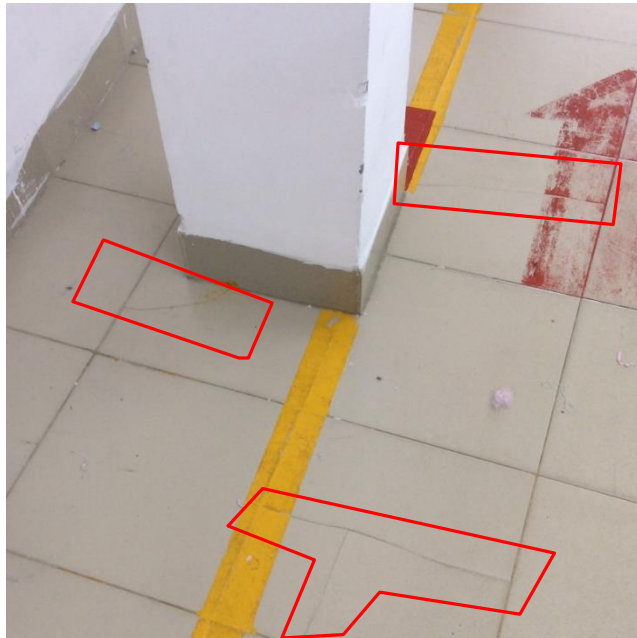
**Cracking above slab at columns.**

Cracking in a number of areas, including area outlined below, in tiles above flat slab junction with columns – area of high slab stresses.

Design check of slabs required for bending moments and punching shear forces.

| Item No. | Observation | Recommended Action Plan | Recommended Timeline |
|---|---|---|---|
| 4 | Cracking above slabs around columns | Building Engineer to check the punching shear capacity at columns for additional applied loads generated by as built geometry. | 6-weeks |
| 5 | Cracking above slabs around columns | Building engineer to submit calculations showing adequacy of floor structure taking into account the factory design imposed loading and the as built structure. | 6-weeks |

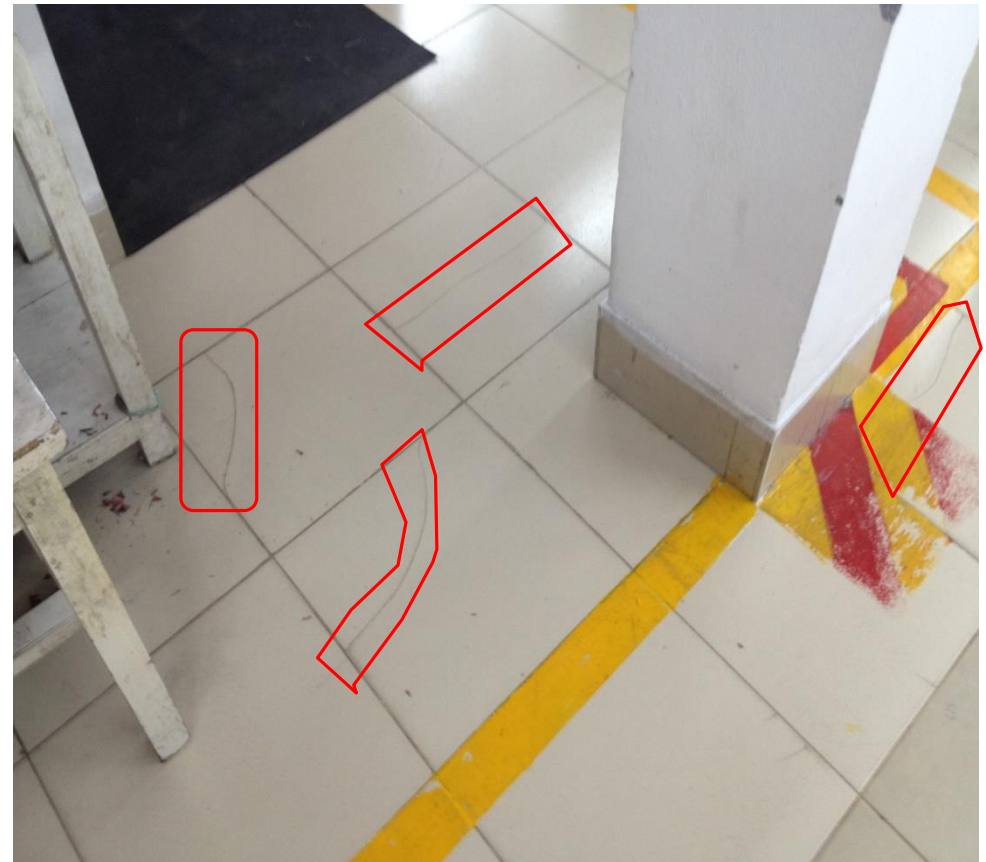
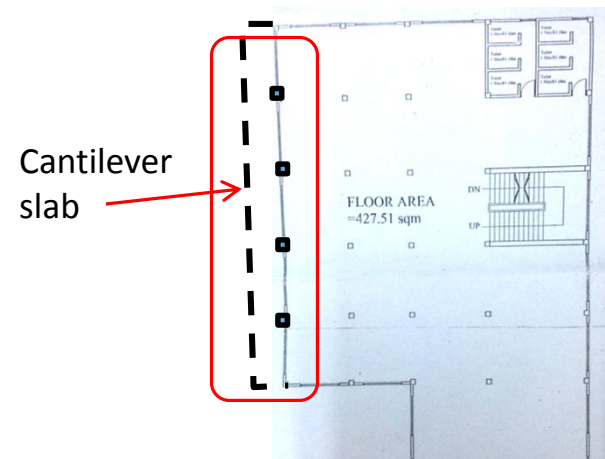
Cracks observed – 3<sup>rd</sup> Floor

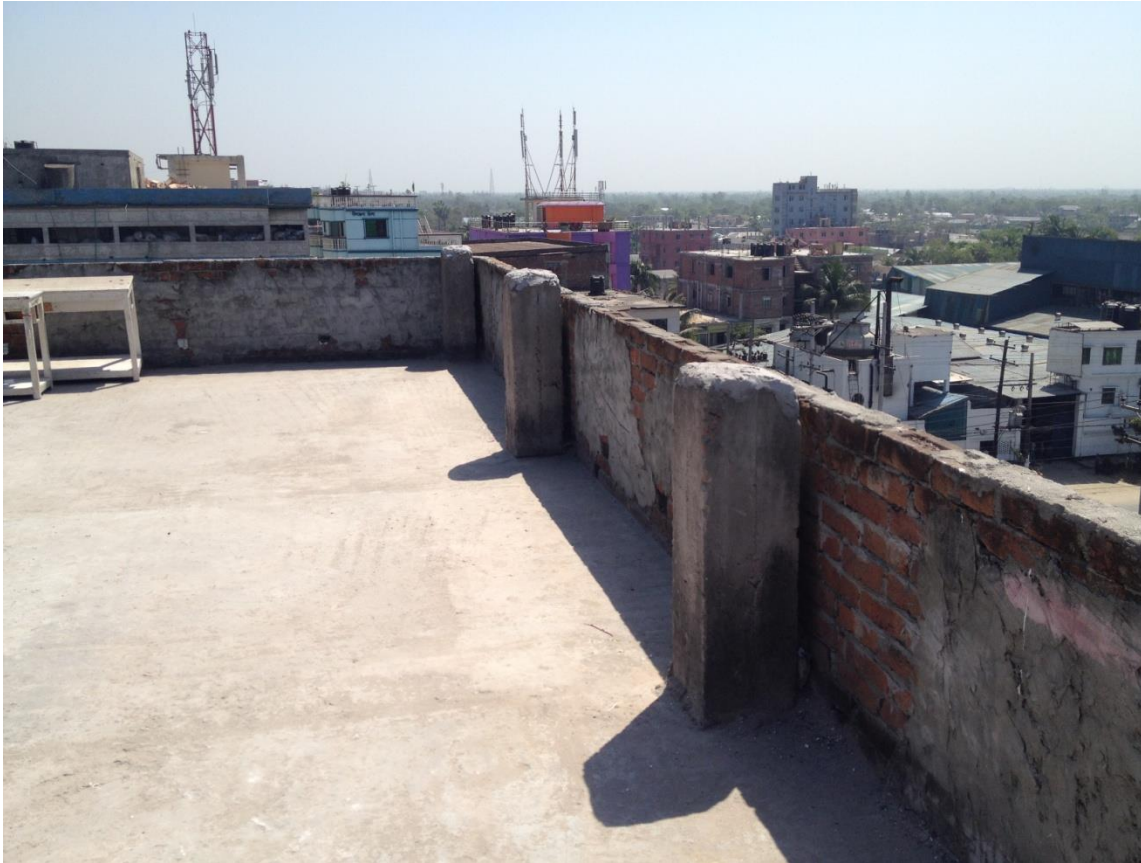
**Single brick masonry  
parapets unrestrained at  
roof level around  
perimeter of the building.**

**Wall is not tied into  
columns.**

| Item No. | Observation | Recommended Action Plan | Recommended Timeline |
|---|---|---|---|
| 12 | Unrestrained parapet at roof level | Building engineer to assess stability and condition of the roof parapets | 6-weeks |
| 13 | Unrestrained parapet at roof level | Repairs and strengthening to be carried out as required by engineering assessment | 6-months |

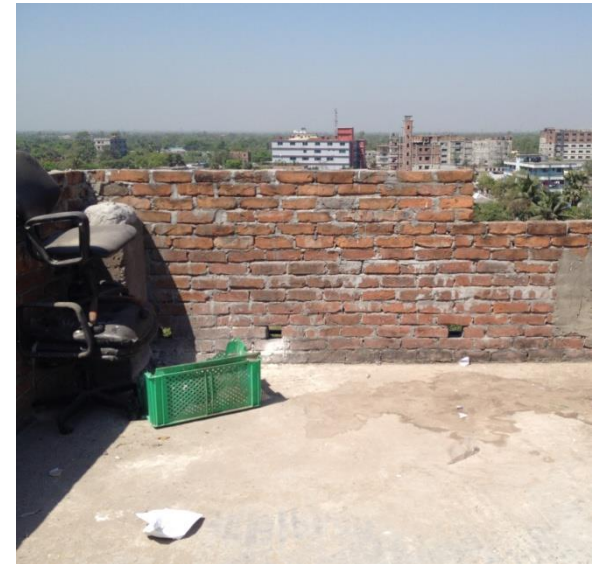
## **Unrestrained roof parapets**
