# Incredible Fashions Ltd. (Extension)

Karol, Surichala, Mouchak, Kaliakoir, Gazipur.

01 January 2023

**Storage Building:** This structure is a five storied (G+4) reinforced concrete (RC) building.

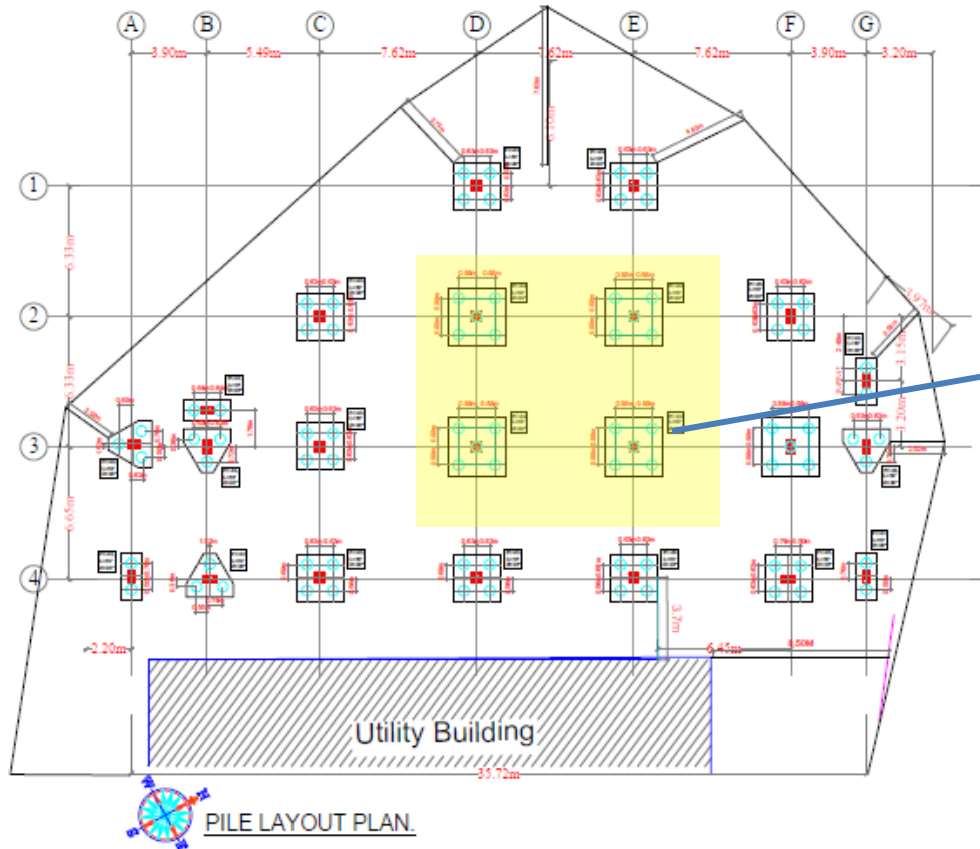
Pile Layout Plan

**Foundation stressed above  
normal design limit**

Cursory calculation indicates that bearing capacity of few piles exceeds the normal design limit considering 6 kPa live load on typical floors. Building engineer to review design, loads and foundation stresses.

| Item No. | Observation | Recommended Action Plan | Recommended Timeline |
|---|---|---|---|
| 01 | Foundation stressed above normal design limits. | Building Engineer to review design, loads, and footings stresses. | 6-weeks |
| 02 | Foundation stressed above normal design limits. | Produce and actively manage a loading plan for all floor plates within the factory, considering floor, column and foundation capacity. | 6-weeks |
| 03 | Foundation stressed above normal design limits. | Complete implementation of any remedial works. | 6-months |
| 04 | Foundation stressed above normal design limits. | Continue to implement loading plan. | 6-months |

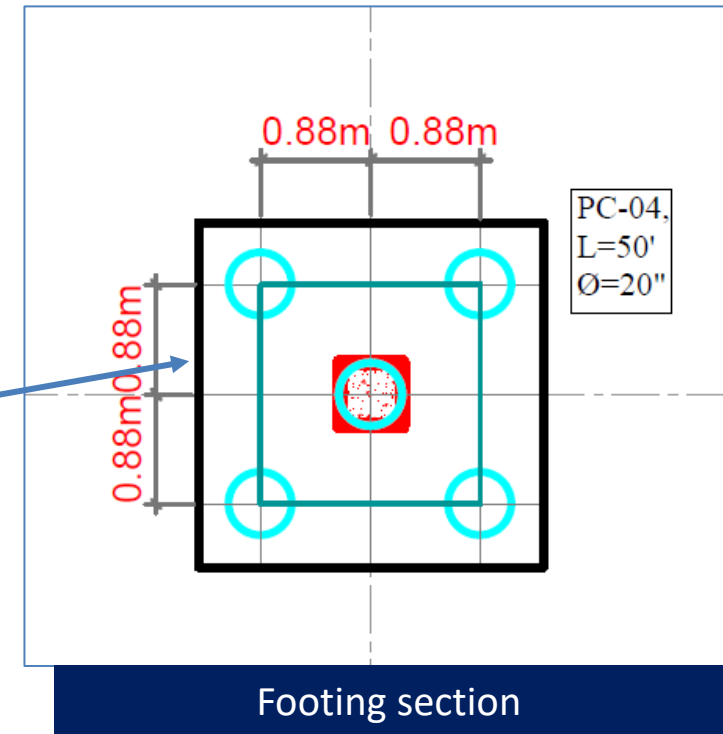
The average bearing capacities (F.S.= 2.5) of different diameter pile with the embedment length up to 50 ft from EGL of each boring may be considered as follows:

- 40 Ton for 18 inch dia pile.
- 50 Ton for 20 inch dia pile.
- 70 Ton for 24 inch dia pile.

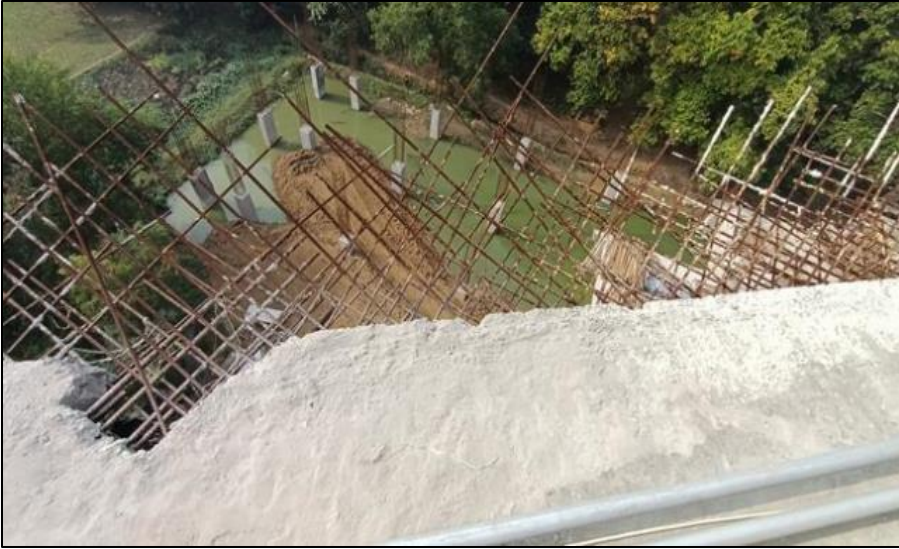
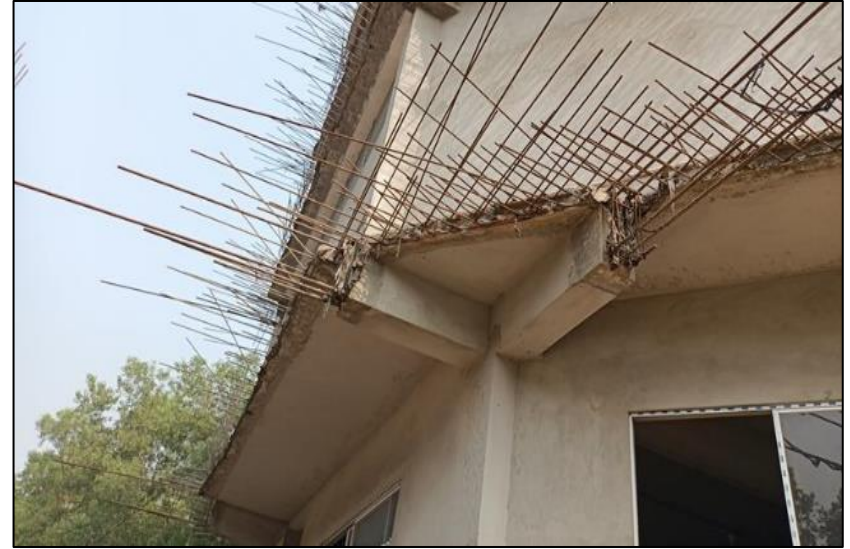
# Corrosion on exposed rebar

Exposed rebar was observed at the roof of the utility building.

Building engineer is required to provide protective coating on the exposed rebar to protect from corrosion.

| Item No. | Observation | Recommended Action Plan | Recommended Timeline |
|---|---|---|---|
| 05 | Corrosion on exposed rebar. | Building engineer is required to provide protective coating on the exposed rebar to protect from corrosion. | 6-weeks |

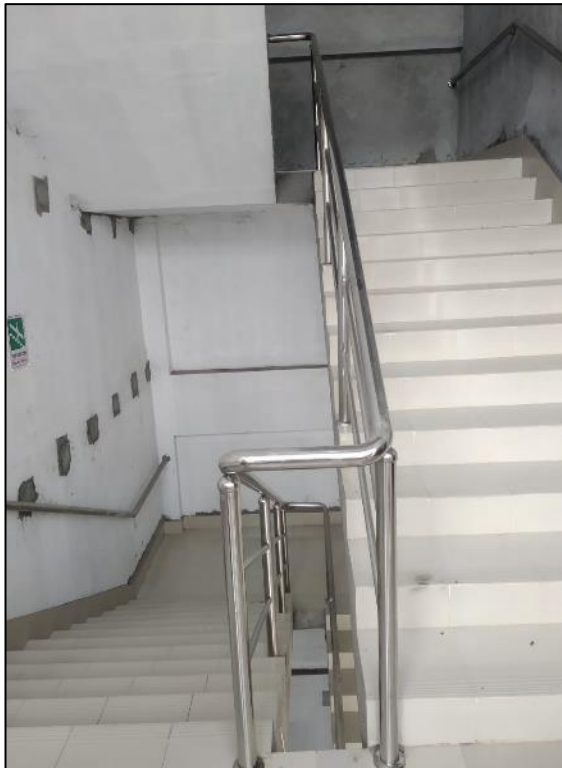
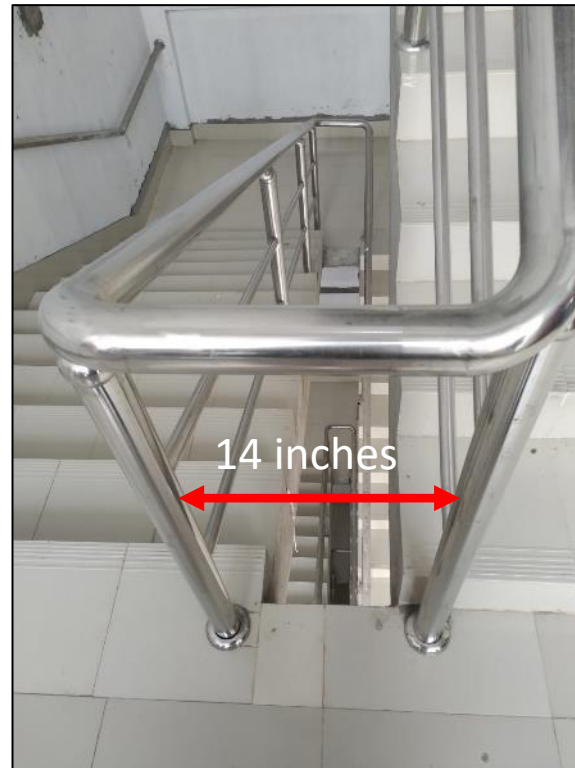
# **Inadequate protection in the handrail of the stair**

The hand railing of the stair was found inadequate to protect falling hazards. Building engineer is required to provide more steel members at the handrail to avoid possible falling hazard.

| Item No. | Observation | Recommended Action Plan | Recommended Timeline |
|---|---|---|---|
| 06 | Inadequate protection in the handrail of the stair. | Building engineer is required to provide more steel members at the handrail to avoid possible falling hazard. | 6-weeks |

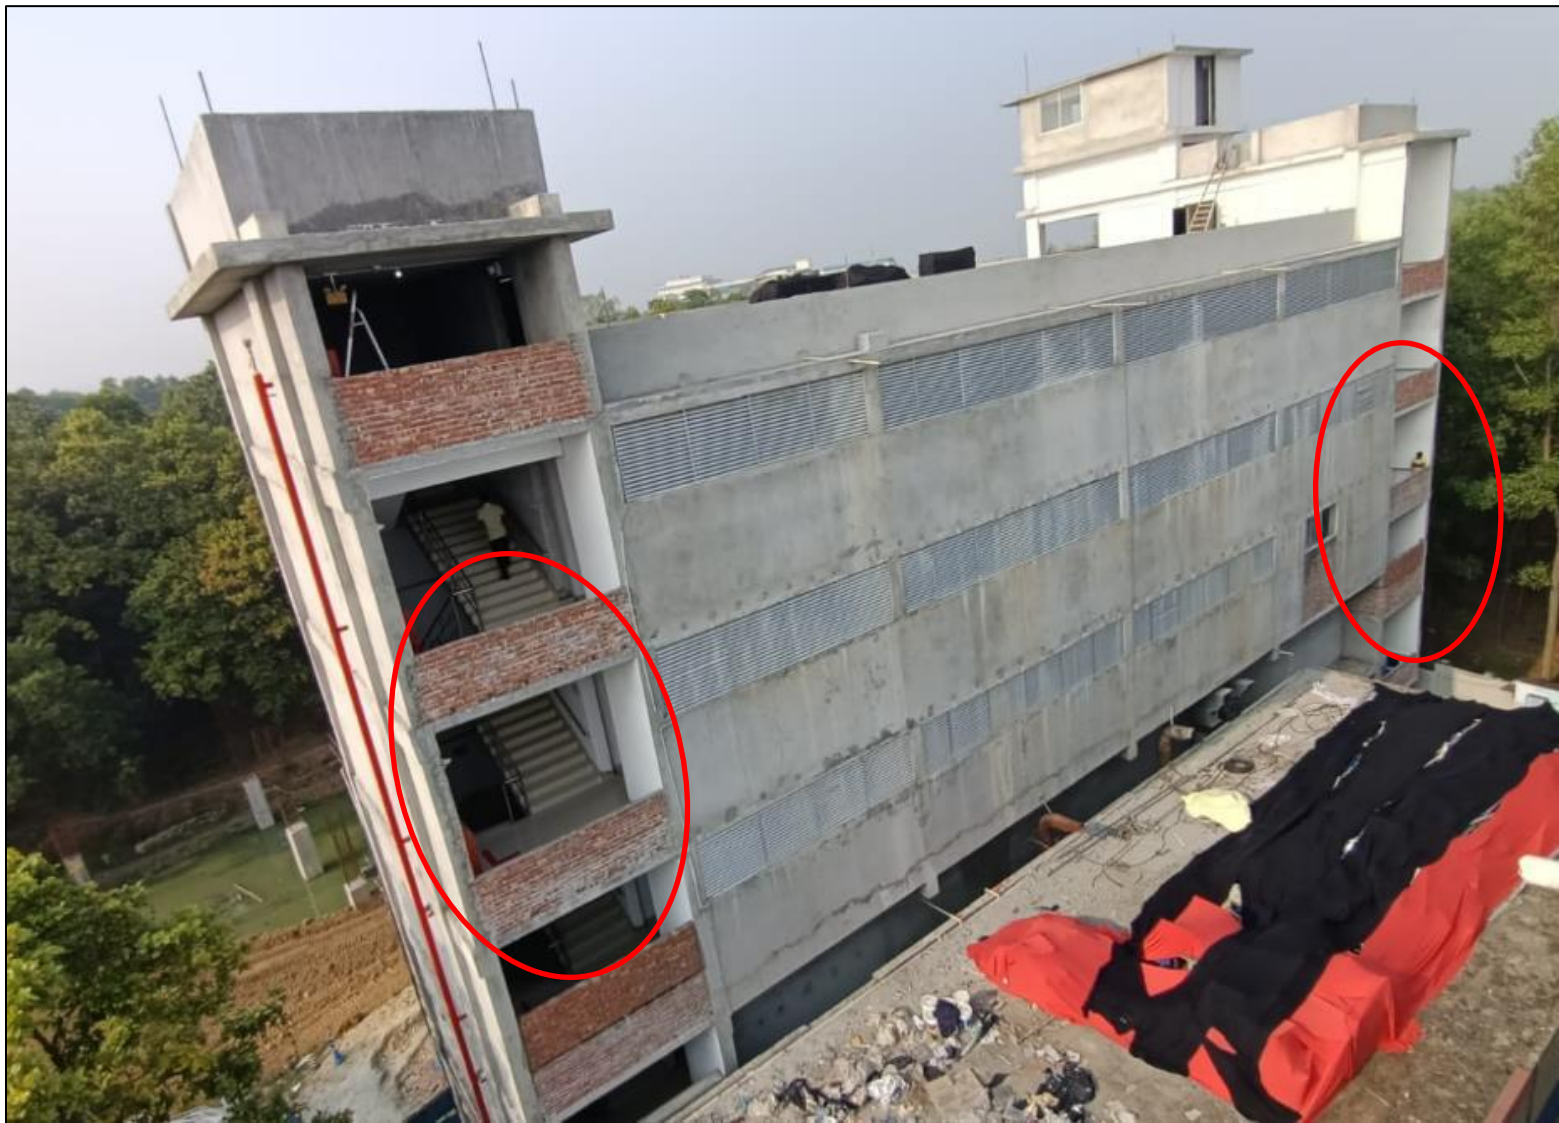
## **Inadequate parapet wall at the stair opening**

The parapet wall of the stair opening was found inadequate to protect falling hazards. Building engineer is required to increase the height of the parapet wall of the stair opening to avoid possible falling hazard.

| Item No. | Observation | Recommended Action Plan | Recommended Timeline |
|---|---|---|---|
| 07 | Inadequate parapet wall at the stair opening. | Building engineer is required to increase the height of the parapet wall of the stair opening to avoid possible falling hazard. | 6-weeks |

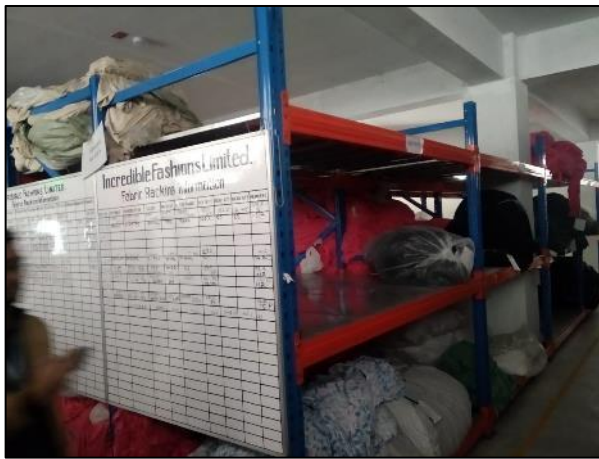
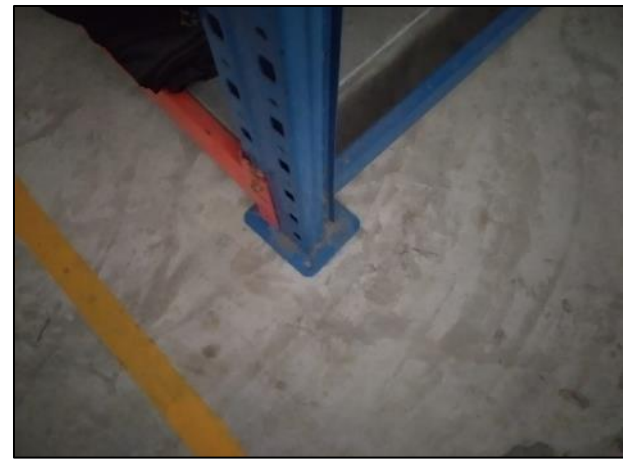
Racks on floor level

**Non-structural elements not  
anchored or braced**

Some racks on different floors are not adequately anchored or braced to resist lateral (earthquake) forces. Building is required to adequately anchor and brace all non-structural elements to resist earthquake forces to comply with the BNBC.

| Item No. | Observation | Recommended Action Plan | Recommended Timeline |
|---|---|---|---|
| 08 | Non-structural elements not anchored or braced. | Building engineer is required to adequately anchor and brace all non-structural elements to resist earthquake forces to comply with the BNBC. | 6-weeks |

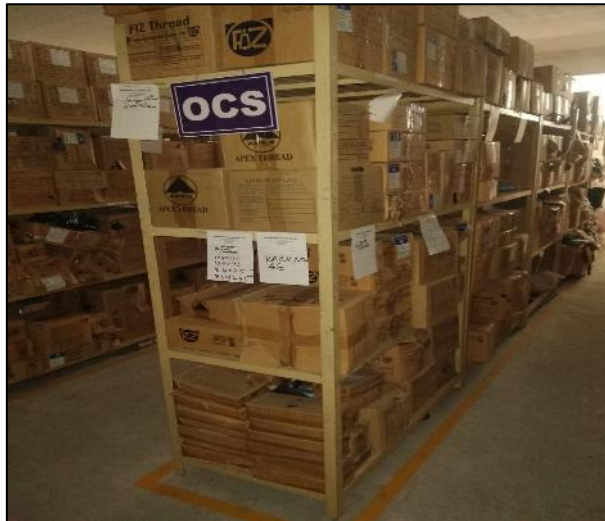
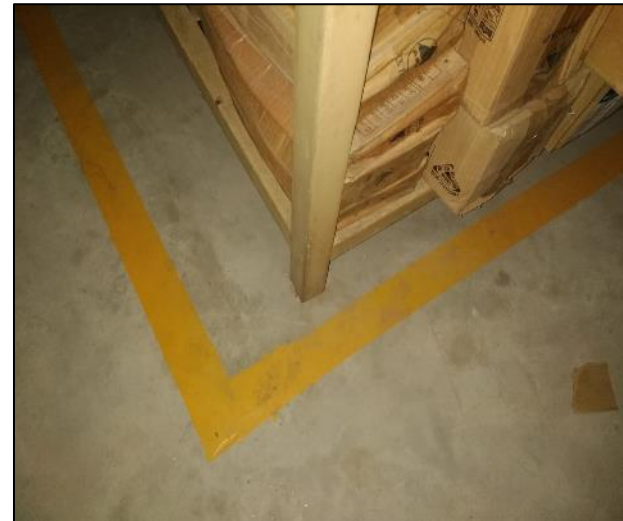
Racks without anchoring
