Bando Design Ltd

Purbo Narsinghapur, Earpur Union, Parishad Road, Ashulia, Dhaka
(23.560502, 90.181293)
29th March 2014

Observations

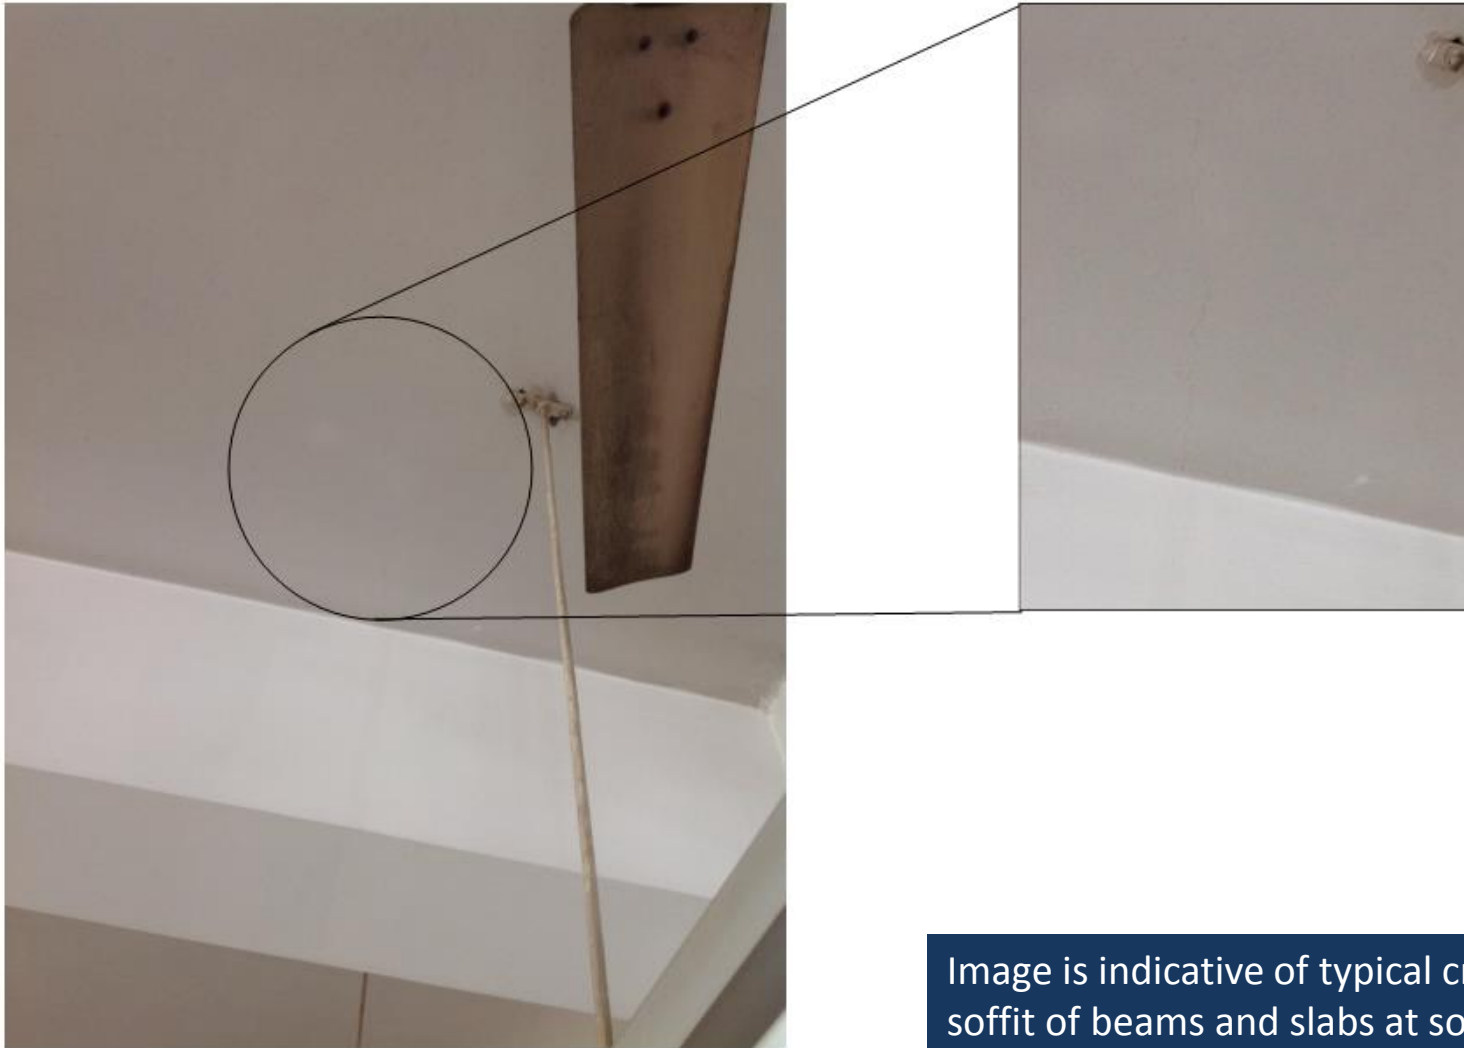
Building 1: Cracking in Beams and Slabs

Image is indicative of typical cracking to soffit of beams and slabs at some levels.

ITEM 1: Cracking on Beams at Upper Levels.

Item No.	Observation	Recommended Action Plan	Recommended Timeline
1	BUILDING 1 Cracking on Beams at Upper Levels	Monitor cracks on beams. Engage an engineer to investigate if cracks are only in the plastering.	6-months
2	BUILDING 1 Cracking on Beams at Upper Levels	Engage an engineer to advise on load reduction and repair and strengthening of the beams if required.	6-months
3	BUILDING 1 Loading from Roof Garden at Level 5	Construction of roof Garden to be halted	6-weeks
4	BUILDING 1 Loading from Roof Garden at Level 5	Building engineer to check the structures and made proposals for the reduction of loads, if required Engineer to carry out assessment for slab and columns to carry roof garden (not on permit drawings) no further development to be carried out until study is completed	6-months
5	BUILDING 2 Facade cracking	Engage an engineer to investigate if cracks are only in the plastering	6-months

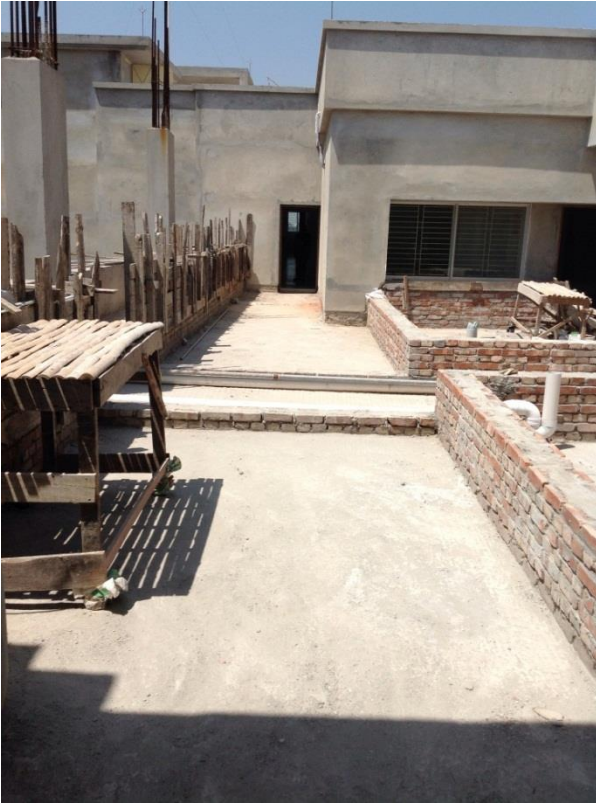
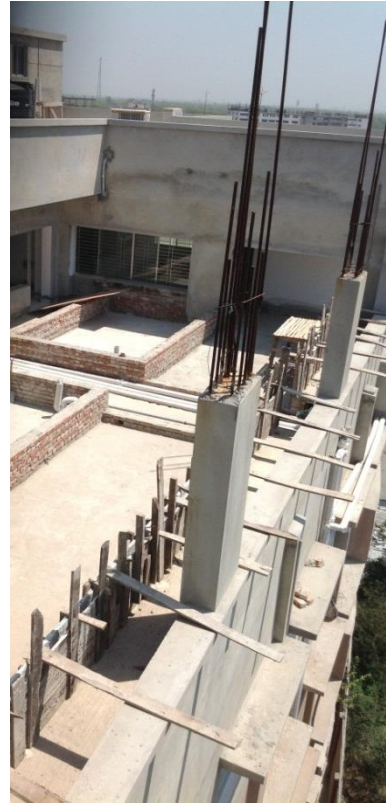
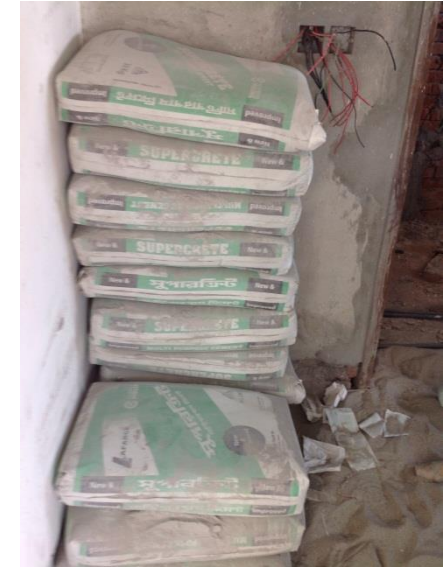
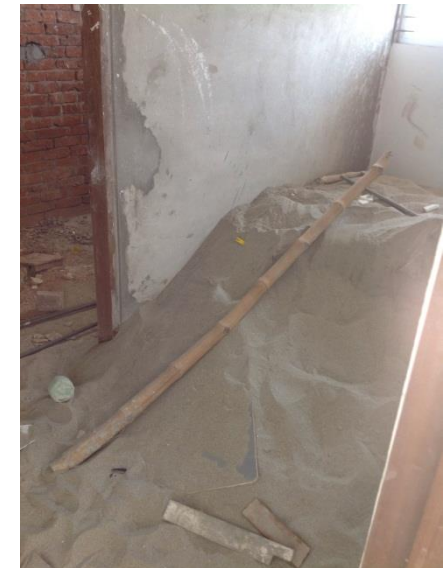
Building 1: Beam and Slab Loading to Level 5 Garden

Structural arrangement to Roof level does not reflect drawings. It is understood that a roof-top garden is currently under construction to Level 5, with a thickness of soil to be added. In addition, within toilets adjacent to garden, building materials have been stored. Engineer to carry out assessment for slab and columns to carry roof garden (not on permit drawings) no further development to be carried out until study is completed

ITEM 2: Loading from Roof Garden at Level 5.

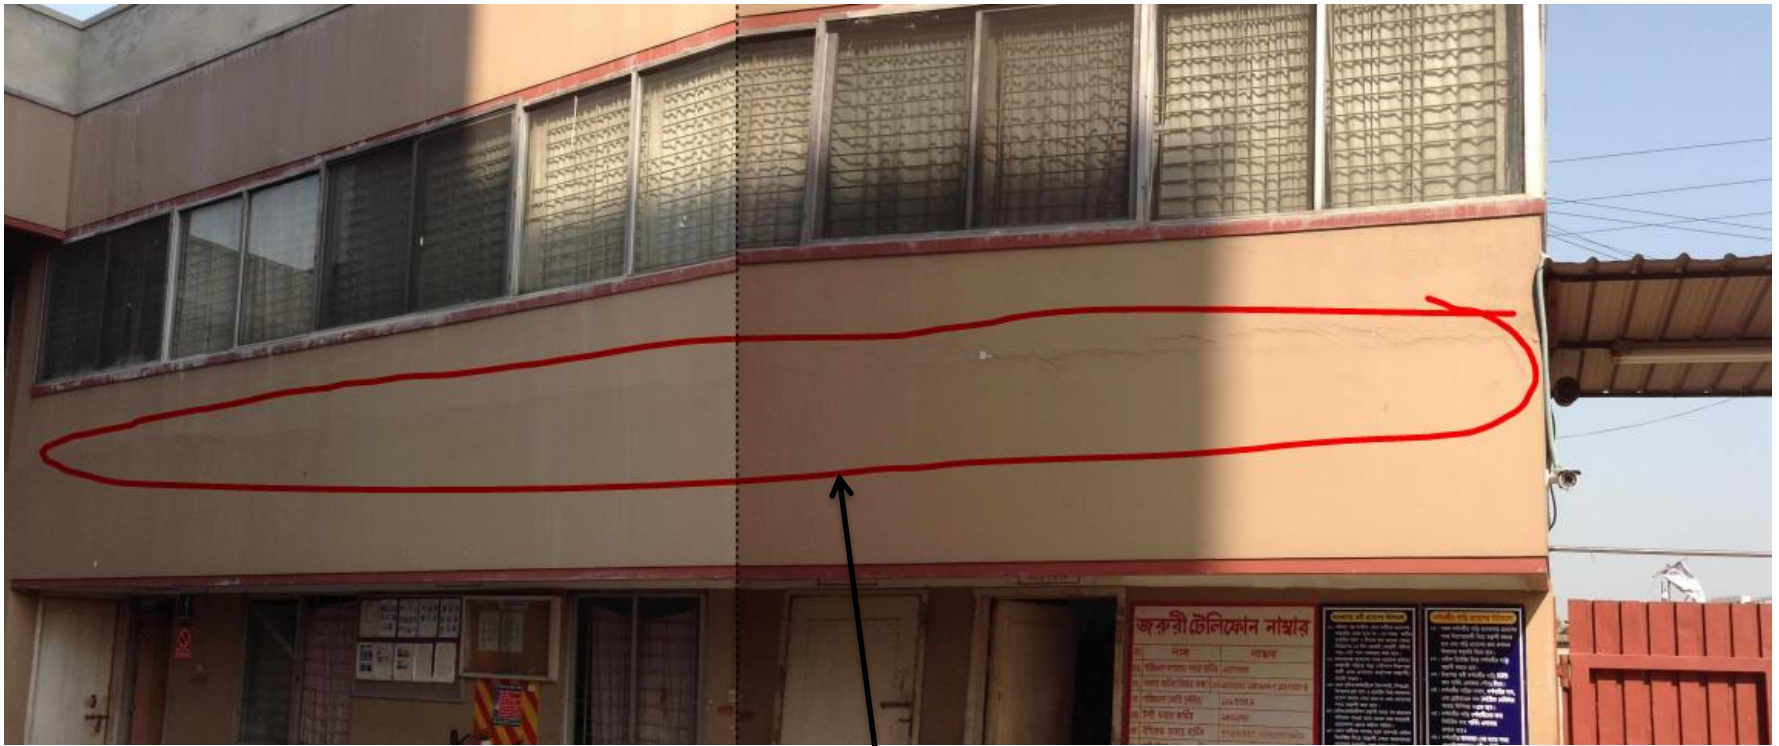
Building 2: Cracking in Facade

Some horizontal cracking is present in the main elevation of Building 2. It is understood to be at the interface between the reinforced slab and masonry wall above.

ITEM 1: Facade cracking.

6	BUILDING 2 Facade cracking	Engage an engineer to advise on load reduction and repairs and strengthening if required	6-months
7	BUILDING 3 Apparently non-engineered roof structures	Building engineer to check the structures and propose additional strengthening and bracing as required	6-weeks

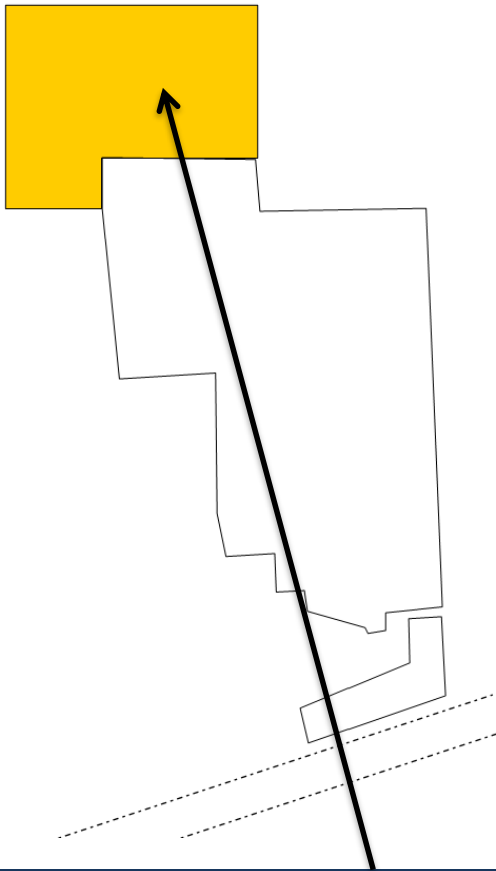
Building 3: Assumed Non-Engineered Steelwork Shed

Building 3 appears to consist of a lightweight steelwork trussed roof supported by steelwork columns or masonry walls. Structure appears to be 'non-engineered', as indicated by the structural form and some connection details, and unclear stability system.

ITEM 1: Apparently non-engineered roof structures.
