# Epoch Garments Ltd

Dholadia, Bhawal Rajabari-1742, Sreepur, Gazipur, Bangladesh

22 December 2019

# Observations

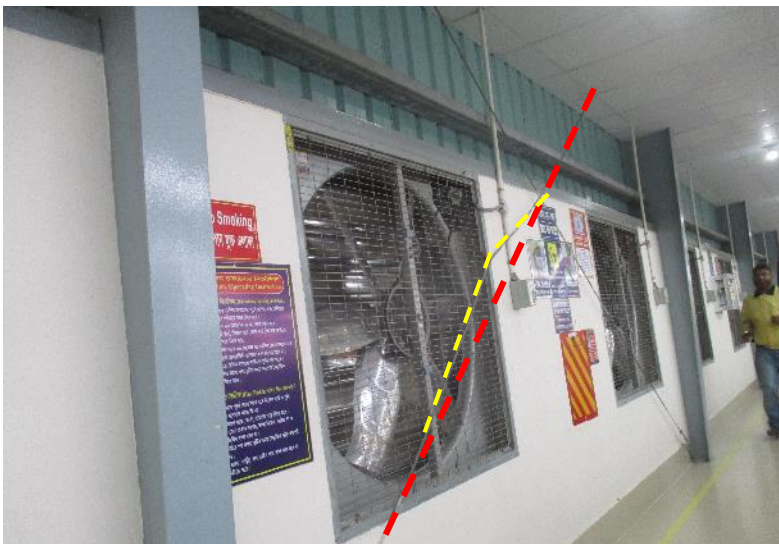
Improper loose wall bracing

Loose, improper connection of wall bracing observed in both sheds. The bracings are inactive and non-functional which may have impact on lateral stability system. Bracings to be properly connected with the columns for proper distribution of lateral load.

| Item No. | Observation | Recommended Action Plan | Recommended Timeline |
|---|---|---|---|
| 01 | Apparently inactive wall bracings in both sheds. (Sewing & Finishing shed) | Bracings to be properly connected with the columns as per drawings for proper distribution of lateral load for both sheds. | (within 6-weeks) |
| 02 | Apparently inactive wall bracings in both sheds. (Sewing & Finishing shed) | Bracings to be tightened. | (within 6-weeks) |

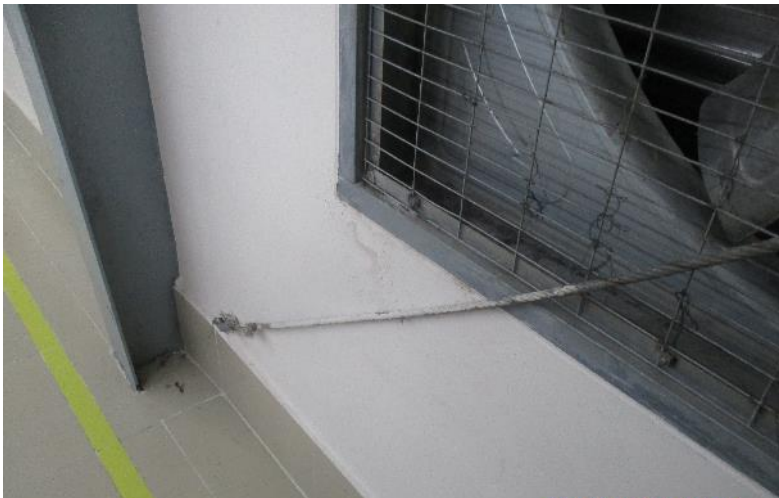
Wall bracing connected to façade wall  
(non-engineered)

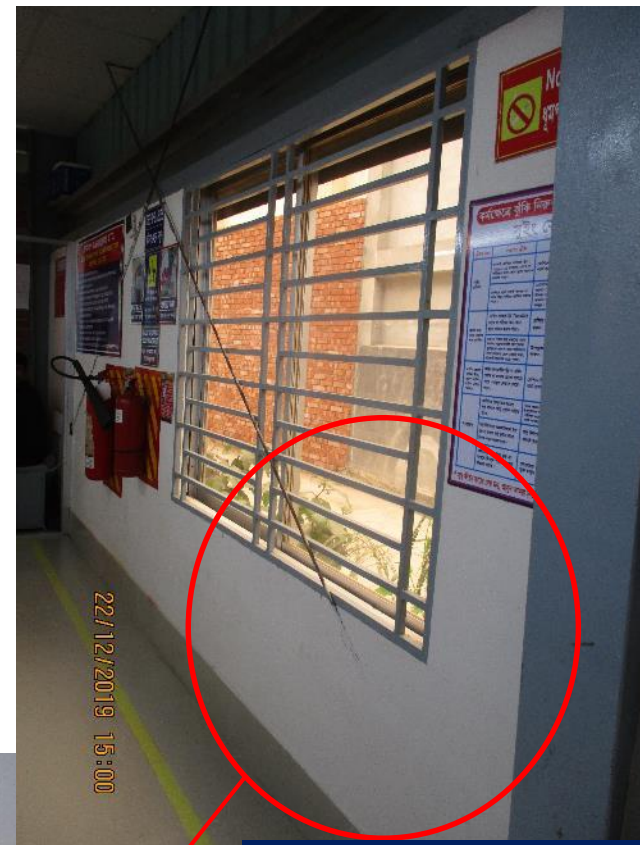
Improper connection  
of wall bracing

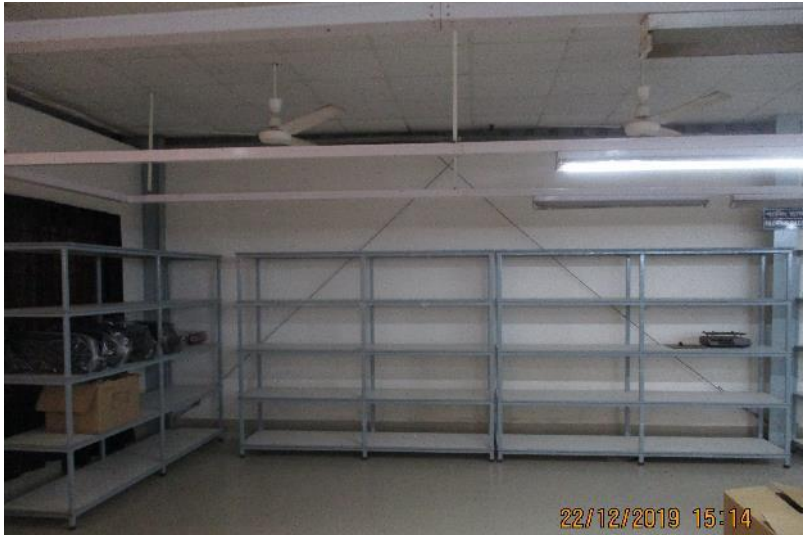
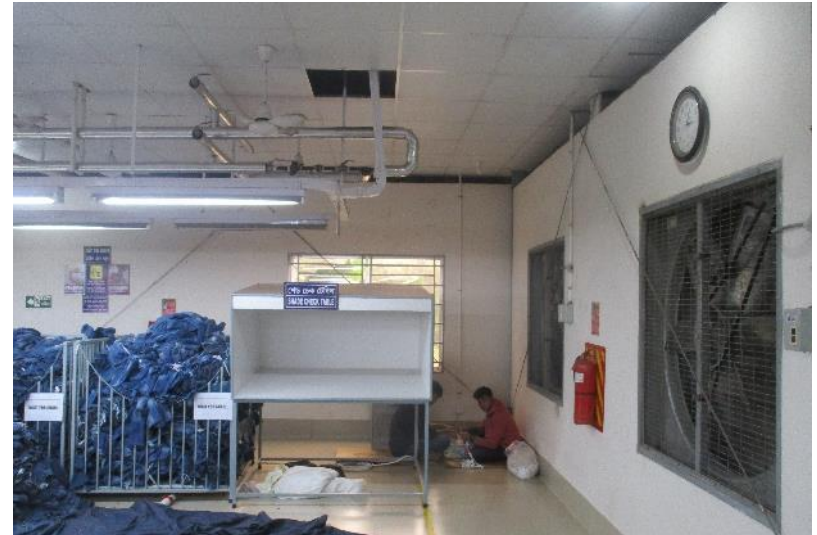
Loose cable bracing

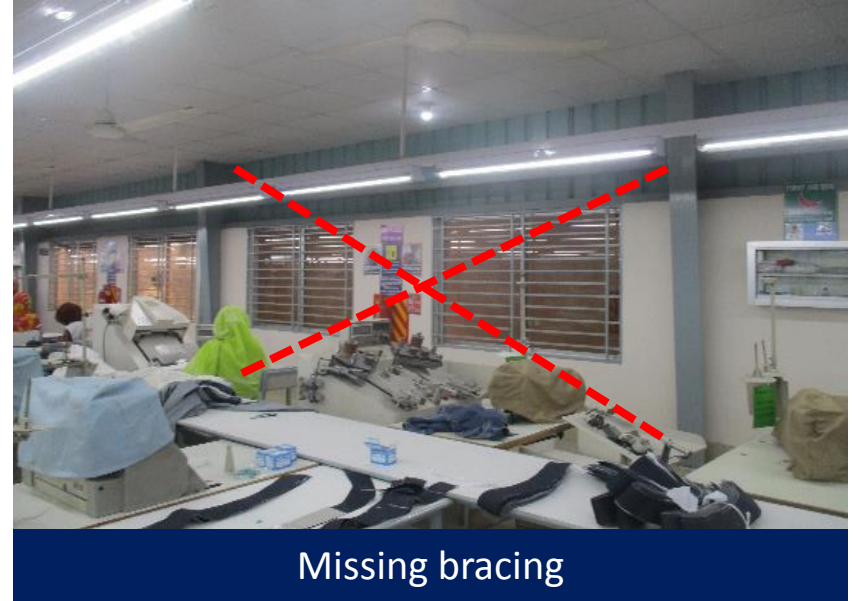
Missing bracing

Wall bracing was found missing at one location.

| Item No. | Observation | Recommended Action Plan | Recommended Timeline |
|---|---|---|---|
| 03 | Missing bracing at sewing shed. (Sewing shed) | Install the missing bracing. | (within 6-weeks) |
