# Fakhruddin Textiles Mills Limited (Extension Area)

Ghargharia, Master Bari, Kewa, Sreepur, Gazipur  
(24.191469, 90.435220)

25 February & 11 August 2021

# Observations

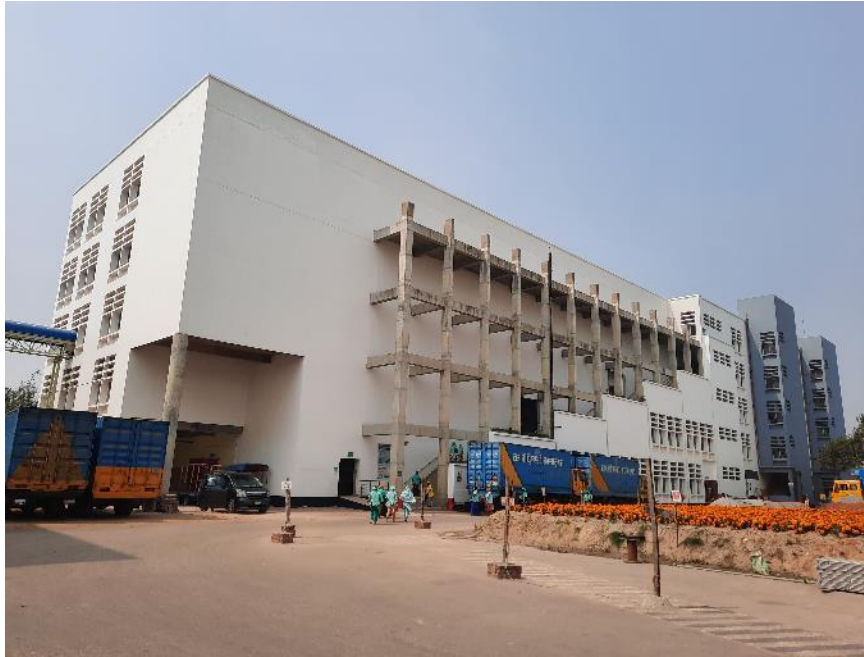
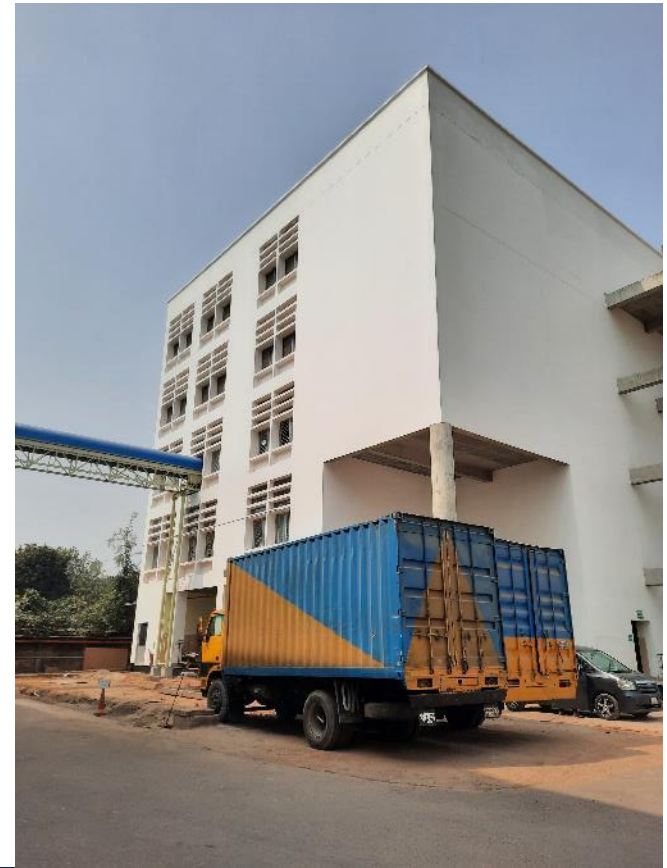
**Structural design reports not available**

As per BNBC, building or structure shall have its design documents prepared in accordance with the provision of Section 1.9.1. The design document shall include a design report and a set of structural drawings which shall be prepared in compliance with section 1.9.1.1 and section 1.9.1.2 as per BNBC.

The design report of the mentioned structures was not found which is required to be prepared in compliance with section 1.9.1.1 (part-6, BNBC).

| Item No. | Observation | Recommended Action Plan | Recommended Timeline |
|---|---|---|---|
| 01 | Structural design reports not available. (Building 09- Store & Dining building). | Building engineer to prepare the design document including a design report and a set of structural drawings in compliance with section 1.9.1.1 and section 1.9.1.2 as per BNBC. | 6-weeks |
| 02 | Structural design reports not available. (Building 09- Store & Dining building). | Complete implementation of any remedial works deemed necessary by the design review. | 6-months |

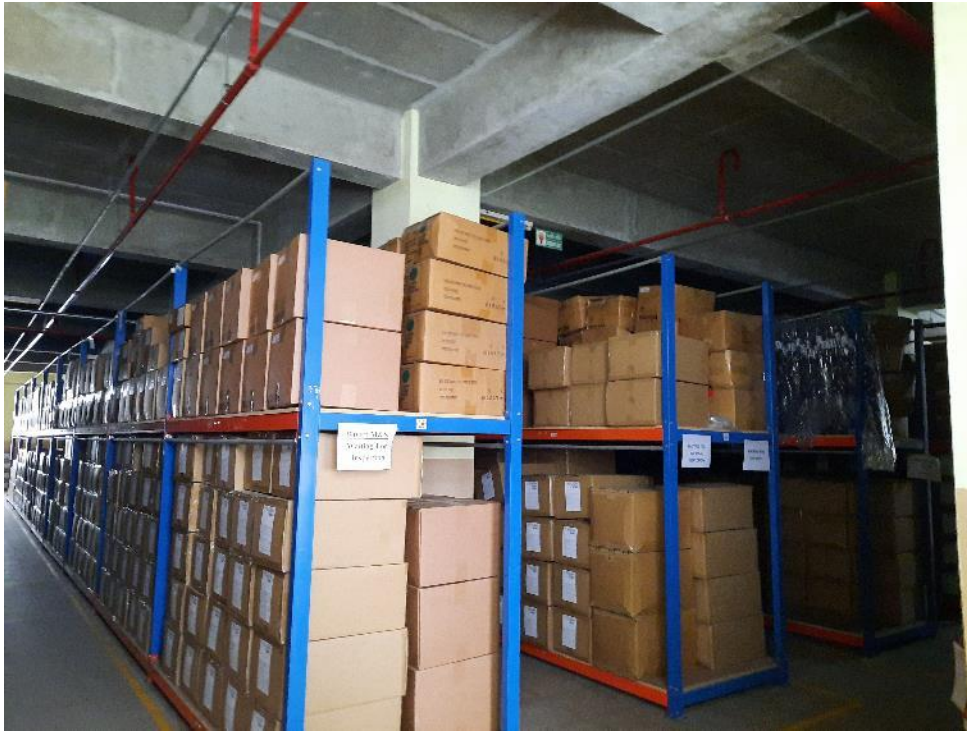
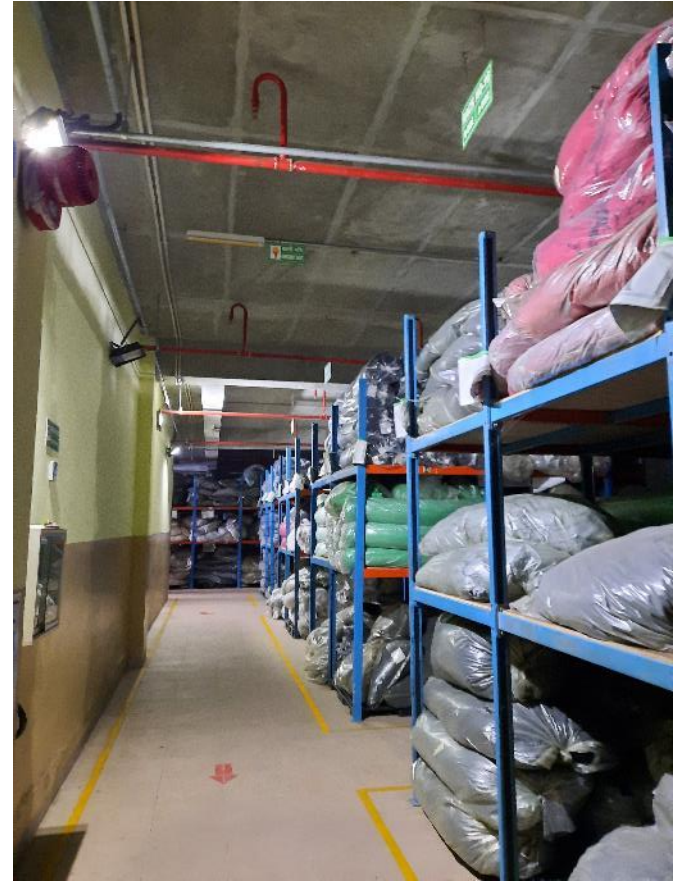
# **Implement floor loading management program**

No load management programs were visible. No load plan posted, load restriction height marking provided. Factory is required to implement load management program as per its floor loading capacity and Follow the load plans for all floors of the buildings and make sure that the workers understand the loading requirements.

| Item No. | Observation | Recommended Action Plan | Recommended Timeline |
|---|---|---|---|
| 03 | Implement floor loading management program. (Building 09- Store & Dining building) | Factory is required to implement load management program by posting, maintaining load plan as per its floor loading capacity. | 6-weeks |

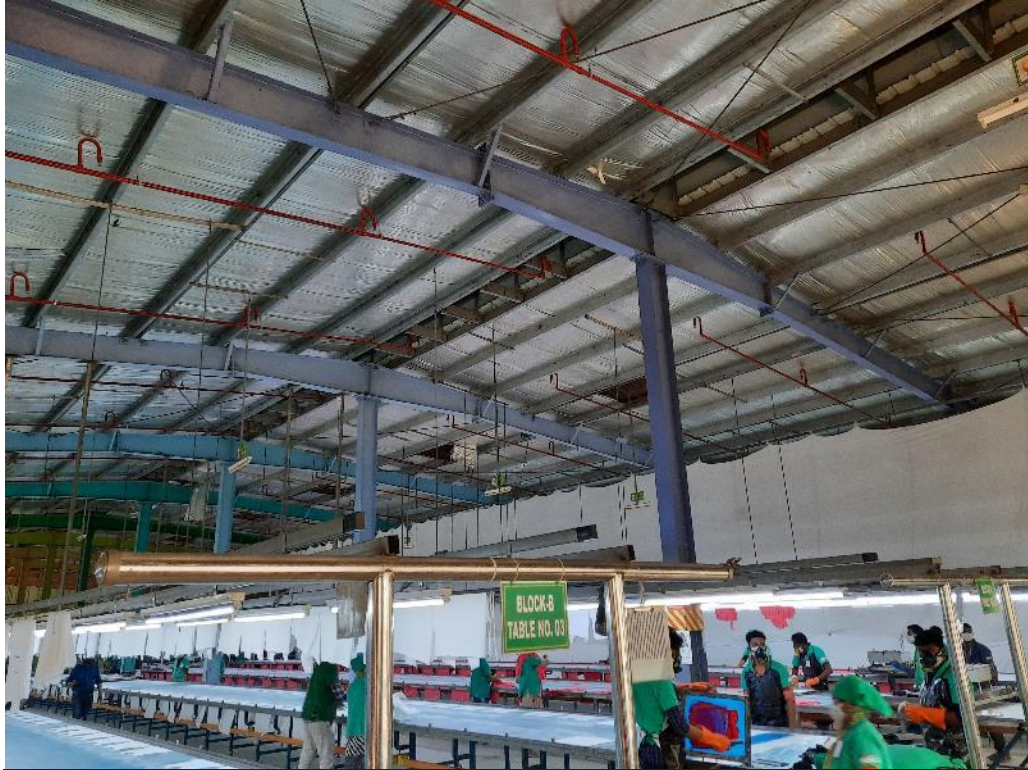
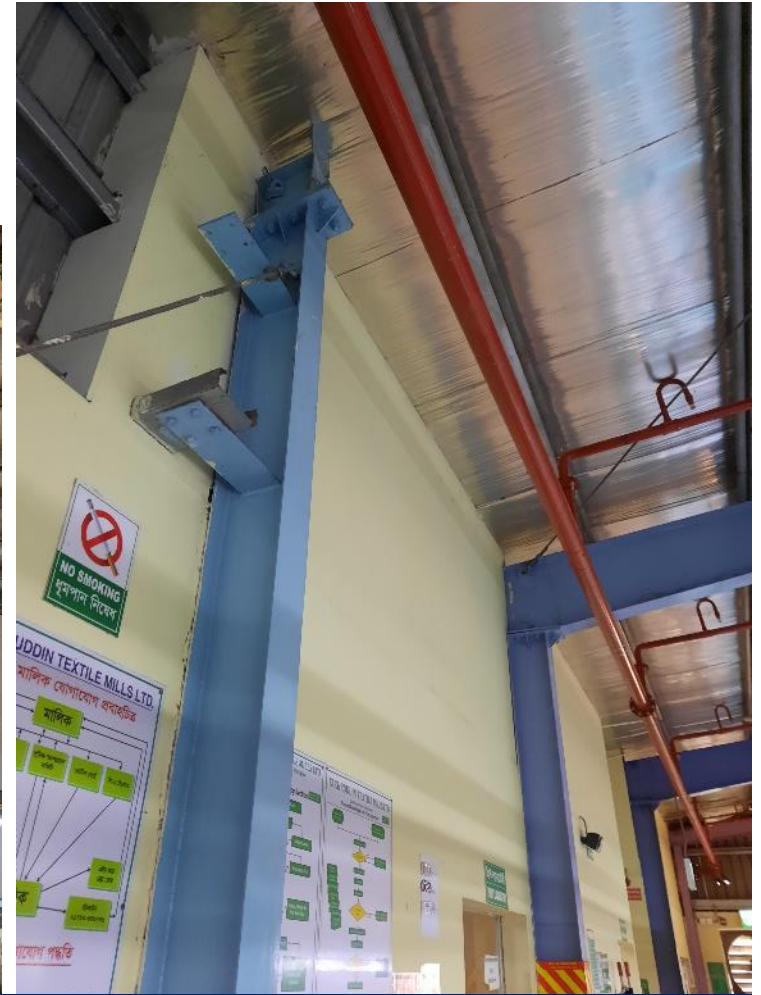
# **Absence of load transfer media in the long direction**

No compression strut/Load transfer media has been provided in the long direction. No design report was available on site. Building engineer is required to check the requirement of the any load transfer media in the long direction.

As per BNBC, every building or structure designed shall have its design documents prepared in accordance with the provision of Section 1.9.1. The design document shall include a design report, and a set of structural drawings, which shall be prepared in compliance with section 1.9.1.1 and section 1.9.1.2 as per BNBC. At the time of inspection, only as-built drawing, load plan and geotechnical report were available, but no design report was available which is required to be prepared in compliance with section 1.9.1.1 (part-6, BNBC).

| Item No. | Observation | Recommended Action Plan | Recommended Timeline |
|---|---|---|---|
| 04 | Absence of load transfer media in the long direction. (Shed 15- Printing Shed) | Building engineer is required to check the requirement of the any load transfer media in the long direction. | 6-weeks |
| 05 | Absence of load transfer media in the long direction. (Shed 15- Printing Shed) | Building Engineer to prepare design report as per BNBC (part-6; Article 1.9.1) by reviewing design, loads and lateral stability. | 6-weeks |

| Item No. | Observation | Recommended Action Plan | Recommended Timeline |
|---|---|---|---|
| 06 | Absence of load transfer media in the long direction. (Shed 15- Printing Shed) | Complete implementation of any remedial works deemed necessary by the Design Report. | 6-months |

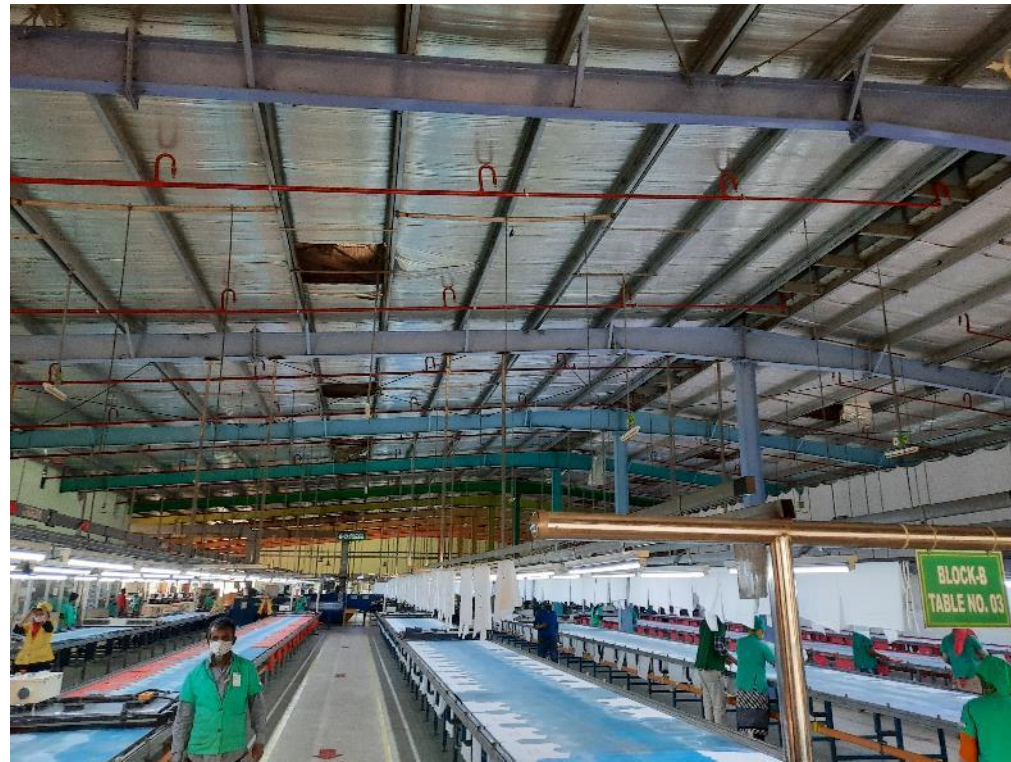
No design report was available for printing shed

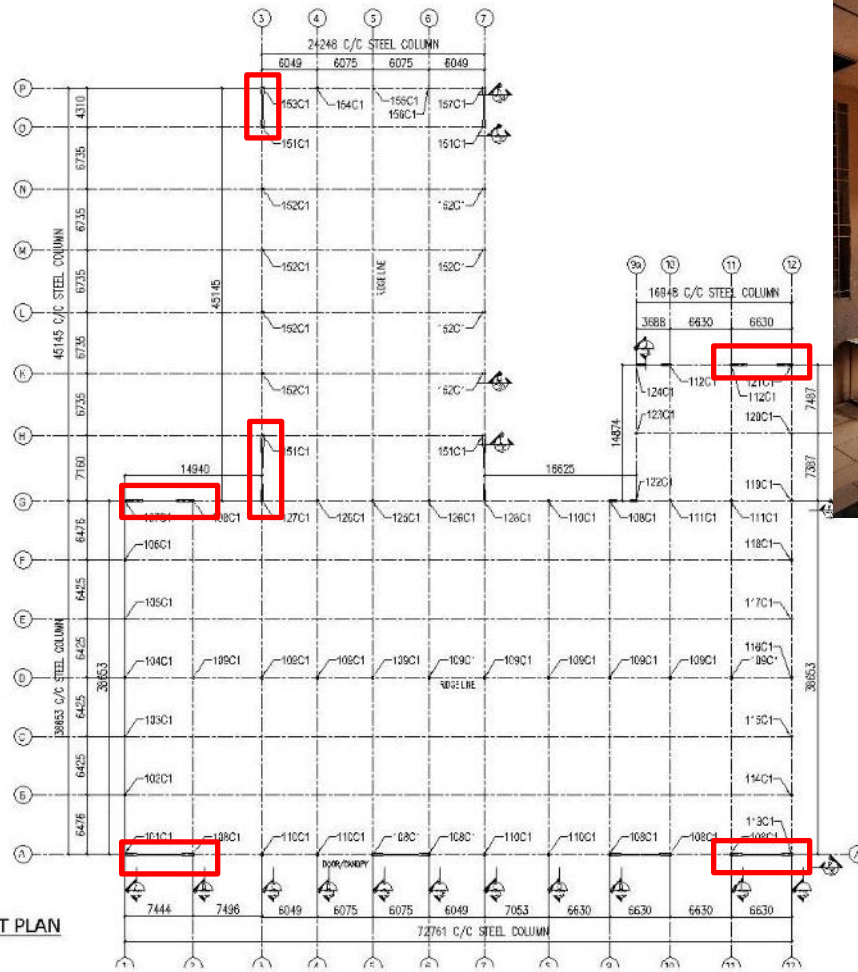
Column & Vertical bracing layout plan

Vertical bracing found missing in several location.

| Item No. | Observation | Recommended Action Plan | Recommended Timeline |
|---|---|---|---|
| 07 | Vertical bracing missing. (Shed 15- Printing Shed). | Building Engineer to Investigate and report on this matter to verify the Structural Integrity of the beams are not compromised. | 6-weeks |
| 08 | Vertical bracing missing. (Shed 15- Printing Shed). | Building engineer is required to check the lateral stability of the shed. | 6-weeks |
| 09 | Vertical bracing missing. (Shed 15- Printing Shed). | Complete implementation of any remedial works deemed necessary by the Design Report. | 6-months |

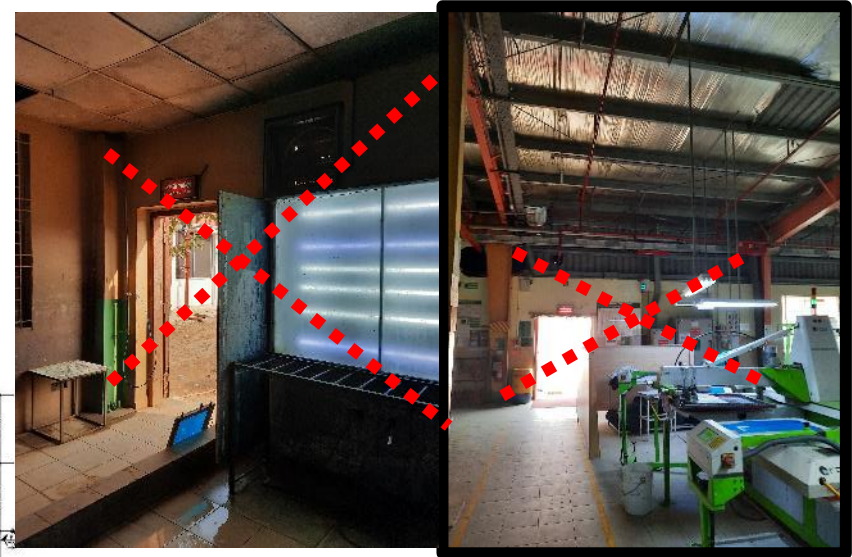
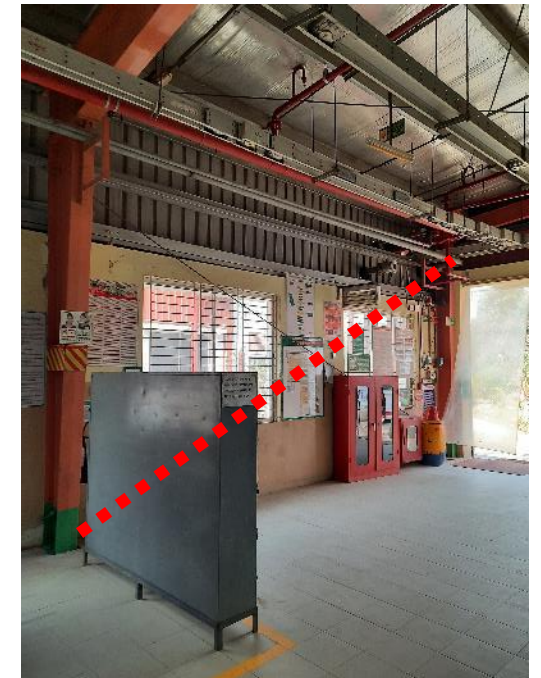
**Vertical bracing missing in several location**

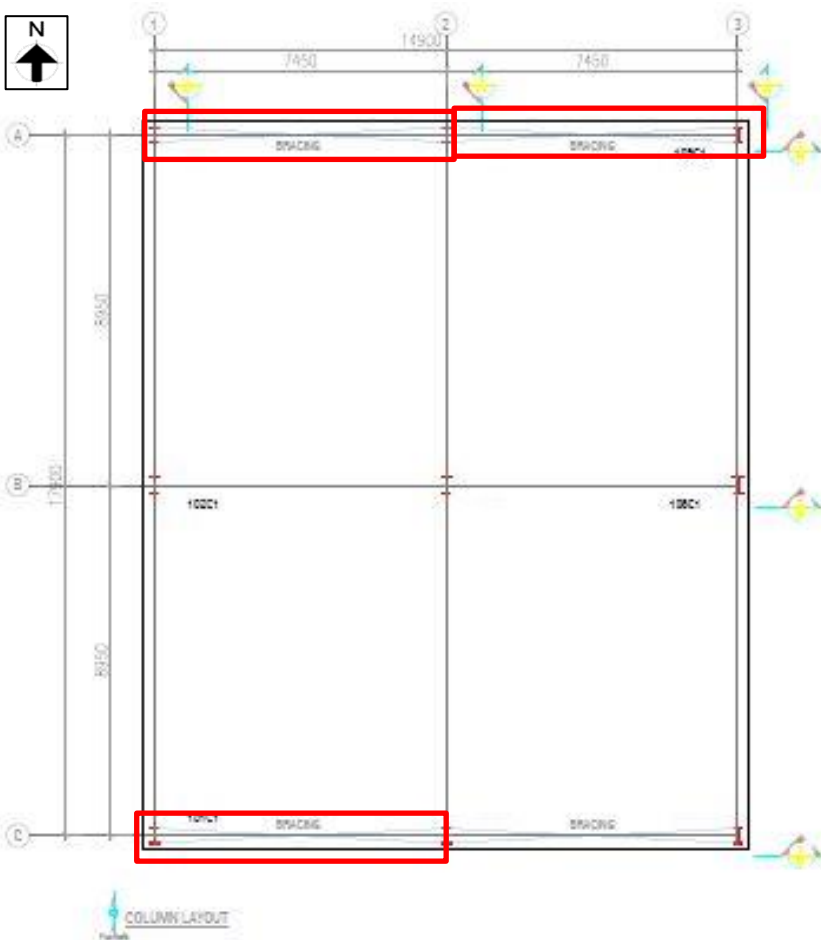
Column & Bracing Layout plan

Vertical bracing found missing in several location. Building engineer is required to check the lateral stability of the building.

| Item No. | Observation | Recommended Action Plan | Recommended Timeline |
|---|---|---|---|
| 10 | Vertical bracing missing in several location. (Shed 14- Utility Building) | Building engineer is required to re-install all the missing bracing as per the design specifications. | 6-weeks |
| 11 | Vertical bracing missing in several location. (Shed 14- Utility Building) | Building engineer is required to check the lateral stability of the shed. | 6-weeks |
| 12 | Vertical bracing missing in several location. (Shed 14- Utility Building) | Complete implementation of any remedial works deemed necessary by the Design Report. | 6-months |

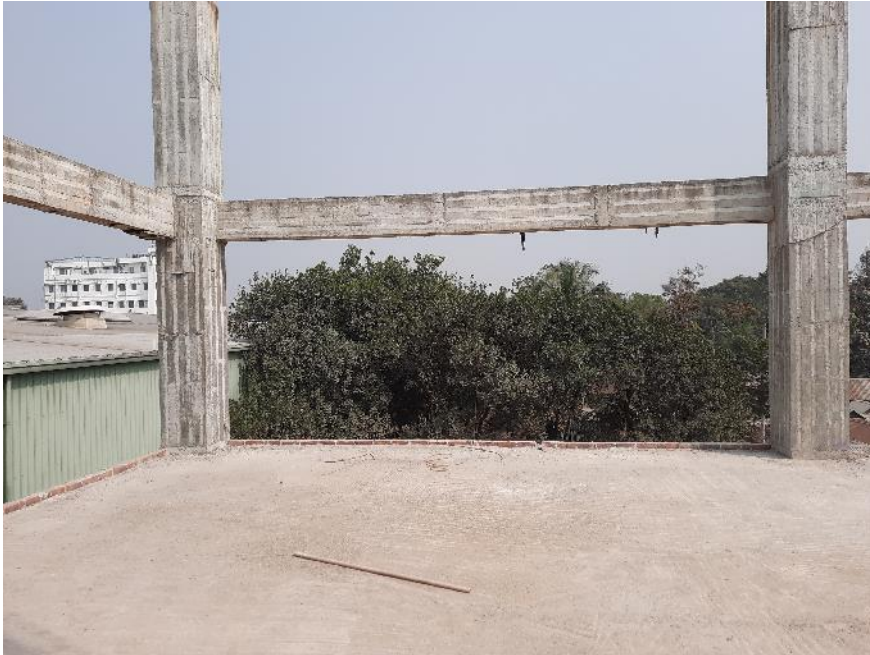
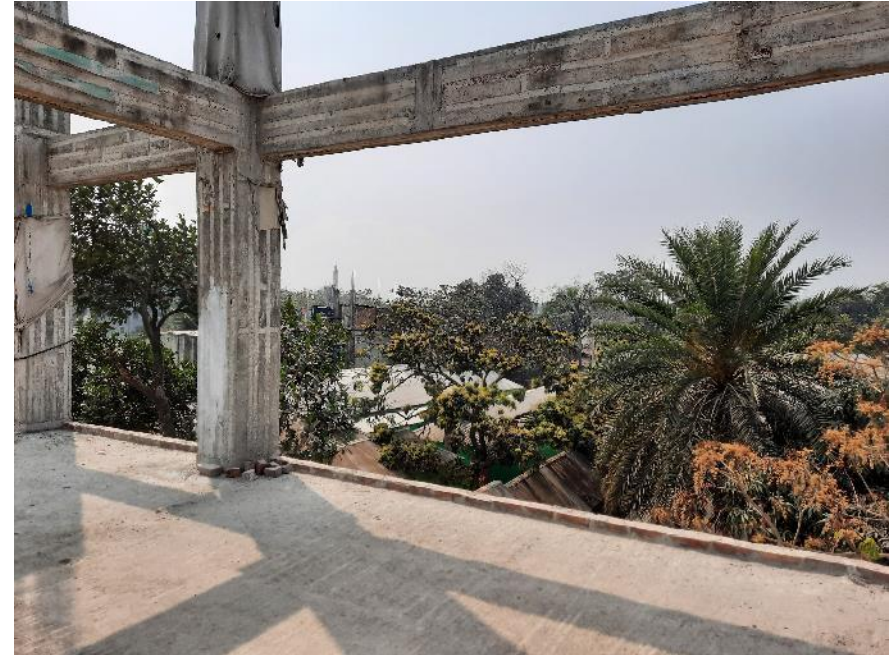
# Falling hazard at roof

No edge protection provided on roof

| Item No. | Observation | Recommended Action Plan | Recommended Timeline |
|---|---|---|---|
| 13 | Falling hazard at roof. (Building 10- Color Service Building) | Complete implementation of any remedial works deemed necessary by the Design Report. | 6-weeks |

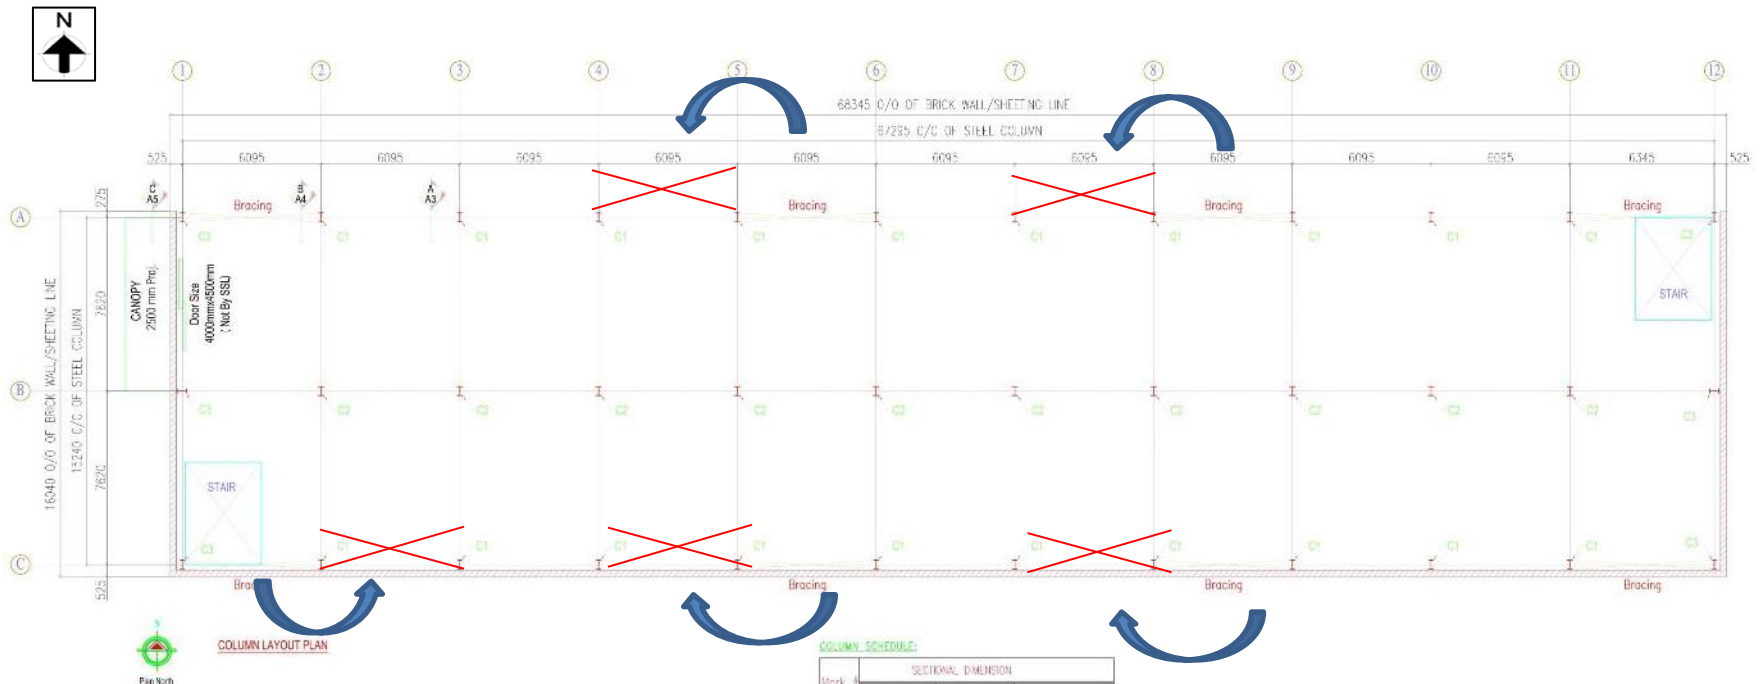
**Wall Bracings at ground floor shifted**

On site Vertical bracing at ground floor shifted from the construction drawing. Building engineer is required to check the existing bracing system for the lateral stability.

| Item No. | Observation | Recommended Action Plan | Recommended Timeline |
|---|---|---|---|
| 14 | Wall Bracings at ground floor shifted. (Shed 13- Garments Dyeing Extension) | Building engineer is required to check the existing bracing system for the lateral stability. | 6-weeks |
| 15 | Wall Bracings at ground floor shifted. (Shed 13- Garments Dyeing Extension) | Building Engineer to prepare design report as per BNBC (part-6; Article 1.9.1) by reviewing design, loads and lateral stability. | 6-weeks |
| 16 | Wall Bracings at ground floor shifted. (Shed 13- Garments Dyeing Extension) | Complete implementation of any remedial works deemed necessary by the Design Report. | 6-months |

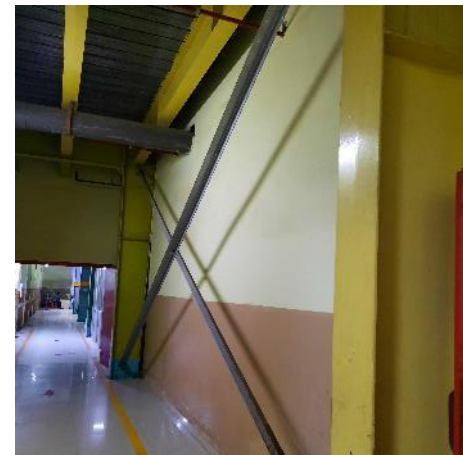
Shifted bracing

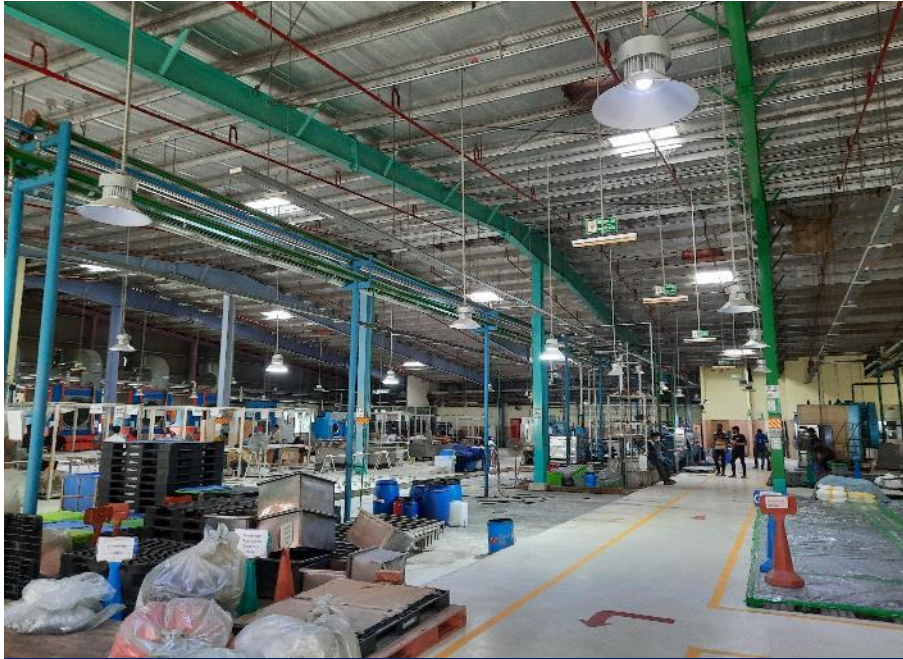
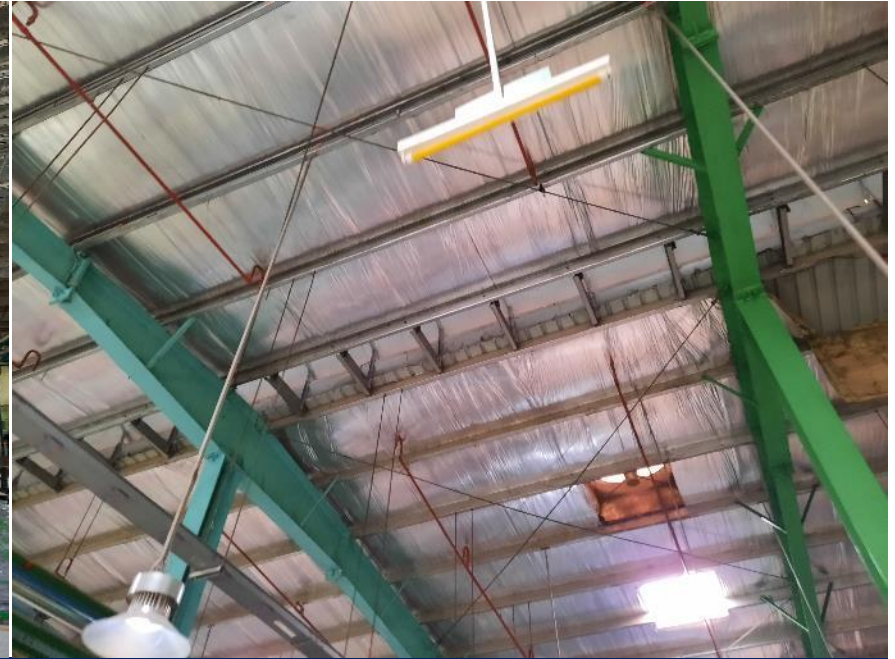
# **Absence of load transfer media in the long direction**

No compression strut/Load transfer media has been provided in the long direction. No design report was available on site. Building engineer is required to check the requirement of the any load transfer media in the long direction.

As per BNBC, every building or structure designed shall have its design documents prepared in accordance with the provision of Section 1.9.1. The design document shall include a design report, and a set of structural drawings, which shall be prepared in compliance with section 1.9.1.1 and section 1.9.1.2 as per BNBC. At the time of inspection, only as-built drawing, load plan and geotechnical report were available, but no design report was available which is required to be prepared in compliance with section 1.9.1.1 (part-6, BNBC).

| Item No. | Observation | Recommended Action Plan | Recommended Timeline |
|---|---|---|---|
| 17 | Absence of load transfer media in the long direction. (Shed 16- Garments Dyeing & Seamless Shed). | Building engineer is required to check the requirement of the any load transfer media in the long direction. | 6-weeks |
| 18 | Absence of load transfer media in the long direction. (Shed 16- Garments Dyeing & Seamless Shed). | Building Engineer to prepare design report as per BNBC (part-6; Article 1.9.1) by reviewing design, loads and lateral stability. | 6-weeks |
| 19 | Absence of load transfer media in the long direction. (Shed 16- Garments Dyeing & Seamless Shed). | Complete implementation of any remedial works deemed necessary by the Design Report. | 6-months |

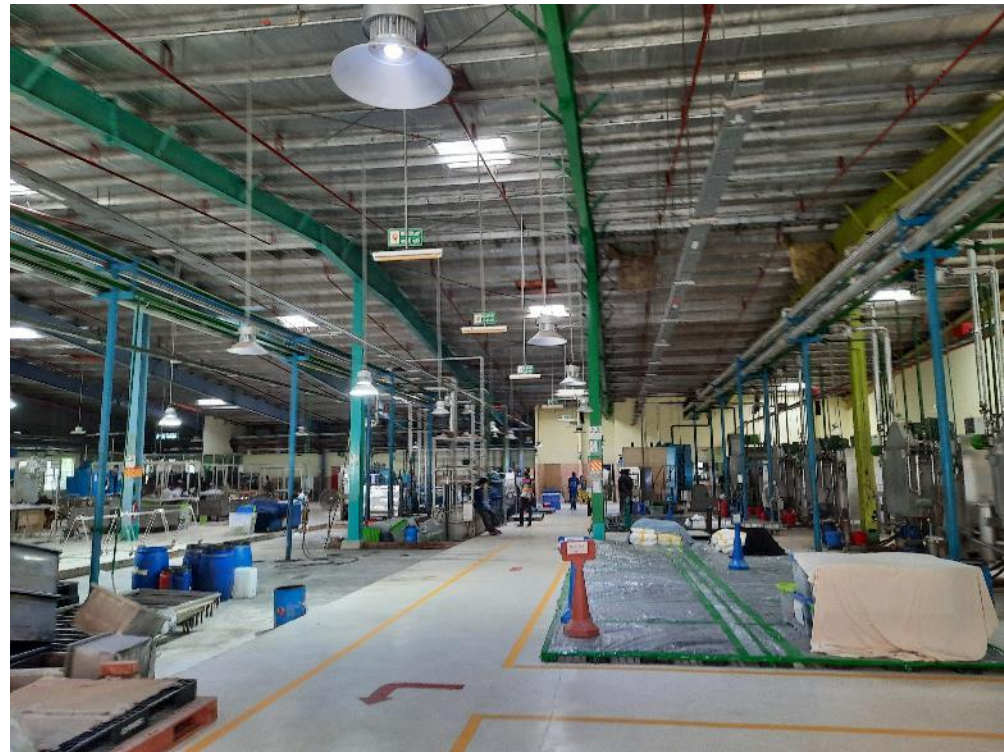
No design report was available for Garments Dyeing & Seamless Shed

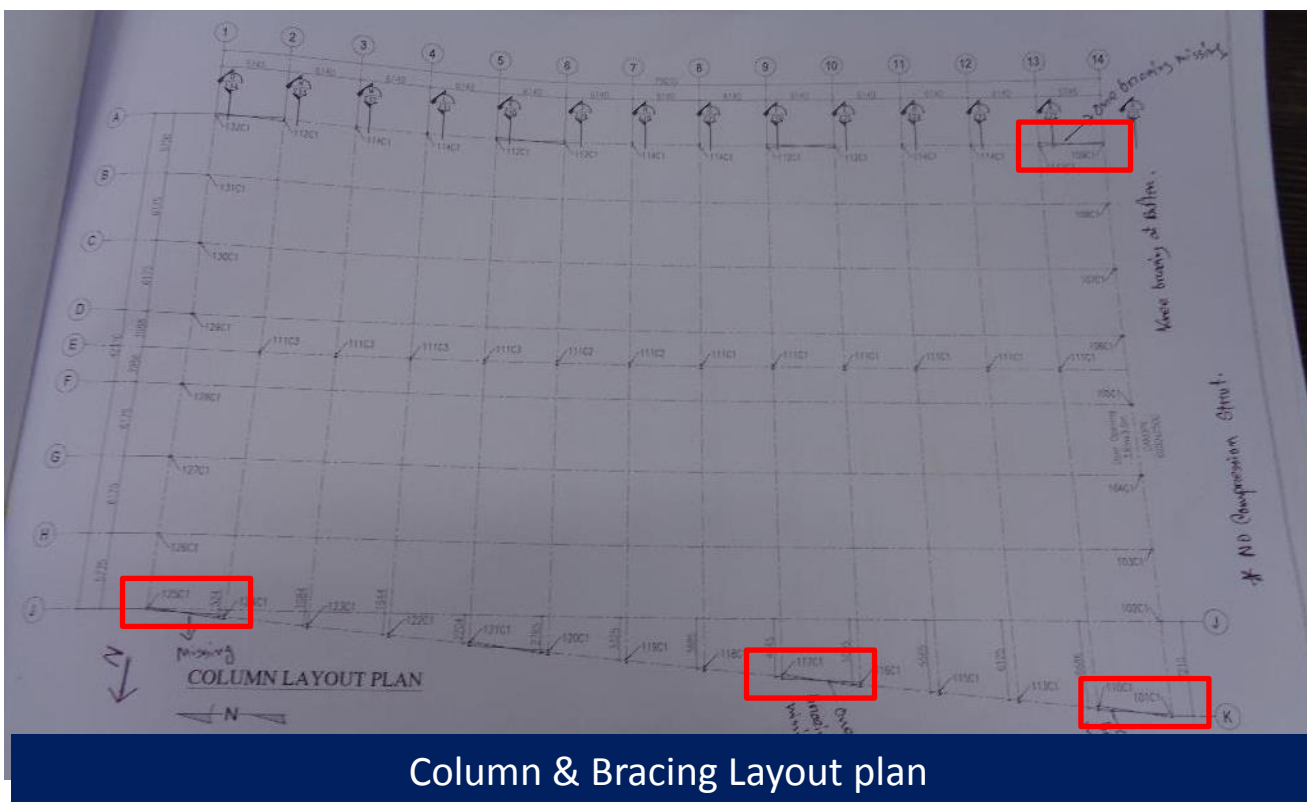
Column & Bracing Layout plan

Vertical bracing found missing in several location.  
Building engineer is required to check the lateral stability  
of the building.

| Item No. | Observation | Recommended Action Plan | Recommended Timeline |
|---|---|---|---|
| 20 | Vertical bracing missing in several location. (Shed 16- Garments Dyeing & Seamless Shed) | Building engineer is required to re-install all the missing bracing as per the design specifications. | 6-weeks |
| 21 | Vertical bracing missing in several location. (Shed 16- Garments Dyeing & Seamless Shed) | Building engineer is required to check the lateral stability of the shed. | 6-weeks |
| 22 | Vertical bracing missing in several location. (Shed 16- Garments Dyeing & Seamless Shed) | Complete implementation of any remedial works deemed necessary by the Design Report. | 6-months |

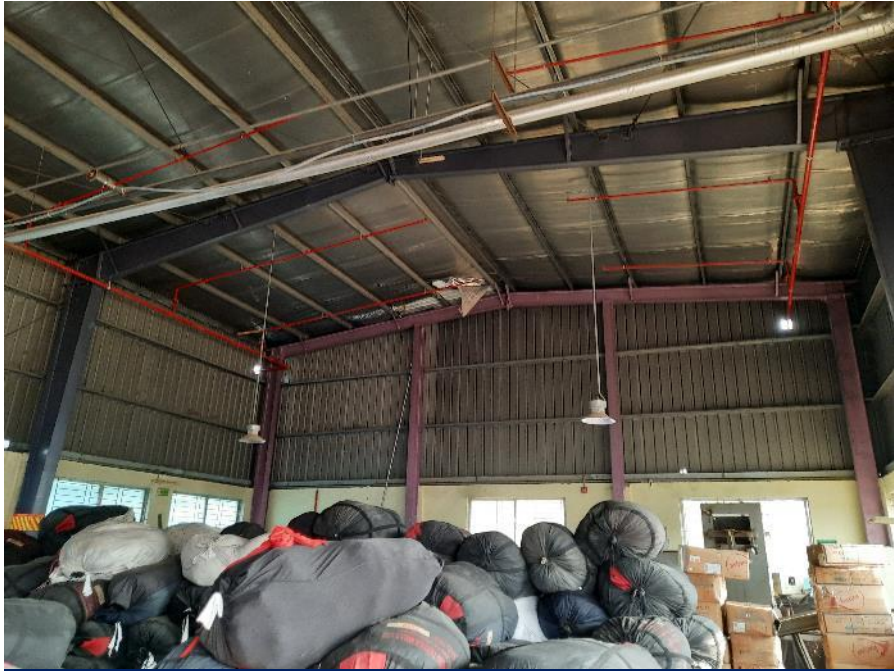
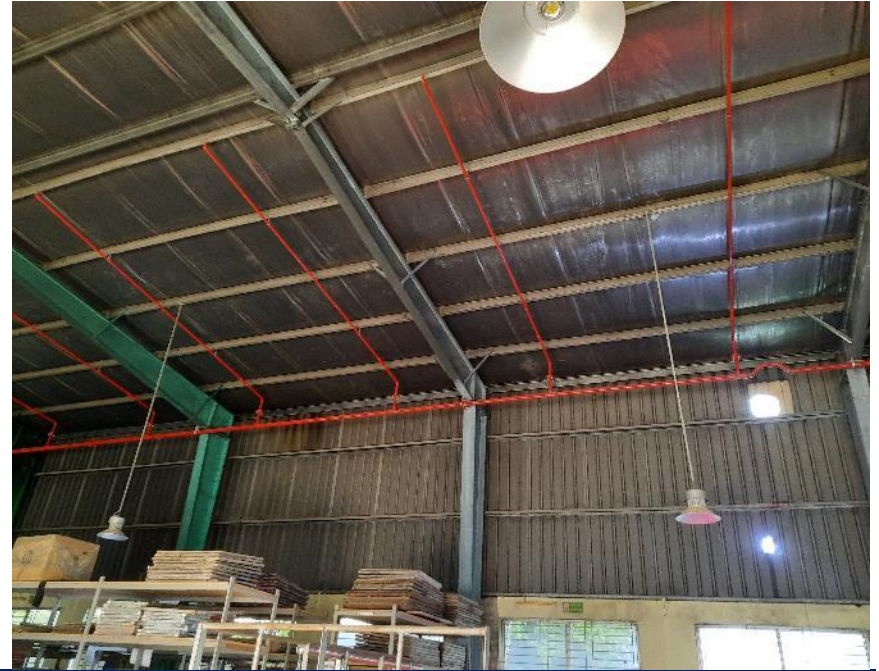
# **Absence of load transfer media in the long direction**

No compression strut/Load transfer media has been provided in the long direction. No design report was available on site. Building engineer is required to check the requirement of the any load transfer media in the long direction.

As per BNBC, every building or structure designed shall have its design documents prepared in accordance with the provision of Section 1.9.1. The design document shall include a design report, and a set of structural drawings, which shall be prepared in compliance with section 1.9.1.1 and section 1.9.1.2 as per BNBC. At the time of inspection, only as-built drawing, load plan and geotechnical report were available, but no design report was available which is required to be prepared in compliance with section 1.9.1.1 (part-6, BNBC).

| Item No. | Observation | Recommended Action Plan | Recommended Timeline |
|---|---|---|---|
| 23 | Absence of load transfer media in the long direction. (Shed 17- Store & Prayer Shed) | Building engineer is required to check the requirement of the any load transfer media in the long direction. | 6-weeks |
| 24 | Absence of load transfer media in the long direction. (Shed 17- Store & Prayer Shed) | Building Engineer to prepare design report as per BNBC (part-6; Article 1.9.1) by reviewing design, loads and lateral stability. | 6-weeks |
| 25 | Absence of load transfer media in the long direction. (Shed 17- Store & Prayer Shed) | Complete implementation of any remedial works deemed necessary by the Design Report. | 6-months |

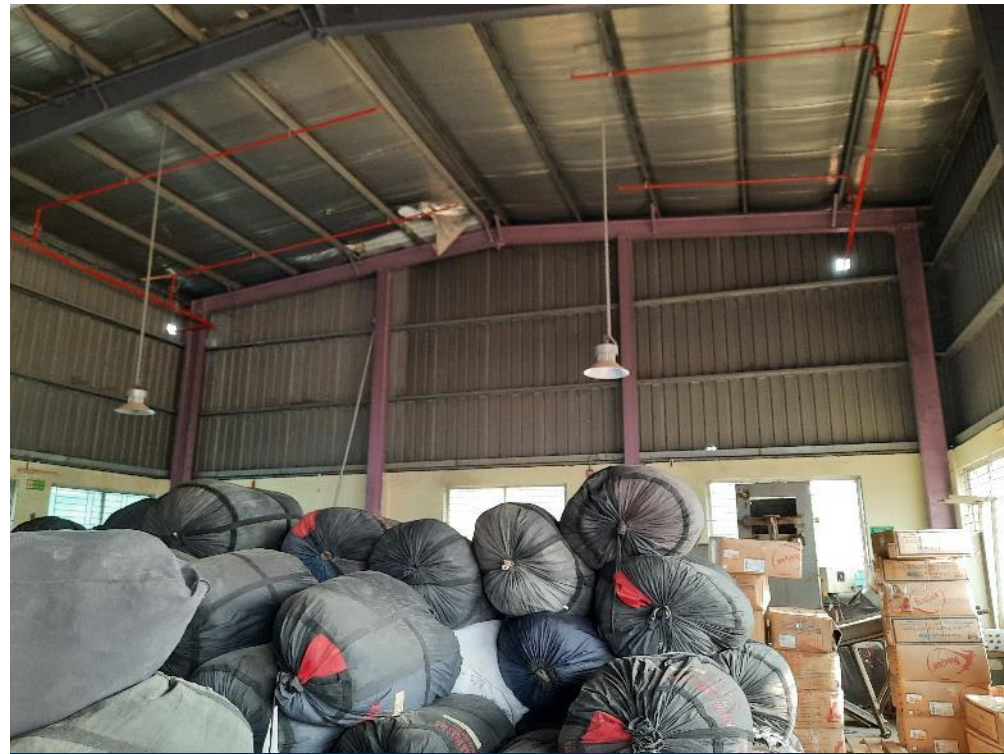
No design report was available for Store & Prayer Shed
