# **M.I.T Apparel (Extension new 5 storied building)**

Pathantuly, Godnail, Siddirganj, Narayanganj.

9<sup>th</sup> June 2021

1. **Extension new 5 storied building** (five storied (G+4) reinforced concrete structure)

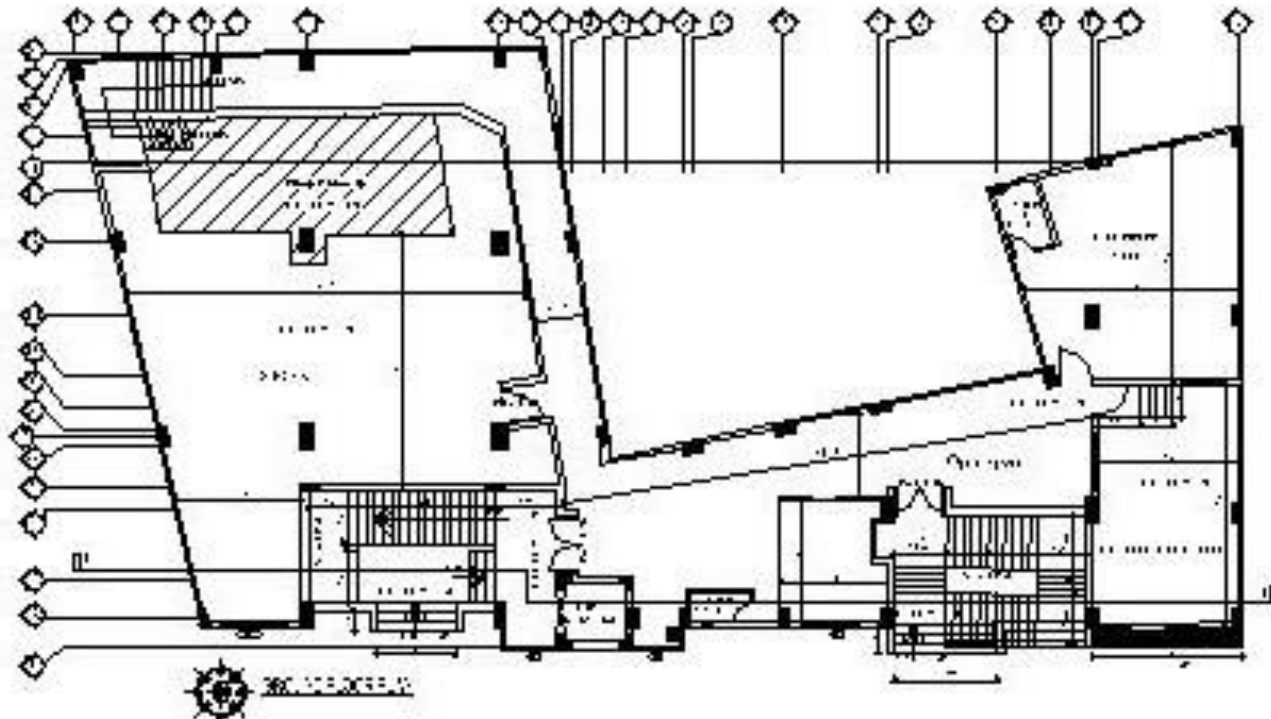
Floor layout plan

The building is geometrically irregular shaped. Due to lateral forces the building might be affected for torsional irregularity. Building engineer is required to check the torsional effect of the building due to lateral forces. Also design report is required to prepare in compliance with section 1.9.1.1 and section 1.9.1.2 as per BNBC.

| Item No. | Observation | Recommended Action Plan | Recommended Timeline |
|---|---|---|---|
| 01 | Torsional irregularity of the building. | Building engineer is required to check the torsional effect of the building due to lateral forces. | 6-weeks |
| 02 | Torsional irregularity of the building. | Building Engineer to prepare design report as per BNBC (part 6; Article 1.9.1) by reviewing design, loads, capacity of structural members & serviceability issues. | 6-weeks |
| 03 | Torsional irregularity of the building. | Carry out any remedial works if required. | 6-months |

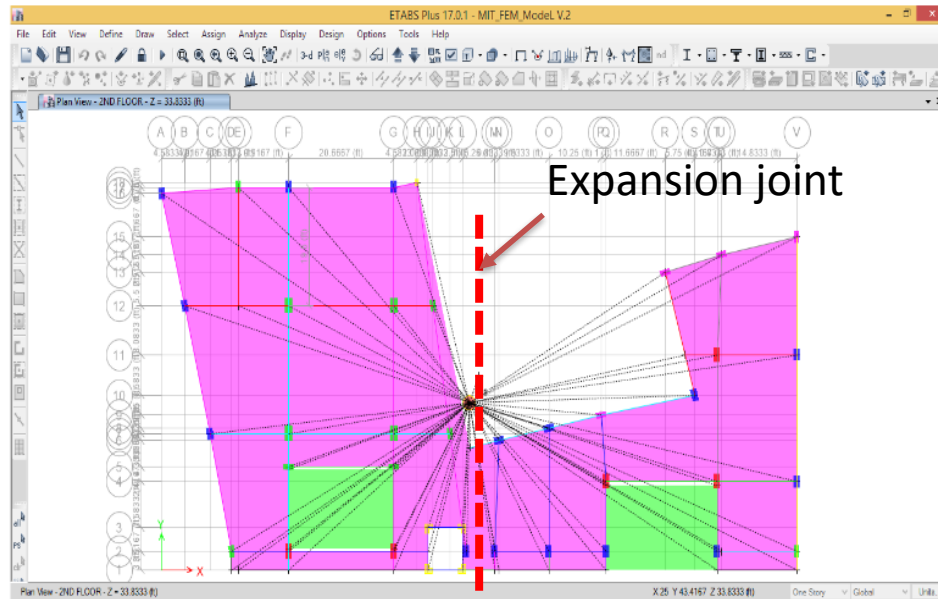
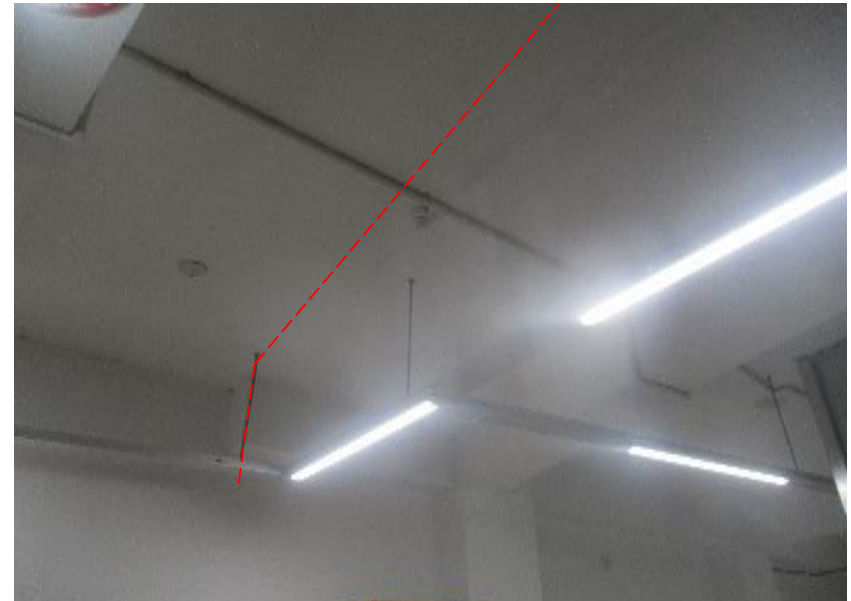
Expansion Joint (1st & 2nd floor only)

Expansion Joint exist on 1st & 2nd floor but in software-based analysis expansion joint is not considered. Single diaphragm is assigned for distribution of lateral forces.

| Item No. | Observation | Recommended Action Plan | Recommended Timeline |
|---|---|---|---|
| 04 | Expansion joint consideration in analysis. | Expansion joint is required to consider in software-based analysis model and revise the design report accordingly. | 6-weeks |

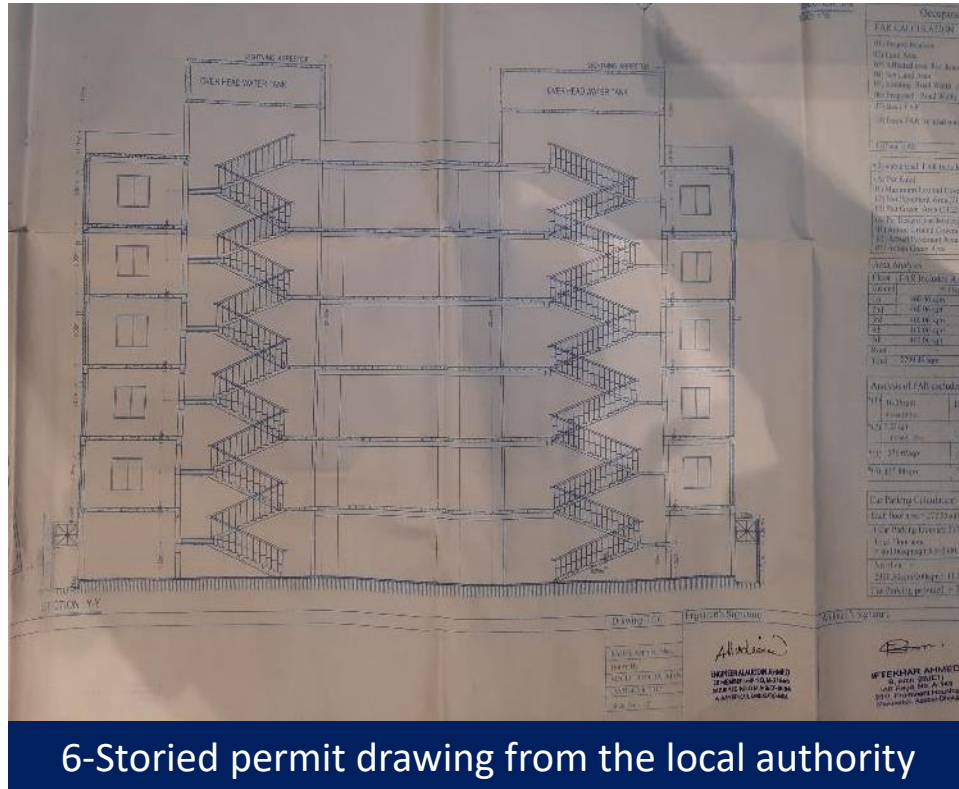
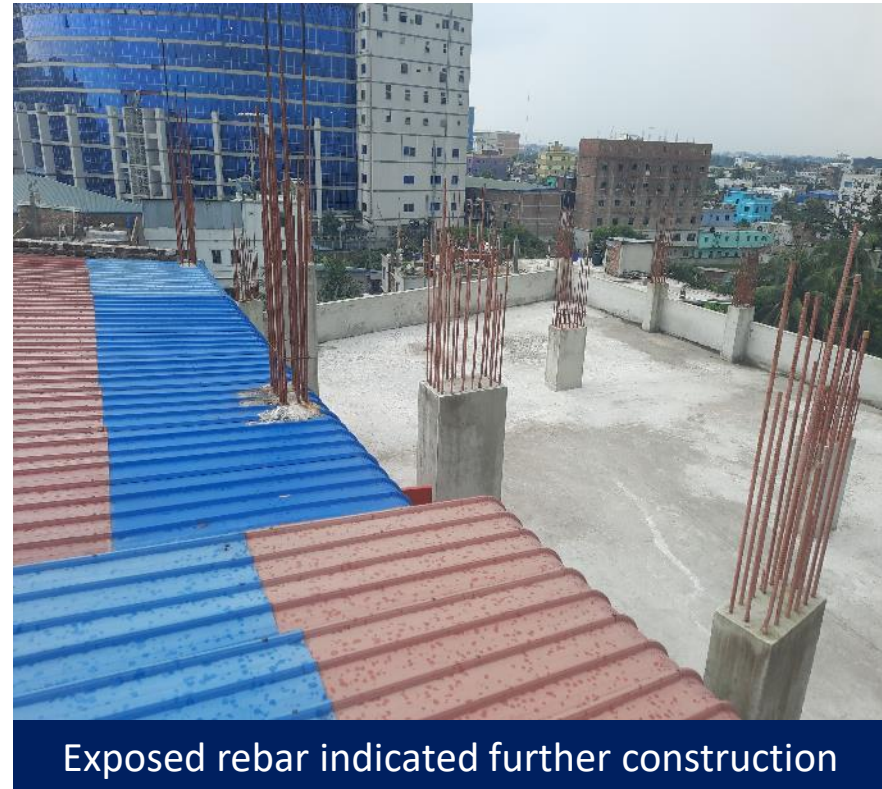
Factory has a plan to extend the building vertically up to 6-Storeyed. Column capacity has been checked for existing condition also design report prepared for the existing condition.

Any extensions or modifications of the existing building, the factory is required to carryout Detail Engineering Assessment by a structural Engineer and in full compliance with the BNBC provision.

| Item No. | Observation | Recommended Action Plan | Recommended Timeline |
|---|---|---|---|
| 05 | Possibility of future extension. | Any extensions or modifications of the existing building, the factory is required to carryout Detail Engineering Assessment by a structural Engineer and in full compliance with the BNBC provision. | 6-months |
| 06 | Possibility of future extension. | Carry out remedial works from outcome of Detail Engineering Assessment where necessary before further construction. | 6-months |

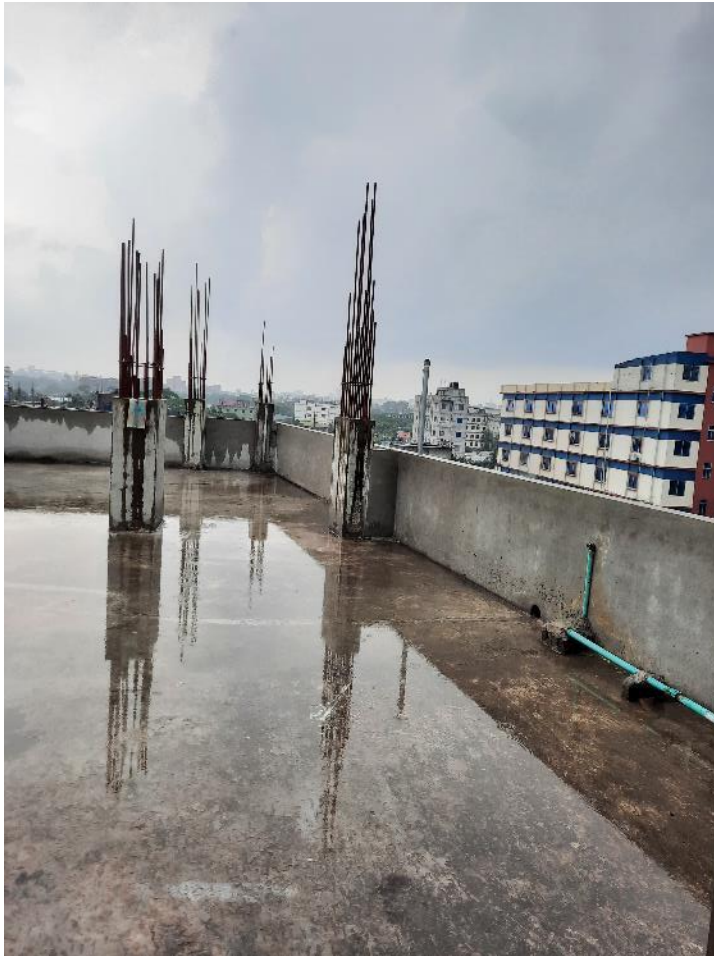
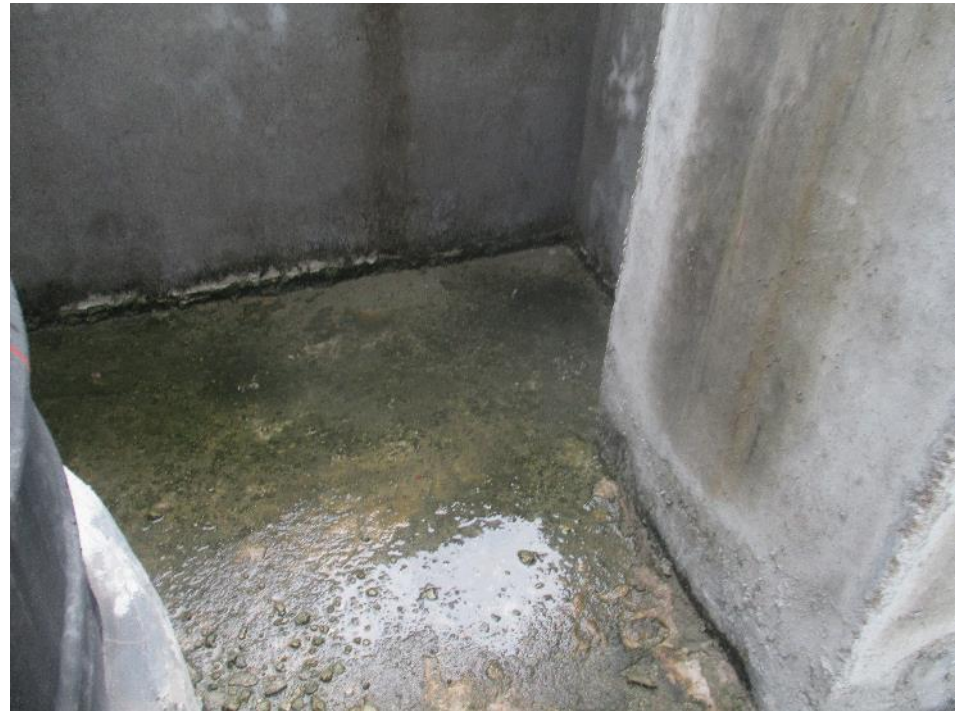
Standing water and algae observed at roof. Building engineer is required to improve the roof drainage system.

| Item No. | Observation | Recommended Action Plan | Recommended Timeline |
|---|---|---|---|
| 07 | Improper roof drainage system. | Building engineer is required to improve the roof drainage system. | 6-weeks |
