# Jinnat Knitwears Limited (Sreepur) (Extension)

Dhanua, Sreepur, Gazipur-1740.

08 January 2023

# Observations

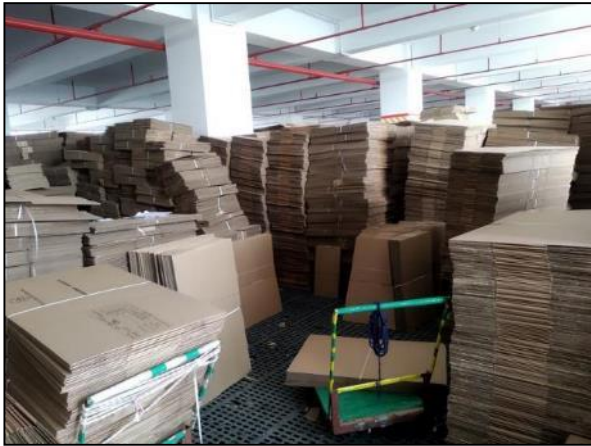
**Design report need to be revised**

General store at 7<sup>th</sup> floor

The building engineer is required to revise the load plan for storage area based on BNBC live load requirement and update the design report & FEA model accordingly.

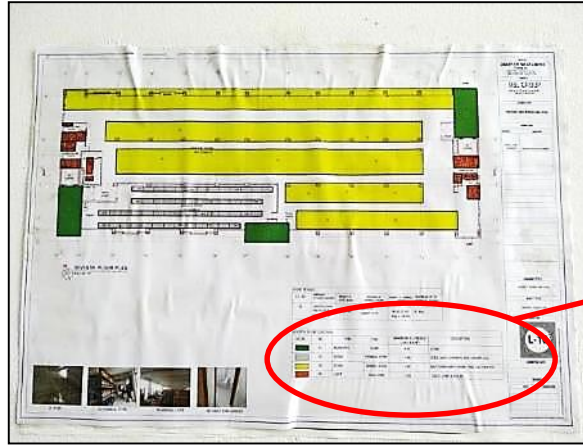
Load plan posted on site

Prepared live load plan not comply with BNBC

As per BNBC, the minimum floor live load for light storage is 6 kN/m<sup>2</sup> (126 psf). The storage in this building is designed for 4 kN/m<sup>2</sup> live loads.

| Item No. | Observation | Recommended Action Plan | Recommended Timeline |
|---|---|---|---|
| 01 | Design report need to be revised. (Printing Building) | The building engineer is required to revise the load plan for storage area based on BNBC live load requirement and update the design report & FEA model accordingly. And submit design documents to RSC for review. | 6-weeks |

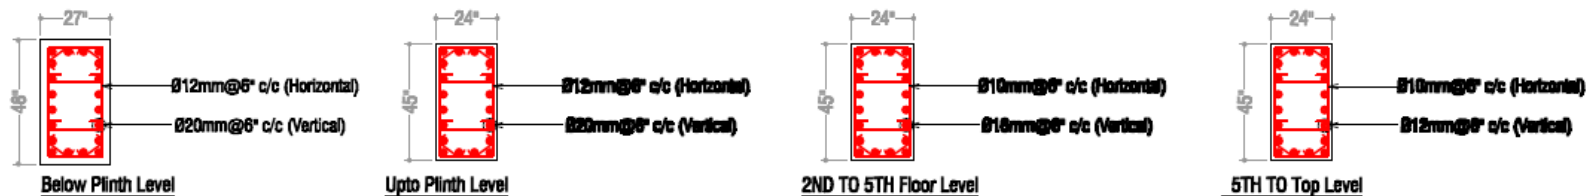
SW- 1 DETAILS

In design report the columns (at grid 7F & 8F) are considered as shear wall.

In design report and in the provided as-built drawing, the columns at grid 7F & 8F are considered as shear wall where the ratio of breadth/width of the columns  $< 0.4$ . Building engineer is required to provide clarification for the consideration (columns as a shear wall) and revise the design report & FEA model accordingly and submit to RSC for review.

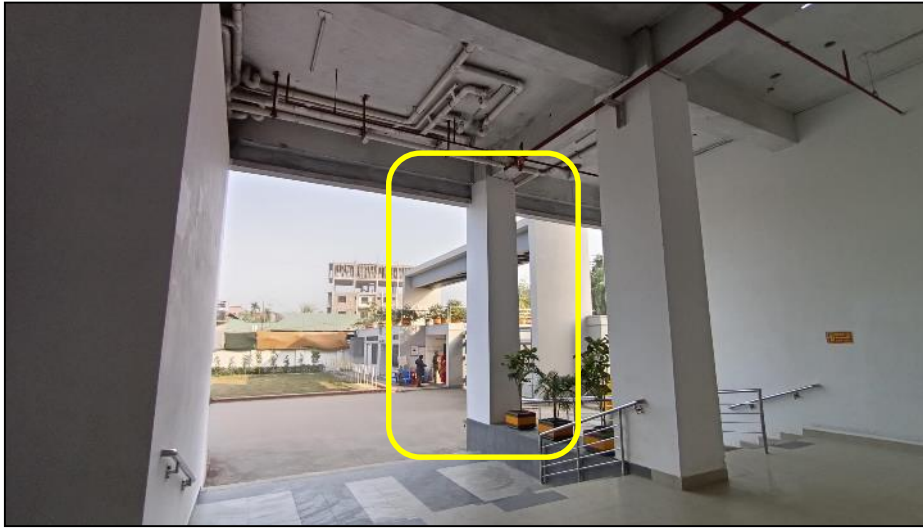
Columns on loading/unloading areas are susceptible to vehicle impact. The factory engineer is required to take necessary action to prevent the vehicle impact in the columns.

| Item No. | Observation | Recommended Action Plan | Recommended Timeline |
|---|---|---|---|
| 04 | Column Susceptible to vehicle impact. (Printing Building) | The factory engineer is required to provide barrier around the column to prevent the vehicle impact in the columns. | 6-weeks |

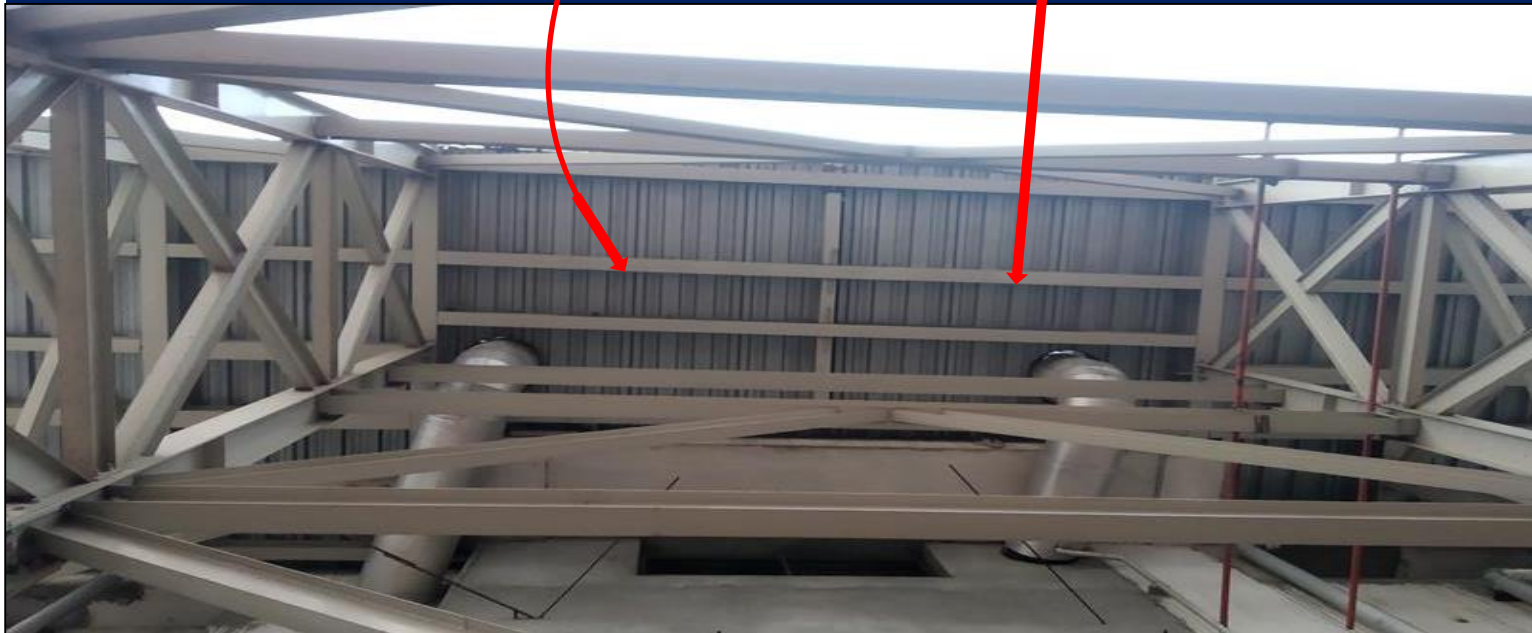
Some sub-beam found missing at on-site

Discrepancies were observed between the provided as-built drawing and on-site condition. Building engineer is required to produce accurate as-built drawing.

| Item No. | Observation | Recommended Action Plan | Recommended Timeline |
|---|---|---|---|
| 05 | Mismatch between drawings and as-built conditions. (EGB Room ) | The building engineer is required to check the structure, collect information and produce accurate as-built structural drawings. | 6-weeks |

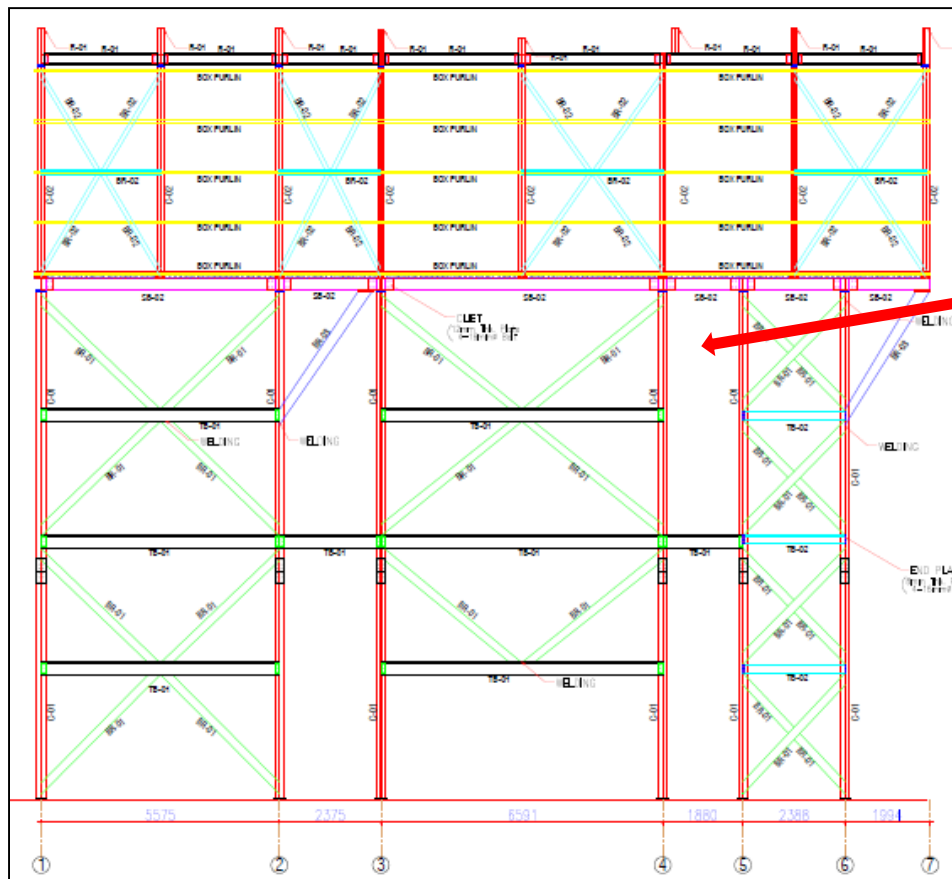
Vertical bracing found missing in provided as-built drawing.

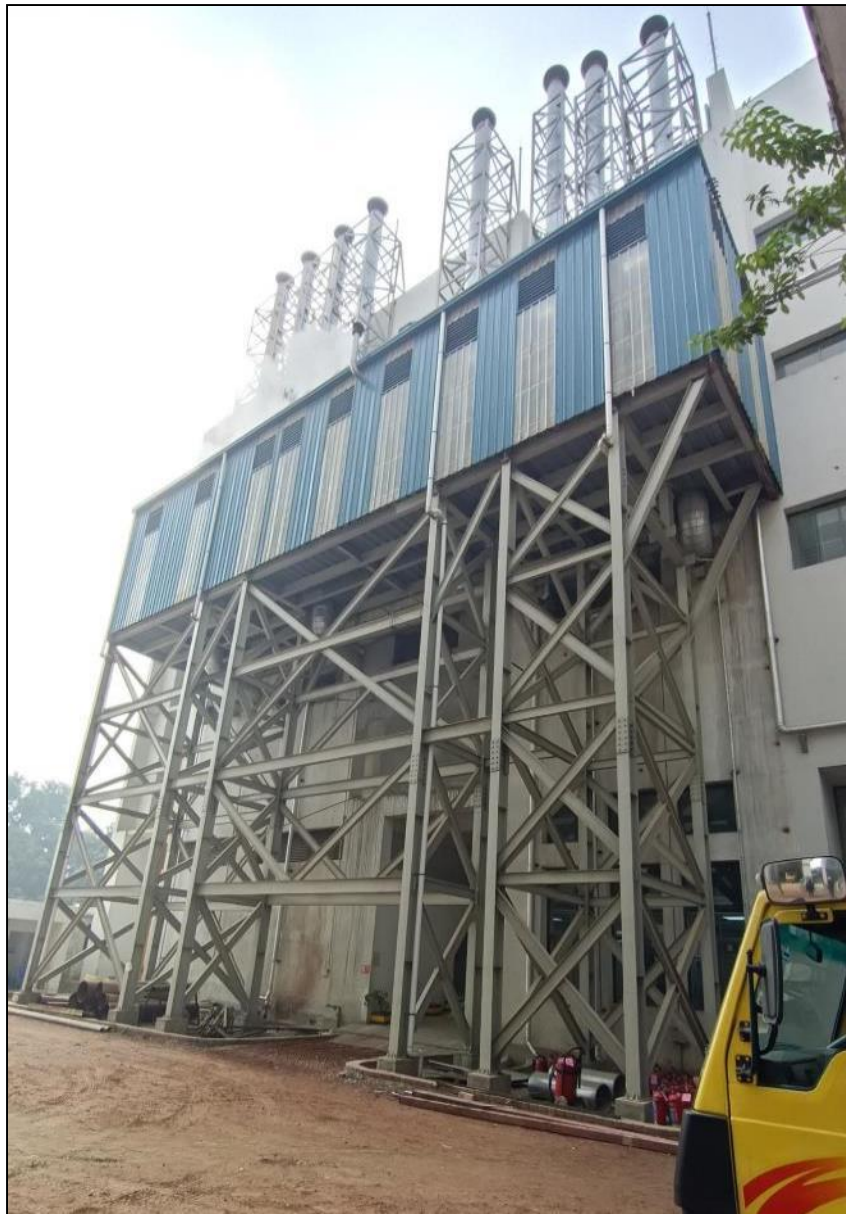
No design report was available for EGB

At the time of inspection, only as-built drawing and geotechnical report were available, but no design report & load plan were available which are required to be prepared in compliance with section 1.9.1 (part-6, BNBC).

| Item No. | Observation | Recommended Action Plan | Recommended Timeline |
|---|---|---|---|
| 06 | Absence of design documents. (EGB Room) | Building engineer is required to prepare the design documents including a design report, and a set of structural drawings in compliance with section 1.9.1, part-6 of BNBC and submit to RSC for review. | 6-weeks |

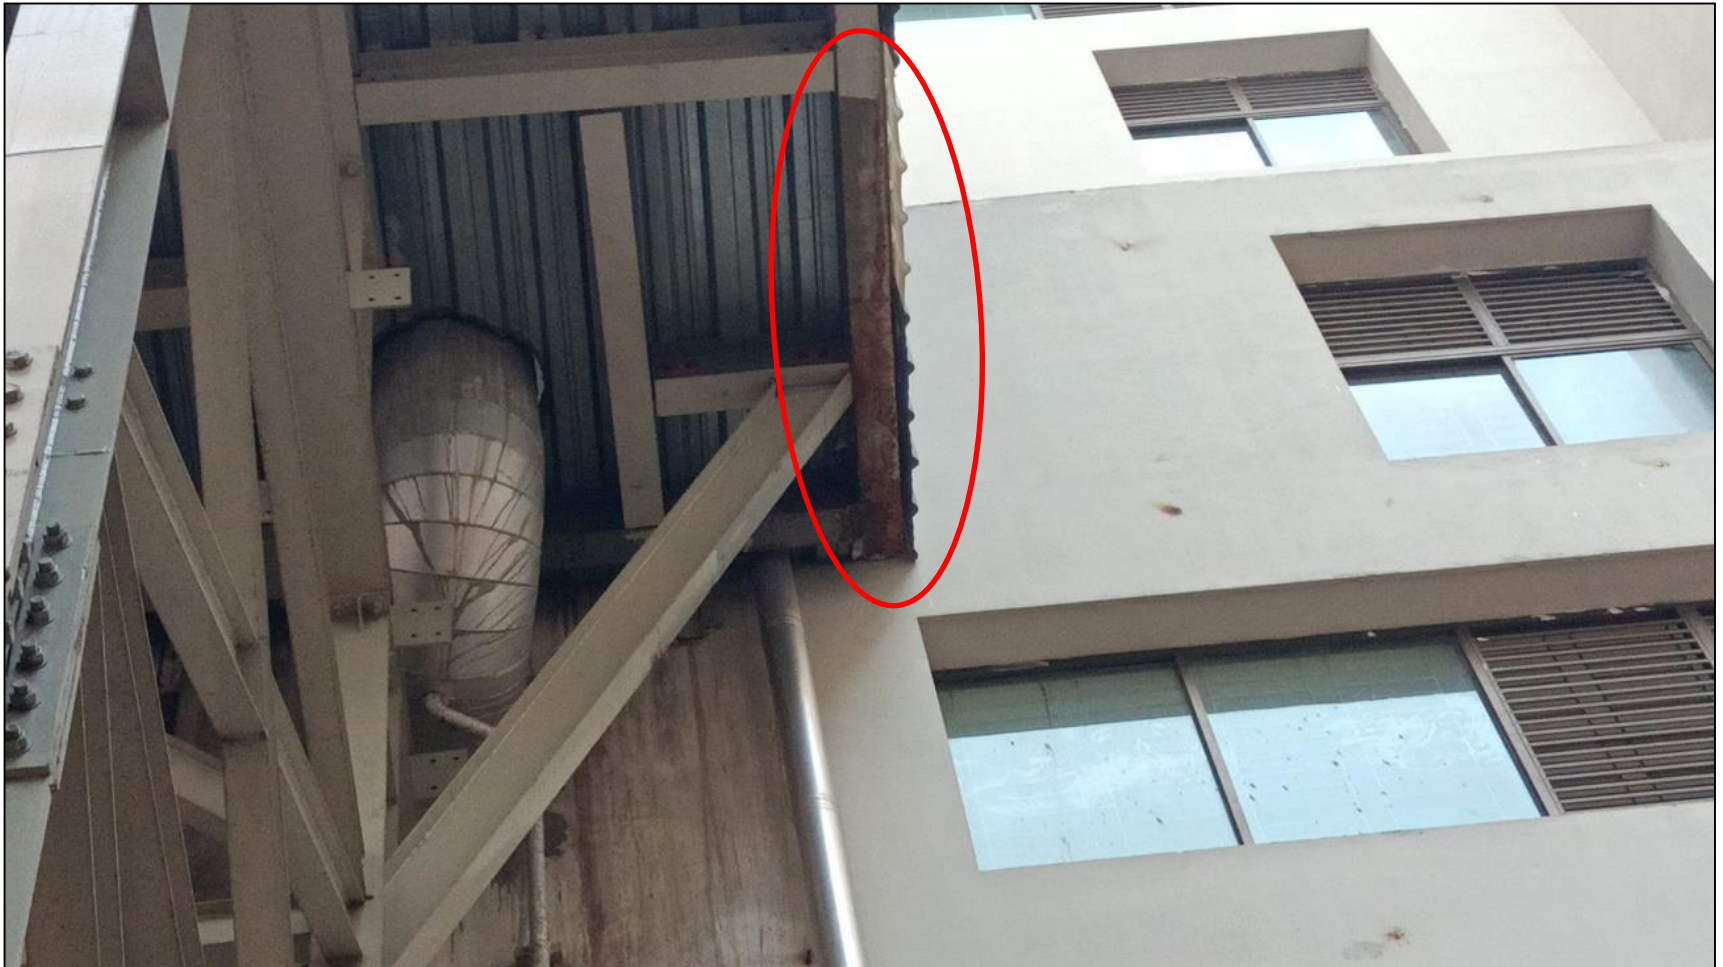
Corrosion in cantilever steel beam

Corrosion in steel member was observed in cantilever portion at North. The factory is required to remove the corrosion and apply suitable corrosion resistance coating to the steel members.

| Item No. | Observation | Recommended Action Plan | Recommended Timeline |
|---|---|---|---|
| 08 | Corrosion in steel member. (EGB Room) | The factory is required to remove the corrosion and apply suitable corrosion resistance coating to the steel members. | 6-weeks |
