# Nipa Fashion Wear Ind. Ltd.--Extended Building

Selina Tower - 6, Holan Road, Islam Bag, Dhaka  
(23.85637, 90.43121)

8<sup>th</sup> June 2021

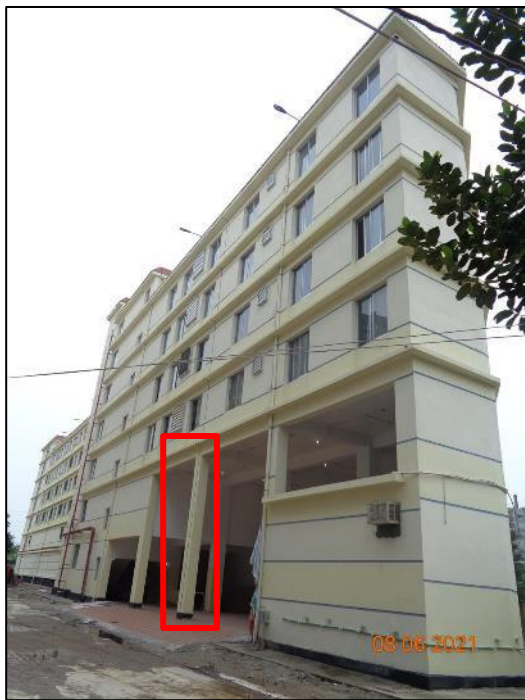
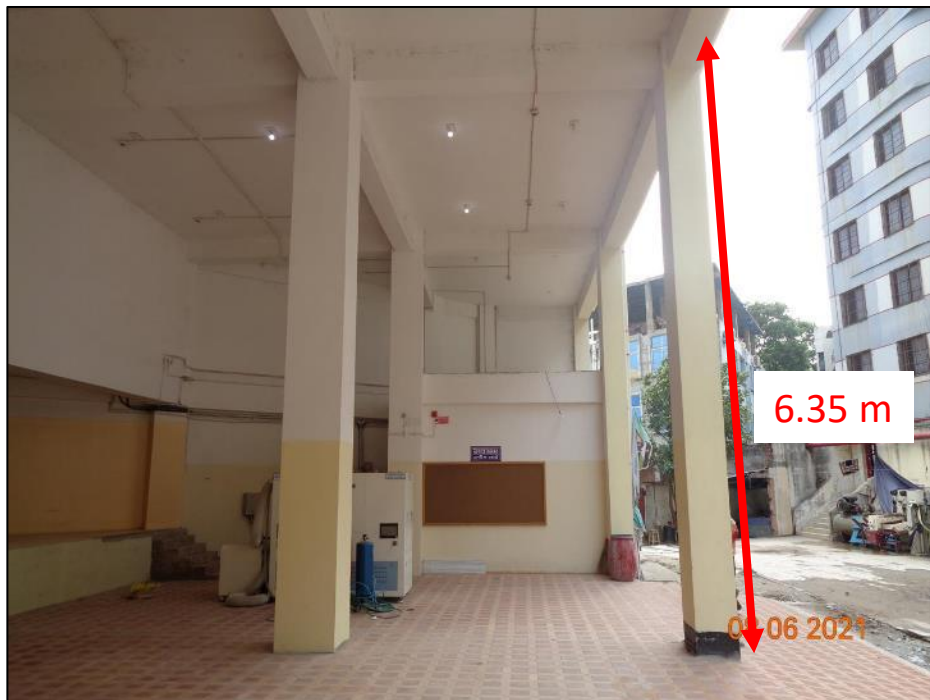
C3 Column

Column at loading-unloading area.

Ground floor column 6.35 m in length and 600X375 mm in size. The length/width=16.9 indicate that the columns are critical for slenderness effect. So, the factory engineer is required to check and address this issue in the design report.

| Item No. | Observation | Recommended Action Plan | Recommended Timeline |
|---|---|---|---|
| 1 | Design report need to be revised (Selina Tower-6) | Building engineer to update the design document including a design report, and a set of structural drawings in compliance with section 1.9.1.1 and section 1.9.1.2 as per BNBC. | Within 6 weeks |

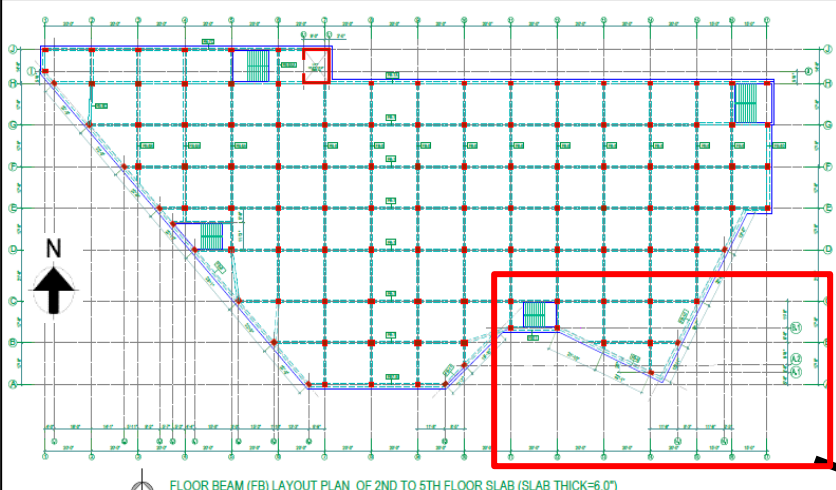
Beam Layout plan

Beam layout plan does not match with the as-built drawing. A beam marked in the layout has been shown in drawing but during inspection, the beam was not found at site condition. Factory engineer is required to survey the structures and prepare accurate as-built drawings.

| Item No. | Observation | Recommended Action Plan | Recommended Timeline |
|---|---|---|---|
| 3 | Discrepancy in as-built drawing (Selina Tower-6) | Building Engineer to survey the structure and prepare accurate as-built (architectural and structural) drawings in compliance with section 1.9.1.1 and section 1.9.1.2 as per BNBC. | Within 6 weeks |

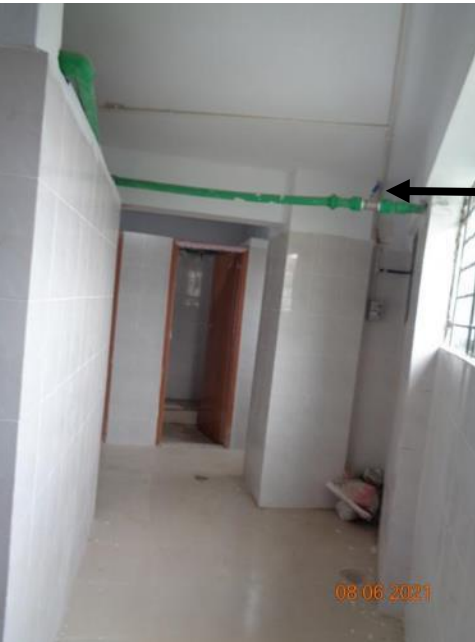
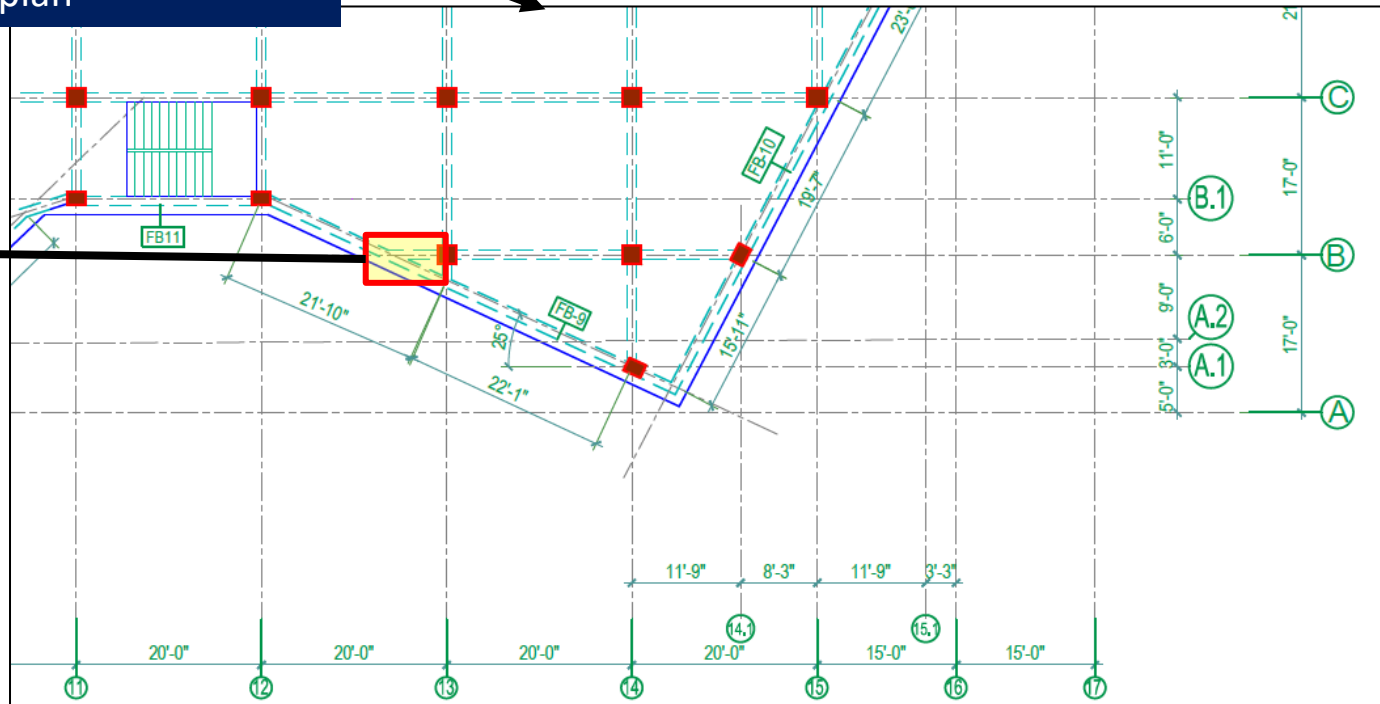
Beam found missing at marked location

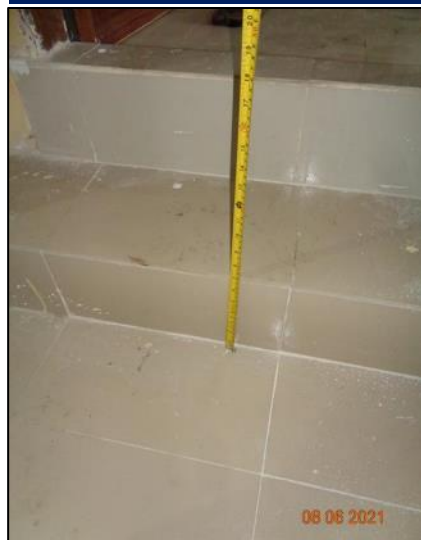
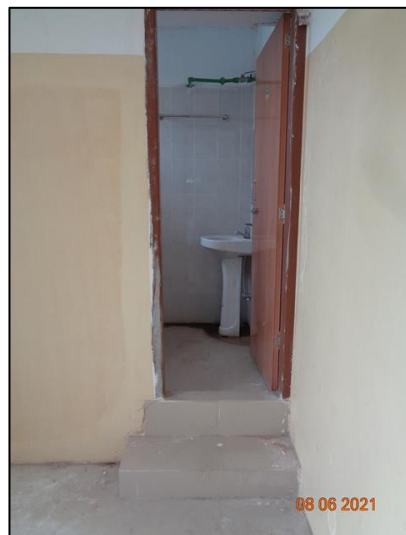
Toilet Build-up Found

Build up was found approximately 317 mm at all the toilet zone area. But the build up information has not been provided in architectural drawing. Factory engineer is required to survey the whole structure and update the accurate as-built architectural drawing.

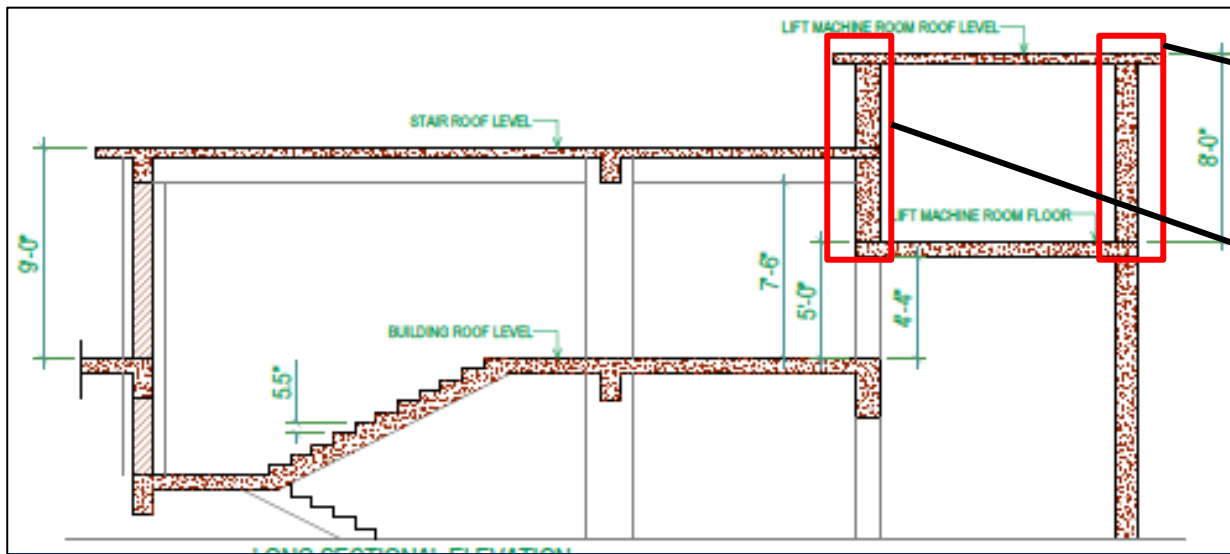
Sectional Elevation of the lift-core

In as-built drawing, the lift machine room periphery wall has been shown as RC wall. At site condition the wall was found constructed by brick. Factory engineer is required to survey the structures and prepare as-built drawings that are compliance with section 1.9.1.2 as per BNBC

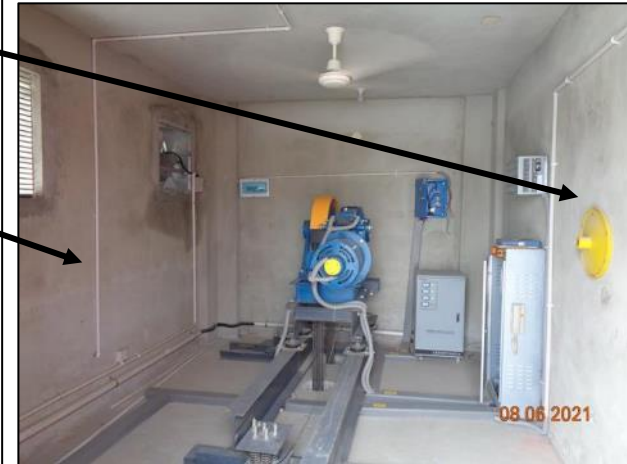
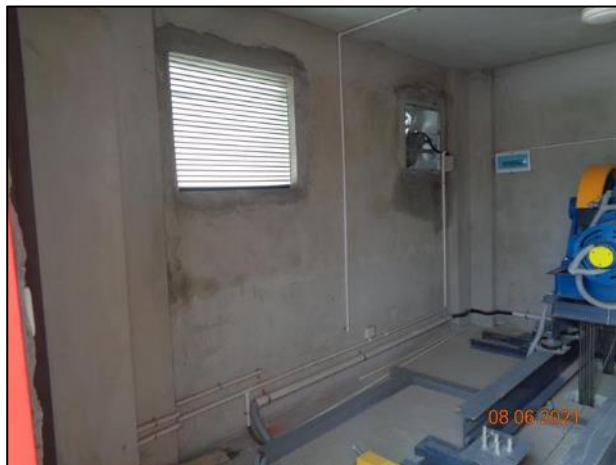
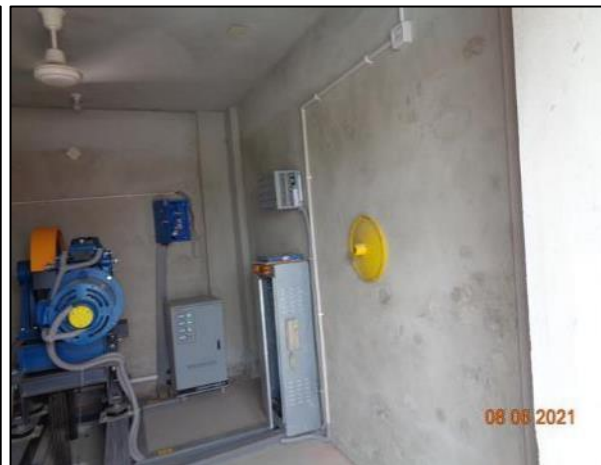
Lift machine room wall is constructed by brick

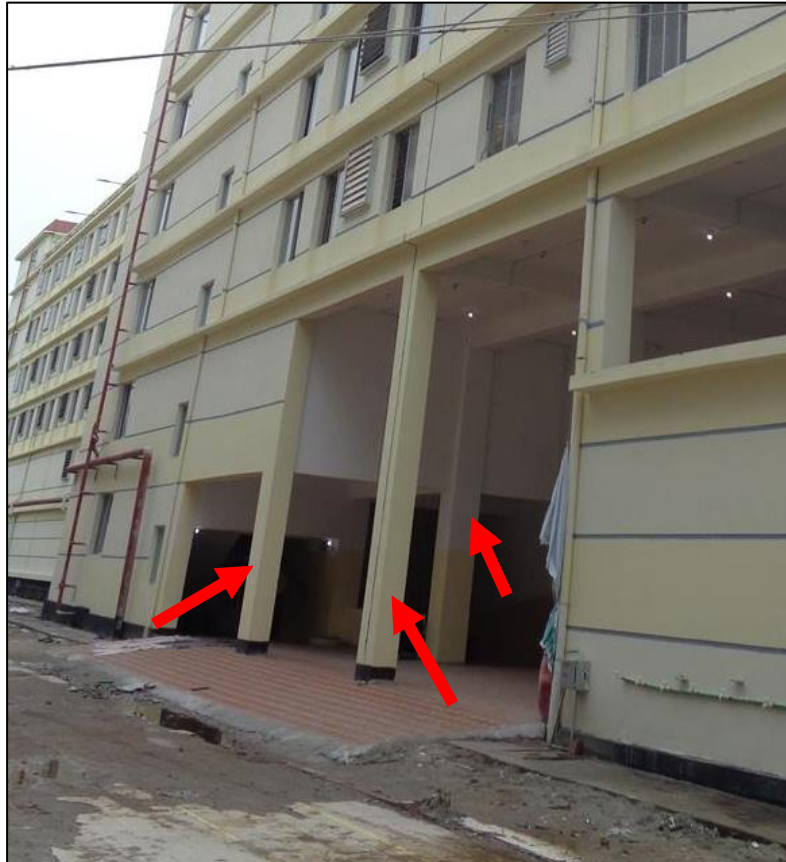
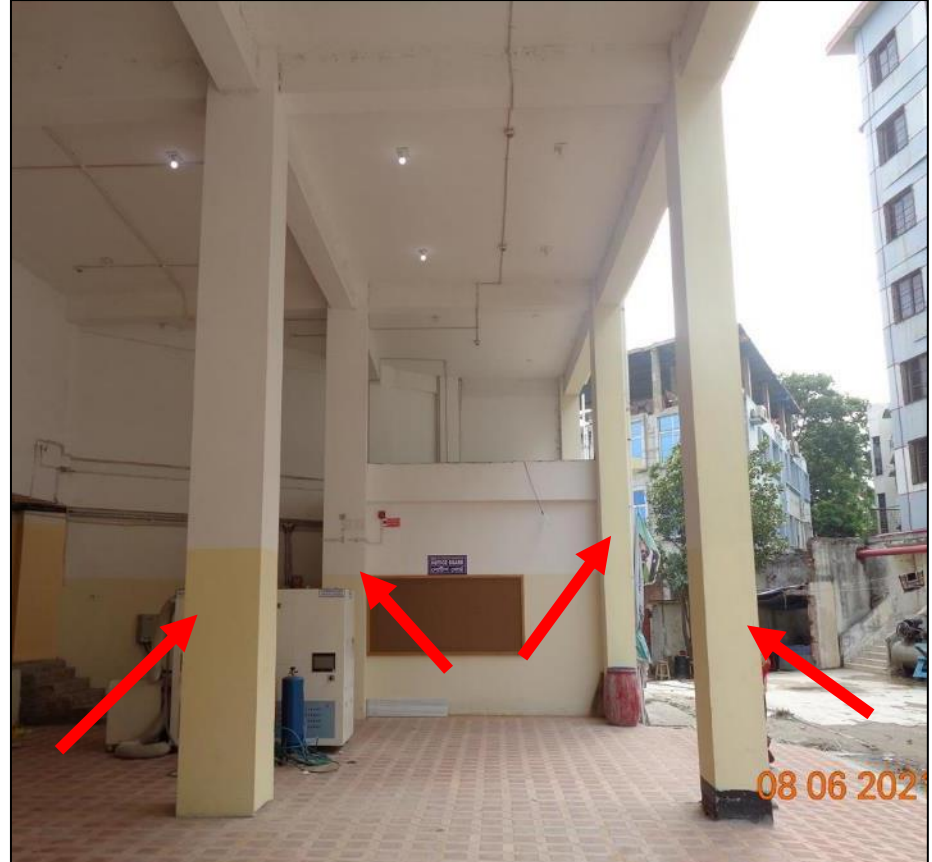
Columns having no barrier/protection at ground floor

Columns of the loading-unloading area are susceptible to vehicle impact. The factory engineer is required to take necessary measures to prevent the vehicle impact by providing the barrier around the columns.

| Item No. | Observation | Recommended Action Plan | Recommended Timeline |
|---|---|---|---|
| 4 | Column susceptible to vehicle impact (Selina Tower-6) | The factory engineer is required to take necessary measures to prevent the vehicle impact by providing barrier around the columns. | Within 6 weeks |

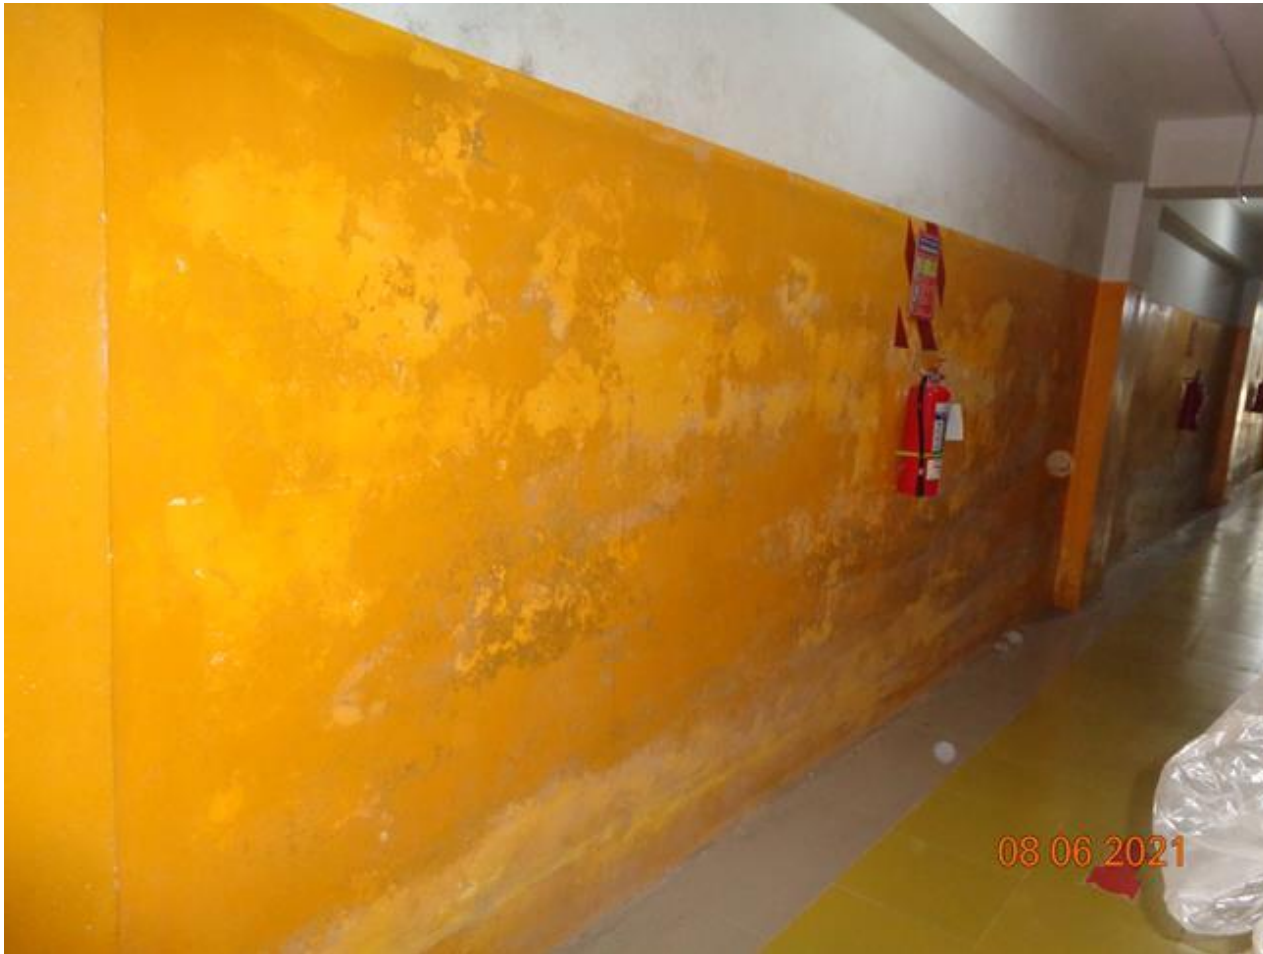
Dampness was found on ground floor periphery wall. Factory engineer is required to investigate the source of dampness and take necessary measures to prevent the dampness.

| Item No. | Observation | Recommended Action Plan | Recommended Timeline |
|---|---|---|---|
| 5 | Dampness on periphery wall (Selina Tower-6) | Building Engineer is required to investigate the reason of dampness & apply suitable method to repair dampness. | Within 6 weeks |

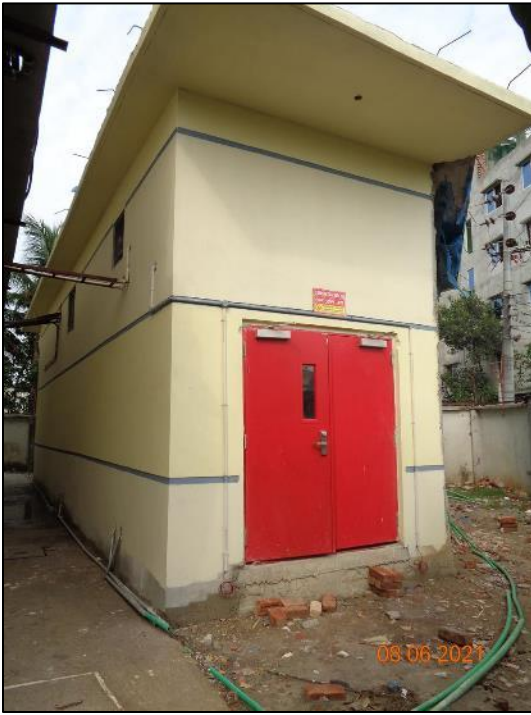
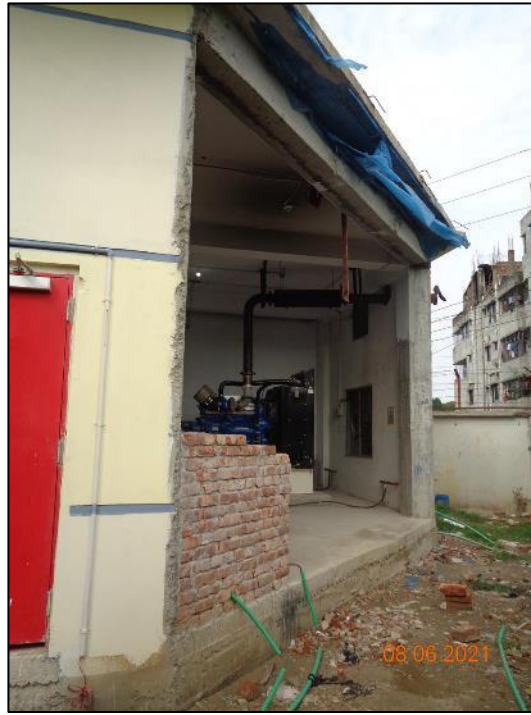
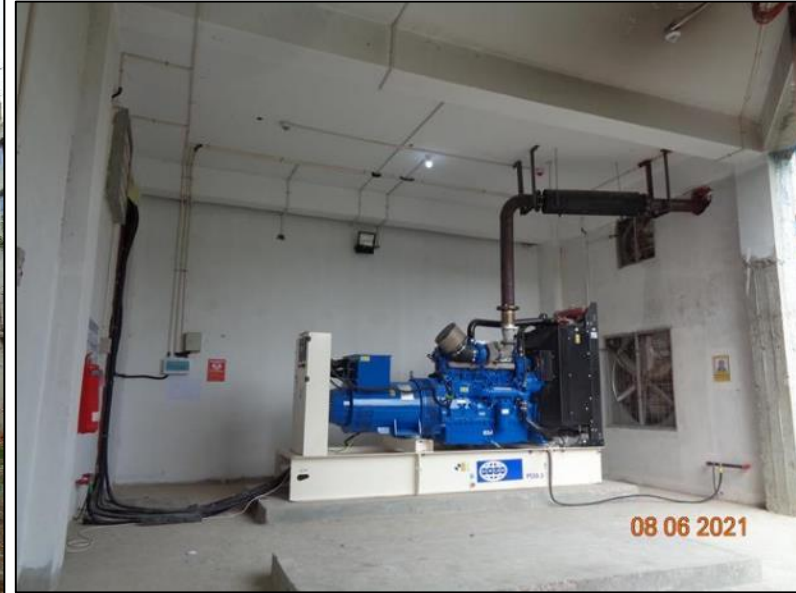
As per BNBC every building or structure designed shall have its design documents prepared in accordance with the provision of Section 1.9.1. The design document shall include a design report, and a set of structural drawings, which shall be prepared in compliance with section 1.9.1.1 and section 1.9.1.2 as per BNBC. During the inspection, the design report was not found which is required to be prepared in compliance with section 1.9.1 (part-6, BNBC).

| Item No. | Observation | Recommended Action Plan | Recommended Timeline |
|---|---|---|---|
| 6 | Design report needs to be prepared (Generator Room) | Building engineer to prepare the design document including a design report, and a set of structural drawings in compliance with section 1.9.1.1 and section 1.9.1.2 as per BNBC. | Within 6 weeks |
| 7 | Design report needs to be prepared (Generator Room) | Complete any remedial works arising from design report after reviewing by RSC. | Within 6 Months |
