# ABLOOM DESIGN LIMITED (Extension)

37, South Shastapur, Upazila Road, Fatullah, Narayanganj  
(23.637976, 90.491952)  
26 December 2022

# Building Information

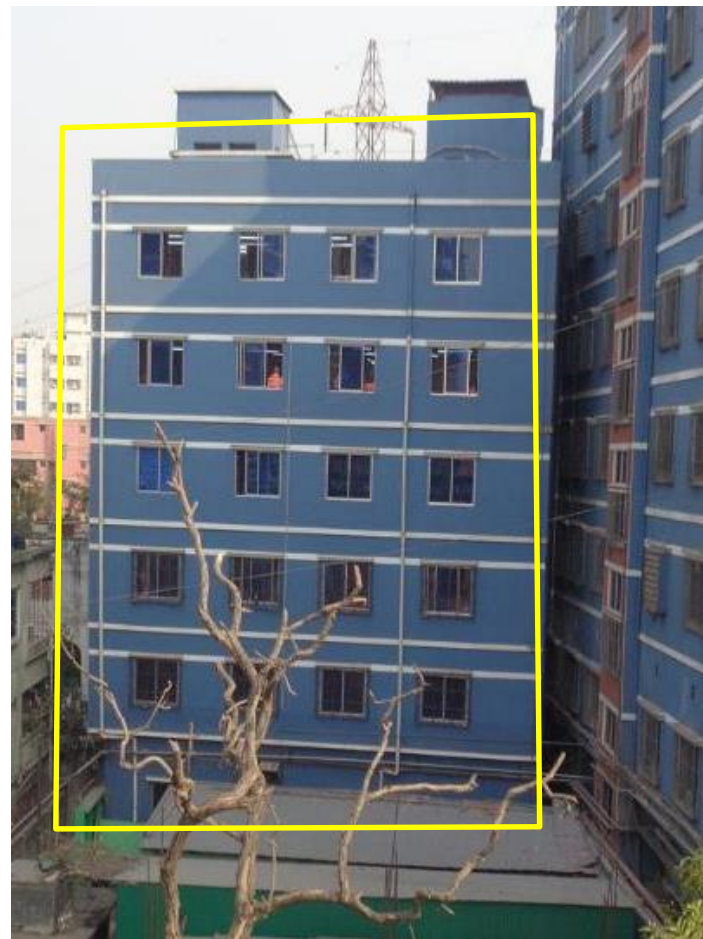
Core test report

Concrete core test reports were available on factory site but design report was not prepared yet. The building engineer is required to produce design report based on equivalent material strength of concrete cores following BNBC.

| Item No. | Observation | Recommended Action Plan | Recommended Timeline |
|---|---|---|---|
| 01 | Lack of design report (Building-3) | The building engineer is required to prepare design report of the building in compliance with section 1.9.1 of BNBC (part-6). | 6-weeks |

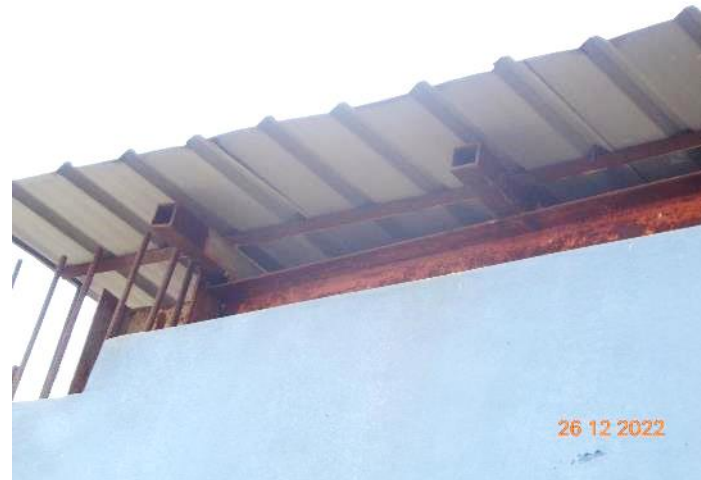
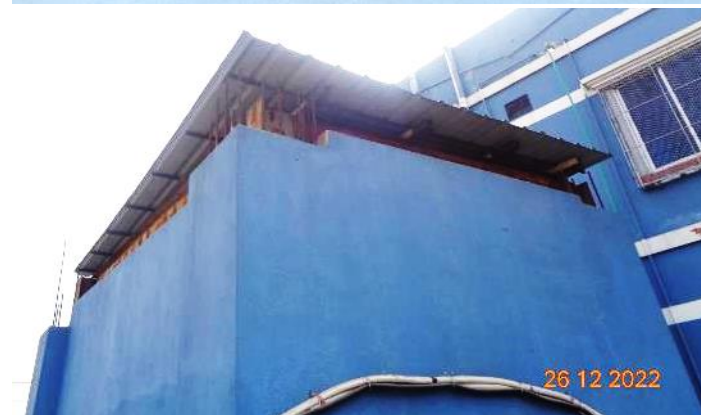
Steel I-section inside RC column

Steel I-section observed inside the RC columns of stair zone. The building engineer is required to incorporate those composite column effect in the design report.

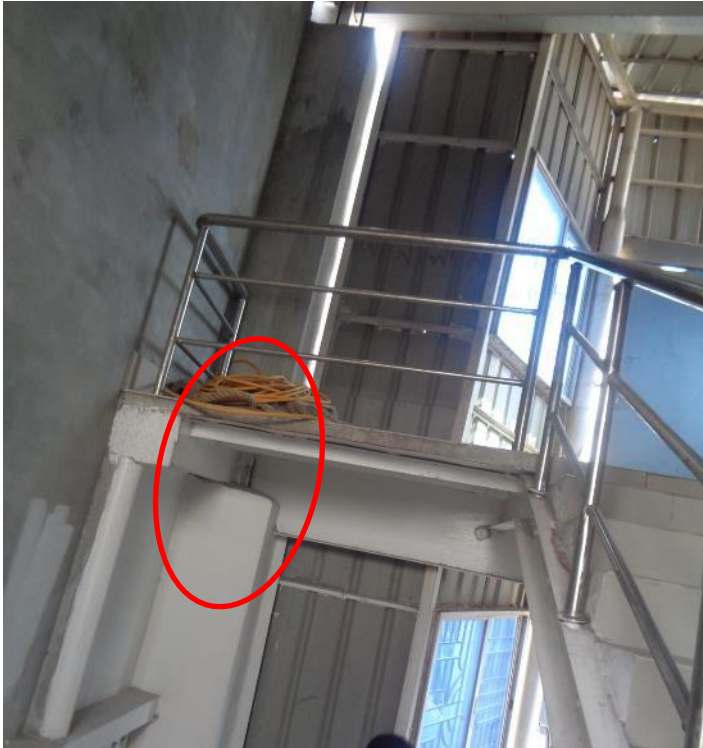
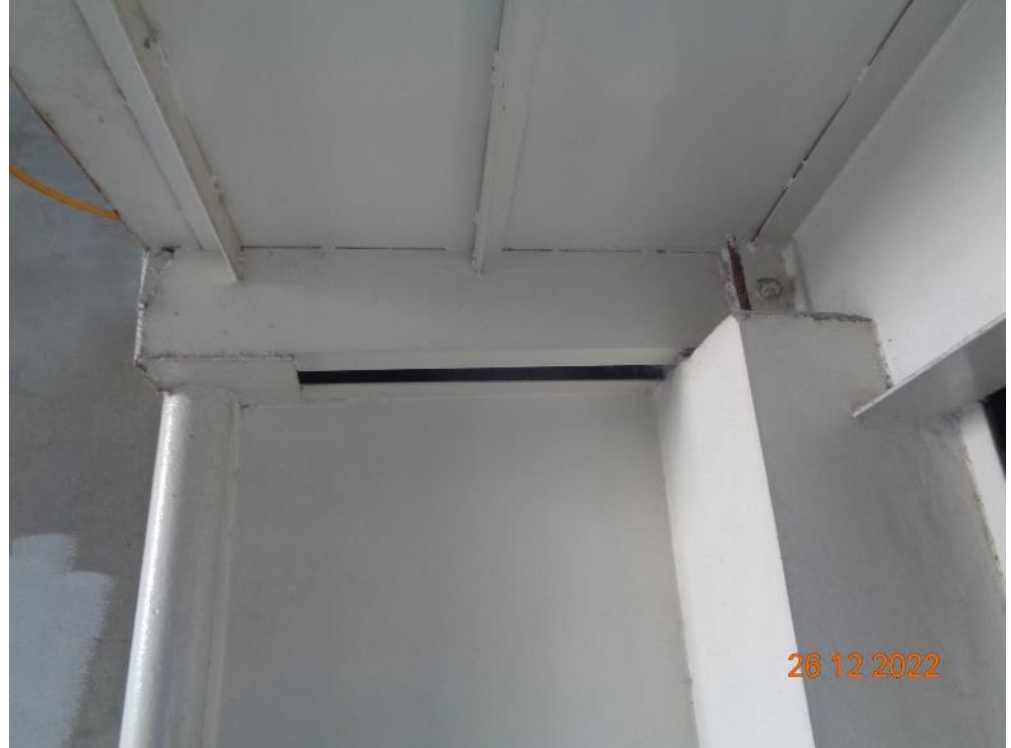
### Discontinuity of RC column at stair landing portion

The factory constructed 4 RC columns around the existing steel stair columns. But in the joint of stair landing beam and column, RC casting has not done which makes the column discontinue and non-uniform through its length. The building engineer is required to investigate the beam-column joint and suggest necessary remedial actions.

| Item No. | Observation | Recommended Action Plan | Recommended Timeline |
|---|---|---|---|
| 06 | Discontinuity of RC column in stair zone (Building-3) | <ul style="list-style-type: none"> <li>The building engineer is required to survey the structure and prepare accurate as-built drawings with structural details.</li> </ul> | 6-weeks |

| Item No. | Observation | Recommended Action Plan | Recommended Timeline |
|---|---|---|---|
| 07 | Discontinuity of RC column in stair zone (Building-3) | <ul style="list-style-type: none"> <li>Carry out suggested remedial works.</li> </ul> | 6-months |

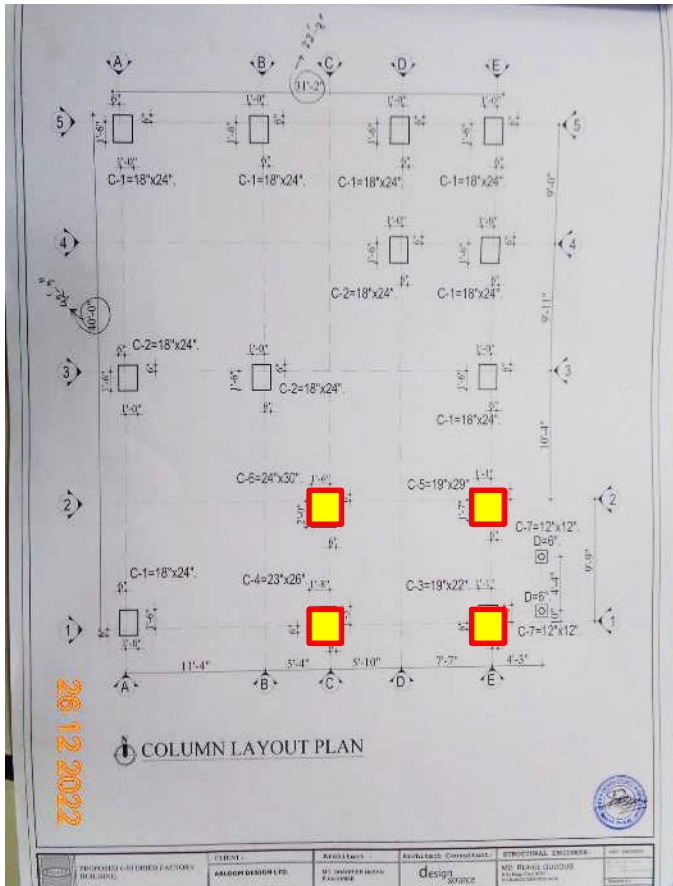
Marks composite columns were not shown in the structural drawings

The building engineer is required to survey the structure and prepare accurate as-built drawings with structural details.

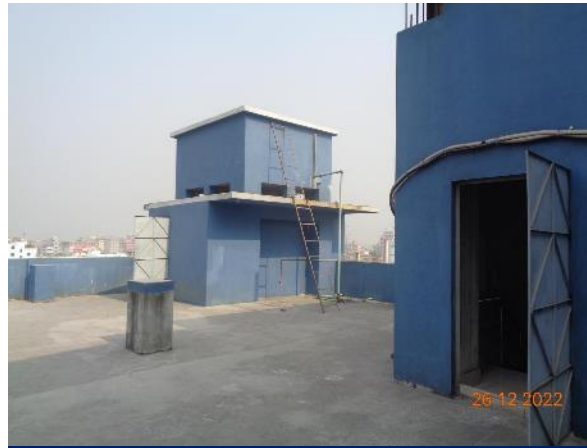
Roof layout and detail of OHWT was missing in the drawing.

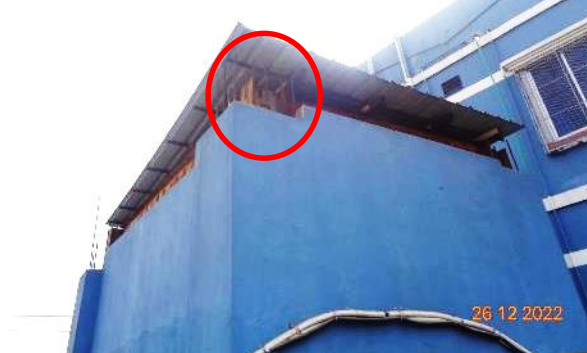
I-section inside the RC column.

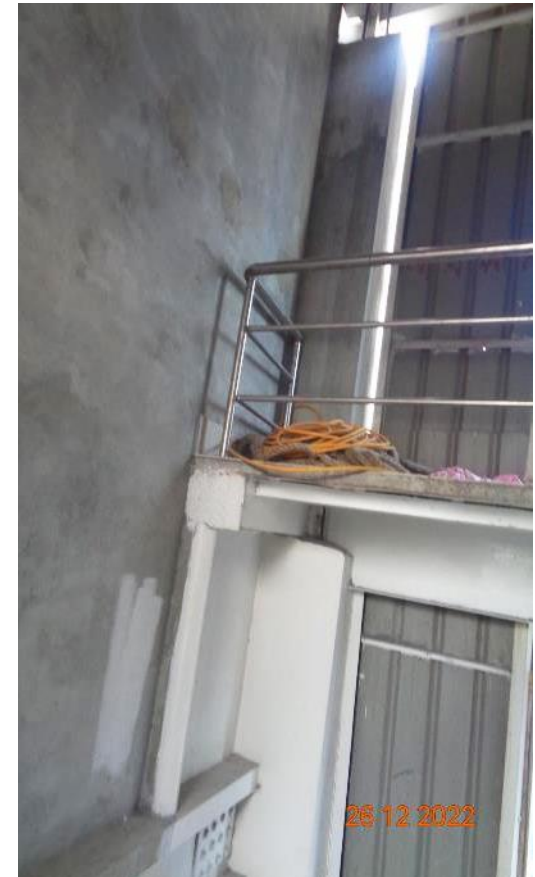
Connection details of steel section was missing in the drawing.

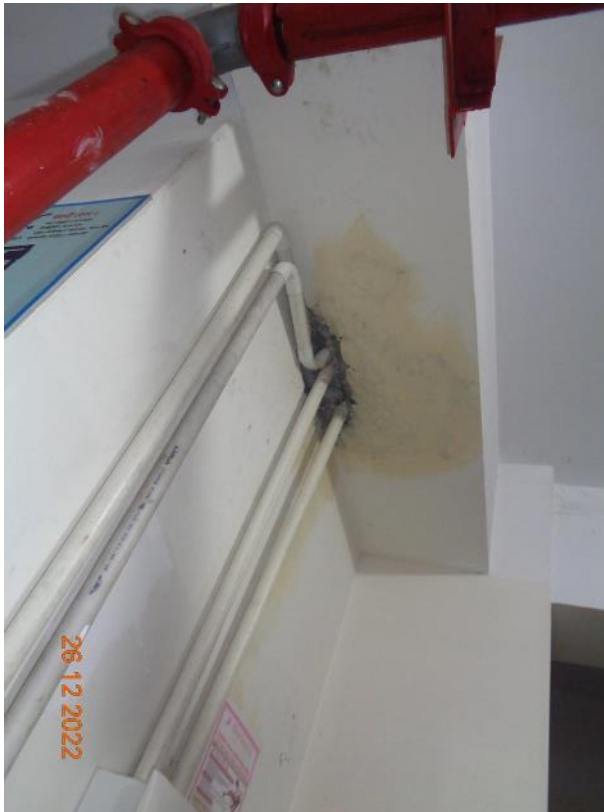
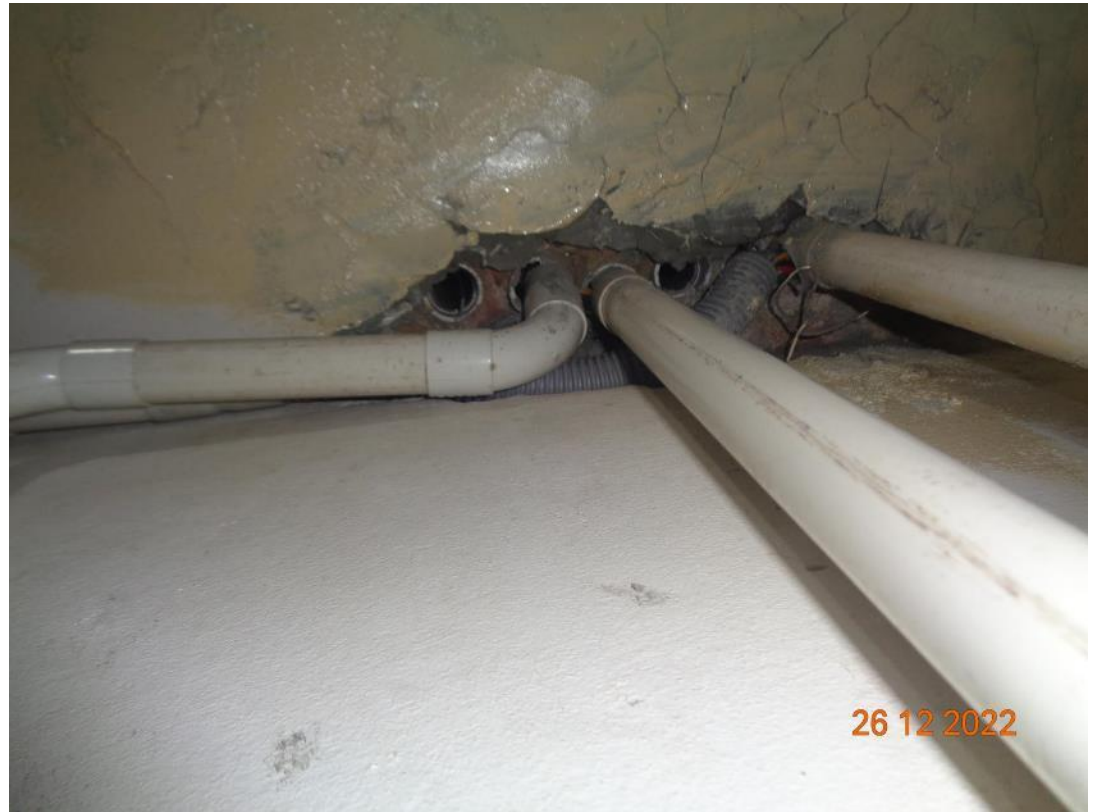
Electrical Cables have been cut into and pass through beams.

Electrical Cables have been cut into and pass through main structural beams throughout various floor levels of the factory. Structural Engineer to Investigate and report on this matter to verify the Structural Integrity of the beams are not compromised.

| Item No. | Observation | Recommended Action Plan | Recommended Timeline |
|---|---|---|---|
| 09 | Electrical cables cut into and pass through main structural beams.(Building-3) | <ul style="list-style-type: none"> <li>Building Engineer to Investigate and report on this matter to verify the Structural Integrity of the beams are not compromised.</li> </ul> | 6-weeks |
| 10 | Electrical cables cut into and pass through main structural beams.(Building-3) | <ul style="list-style-type: none"> <li>Carry out suggested remedial works</li> </ul> | 6-months |

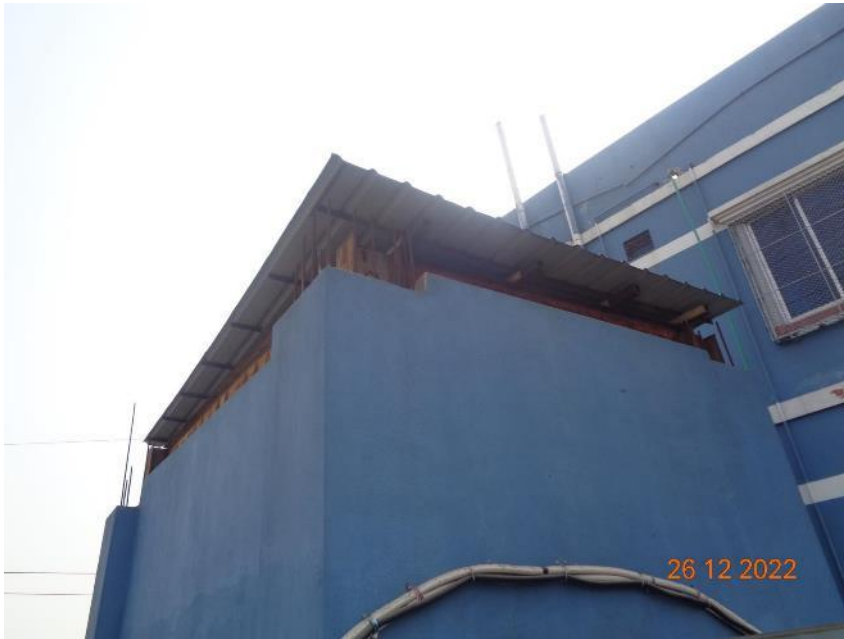
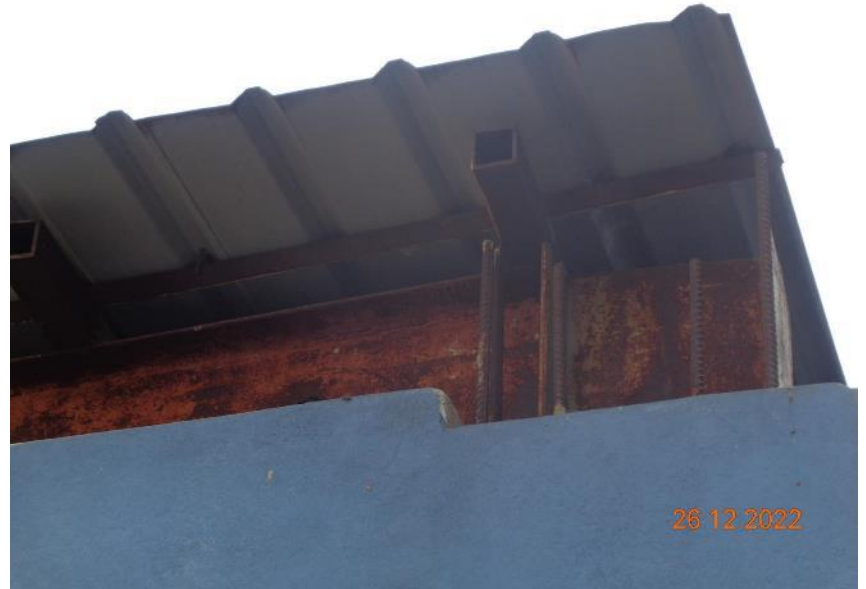
Corrosion in the steel beams

Building engineer is required to remove the corrosion from the steel members and apply suitable corrosion resistance coating.

| Item No. | Observation | Recommended Action Plan | Recommended Timeline |
|---|---|---|---|
| 11 | Corrosion in steel beam (Building-3) | <ul style="list-style-type: none"> <li>Building engineer is required to remove corrosion and provide rust proof coating on exposed steel members to protect from corrosion</li> </ul> | 6-weeks |

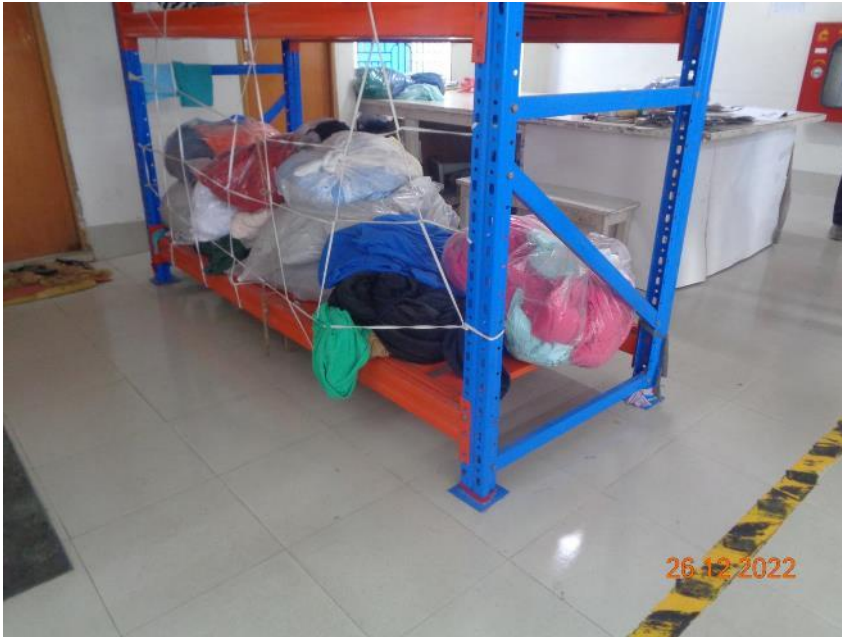
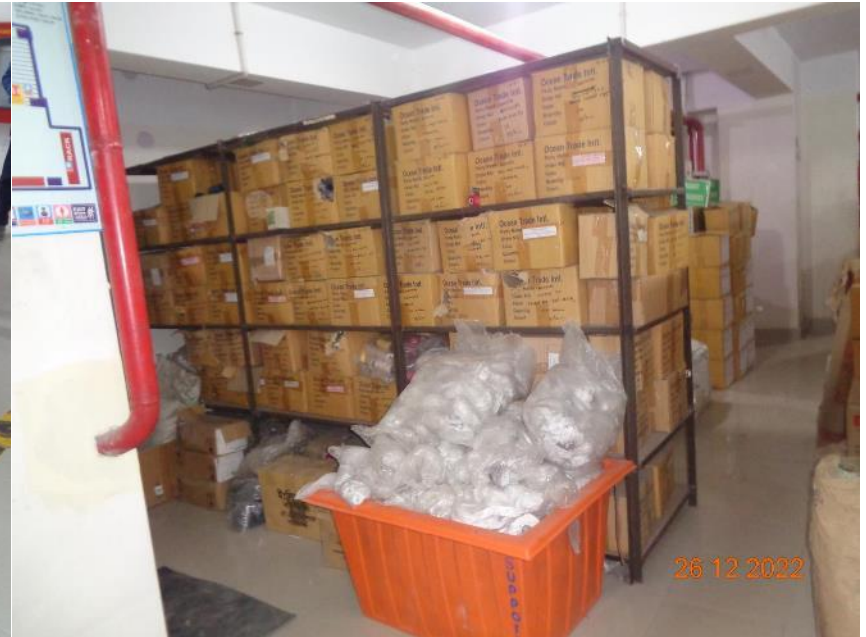
Lack of anchorage/lateral bracing for the storage racks

Building engineer is required to provide adequate anchorage or lateral bracing to the storage racks.

| Item No. | Observation | Recommended Action Plan | Recommended Timeline |
|---|---|---|---|
| 12 | Lack of anchorage/lateral bracing of storage racks (Building-3) | <ul style="list-style-type: none"> <li>Building engineer is required to provide adequate anchorage or lateral bracing for the storage racks.</li> </ul> | 6-weeks |

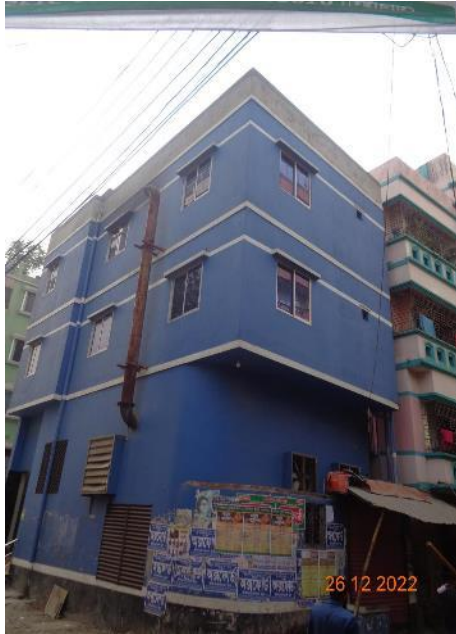
Building-3

As per BNBC, every building or structure designed shall have its design documents prepared in accordance with the provision of Section 1.9.1. The design document shall include a design report, and a set of structural drawings, which shall be prepared in compliance with section 1.9.1.1 and section 1.9.1.2 of BNBC (part-6). During inspection, design report was not found which is required to be prepared in compliance with section 1.9.1.1 (part-6, BNBC).

| Item No. | Observation | Recommended Action Plan | Recommended Timeline |
|---|---|---|---|
| 13 | Lack of design report (Building-4) | <ul style="list-style-type: none"> <li>The building engineer is required to produce design report based on equivalent material strength of concrete cores following BNBC and suggest proper remedial actions.</li> </ul> | 6-weeks |

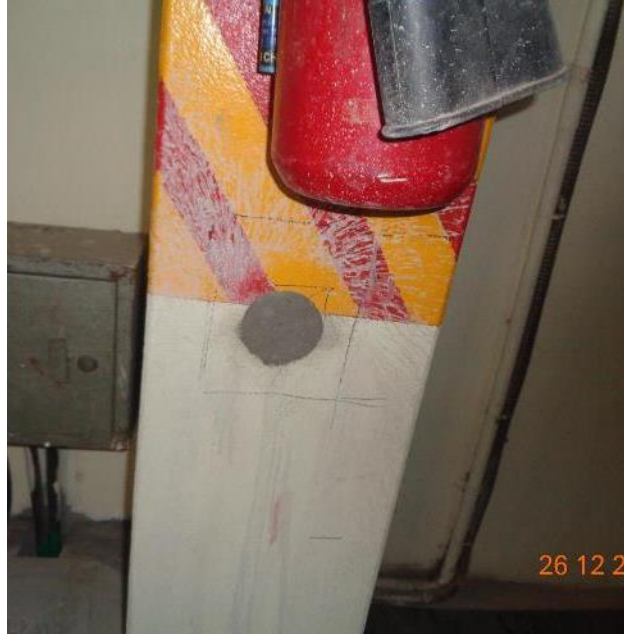
Concrete core taken from column

However, concrete cores have taken from several column locations. Also, there was a large offset of beam from column. The building engineer is required to incorporate in-situ material strength and actual framing system in the design report.

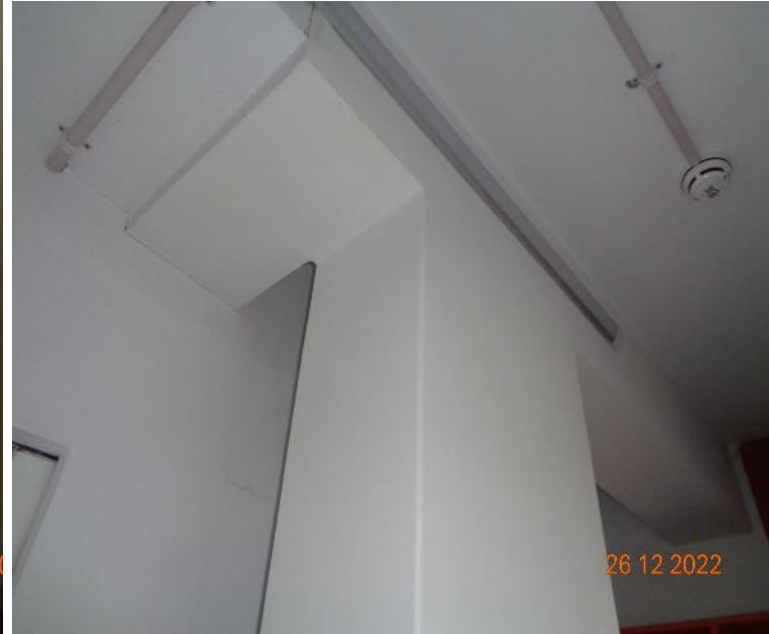
Large offset of beam from column line

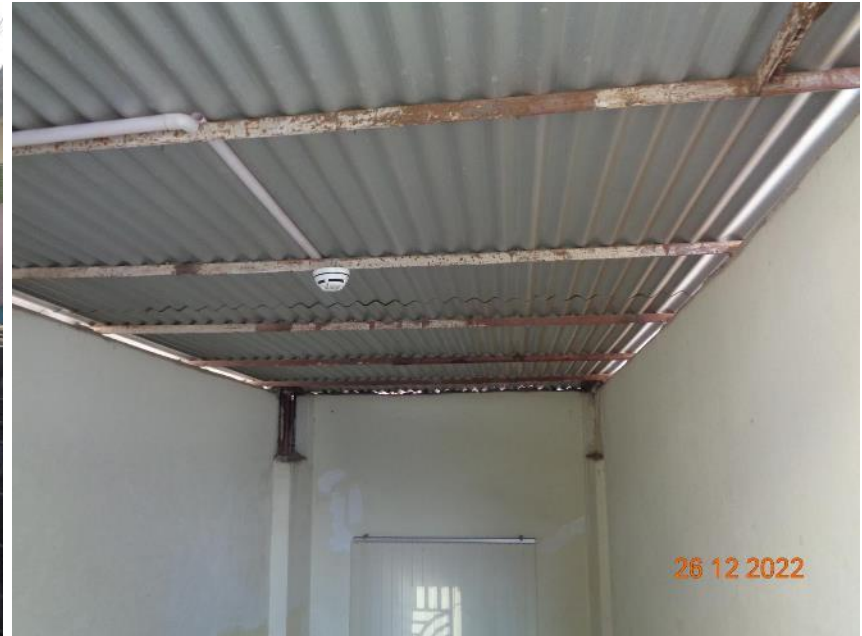
Lack of anchorage between roof and columns

The building engineer is required to check the connections for the uplift forces and suggest proper guideline accordingly.

| Item No. | Observation | Recommended Action Plan | Recommended Timeline |
|---|---|---|---|
| 17 | Lack of anchorage of stair roof for uplift forces (Building-4) | <ul style="list-style-type: none"> <li>The building engineer is required to check the connections for the uplift forces and suggest proper remedial measures accordingly</li> </ul> | 6-weeks |
