# Meghna Denims Ltd.

07, Kewa, Anser Road, Sreepur, Gazipur, Dhaka, Bangladesh

# Building Information

# Observations

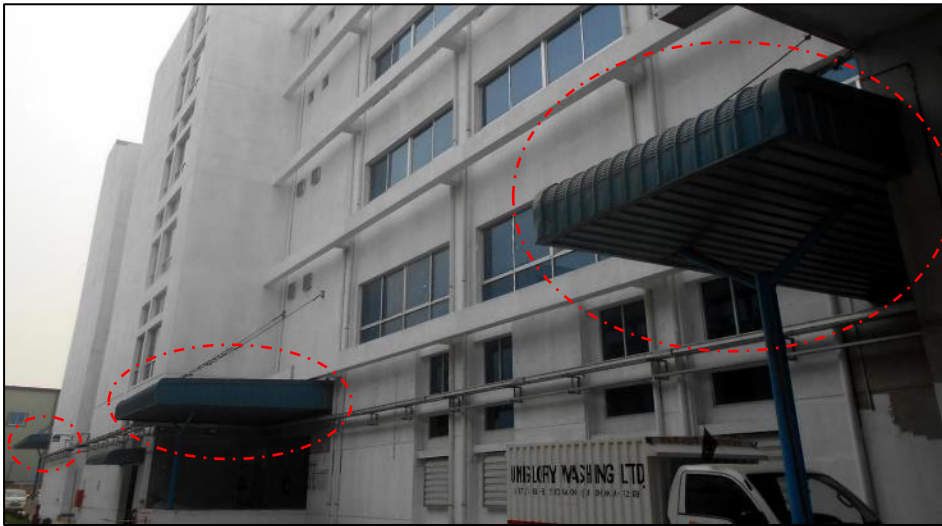
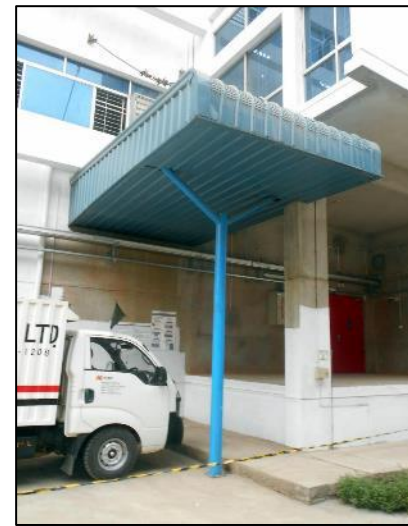
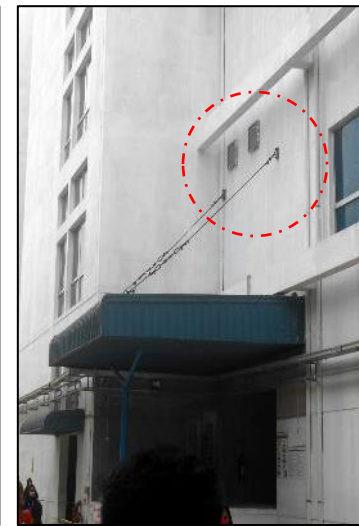
Drawing missing for the canopy structures around the stair area of RMG buildings. The connection of the canopy was not sufficient as well. Cable connection from wall was observed for some canopy.

Canopy structures around the stair

| Item No. | Observation | Recommended Action Plan | Recommended Timeline |
|---|---|---|---|
| 01 | Building 1: Drawing missing of the canopy structures | * Building Engineer to survey the whole structure and prepare accurate as-built drawings. | Within 6 weeks. |
| 02 | Building 1: Drawing missing of the canopy structures | * Assess the connection capacity | Within 6 weeks. |
| 03 | Building 1: Drawing missing of the canopy structures | * Carry out remedial works as per report recommendation if required. | Within 6 months. |

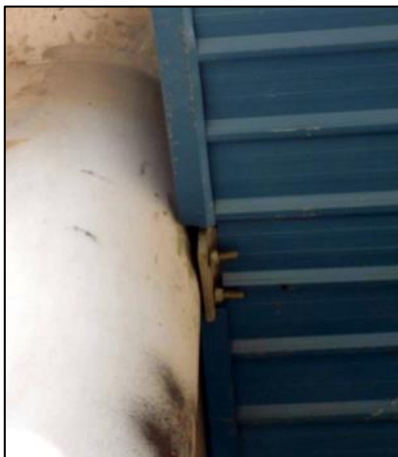
Gap in the Connection to column

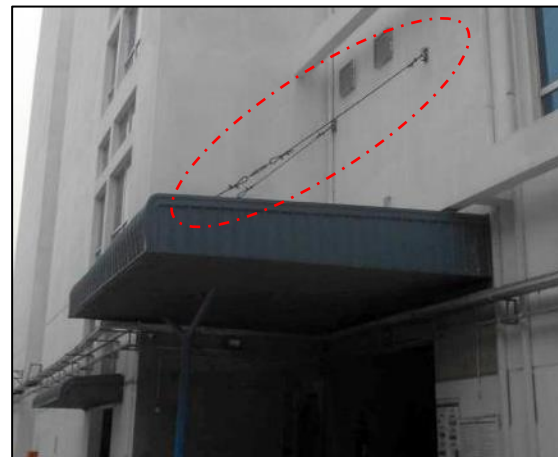
Cable Connection to wall

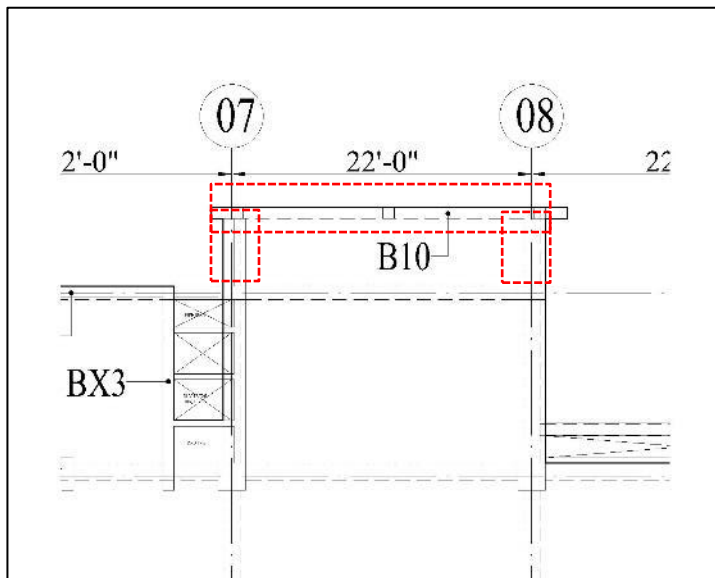
Tie beam elevation info was not available in the drawing. Some Beams on the edge was not found on site though these beams are shown in the drawing. 1<sup>st</sup> floor slab layout needs minor modification

Beam on drawing

| Item No. | Observation | Recommended Action Plan | Recommended Timeline |
|---|---|---|---|
| 04 | Building 1: Discrepancy in the drawing | * Building Engineer to survey the whole structure and prepare accurate as built drawings. | Within 6 weeks. |

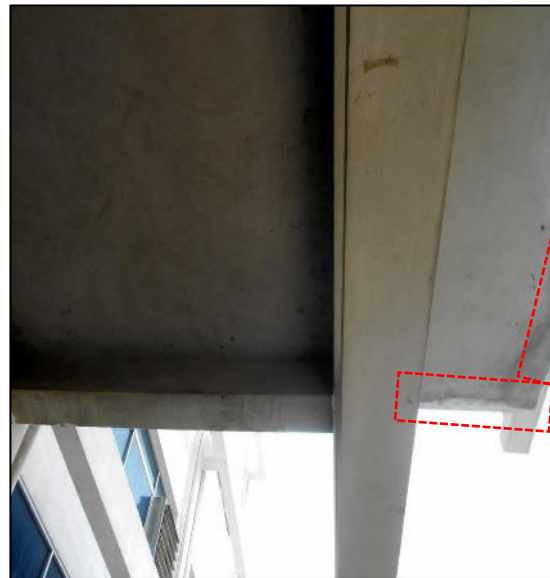
Beam missing on site

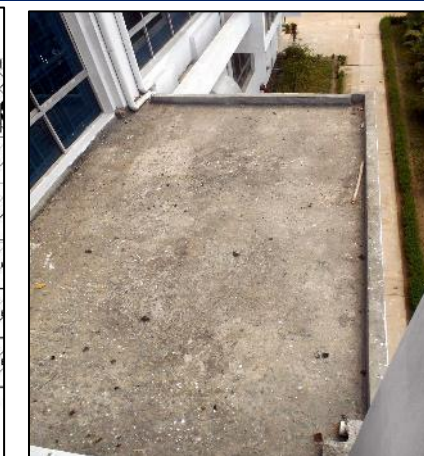
Extra slab on 1<sup>st</sup> floor

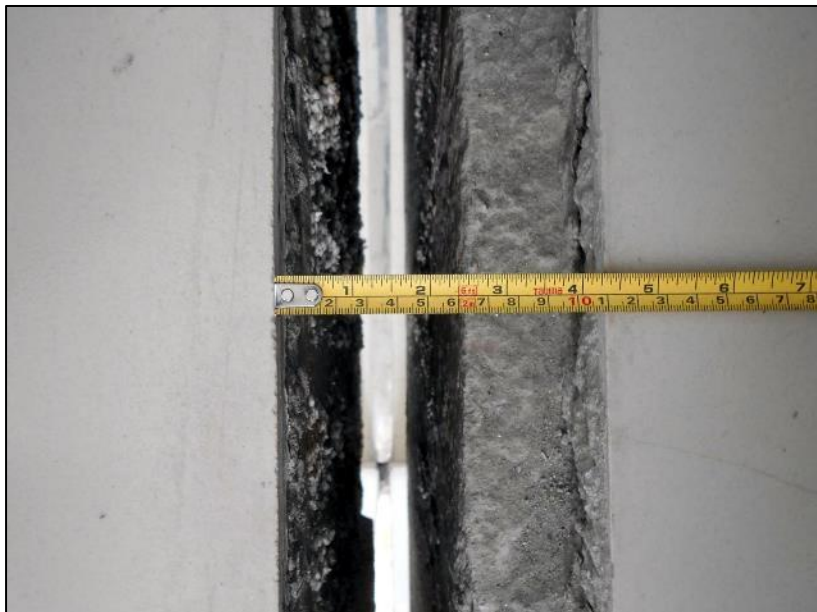
Injury among worker is susceptible due to large gap in the expansion joint

Expansion gap with 2.5 inch was found on 3<sup>rd</sup> and 4<sup>th</sup> floor

| Item No. | Observation | Recommended Action Plan | Recommended Timeline |
|---|---|---|---|
| 05 | Building 1: Susceptible to injury due to gap in expansion joint | *Building Engineer to survey the whole structure and fill the gaps with appropriate materials. | Within 6 weeks. |

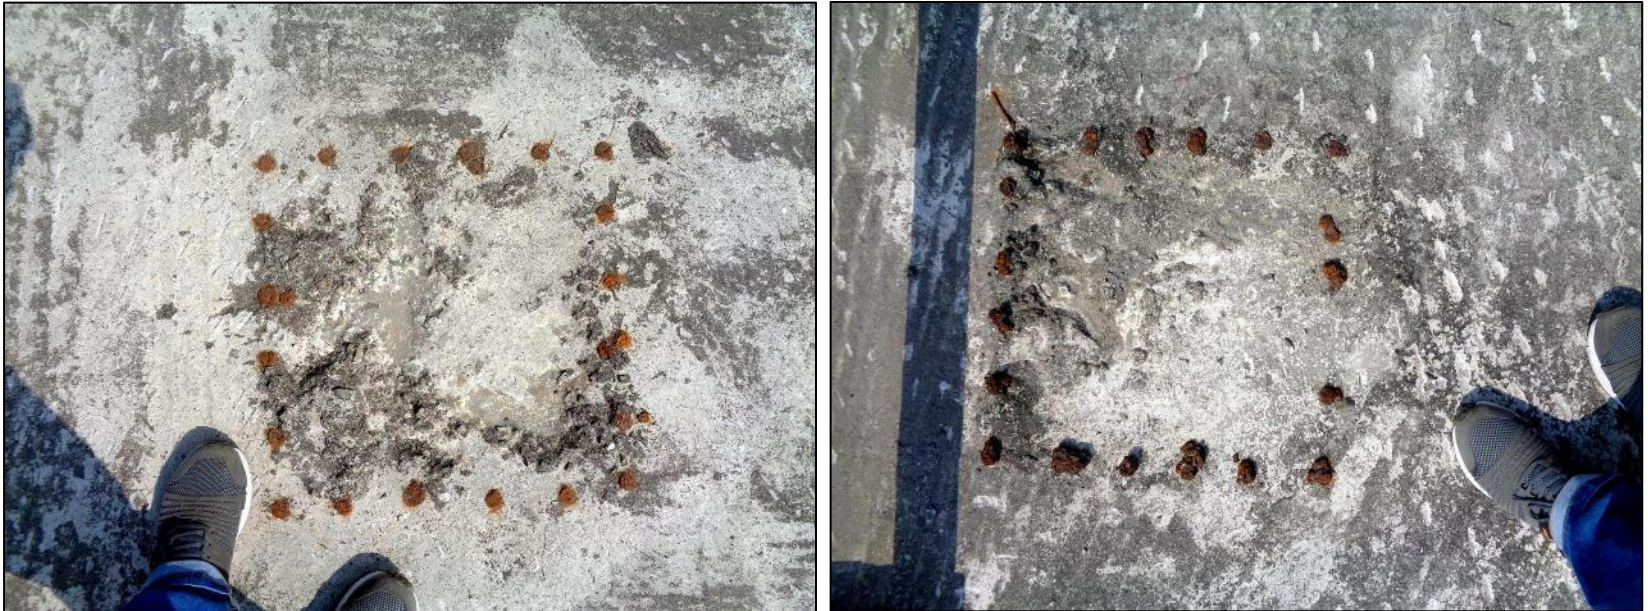
Exposed rebar on the roof was found corroded.

Corrosion in the column rebar which is exposed to environment.

| Item No. | Observation | Recommended Action Plan | Recommended Timeline |
|---|---|---|---|
| 06 | Building 1: Exposed reinforcements on the roof | *Building Engineer to remediate the corroded rebar. | Within 6 months. |

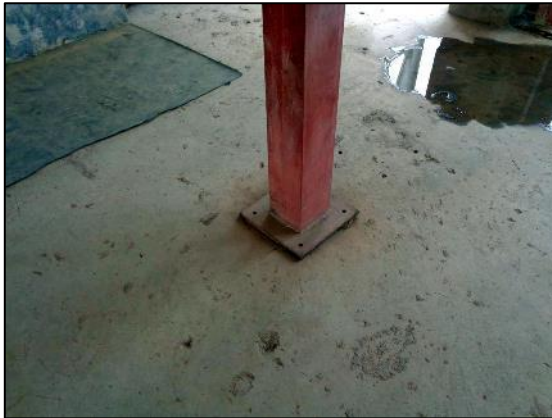
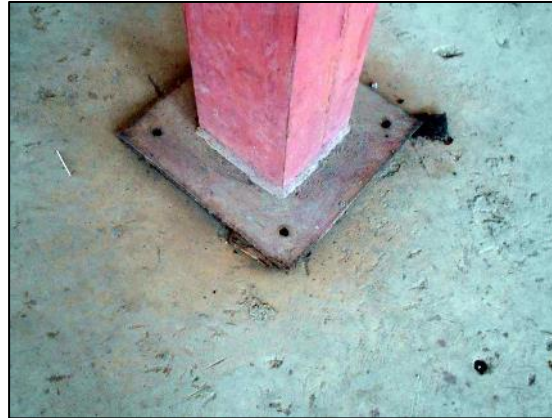
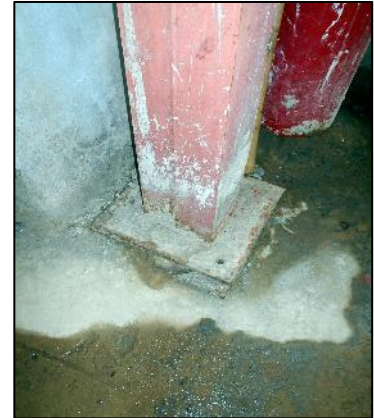
Support columns of the water tank

| Item No. | Observation | Recommended Action Plan | Recommended Timeline |
|---|---|---|---|
| 07 | Building 4: Free standing water tank without any restrain | *Building Engineer to fix the support so that the water tank can withstand vertical loading. | Within 6 weeks. |

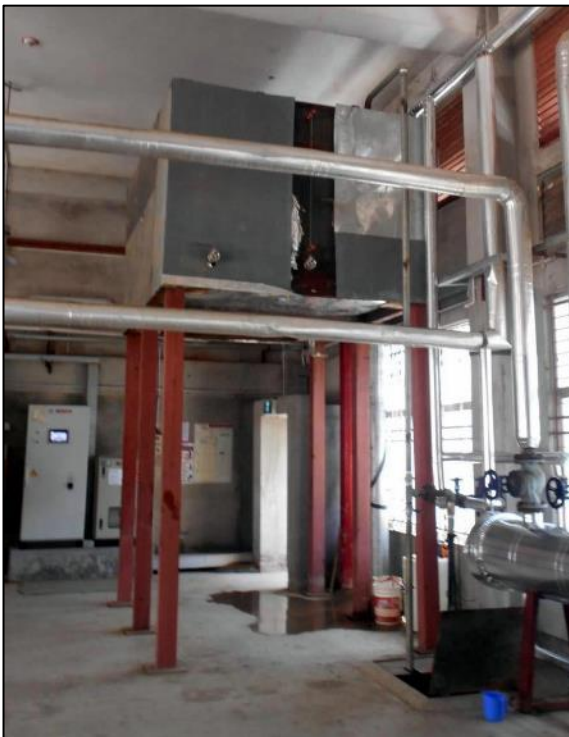
Free standing water tank without any restraint was found on the ground floor. Free standing water tank may susceptible to damage structural components if any vertical load (EQ) incurred.

| Item No. | Observation | Recommended Action Plan | Recommended Timeline |
|---|---|---|---|
| 08 | Building 4: Free standing water tank without any restrain | *Carry out remedial works as per report recommendation if | Within 6 months. |

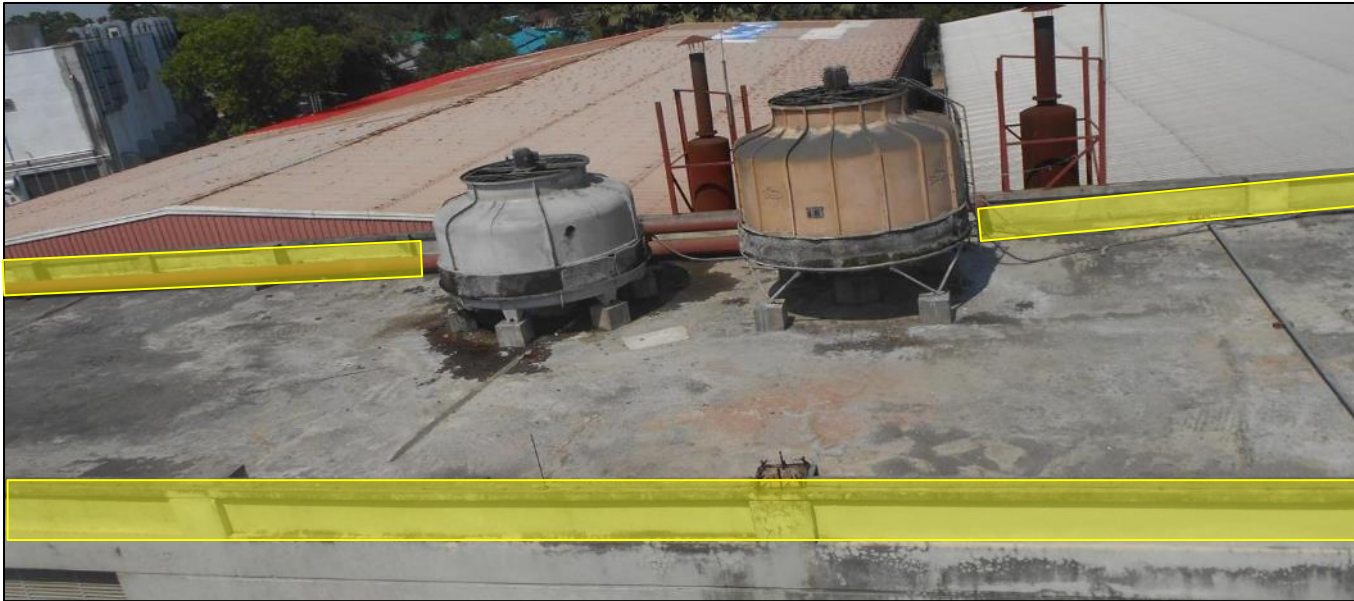
## Parapet wall found very low in the roof of building 5

Susceptible to falling hazard may incur for this low parapet wall (marked in yellow) .

| Item No. | Observation | Recommended Action Plan | Recommended Timeline |
|---|---|---|---|
| 09 | Building 5: Insufficient parapet wall on roof | Building Engineer to provide parapet walls. | Within 6 weeks. |

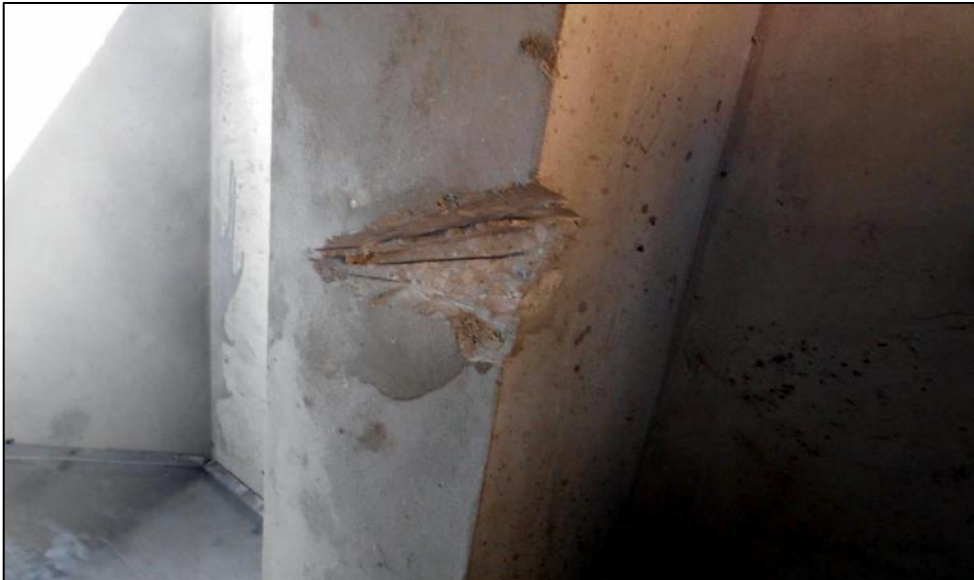
Damaged beam was found on the external stair of ETP

The stair beam may reach critical stress and fail as the section of the beam is reduced

| Item No. | Observation | Recommended Action Plan | Recommended Timeline |
|---|---|---|---|
| 10 | Building 9: Damaged beam on stair | Prior any extension work, prepare a Detailed Engineering Assessment (DEA) report of the building and submit. Otherwise, provide consent letter. | Within 6 months. |

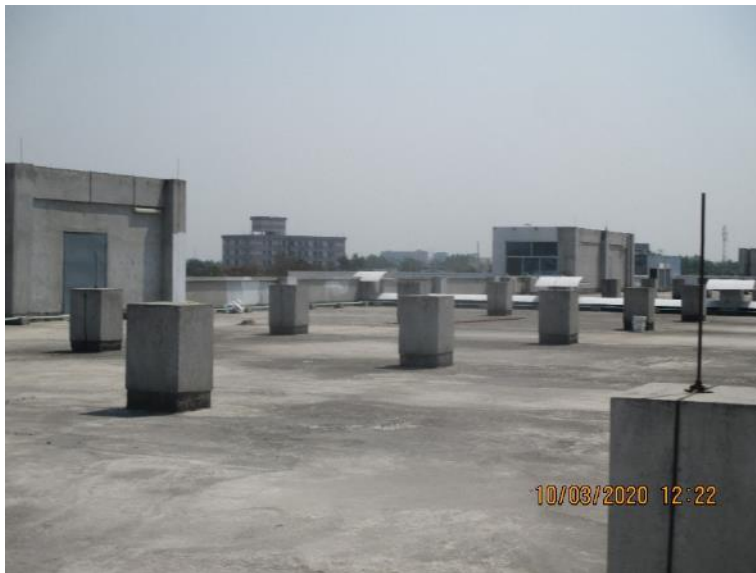
Current roof of factory building

Currently the building is 2 storied. Building owner has a future plan to extend the building vertically up to 3 storey. They have prepared DEA considering 3-storied building. Factory engineer is required to review the Detail Engineering Assessment considering BNBC provision prior to any extension work.

| Item No. | Observation | Recommended Action Plan | Recommended Timeline |
|---|---|---|---|
| 11 | Building 10-11: Possible vertical extension (Washing & Storage building) | In case of extension, factory engineer require to submit the Detailed Engineering Assessment report following BNBC requirements. | Within 6 weeks. |

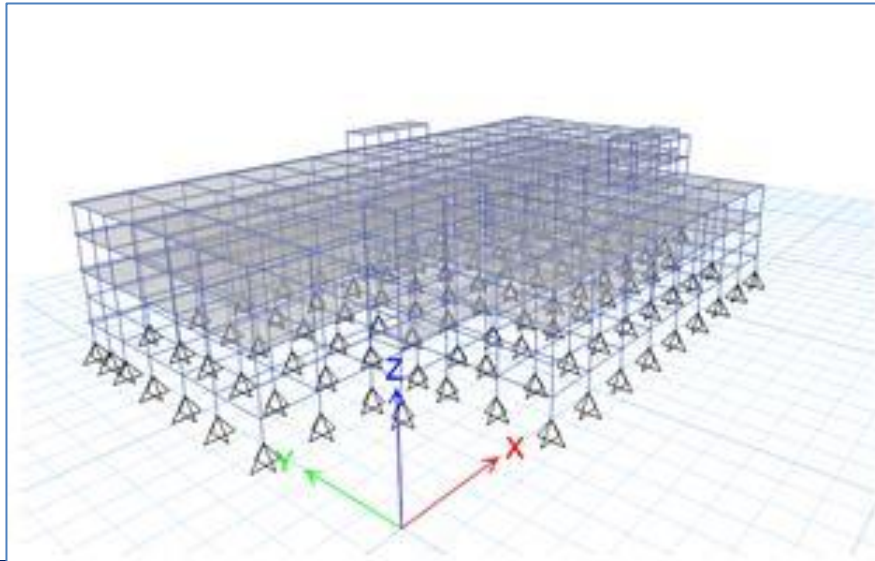
DEA report prepared for 3-storied structure
