# IFS TEXWEAR Extension)

631, KUTUBPUR, FATULLAH, NARAYANGONJ  
(23.6471165, 90.5020197)  
19 December 2022

# Buildings Information

1. ETP Building is a partial seven storied (G+M+6) reinforced concrete (RC) building.
2. Utility shed is a single storied shed.

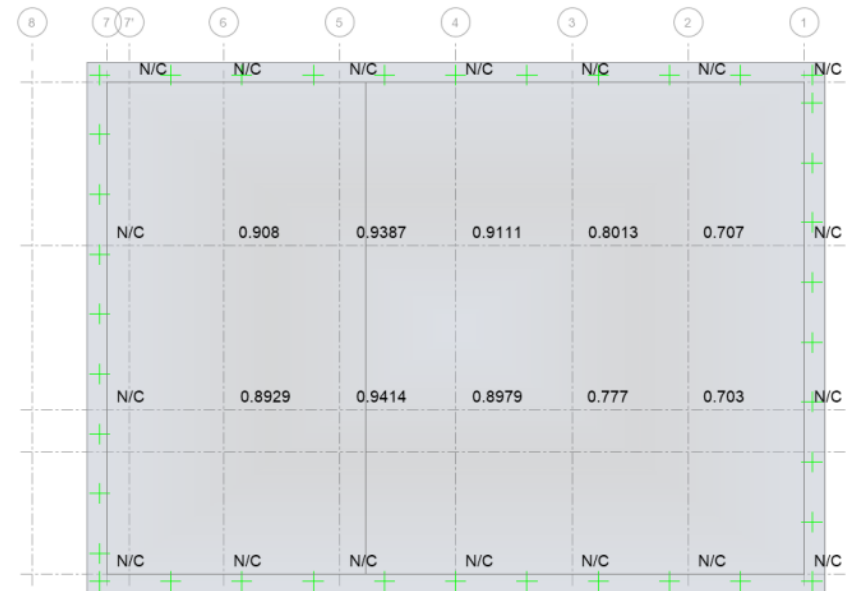
Flexural and punching adequacy of mat foundation has been checked using SAFE model.

Fig.: Punching ratio from SAFE Model

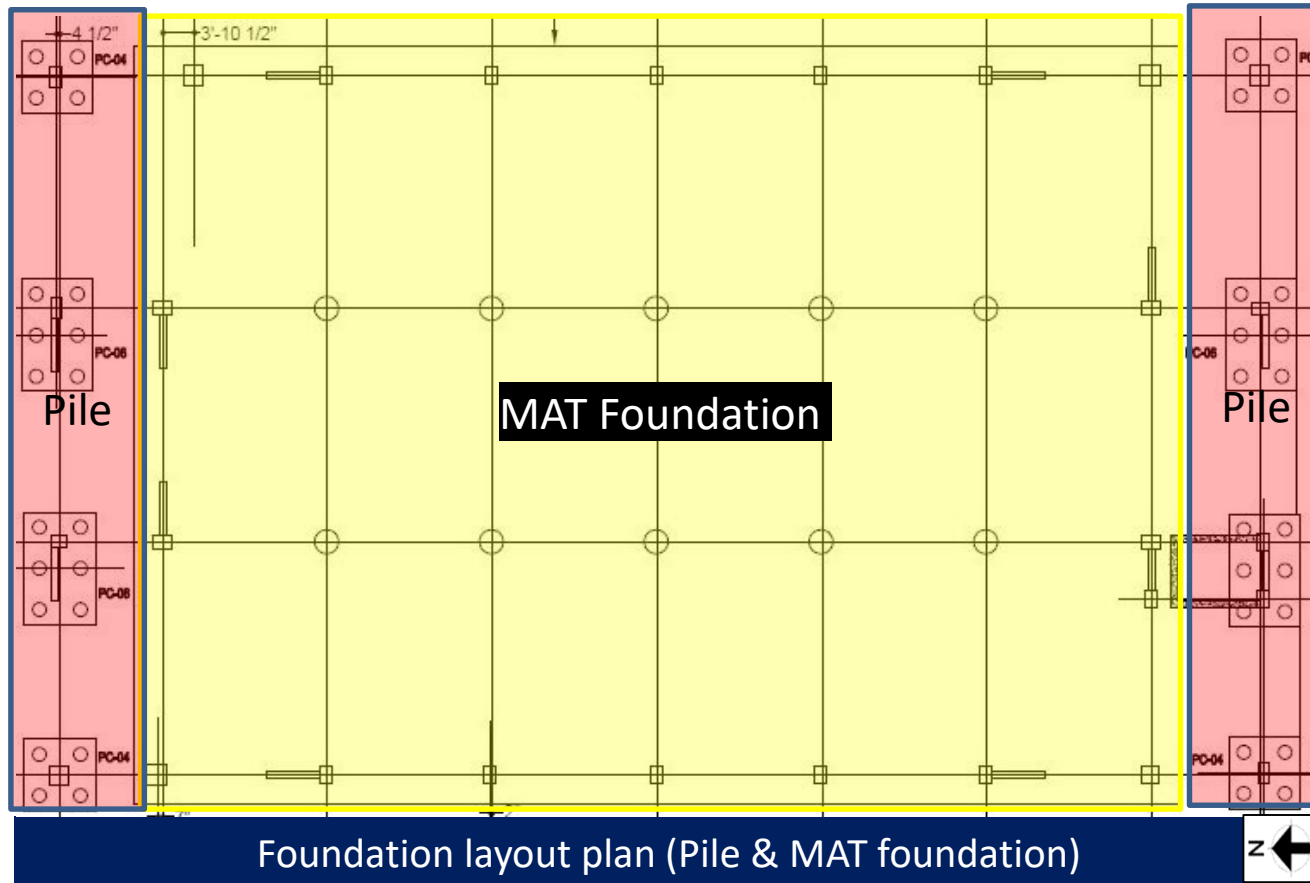
### Foundation punching stress in design report

Both shallow and deep foundation constructed in the structure. Building engineer is required to check the allowable settlement of the foundations and incorporate it in the design report.

| Item No. | Observation | Recommended Action Plan | Recommended Timeline |
|---|---|---|---|
| 02 | Inconsistency in the design report. | Check the allowable settlement of pile & MAT foundations and incorporate it in the design report. | 6-weeks |

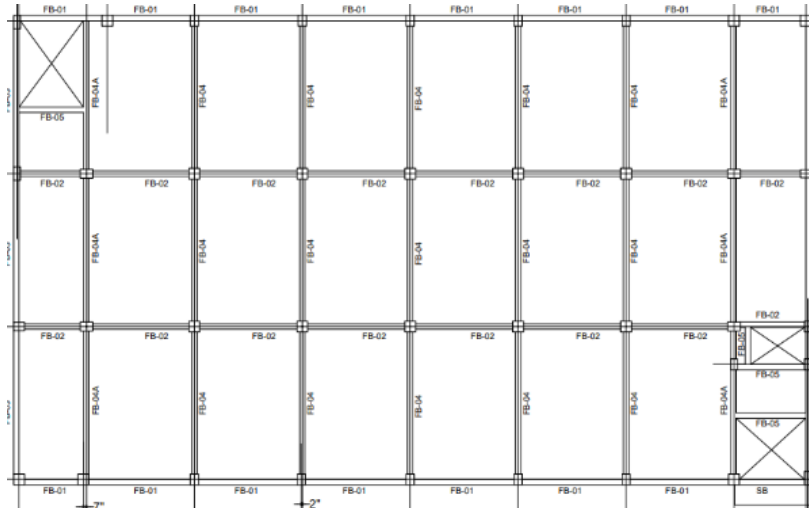
6<sup>th</sup> floor beam layout (two way slab)

During inspection 6<sup>th</sup> floor beam layout was found not matched with as built drawing. Secondary beam was found in 6<sup>th</sup> floor level which was not shown in drawing. The building engineer is required to survey the structure and update the as built drawings accordingly.

| Item No. | Observation | Recommended Action Plan | Recommended Timeline |
|---|---|---|---|
| 04 | Discrepancies in the as-built drawing. (ETP Building). | Building engineer is required to survey the structure and prepare accurate as-built drawings. | 6-weeks |

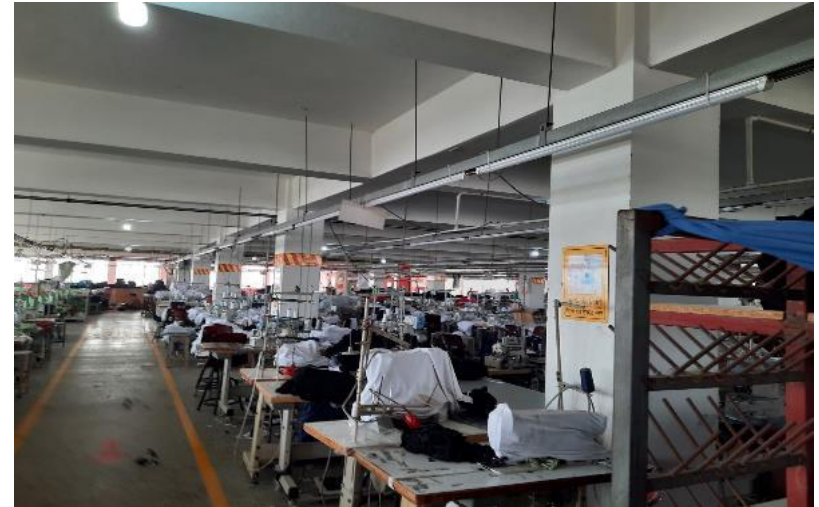
6<sup>th</sup> floor onsite beam layout (one way slab).

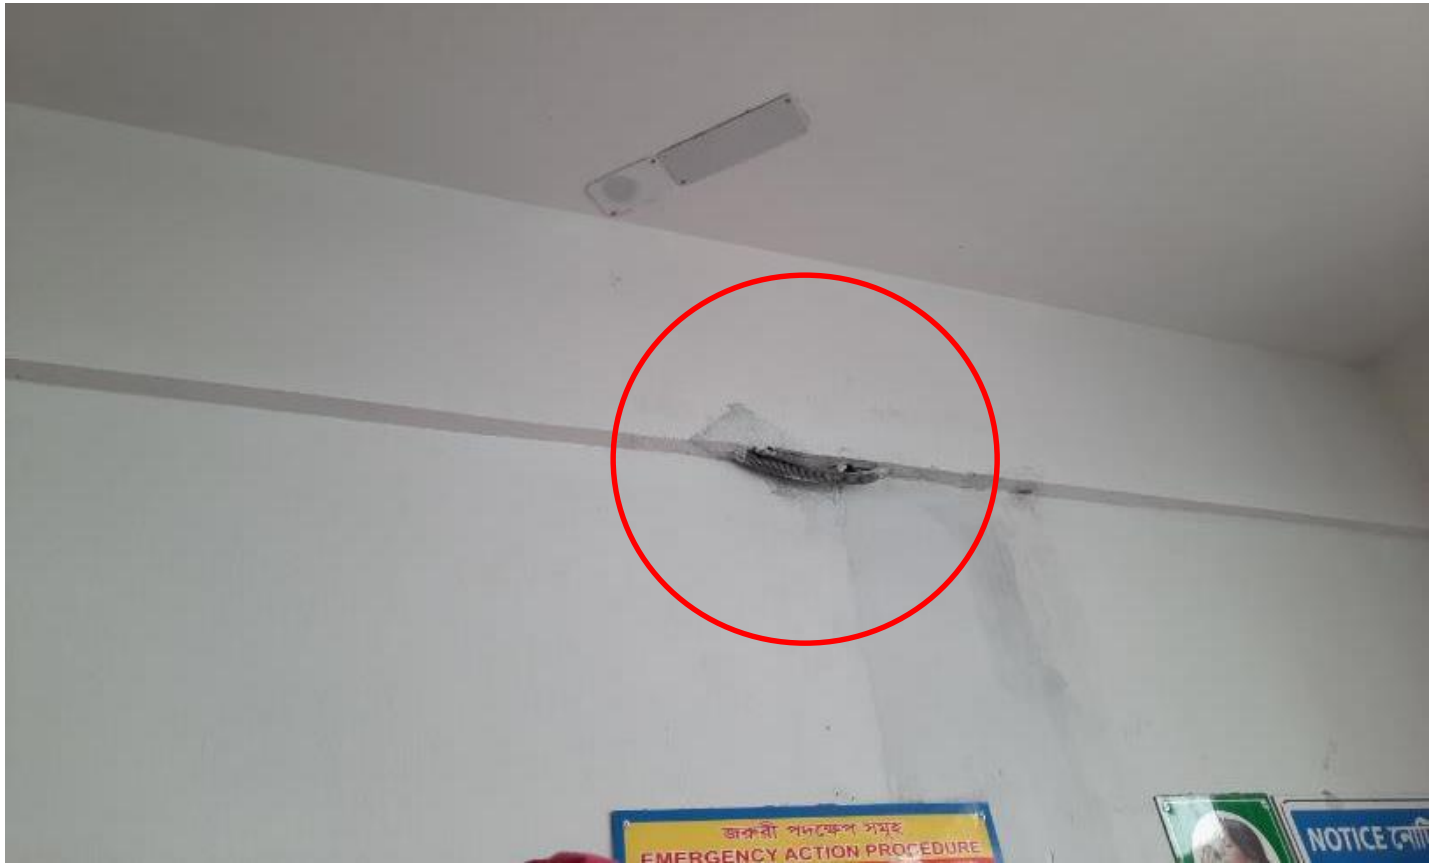
**Electrical conduit passes through main structural beams**

Electrical conduits have been passes through the main structural beams throughout various floor levels of the building. The building engineer is required to investigate the conditions and report on this matter to verify the structural integrity of the beams are not compromised.

| Item No. | Observation | Recommended Action Plan | Recommended Timeline |
|---|---|---|---|
| 05 | Electrical conduit passes through main structural beams. (ETP Building) | The building engineer is required to investigate the conditions and report on this matter to verify the structural integrity of the beams are not compromised. | 6-weeks |

| Item No. | Observation | Recommended Action Plan | Recommended Timeline |
|---|---|---|---|
| 06 | Electrical conduit passes through main structural beams. (ETP Building). | Carry out any remedial works if necessary. | 6-weeks |

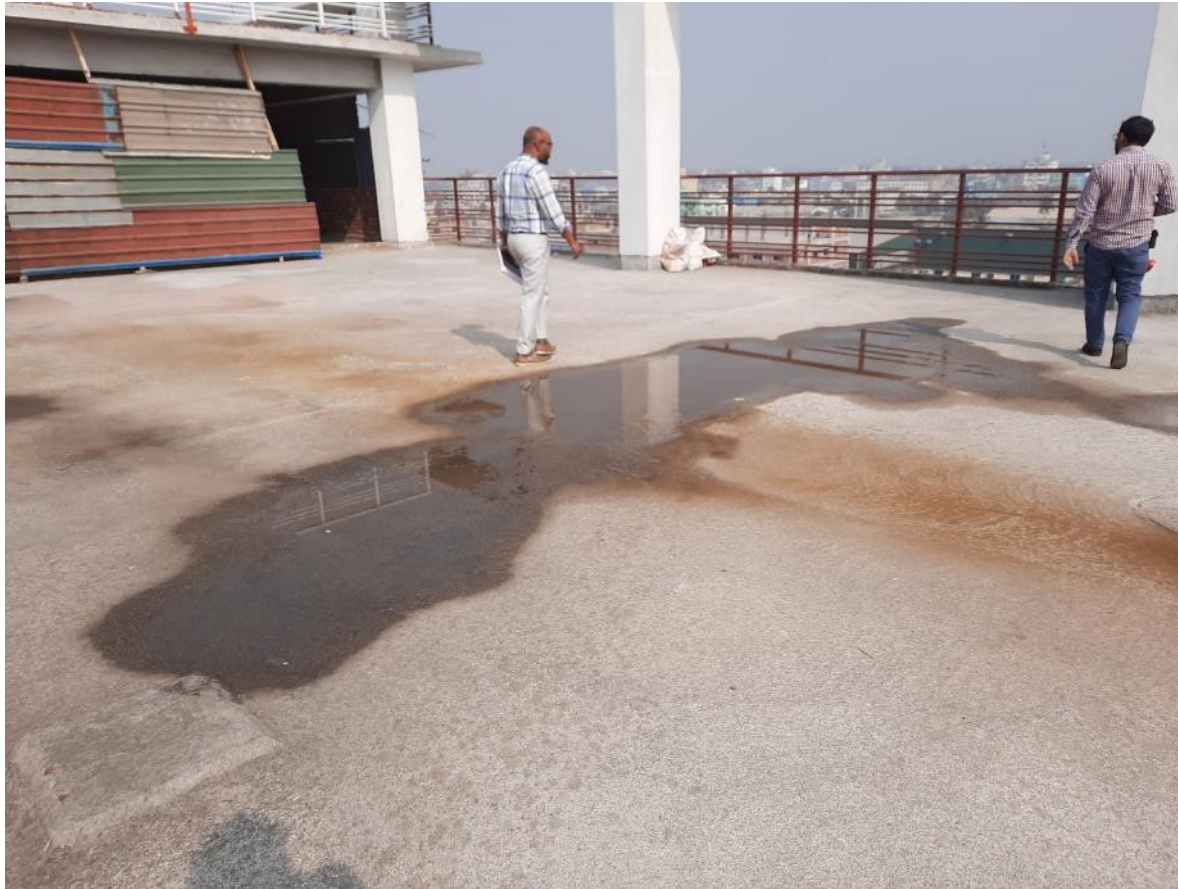
**Stagnant of water on the roof**

Stagnant of water observed on the roof. The factory is required to improve the roof drainage system.

| Item No. | Observation | Recommended Action Plan | Recommended Timeline |
|---|---|---|---|
| 07 | Stagnant of water on the roof. (ETP Building). | Building engineer is required to provide adequate number of water outlets and improve the roof drainage system with adequate slope. | 6-months |

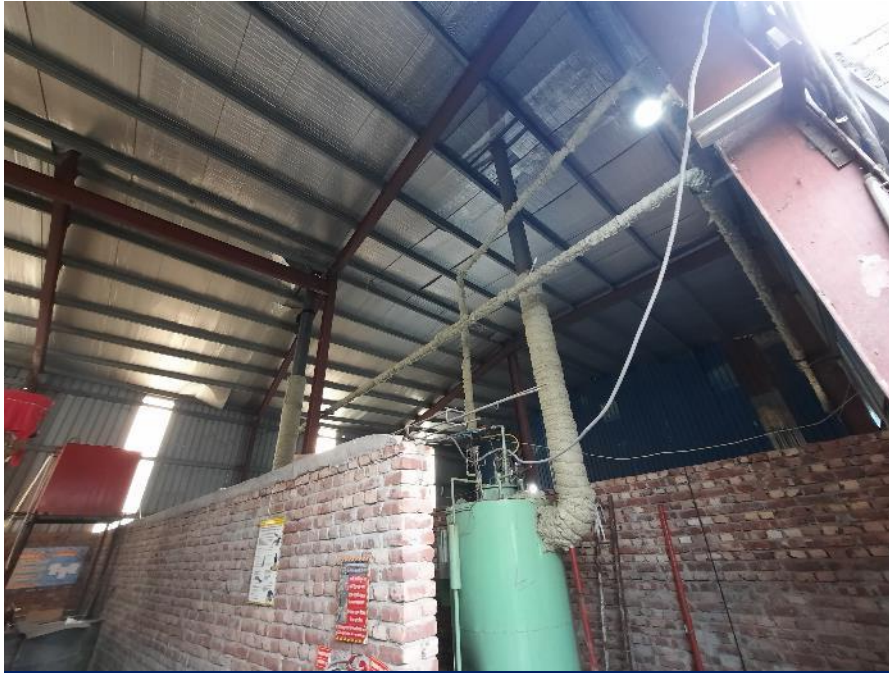
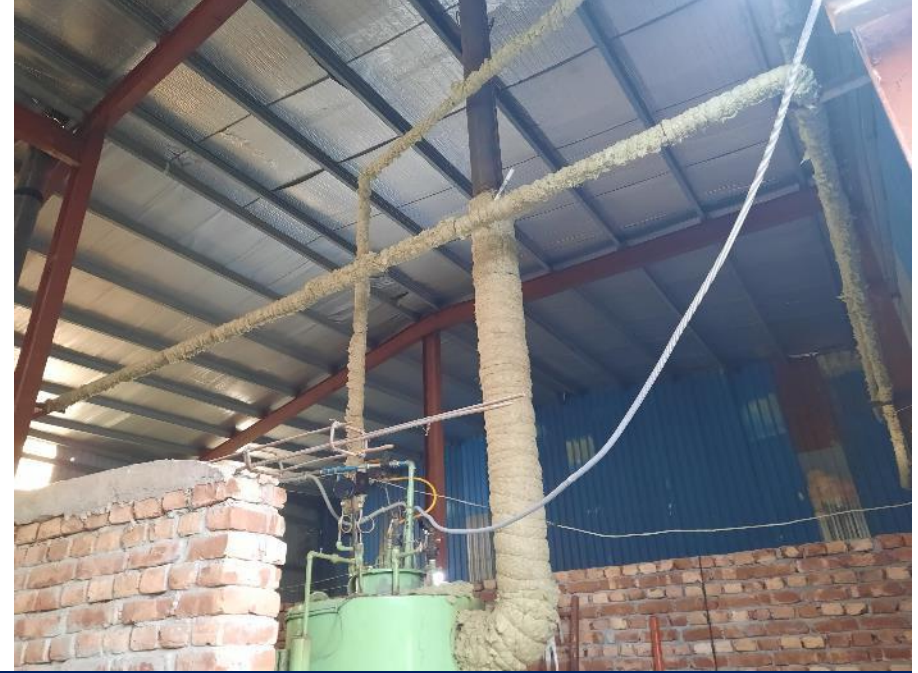
## **Lack of lateral stability system**

Lateral load transfer media (compression strut) and load resisting system (bracing) was not observed in the structure. Also, as-built design documents were not available. The building engineer is required to carry out Engineering Assessment (EA) to check the lateral stability system and prepare design documents as per BNBC 1.9.1

| Item No. | Observation | Recommended Action Plan | Recommended Timeline |
|---|---|---|---|
| 08 | Lack of lateral stability system. (Utility Shed). | The building engineer is required to carry out Engineering Assessment (EA) to check the lateral stability system and prepare design documents as per BNBC 1.9.1 with necessary remedial actions. | 6-weeks |
| 09 | Lack of lateral stability system. (Utility Shed). | Carry out the remedial works as per EA. | 6-months |

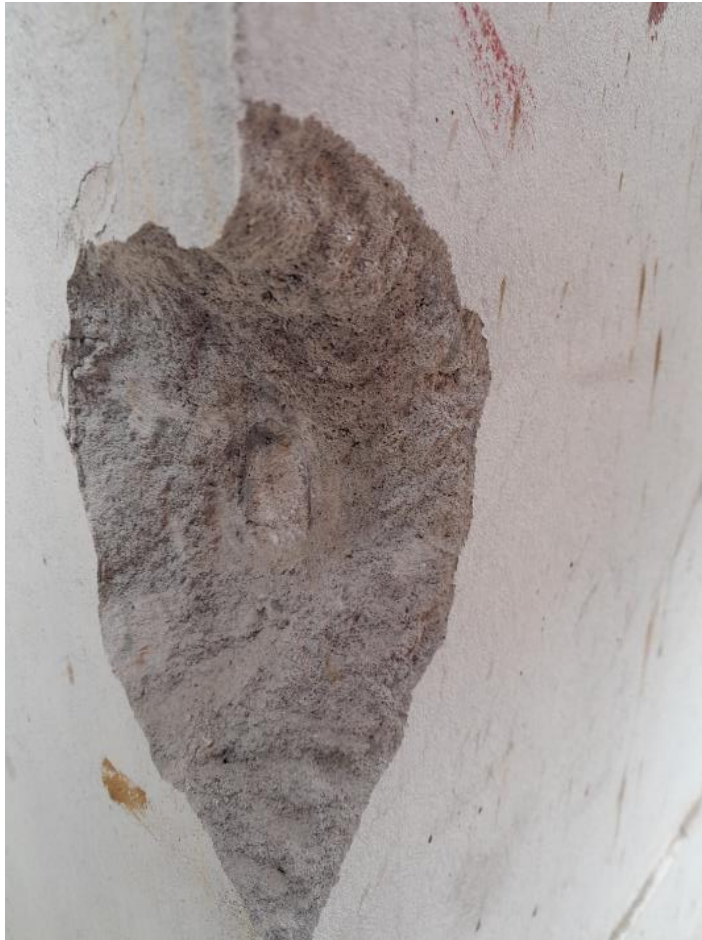
Stone chips aggregate concrete in the column of ETP Building
