SEWTECH FASHIONS LIMITED

SFB-10, Factory Building, Factory Bay Area, CEPZ, Chattogram
(22.291352, 91.778089)

15 December 2022

Observation: SFB#10 Factory Building

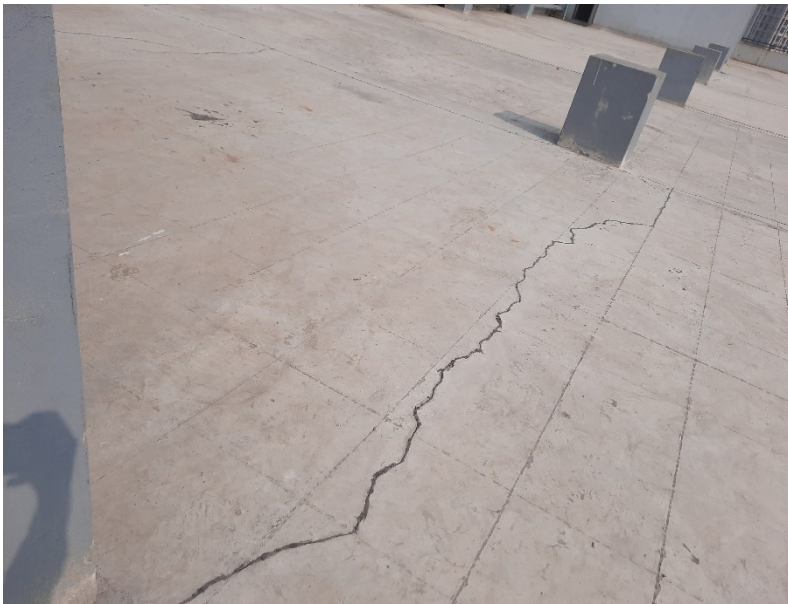
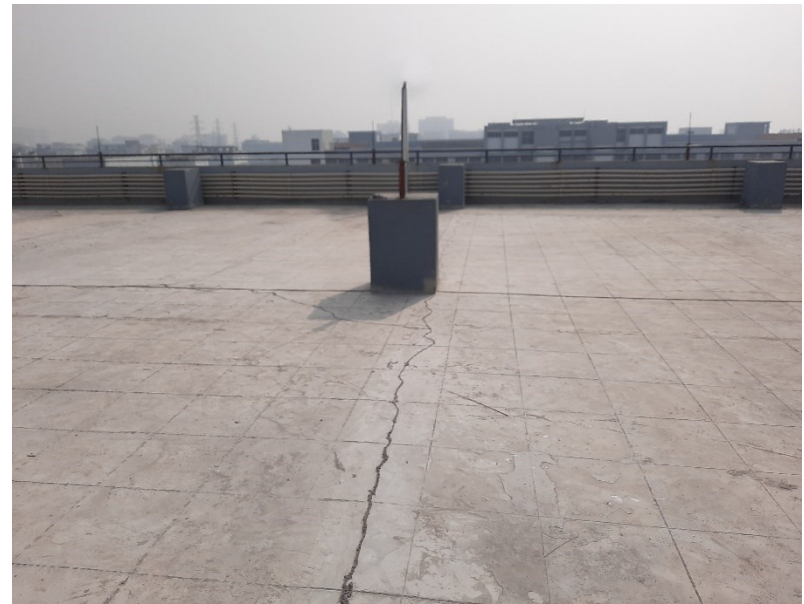
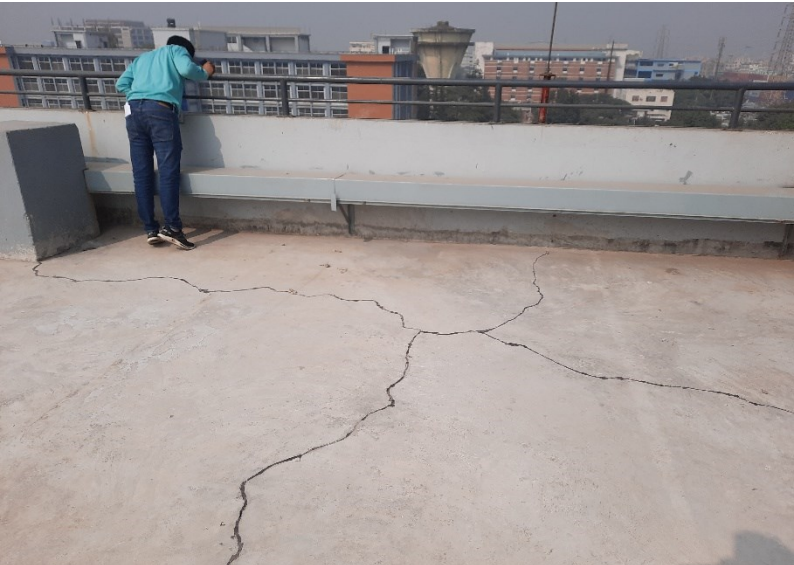
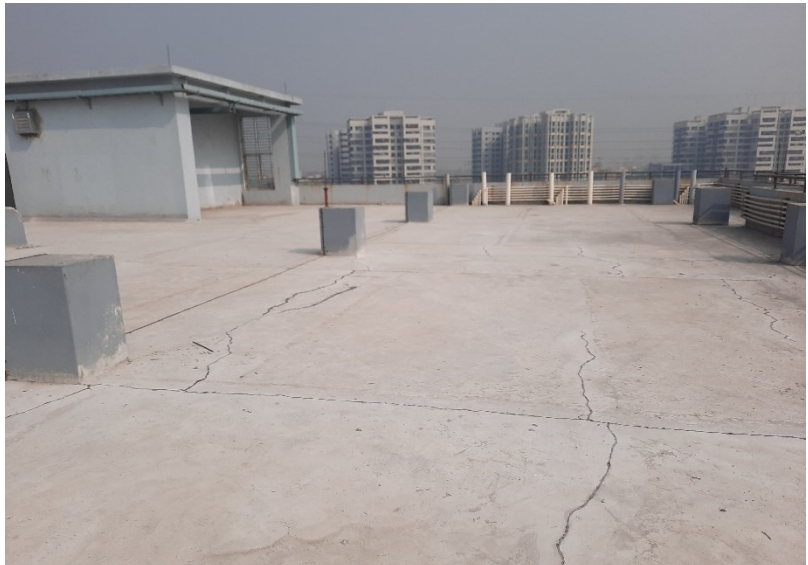
Crack on the floor finish of roof

Crack on the rooftop screeding. Building engineer is required to repair the crack with suitable repair method.

Item 02: Crack on the floor finish of roof.

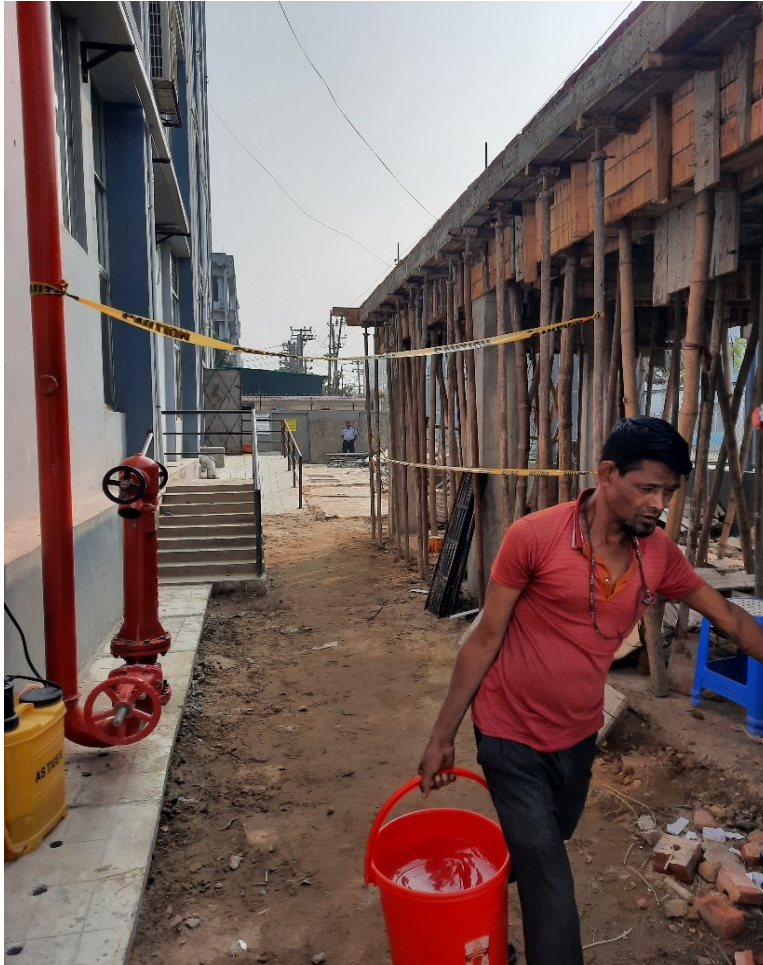
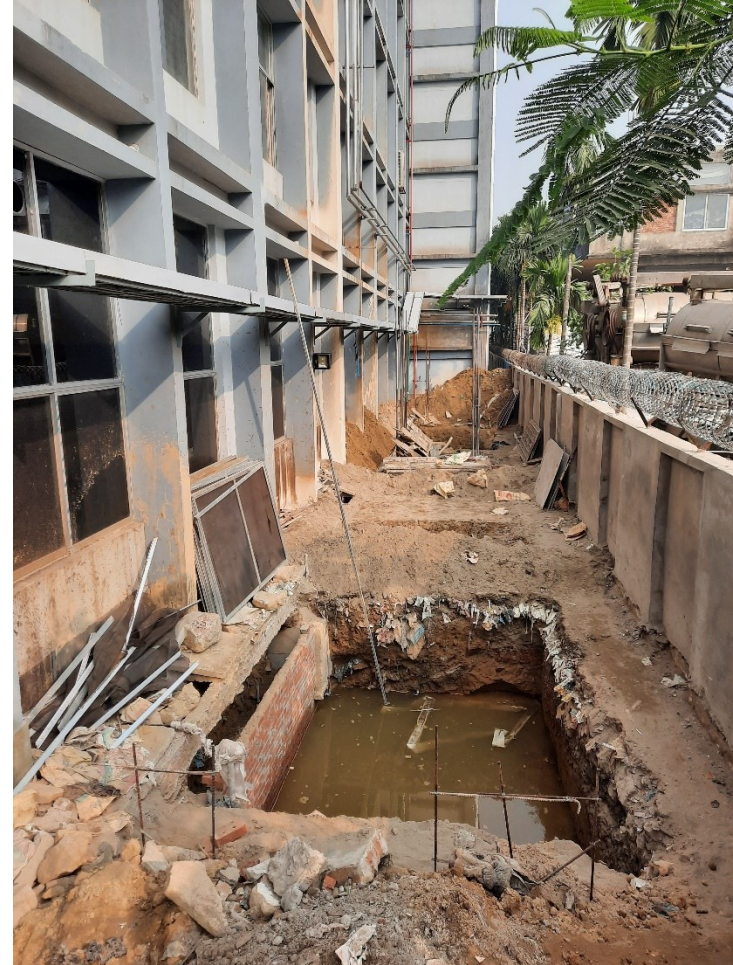
Construction safety practice in the factory premises

Lack of construction safety practice observed in the factory premises. Building engineer is required to follow all the construction safety practice according to Part 7, Chapter 3 of BNBC.

Item 03: Construction safety practice in the factory premises.
