# Hera Sweaters Ltd.

Pechain, Jampur, Sonargaon, Narayanganj  
(23.748314N, 90.584084E)

27<sup>th</sup> January and 8<sup>th</sup> March 2020

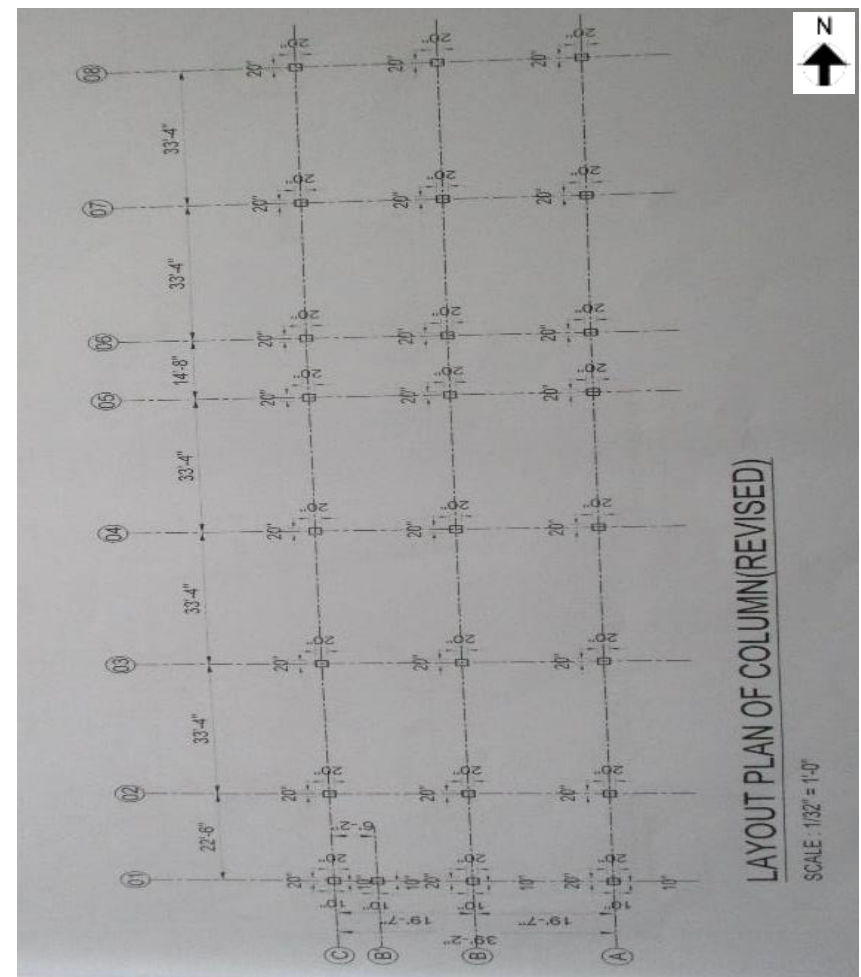
In layout column indications were not shown

In column layout column type/indication was not mentioned therefore there was an ambiguity to indicate the actual column type in onsite condition. Factory engineer is required to update the as-built drawing showing all the column type.

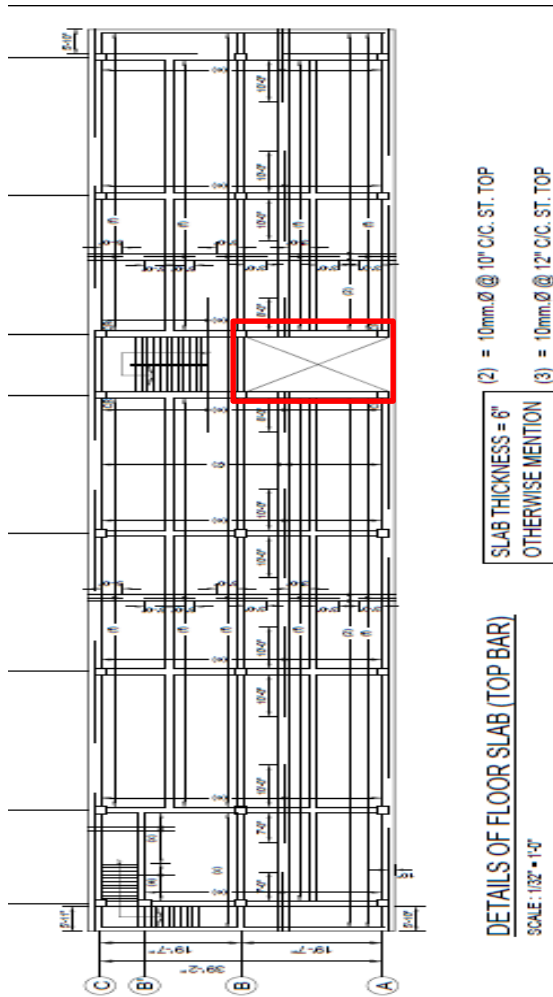
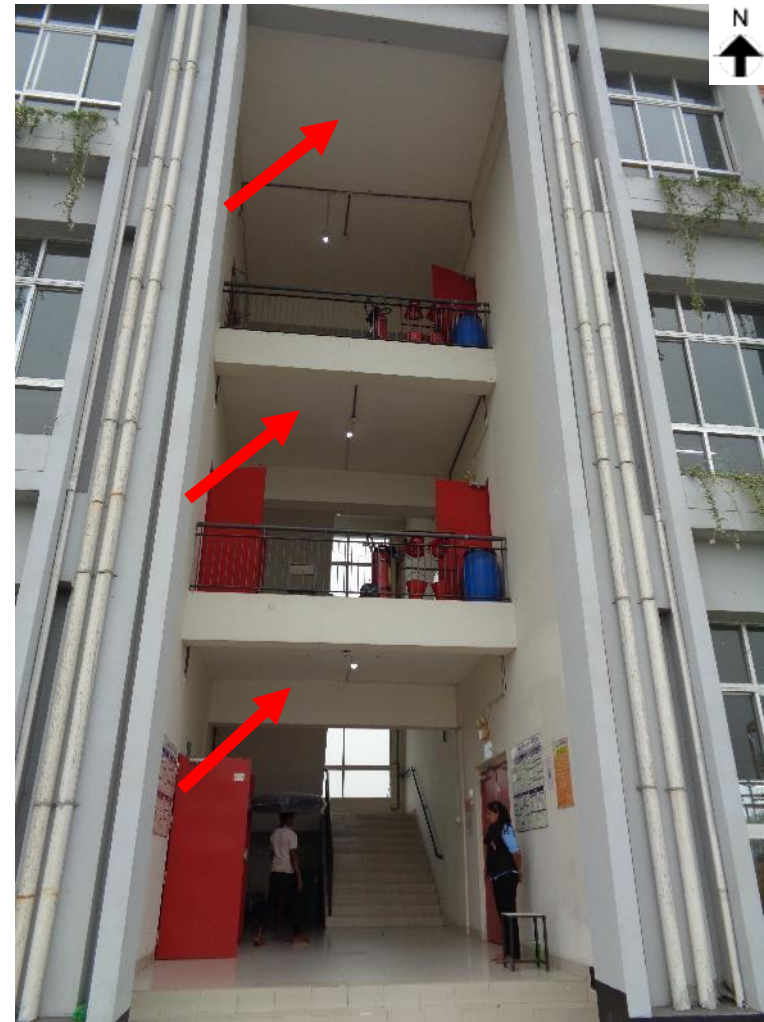
Portion of slab at staircase was not shown in Slab layout

Factory engineer is required to update the as-built drawing as per onsite condition

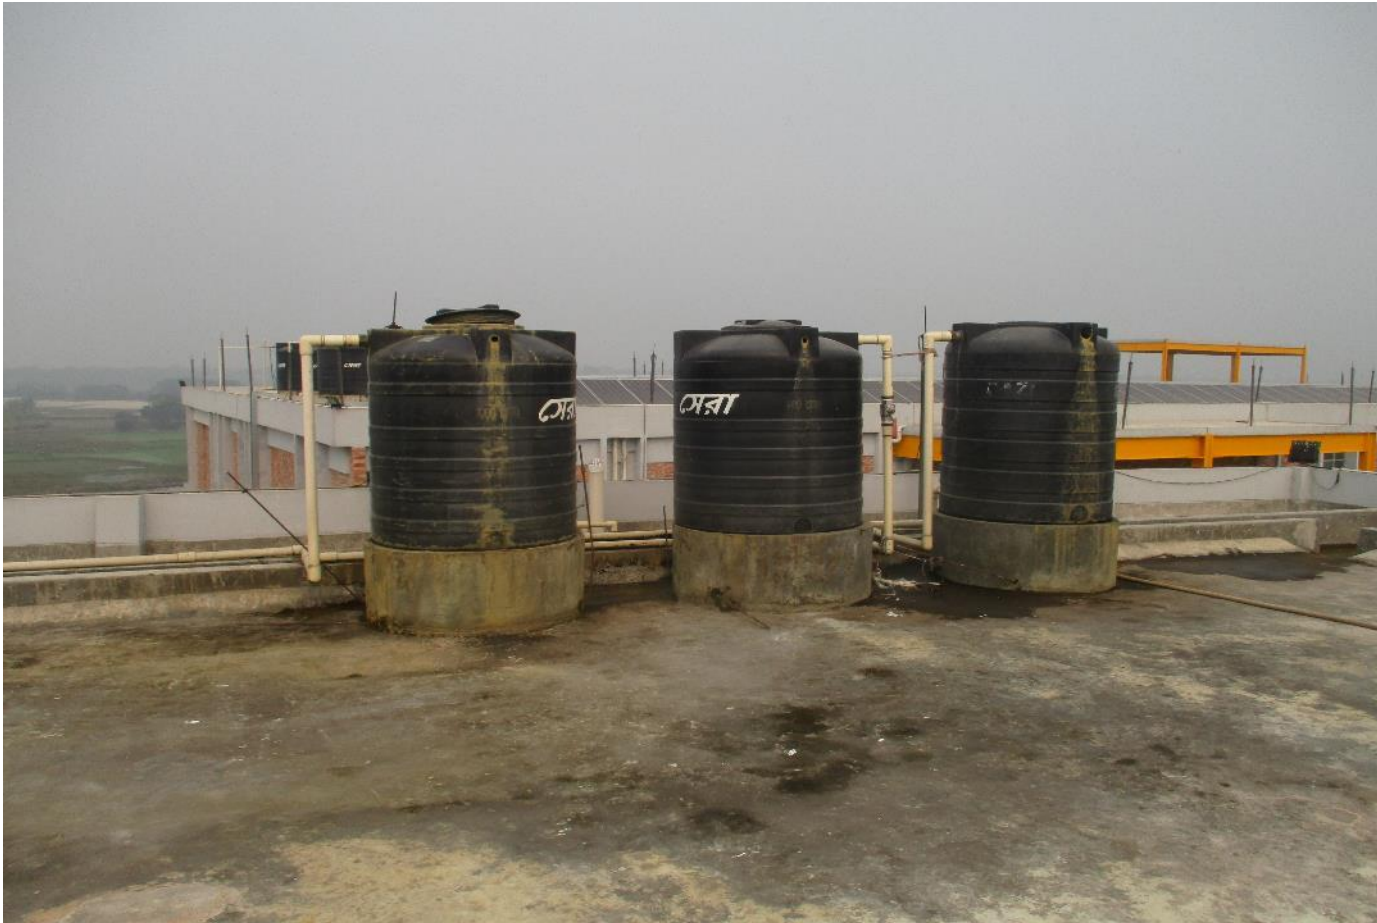
Roof plan was not incorporate in provided drawing. Three 1000-liter plastic water tanks were found on roof slab at north end which were not shown in drawing.

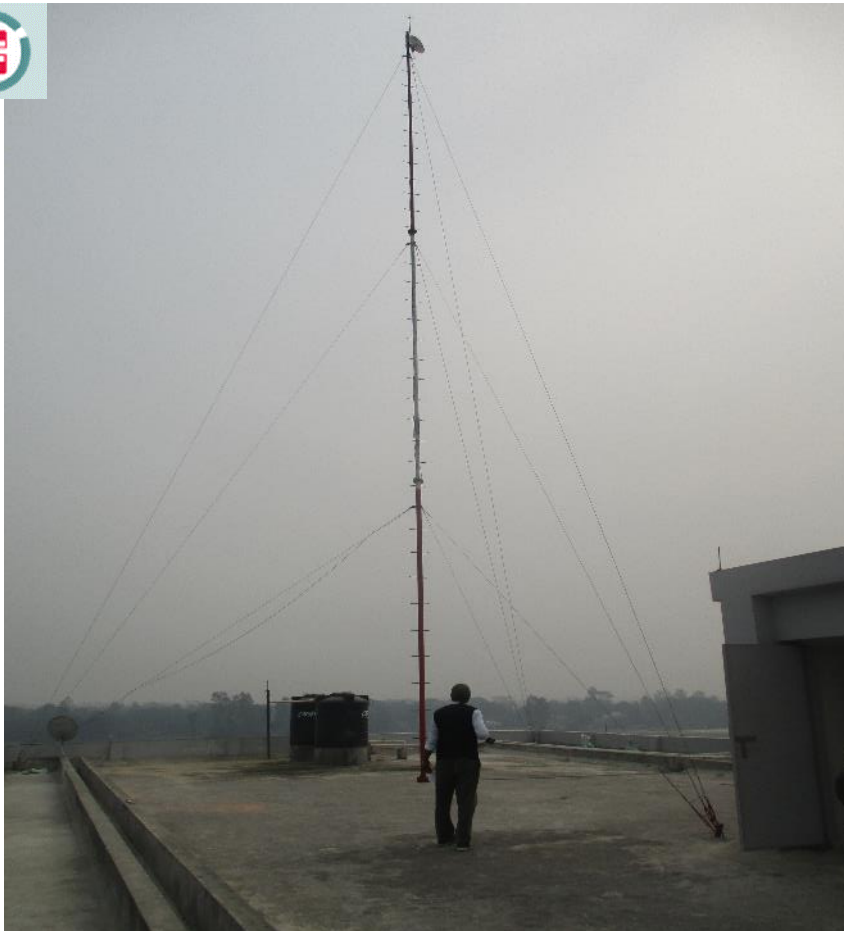
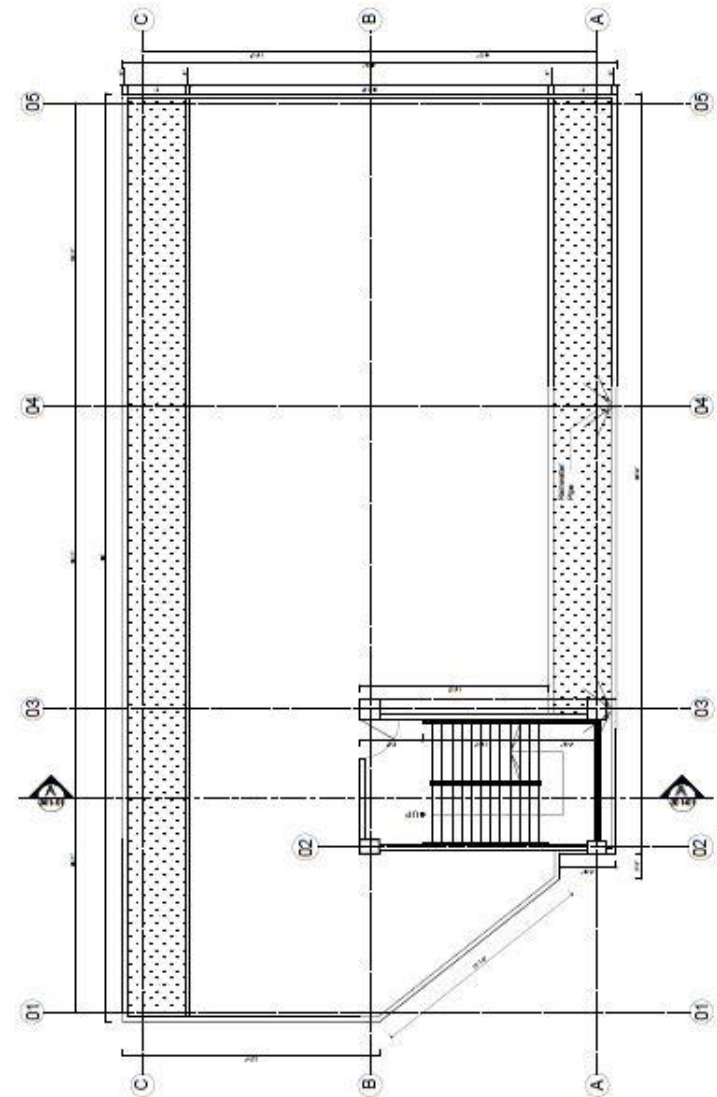
Two plastic water tanks and a tower (each of 1000 liter) were found on roof slab.

Water tanks and tower were not shown in drawing

Factory engineer is required to update the as-built drawing as per onsite condition.

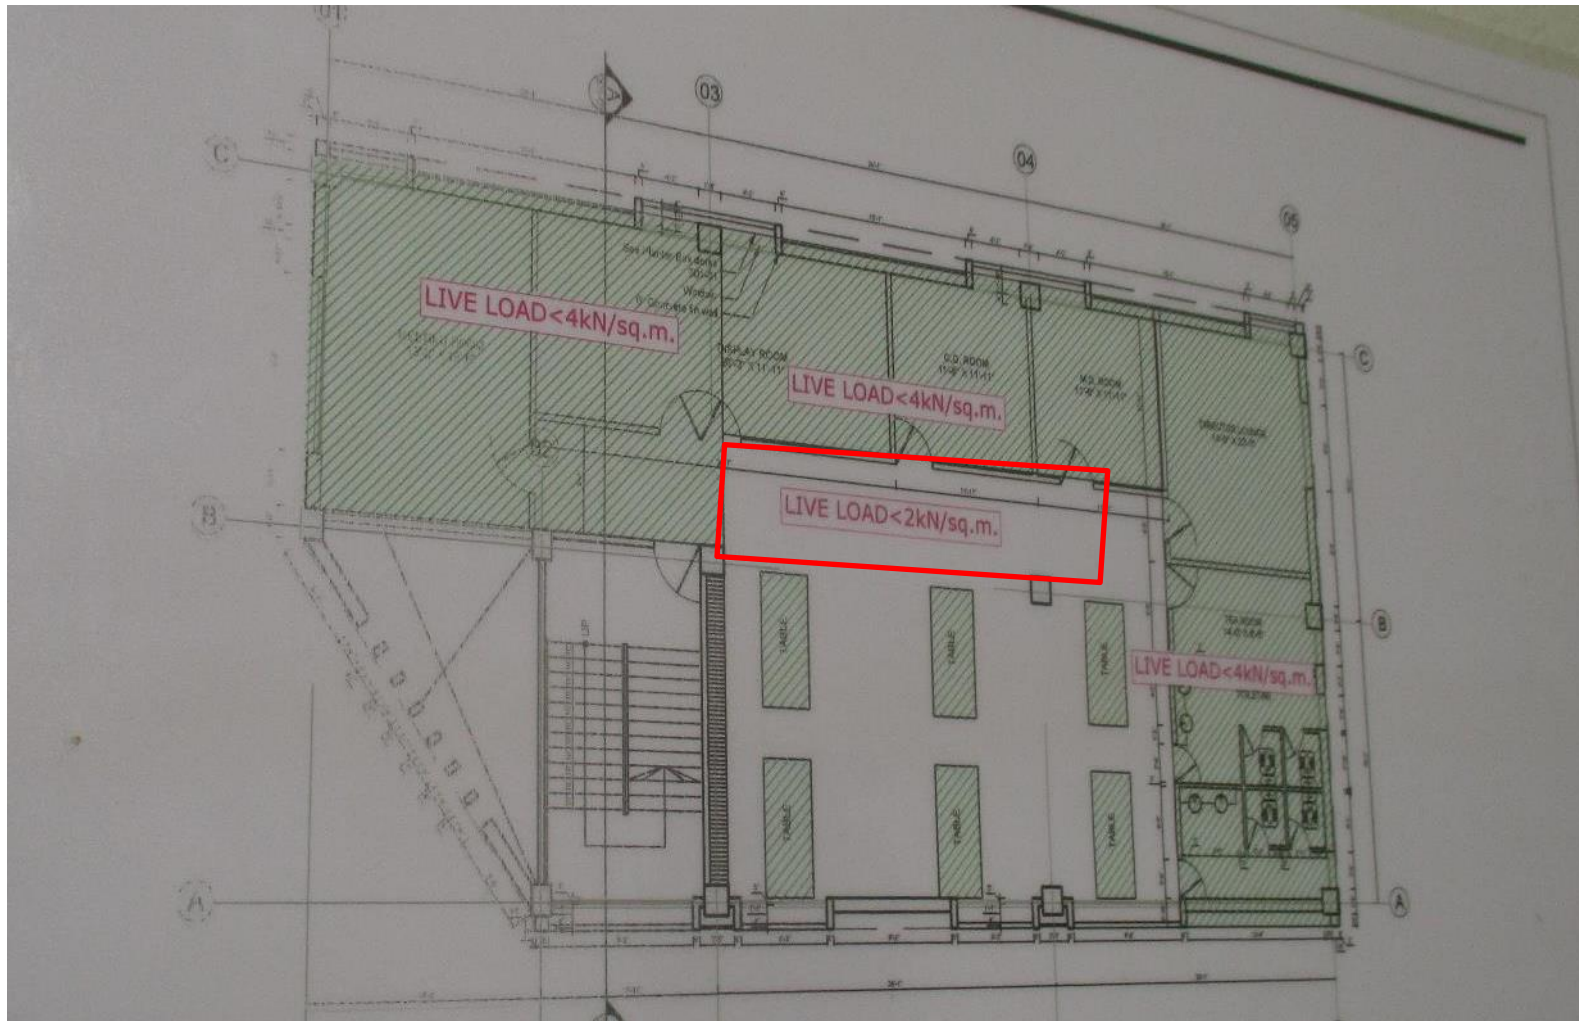
Live load was mentioned as 2 KN/m<sup>2</sup> for some places in posted load plan

Live load was mentioned as 2 KN/m<sup>2</sup> for some places in posted load plan. which doesn't comply the BNBC standard. Factory engineer is required to Produce load plan as per BNBC standard.

| Item No. | Observation | Recommended Action Plan | Recommended Timeline |
|---|---|---|---|
| 02 | Load plan doesn't comply with BNBC standard (Admin Building) | Factory engineer is required to Produce load plan as per BNBC standard. | (within 6-weeks) |

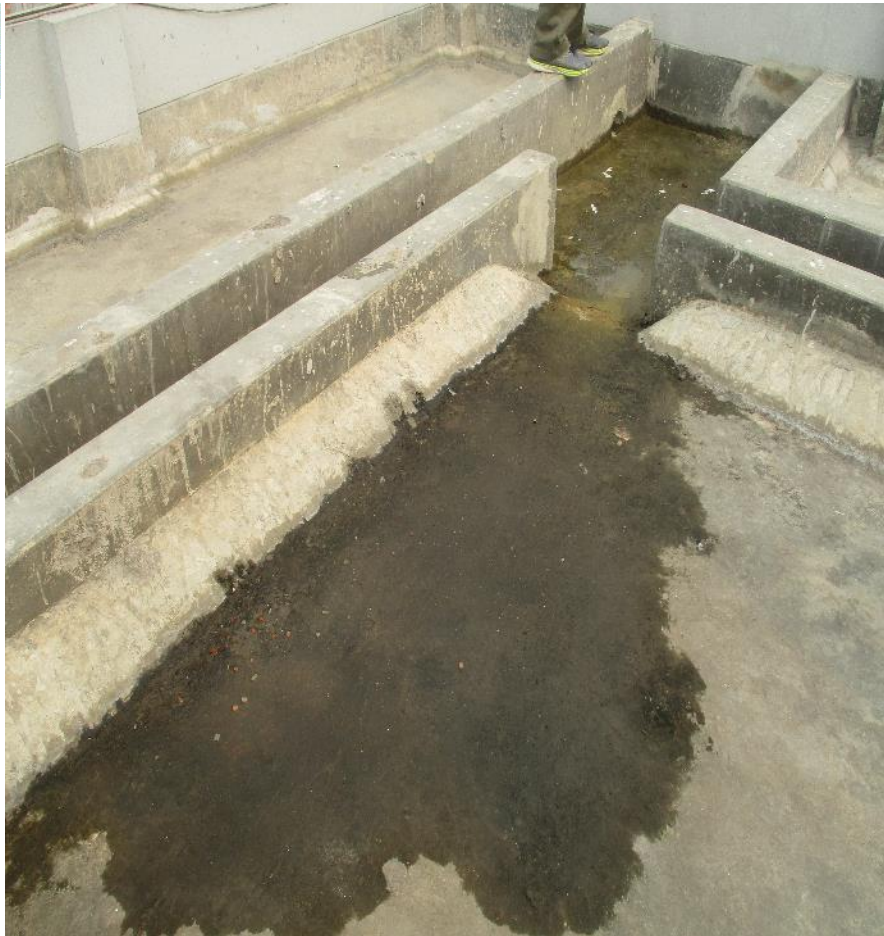
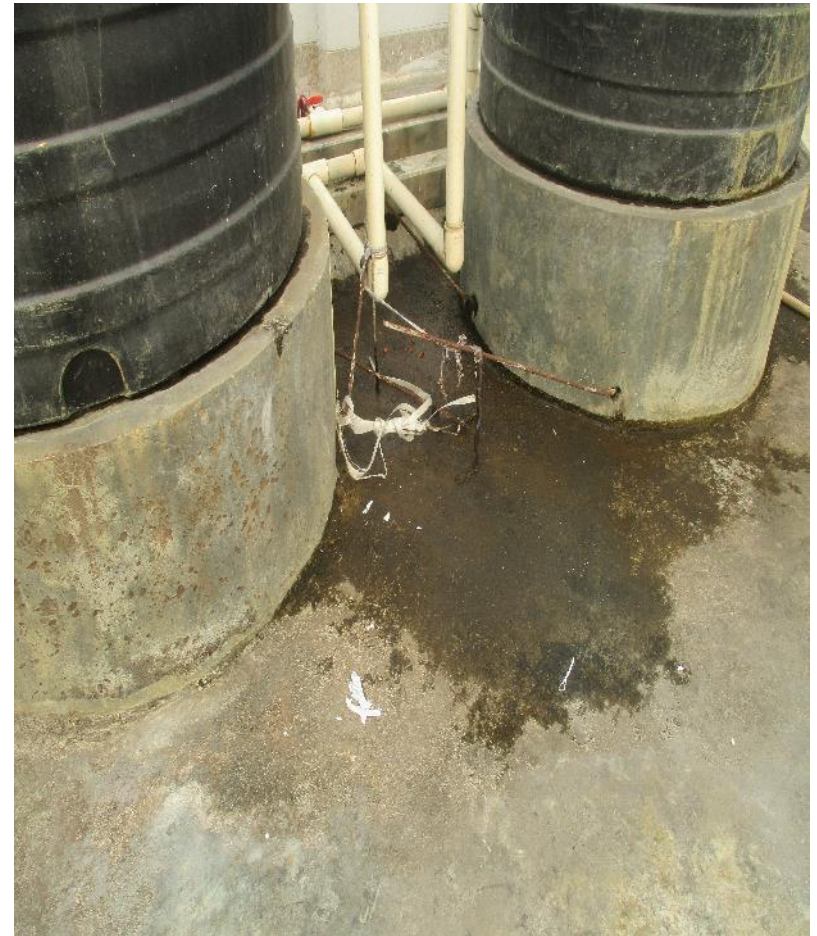
Dampness was found on roof slab at north side

Factory is required to improve drainage system to prevent water ponding and dampness on roof slab.

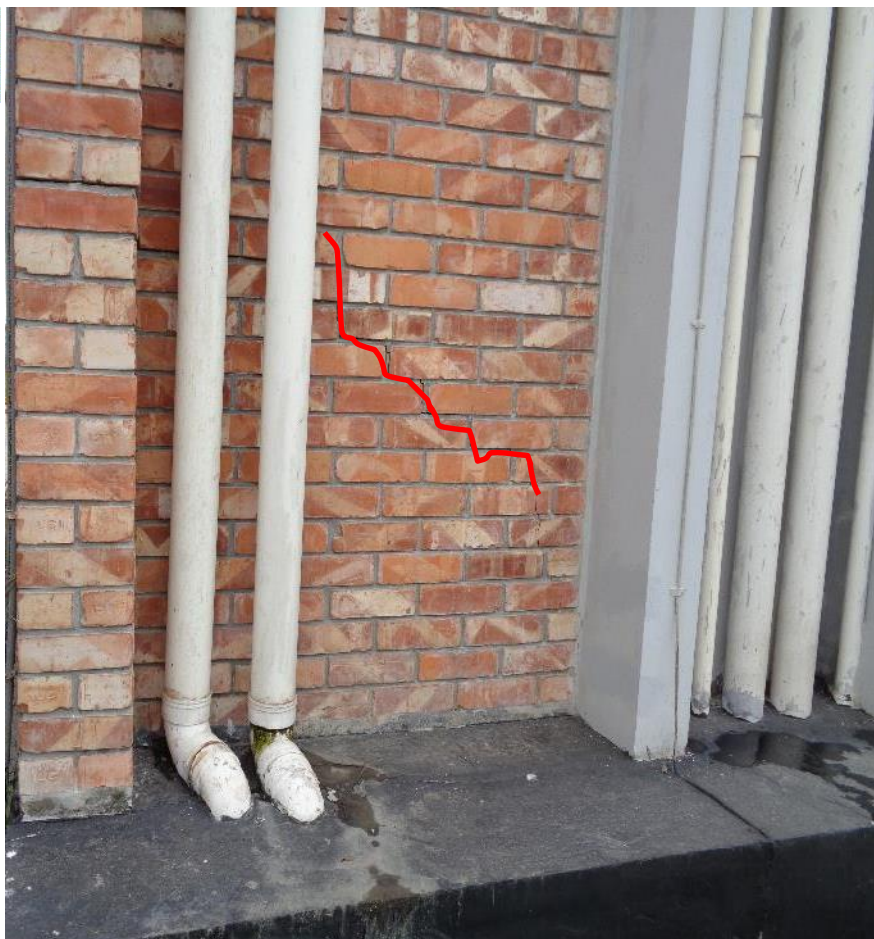
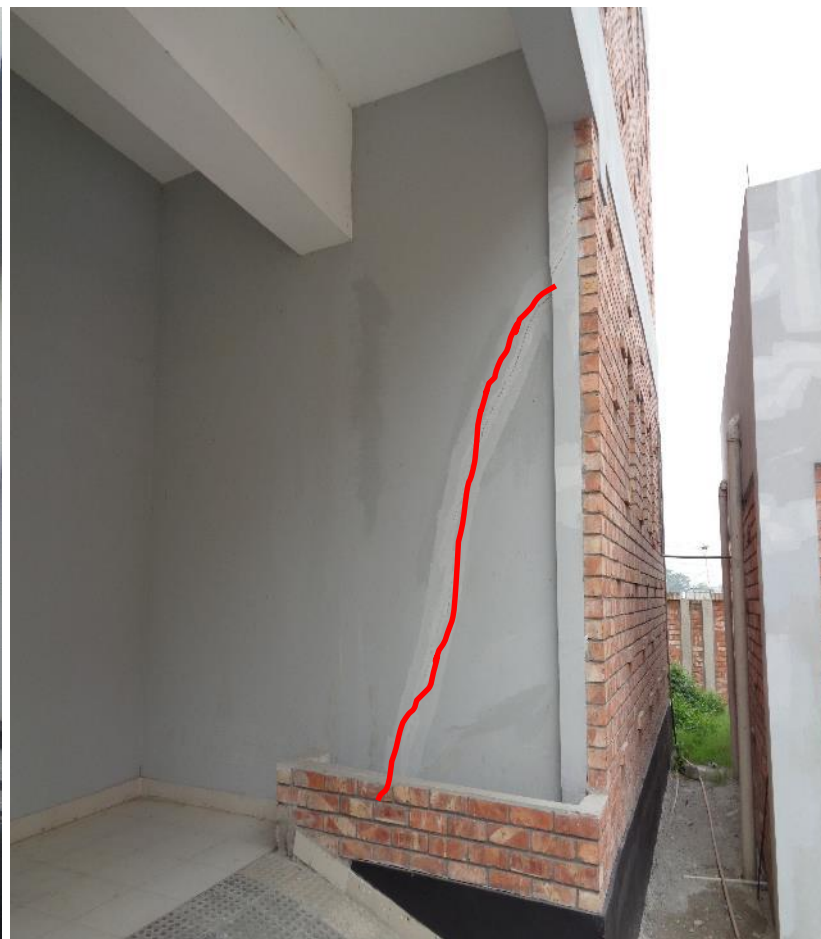
Crack was found in brick wall at ground floor cantilever area (north end)

Factory engineer is required to investigate the cause of crack and repair with a suitable method.

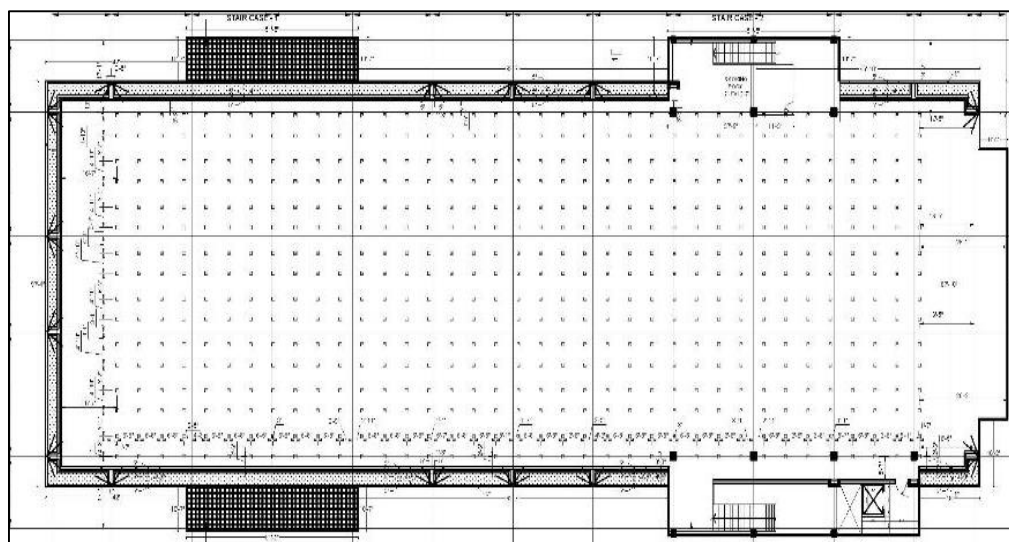
Water tank is not shown in the provided drawing

| Item No. | Observation | Recommended Action Plan | Recommended Timeline |
|---|---|---|---|
| 05 | Inconsistency in as-built drawing (Production Building) | Building engineer is required to update the as-built drawing as per actual site condition. | (within 6-weeks) |

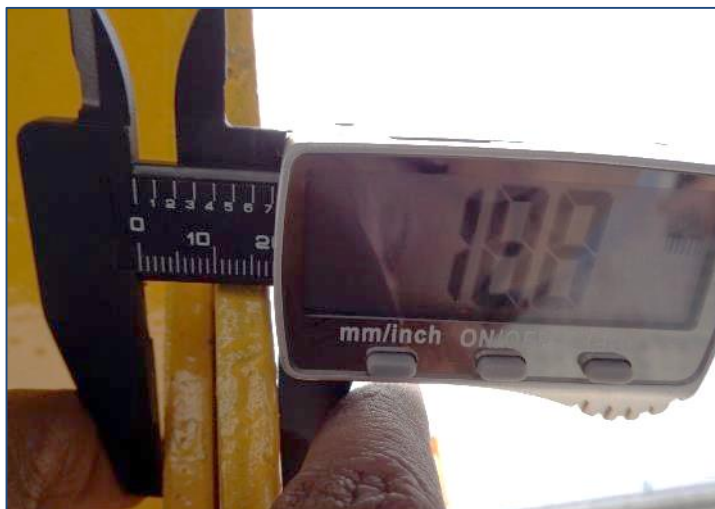
Flange thickness in C-209 column found 18 mm (double plate) instead of 10 mm (single plate)

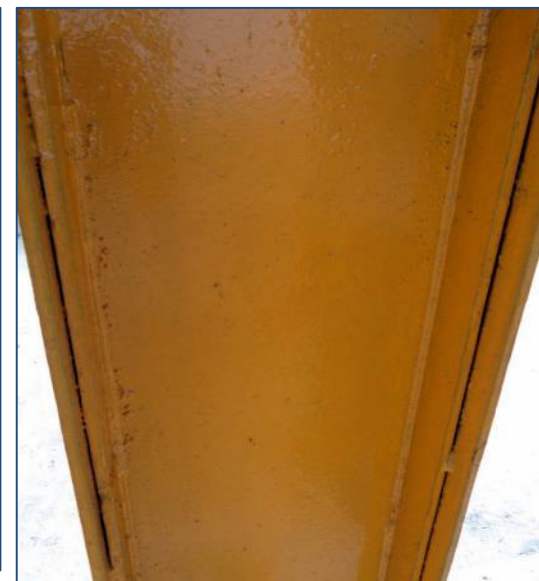
Additional plate was found in the C-209 steel column

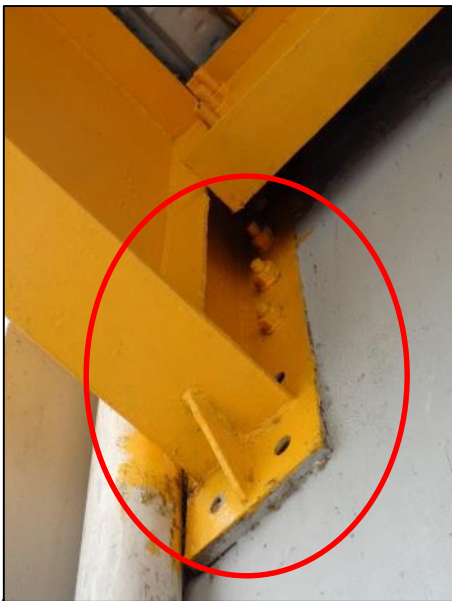
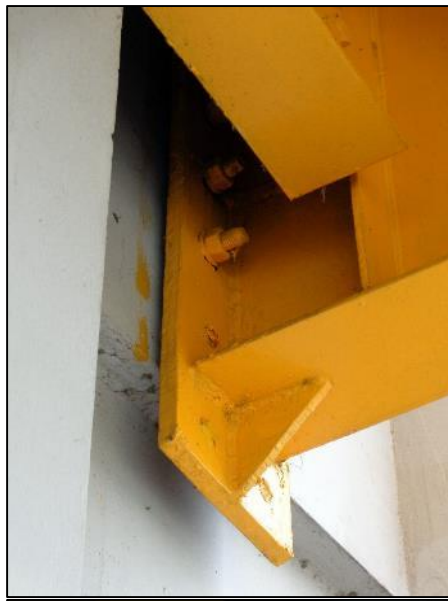
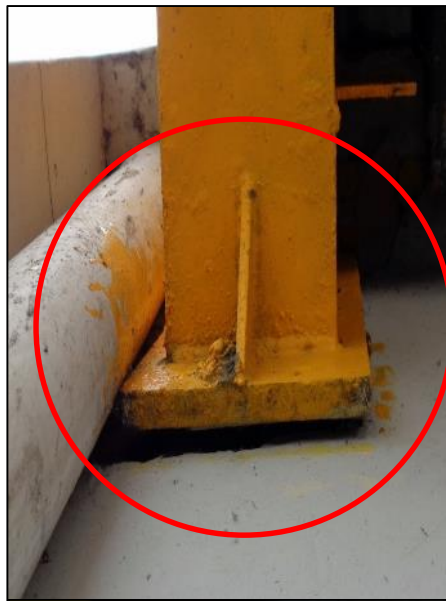
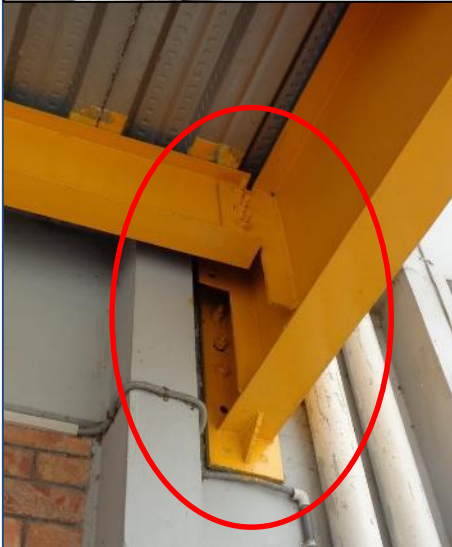
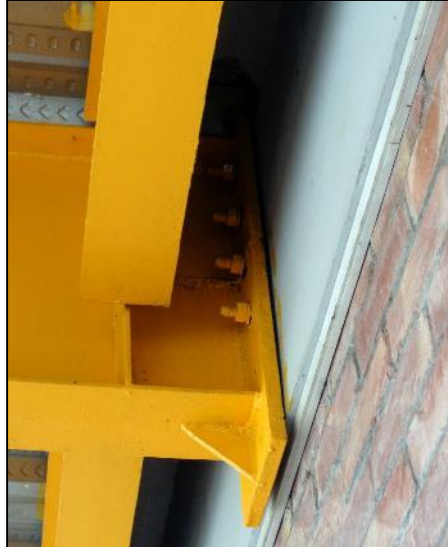
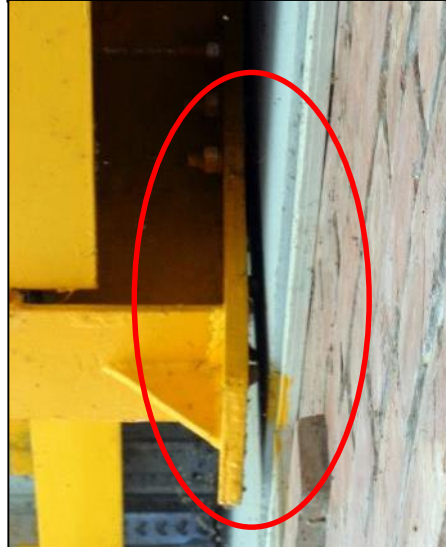
Significant gap found at connection plate joint and RC member. In some places, the connection was found with brick wall. Missing bolt was found in several places. Connections were not constructed as per drawing in several places.

Missing bolt

Improper connection

Gap in connection

Bolt found missing, Significant gap was observed. Apparently, load bearing, and transfer capacity is reduced.

| Item No. | Observation | Recommended Action Plan | Recommended Timeline |
|---|---|---|---|
| 06 | Improper Connection, missing bolt and Gap between member in all steel stairs (Production Building Stairs) | Building Engineer to investigate, verify and prepare a report on the load transfer capacity of all faulty connections. | (within 6-weeks) |
| 07 | Improper Connection, missing bolt and Gap between member in all steel stairs (Production Building Stairs) | Check all the connection adequacy. | (within 6-weeks) |
| 08 | Improper Connection, missing bolt and Gap between member in all steel stairs (Production Building Stairs) | Carry out any remedial works if required. | (within 6-months) |

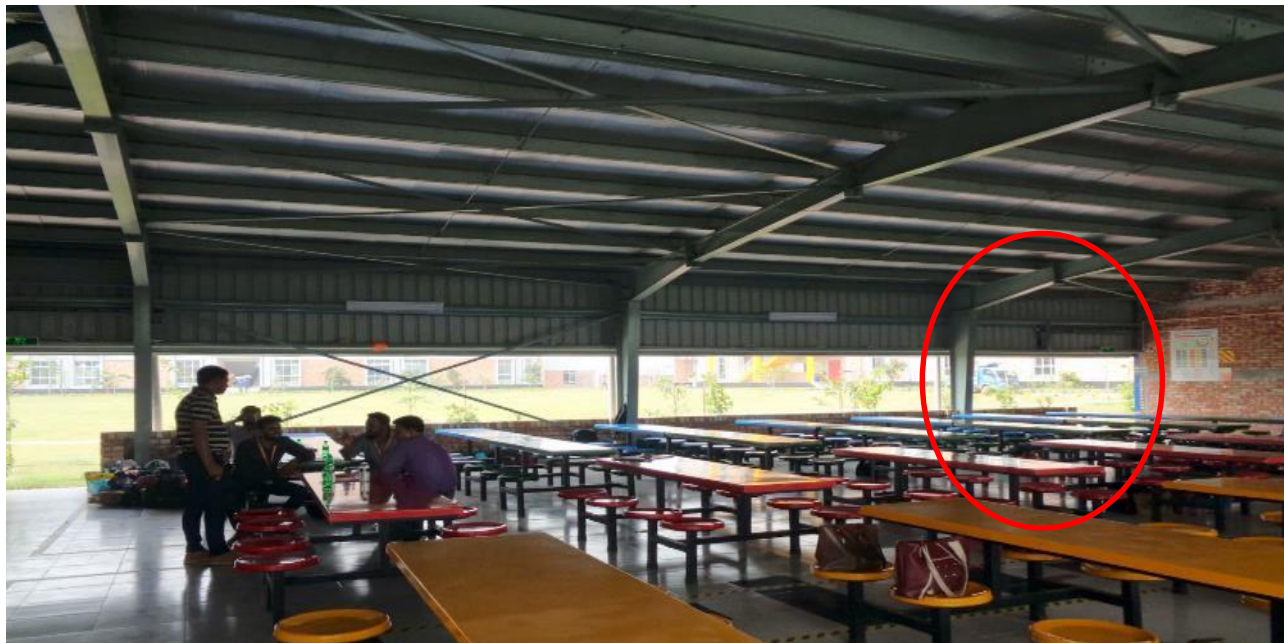
Bracing missing this marked location

Vertical bracing at marked location found missing. Factory engineer is required to install the missing bracing or check the lateral stability of the shed.

| Item No. | Observation | Recommended Action Plan | Recommended Timeline |
|---|---|---|---|
| 09 | Vertical bracing missing (Multipurpose shed) | Factory engineer is required to install the missing bracing or check the lateral stability of the shed. | (within 6-weeks) |
| 10 | Vertical bracing missing (Multipurpose shed) | Carry out any remedial works if required. | (within 6-months) |
