# SQUARE FASHIONS LTD (Extension)

ROKEYAPUR, JAMIRDIA, HABIR BARI, VALUKA  
(24.292326, 90.385091)  
9 January 2023

# Observations

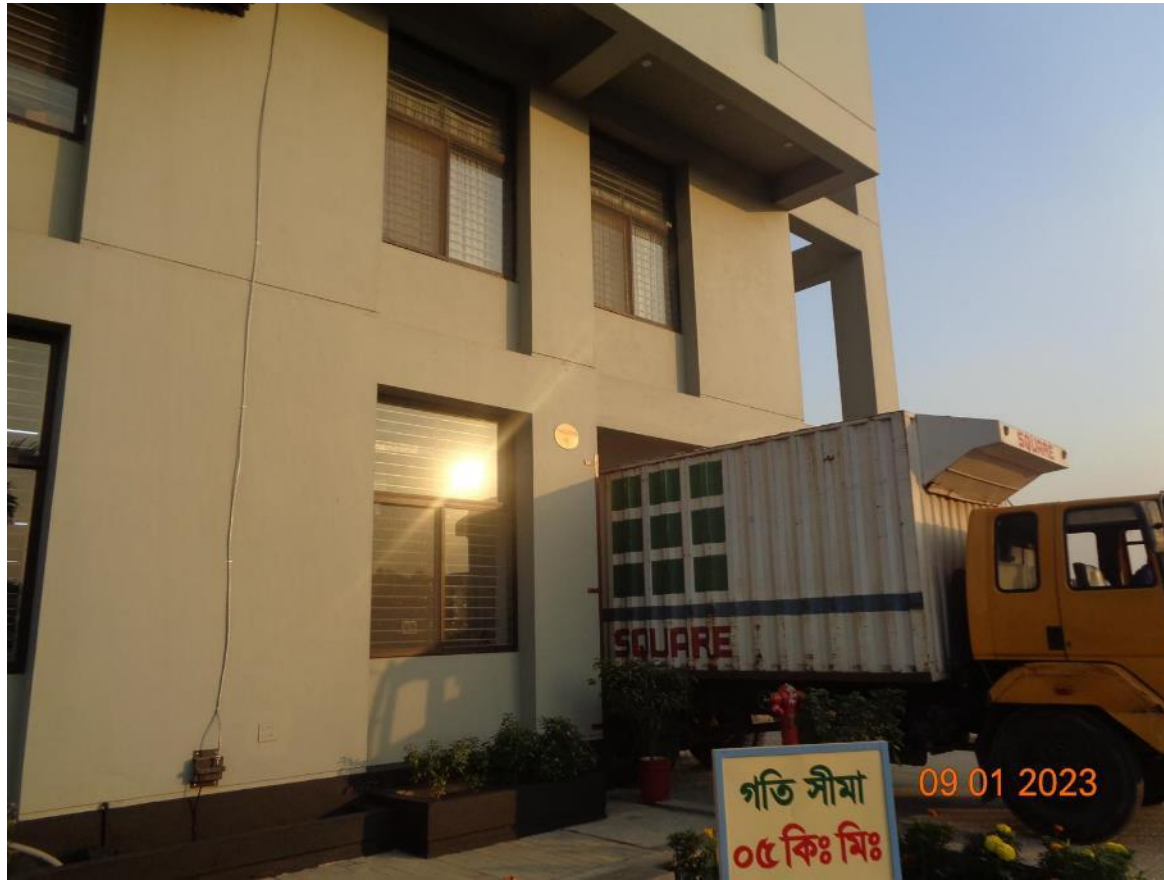
**Observation: Building-15**

**Column/beam susceptible to vehicle impact**

Possibility of vehicle impact in the column & beam of Building-15

Item 1: Column/beam susceptible to vehicle impact.

The factory is required to take proper measure to protect the building columns and beams from the possible vehicle impact.

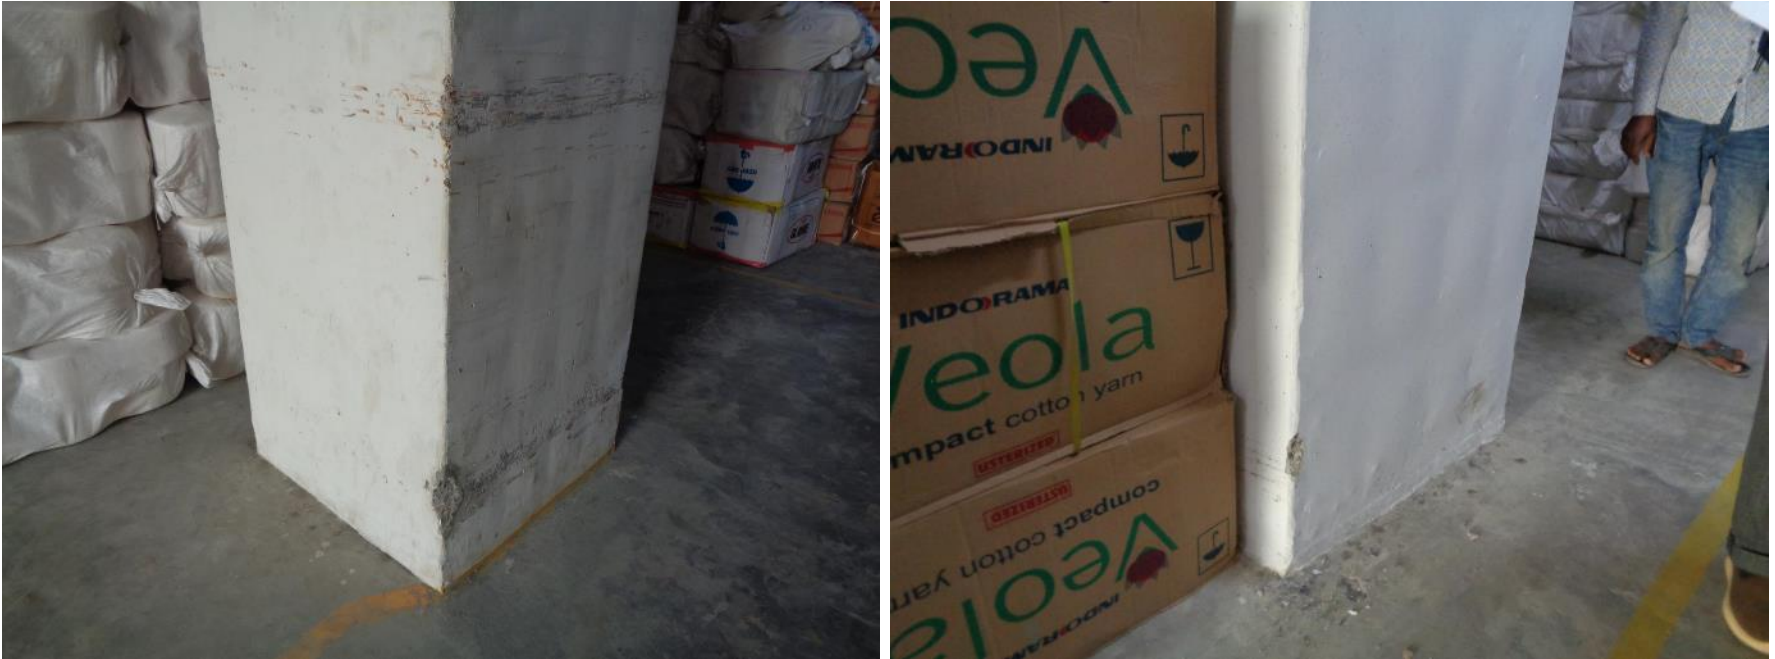
**Observation: Building-16**

Column damage due to trolley impact

Item 2: Column damage due to trolley impact.

Building engineer is required to repair the damage surface of the column and provide adequate protection system to resist trolley impact.

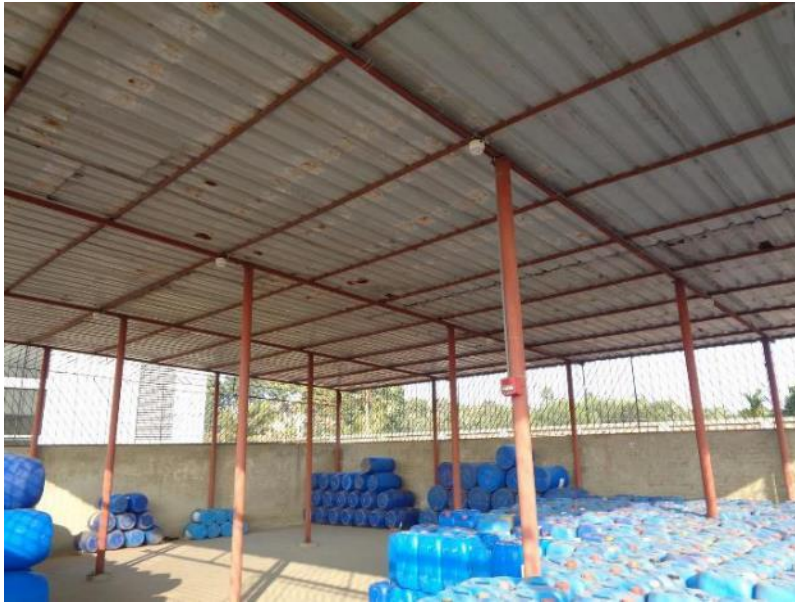
**Observation: Storage Shed**

Lateral load resisting system (bracing, compression strut) is absent

Item 3: Lack of lateral load resisting system.

The building engineer is required to carry out Engineering Assessment (EA) to check the lateral stability of the structure and prepare a set of design documents including structural drawings and design report. Submit the documents to RSC for review.

04	Lack of lateral load resisting system. (Storage Shed)	Carry out remedial action where required.	(6-months)

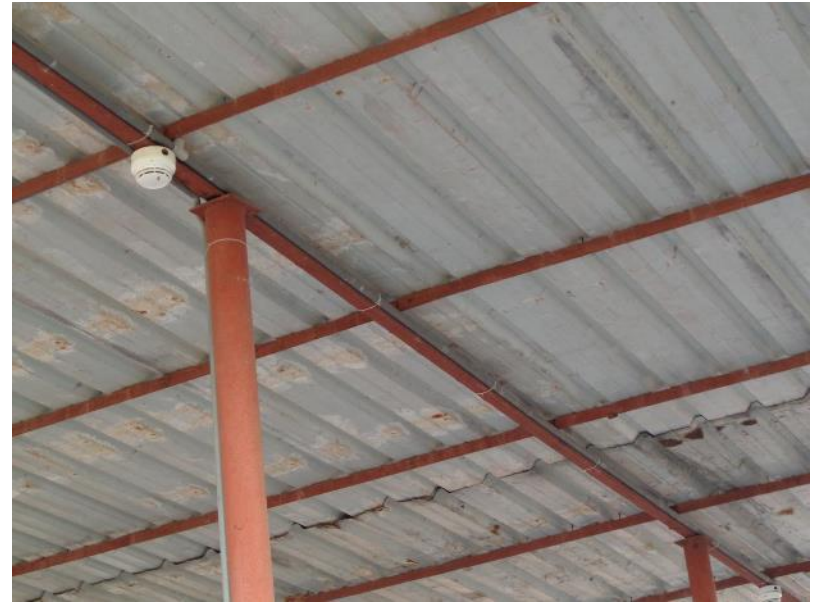
Apparently inadequate connections (minimum size of welding)

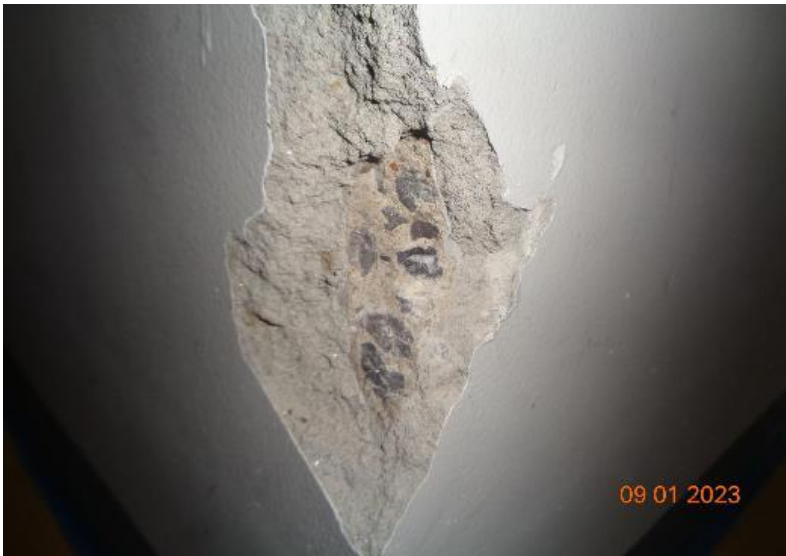
Stone aggregate in column of Building-15

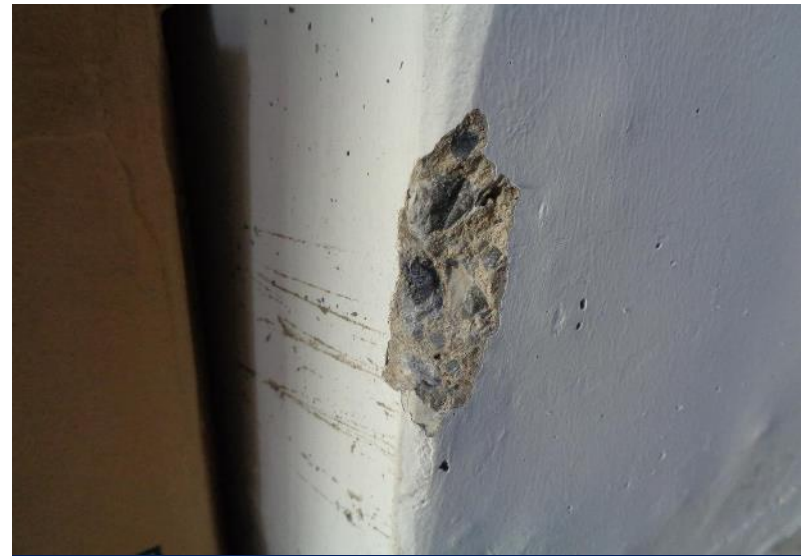
Brick aggregate in column of Building-16

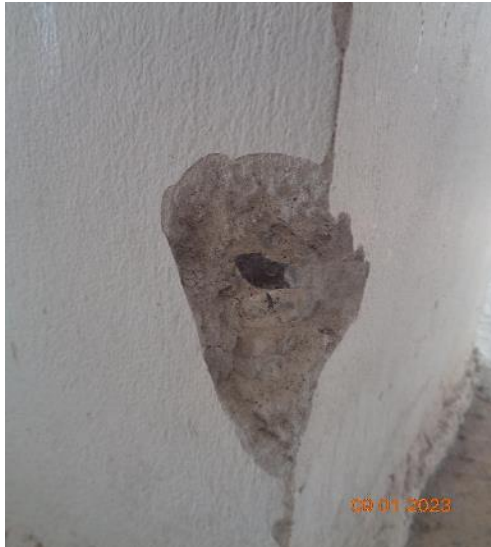
Stone aggregate in column of Building-17

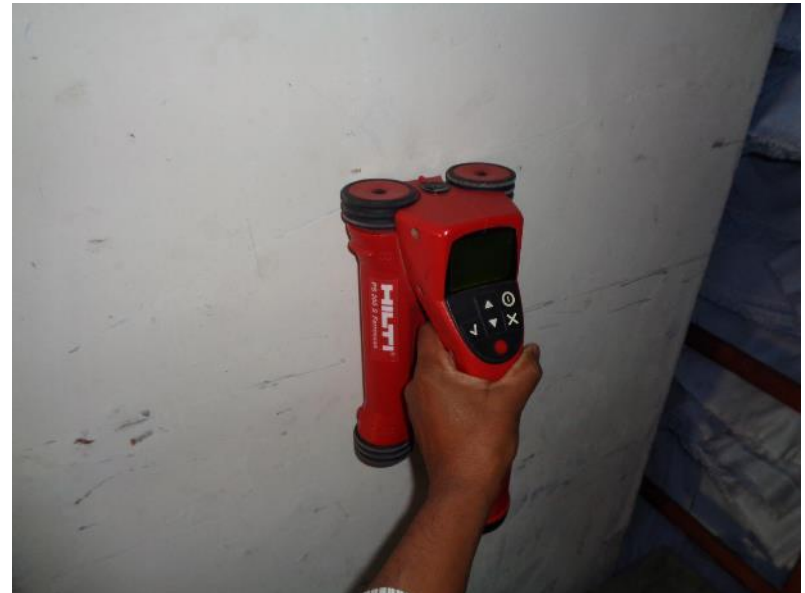
Rebar checked by ferro scanner
