# BABYLON CASUALWEAR LTD & ABONI FASHION (Extension)

Plot 23,24,25, Tetuljhora, Hemayetpur, Savar, Dhaka-1340.

30 January 2023

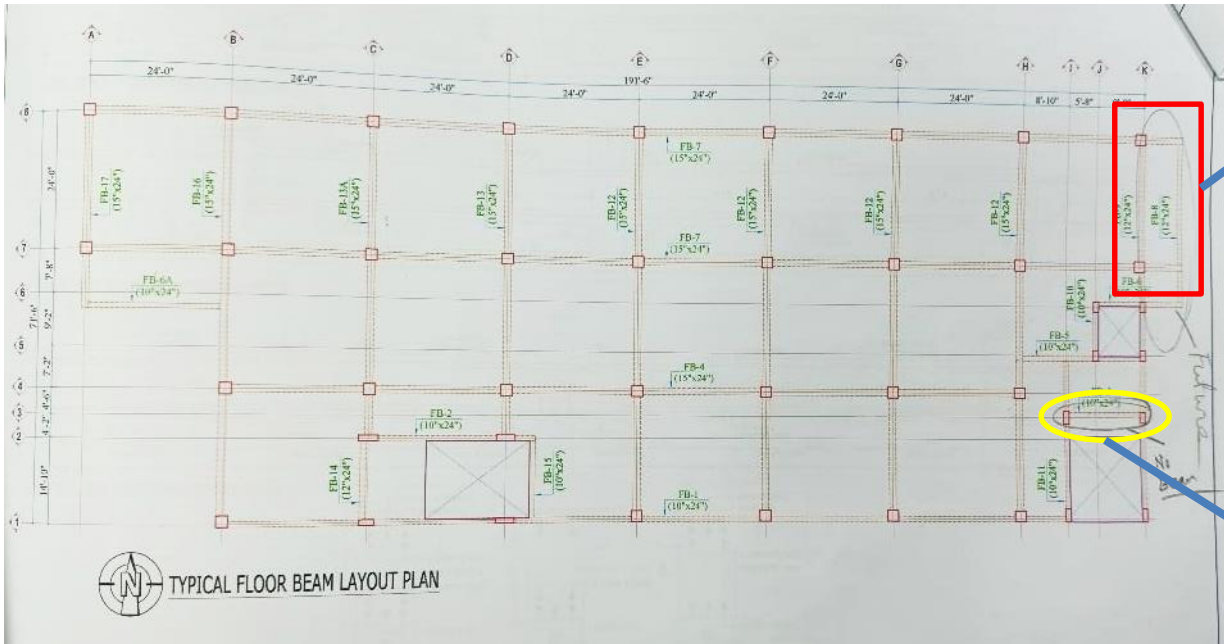
Typical Beam Layout

Beam at East side stair was not found. Also, cantilever portion of north-east corner has not been constructed as per drawings.

The building engineer is required to survey the whole structure and prepare accurate as-built drawings and submit to RSC.

| Item No. | Observation | Recommended Action Plan | Recommended Timeline |
|---|---|---|---|
| 01 | Mismatch in beam layout.<br>(6-Storied Production Building) | The building engineer is required to survey the whole structure and prepare accurate as-built drawings. | 6-weeks |

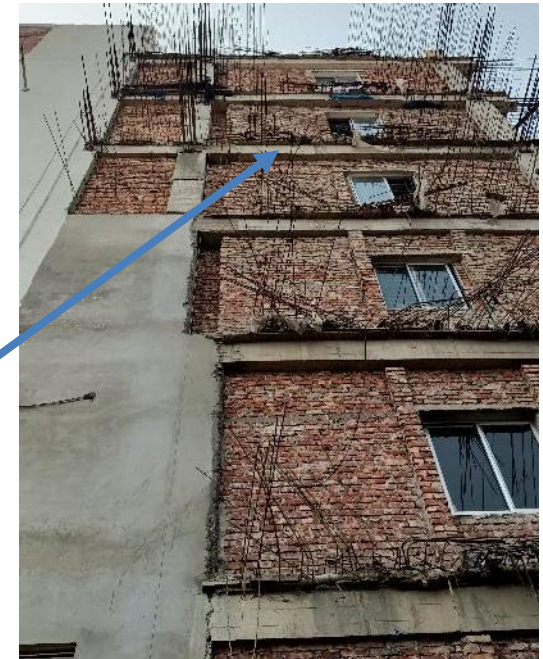
Cantilever not constructed

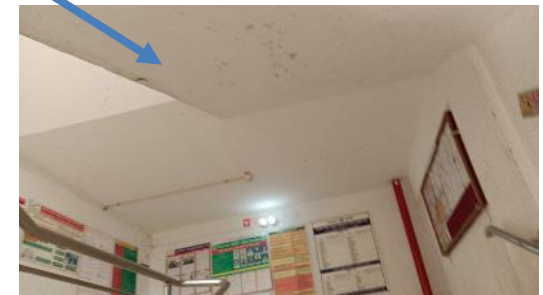
Missing beam at stair landing

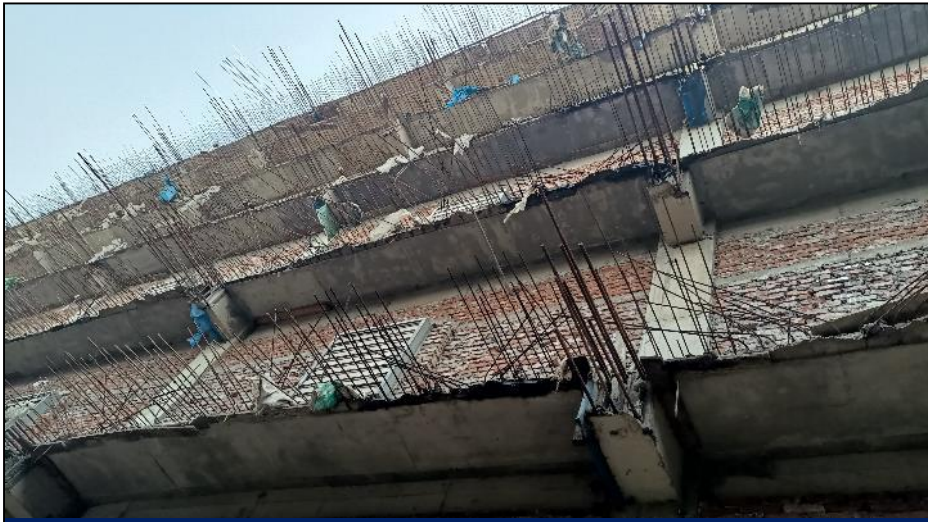
Exposed rebar kept at north side for horizontal extension

Exposed rebar was observed due to horizontal extension. In case of extension, building engineer to be carried out Detail Engineering Assessment (DEA) following BNBC provision.

| Item No. | Observation | Recommended Action Plan | Recommended Timeline |
|---|---|---|---|
| 02 | Possible horizontal extension.<br>(6-Storied Production Building) | In case of extension, building engineer to be carried out Detail Engineering Assessment (DEA) following BNBC provision. | 6-weeks |
| 03 | Possible horizontal extension.<br>(6-Storied Production Building) | Carry out remedial measures if required by DEA. | 6-months |

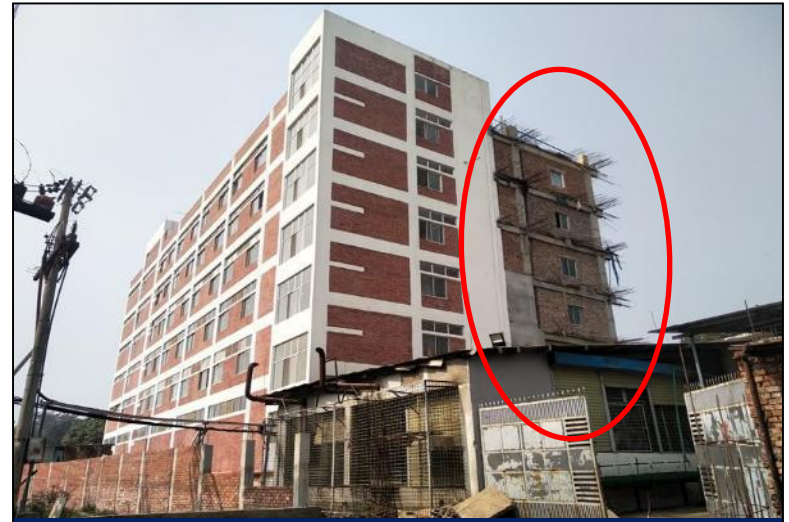
Exposed rebar kept at east side for horizontal extension

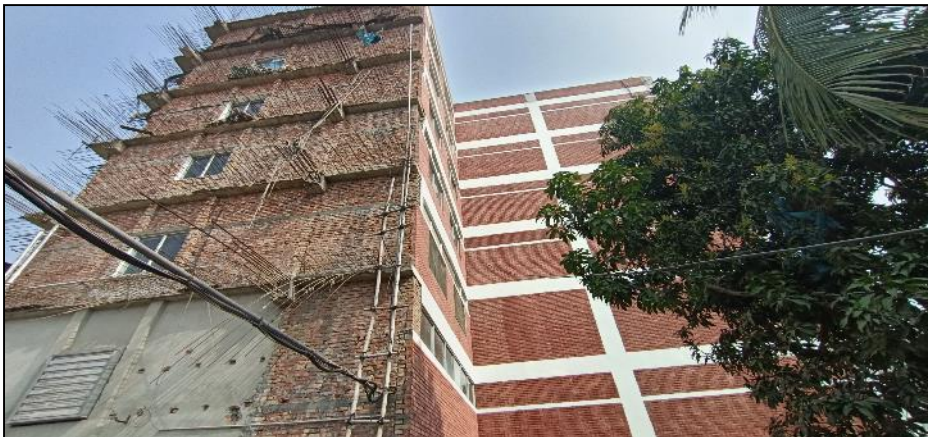
Exposed rebar kept at west side for horizontal extension

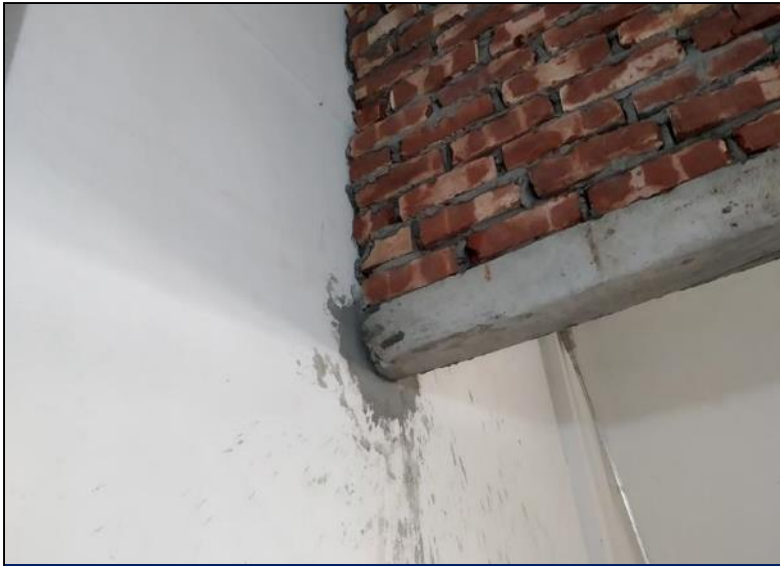
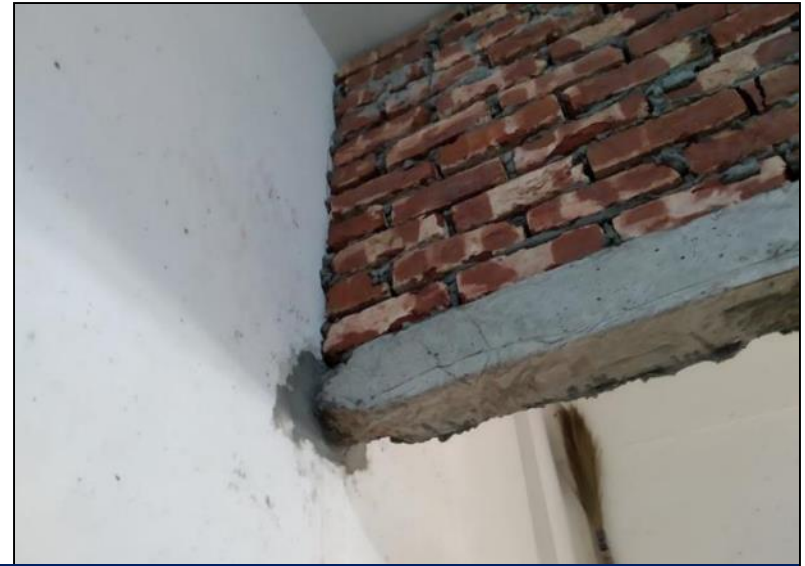
Inadequate lintel support at toilet zone

Inadequate lintel support was observed at the several locations especially at the RO plant and at the toilet access. Building engineer is required to take proper remedial measure to avoid any kind of falling hazard.

| Item No. | Observation | Recommended Action Plan | Recommended Timeline |
|---|---|---|---|
| 04 | Inadequate lintel support.<br>(6-Storied Production Building) | Building engineer is required to take proper remedial measure to avoid possible falling hazard. | 6-weeks |

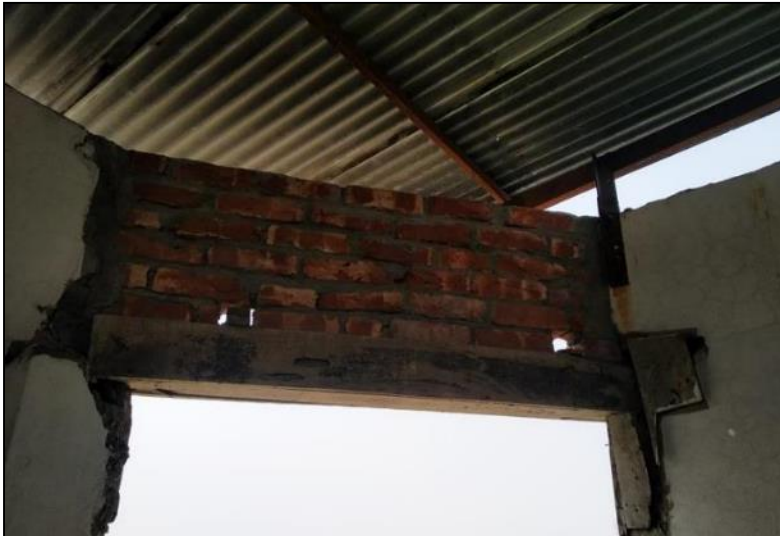
Inadequate lintel support at RO plant at roof level

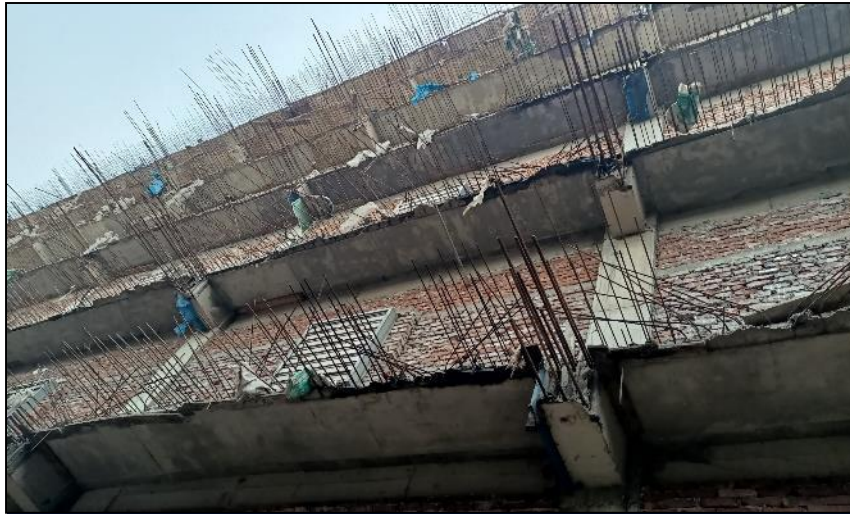
Exposed rebar at north side

Corrosion was observed at the exposed rebar of the production building. The factory is required to remove the corrosion and apply suitable corrosion resistance coating on the rebar.

| Item No. | Observation | Recommended Action Plan | Recommended Timeline |
|---|---|---|---|
| 05 | Corrosion in exposed rebar and steel member.<br>(6-Storied Production Building) | The factory is required to remove the corrosion and apply suitable corrosion resistance coating on the steel rebar & members. | 6-weeks |

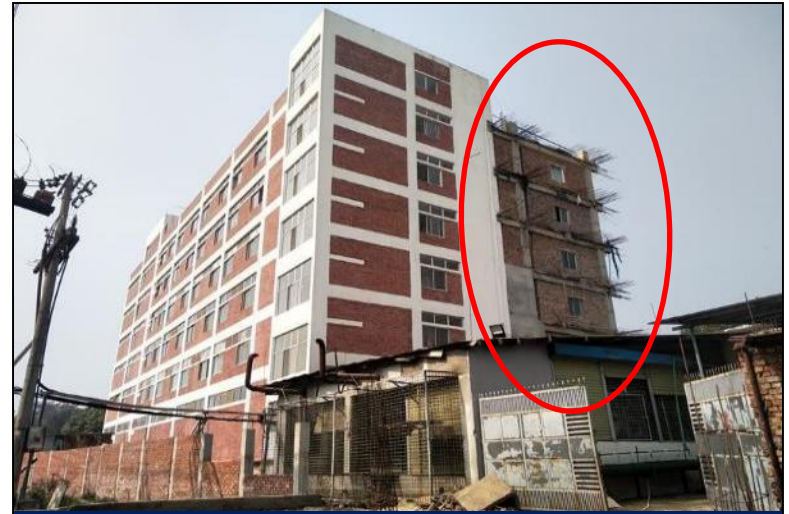
Exposed rebar at east side

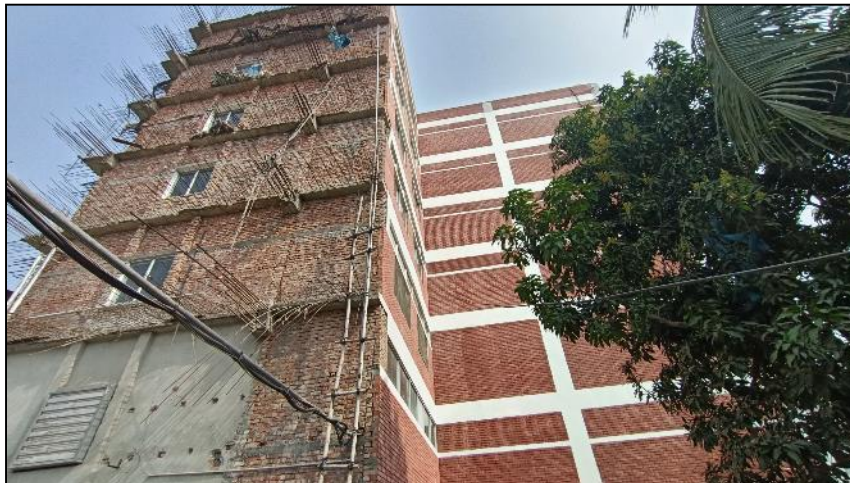
Exposed rebar at west side

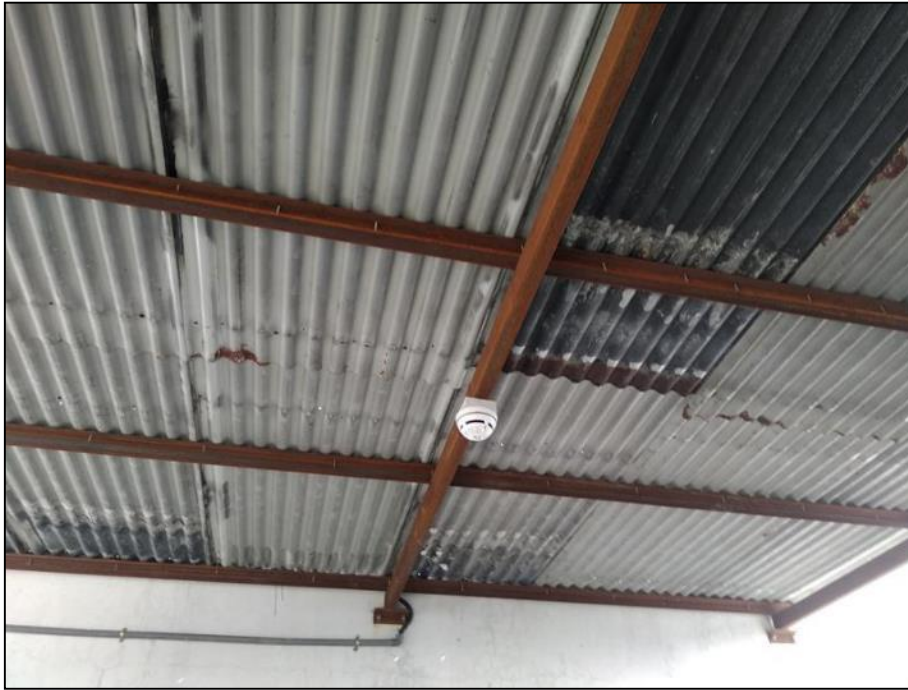
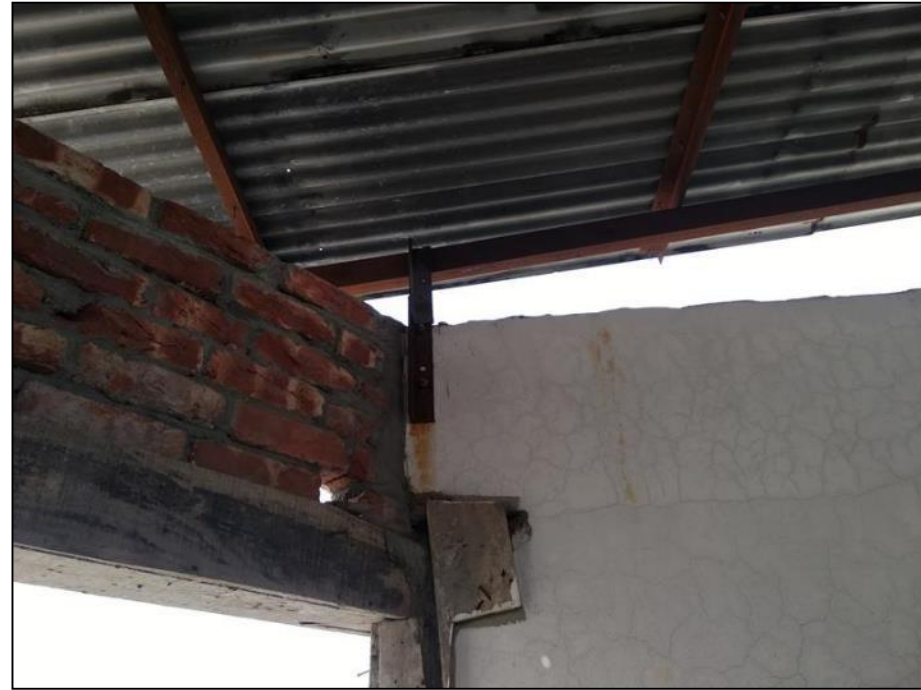
Corrosion in the steel members of the RO plant at rooftop.

Corrosion in the steel member was observed in the rooftop RO plant. The factory is required to remove the corrosion and apply suitable corrosion resistance coating to the steel members.

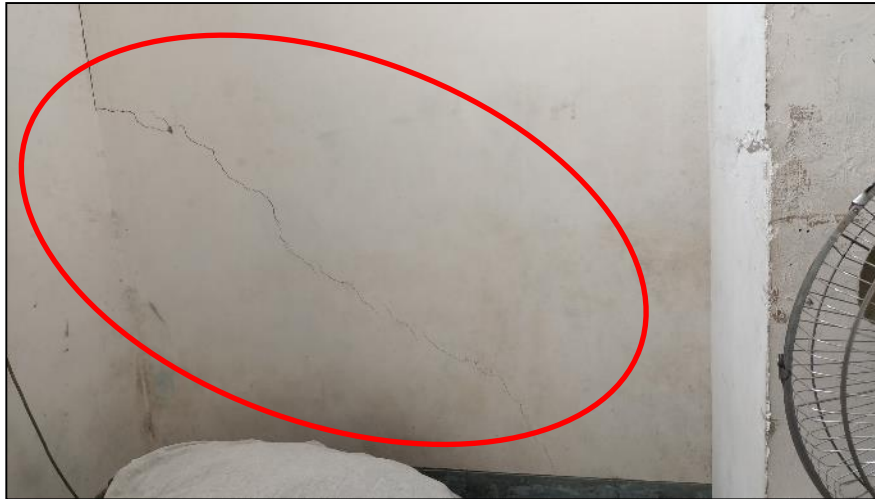
Crack at ground floor

Diagonal cracks at brick wall were observed at the ground floor and 5<sup>th</sup> floor of the building. Building engineer is required to prepare an investigation report to determine the reason of the cracks with proper remedial measures.

| Item No. | Observation | Recommended Action Plan | Recommended Timeline |
|---|---|---|---|
| 06 | Diagonal cracks on brick wall.<br>(6-Storied Production Building) | Building engineer is required to prepare an investigation report to determine the reason of the crack with proper remedial measures. | 6-weeks |

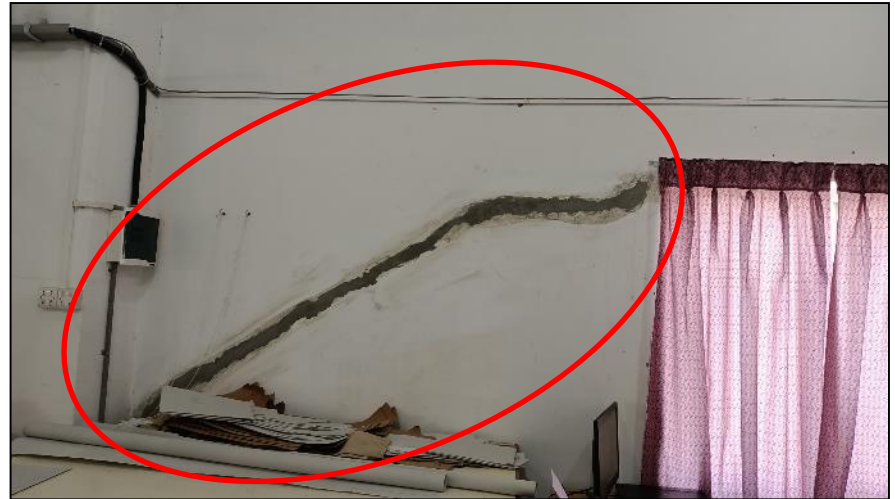
Crack at 5<sup>th</sup> floor

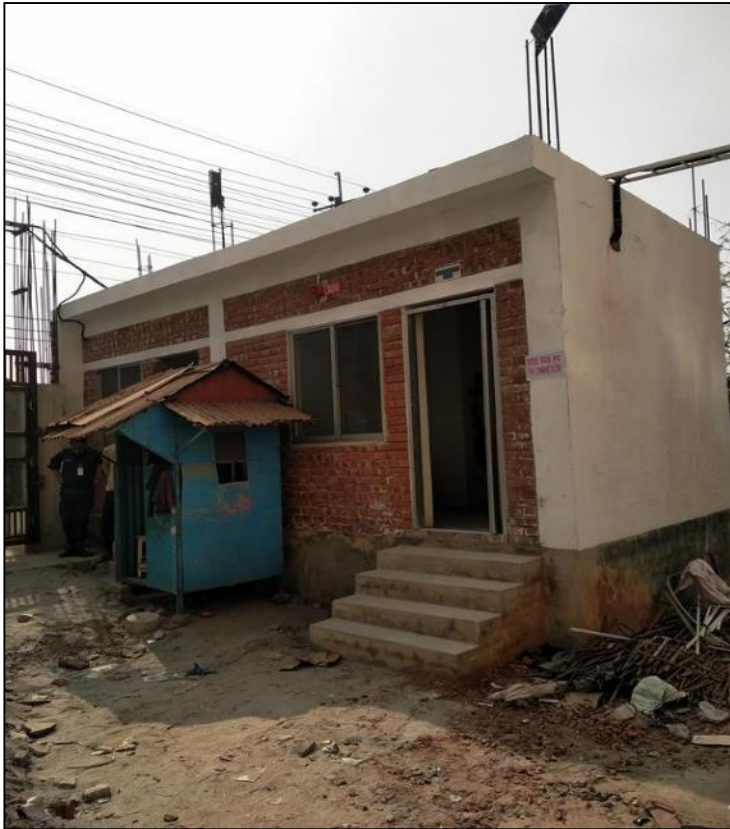
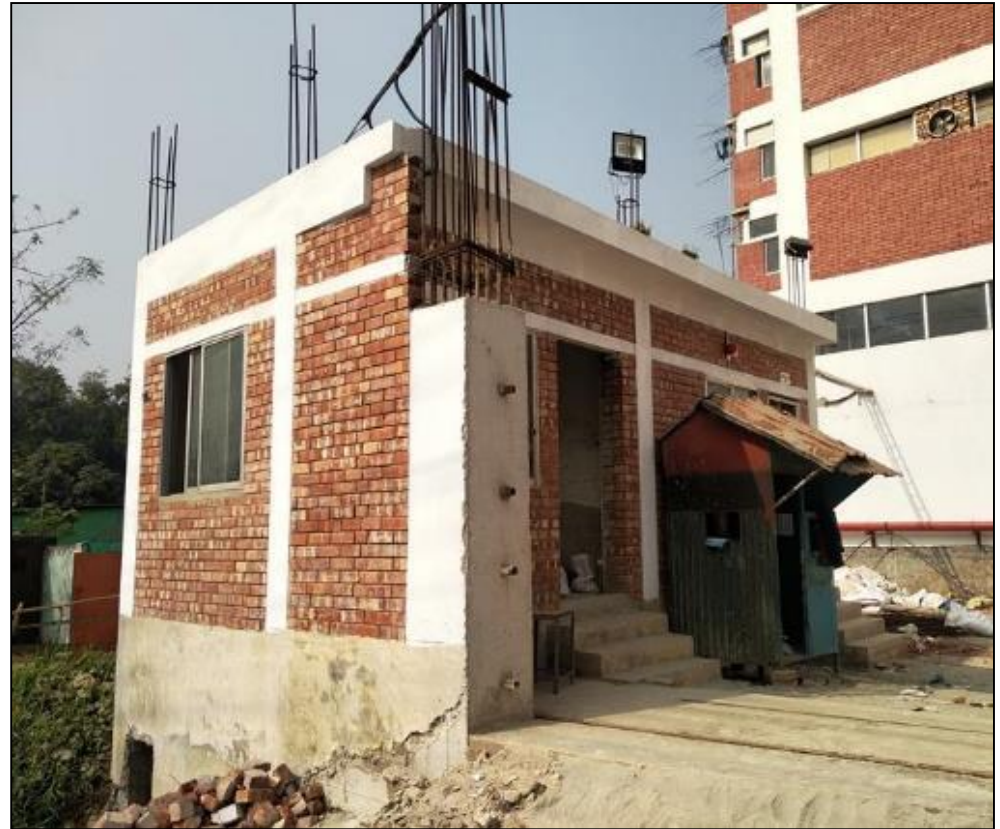
As-built drawing of the fire command room & security building was not available on-site.

As-built drawing was not found on-site. Building engineer is required to prepare an accurate as-built drawing.

| Item No. | Observation | Recommended Action Plan | Recommended Timeline |
|---|---|---|---|
| 07 | Absence of as-built drawing.<br>(Fire Command Room & Security Building) | Building engineer is required to prepare an accurate as-built drawing. | 6-weeks |

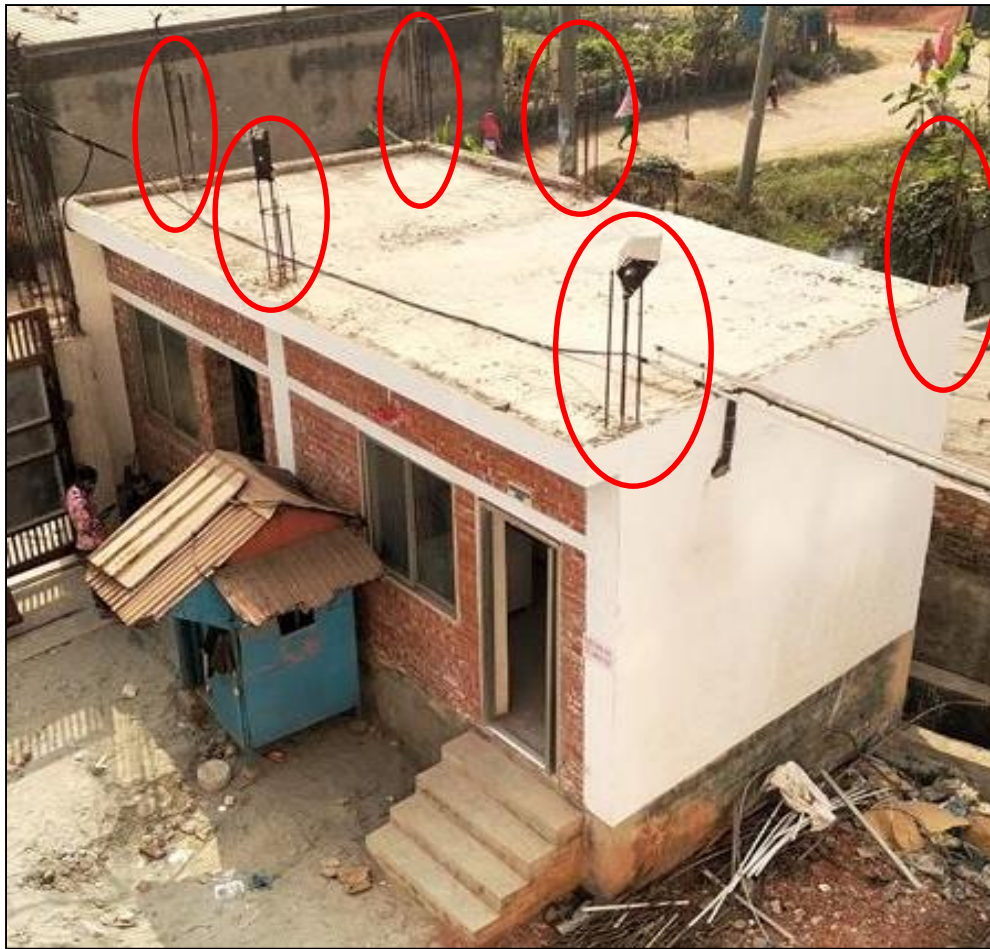
Exposed rebar at rooftop

Exposed rebar was observed at the rooftop of the building. Building engineer is required to take proper measure to protect the exposed rebar from corrosion.

| Item No. | Observation | Recommended Action Plan | Recommended Timeline |
|---|---|---|---|
| 08 | Exposed rebar at rooftop.<br>(Fire Command Room & Security Building) | Building engineer is required to take proper measure to protect the exposed rebar from corrosion. | 6-weeks |
