# ELECTRICAL SAFETY INSPECTION REPORT

## ESSENTIAL CLOTHING LTD. (EXTENSION)

**Inspected on:** January 23, 2023

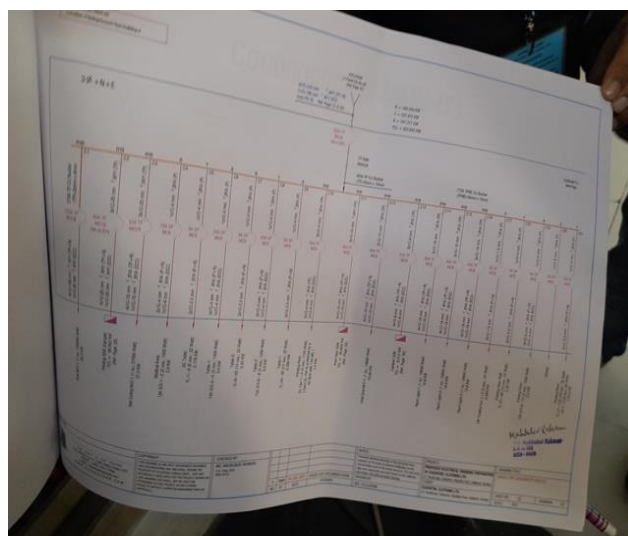
| <b>FINDING NO:</b> | <b>E - 1</b> |

| <b>FINDING:</b> | Field information has less reflection in existing SLD. |

| <b>RECOMMENDATION:</b> | Draw as built electrical SLD mentioning all required information by qualified engineer and get it reviewed by RSC. Electrical SLD must be updated properly when electrical system is modified. |

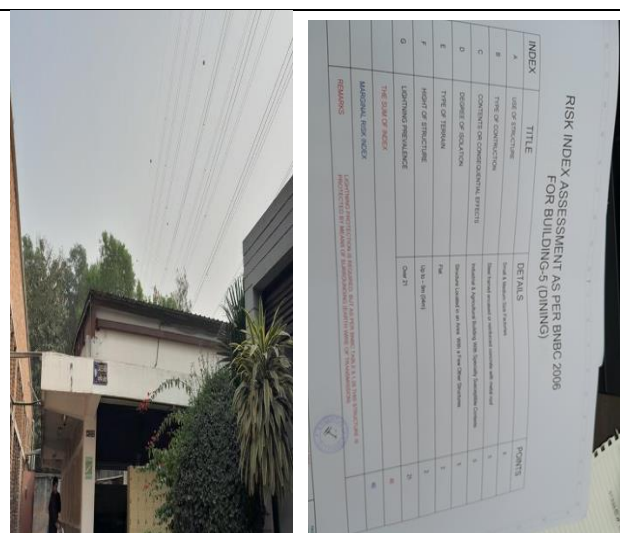
| <b>FINDING NO:</b> | <b>E - 2</b> |

| <b>FINDING:</b> | Zone protection Calculation of Lightning Protection System is not mentioned for Dinning Shed. |

| <b>RECOMMENDATION:</b> | Factory shall calculate the Zone protection calculation for dinning shed and LPS is designed properly, installation must be done accordingly if required or keep the updated drawing in factory for next follow-up. |
