# FIRE SAFETY INSPECTION REPORT

## Essential Clothing Ltd. (Extension)

Factory ID: 24541

Date: 23 January 2023

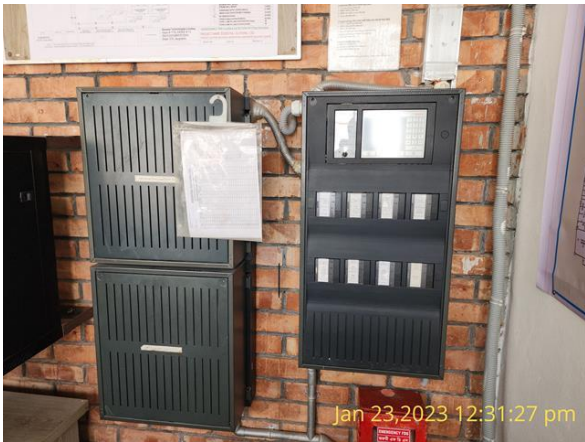
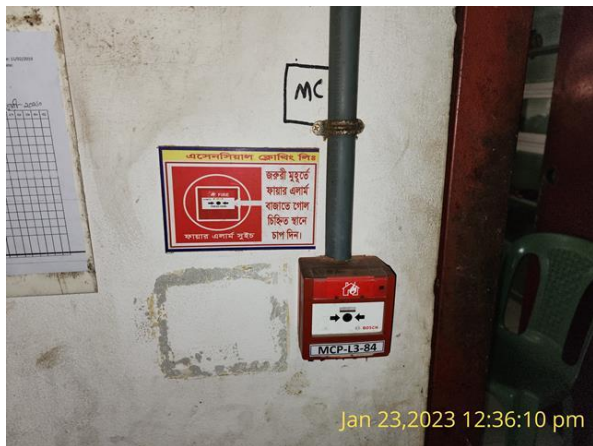
| No. | Category | Finding | Recommendation | Remediation Timeframe |
|---|---|---|---|---|
| F-1 | Fire Protection | The fire alarm & detection system installation requires detailed review to confirm compliance with NFPA 72 and RSC standard. | Submit as-built drawings, testing records, equipment certification and other relevant documentation to the RSC for review and then approval/acceptance test. | Within 4 months |

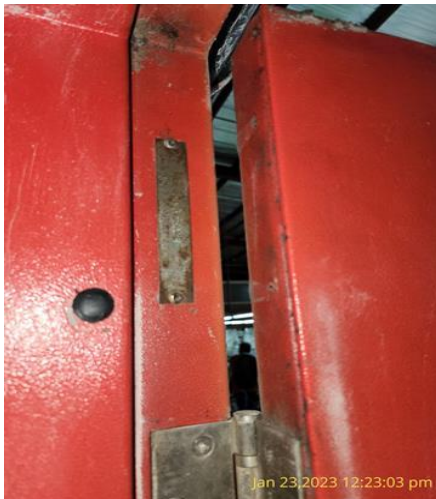
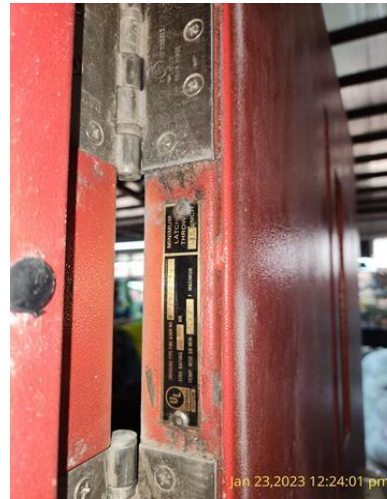
| No. | Category | Finding | Recommendation | Remediation Timeframe |
|---|---|---|---|---|
| F-2 | Fire Rated Construction | Rooms used for combustible storage and diesel storage is separated by 2-hr fire rated doors however certification number not found in the label. | Provide dedicated storage rooms separated by minimum 1-hr fire-rated construction. | Within 3 months |

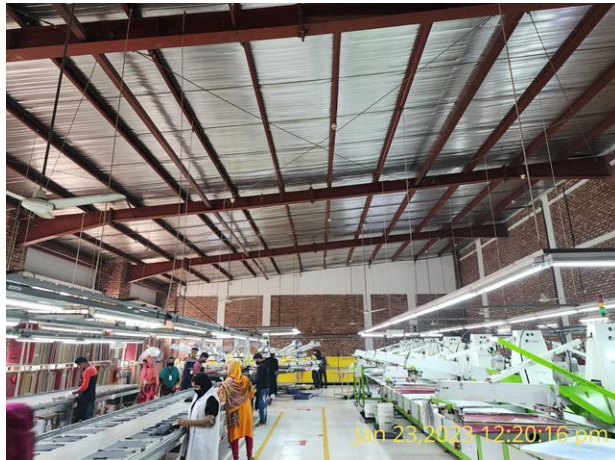
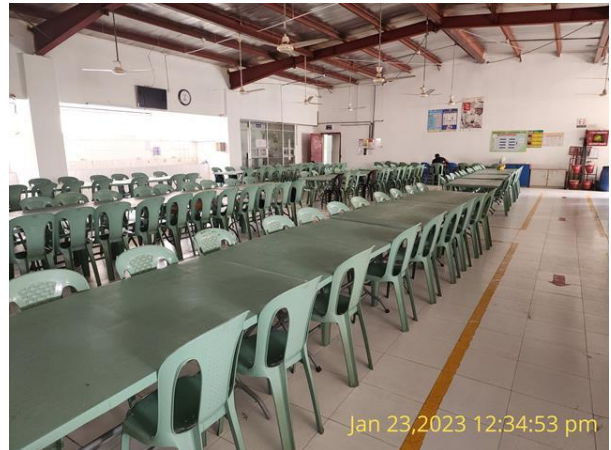
| F-4 | Fire rated Construction | The factory sheds is steel construction which appears to be nonrated and were found in exposed condition.<br>(Construction date was Jan 2016 – Feb 2017, thus the interim building shall meet BNBC 2006) (Building 4 and 5) | Interim construction shall be Type-1 or Type-2 construction in accordance with RSC standard 3.5.2.1 and BNBC-2006 Part-2, Table-3.2.4.<br>Ensure fire resistive rated construction following Section 4.4 and Table 4.4.1 of the RSC Standard or Table 3.3.1 and Table 4.1.1 from BNBC-2006 Part 4.<br>Consult a qualified fire protection engineer to achieve the required fire rating.<br><br>Chemical storage shall be Type-1 construction.<br>(Building 4) | Within 6 months |

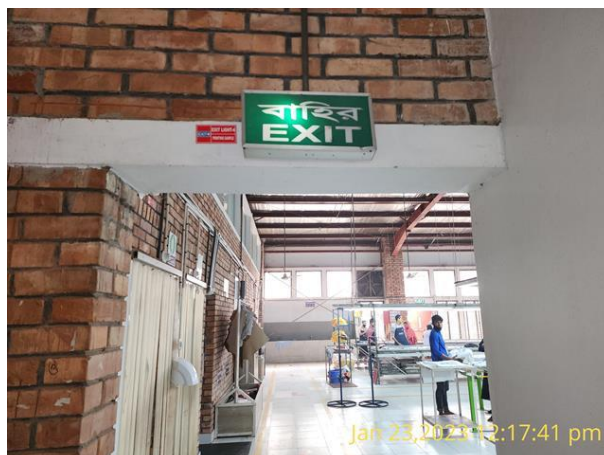
| F-6 | Egress Lighting | Exit signs were placed in areas that were not exits. | Remove exit signs (double sided) from noted areas to avoid confusion from actual exits. | Within 1 month |
