# Essential Clothing Ltd. (Extension)

Akulichala, Sakashor, Maddha Para, Kaliakoir Gazipur, Dhaka, Bangladesh.

23 January 2023

# Observations

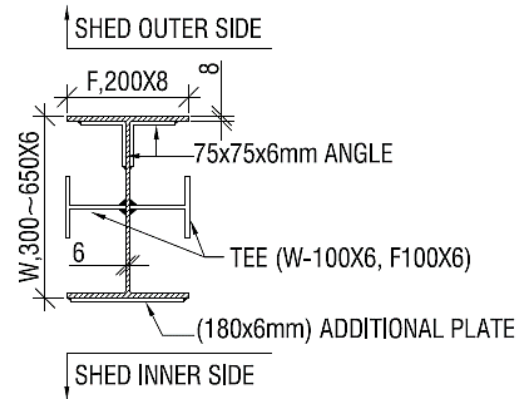
**DETAILS OF STEEL COLUMN (SC1A)  
MEZZANINE FLOOR TO ABOVE LEVEL**

The factory conducted retrofitting with some irregular sections which are modeled with equivalent sections in the analysis software. During inspection Engineering Assessment (EA) report was available onsite. The factory is required to submit the EA report to the RSC for detail review.

| Item No. | Observation | Recommended Action Plan | Recommended Timeline |
|---|---|---|---|
| 01 | Retrofitting design requires detail review (Building-4). | <ul style="list-style-type: none"> <li>The factory is required to submit the Engineering Assessment (EA) to the RSC for detail review.</li> </ul> | (6-weeks) |

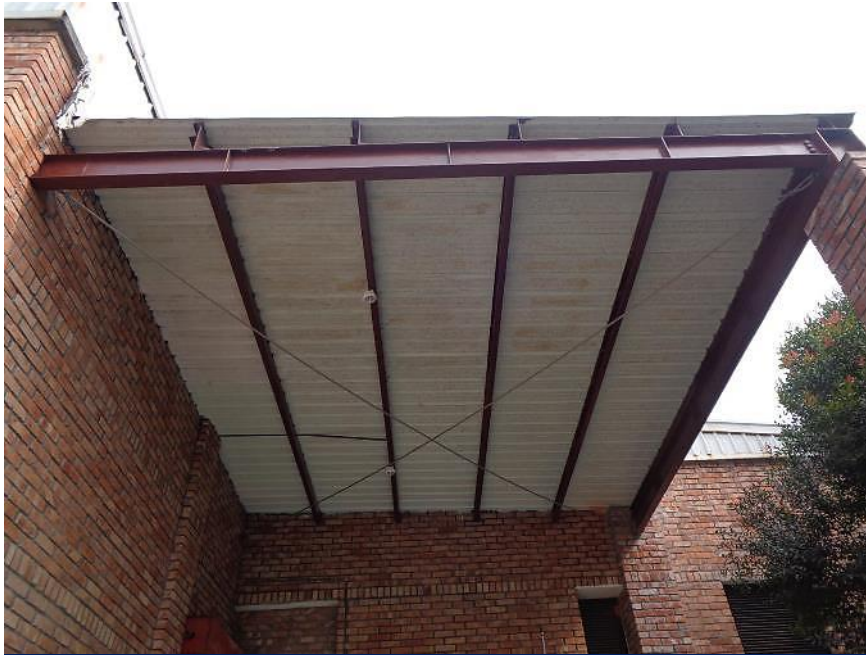
The rafter of loading-unloading zone

The flange of RF6 rafter was measured 100 mm instead of 150 mm.  
The building engineer is required to survey the structures and prepare accurate as-built drawings and submit to RSC.

| Item No. | Observation | Recommended Action Plan | Recommended Timeline |
|---|---|---|---|
| 03 | Mismatch between as-built drawing and onsite conditions (Building-4). | <ul style="list-style-type: none"> <li>The building engineer is required to prepare accurate as-built drawings and submit to RSC.</li> </ul> | (6-weeks) |

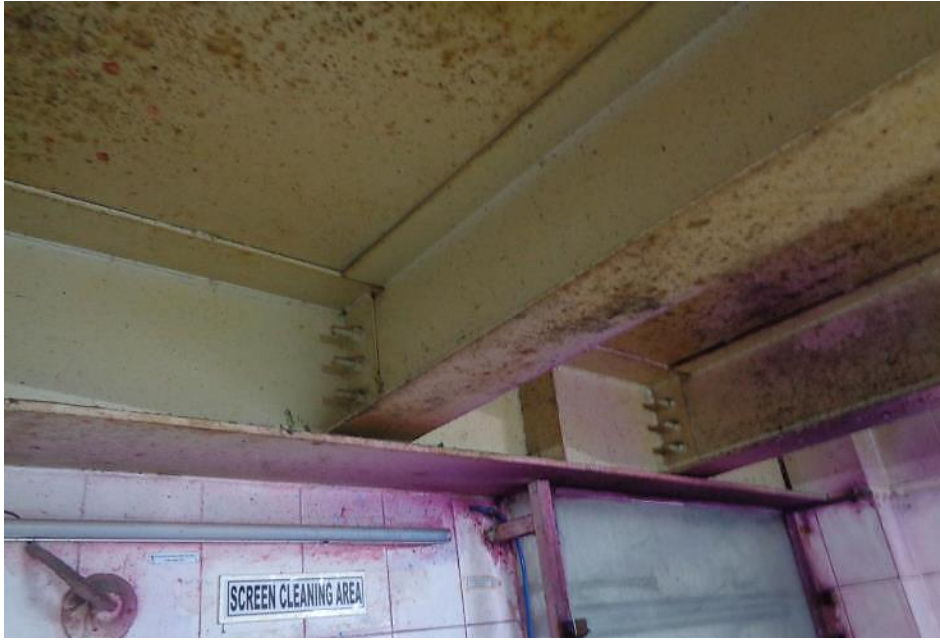
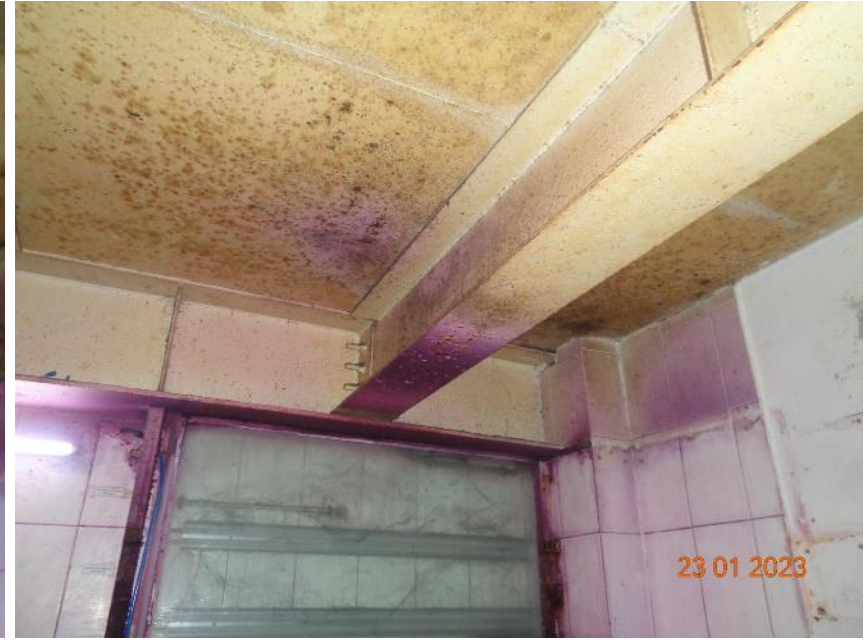
Appearance of corrosion in steel members

The factory is required to remove the corrosion and apply suitable corrosion resistance coating to the steel members.

| Item No. | Observation | Recommended Action Plan | Recommended Timeline |
|---|---|---|---|
| 04 | Corrosion in steel members (Building-4). | The factory is required to remove the corrosion and apply suitable corrosion resistance coating to the steel members. | (6-weeks) |

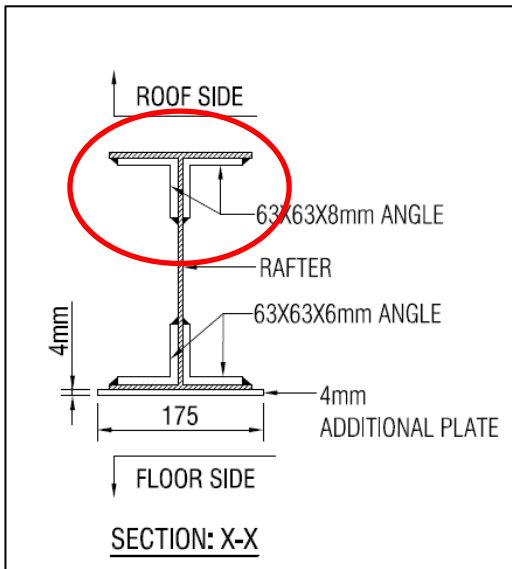
## Retrofitting Rafter Section

As per retrofitting scheme, additional angle section was required to be added both up & down sides of the steel rafter, but angle section added only to the downside rafter. The building engineer is required to check the adequacy of the current steel rafter and update the EA documents accordingly.

| Item No. | Observation | Recommended Action Plan | Recommended Timeline |
|---|---|---|---|
| 05 | Mismatch between retrofitting drawing and onsite conditions (Building-5). | The building engineer is required to prepare accurate retrofitting drawings, check the design and submit the design documents (EA & retrofitting drawings) report to the RSC for detail review. | (6-weeks) |

| Item No. | Observation | Recommended Action Plan | Recommended Timeline |
|---|---|---|---|
| 06 | Mismatch between retrofitting drawing and onsite conditions (Building-5). | Carry out remedial action if required. | (6-months) |

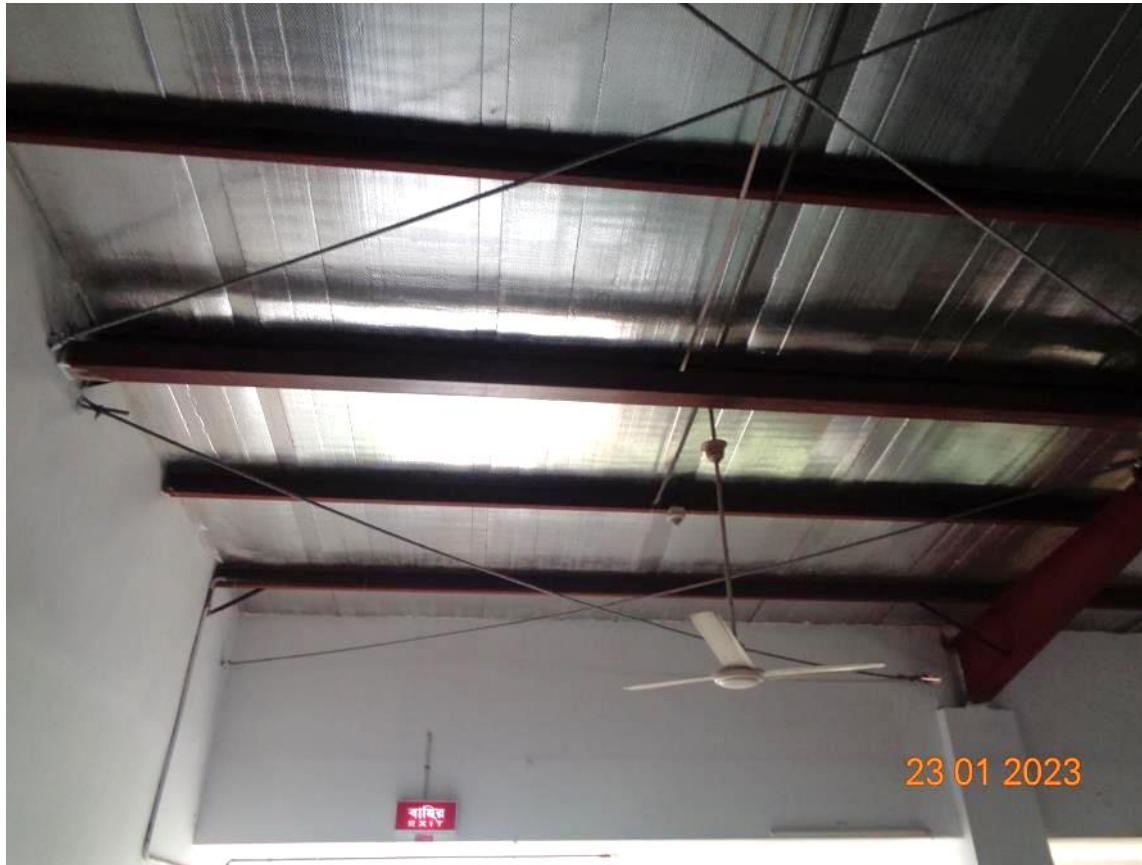
Loose cable bracing at roof.

The factory is required to tighten the loose bracings.

| Item No. | Observation | Recommended Action Plan | Recommended Timeline |
|---|---|---|---|
| 07 | Loose cable bracings at roof (Building-5). | <ul style="list-style-type: none"> <li>The factory is required to tighten the loose bracings.</li> </ul> | (6-weeks) |

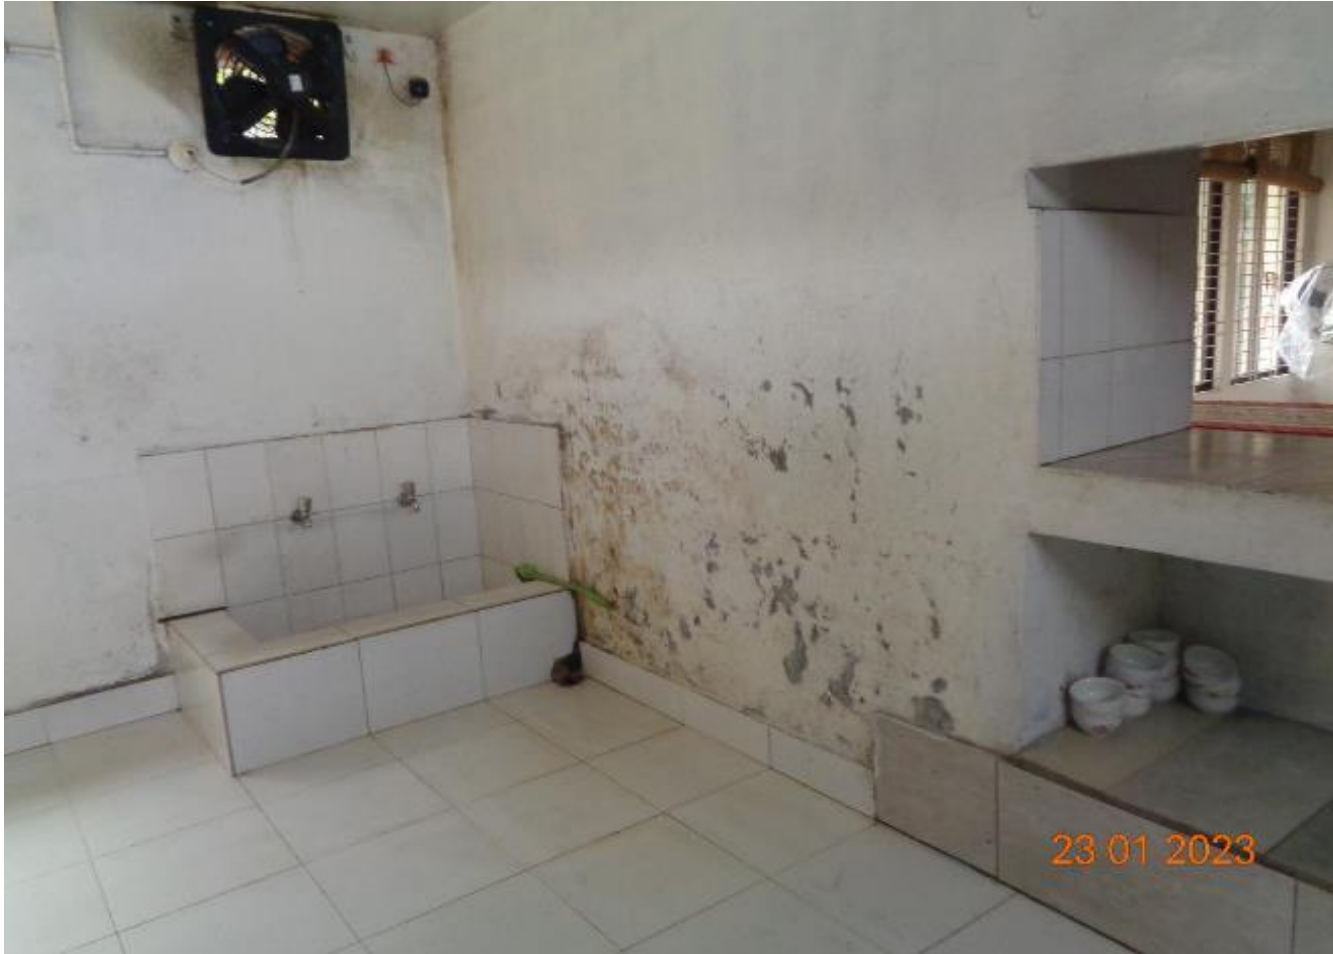
Dampness observed on RC portion of Dinning Shed. The factory is required to seal the source of water and repair the damp areas with the suggestion of building engineer.

| Item No. | Observation | Recommended Action Plan | Recommended Timeline |
|---|---|---|---|
| 08 | Dampness on brick walls (Building-5). | <ul style="list-style-type: none"> <li>The factory is required to seal the source of water intrusion and repair the damp areas with the suggestion of building engineer.</li> </ul> | (6-weeks) |

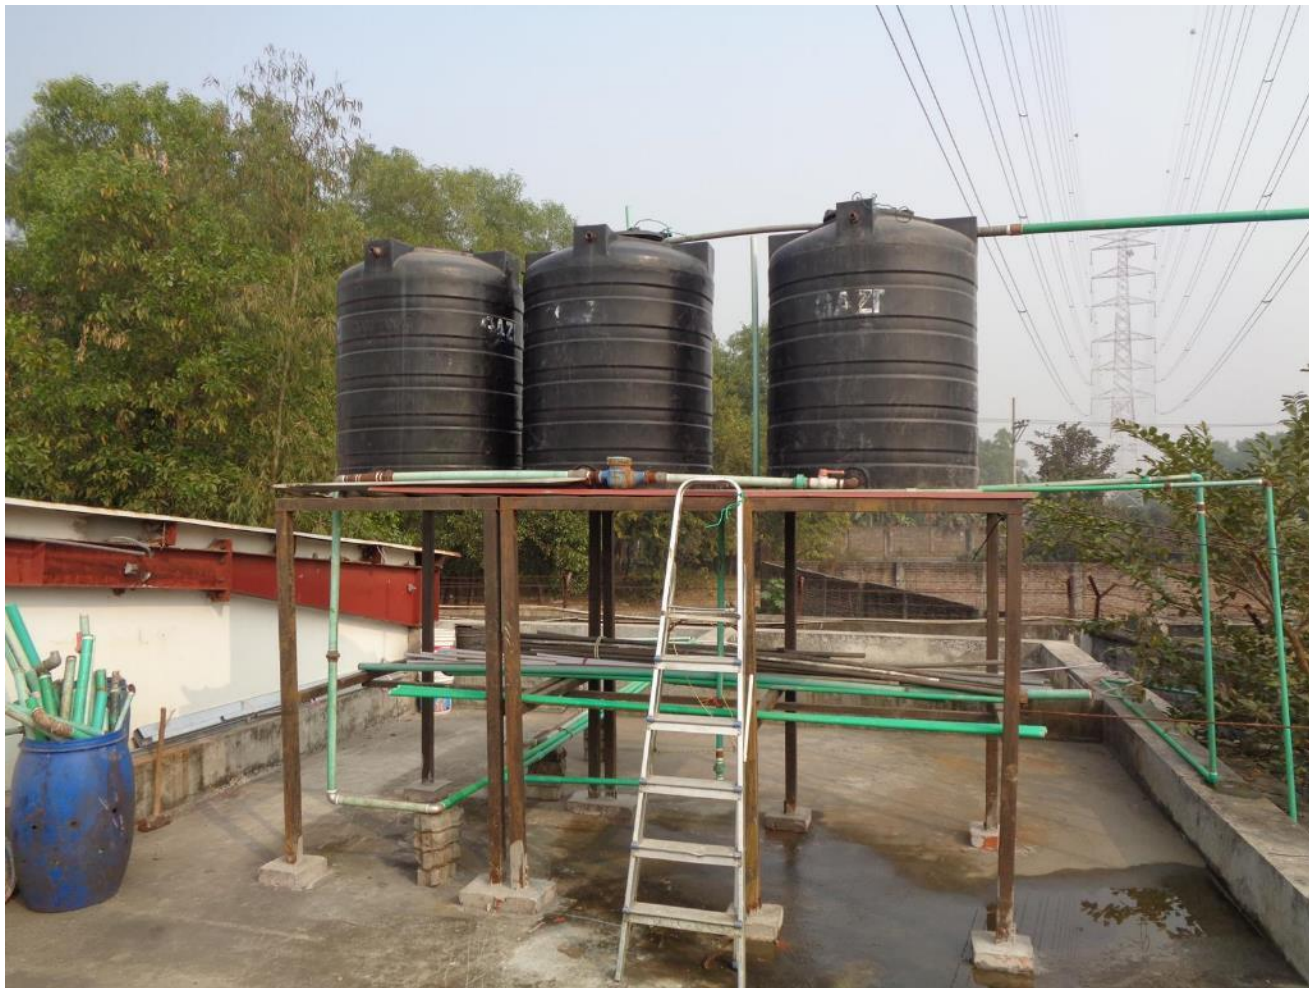
Unbraced plastic water tanks on roof

The factory is required to provide necessary bracing to the steel platform and plastic water tanks with the suggestion of building engineer.

| Item No. | Observation | Recommended Action Plan | Recommended Timeline |
|---|---|---|---|
| 09 | Unbraced rooftop water tanks (Building-5). | <ul style="list-style-type: none"> <li>The factory is required to provide necessary bracing to the steel platform and plastic water tanks with the suggestion of building engineer.</li> </ul> | (6-weeks) |

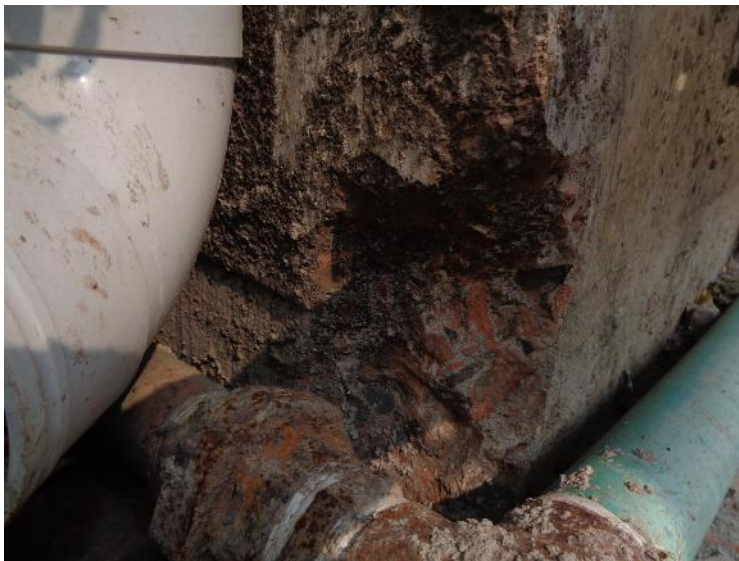
Brick aggregate in column of Building-4

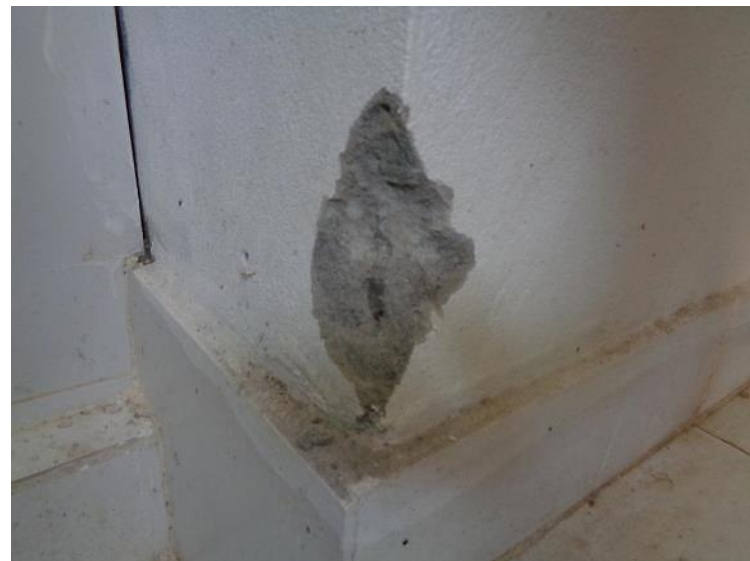
Stone aggregate in retrofitting column  
of Building-5

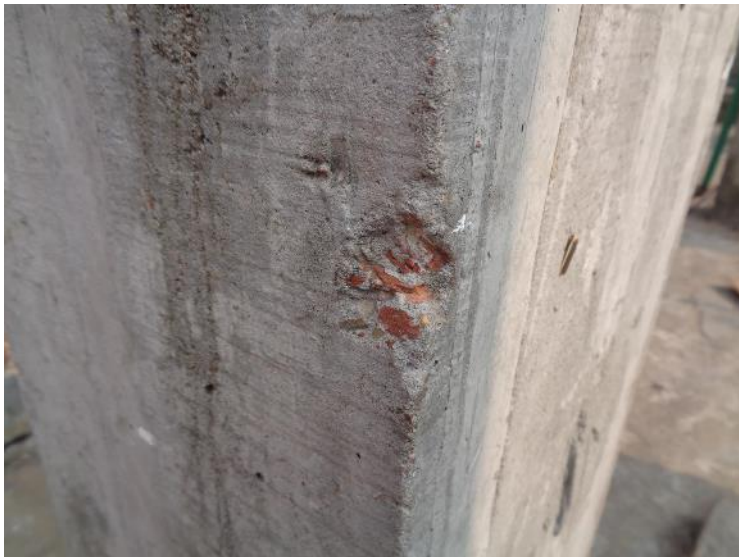
Brick aggregate in column of Building-13

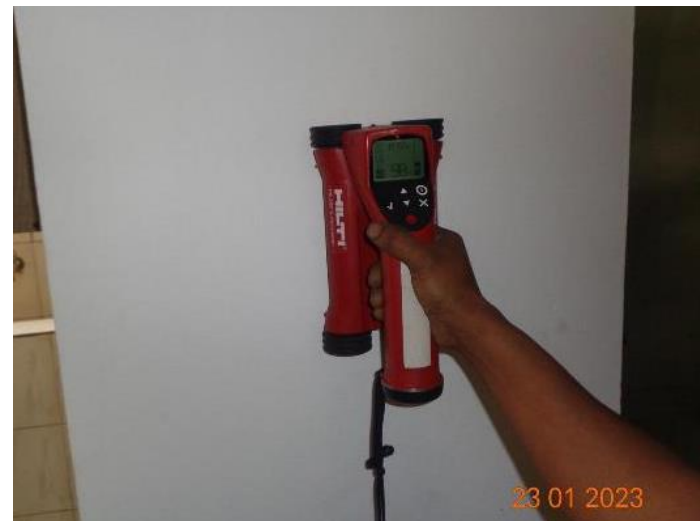
Rebar checked by ferro scanner
