Well Lord Knitwears Ltd.

## Preliminary Factory Safety Inspection

### Electrical Safety Assessment Report for Well Lord Knitwears Factory

Issue | May 9, 2018

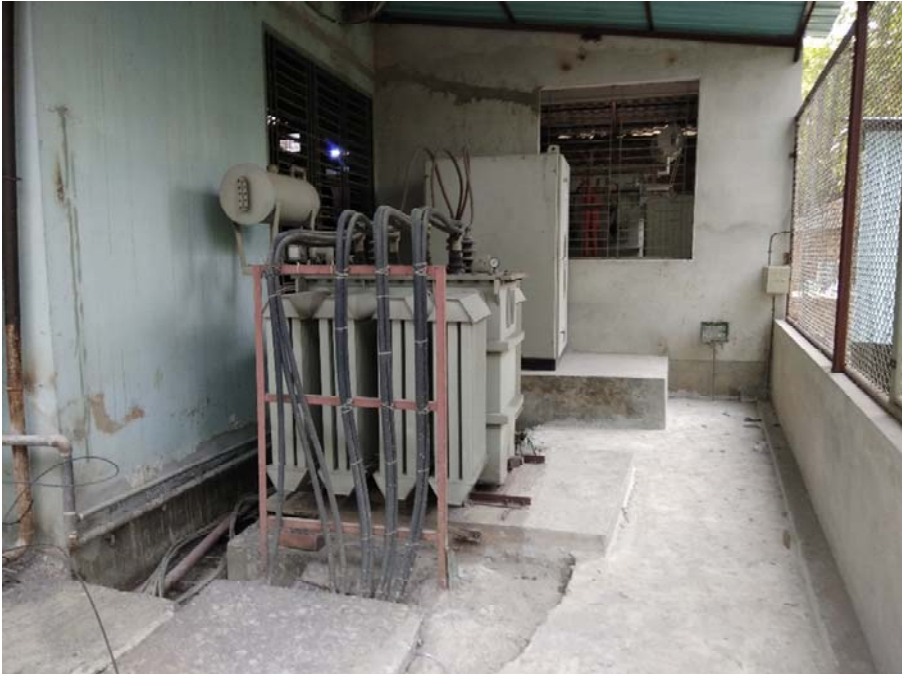
| Ref No. | Issue Type | Sub-header |
|---|---|---|
| E-1 | Distribution | Exposed live part |

| Ref No. | Issue Type | Sub-header |
|---|---|---|
| Observation:<br>The transformer live part are exposed, there is no locked fencing around transformer. | | |
| Figure 7 Exposed live terminals of transformer. | | |

| Item No | Accord Inspection Observation | Accord Action Plan | Accord Timeline |
|---|---|---|---|
| E-1 Distribution | The transformer live part are exposed, there is no locked fencing around transformer. | The live part of the transformer terminal must be enclosed inside an enclosure. The transformer room must have controlled access, so that no authorized person can enter into the transformer area | Immediate |

| Ref No. | Issue Type | Sub-header |
|---|---|---|
| The live part of the transformer terminal must be enclosed inside an enclosure. The transformer room must have controlled access, so that no authorised person can enter into the transformer area. | | |

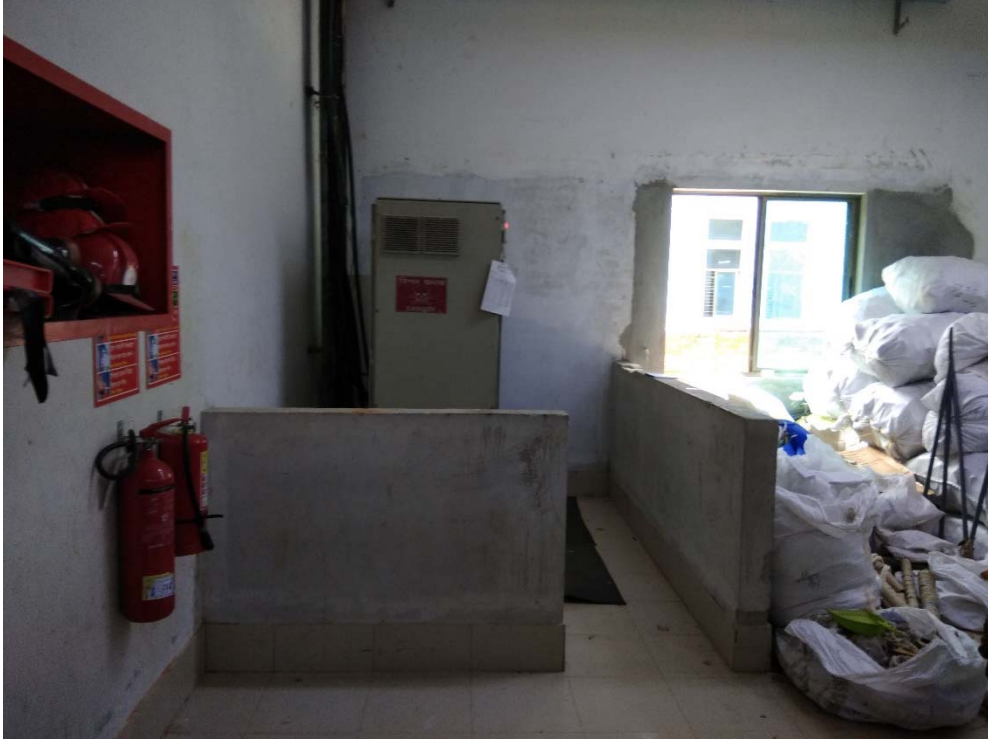
| Ref No. | Issue Type | Sub-Header |
|---|---|---|
| E-2 | Distribution | Flammable material storage |

| Ref No. | Issue Type | Sub-Header |
|---|---|---|
| <p>Observations:</p> <p>Exposed main electrical panel, no restricted access. Combustible material Storage near main LT panel.</p> | | |
| <p>Figure 8 Exposed main Electrical panels and storage.</p> | | |

| Item No | Accord Inspection Observation | Accord Action Plan | Accord Timeline |
|---|---|---|---|
| E-2 Distribution | Exposed main electrical panel, no restricted access. Combustible material Storage near main LT panel | The main LT panel shall be provided with dedicated room and shall have controlled access to this room. The storage near main LT panel shall be removed and shall be kept in a dedicated store rooms. | Within 1 Month |

| Ref No. | Issue Type | Sub-Header |
|---|---|---|
| <p>The main LT panel shall be provided with dedicated room and shall have controlled access to this room. The storage near main LT panel shall be removed and shall be kept in a dedicated store rooms.</p> | | |

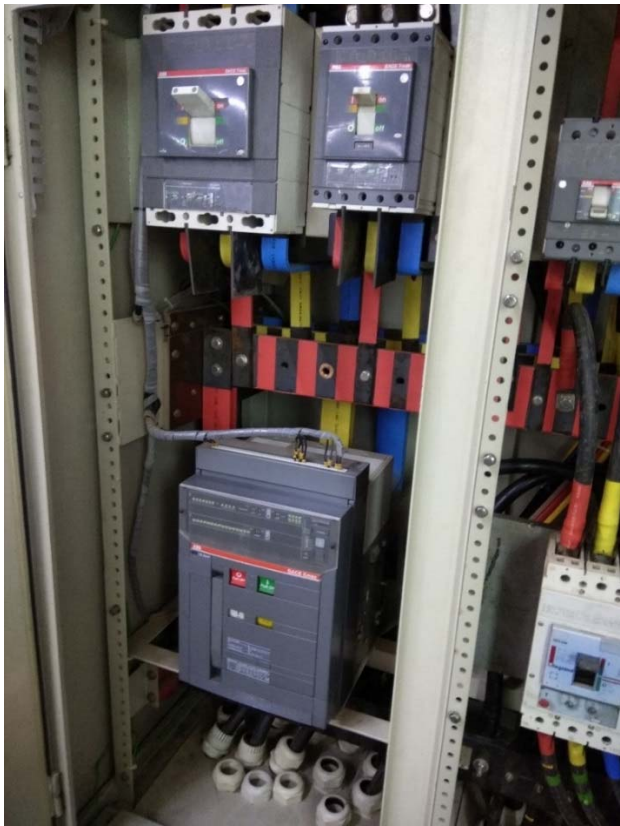
| Ref No. | Issue Type | Sub-Header |
|---|---|---|
| <p>Observation:</p> <p>The presence of all incoming and outgoing switchgear, busbars and cables are in a single compartment which presents a risk to an electrician working on a panel for maintenance.</p> | | |
| <p>Figure 9 No compartment for various panel component.</p> | | |

| Item No | Accord Inspection Observation | Accord Action Plan | Accord Timeline |
|---|---|---|---|
| E-3 Distribution | The presence of all incoming and outgoing switchgear, busbars and cables are in a single compartment which presents a risk to an electrician working on a panel for maintenance. | As per IEC 61439 (International Electrotechnical Commission) the electrical panel board shall have separation. The level of separation is further classified as Form 1, Form 2, Form 3 and Form 4. Forms 2, 3 and 4 are further broken down into Form 2a, 2b, 3a, 3b, 4a and 4b. Apply local code requirement for separation. | Within 6 Month |

| Ref No. | Issue Type | Sub-Header |
|---|---|---|
| <p><b>Recommended Action</b></p> <p>As per IEC 61439 (International Electrotechnical Commission) the electrical panel board shall have separation. The level of separation is further classified as Form 1, Form 2, Form 3 and Form 4. Forms 2, 3 and 4 are further broken down into Form 2a, 2b, 3a, 3b, 4a and 4b.</p> <p>Apply local code requirement for separation.</p> | | |

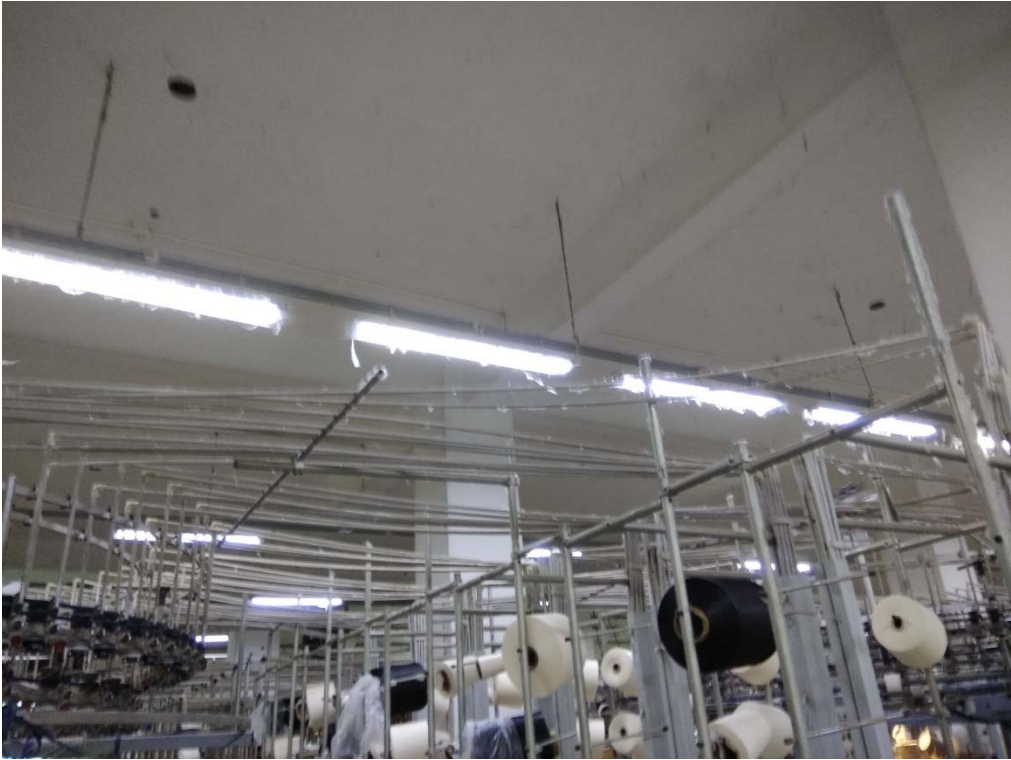
| Ref No. | Issue Type | Sub-header |
|---|---|---|
| E-4 | Distribution | Dust particles |

| Ref No. | Issue Type | Sub-header |
|---|---|---|
| Observation:<br>Presence of dust particles on light fixtures and cable trunking. | | |
| Figure 10 Dust accumulation of electrical installations. | | |

| Item No | Accord Inspection Observation | Accord Action Plan | Accord Timeline |
|---|---|---|---|
| E-4 Distribution | Presence of dust particles on light fixtures and cable trunking. | The formation of dust must be removed from all electrical light fixtures, cable tray, trunking and other electrical items. | Within 1 Month |

| Ref No. | Issue Type | Sub-header |
|---|---|---|
| The fomration of dust must be removed from all electrical light fixtures, cable tray, trunking and other electrical items. | | |

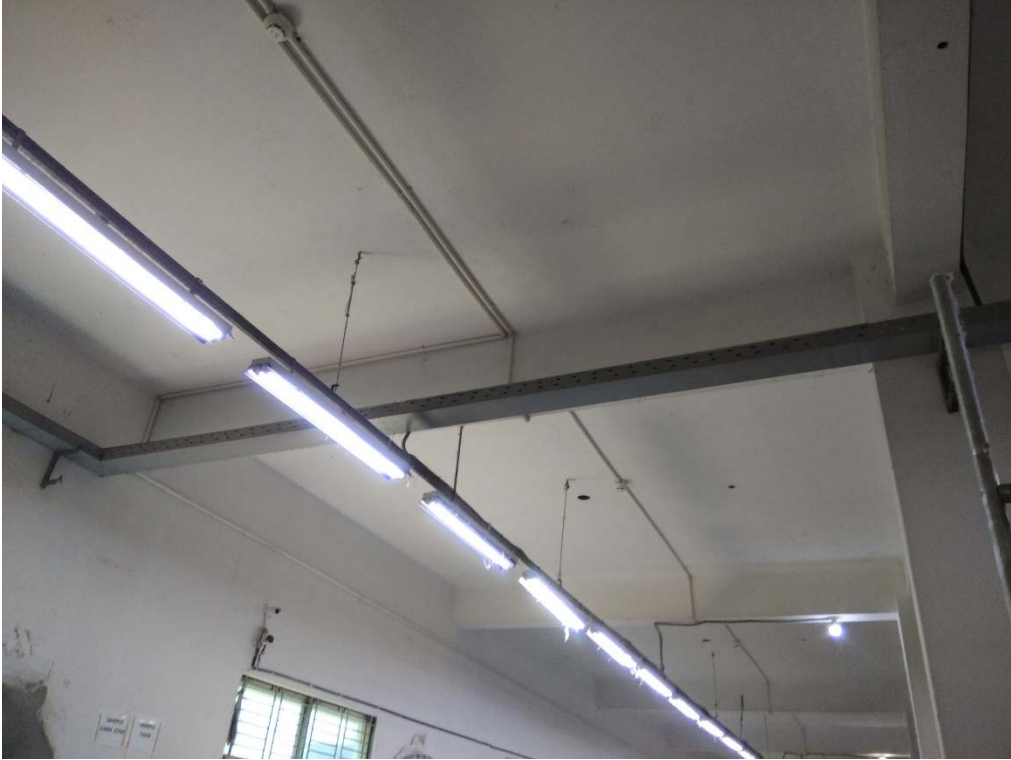
| Ref No. | Issue Type | Sub-Header |
|---|---|---|
| E-5 | Distribution | Inadequate support |

| Ref No. | Issue Type | Sub-Header |
|---|---|---|
| <p>Observation:</p> <p>The distance between the cable tray supports is very large. At some places, the cable trays are supported at every column and there is no intermediate support.</p> | | |
| <p>Figure 11 Improper cable tray support</p> | | |

| Item No | Accord Inspection Observation | Accord Action Plan | Accord Timeline |
|---|---|---|---|
| E-5 Distribution | The distance between the cable try supports is very large. At some places, the cable trays are supported at every column and there is no intermediate support. | The main trunking has improper support, the cable trunking support shall be at least between 1 to 1.5 m apart based on loading of the trunking. | Within 1 Month |

| Ref No. | Issue Type | Sub-Header |
|---|---|---|
| <p>The main trunking has improper support, the cable trunking support shall be at least between 1 to 1.5 m apart based on loading of the trunking.</p> | | |

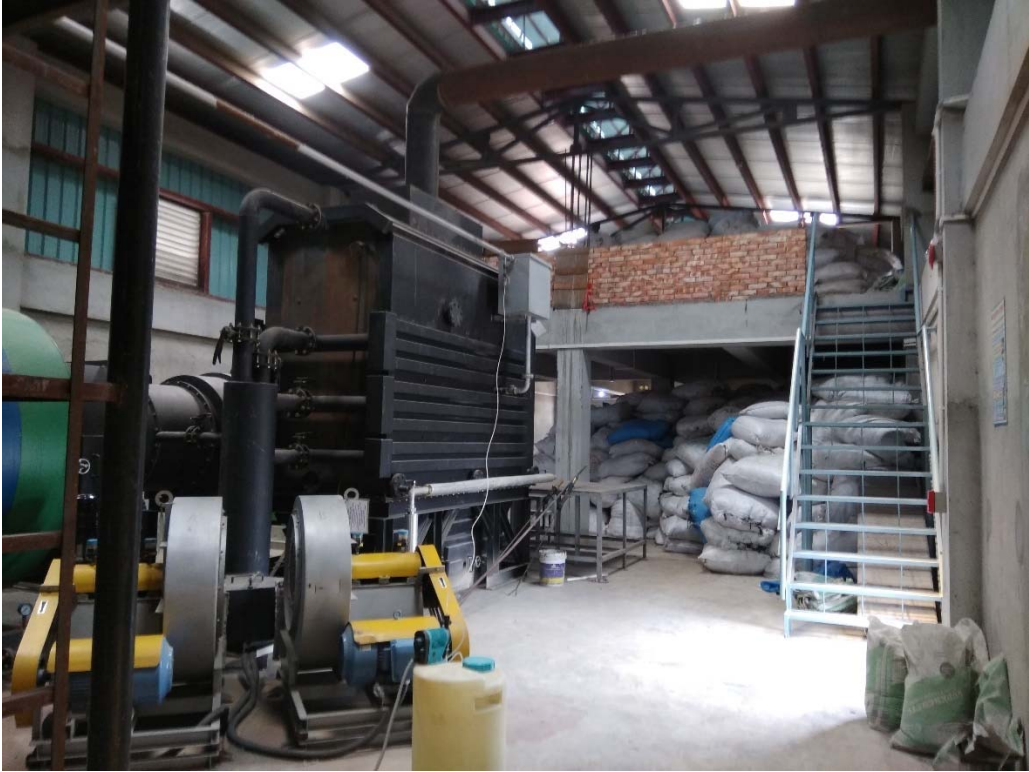
| Ref No. | Issue Type | Sub-Header |
|---|---|---|
| E-6 | Distribution | Insufficient lighting |

| Ref No. | Issue Type | Sub-Header |
|---|---|---|
| <p>Observation:</p> <p>There is no general lighting provided in the double height area of boiler room.</p> | | |
| <p>Figure 12 No general lighting inside boiler room</p> | | |

| Item No | Accord Inspection Observation | Accord Action Plan | Accord Timeline |
|---|---|---|---|
| E-6 Distribution | There is no general lighting provided in the double height area of boiler room. | The double height boiler room doesn't have any localized lighting. A dedicated lighting with emergency lighting (10 Lux minimum) shall be provided. | Within 1 Month |

| Ref No. | Issue Type | Sub-Header |
|---|---|---|
| <p>The double height boiler room doesn't have any localised lighting. A dedicated lighting with emergency lighting (10 Lux minimum) shall be provided.</p> | | |

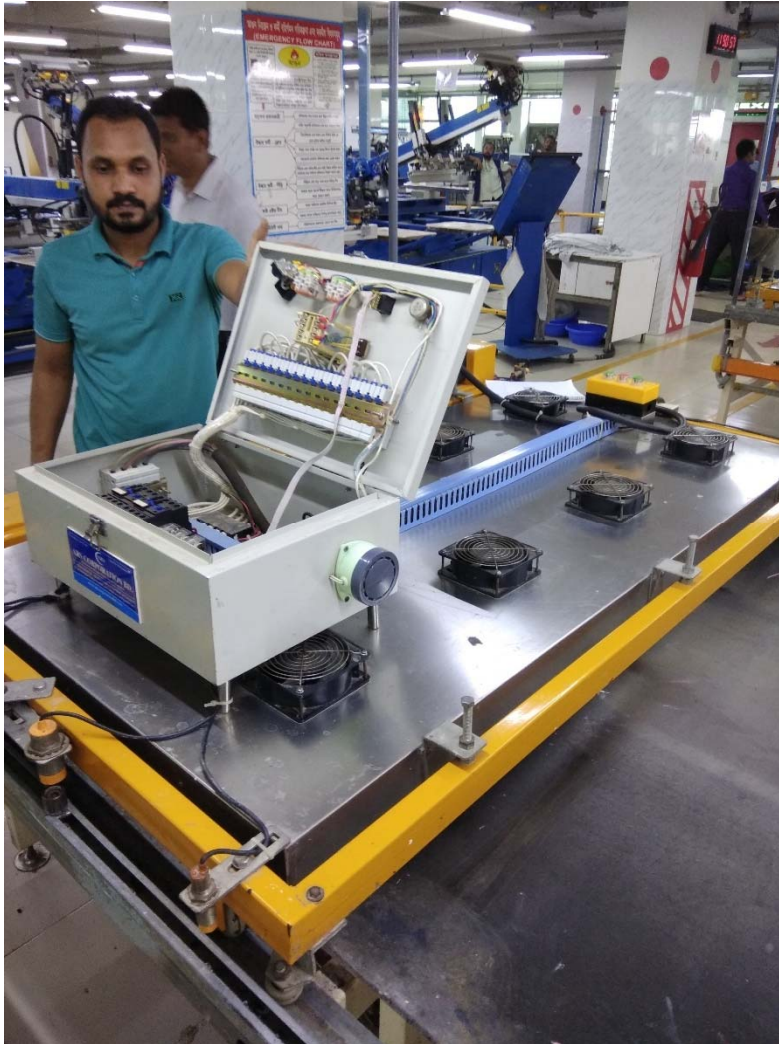
| Ref No. | Issue Type | Sub-Header |
|---|---|---|
| E-7 | Earthing and bonding | Improper earthing |

| Ref No. | Issue Type | Sub-Header |
|---|---|---|
| <p>Observation:</p> <p>The metal table of the dryer machine is earthed but the moving platform is not connected to earth. The dryer platform has power box and three phase power supply.</p> | | |
| <p>Figure 13 No earthing on dryer platform</p> | | |

| Item No | Accord Inspection Observation | Accord Action Plan | Accord Timeline |
|---|---|---|---|
| E-7 Distribution | The metal table of the dryer machine is earthed but the moving platform is not connected to earth. The dryer platform has power box and three phase power supply. | A proper dedicated body earthing to be provided for all metal part of the machine. | Immediate |

| Ref No. | Issue Type | Sub-Header |
|---|---|---|
| <p><b>Recommended Action</b></p> <p>A proper dedicated body earthing to be provided for all metal part of the machine.</p> | | |

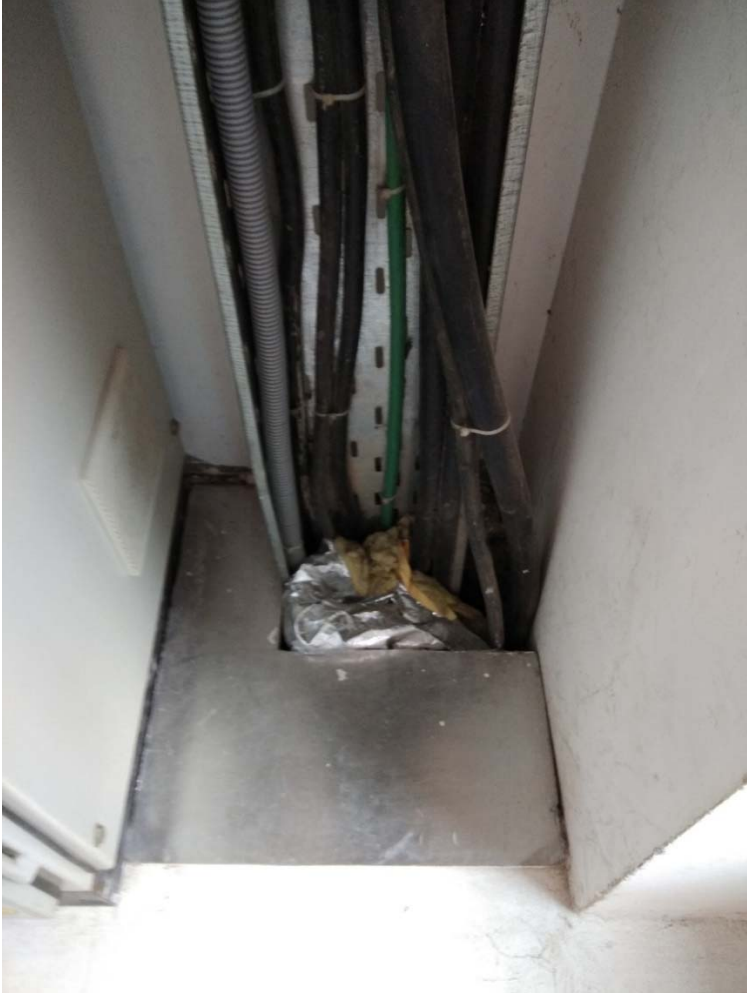
| Ref No. | Issue Type | Sub-Header |
|---|---|---|
| E-8 | Fire | See Fire Safety report |

| Ref No. | Issue Type | Sub-Header |
|---|---|---|
| Observation: Penetrations in the floor of the electrical shaft have been partially sealed. | | |
| Figure 14 Inter-floor shaft opening | | |

| Item No | Accord Inspection Observation | Accord Action Plan | Accord Timeline |
|---|---|---|---|
| E-8 Fire | Penetrations in the floor of the electrical shaft have been partially sealed. | The interfloor opening for all the shaft must be closed properly by using proper sealant. | Within 3 Month |

| Ref No. | Issue Type | Sub-Header |
|---|---|---|
| The interfloor opening for all the shaft must be closed properly by using proper sealant. | | |

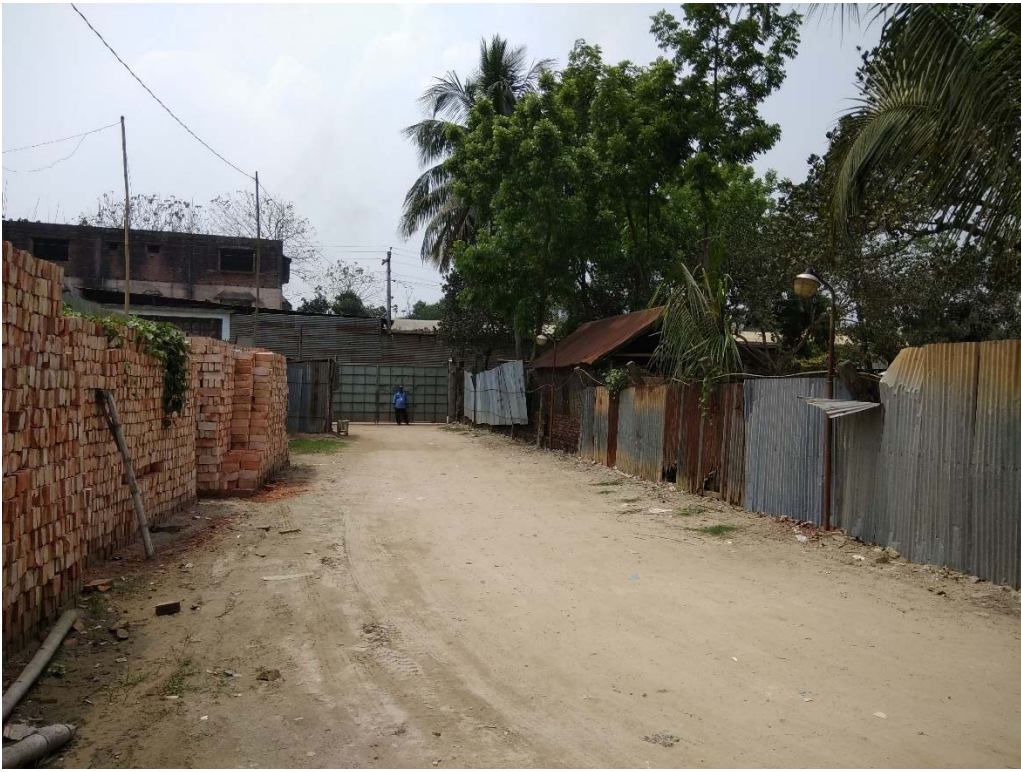
| Ref No. | Issue Type | Sub-Header |
|---|---|---|
| E-9 | Distribution | Insufficient lighting |

| Ref No. | Issue Type | Sub-Header |
|---|---|---|
| <p>Observation:</p> <p>The internal approach road to main production building and warehouse has insufficient lighting.</p> | | |
| Figure 15 Insufficient road lighting | | |

| Item No | Accord Inspection Observation | Accord Action Plan | Accord Timeline |
|---|---|---|---|
| E-9 Distribution | The internal approach road to main production building and warehouse has insufficient lighting. | A proper internal road lighting must be designed and installed. | Within 6 Month |

| Ref No. | Issue Type | Sub-Header |
|---|---|---|
| A proper internal road lighting must be designed and installed. | | |
