Ayesha Fashion Limited

Plot No. 256, 257 & 258, Adamjee EPZ, Siddirganj, Narayanganj, Bangladesh.
(23.678461, 90.523814)

06 February 2023

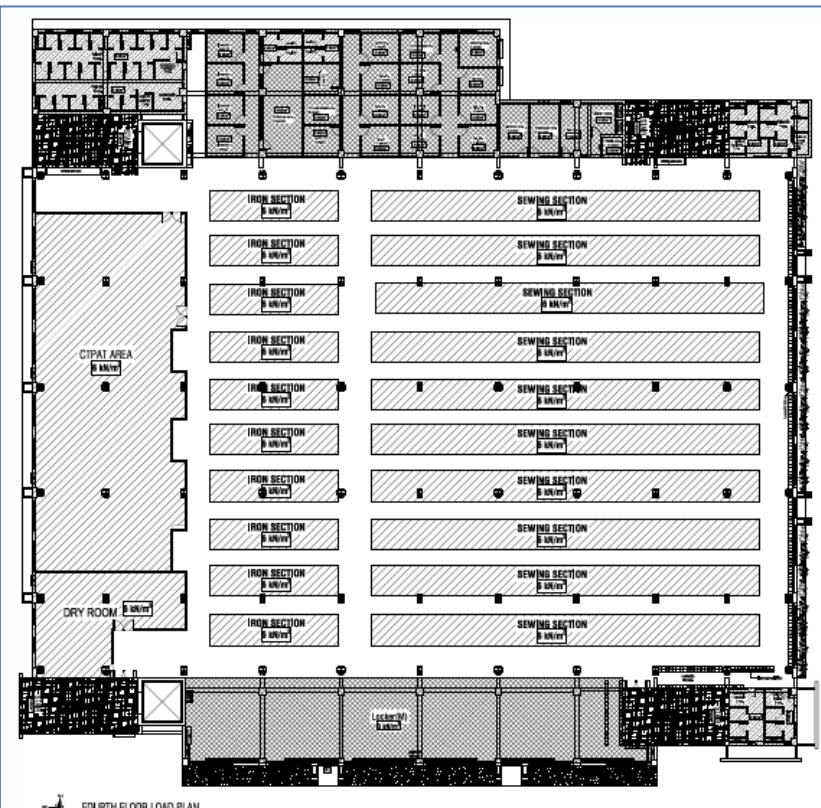
Load plan (6 KPa)

Cursory calculation indicates internal steel columns stressed above normal design limit

The cursory calculation indicates that internal columns stress exceeds the normal design limit considering a typical floor live load 6 kPa, and minimum tensile strength of steel plate 250 MPa. The building engineer is required to review the design, loads, and column stresses.

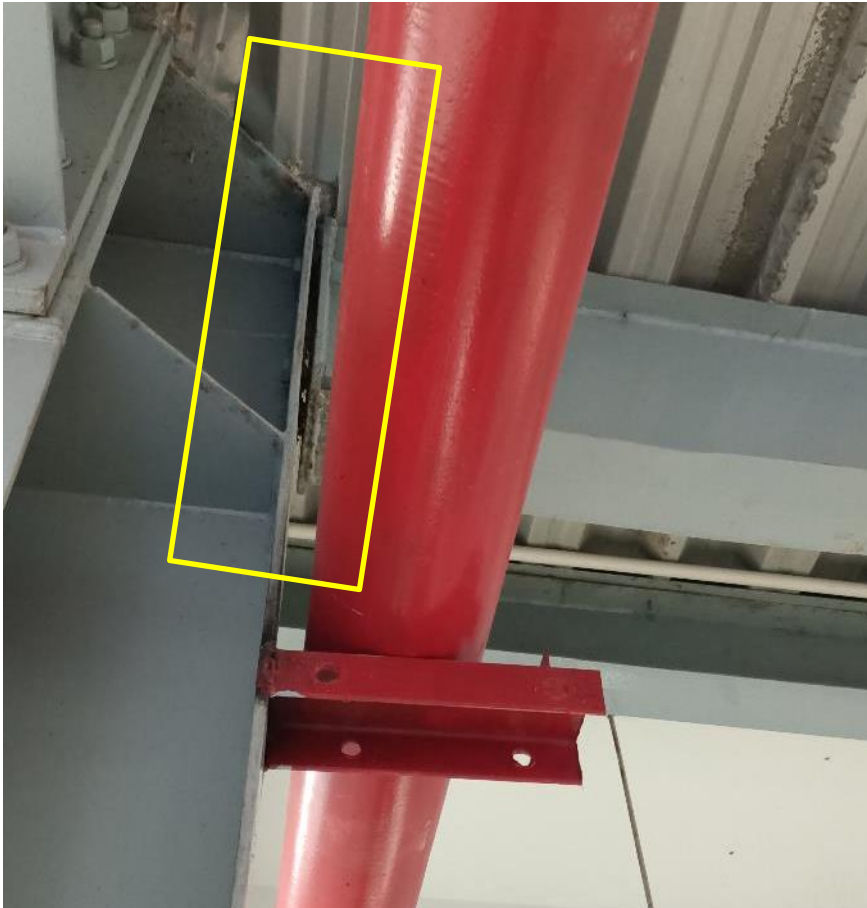
Gap observed in connections

Bolt missing and connection gap

Bolt missing and significant gaps observed in beam-column joint at several locations. Building engineer is required to carry out suitable remedial works.

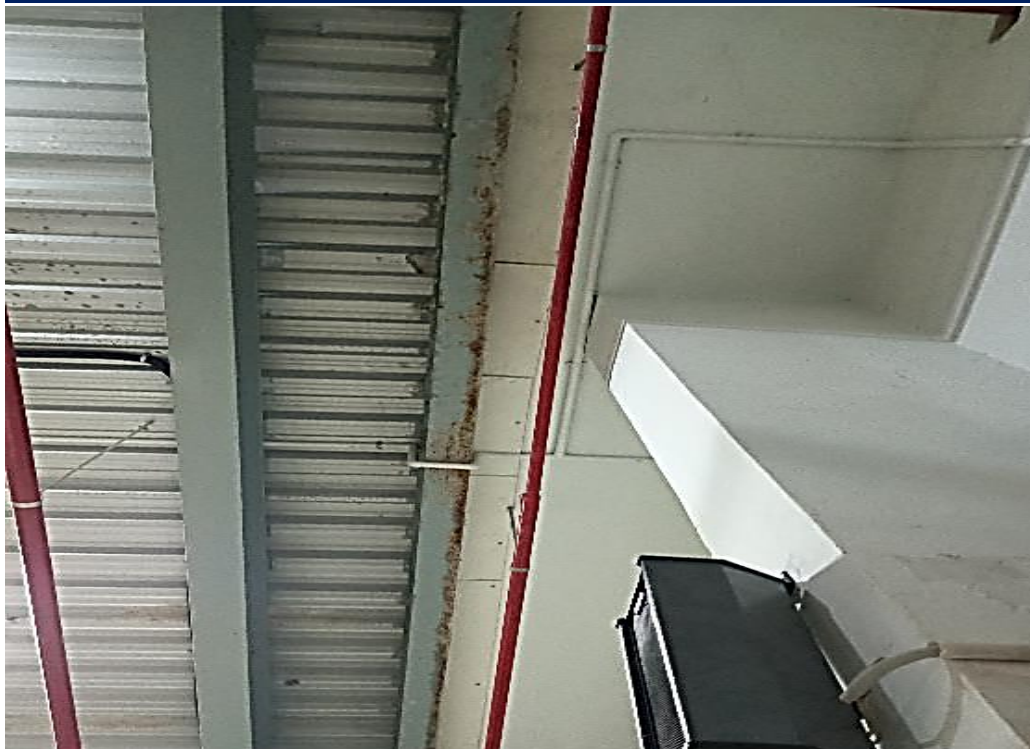
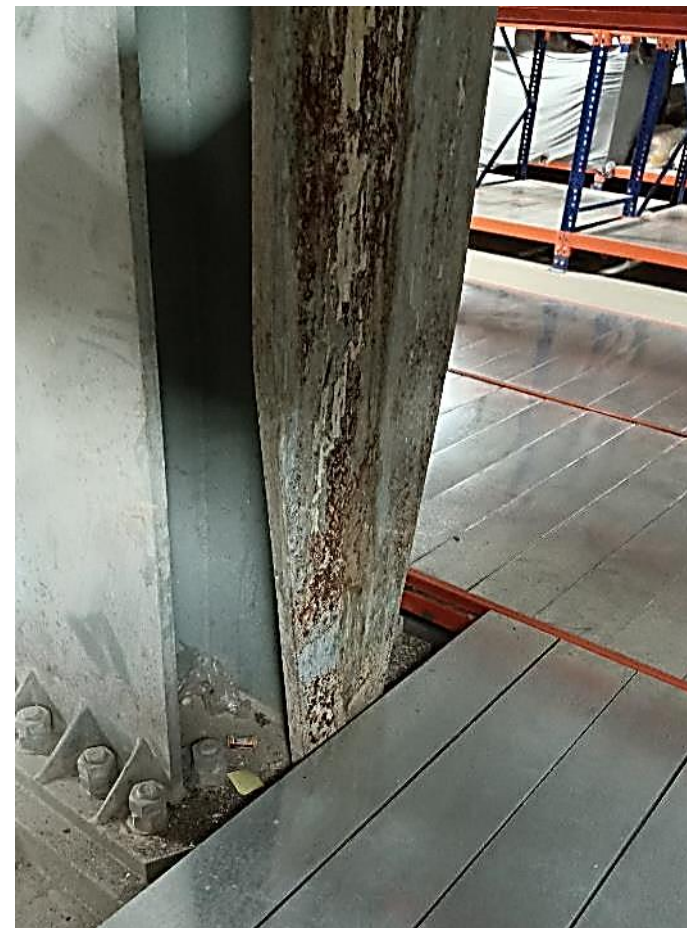
Corrosion in steel member

Corrosion in steel member of staircase was observed in the several locations. The building engineer is required to suggest proper remedial measure accordingly

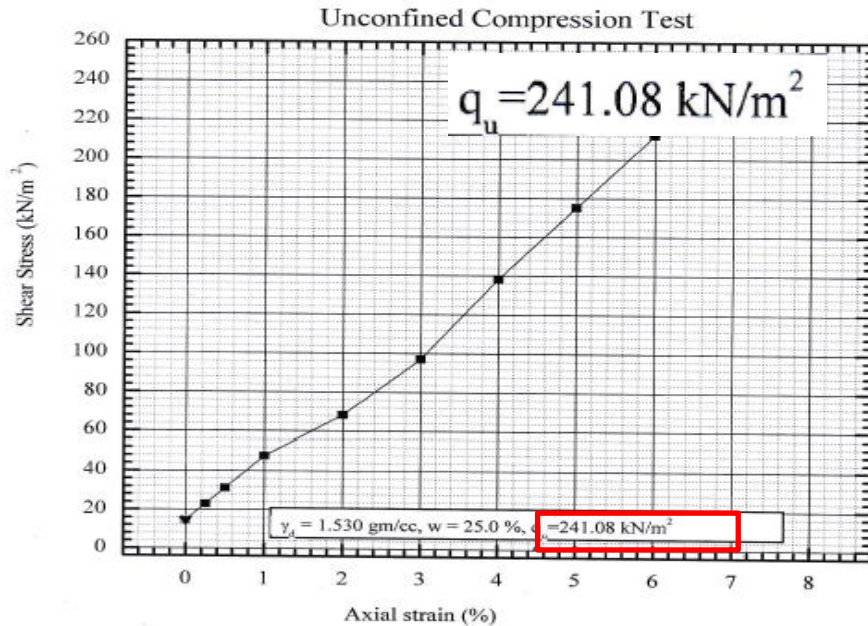
Soil test report

Design report need to be revised

Foundation capacity required to revise in the design report. As per provided soil test report $q_u=241.08$ KN/m² but in the design report $q_u = 400$ KN/m² considered for pile capacity calculation. Moreover, Serviceability and irregularity check was not found in this design report.

Building engineer is required to revise the design report for foundation calculation and submit to RSC.

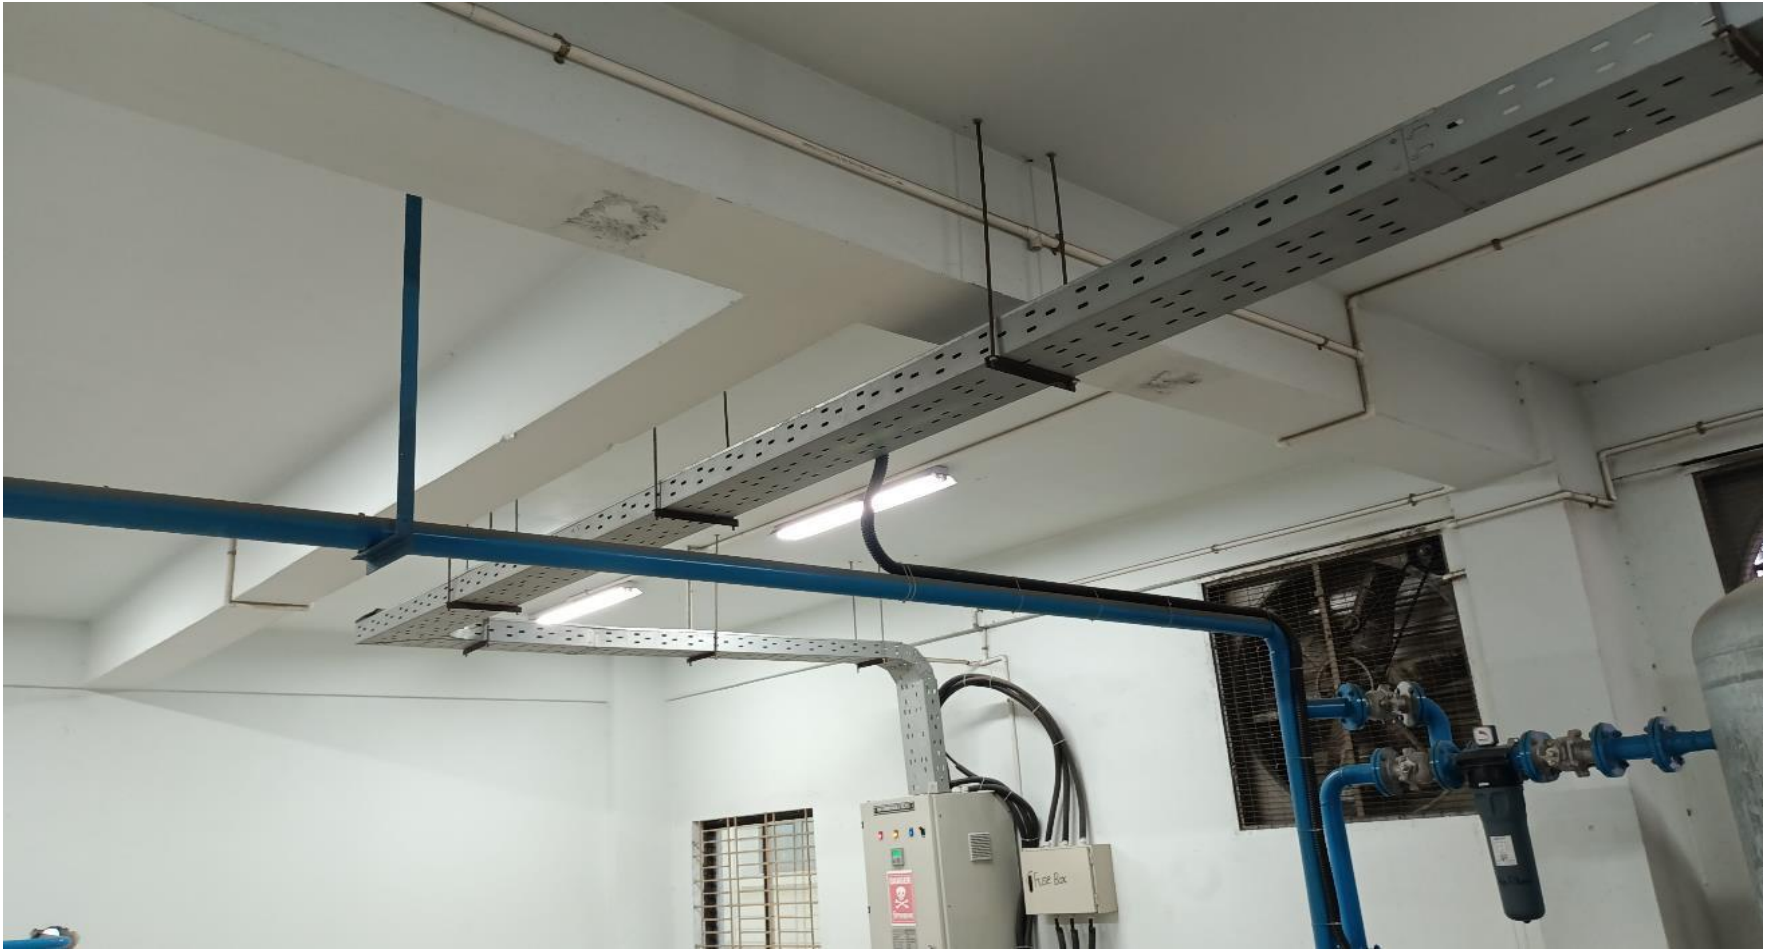
First floor beam

Beam layout missing for 1st floor

Beam layout was not found in the provided drawings of the Utility Building. The building is required to survey the whole structure and prepare full set of as-built drawings with complete information.
