# Magic Works Ltd

8/54 Jhalpaza, 10 Hobirbari Mymensingh, Bhaluka, Mymensingh, 2240  
(24.342420, 90.419369)  
29 January 2023

# Building Information

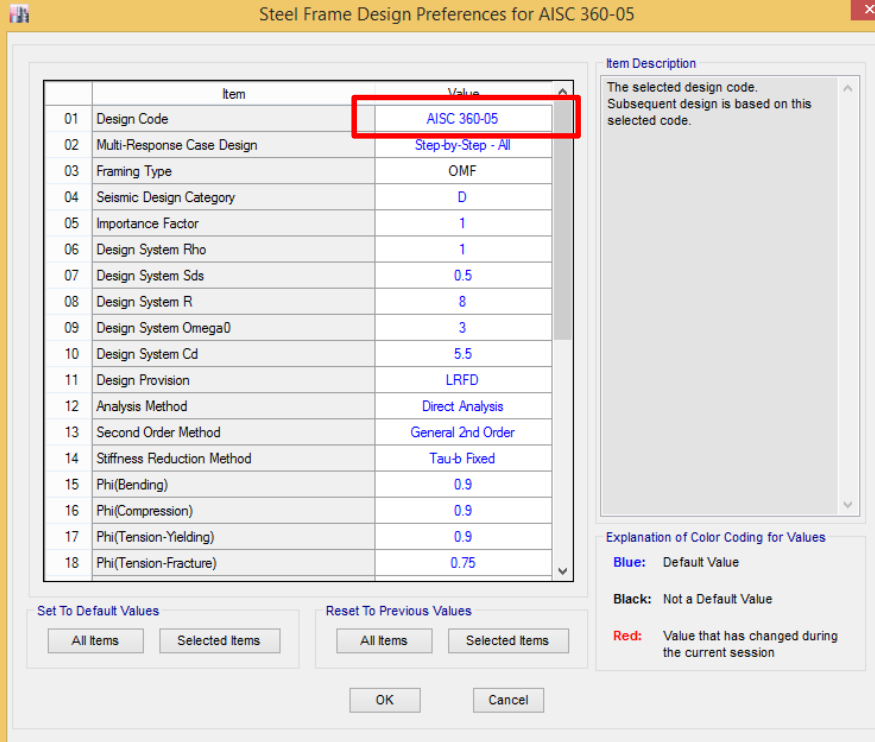
Building engineer has reviewed the design of the steel member as per AISC 360-05 method but the building under the code of BNBC-2006 shall require to evaluate as per AISC-LRFD 93 method

| Item No. | Observation | Recommended Action Plan | Recommended Timeline |
|---|---|---|---|
| 01 | Inconsistencies in design report (Building-1: Factory Building). | Building engineer is require to evaluate the design of steel members as per BNBC-2006 (equivalent to AISC-LRFD 93 method) | 6-weeks |

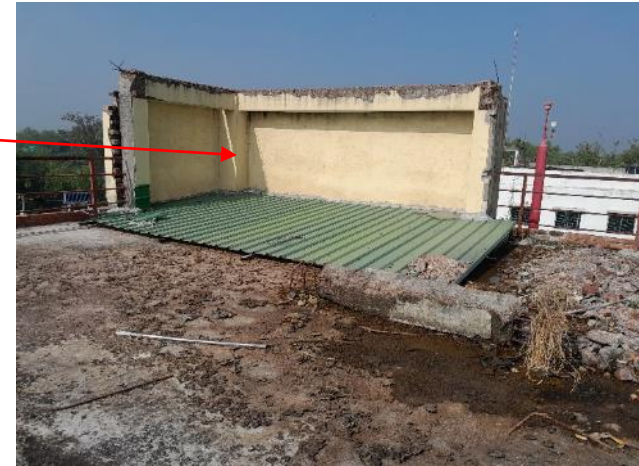
Stair was found demolished.

| Item No. | Observation | Recommended Action Plan | Recommended Timeline |
|---|---|---|---|
| 04 | Discrepancy in as built drawing (Building-1: Factory Building) | Building engineer is require to update the as-built drawing as per as-built condition. | 6-weeks |

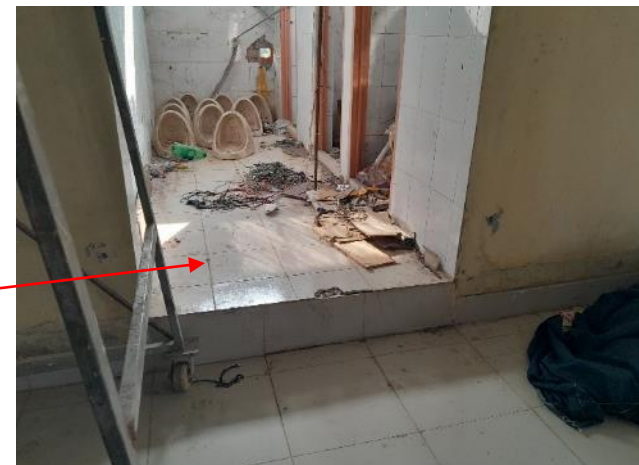
200 mm build up found at toilet

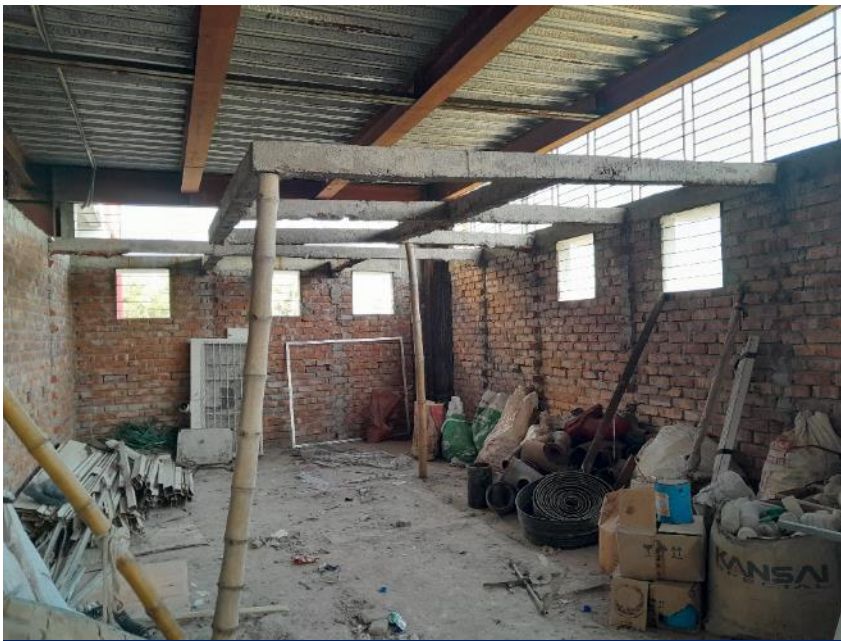
Unstable bamboo support on the demolition works which may slip away anytime.

Lack of demolition safety practice observed in the factory. Building engineer is required to follow the BNBC Part-7 chapter-4 for safe demolition works.

| Item No. | Observation | Recommended Action Plan | Recommended Timeline |
|---|---|---|---|
| 05 | Lack of construction safety practices in demolition works and falling hazard (Building-1: Factory Building) | Building engineer is required to follow the BNBC Part-7 Chapter-3 for safe demolition works. | 6-weeks |

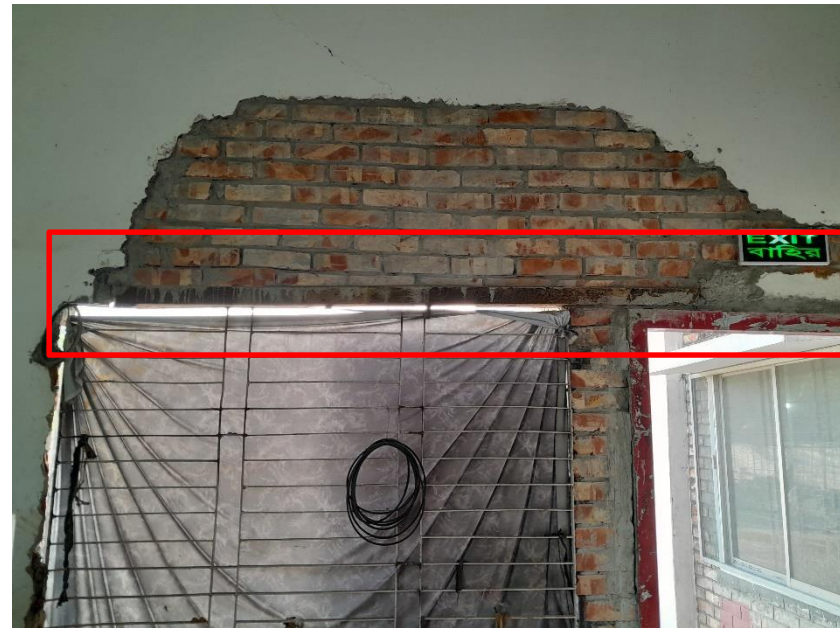
Corroded and deflected steel member support instead of lintel

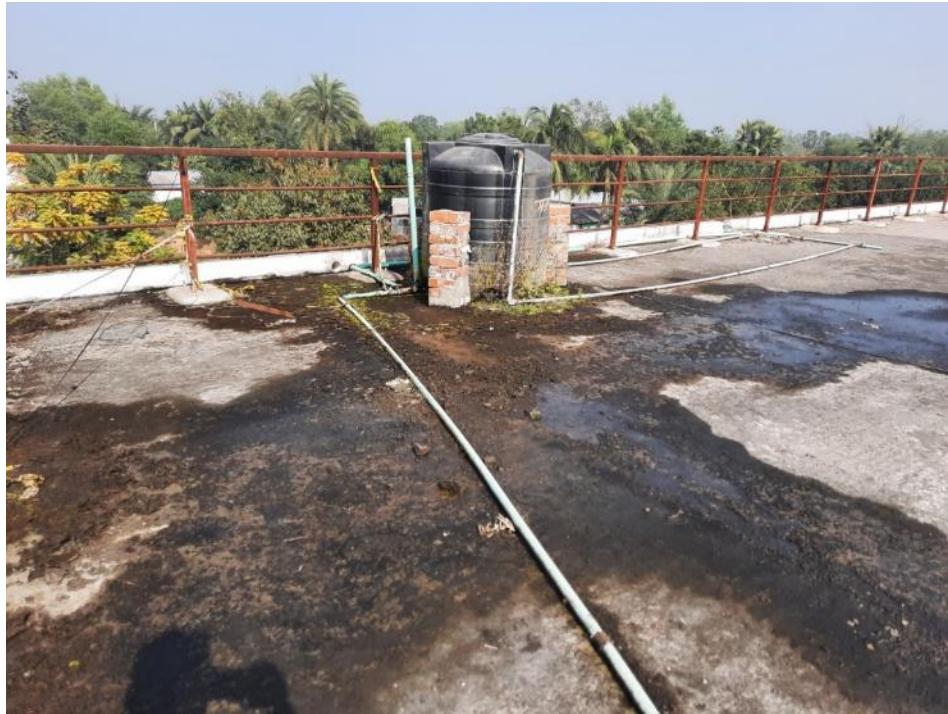
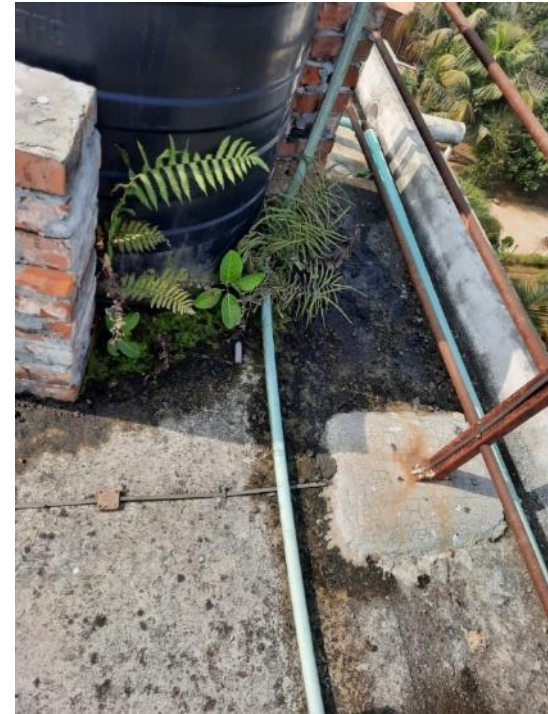
Water ponding and vegetation observed on the roof.

Building engineer is required to develop water drainage system and apply water proofing layer on the roof with adequate slope.

| Item No. | Observation | Recommended Action Plan | Recommended Timeline |
|---|---|---|---|
| 06 | Water ponding and vegetation on the roof (Building-1: Factory Building) | Building engineer is required to develop water drainage system and apply water proofing layer on the roof with adequate slope. | 6-weeks |

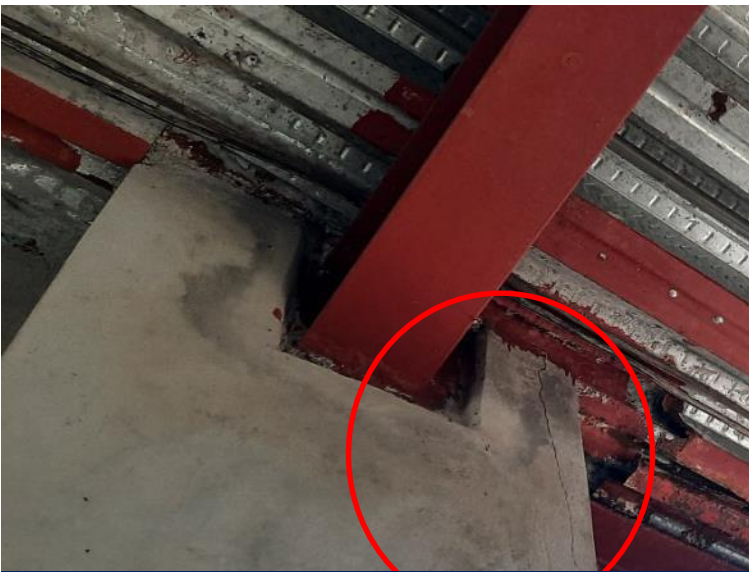
Crack on RC column and steel beam joint

Crack in the connection of RC beam-column joint of stair case and steel-RC member connection were observed. Building engineer is required to investigate the extent of the crack and suggest proper remedial actions.

| Item No. | Observation | Recommended Action Plan | Recommended Timeline |
|---|---|---|---|
| 07 | Crack in the connection of RC beam-column joint of staircase and steel-RC member connection (Building-1: Factory Building) | Building engineer is required to investigate the extent of the crack and suggest proper remedial actions. | 6-weeks |
| 08 | Crack in the connection of RC beam-column joint of staircase and steel-RC member connection (Building-1: Factory Building) | Implement suitable repair works. | 6-months |

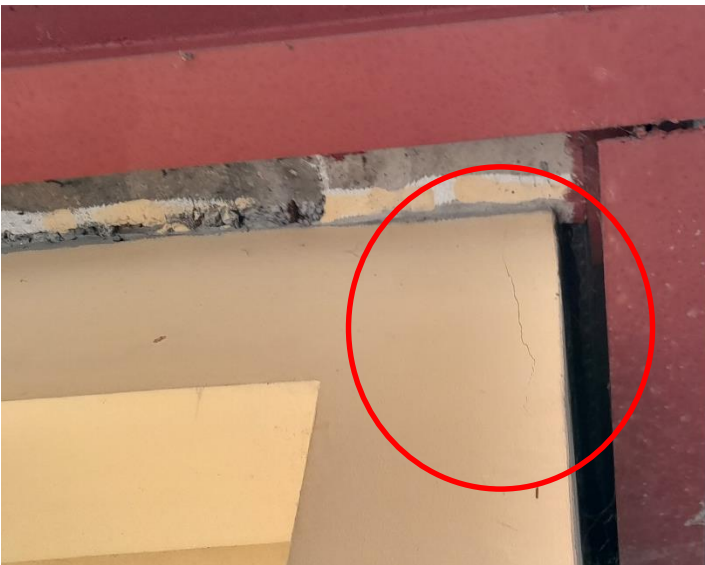
Crack on RC beam-column joint

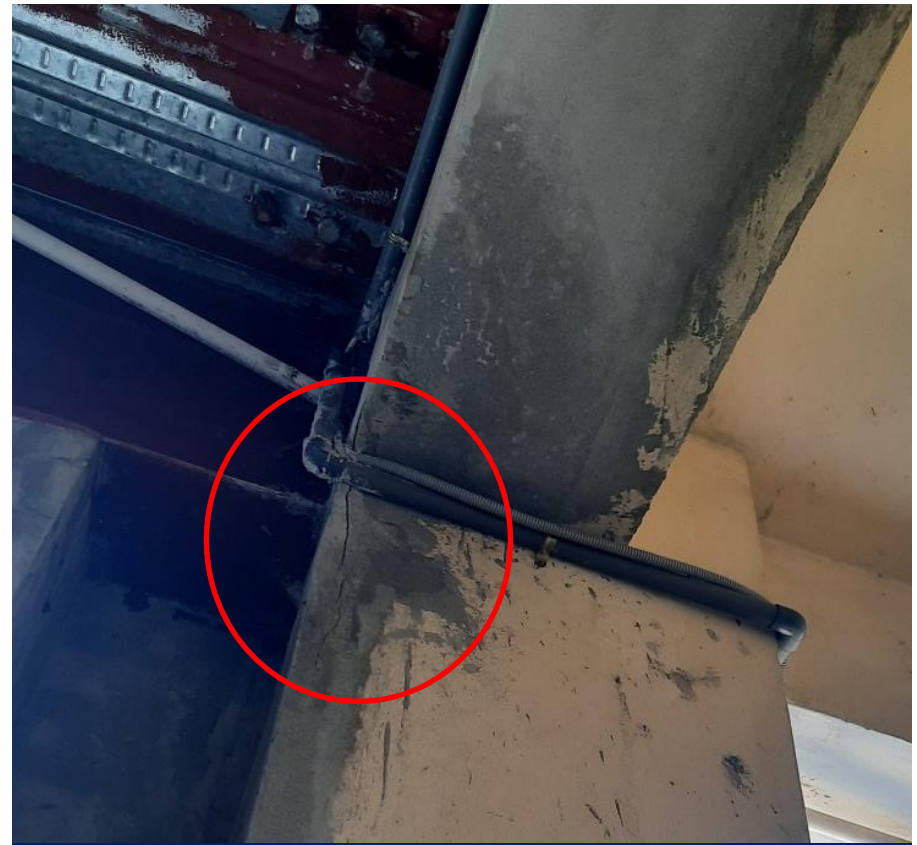
Crack on RC column and steel beam joint

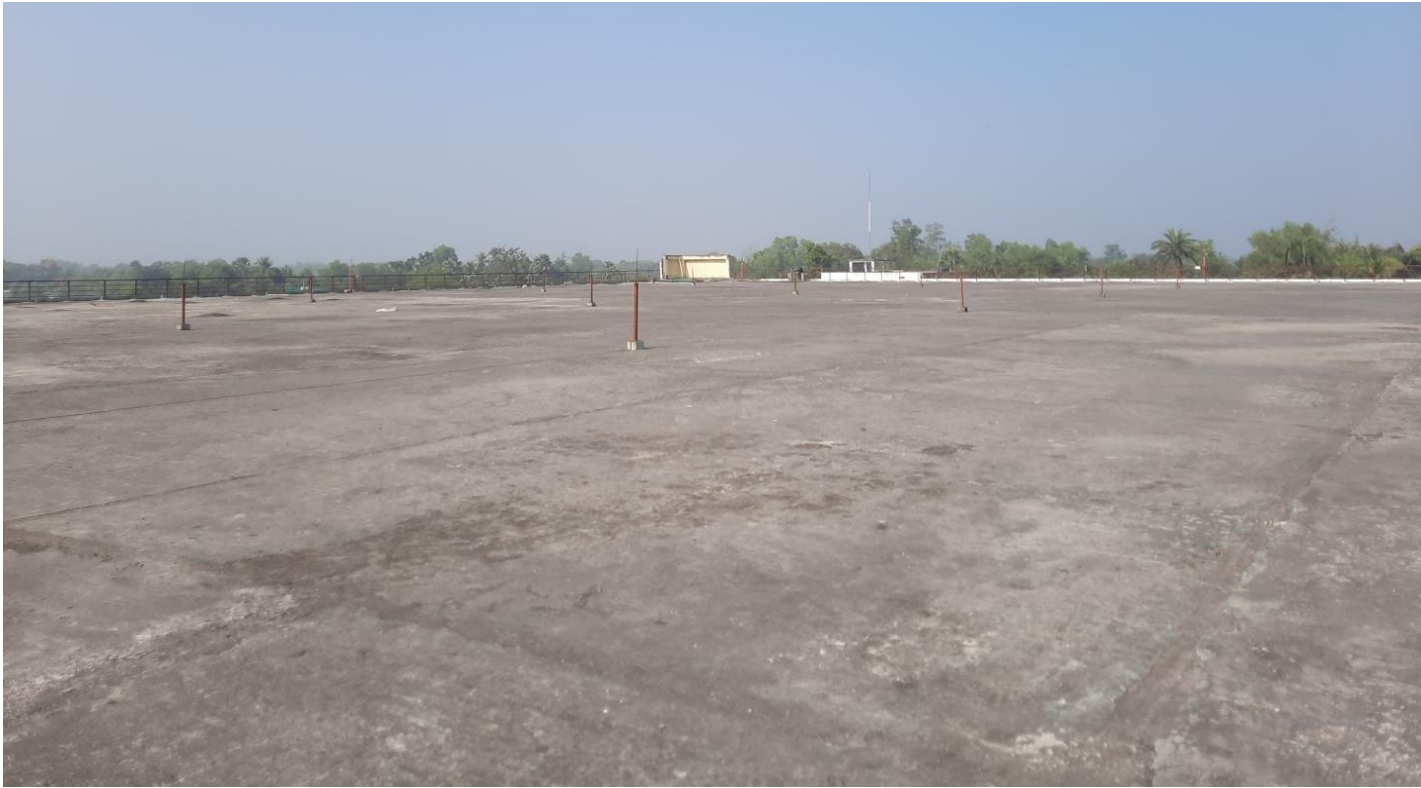
Total slab area is approximately 7000 sqm. There is no construction/movement joint in the slab. During inspection we Vibration of roof slab . Building engineer is required to investigate the reason of the vibration and suggest proper remedial actions accordingly.

| Item No. | Observation | Recommended Action Plan | Recommended Timeline |
|---|---|---|---|
| 09 | Vibration of roof slab (Building-1: Factory Building) | Building engineer is required to investigate the reason of the vibration and suggest proper remedial action accordingly. | 6-weeks |

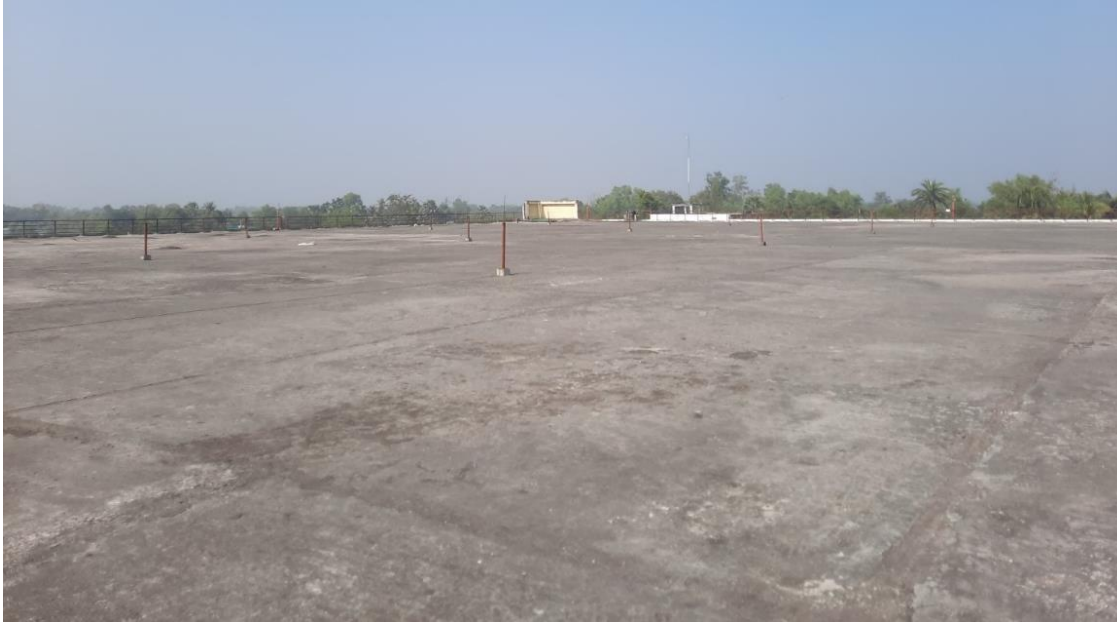
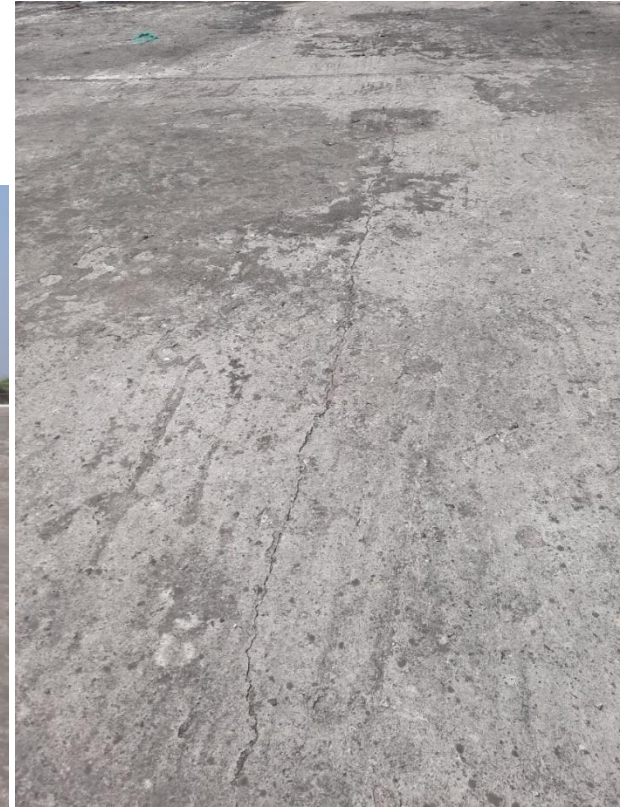
Total slab area is approximately 7000 sqm. There is no construction/movement joint in the slab. Crack appeared on the roof surface. Building engineer is required to investigate the reason of the crack and suggest proper remedial action accordingly.

| Item No. | Observation | Recommended Action Plan | Recommended Timeline |
|---|---|---|---|
| 10 | Crack on the roof surface (Building-1: Factory Building) | Building engineer is required to investigate the reason of the crack and suggest proper remedial action. | 6-weeks |

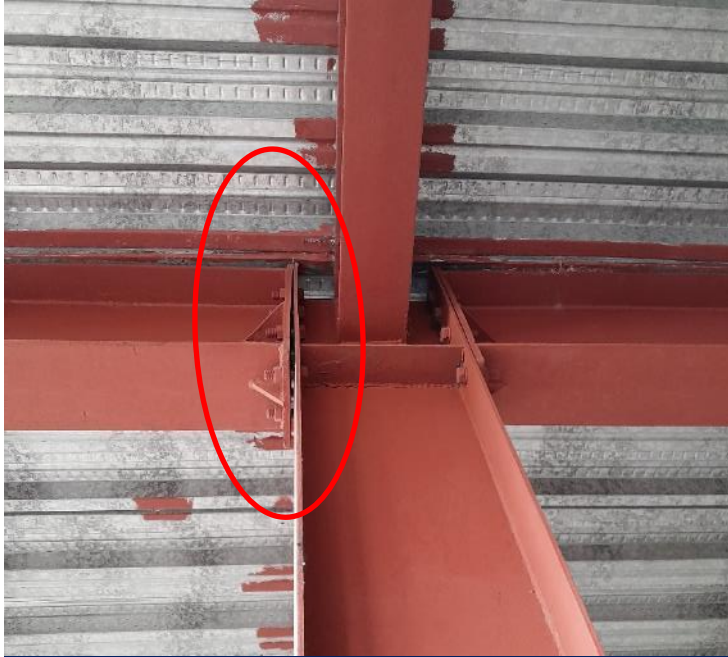
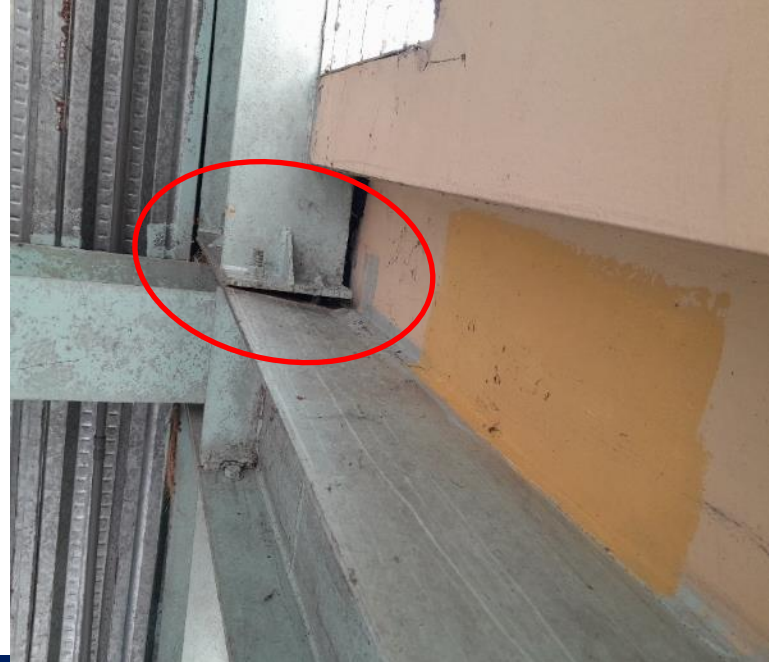
Significant gap was found in beam-column joint. Building engineer is required to identify all the connection gaps and fill the gaps with a suitable method.

| Item No. | Observation | Recommended Action Plan | Recommended Timeline |
|---|---|---|---|
| 11 | Significant gap in beam-column joint at several locations (Building-1: Factory Building) | Building engineer is required to identify all the connection gaps and fill the gaps with a suitable method. | 6-weeks |

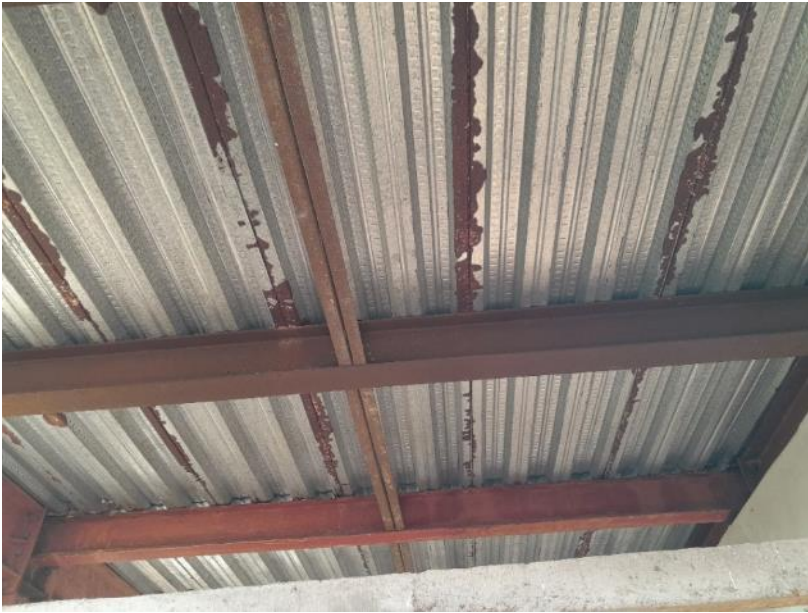
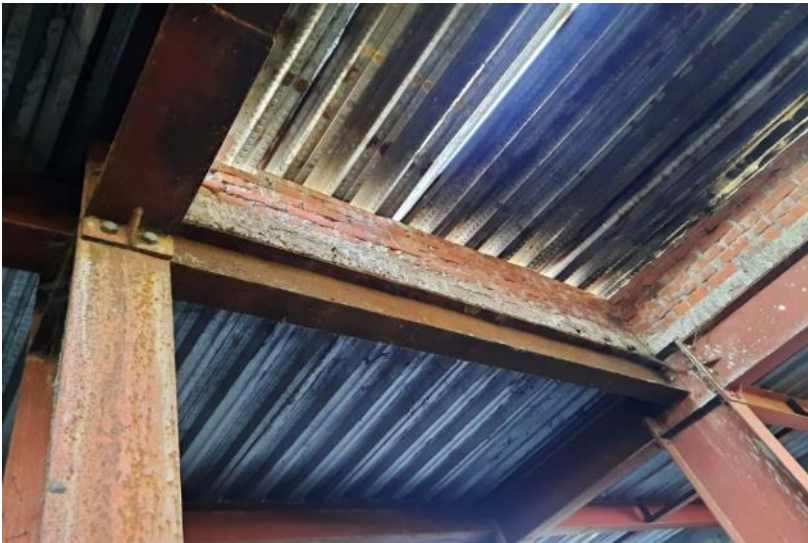
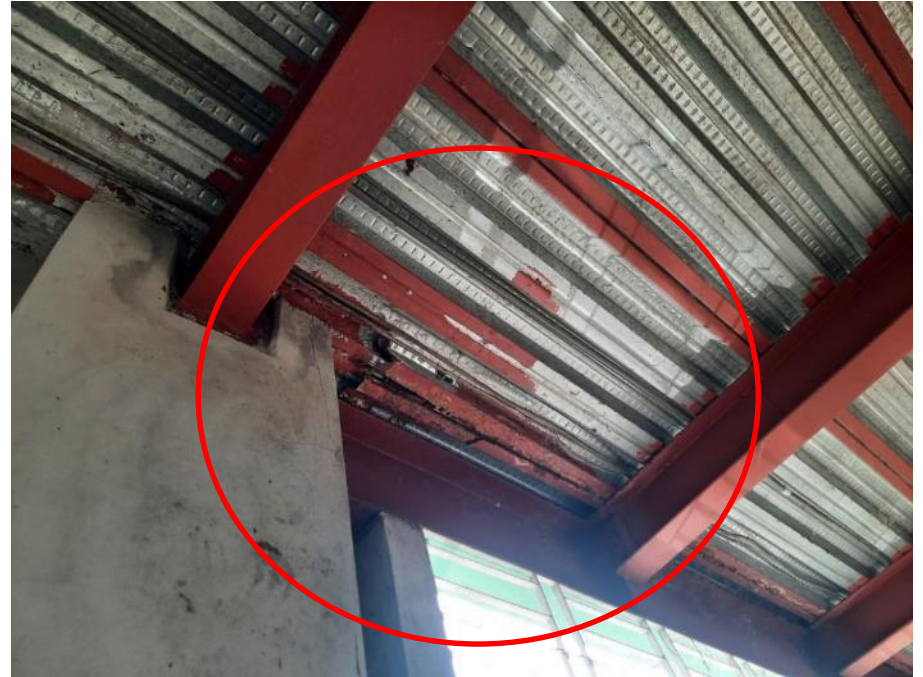
Severe corrosion on steel members

Severe corrosion was observed in steel members. Building engineer is required to remove the corrosion and provide rust proof paint on all steel members.

| Item No. | Observation | Recommended Action Plan | Recommended Timeline |
|---|---|---|---|
| 12 | Severe corrosion on steel members (Building-1: Factory Building) | Building engineer is required to remove the corrosion and provide rust proof paint on all steel members to protect from corrosion. | 6-weeks |

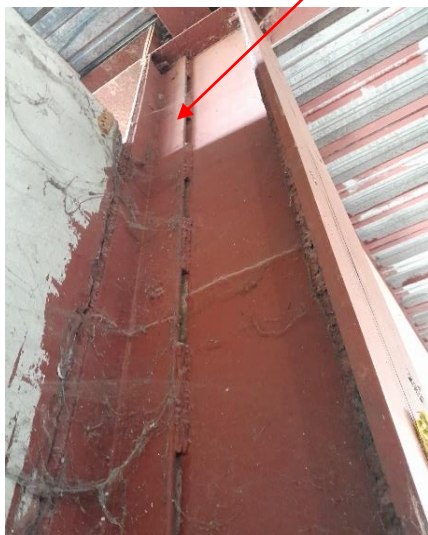
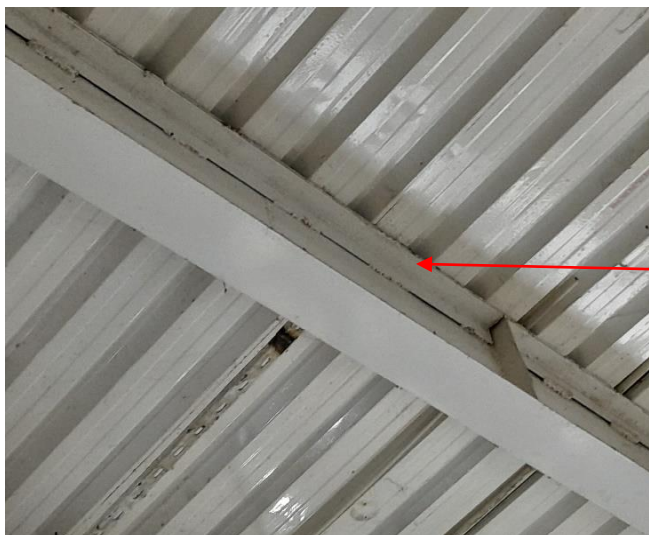
Tack welding found instead of continuous welding at steel column and beam retrofitting

Addition of plate/angle sections were proposed as retrofitting elements with the existing steel beams and columns. But during inspection additional plate & angle sections were found welded by tack welding where continuous welding was recommended in the retrofitting drawing. Also, the bottom flange of the retrofitted beams were disconnected. However, the building engineer is required to check the current retrofitting conditions, update the connection details, revise the EA report and submit the EA documents to RSC for detail review.

| Item No. | Observation | Recommended Action Plan | Recommended Timeline |
|---|---|---|---|
| 13 | Faulty retrofitting works (Building-1: Factory Building) | The building engineer is required to check the current retrofitting conditions, update the connection details, revise the EA report and submit the EA documents to RSC for detail review. | 6-weeks |
| 14 | Faulty retrofitting works (Building-1: Factory Building) | Complete all remediation as per accepted EA. | 6-months |

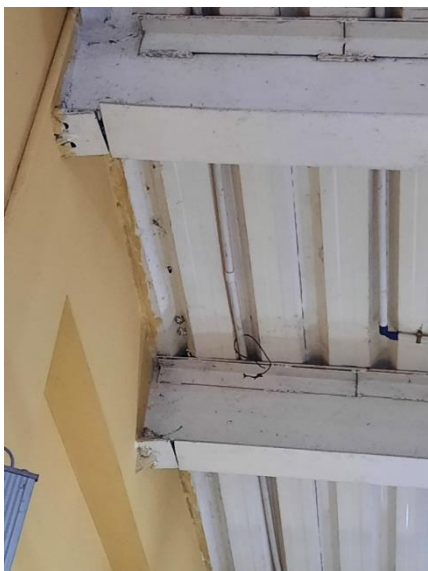
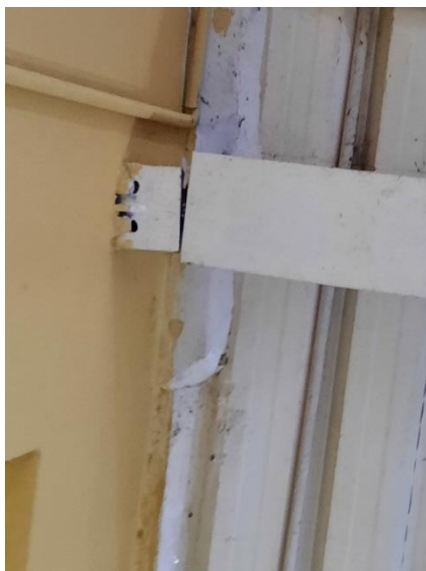
Faulty retrofitting works (disconnected flange).

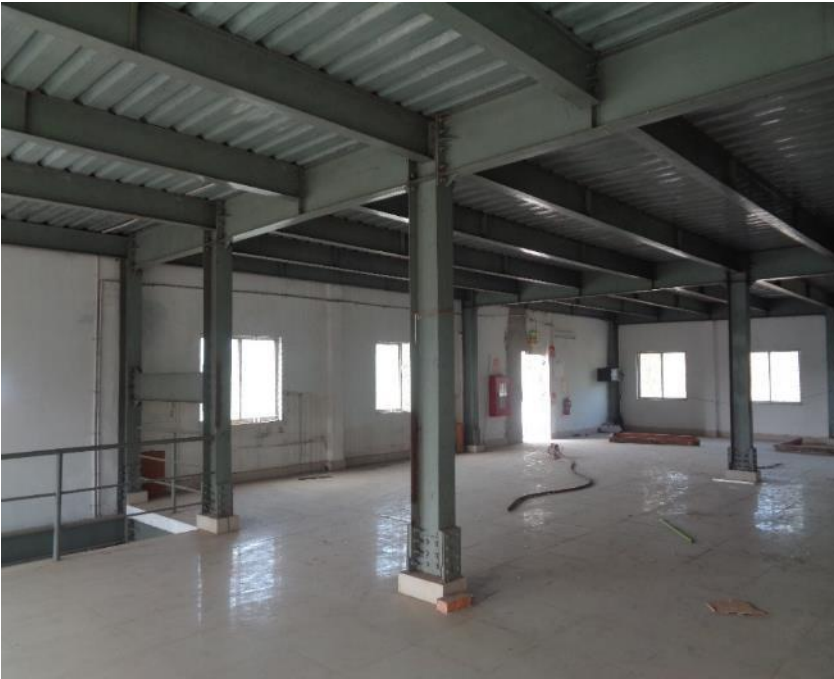
Moment resisting frame is only provided along short direction at 1<sup>st</sup> and 2<sup>nd</sup> floor

Moment resisting frame is only provided along short direction and no wall bracing is provided along long direction at 1<sup>st</sup> and 2<sup>nd</sup> floor therefore lateral stability along long direction is questionable. Building engineer is required to check the lateral stability of the structure.

| Item No. | Observation | Recommended Action Plan | Recommended Timeline |
|---|---|---|---|
| 15 | Lack of lateral stability (Building-2: Office Building) | Building engineer is required to check the lateral stability of the structure. | 6-weeks |

| Item No. | Observation | Recommended Action Plan | Recommended Timeline |
|---|---|---|---|
| 16 | Lack of lateral stability (Building-2: Office Building) | Implement remediation work if required. | 6-months |

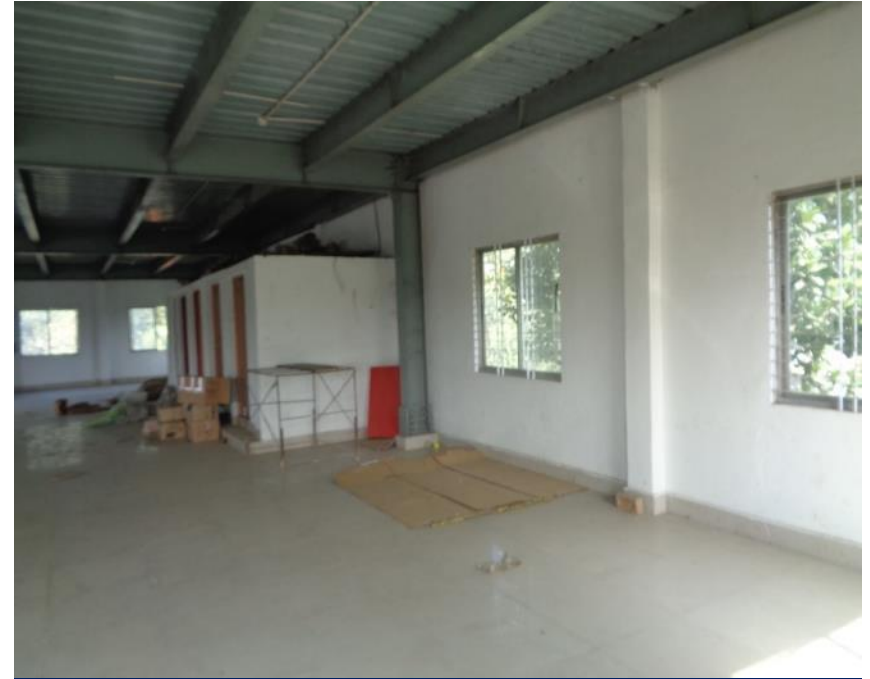
No wall bracing is provided along long direction at 1<sup>st</sup> and 2<sup>nd</sup> floor

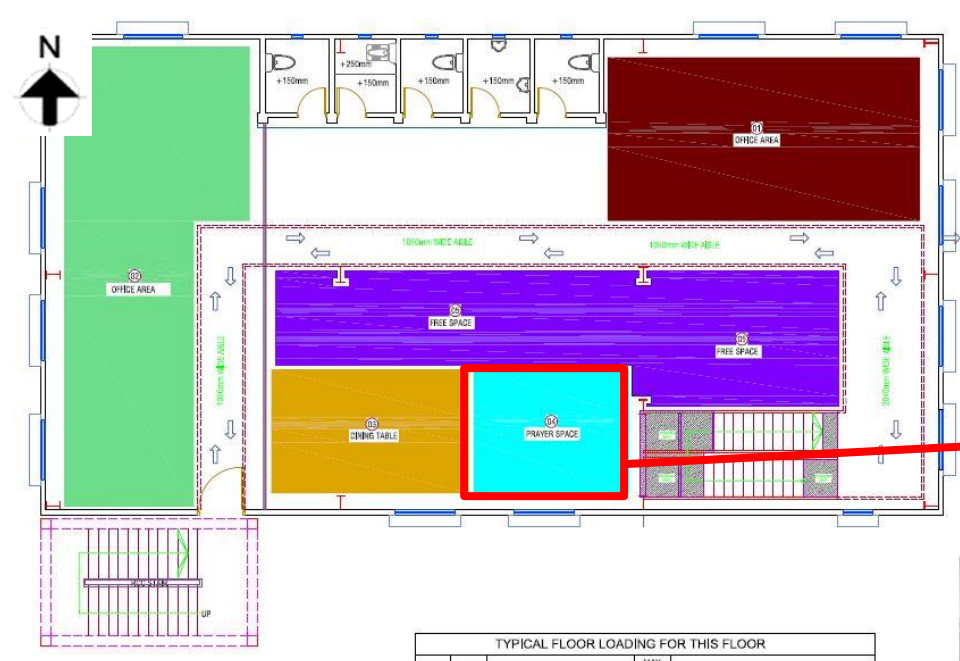
Live load plan- 1<sup>st</sup> floor

Live load considered as 3 kPa for Prayer

Live load for prayer on 1<sup>st</sup> floor is considered as 3 kPa in prepared load plan. As per BNBC- Part 6, live load for assembly (without fixed seat) is required to be considered minimum 5 kPa. However, the building engineer is required to update the load plan as per BNBC requirement, revise the design report and submit to RSC for review.

| Item No. | Observation | Recommended Action Plan | Recommended Timeline |
|---|---|---|---|
| 17 | Load plan doesn't comply with BNBC (Building-2: Office Building) | Building engineer is required to revise the load plan as per BNBC requirement and check the design accordingly. | 6-weeks |
| 18 | Load plan doesn't comply with BNBC (Building-2: Office Building) | Implement remediation work if required. | 6-months |

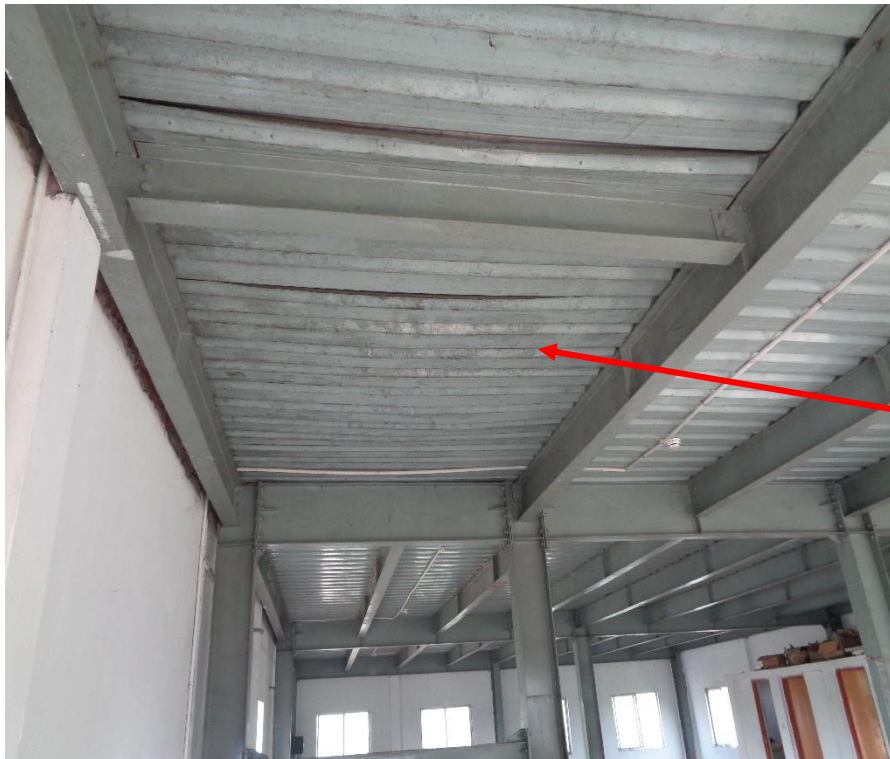
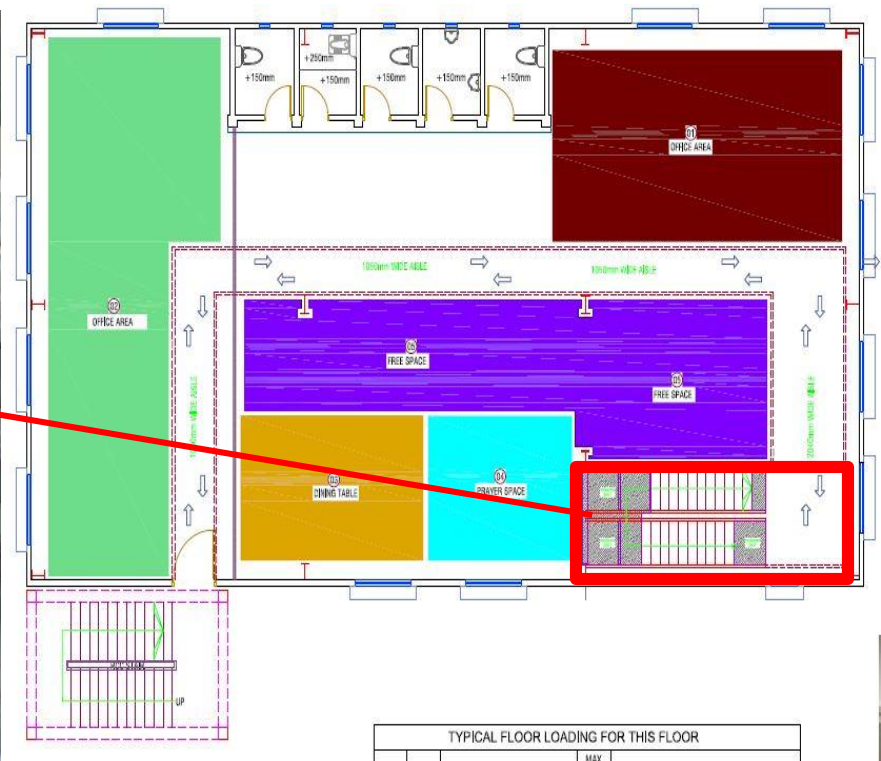
Deflection in steel deck slab (roof)

Deflection was found in steel deck slab (roof) at highlighted location. Building engineer is required to check the slab adequacy and propose remediation plan. Submit the remediation scheme to RSC for review.

| Item No. | Observation | Recommended Action Plan | Recommended Timeline |
|---|---|---|---|
| 19 | Deflection in steel deck slab (Building-2: Office Building) | Building engineer is required to check the slab adequacy, prepare remediation scheme and submit the design documents to the RSC for review. | 6-months |
| 20 | Deflection in steel deck slab (Building-2: Office Building) | Carry out remediation works where required. | 6-months |

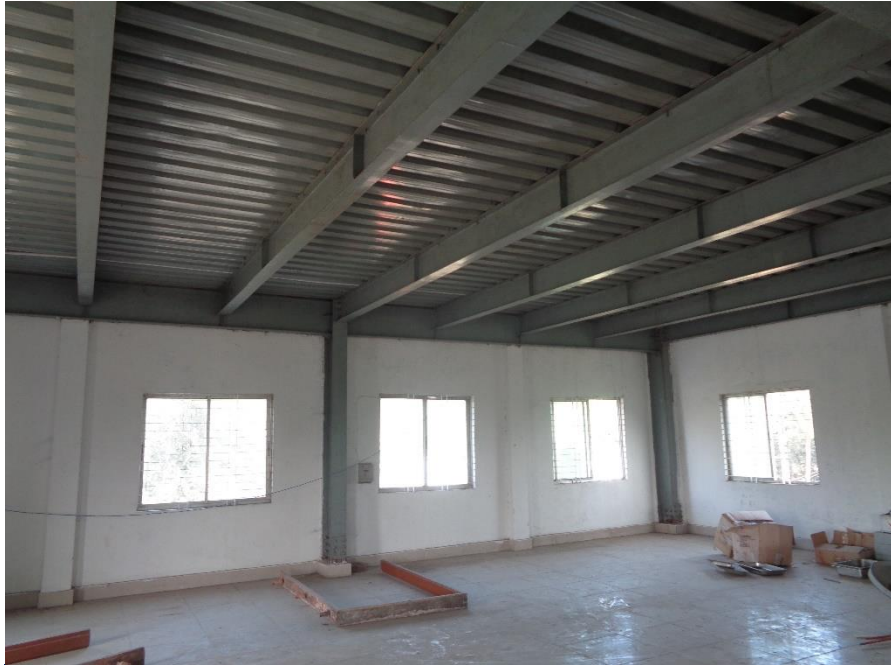
Additional plate not installed in steel beam

Additional plate is proposed for steel beam (at roof) but not installed. However, the factory is required to submit retrofitting design along with Engineering Assessment (EA) to the RSC for review. Complete all remediation work once the EA is accepted from RSC.

| Item No. | Observation | Recommended Action Plan | Recommended Timeline |
|---|---|---|---|
| 21 | Required remediation work is not completed (Building-2: Office Building) | Building engineer is required to check the slab adequacy, prepare remediation scheme and submit the design documents to the RSC for review. | 6-weeks |
| 22 | Required remediation work is not completed (Building-2: Office Building) | Complete all remediation work once the EA is accepted from RSC. | 6-months |

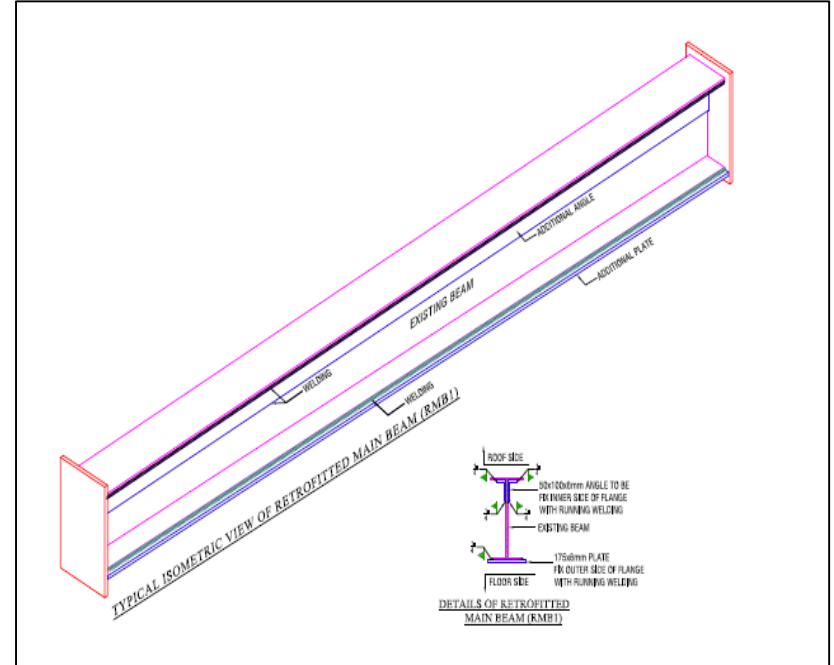
Additional plate is proposed for steel beam

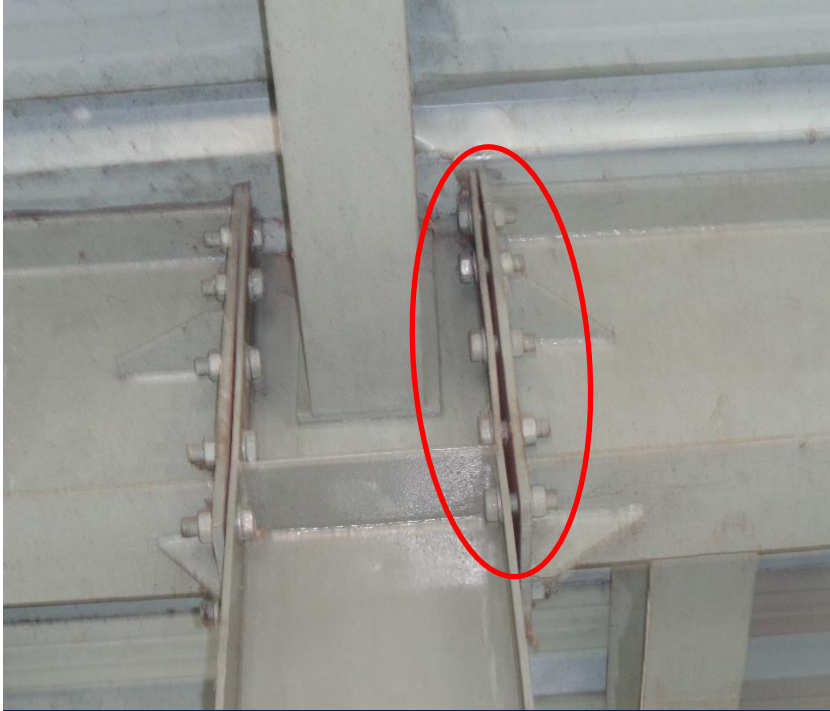
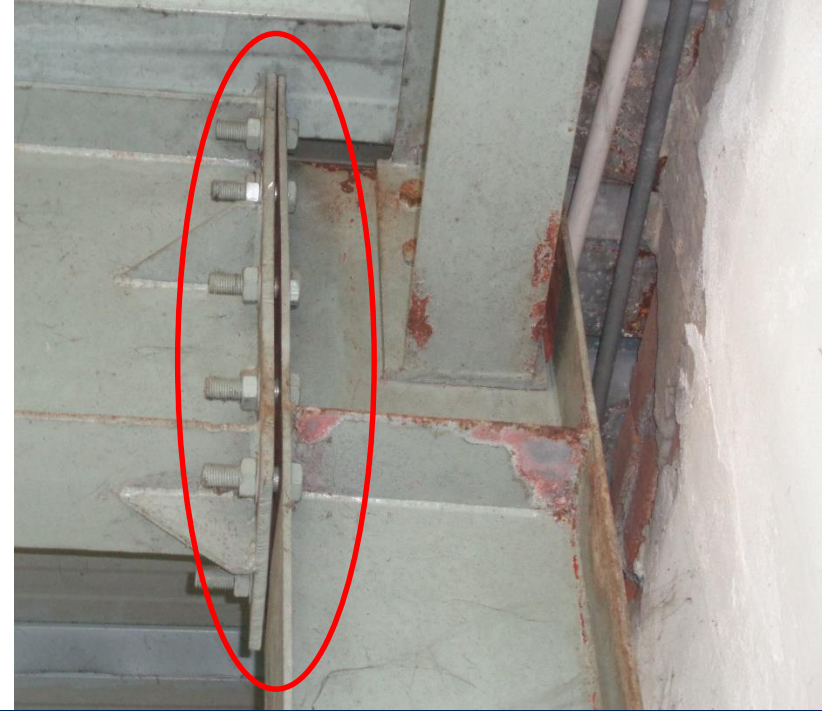
Significant gap in beam-column joint.

Significant gap was found in beam-column joint. Building engineer is required to identify all the connection gaps and fill the gaps with a suitable method.

| Item No. | Observation | Recommended Action Plan | Recommended Timeline |
|---|---|---|---|
| 23 | Significant gap in beam-column joint at several locations (Building-2: Office Building) | Building engineer is required to identify all the connection gap and fill the gaps with a suitable method. | 6-weeks |

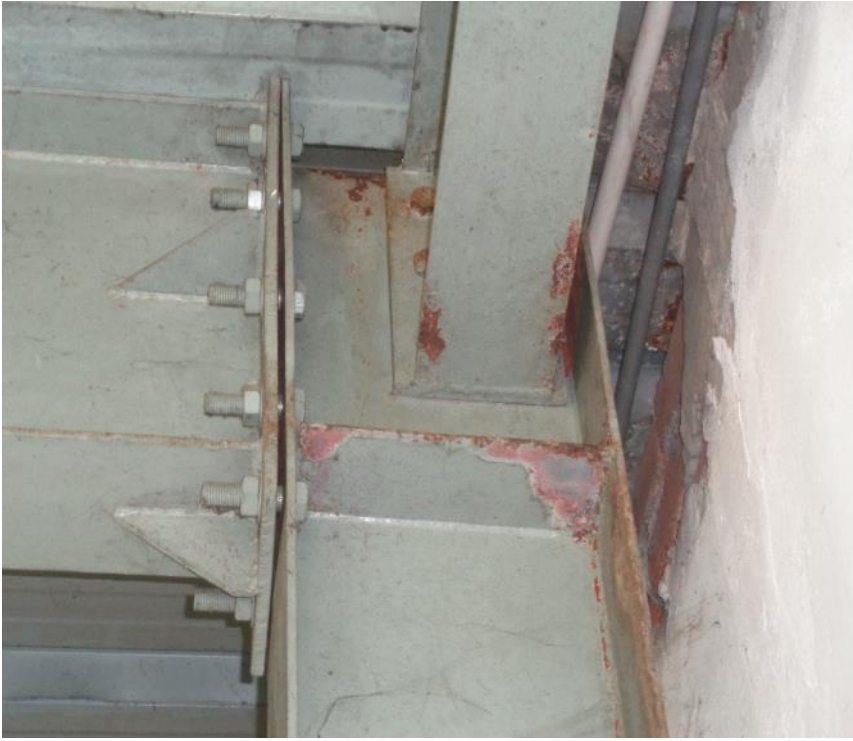
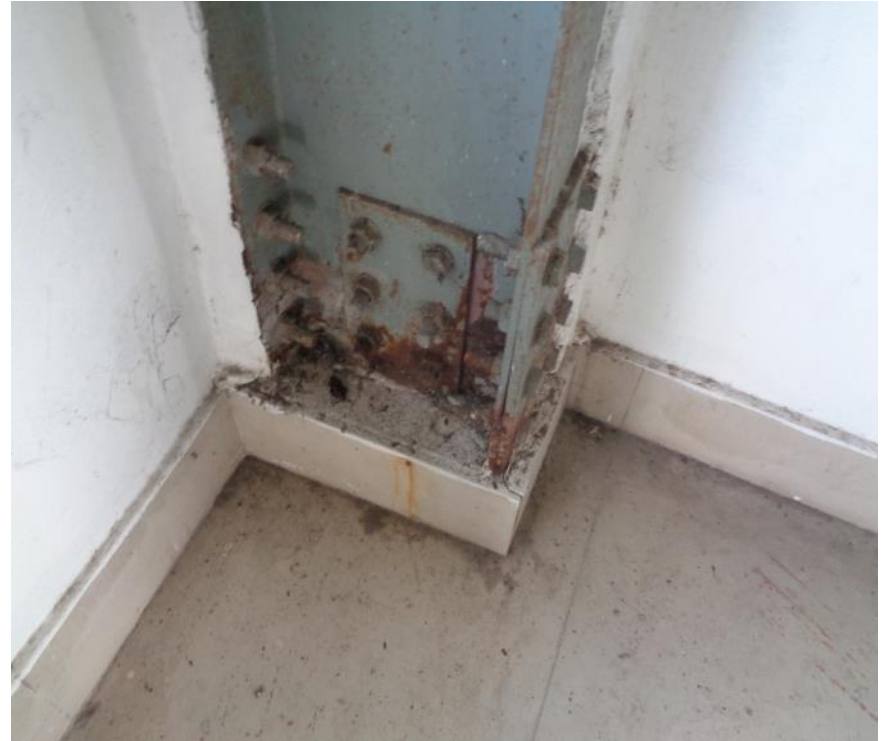
Severe corrosion in steel members

Severe corrosion was observed in steel members. Factory is required to remove the corrosion and provide rust proof paint on all steel members to protect from further corrosion.

| Item No. | Observation | Recommended Action Plan | Recommended Timeline |
|---|---|---|---|
| 24 | Severe corrosion in steel members (Building-2: Office Building) | Factory is required to provide rust proof paint on all steel members to protect from corrosion. | 6-weeks |

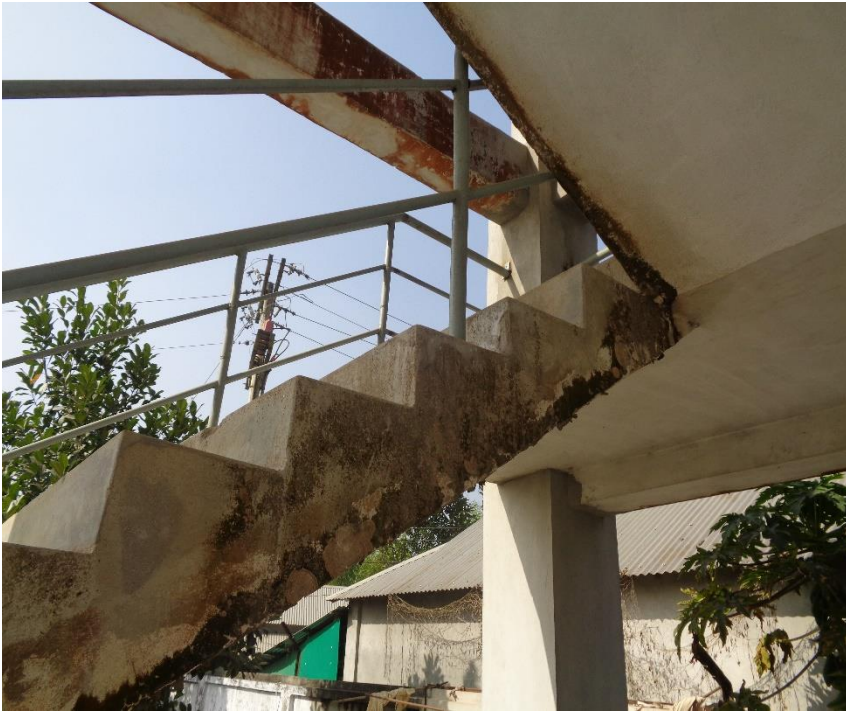
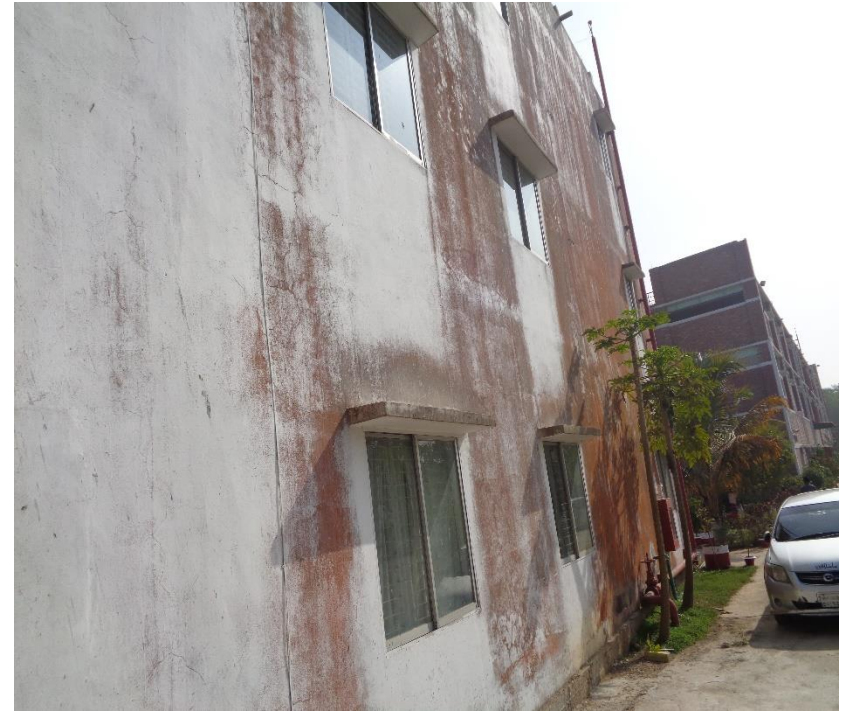
Dampness was found on periphery brick wall and stair zone

Dampness was found on periphery brick wall and stair zone. Factory is required to repair all damp areas as per suggestion of building engineer.

| Item No. | Observation | Recommended Action Plan | Recommended Timeline |
|---|---|---|---|
| 25 | Dampness on brick wall (Building-2: Office Building) | Factory is required to repair all damp areas as per suggestion of building engineer. | 6-weeks |

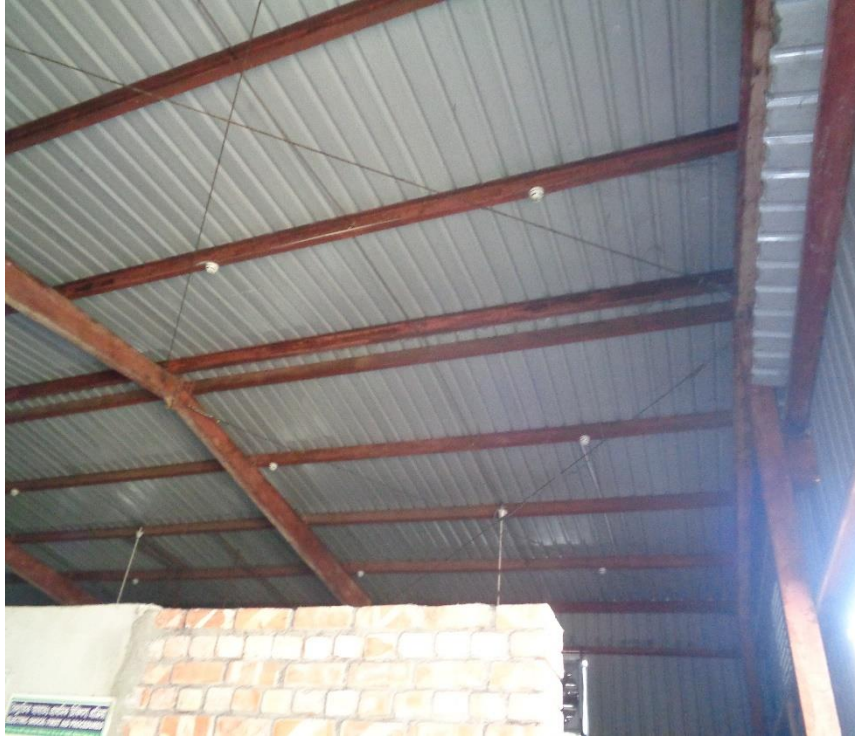
Roof bracing is provided at some locations

Roof bracing is provided at some locations but no compression member is provided from frame to frame to transmit the lateral load. Therefore, lateral stability system in the structure is apparently incomplete. Building engineer is required to carry out Engineering Assessment (EA) to check the lateral stability of the structure and submit the EA documents to RSC for review.

| Item No. | Observation | Recommended Action Plan | Recommended Timeline |
|---|---|---|---|
| 26 | Incomplete lateral stability system (Building-6 :Generator & Substation Room) | Building engineer is required to carry out Engineering Assessment (EA) to check the lateral stability of the structure and submit the EA documents to RSC for review. | 6-weeks |
| 27 | Incomplete lateral stability system (Building-6 :Generator & Substation Room) | Implement remediation work where required. | 6-months |
