# Magic Works Ltd

8/54 Jhalpaza, 10 Hobirbari Mymensingh, Bhaluka, Mymensingh, 2240  
(24.342420, 90.419369)  
29 January 2023

# Building Information

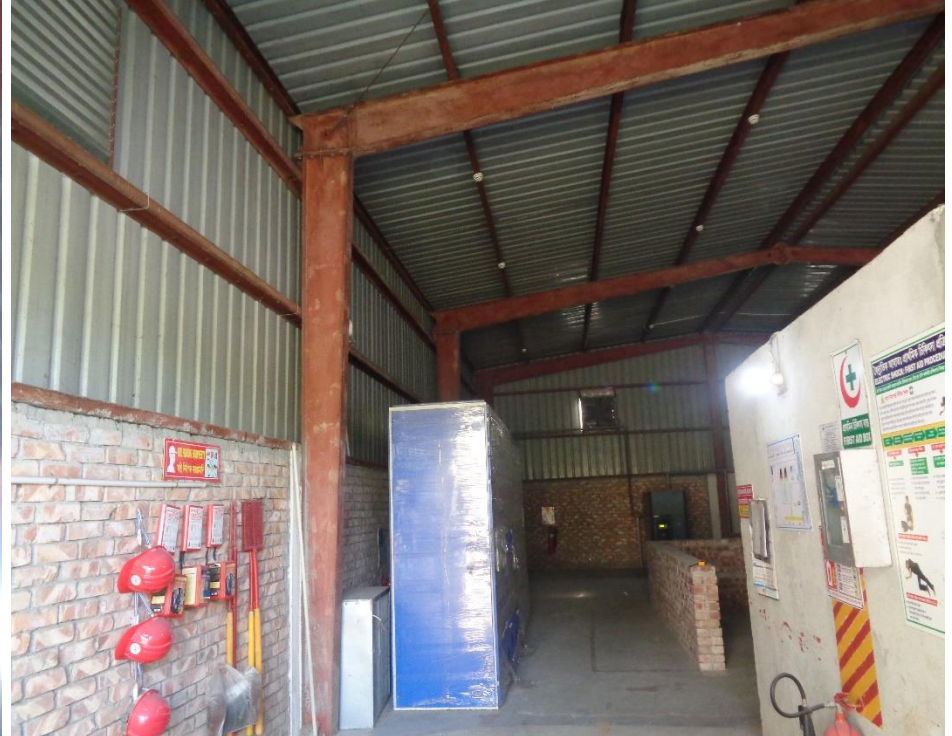
No compression member provided

Roof bracing is provided at some locations but no compression member is provided from frame to frame to transmit the lateral load. Therefore, lateral stability system in the structure is apparently incomplete. Building engineer is required to carry out Engineering Assessment (EA) to check the lateral stability of the structure and submit the EA documents to RSC for review.

| Item No. | Observation | Recommended Action Plan | Recommended Timeline |
|---|---|---|---|
| 26 | Incomplete lateral stability system (Building-6 :Generator & Substation Room) | Building engineer is required to carry out Engineering Assessment (EA) to check the lateral stability of the structure and submit the EA documents to RSC for review. | 6-weeks |
| 27 | Incomplete lateral stability system (Building-6 :Generator & Substation Room) | Implement remediation work where required. | 6-months |

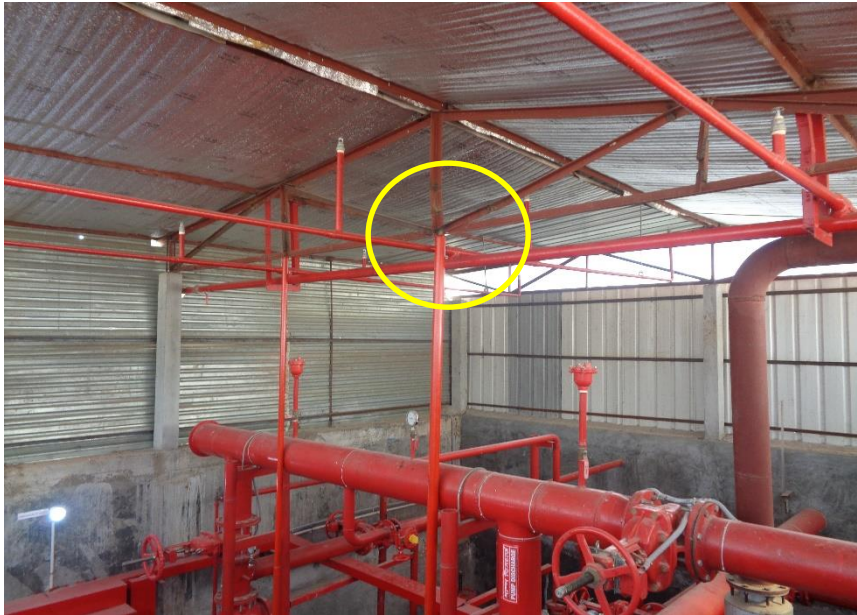
No joint plate observed in truss to column joint

Connection of truss to column was appeared to be inadequate due to poor connection (absence of baseplate, purlin inserted to brick wall). Building engineer is required to check the connection adequacy for uplift forces.

| Item No. | Observation | Recommended Action Plan | Recommended Timeline |
|---|---|---|---|
| 28 | Apparently inadequate connection (Building-7: Pump Room, Building-8: Workshop Shed) | Building engineer is required to check the connection adequacy for uplift forces. | 6-weeks |

| Item No. | Observation | Recommended Action Plan | Recommended Timeline |
|---|---|---|---|
| 29 | Apparently inadequate connection (Building-7: Pump Room, Building-8: Workshop Shed) | Implement remediation work where required. | 6-months |

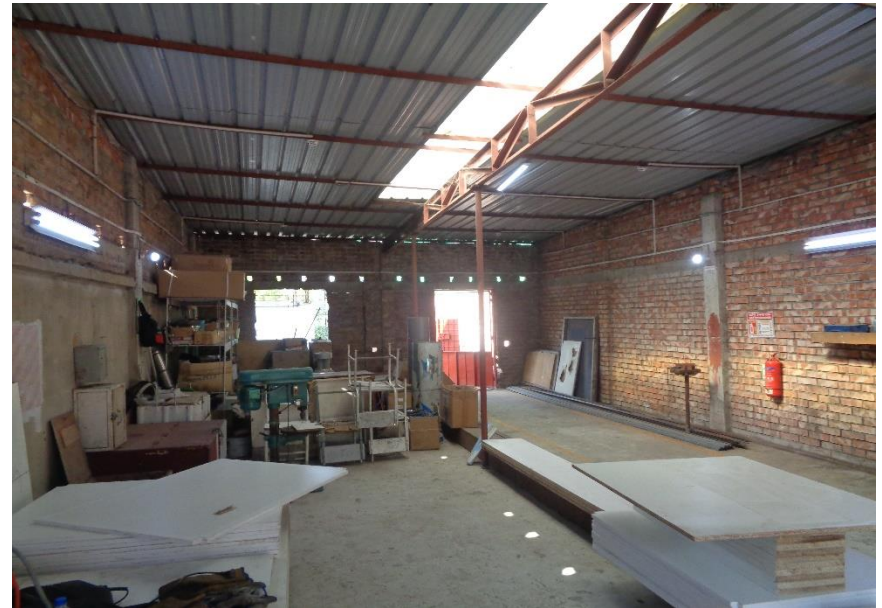
Purlin inserted to brick wall
