# KM APPAREL KNIT (Pvt) LTD. (Extensions)

Holding No-8/A, Chanpara, P.O: Azampur, Uttarkhan, Dhaka-1230  
(23.881119, 90.438585)  
05 February 2023

# Buildings Information

# Observations

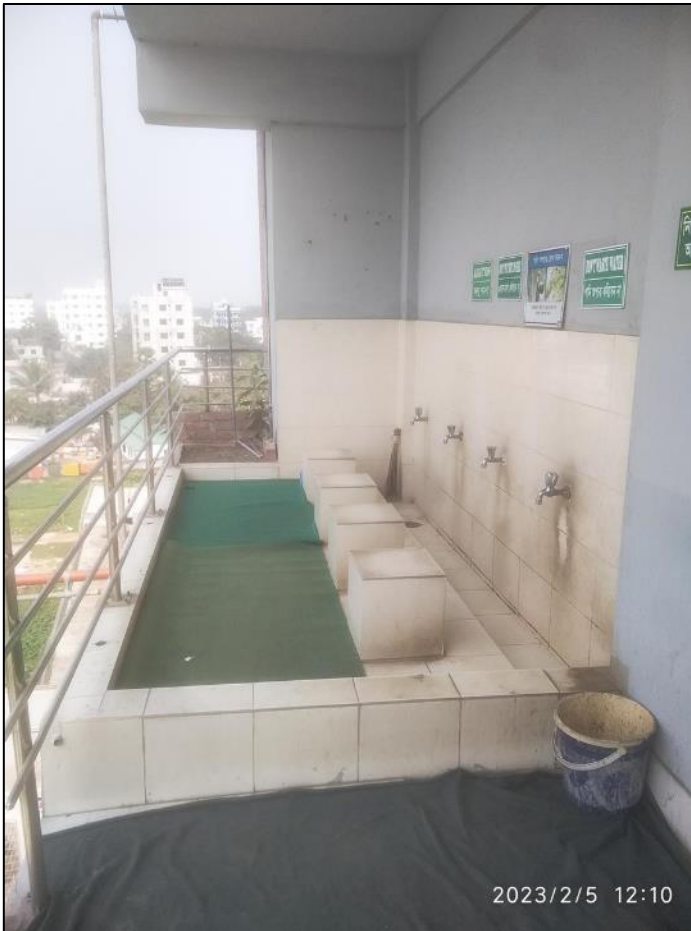
Source of water

Dampness due to water ingress was found in the female prayer room. The building engineer is required to seal the source of water and repair the damp area.

| Item No. | Observation | Recommended Action Plan | Recommended Timeline |
|---|---|---|---|
| 04 | Dampness due to water ingress. Building-2 (New Production Building) | The building engineer is required to seal the source of water and repair the damp area. | 6-weeks |

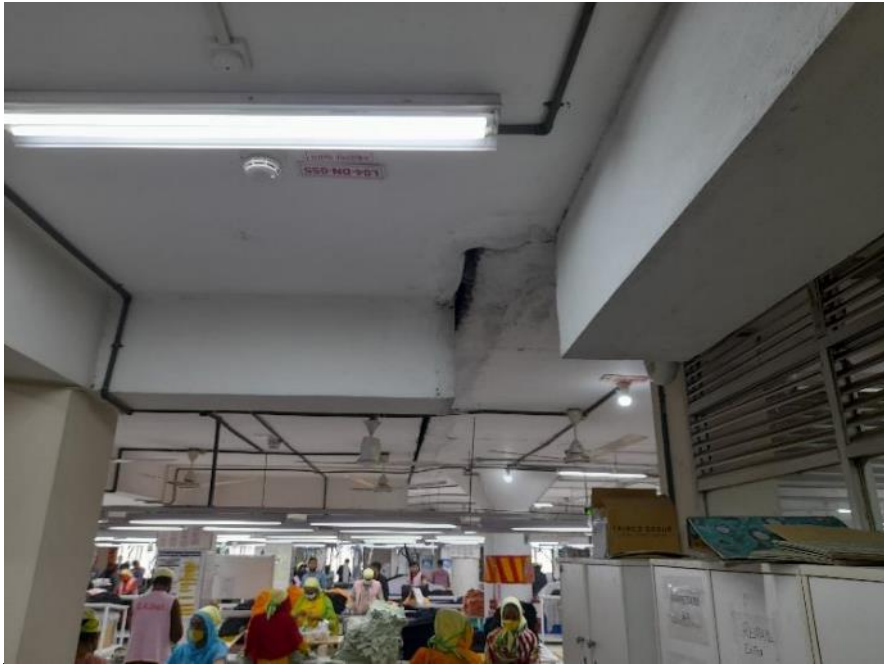
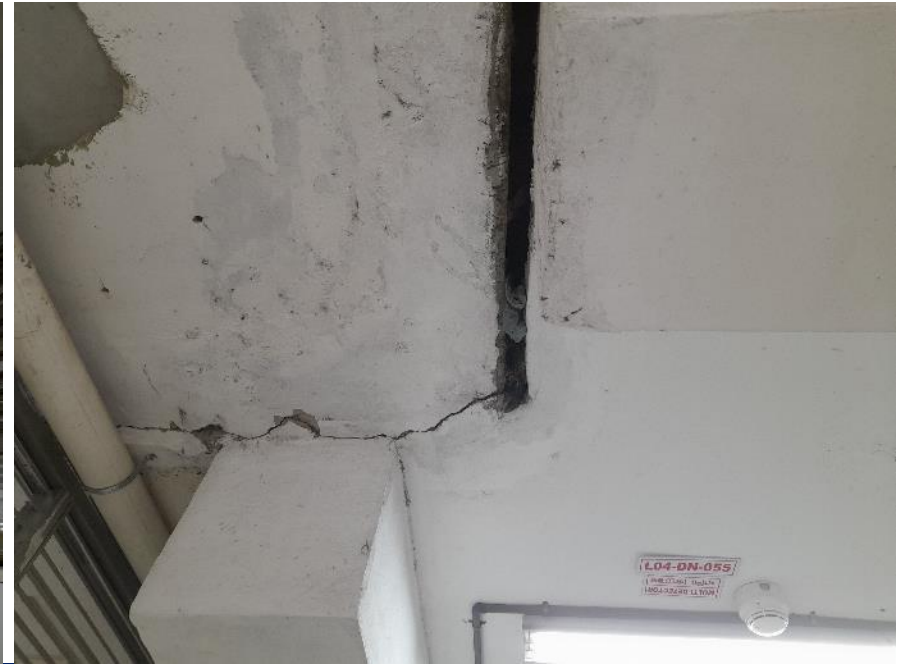
Loose material along the movement joints

Loose material observed along the movement joints which may be the cause of falling hazard. The factory is required to remove the loose plaster from the joints and as per the suggestion of building engineer fill the gap with appropriate (fireproof & compressible) materials.

| Item No. | Observation | Recommended Action Plan | Recommended Timeline |
|---|---|---|---|
| 5 | Loose material along the movement joints. Building-2 (New Production Building) | The building engineer is required to remove the loose concrete works from the joints. | 6-weeks |

| Item No. | Observation | Recommended Action Plan | Recommended Timeline |
|---|---|---|---|
| 06 | Loose material along the movement joints. Building-2 (New Production Building) | As per the suggestion of building engineer fill the gap with appropriate (fireproof & compressible) materials. | 6-months |

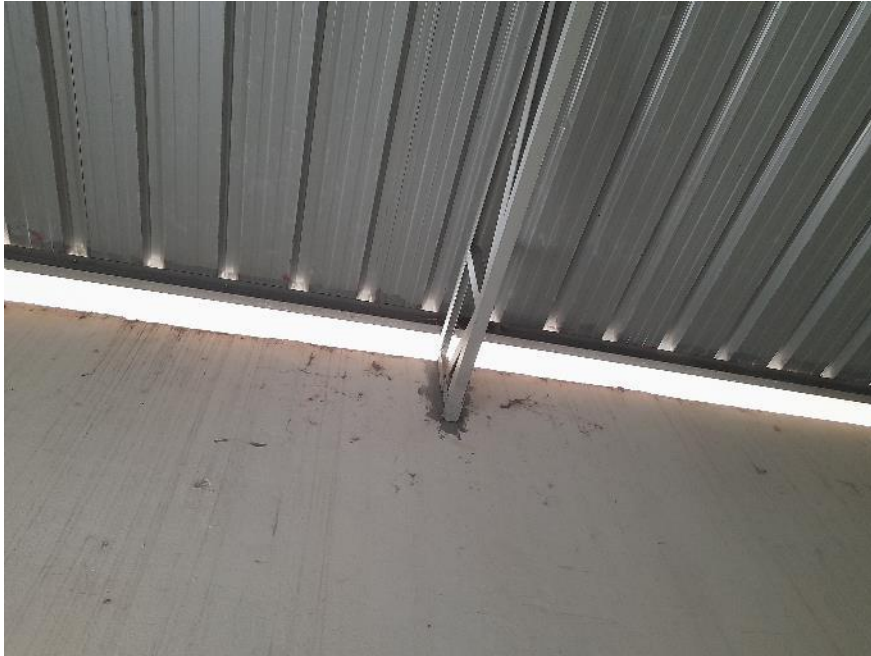
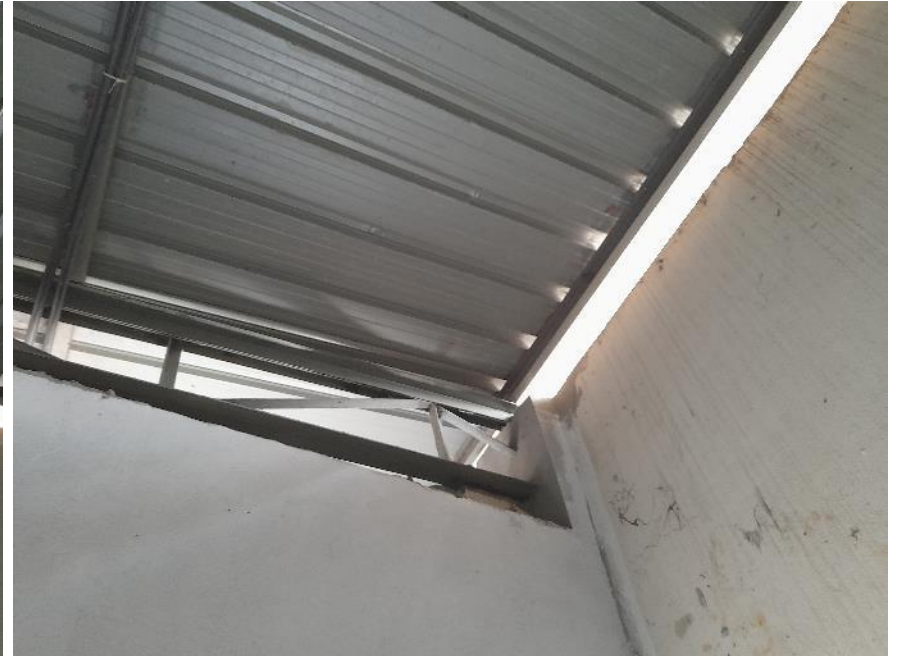
Truss to masonry wall connection

# **Anchorage for uplift forces**

The building engineer to verify the connection adequacy for uplift forces.

| Item No. | Observation | Recommended Action Plan | Recommended Timeline |
|---|---|---|---|
| 10 | Anchorage for uplift forces. (Jhut Room) | The building engineer to verify the connection adequacy for uplift forces. | 6-weeks |
| 11 | Anchorage for uplift forces. (Jhut Room) | Carry out remedial works if required. | 6-months |
