# **FIRE SAFETY INSPECTION REPORT**

**SAYEM FASHIONS LTD**  
**KAMARJURI, NATIONAL UNIVERSITY**

**ACCORD**  
on Fire and Building Safety in Bangladesh

August 24, 2014

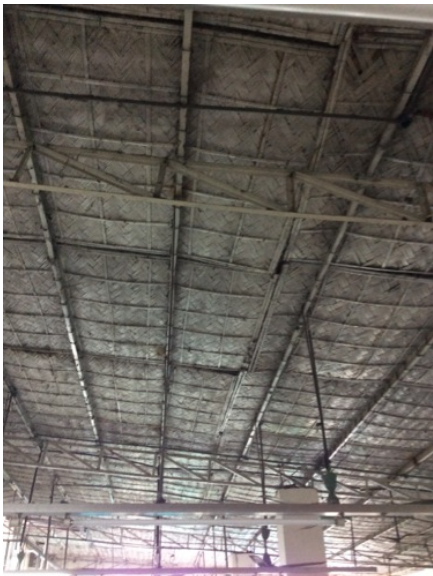
| No. | Category | Finding | Recommendation | Remediation Timeframe |
|---|---|---|---|---|
| F-1 | Fire Rated Construction | Building 1<br><br>The ceiling construction of the seventh floor west half was from a combustible material. | Remove the combustible material from the ceiling of the Building 1 seventh floor.. | Within 1 month |

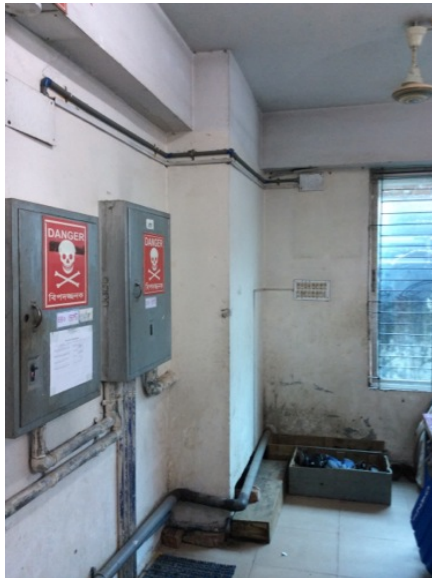
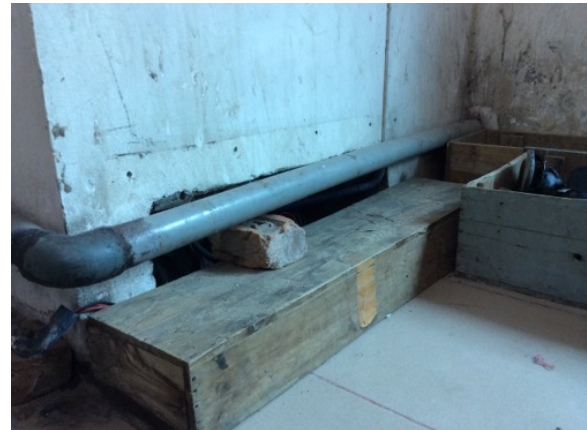
| No. | Category | Finding | Recommendation | Remediation Timeframe |
|---|---|---|---|---|
| F-2 | Fire Rated Construction | Building 1<br><br>The electrical shaft, located in the southwest corner, was not enclosed on the ground floor. | Enclose the electrical shaft on all floors. | Within 1 month |

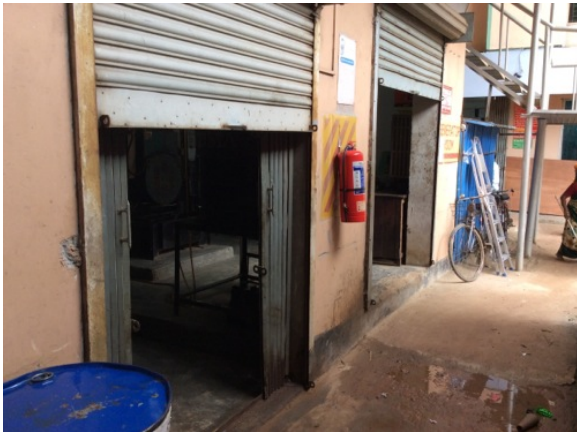
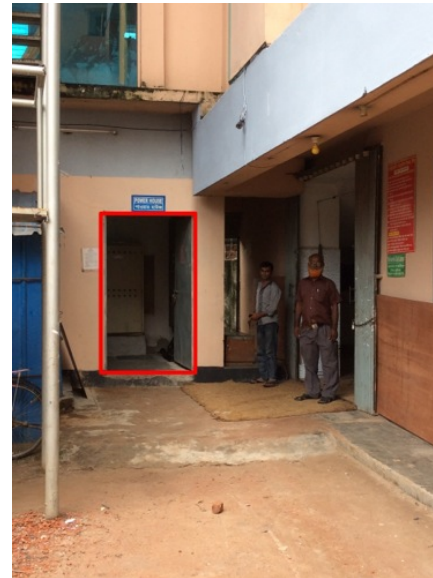
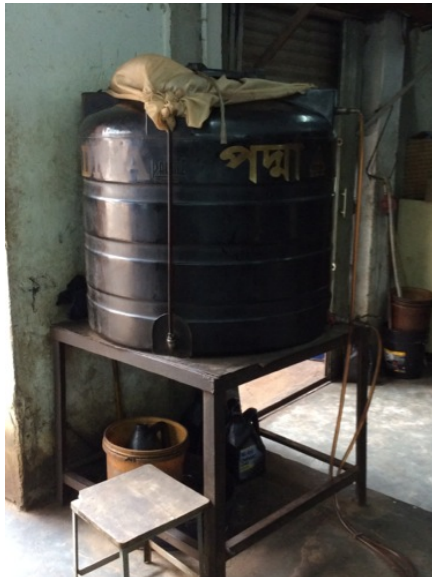
| F-3 | Fire Rated Construction | <p>Building 2</p> <p>The generator and transformer room, located on the ground floor is not separated by fire-rated construction due to non-rated doors, openings and penetrations.</p> <p>The generators and transformer were not separated from each other.</p> <p>Additional diesel fuel storage was present within the generator room.</p> | <p>Separate the generator and transformer room by a minimum 2-hr fire-rated construction. Seal and/or protected all openings to maintain the required fire separations.</p> <p>Separate the generators from the transformer by 2-hr fire-rated construction.</p> <p>Separate the diesel fuel storage from the utility room by 2-hr fire-rated construction.</p> | Within 3 months |

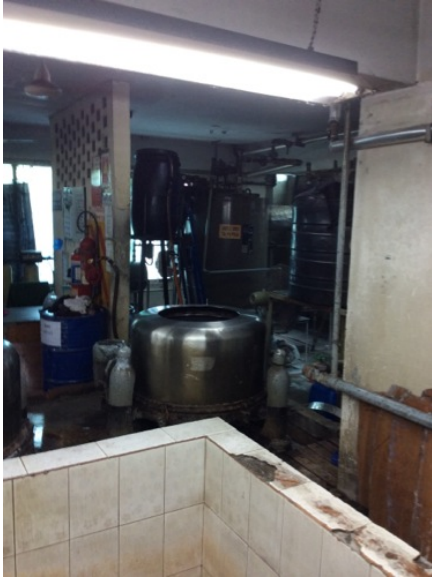
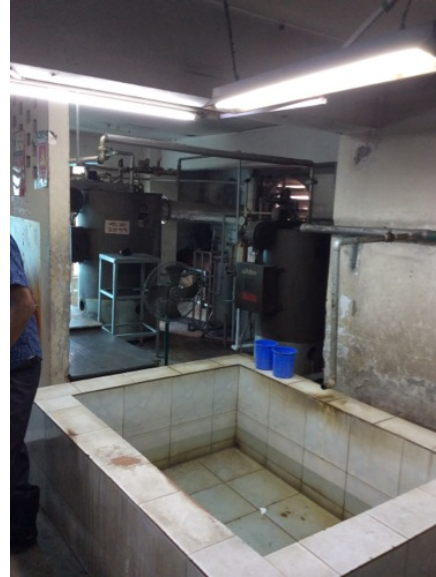
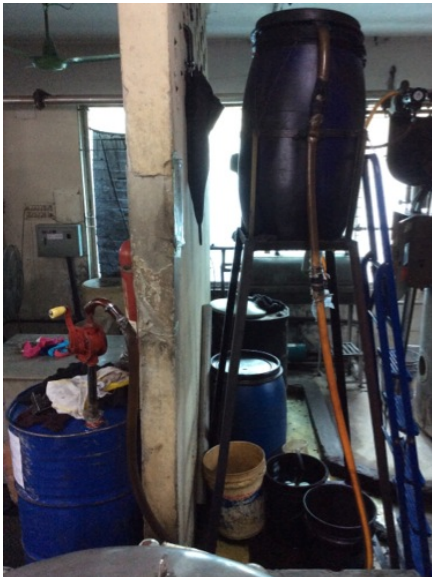
| F-4 | Fire Rated Construction | <p>Building 1</p> <p>The ground and first floor boiler rooms were not separated by fire-rated construction and open to the factory floors.</p> <p>Additional diesel fuel storage was located adjacent to the ground floor diesel boilers.</p> | <p>Separate the boiler rooms by a minimum 2-hr fire-rated construction. Seal and/or protected all openings to maintain the required fire separations.</p> <p>Separate the diesel fuel storage from the factory floor and ground floor boiler room by 2-hr fire-rated construction.</p> | <p>Within 3 months</p> |

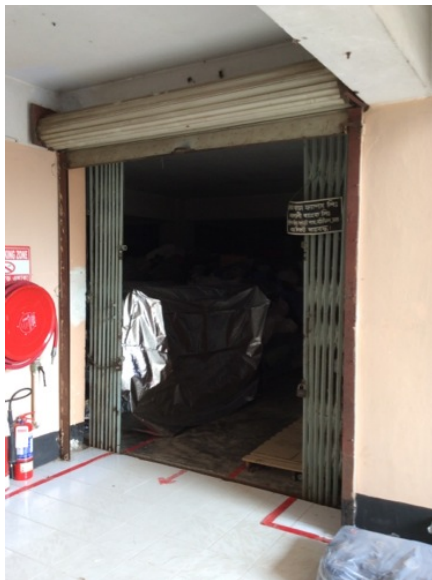
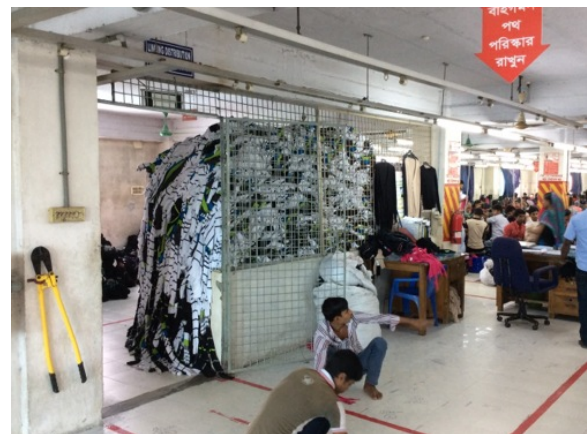
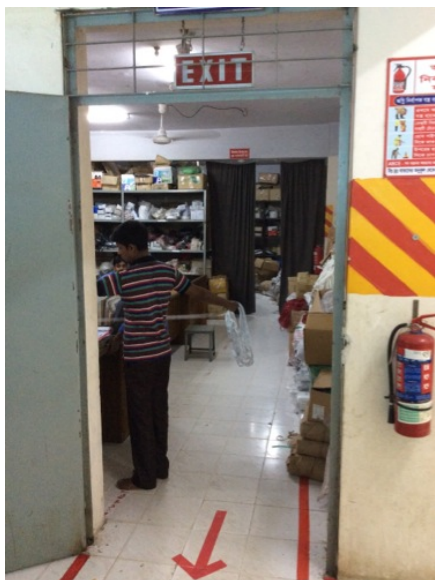
| F-5 | Fire Rated Construction | <p>Building 1</p> <p>Rooms used for combustible storage were not separated by fire-rated construction. Specifically, Building 1 had dedicated storage rooms on the ground (yarn store, packing section), first (metal free zone), second (accessory stores, knitting distribution), third (knitting distribution), sixth (linking distribution, knitting distribution) and seventh (distribution section) floors.</p> | Provide dedicated storage rooms separated by minimum 1-hr fire-rated construction. | Within 3 months |

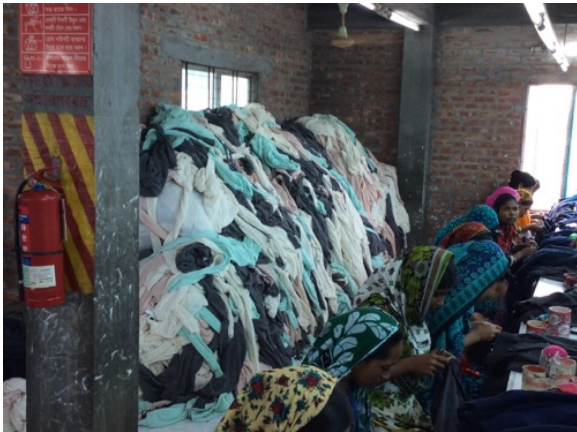
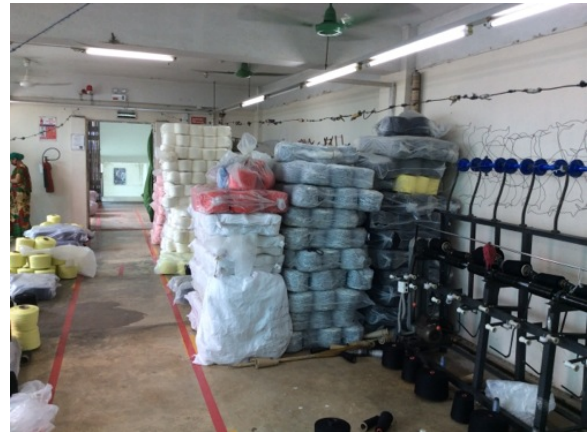
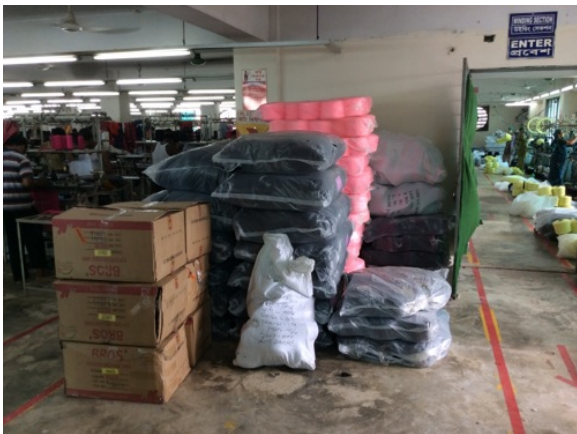
| F-6 | Fire Rated Construction | <p>Building 1/2</p> <p>Areas used for combustible storage, open to the factory floors, were not separated by fire-rated construction. Specifically, storage was open to the factory floor of Building 1 on all floors occupied by the factory (except the seventh) and in Building 2 on the third floor.</p> | <p>Provide dedicated storage rooms separated by minimum 1-hr fire-rated construction.</p> <p>Where separate storage rooms are not feasible, provide defined storage areas and limit the storage arrangement as follows:</p> <ul style="list-style-type: none"> <li>- Maximum height of 2.4m and maximum area of 23m<sup>2</sup></li> <li>- If sprinkler protected: maximum height of 3.66m and maximum area of 93m<sup>2</sup></li> </ul> <p>Separate areas of unenclosed combustible storage by a minimum clear distance of 3m.</p> | Within 3 months |

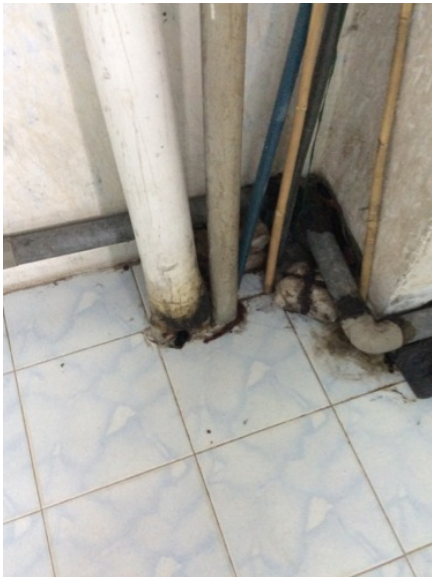
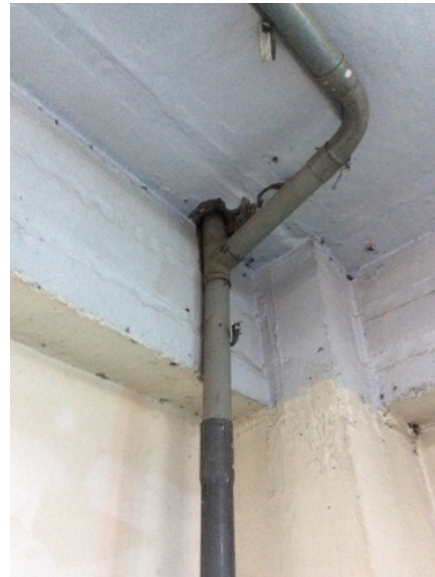
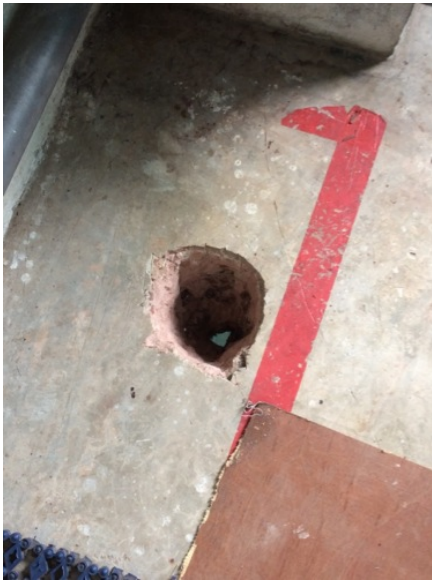
| F-7 | Fire Rated Construction | <p>Building 1</p> <p>Unsealed penetrations and openings are located in the fire-rated floor/ceiling assemblies. Specifically, there were floor/ceiling penetrations (non rated electrical piping) on the fourth through seventh floors. The fourth floor had an opening in the floor assembly to the third floor.</p> | <p>Provide a minimum 2-hr fire-rated shaft to separate the utility risers (electrical piping) from each floor level.</p> <p>Seal all penetrations and openings in floor/ceiling assemblies to maintain the fire separation.</p> | Within 3 months |

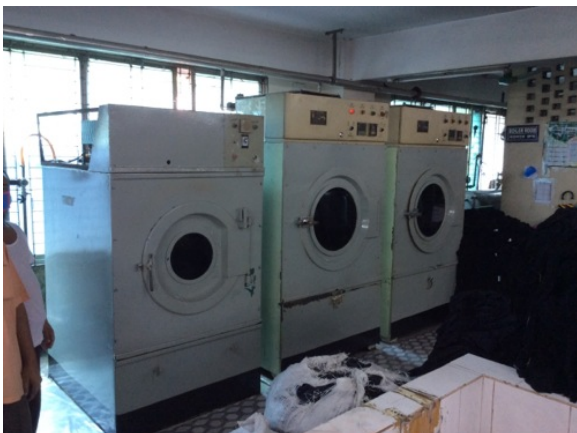
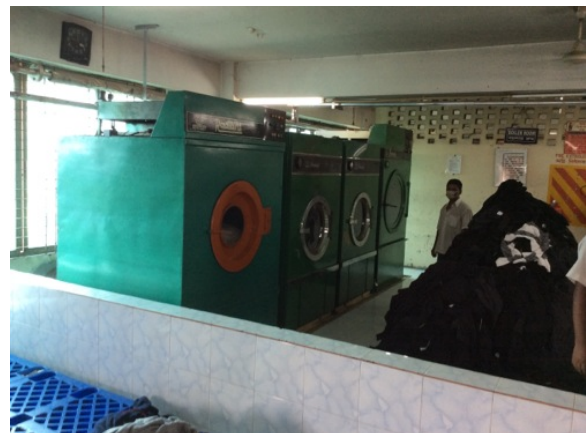
| F-8 | Fire Rated Construction | Building 1<br><br>The gas dryers (one (1) on the ground floor and (2) on the first floor) were not separated by fire-rated construction and open to the factory floors. | Separate the gas dryer areas by a minimum 2-hr fire-rated construction. Seal and/or protected all openings to maintain the required fire separations. | Within 3 months |

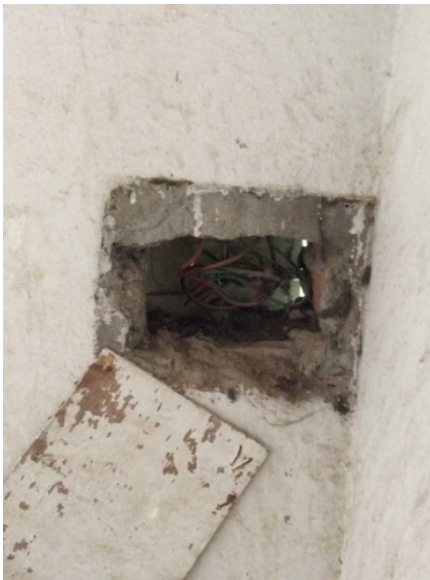
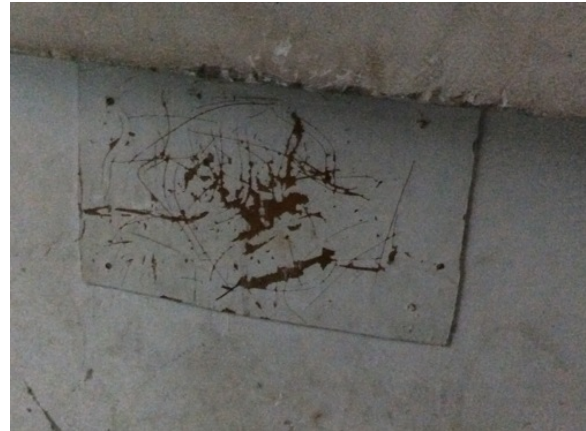
| F-9 | Fire Rated Construction | Building 3<br><br>Unsealed penetrations and openings are located in the exit stair enclosure on several floors. | Seal all penetrations and openings in the Building 3 exit stair enclosure walls to maintain the fire separation. | Within 3 months |

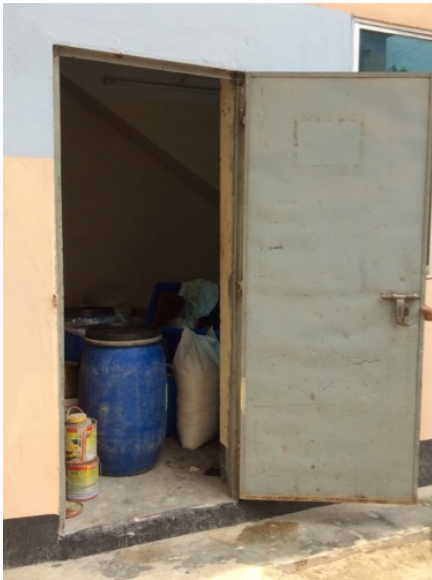
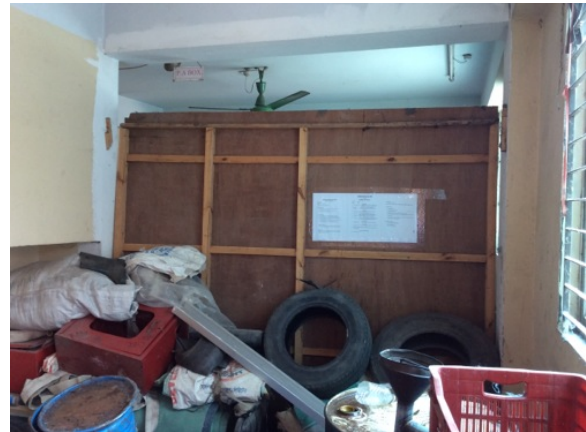
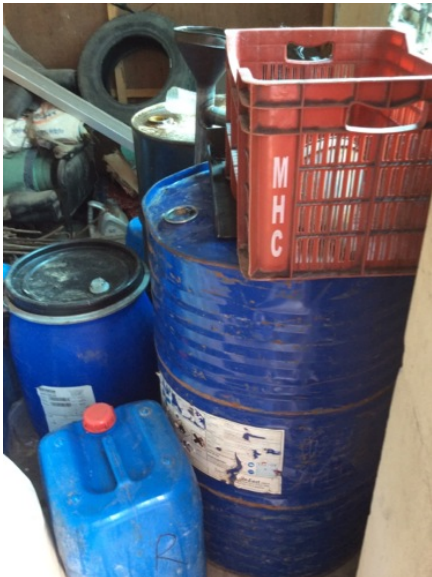
| F-10 | Fire Rated Construction | Building 3<br><br>Flammable liquid storage was present in the ground floor wastage godown and not separated by fire-rated construction due to openings and a non-rated door. | Separate the flammable liquid storage by a minimum 2-hr fire-rated construction. Seal and/or protected all openings to maintain the required fire separations. | Within 3 months |

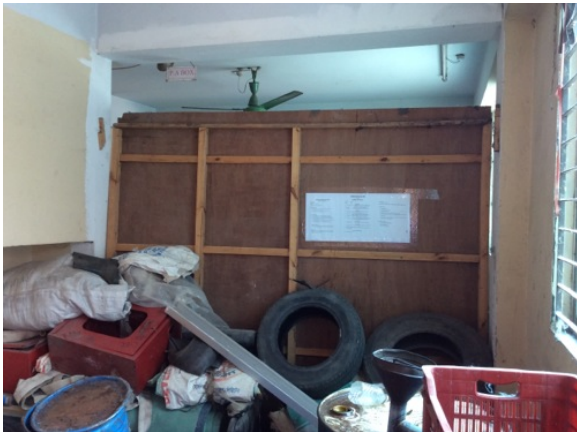
| F-11 | Fire Rated Construction | <p>Building 3</p> <p>A room used for combustible storage on the ground floor (wastage godown) was not separated by fire-rated construction and open to the placket section.</p> | <p>Provide dedicated storage rooms separated by minimum 1-hr fire-rated construction.</p> | <p>Within 3 months</p> |

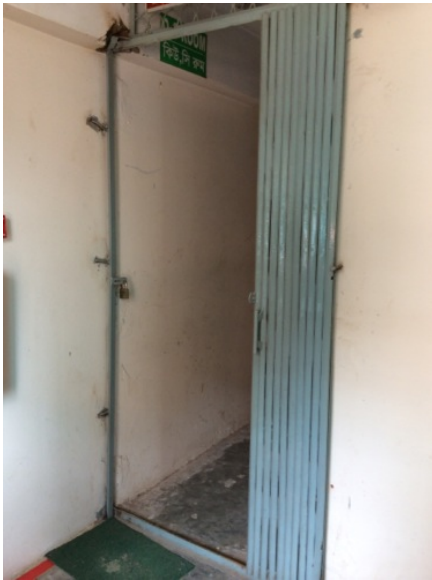
| F-12 | Fire Rated Construction | Building 3 | <p>Provide minimum 1.5-hr fire rated doors and seal all unprotected openings to separate the exit stairs from work areas and other building spaces on all floor levels. Ensure that the fire doors are self-closing and positive latching and that they are provided with fire exit (panic) hardware where serving production floors.</p> <p>If fire doors are required to be held open for functional reasons, provide automatic-closing devices tied to the fire alarm system.</p> | Within 3 months |

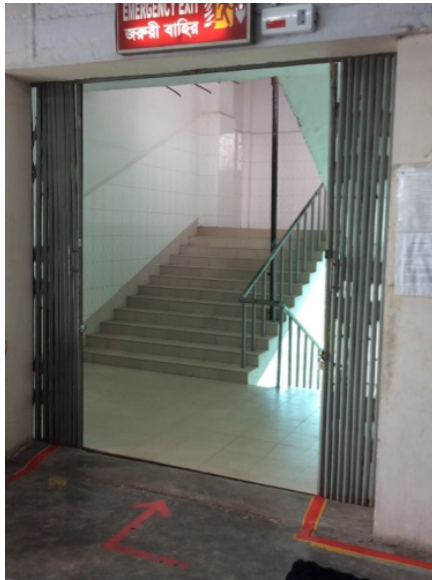
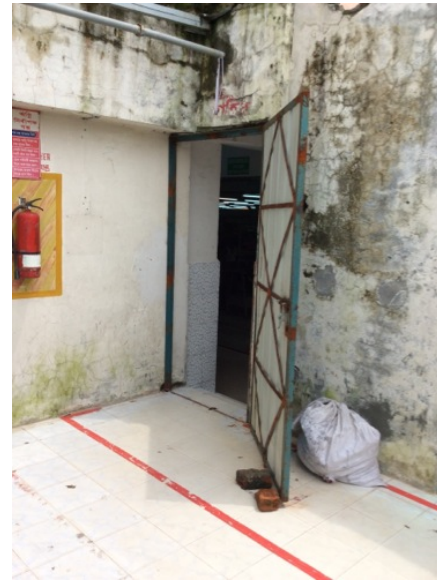
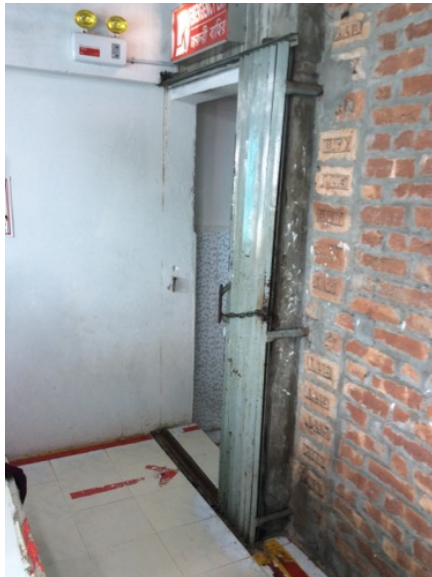
| F-13 | Fire Rated Construction | Building 1/2 | <p>The exit stairs are not separated from work areas and other spaces on each floor by fire-rated construction.</p> | <p>Provide minimum 1.5-hr fire rated doors and seal all unprotected openings to separate the exit stairs from work areas and other building spaces on all floor levels. Ensure that the fire doors are self-closing and positive latching and that they are provided with fire exit (panic) hardware where serving production floors.</p> <p>If fire doors are required to be held open for functional reasons, provide automatic-closing devices tied to the fire alarm system.</p> | Within 3 months |

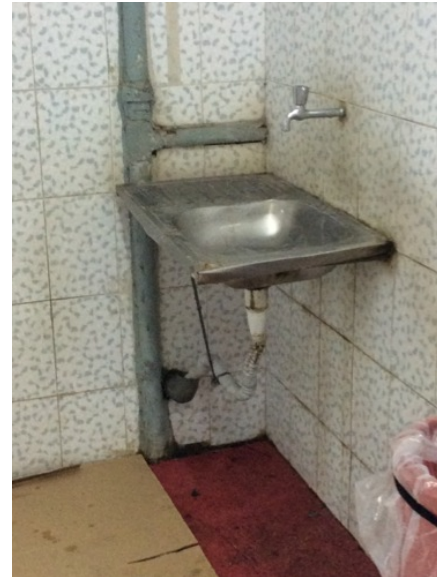
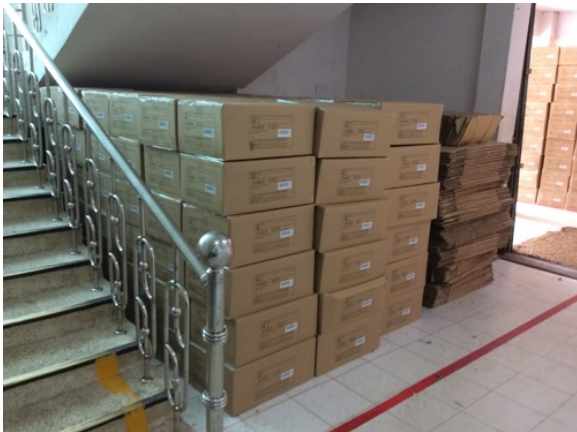
| F-14 | Egress | Building 1/2 | Remove all storage from all exit stairs and egress paths. | Immediate |
| <p>Storage was located in all exit stairs. Specifically, there was storage on all floors, in each exit stair of Building 1 (trash bins). The southwest exit stair of Building 1 (also shared with Building 2) had water sinks by floor, at the main floor landings and a garment chute from the fifth to ground floor. The southeast exit stair of Building 1 had packaged box storage on the ground floor. The Building 2 exterior exit stair had storage (garment bags) at the fourth floor landing.</p> | | | | |

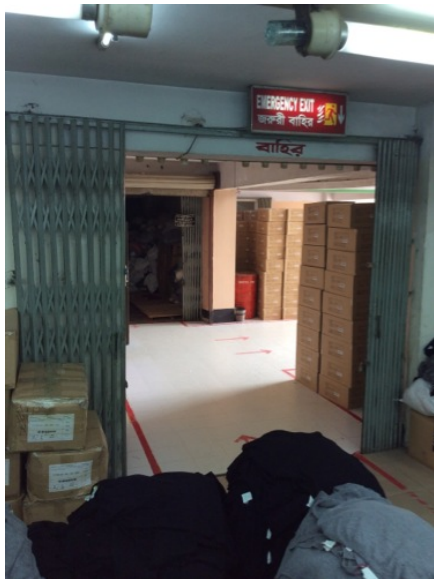
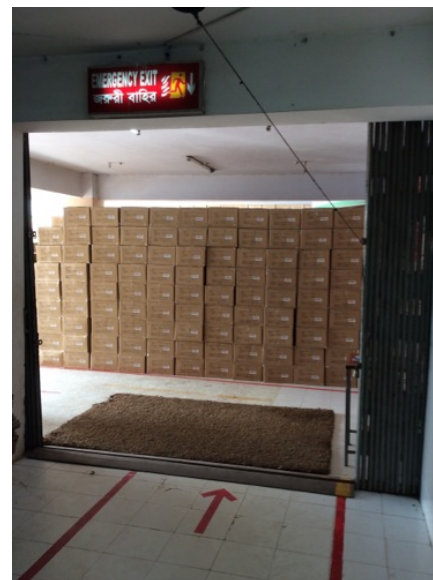
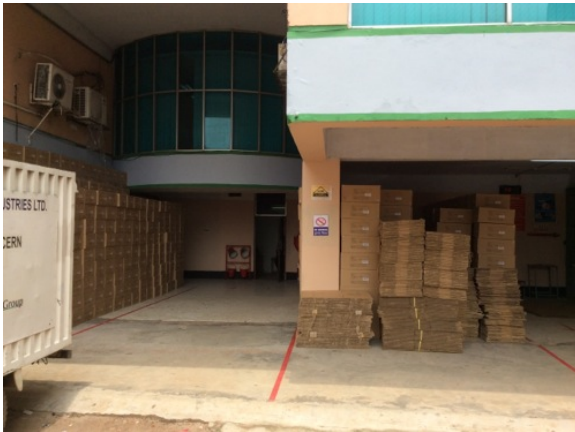
| F-15 | Egress | Building 1 | Immediately remove storage from the exit discharges or provide fire-rated separation of the storage areas. | Immediate |
| | | Storage was open to the exit discharge of the ground floor central exit and southeast exit stair. | | |

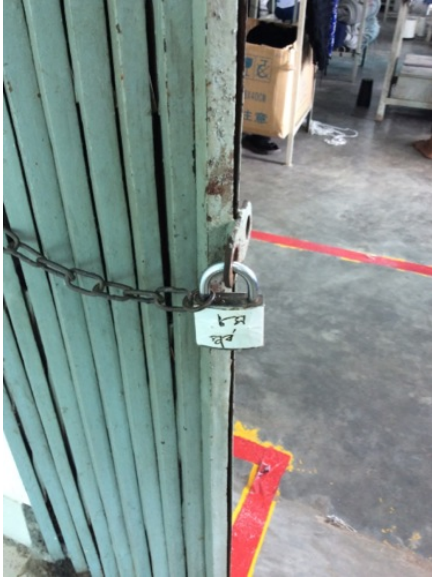
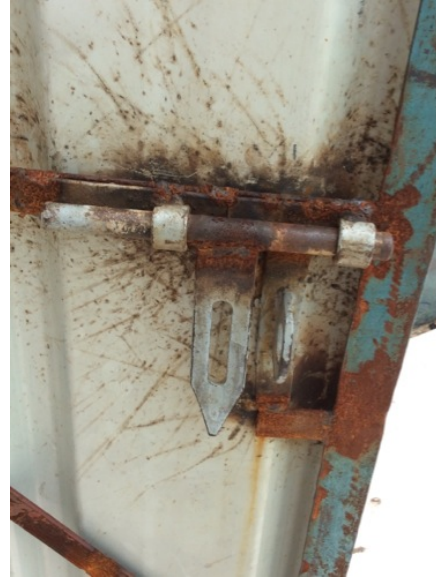
| F-16 | Egress | Building 1/2 | Remove locking features from all egress doors and gates. | Immediate |
| | | Egress doors and gates with locking features are provided at building exits, exit stairs and at exit discharge throughout Building 1 and egress gates with locking features are provided at exit stairs, along egress routes and at exit discharge throughout Building 2. | If locks are required for security reasons, utilize special door locking features complying with NFPA 101. | |
| | | All gates and doors throughout were open and unlocked during the inspection. | | |

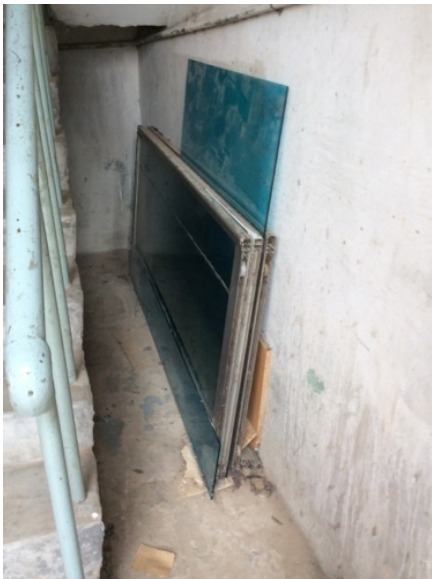
F-17 Egress

Storage was located in  
the exit stair on the  
ground floor (glass  
panes).

Remove all storage from exit  
stairs and egress paths.

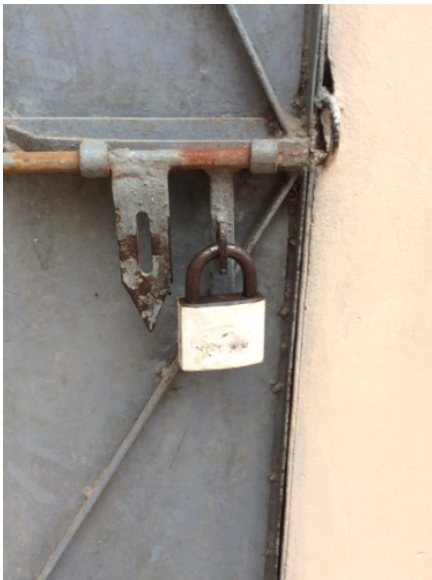
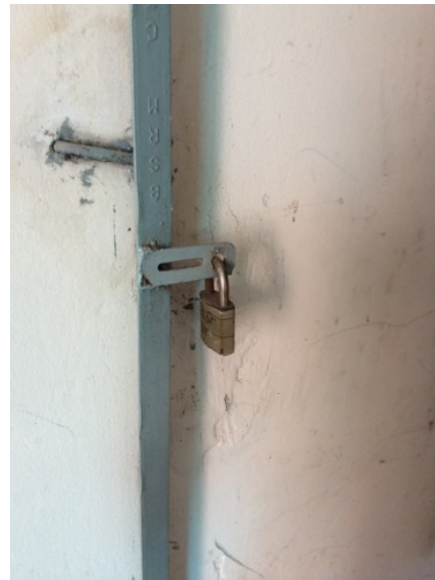
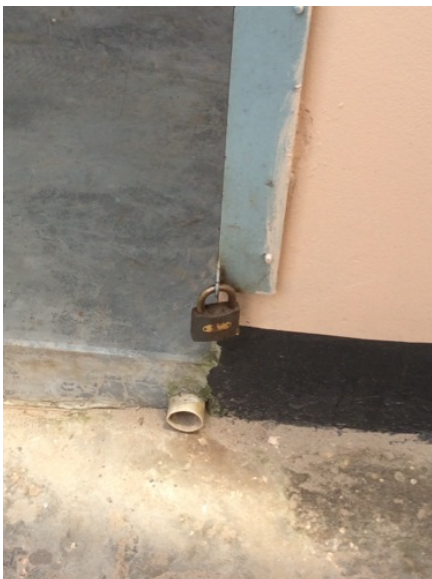
| F-18 | Egress | Building 3 | Remove locking features from all egress doors and gates. | Immediate |
| | | Egress doors and gates with locking features are provided at exit stairs, building exits and at exit discharge. | If locks are required for security reasons, utilize special door locking features complying with NFPA 101. | |
| | | All gates and doors were open and unlocked during the inspection. | | |

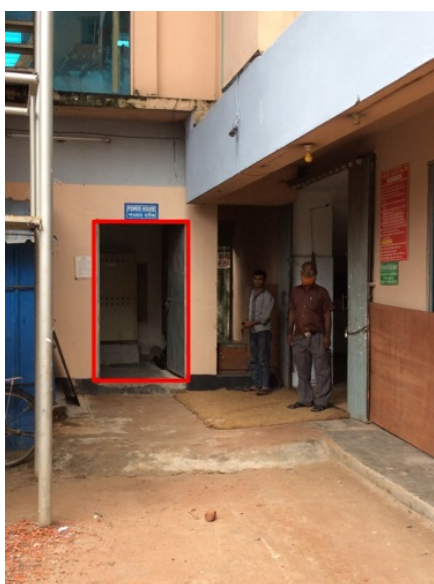
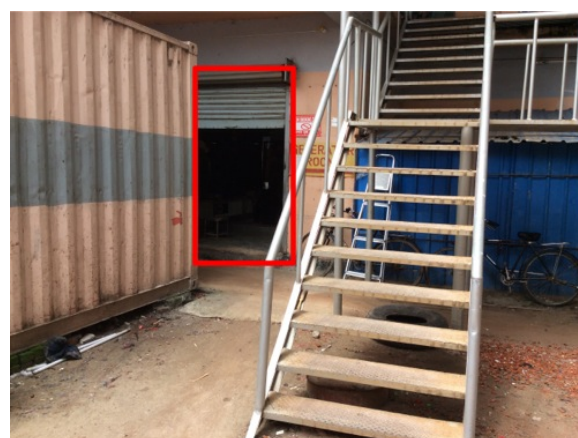
| F-20 | Egress | <p>Building 1/2</p> <p>Both the Building 2 exterior exit stair and the Building 1 southwest exit stair (also the Building 2 exit stair) discharge to unprotected openings from the Building 2, ground floor utility room.</p> | <p>Provide separation of the Building 2, ground floor utility room from the discharge of both exit stairs.</p> <p>If the maximum travel distance to an exit from the ground floor utility room of Building 2 is less than 26 ft., a single exit is permitted from the room.</p> | Within 1 month |

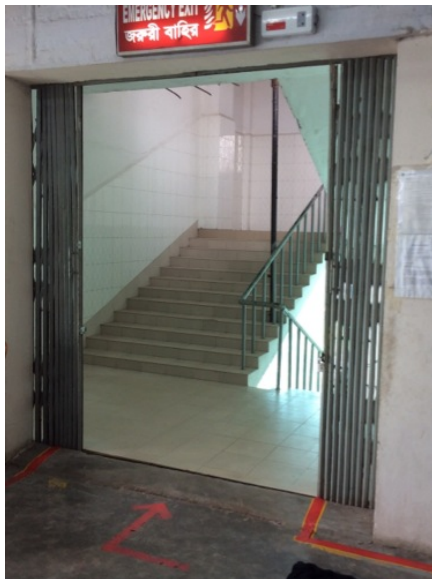
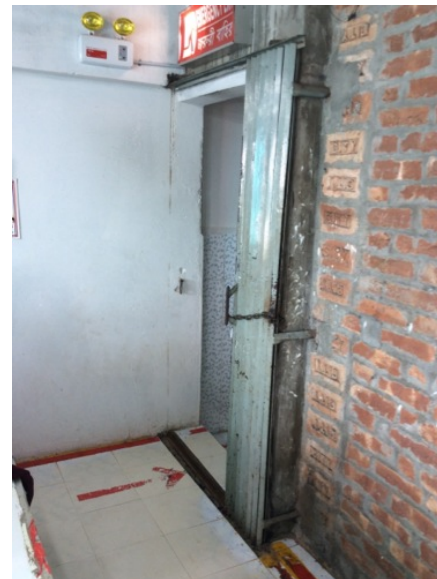
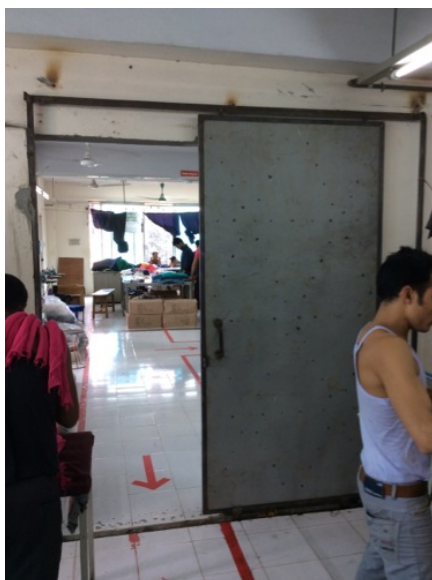
| F-22 | Egress | Building 1/2 | Replace all gates and sliding doors along the means of egress with side-hinged, swinging egress doors.<br><br>If locks are required for security reasons, utilize special door locking features complying with NFPA 101. | Within 1 month |
| | | Collapsible gates and sliding doors are provided at building exits, exit stairs, along egress routes and at exit discharge throughout Building 1 and collapsible gates are provided at exit stairs throughout Building 2. | | |

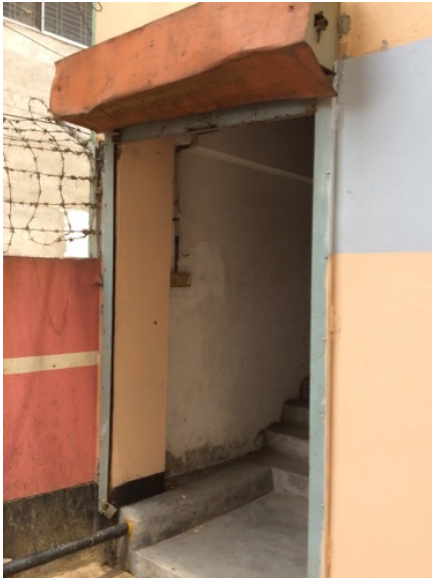
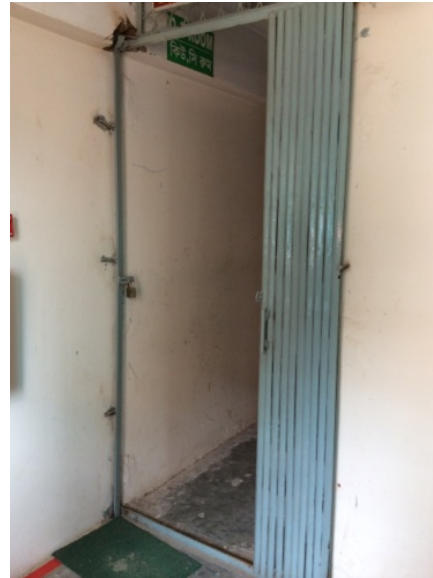
| F-23 | Egress | Building 3 | Replace all gates sliding doors along the means of egress with side-hinged, swinging egress doors. | Within 1 month |
| | | Collapsible gates and sliding door are provided at exit stairs and at exit discharge. | If locks are required for security reasons, utilize special door locking features complying with NFPA 101. | |

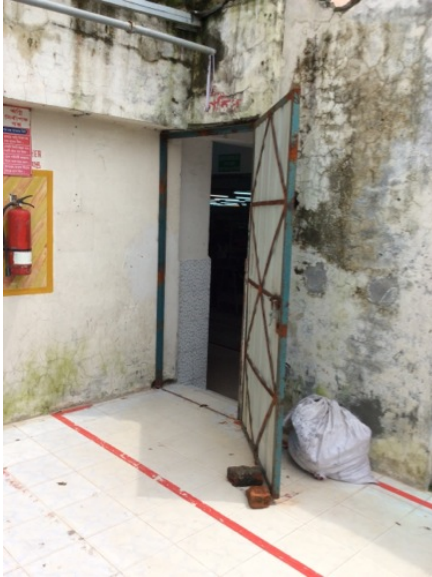
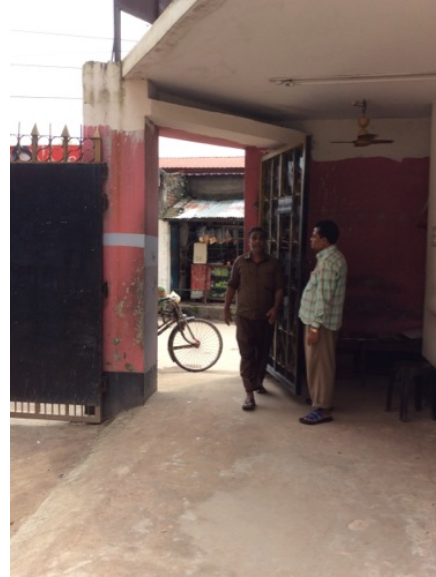
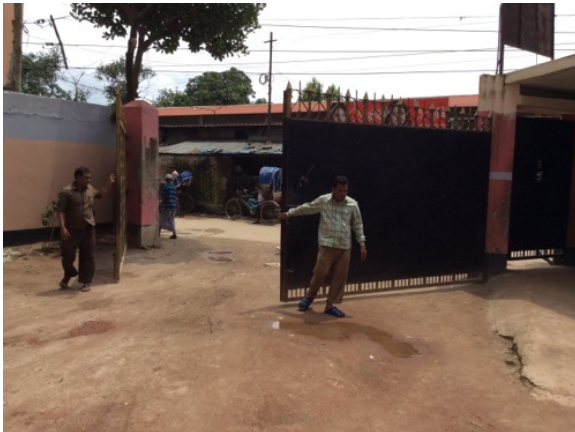
| F-24 | Egress | Building 2 | Modify the egress doors to swing in the direction of egress travel. | Within 3 months |
| | | The fourth floor door to the Building 1 southwest exit stair and the exterior, main entrance factory gates do not swing in the direction of egress travel. | | |

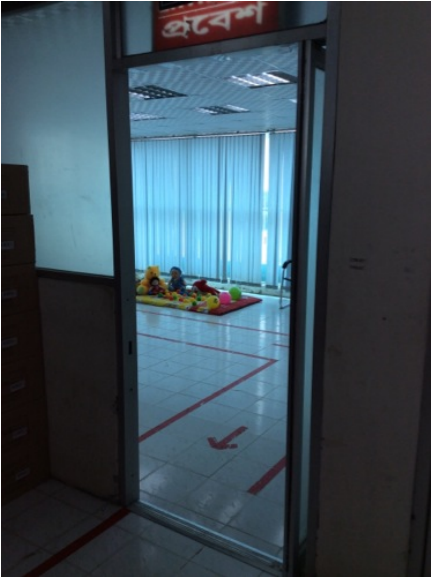
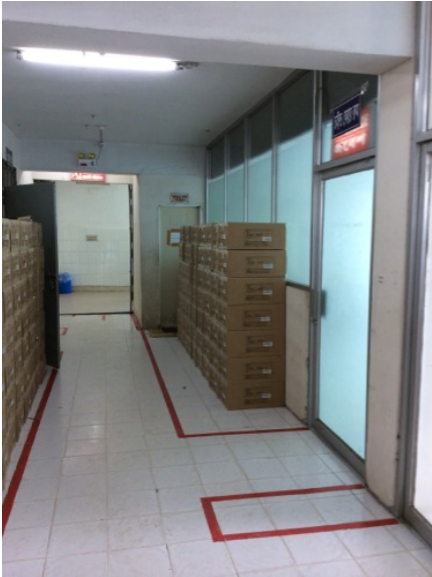
| F-25 | Egress | Building 1 | <p>Relocate the day-care room to a location where there is direct access to an exit stair.</p> <p>Alternately, provide a minimum 2-hr fire-rated exit corridor between the day-care room and the exit stair.</p> <p>Alternately, relocate the day-care room to a ground floor room where the maximum travel distance to the nearest exit is 9m (30 ft).</p> | Within 3 months |
| | | <p>The second floor day-care room does not have direct access to an exit stair. The approximate travel distance to the southeast exit stair is 27 ft.</p> | | |

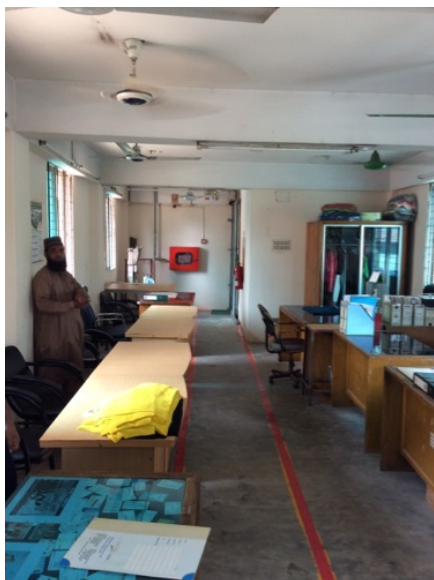
| F-26 | Egress | Building 3 | <p>Provide additional, remote means of egress from Building 3.</p> | Within 3 months |
| | | <p>A single means of egress is provided from the second to fourth floors.</p> <p>Due to the travel distances on the ground and first floor, a single exit is permitted on those floors.</p> | | |

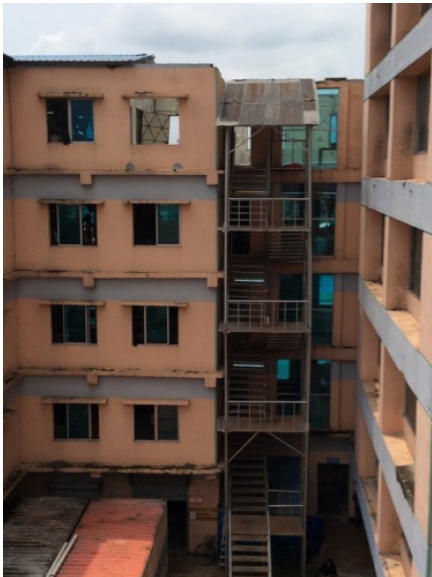
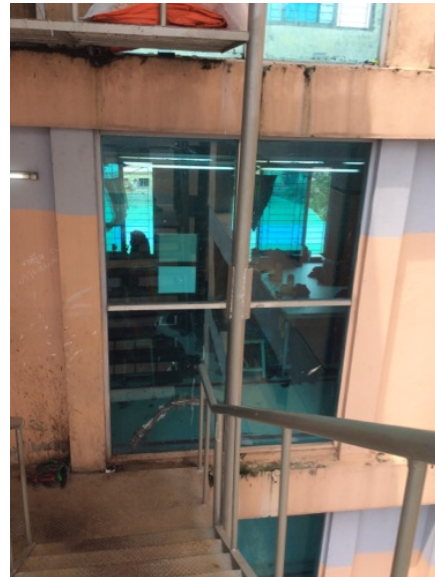
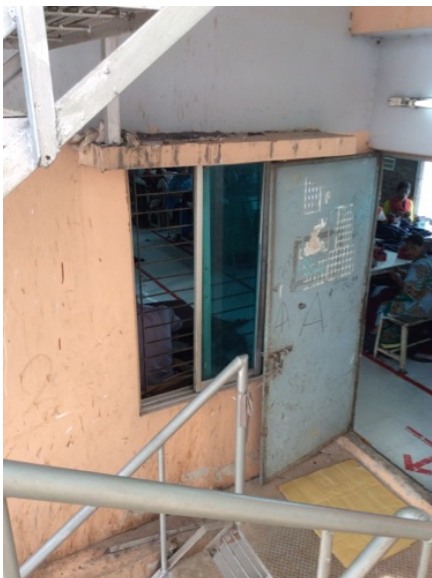
| F-28 | Egress | Building 2 | <p>Provide fire-rated separation of the Building 2 exterior exit stair extending at a distance of 10 ft. from all sides of the exit stair.</p> <p>If the Building 2 exterior exit stair is relocated to provide exit remoteness throughout the first to fourth floors, ensure that the new location of the exit stair meets the separation requirements.</p> | Within 6 months |

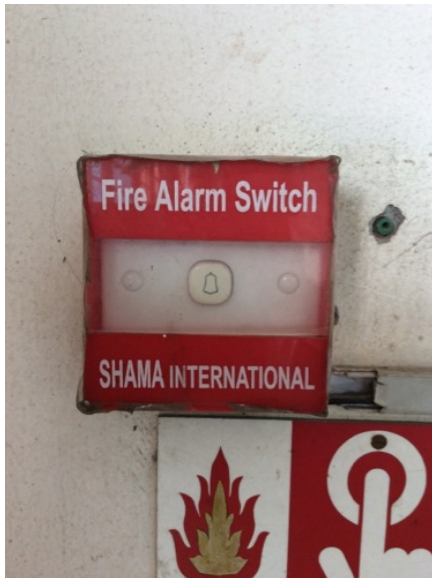
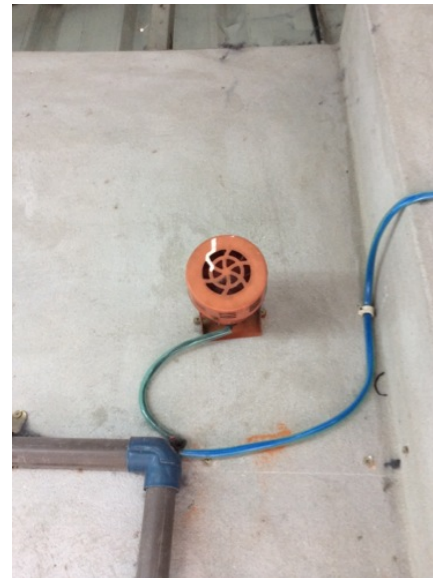
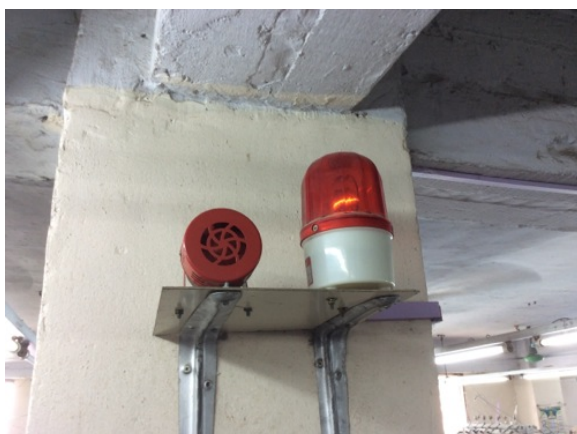
F-29 Fire Protection Building 1/2

The fire alarm system is antiquated, not a listed system, and does not provide alarm and notification features consistent with acceptable standards.

Replace the fire alarm system with a new, listed addressable fire alarm system in accordance with NFPA 72.

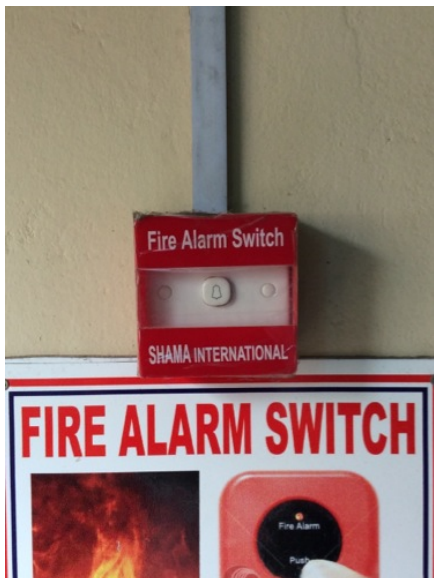
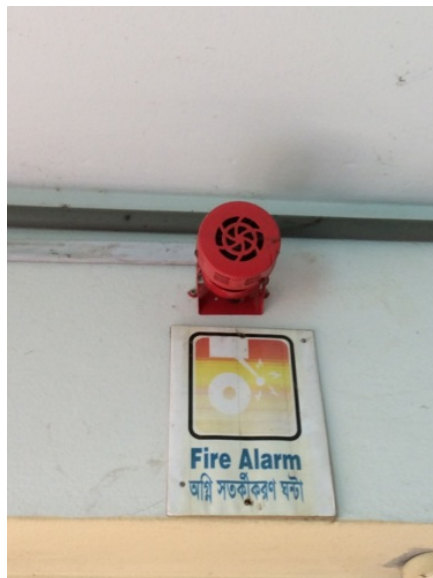
| F-30 | Fire Protection | Building 3 | <p>The fire alarm system is antiquated, not a listed system, and does not provide alarm and notification features consistent with acceptable standards.</p> | <p>Replace the fire alarm system with a new, listed addressable fire alarm system in accordance with NFPA 72.</p> | <p>Design within 4 months, install within 9 months</p> |

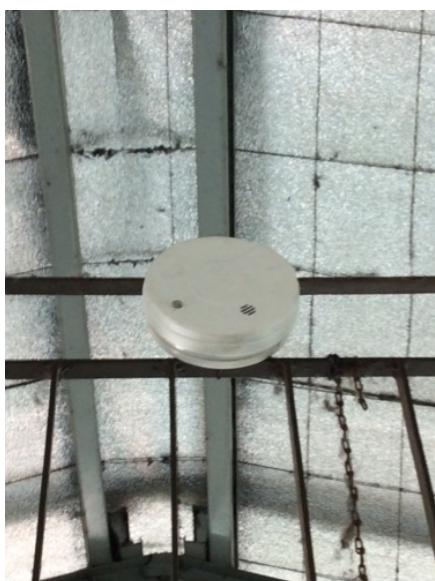
| F-33 | Fire Protection | Building 1/2 | Remove single-station smoke alarms. Provide automatic smoke detection throughout all factory buildings, tied into the fire alarm system, in accordance with NFPA 72. | Within 6 months |
| | | Buildings are equipped with single-station smoke alarms. Smoke alarm activation sounds only a local alarm and does not provide automatic fire alarm notification of occupants. | | |

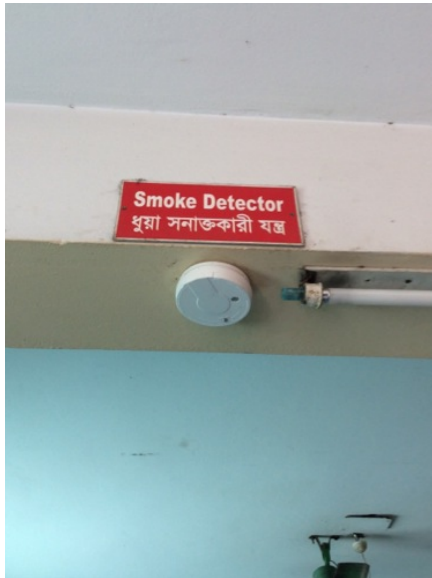
| F-34 | Fire Protection | Building 3 | Remove single-station smoke alarms. Provide automatic smoke detection throughout the building, tied into the fire alarm system, in accordance with NFPA 72. | Within 6 months |
| | | Building is equipped with single-station smoke alarms. Smoke alarm activation sounds only a local alarm and does not provide automatic fire alarm notification of occupants. | | |

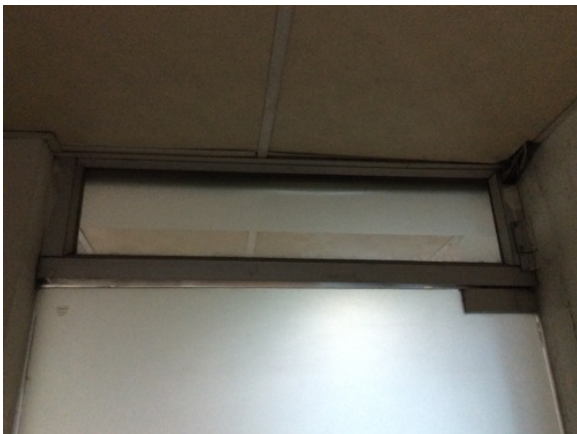
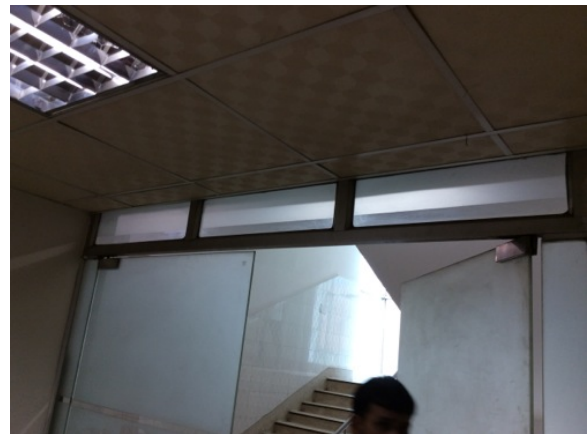
| F-35 | Egress Lighting | Building 1 | Provide exit signs above all exits to the exterior and all doors to the exit stairs. | Within 1 month |
| | | Exit signage not provided from the first floor office area and to the first floor southeast exit stair. | | |

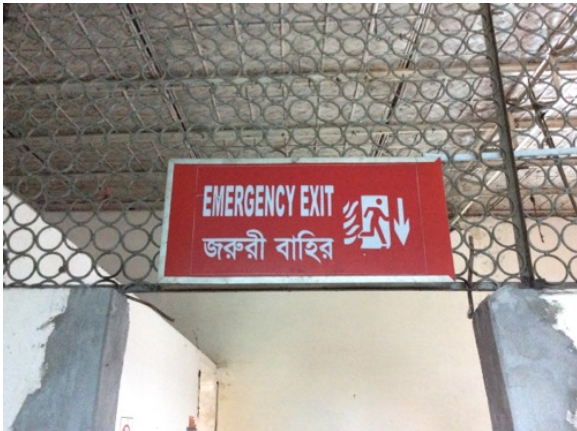
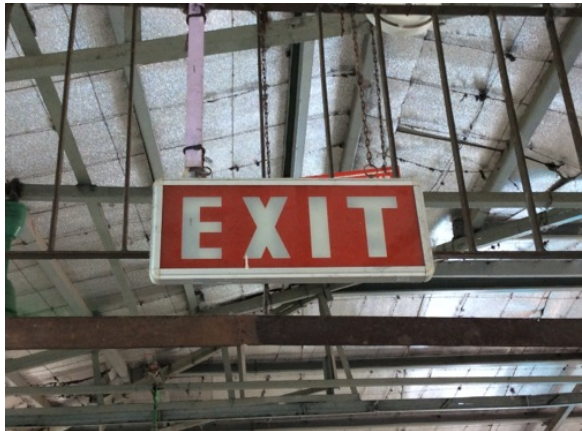
| F-36 | Egress Lighting | <p>Building 1/2</p> <p>Some exit signage was not illuminated (burned out, broken, etc.). Specifically, an exit sign from the Building 1, seventh floor dining area and all exit signs on the fourth floor of Building 2.</p> | <p>Regularly inspect all exit signage and replace/install lights as needed to illuminate signs.</p> | <p>Within 1 month</p> |

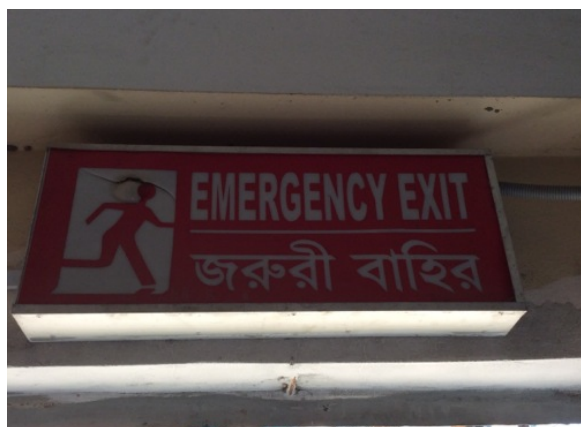
| F-37 | Egress Lighting | <p>Building 3</p> <p>None of the exit signage was illuminated (burned out, broken, etc.). Reportedly the Building 3 exit signs were not illuminated because electricity was disconnected to the building at the time of the inspection.</p> | <p>Regularly inspect all exit signage and replace/install lights as needed to illuminate signs.</p> | <p>Within 1 month</p> |
