# Ananta Jeans Wear Ltd. (Extension)

277/2, (Old 134) kabi Jashim Uddin Road, Pagar, Tongi, Gazipur.

12 March 2023

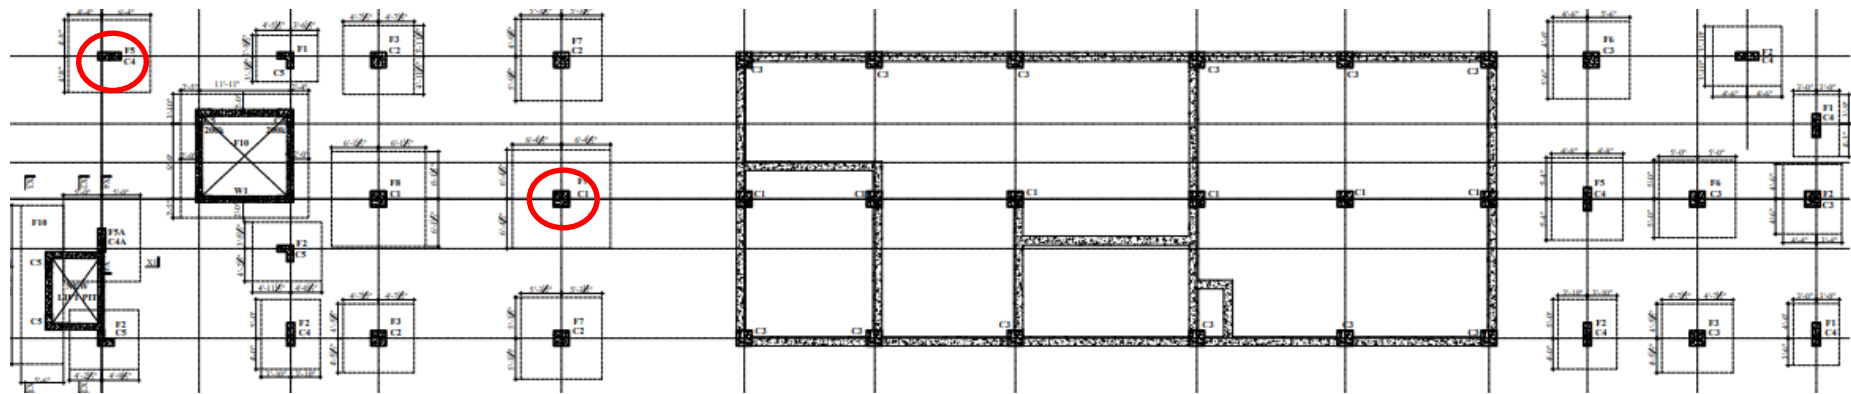
Isolated foundation layout plan

**Isolated footings are stressed above normal design limit**

The cursory calculation indicates that footings are stressed above the normal design limit considering the average soil bearing capacity 1.53 kg/cm<sup>2</sup> (FS 2.5) recommended in the geotechnical investigation reports. Building engineer is required to review the foundation stresses of the area identified above.

| Item No. | Observation | Recommended Action Plan | Recommended Timeline |
|---|---|---|---|
| 01 | Isolated footings are stressed above normal design limit. | Carry out Detail Engineering Assessment (DEA) to check the foundation stresses of the area identified above and suggest proper remedial actions accordingly. | 6-weeks |
| 02 | Isolated footings are stressed above normal design limit. | Carryout remedial works where required. | 6-months |

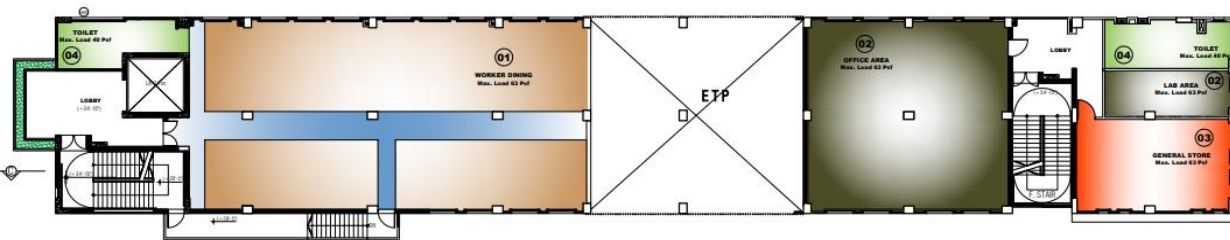
Loading not mentioned in load plan for Staircase, Lobby area and Assembly area. Building engineer is required to produce load plan incorporating all the areas as per BNBC live load requirements.

| Item No. | Observation | Recommended Action Plan | Recommended Timeline |
|---|---|---|---|
| 04 | Inconsistences in design report. | Building engineer is required to produce load plan for all areas of the building following BNBC live load requirements. | 6-weeks |

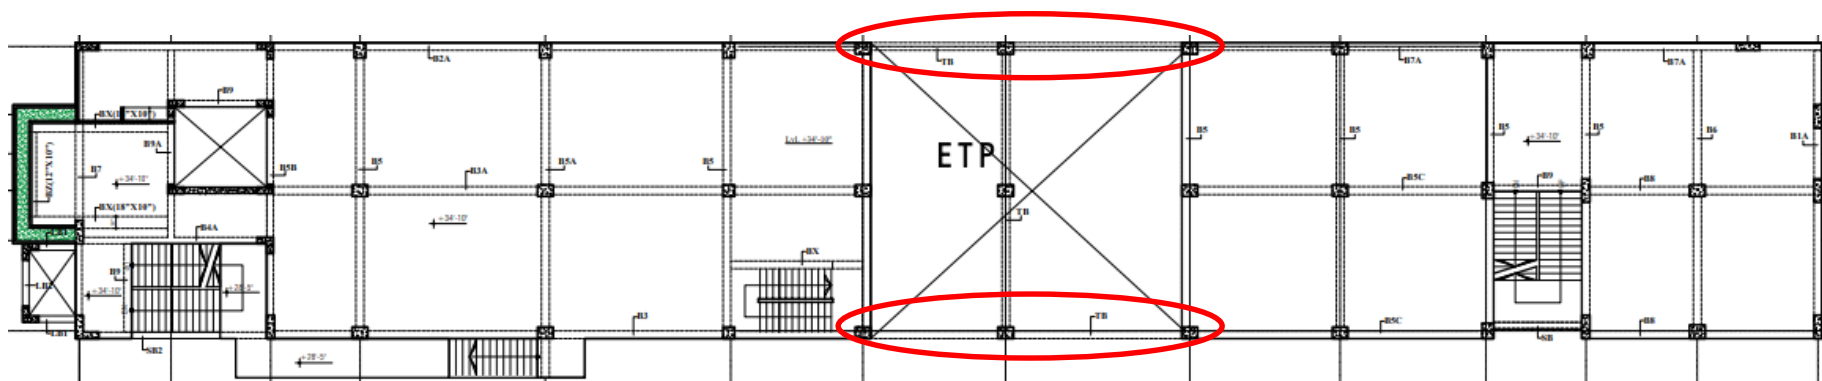
Beam Layout of 2<sup>nd</sup> floor level (At level +34'-10")

During inspection, 4 number of tie beams were found missing at level 34'-10" (10.62 m), which is marked in the beam layout. Building engineer is required to survey the full structure and produce an accurate as-built drawing and review the design accordingly.

| Item No. | Observation | Recommended Action Plan | Recommended Timeline |
|---|---|---|---|
| 08 | Discrepancies in as-built drawings. | Building engineer is required to survey the full structure and produce accurate as-built drawings. | 6-weeks |
| 09 | Discrepancies in as-built drawings. | Revise the design as per accurate as-built drawings. | 6-weeks |
| 10 | Discrepancies in as-built drawings. | Carryout remedial works where required. | 6-months |

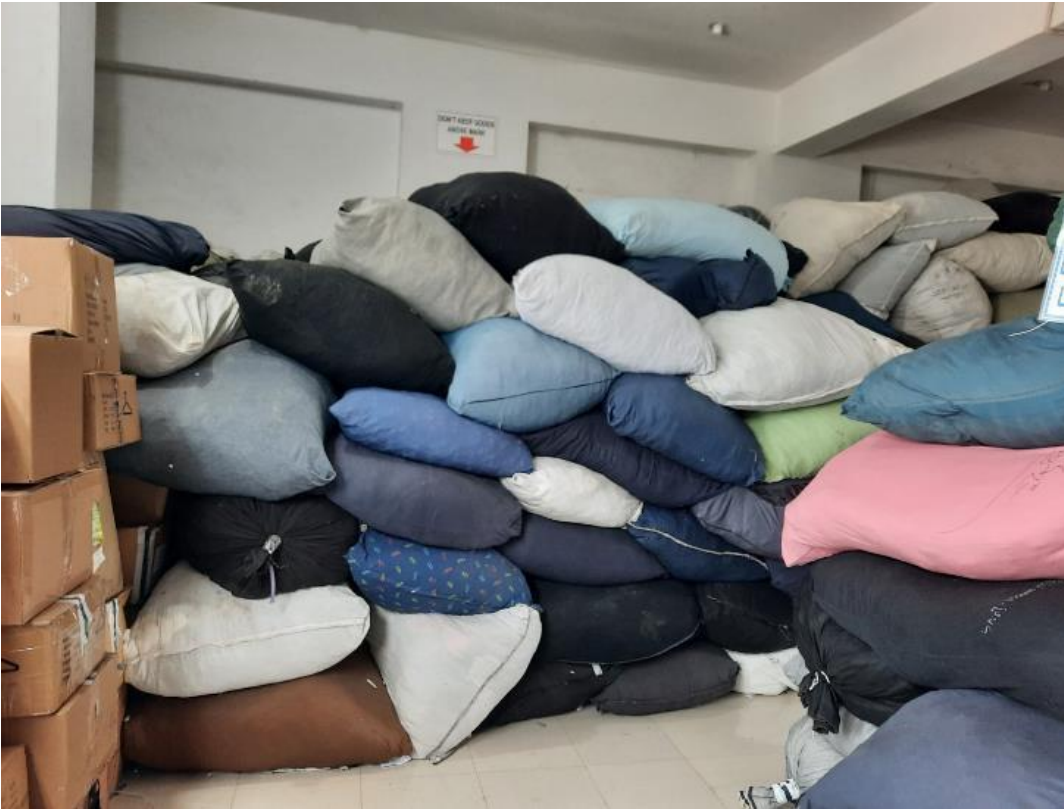
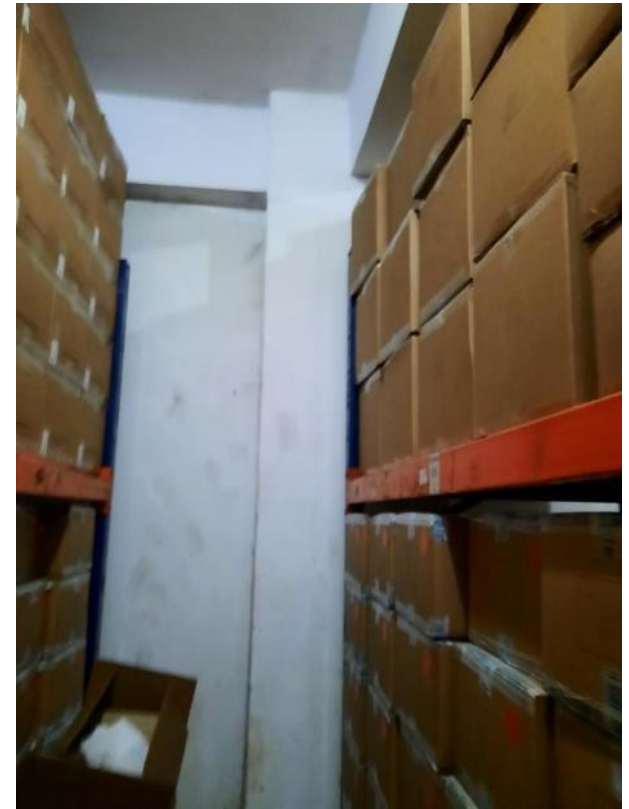
**Implement floor load plan**

Load management program was not implemented. The building engineer is required to implement the floor load management program by posting live load plan, providing signage & load restriction height marking on storage areas and record keeping of the load.

| Item No. | Observation | Recommended Action Plan | Recommended Timeline |
|---|---|---|---|
| 11 | Implement floor load plan. | The building engineer is required to implement the floor load management program by posting live load plan, providing signage & load restriction height marking on storage areas and record keeping of the live load. | 6-weeks |

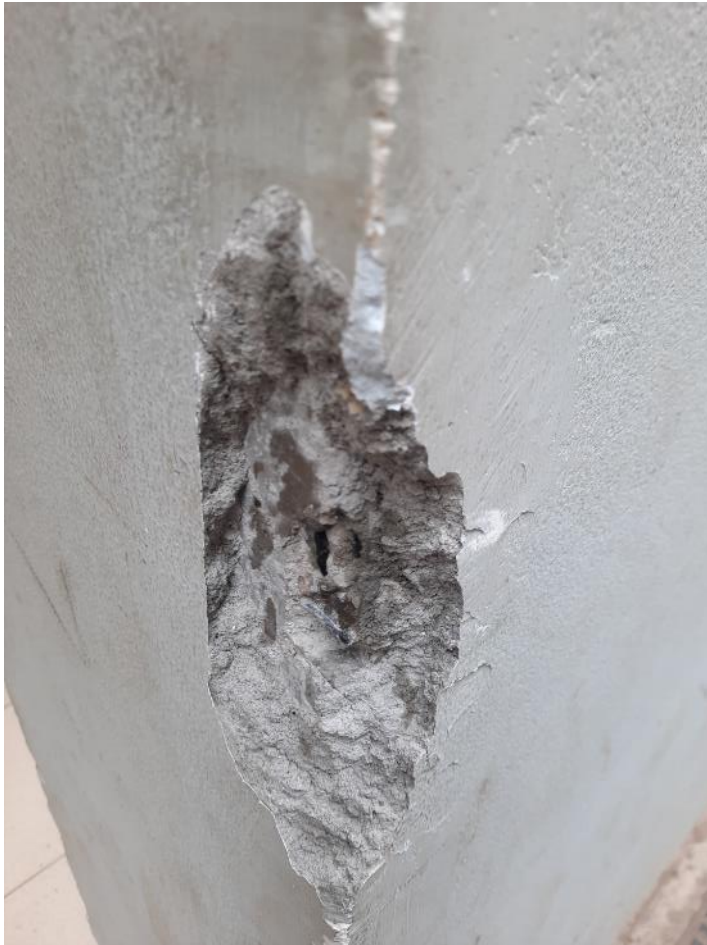
Stone chips aggregate on column

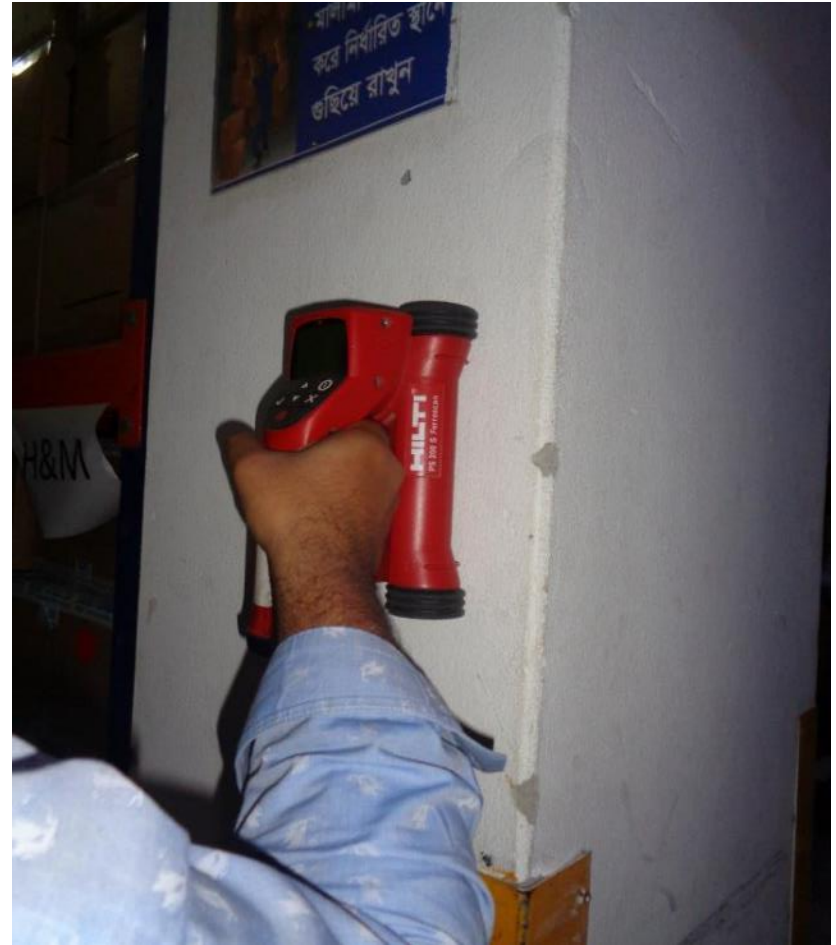
Rebar confirmed on-site by Ferro scan
