# Flamingo Fashions Limited, Unit-2 (Extension)

Mariali, Joydebpur, Gazipur.

16 January 2023 & 26 February 2023

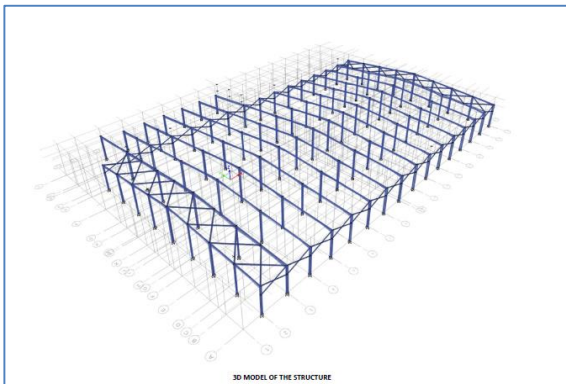
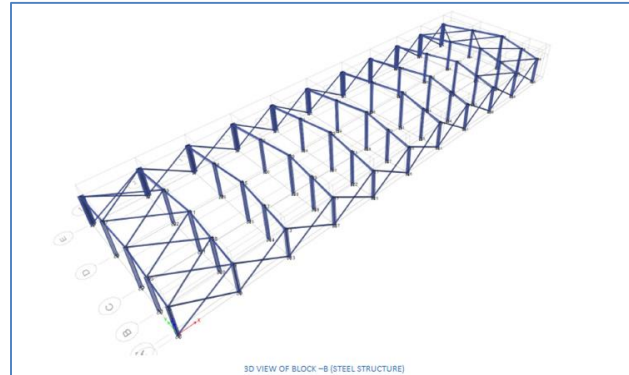
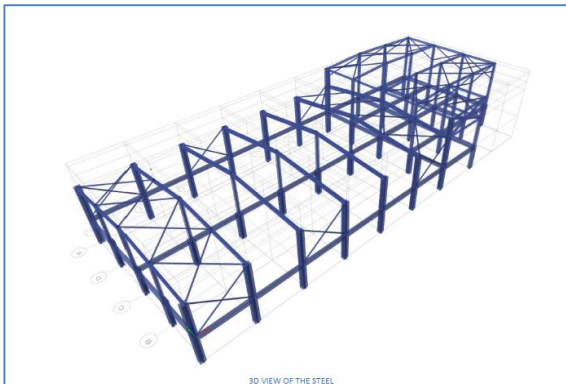
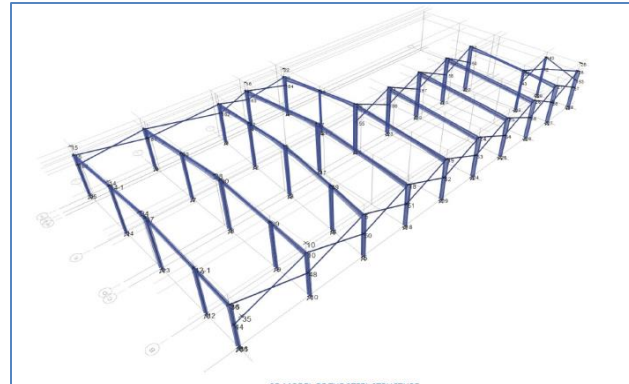
Design Report of A

Design Report of B

Design Report of C

Design Report of D

Moreover, in the provided design report material specification, details calculation of wind and other input values are not mentioned. In FEA model yield strength of rafter has been considered 50 ksi. Before submitting the EA the building engineer is required to incorporate the all the issues in revised EA.

The factory conducted retrofitting with some irregular sections which are modeled with equivalent sections in the analysis software. During inspection Engineering Assessment (EA) report was available onsite. The factory is required to submit the EA report to the RSC for detail review.

| Item No. | Observation | Recommended Action Plan | Recommended Timeline |
|---|---|---|---|
| 01 | Retrofitting design requires detail review. (Lingerie Shed-Part A, B, C & D) | Building engineer is required to submit the Engineering Assessment (EA) to the RSC for detail review. | 6-weeks |
| 02 | Retrofitting design requires detail review. (Lingerie Shed-Part A, B, C & D) | Carry out remedial action if required. | 6-months |

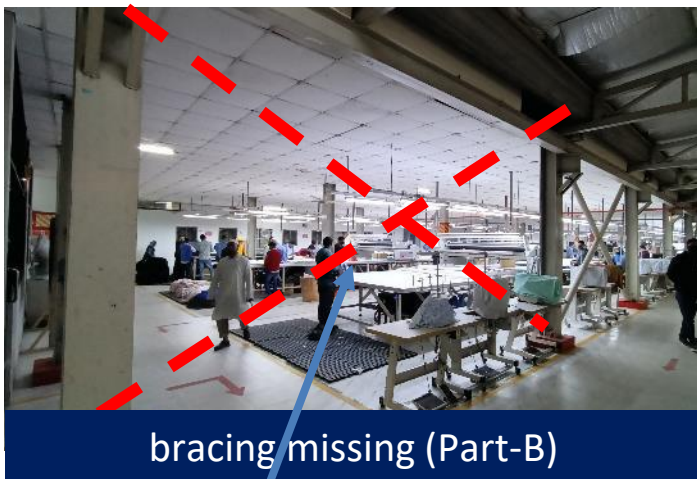
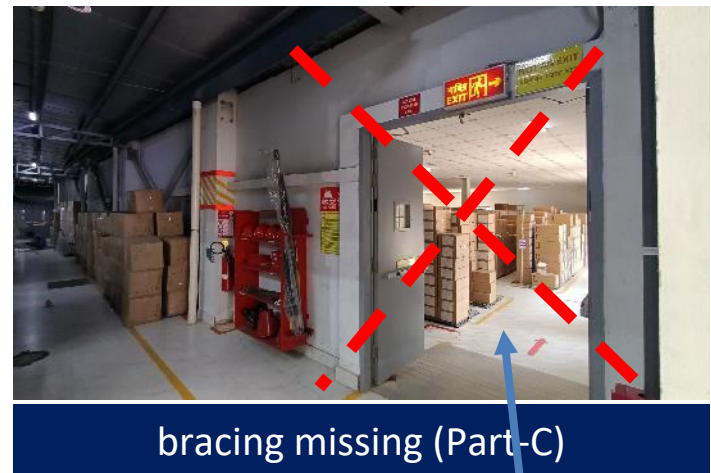
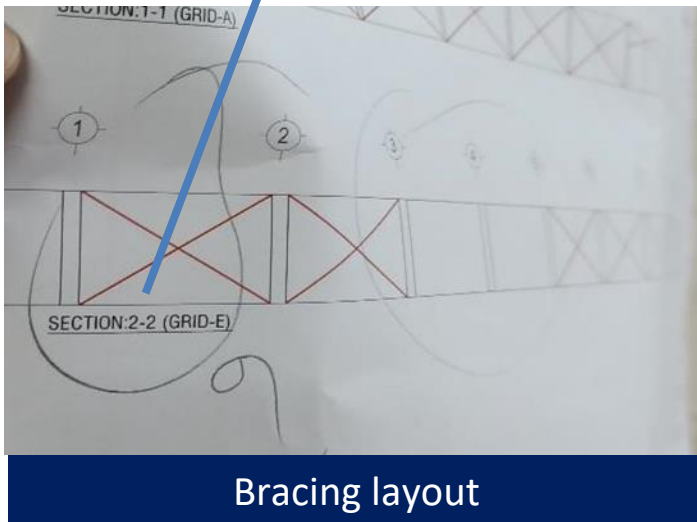
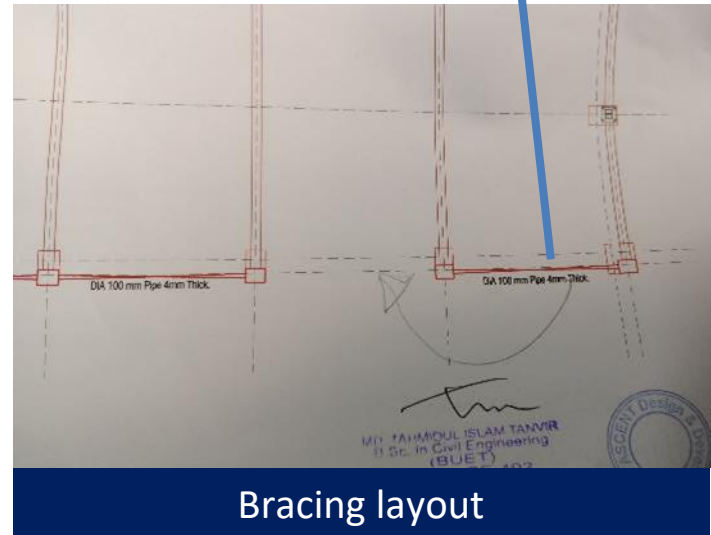
Bracing was found missing at corner grid of Lingerie Shed-part B & C as per the factory provided drawing. Building engineer is required to install the missing bracing as per the accepted drawings.

| Item No. | Observation | Recommended Action Plan | Recommended Timeline |
|---|---|---|---|
| 03 | Vertical bracing missing. (Lingerie Shed-Part B & C) | Install the vertical bracing as per accepted drawings. | 6-weeks |

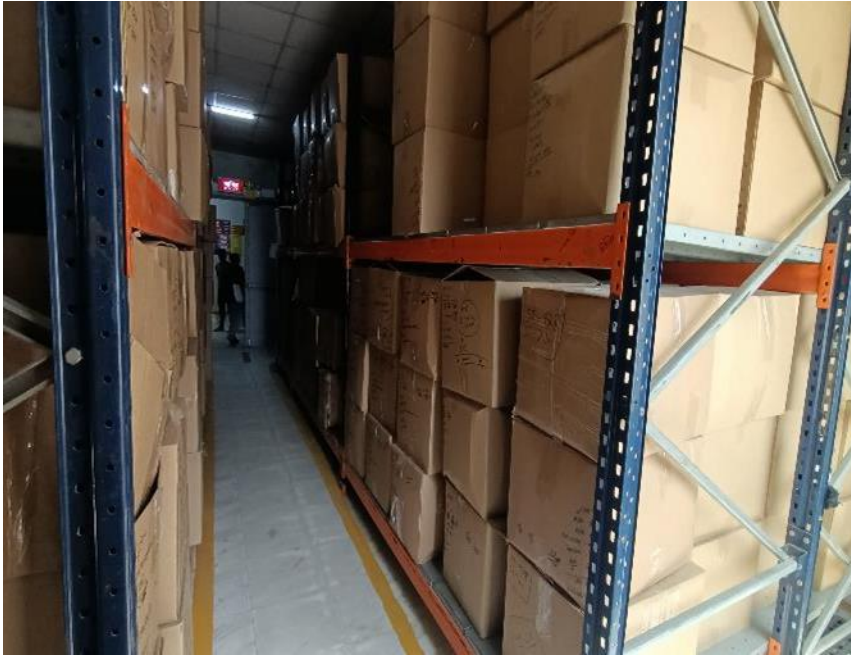
Racks on floor level

Some racks on the floor are not adequately anchored or braced to resist lateral (earthquake) forces. Building engineer is required to adequately anchor and brace all non-structural elements to resist earthquake forces to comply with the BNBC.

| Item No. | Observation | Recommended Action Plan | Recommended Timeline |
|---|---|---|---|
| 04 | Non-structural elements not anchored or braced. (Lingerie Shed-Part C) | Building engineer is required to adequately anchor and brace all non-structural elements to resist earthquake forces to comply with the BNBC. | 6-weeks |

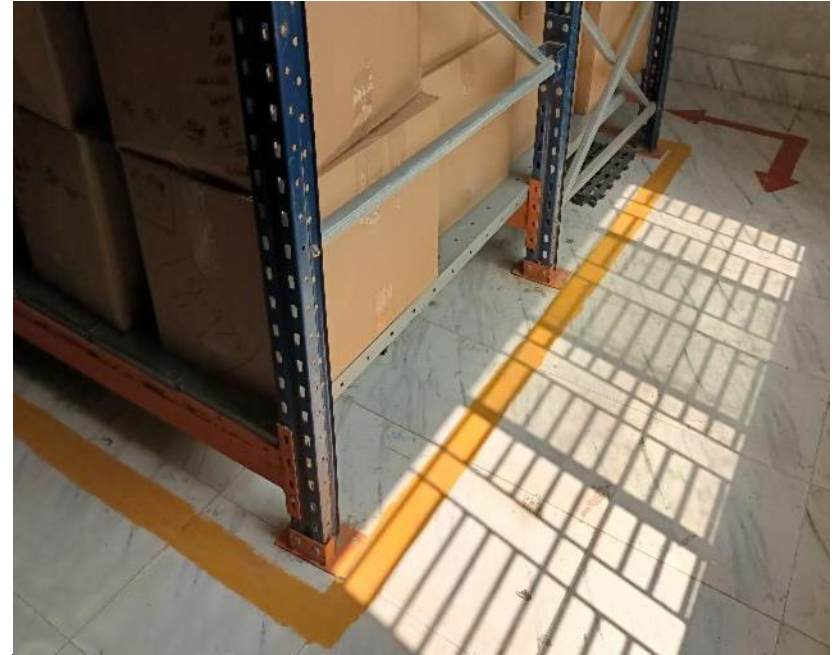
Racks without anchoring

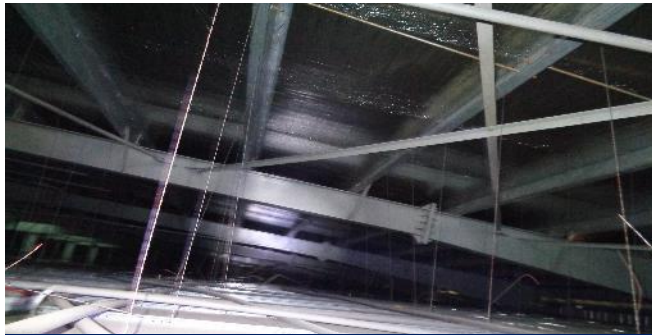
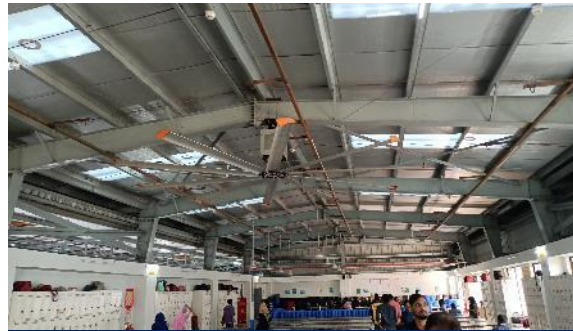
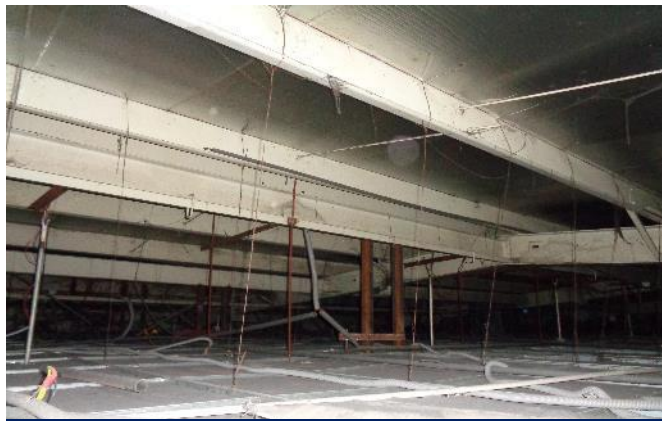
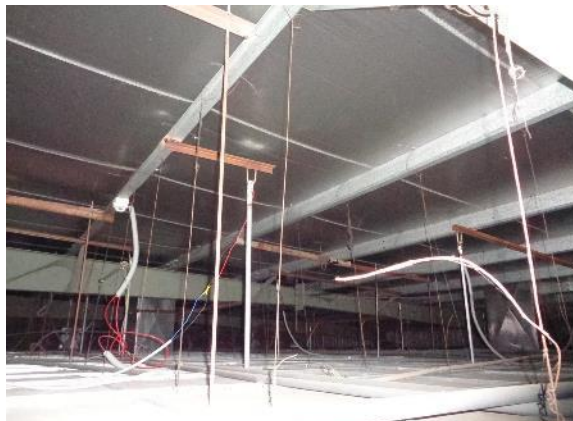
Extension Part 1

Extension Part 2

Extension Part 3

Extension Part 4

As per BNBC, every building or structure designed shall have its design documents prepared in accordance with the provision of Section 1.9.1. The design document shall include a design report, and a set of structural drawings, which shall be prepared in compliance with section 1.9.1.1 and section 1.9.1.2, part-6 of BNBC. At the time of inspection, only as-built drawings were available, but no design report was available which are required to be prepared in compliance with section 1.9.1.1 (part-6, BNBC).

No design report was available for the extension part of 1, 2 3 & 4 of Lingerie Shed.

| Item No. | Observation | Recommended Action Plan | Recommended Timeline |
|---|---|---|---|
| 05 | Absence of design documents. (Lingerie Shed-Extension Part 1, 2, 3 & 4) | Building engineer is required to prepare the design documents including a design report, and a set of structural drawings in compliance with section 1.9.1.1 and section 1.9.1.2, part-6 of BNBC and submit it to RSC for review. | 6-weeks |
| 06 | Absence of design documents. (Lingerie Shed-Extension Part 1, 2, 3 & 4) | Carry out remedial works (if any) after reviewed by the RSC. | 6-months |

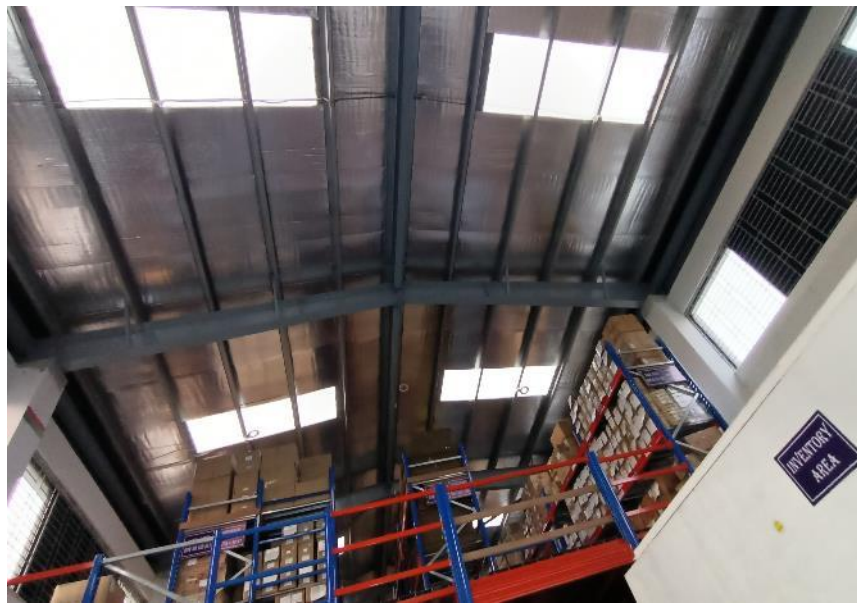
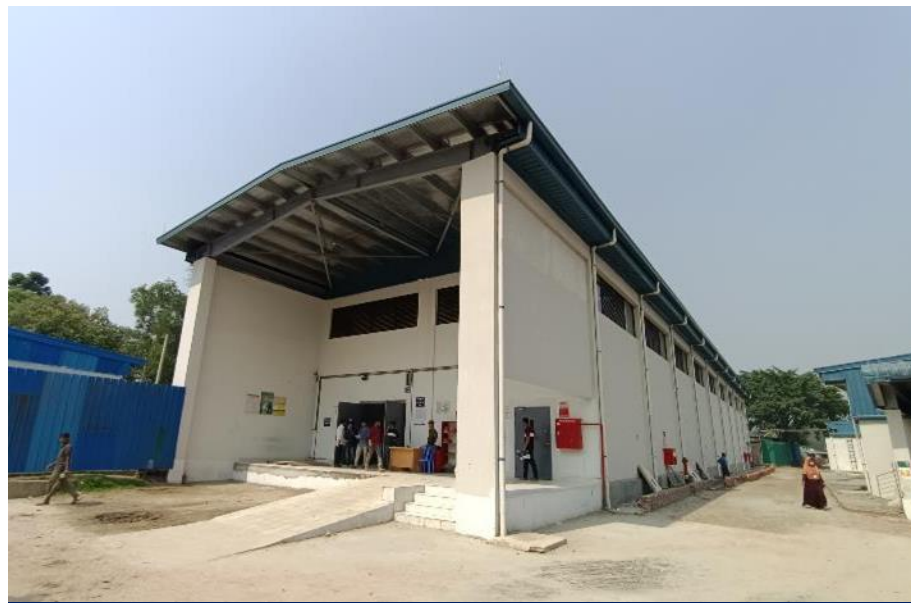
As per BNBC, every building or structure designed shall have its design documents prepared in accordance with the provision of Section 1.9.1. The design document shall include a design report, and a set of structural drawings, which shall be prepared in compliance with section 1.9.1.1 and section 1.9.1.2, part-6 of BNBC. At the time of inspection, only as-built drawings were available, but no design report were available which are required to be prepared in compliance with section 1.9.1.1 (part-6, BNBC).

| Item No. | Observation | Recommended Action Plan | Recommended Timeline |
|---|---|---|---|
| 07 | Lack of design documents. (Store Shed) | Building engineer is required to prepare the design documents including a design report, and a set of structural drawings in compliance with section 1.9.1.1 and section 1.9.1.2, part-6 of BNBC and submit it to RSC for review. | 6-weeks |
| 08 | Lack of design documents. (Store Shed) | Carry out remedial works (if any) after reviewed by the RSC. | 6-months |

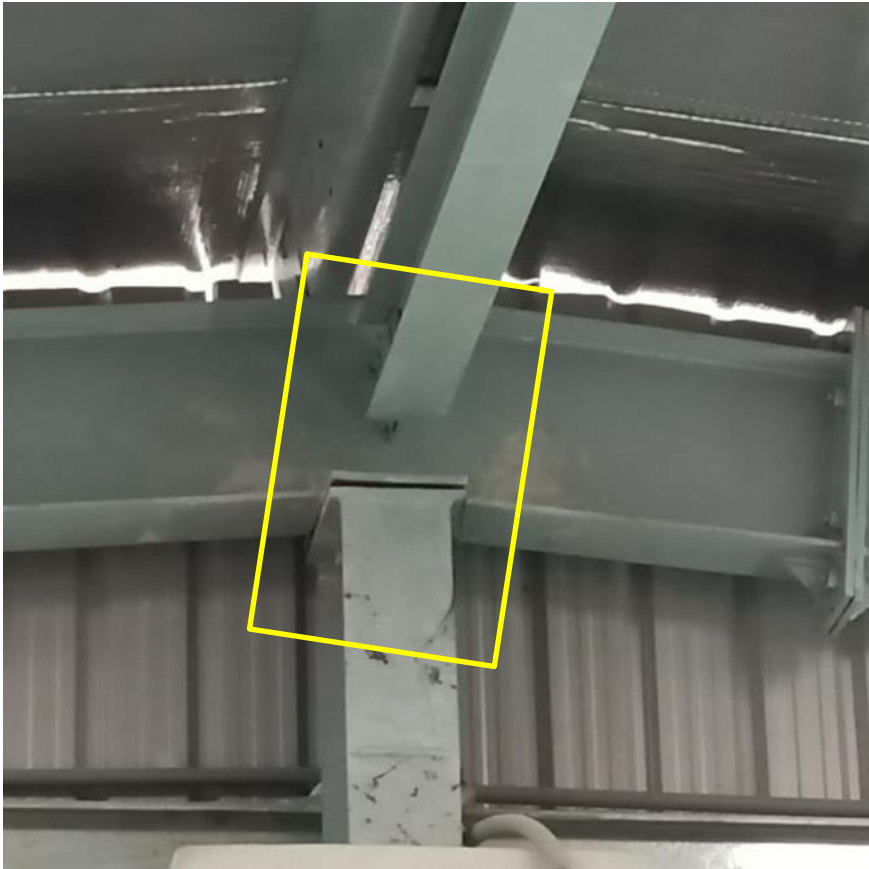
Bolt missing and significant gaps observed in Rafter-column joint at several locations. Building engineer is required to carry out suitable remedial works.

Gap observed in connections

| Item No. | Observation | Recommended Action Plan | Recommended Timeline |
|---|---|---|---|
| 10 | Bolt missing and connection gap. (Store Shed) | Building engineer is required to repair the gap in connections with a suitable method. | 6-weeks |

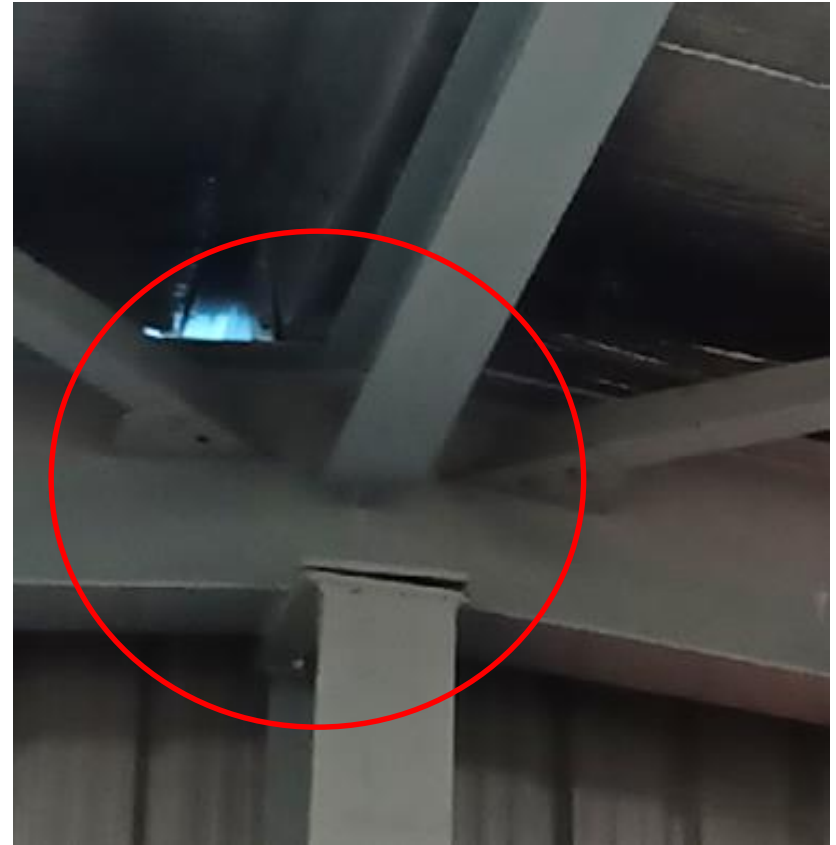
Bolt missing

| Item No. | Observation | Recommended Action Plan | Recommended Timeline |
|---|---|---|---|
| 09 | Bolt missing and connection gap. (Store Shed) | Install the missing bolts where necessary. | 6-weeks |

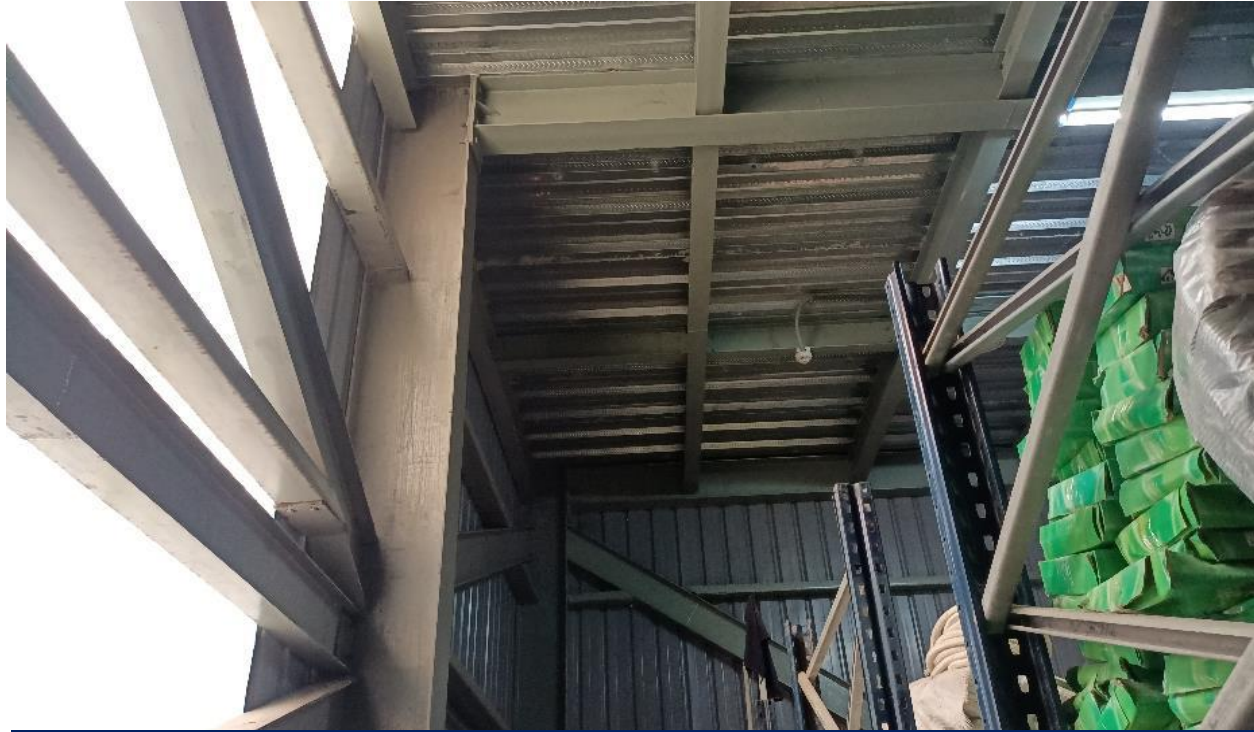
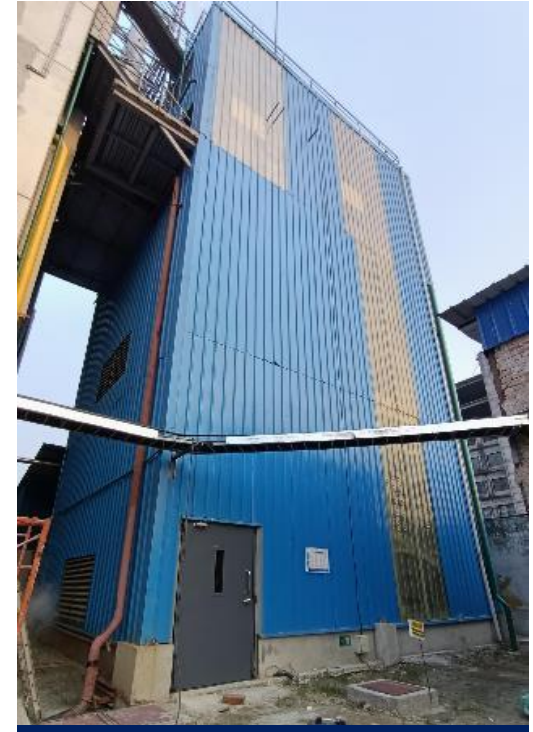
As per BNBC, every building or structure designed shall have its design documents prepared in accordance with the provision of Section 1.9.1. The design document shall include a design report, and a set of structural drawings, which shall be prepared in compliance with section 1.9.1.1 and section 1.9.1.2, part-6 of BNBC. At the time of inspection, only as-built drawings were available for RC part, but no design report and as built drawing for steel part were available which are required to be prepared in compliance with section 1.9.1.1 (part-6, BNBC).

| Item No. | Observation | Recommended Action Plan | Recommended Timeline |
|---|---|---|---|
| 11 | Lack of design documents. (EGB Steel Building) | Building engineer is required to prepare the design documents including a design report, and a set of structural drawings in compliance with section 1.9.1.1 and section 1.9.1.2, part-6 of BNBC and submit it to RSC for review. | 6-weeks |
| 12 | Lack of design documents. (EGB Steel Building) | Carry out remedial works (if any) after reviewed by the RSC. | 6-months |

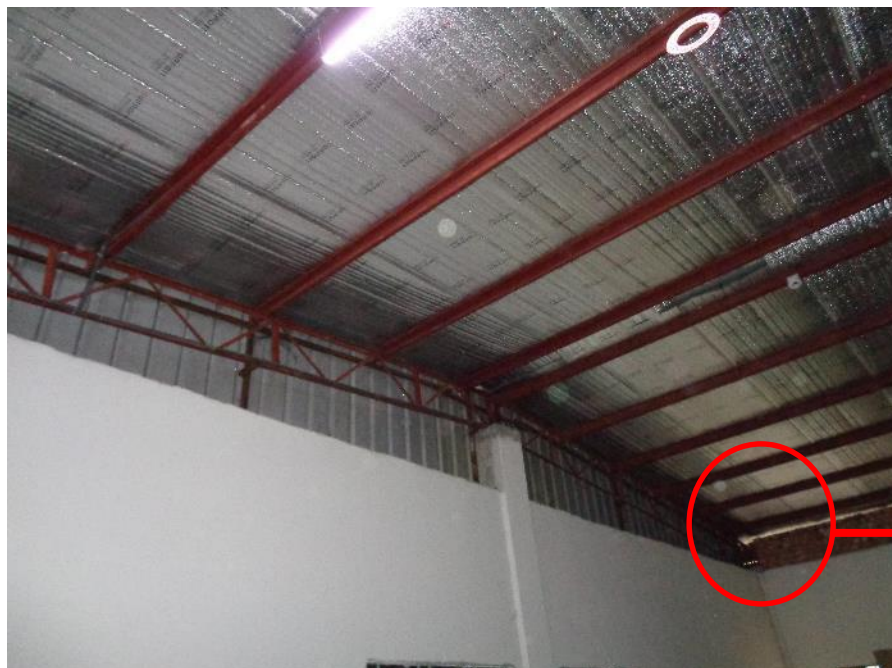
Truss member

Apparently inadequate connection between truss and RC column was observed. Truss members were welded with base plate and base plates were welded with the rebar of RC column. On other hand connection details were not found in the provided drawings. Building engineer is required to check the connection adequacy of the truss against uplift force of wind.

| Item No. | Observation | Recommended Action Plan | Recommended Timeline |
|---|---|---|---|
| 13 | Lack of design documents. (EGB Steel Building) | Building engineer is required to carry out the Engineering Assessment (EA) to check connection adequacy against the uplift force. | 6-weeks |
| 14 | Lack of design documents. (EGB Steel Building) | Carryout remedial work if required. | 6-months |

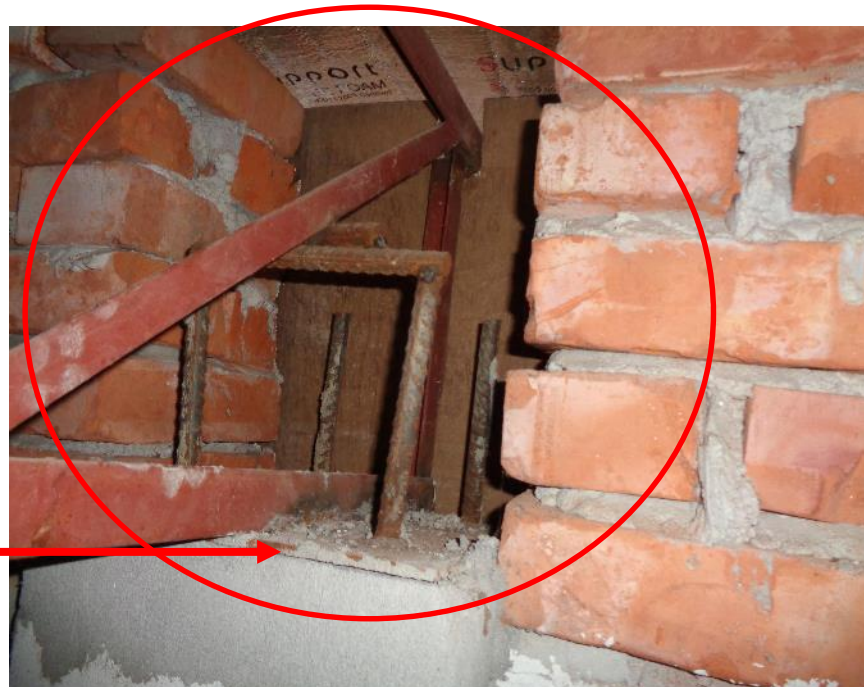
Connection with RC column
