# BARAKA FASHIONS LIMITED (Extension)

6 Shing Bari Road Boro Dewra Tongi, Gazipur-1700.

13 March 2023

# Building Information

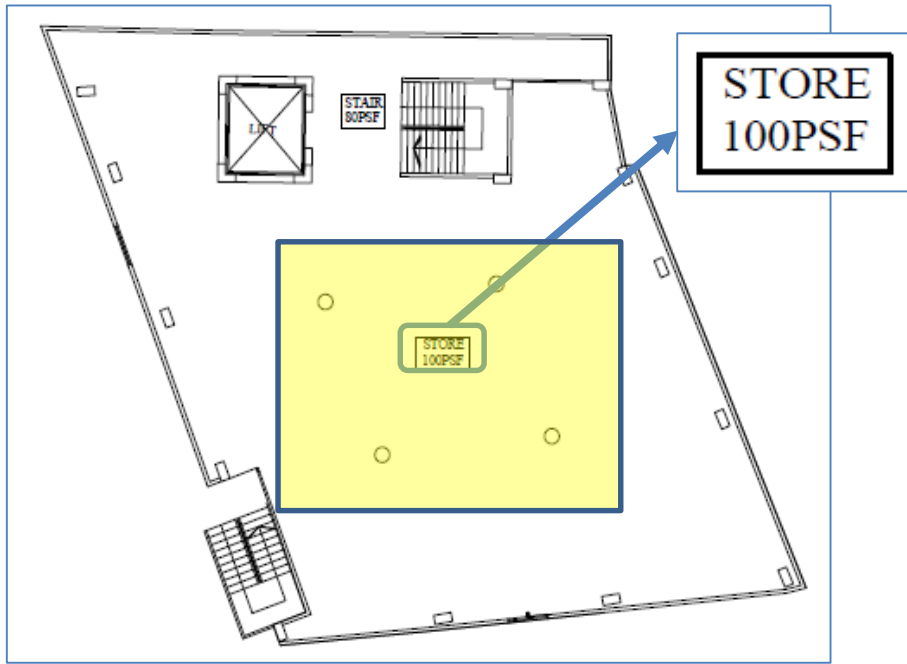
**Internal column stressed above normal design limit**

Load plan with 100 psf (5 kN/m<sup>2</sup>) for all floor

The cursory calculation indicates that internal columns stress exceeds the normal design limit considering a typical floor live load 6 kPa, and minimum concrete strength 16.3 MPa based on aggregate type. The building engineer is required to review the design, loads, and column stresses.

| Item No. | Observation | Recommended Action Plan | Recommended Timeline |
|---|---|---|---|
| 01 | Internal column stressed above normal design limit. | Building engineer is required to verify in-situ concrete strength by taking cores from lower tier columns. | 6-weeks |
| 02 | Internal column stressed above normal design limit. | Building Engineer to review design, loads and column stresses. | 6-weeks |
| 03 | Internal column stressed above normal design limit. | Produce and actively manage a loading plan for all floor plates within the factory, considering floor, column and foundation capacity. | 6-weeks |

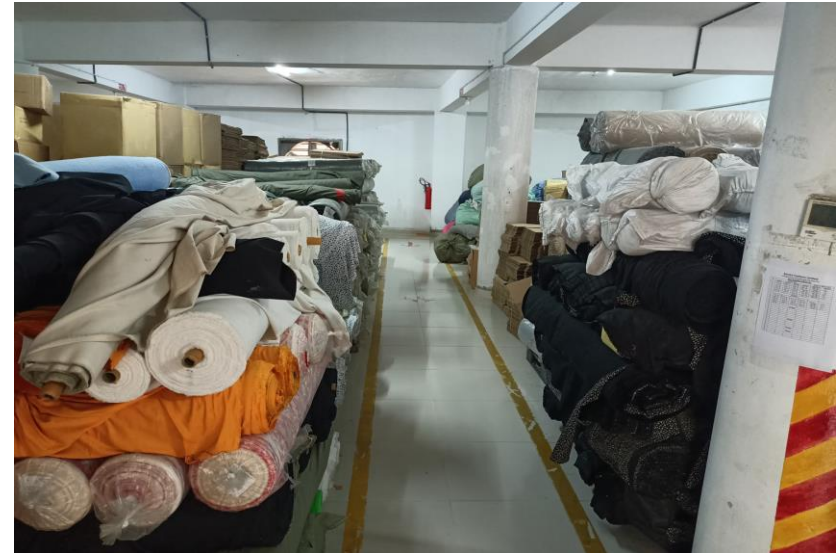
Storage on typical floors

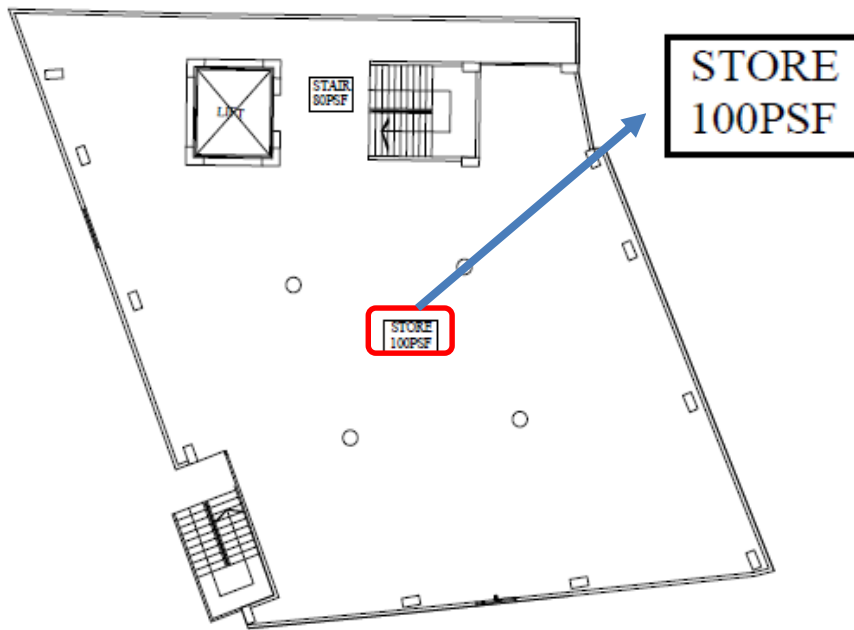
**Load plan & design report not comply  
with BNBC requirements**

Load plan with 100 psf (5 kN/m<sup>2</sup>) for all floor

Currently, the typical floor of the building is being allotted for fabric store. As per BNBC, the minimum floor live load for light storage is 6 kN/m<sup>2</sup> (125 psf). But the storage (typical floors) area of the building is designed for 5 kN/m<sup>2</sup> live loads. The building engineer is required to revise the storage live load limit and related design documents based on BNBC requirement.

| Item No. | Observation | Recommended Action Plan | Recommended Timeline |
|---|---|---|---|
| 06 | Load plan & design report not comply with BNBC requirements. | The building engineer is required to revise the storage live load limit and related design documents based on BNBC requirement. | 6-weeks |

| Item No. | Observation | Recommended Action Plan | Recommended Timeline |
|---|---|---|---|
| 07 | Load plan & design report not comply with BNBC requirements. | Revise and actively manage a set of floor loading plan following BNBC. | 6-weeks |

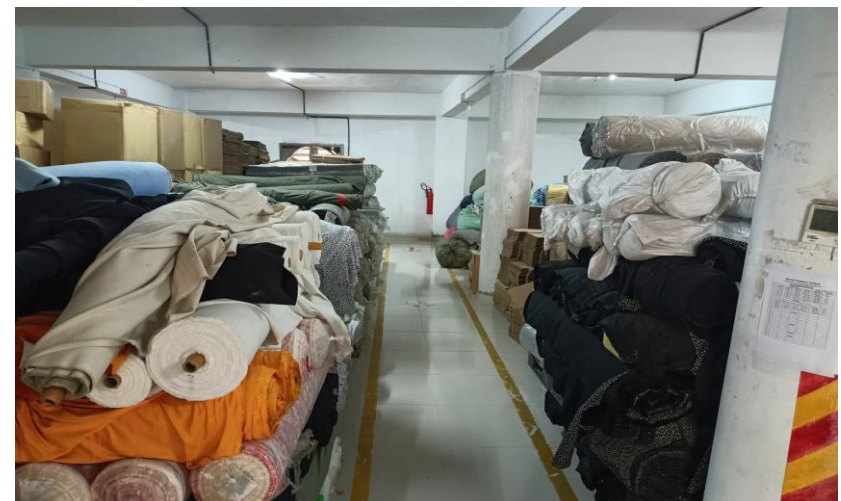
Storage on typical floors

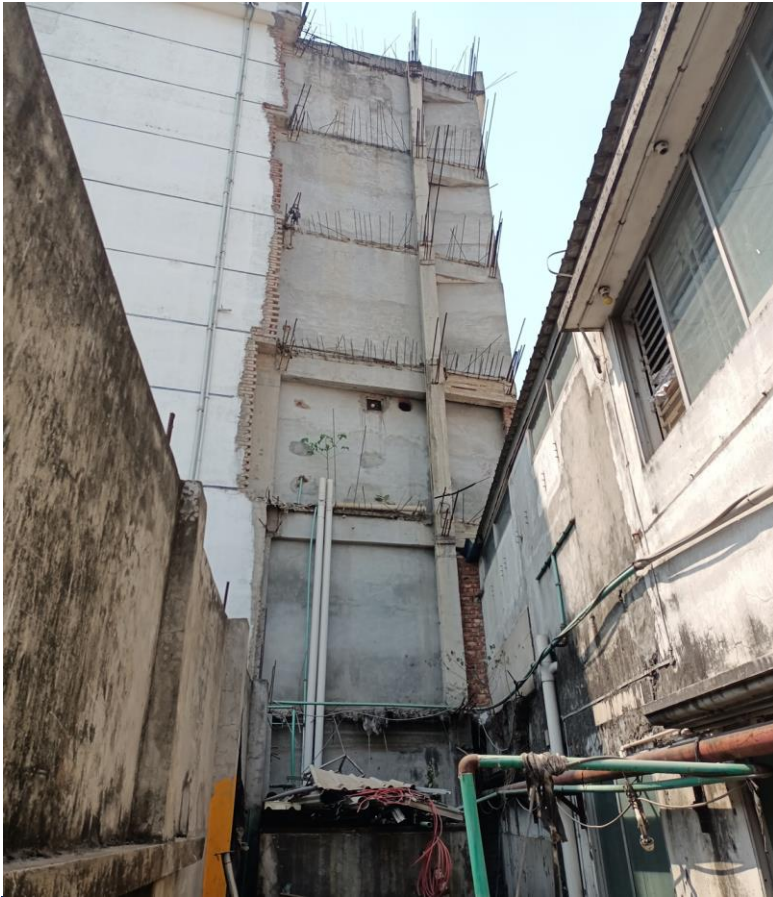
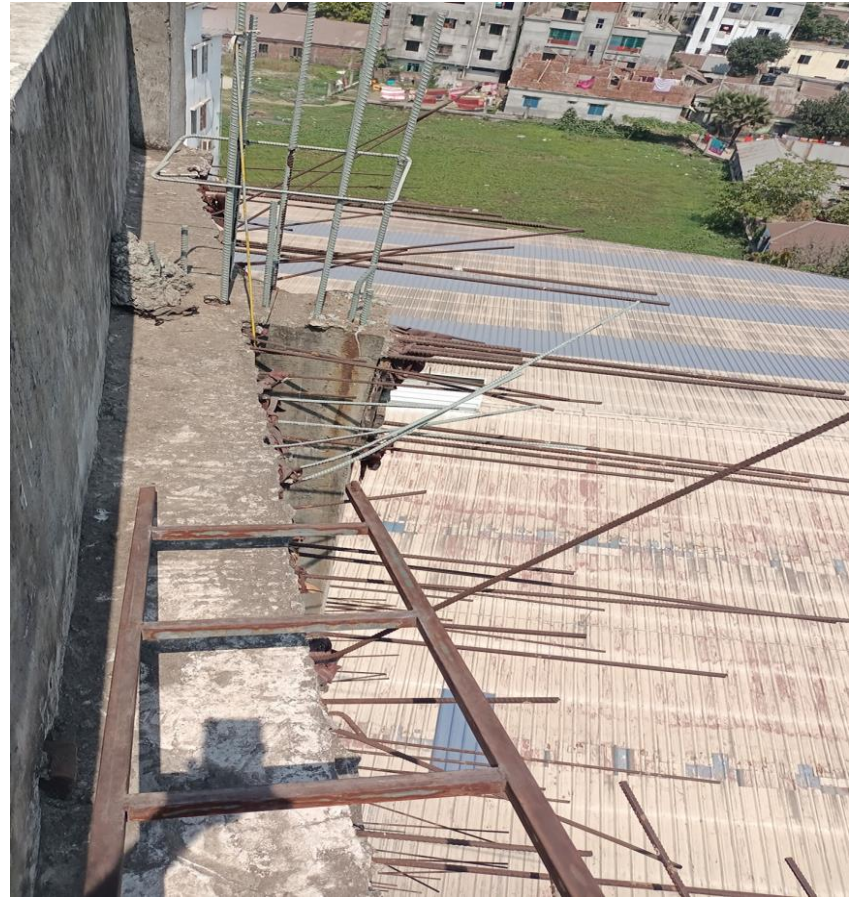
Corrosion at exposed rebar

Corrosion observed at exposed rebar. Building engineer is required to take proper measure to protect the rebar from corrosion.

| Item No. | Observation | Recommended Action Plan | Recommended Timeline |
|---|---|---|---|
| 10 | Corrosion on exposed rebar. | Building engineer is required to take proper measure to protect the rebar from corrosion. | 6-weeks |

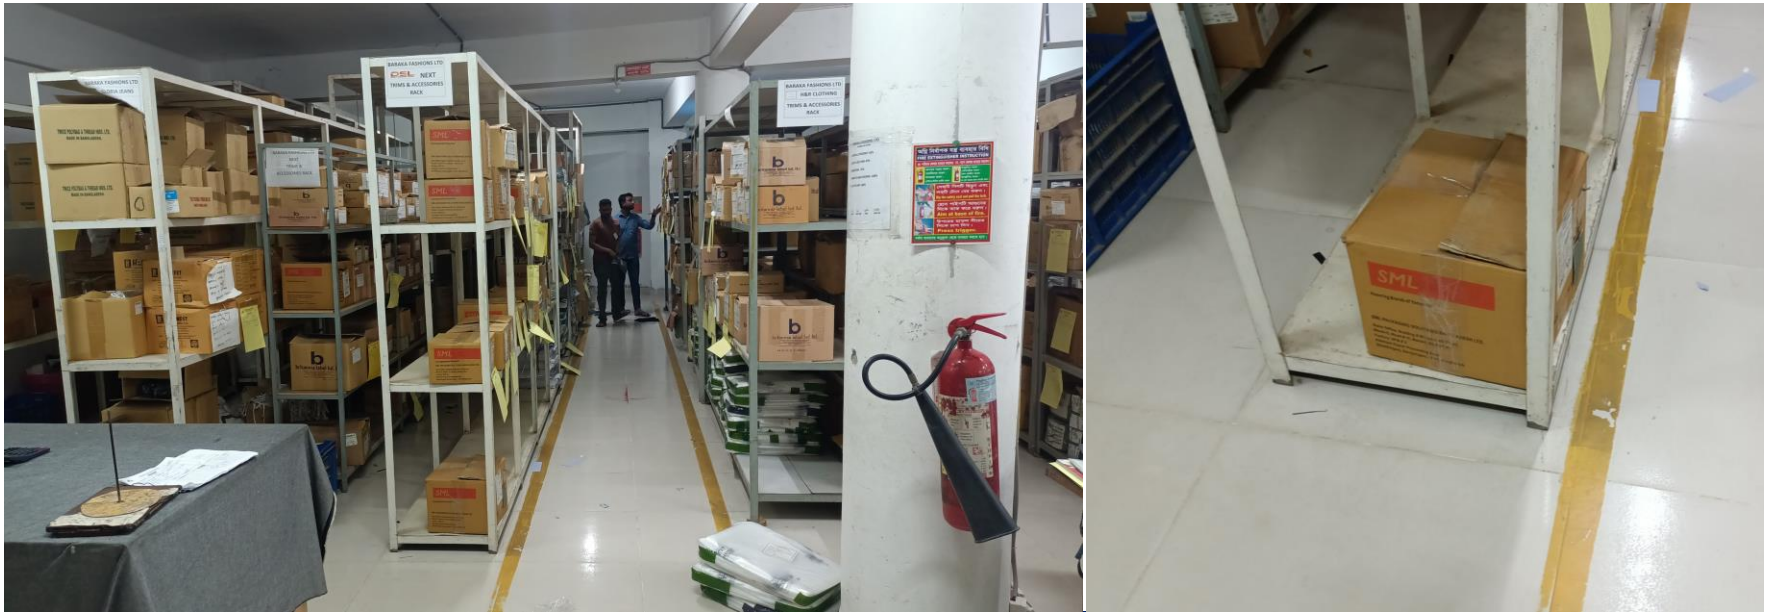
Non-anchored storage rack at several floors

Some racks on different floors and rooftop plastic water tanks are not anchored or braced to resist lateral (earthquake) forces. The factory is required to anchor/brace all non-structural elements adequately to resist earthquake forces.

| Item No. | Observation | Recommended Action Plan | Recommended Timeline |
|---|---|---|---|
| 11 | Racks and plastic water tanks not anchored or braced. | Building is required to adequately anchor/brace all non-structural elements to resist earthquake forces to comply with the BNBC. | 6-weeks |

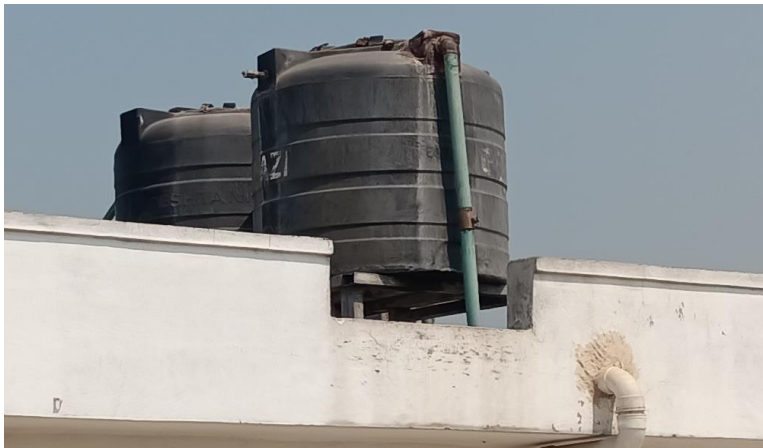
Plastic water tank not braced
