Shipra Fashion Ltd.

20 March 2023

Observations

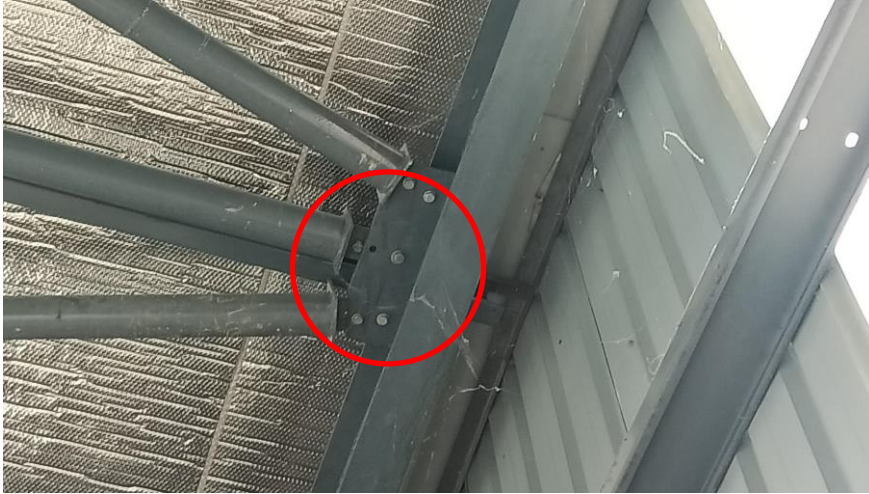
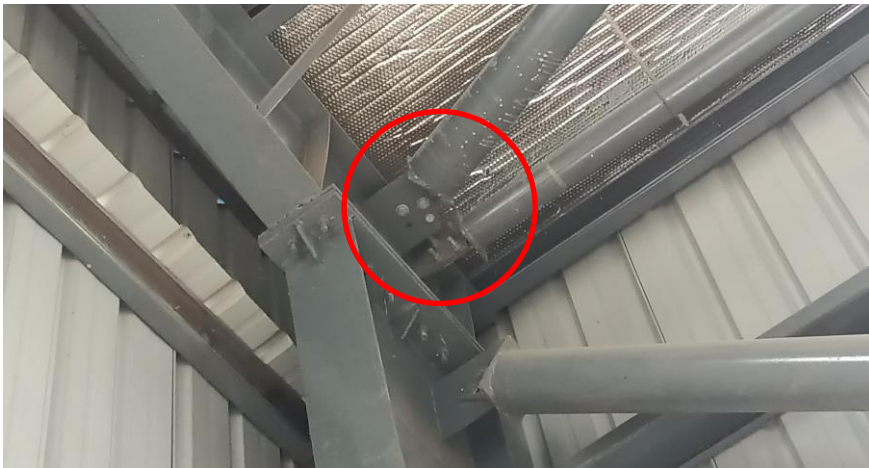
Bolt missing and connection gap

Bolt missing and significant gaps observed in rafter-column joint at several locations. Building engineer is required to install the missing bolts and carry out suitable remedial works.

Bolt missing

Item No.	Observation	Recommended Action Plan	Recommended Timeline
01	Bolt missing and connection gap. (Finishing & Warehouse Shed)	Building engineer is required to repair the gap in connections with a suitable method.	6-weeks
02	Bolt missing and connection gap. (Finishing & Warehouse Shed)	Install the missing bolt where necessary.	6-weeks
03	Bolt placed out gusset plate. (Finishing & Warehouse Shed)	The building engineer is required check the connection type, code requirements for long slotted holes & connection design method and suggest suitable repair action accordingly.	6-weeks
04	Bolt placed out gusset plate. (Finishing & Warehouse Shed)	Carry out repair works if required.	6-months
05	Lack of water proofing at MCAC roof. (Child Care & Office Building)	Provide water proofing layer and maintain proper slope on the roof.	6-weeks

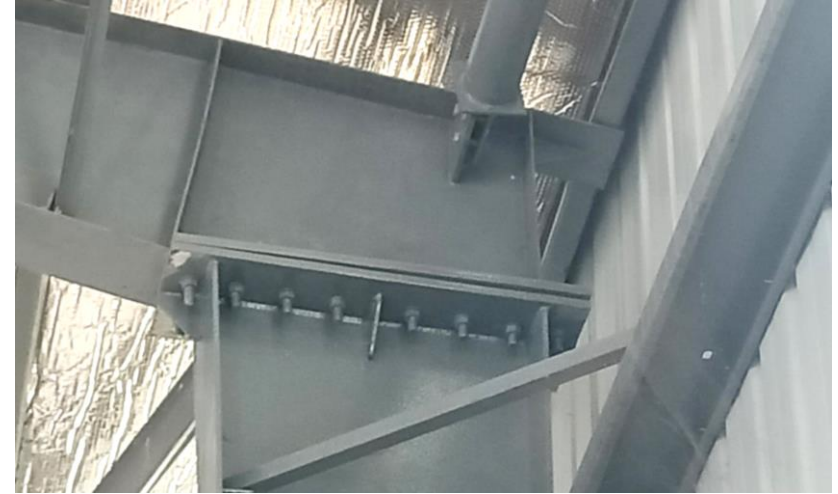
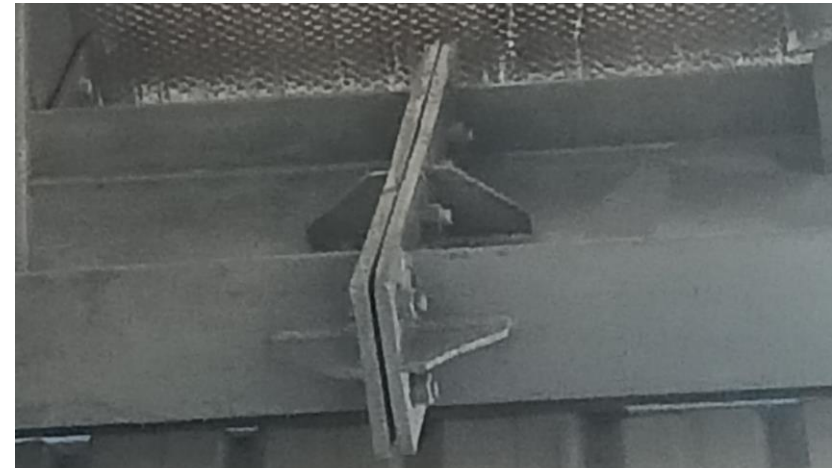
Gap observed in connections

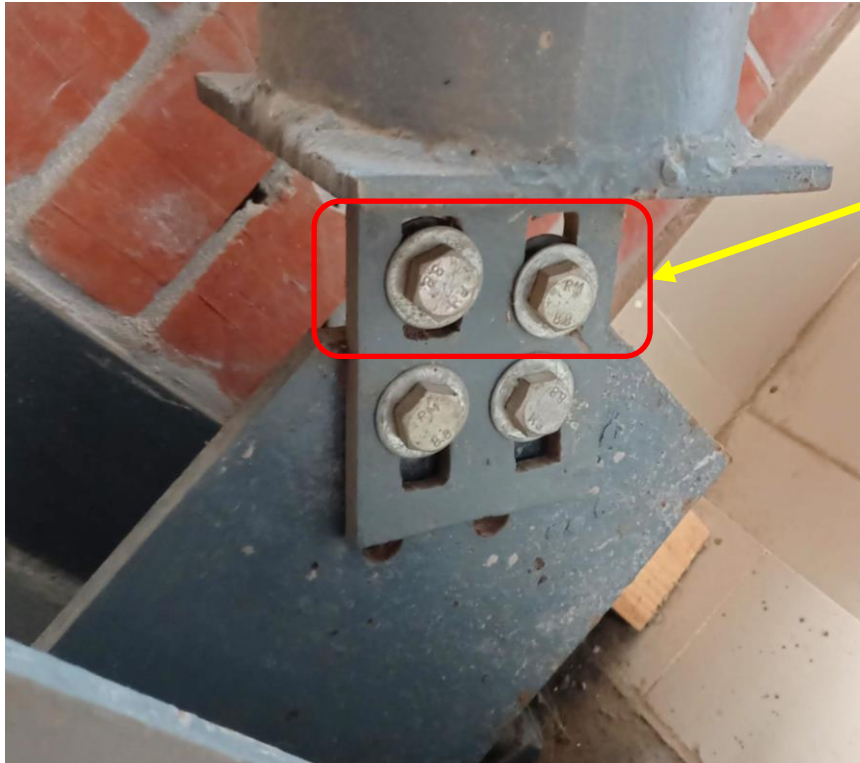
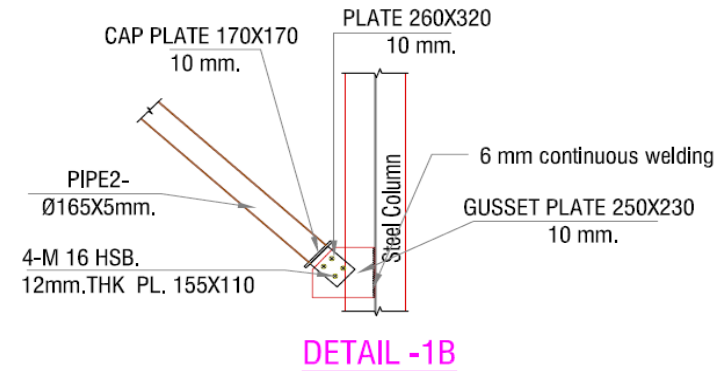
Bolt placed out gusset plate

2 out bolts are not connected with gusset plate and Long slotted holes in the connection

2 out of 4 bolts are not connected with gusset plate. Rest of 2 bolts are connected with large slotted holes which is placed along the line of action of forces. The connection may not functional due to lack of active bolts and loose connections. However, the building engineer is required check the connection type, code requirements for long slotted holes & connection design method and suggest suitable repair action accordingly.

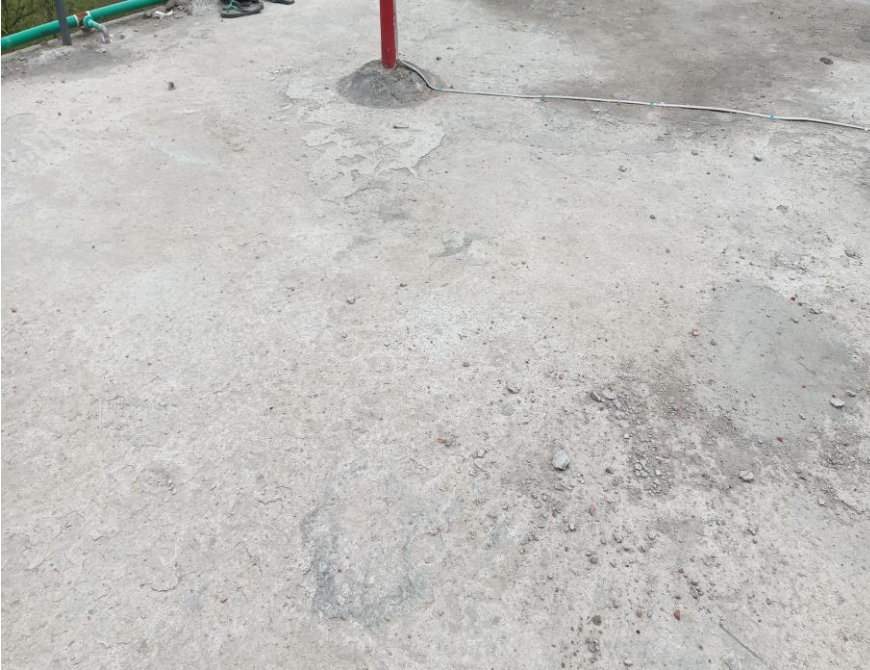
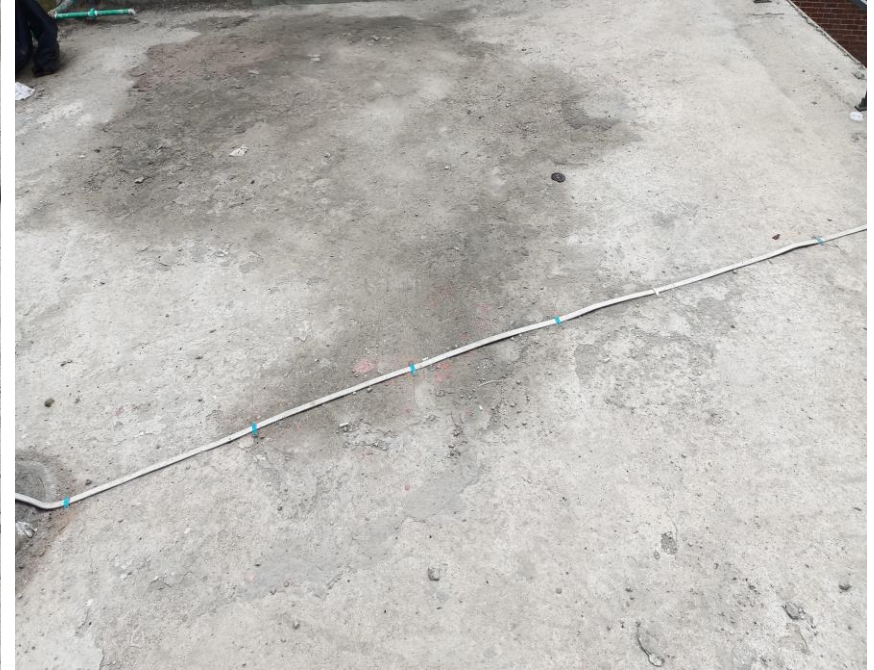
MCAC roof of Child Care & Office Building

Lack of water proofing at MCAC roof

Water proofing was not applied on the roof. The roof is made of brick aggregate concrete. The building engineer is required to apply the water proofing layer on the current roof with proper slope.

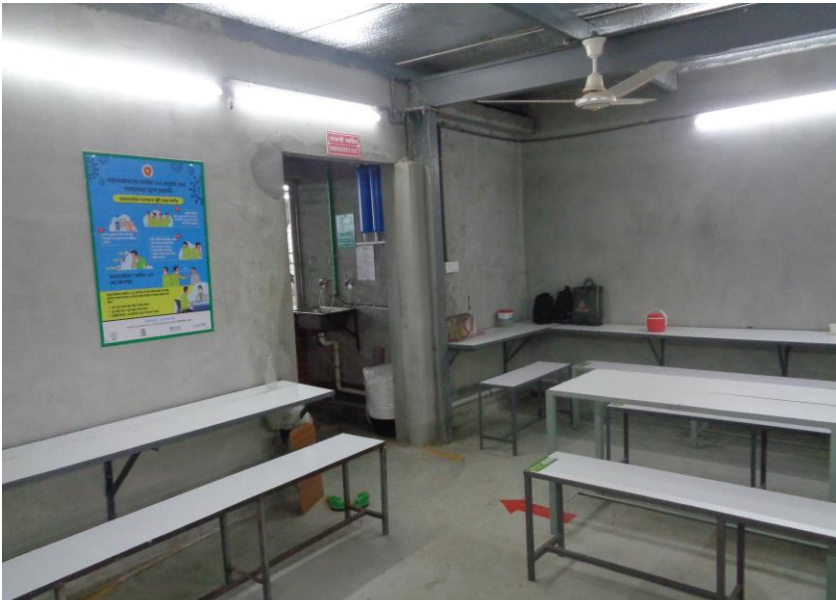
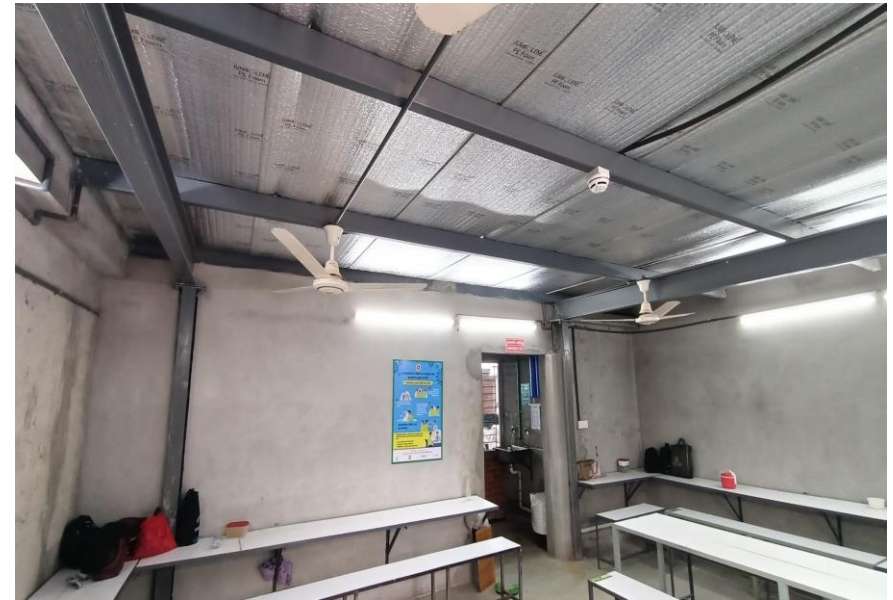
Lack of lateral stability system

Lack of compression member along long direction of the shed

The building engineer is required to check the lateral stability system of the steel shed.

Item No.	Observation	Recommended Action Plan	Recommended Timeline
06	Lack of lateral stability system. (Canteen & Pump Room Shed)	Building engineer is required to check the lateral stability system and suggest proper remedial actions accordingly.	6-weeks
07	Lack of lateral stability system. (Canteen & Pump Room Shed)	Carry out suggested remedial works.	6-months
